Specialist basic assessment report: Tshatane/Lesego project

Dr Wynand Vlok (BioAssets)

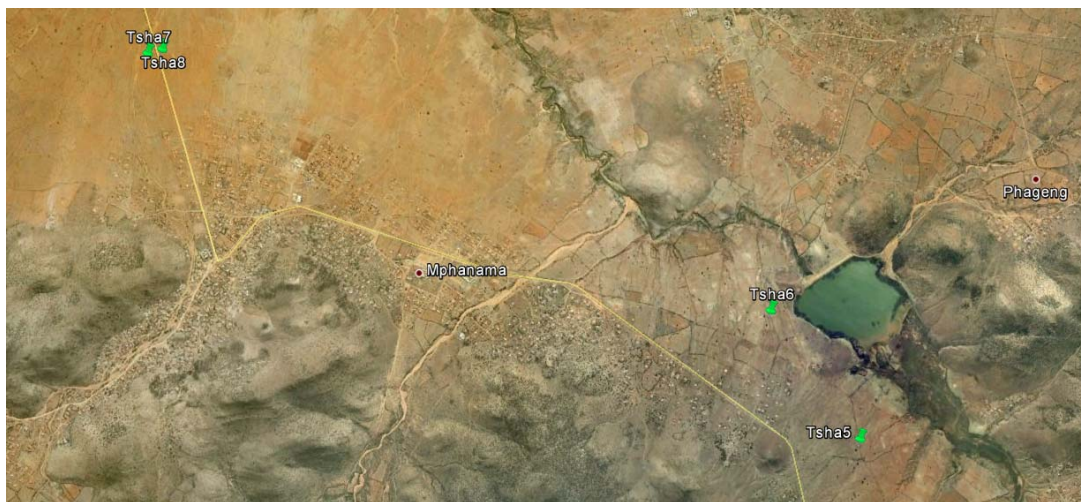
Figure 30: Aerial view of sector – note land use practices and disturbed and modified natural vegetation and erosion.

A number of stream crossings are encountered along the sector of the corridor and pylons must be placed at least 75m from it. Existing roads must be used for access and construction vehicles must be limited on the servitude as this will ensure that erosion is limited. Access to the proposed new power line servitude will be from the villages and this will ensure that impacts along the corridor will be lower (Figure 31 – 40).

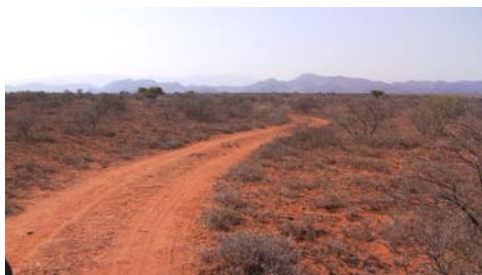
Figure 53: The corridor swings northwest towards Apel – many roads to areas where wood harvesting takes place.

Where the corridor moves away from the D4200, it cuts through grazing and cultivated areas. Another problem is the high incidence of wood harvesting and all of this leads to erosion in the area (Figure 53 – 58). During construction, care must be taken to limit vehicle movement along the servitude, as this will contribute to the serious erosion problems in the area. The corridor crosses the Lepellane River and this is considered a sensitive area (Figure 51 and 52). Pylons must be placed at least 75m from the river banks and during the walk down study all protected trees must be mapped (GPS). This information is needed for the permit application to cut or trim protected trees. The clearing of the servitude can only commence once the permits are obtained.

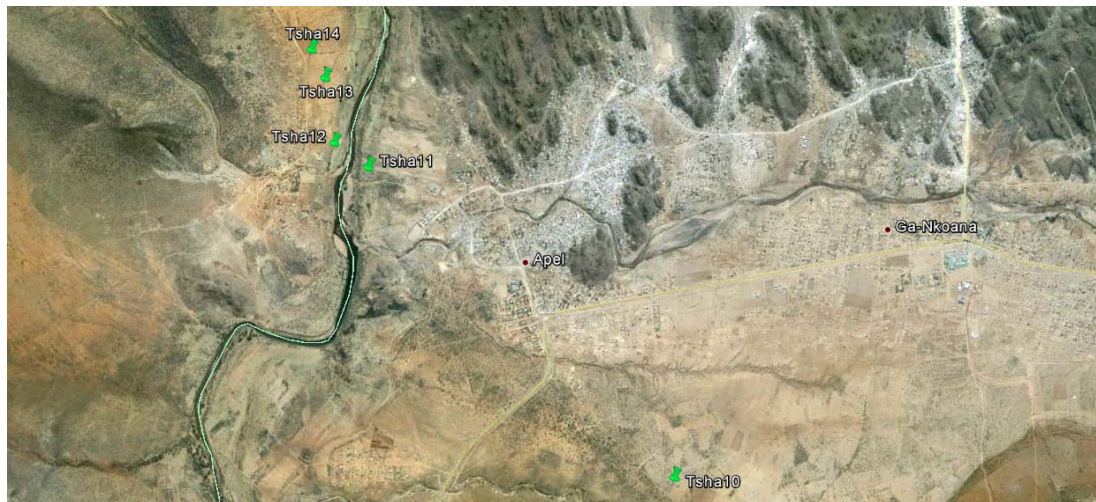
Figure 60: Aerial view of corridor where it crosses the Olifants River.

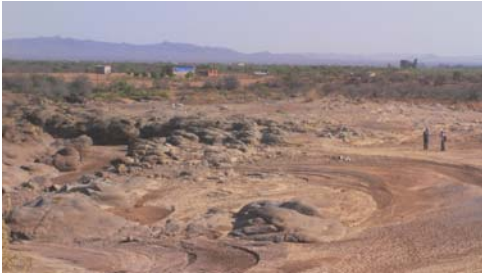
Figure 61: Stream crossing present along the corridor.

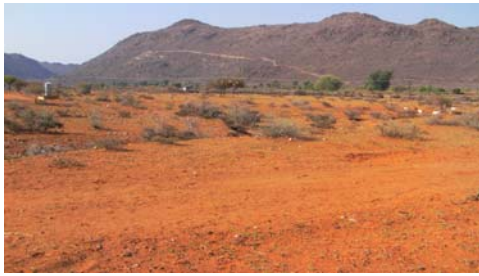
Figure 67: Over grazing leads to severe erosion in the area.

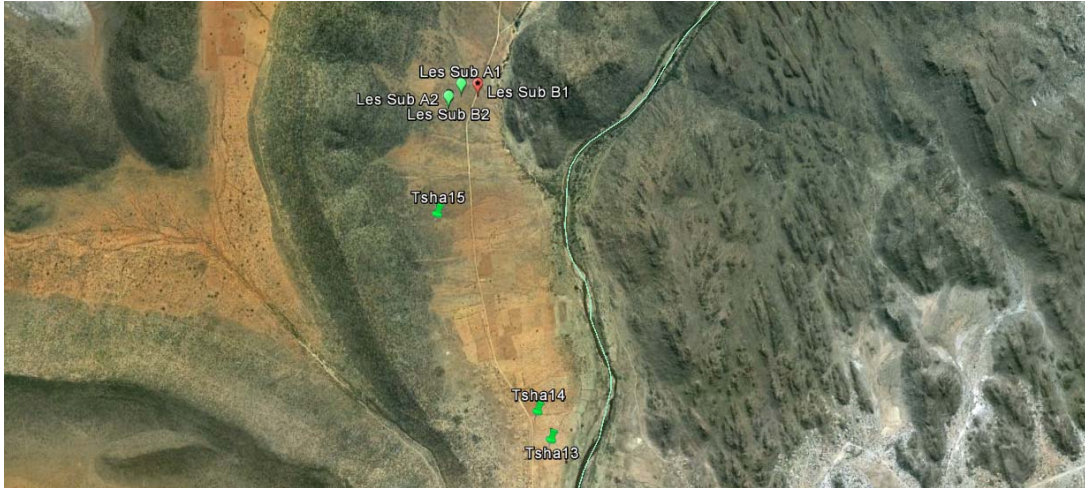
Figure 69: Aerial view of the sector to the new proposed Lesego substation sites.

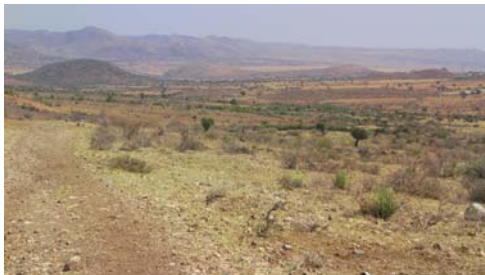
Figure 86: Point where the corridor is to the south of the road.

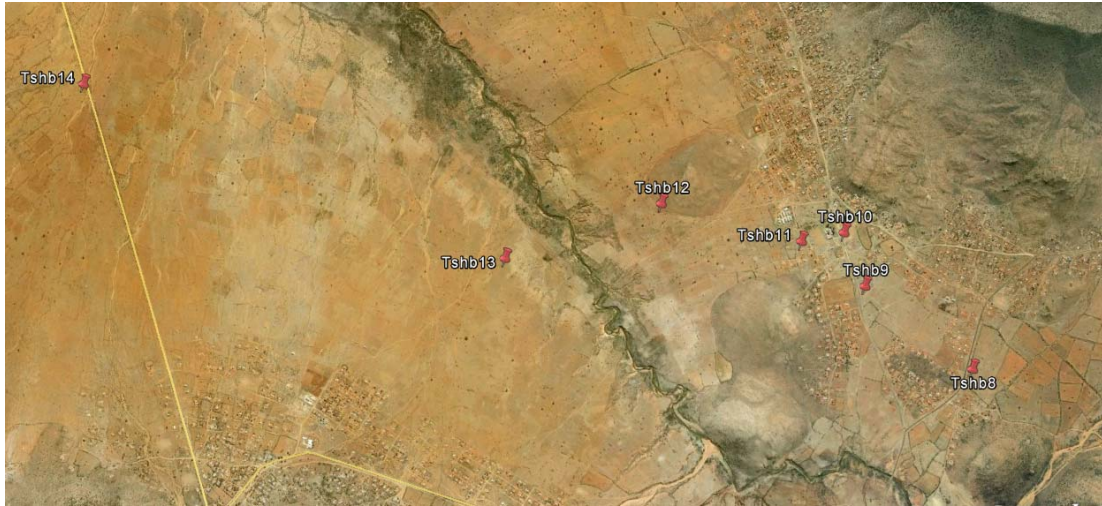
Figure 93: Last sector of the Alternative 2 route before it follows the same corridor north to the new proposed Lesego substation sites.
