CONSERVATION MANAGEMENT PLAN FOR “BLACKIE” A SPECIFICALLY DECLARED STEAM RAILWAY LOCOMOTIVE

SAHRA/HO/07/2014

DRAFT

27 March 2015

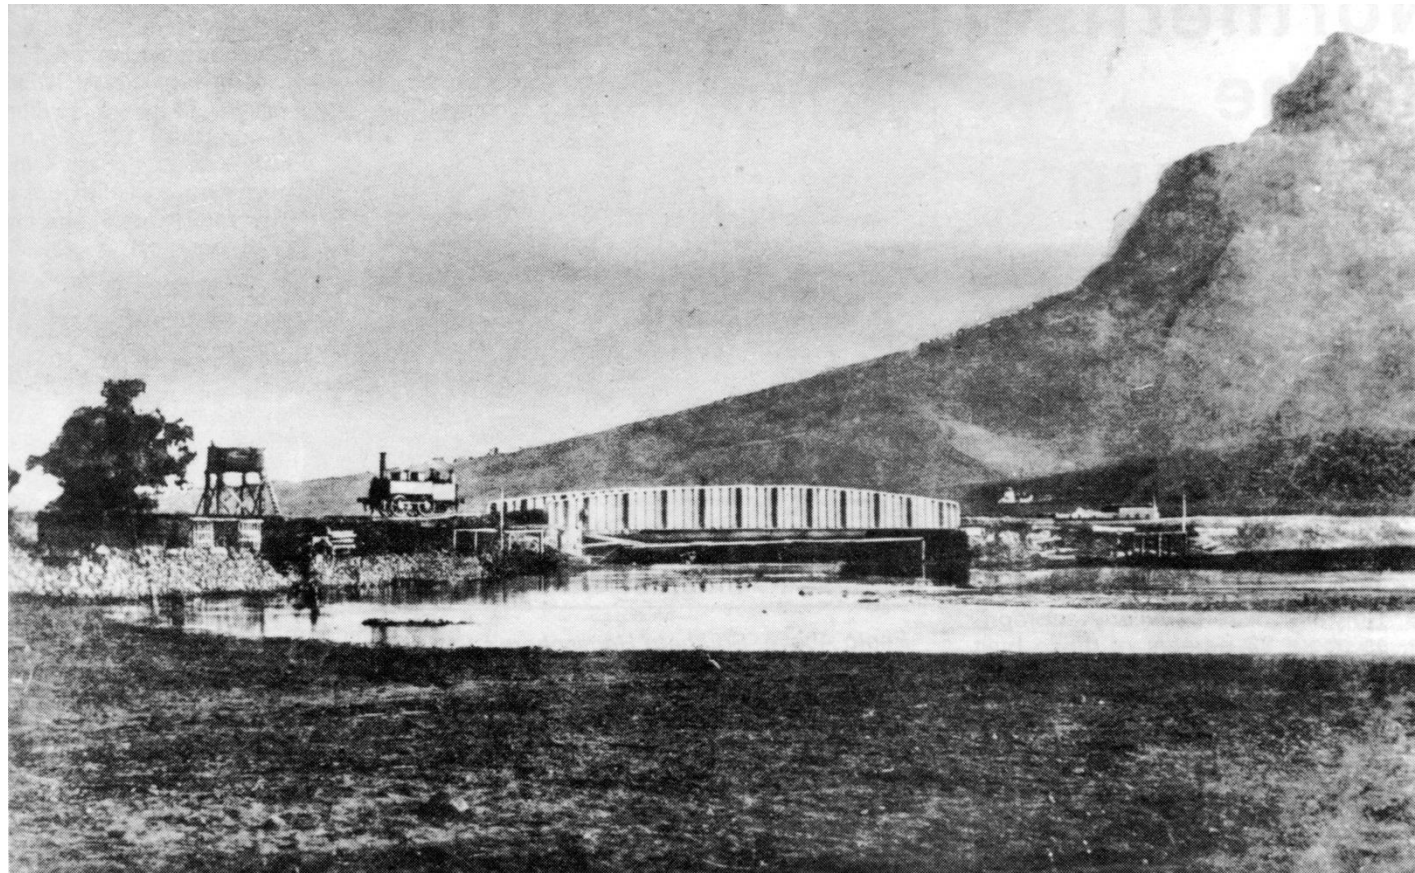
6.18. Based on the old photograph of "Blackie" as a 0-4-0 a number of differences in her appearance are evident:

6.18.1. Originally had no cab roof.

6.18.2. Shortened cab area – no rear bunker or side access openings.

6.18.4. Two rectangular boxes positioned above the boiler.

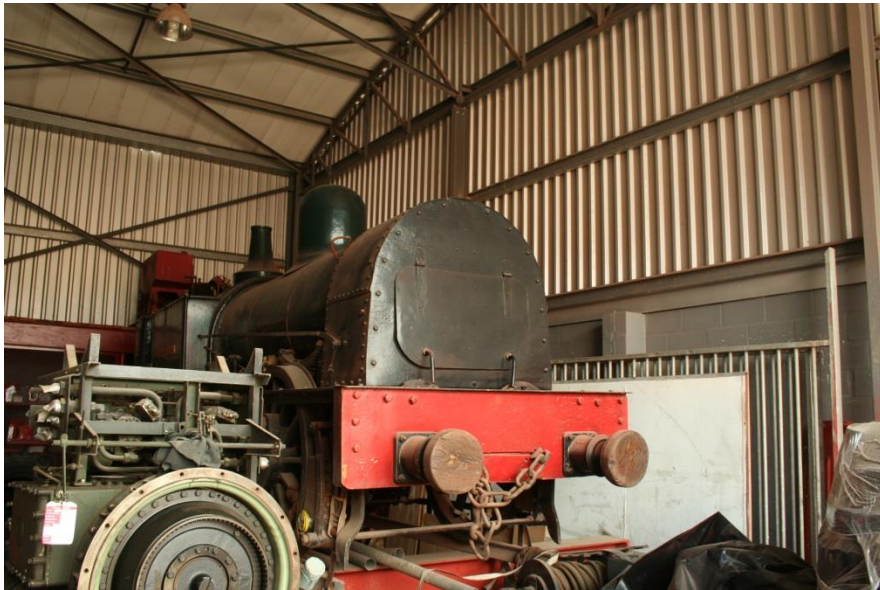
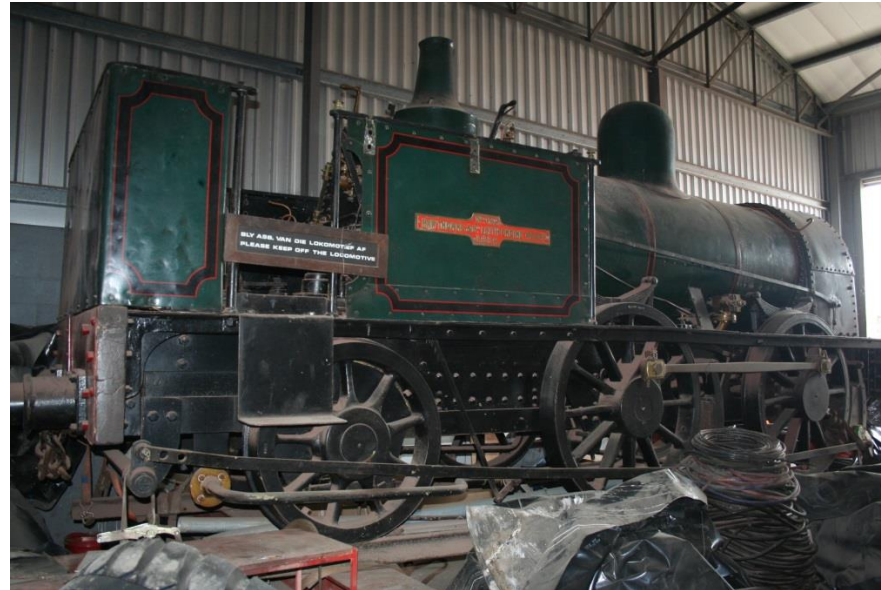
- 8.1. The locomotive "Blackie" was inspected on 04 February 2015, at the premises of ALE at Firgrove where it is in temporary storage.
- 8.2. The locomotive although under cover inside a building is not in a climate controlled environment.

- 8.3. From the information given to us the locomotive has been moved whilst in storage at ALE.
- 8.4. The locomotive is currently covered in black plastic sheeting with no protective material between the paintwork and the sheeting.
- 8.5. At present neither the cab roof or the smokestack (chimney) are fitted to the locomotive nor were these not available for viewing.
- 8.6. The locomotive is currently extremely dirty and will need to be properly cleaned before a final review of the condition of the paintwork can be finally determined – it looks to be in a reasonable condition and should not need any repainting.
- 8.7. The underside of the locomotive and the motion are covered in dust and fluff and will need to be thoroughly cleaned.

- 8.8.1. We recommend that additional supports be inserted under the rails below the rear driving wheels (centre wheels) to avoid any further possible damage.

- 8.8.2. Provided that the rails on which "Blackie" is standing are propped up to ensure that they are level the locomotive should not need any structural repair work.

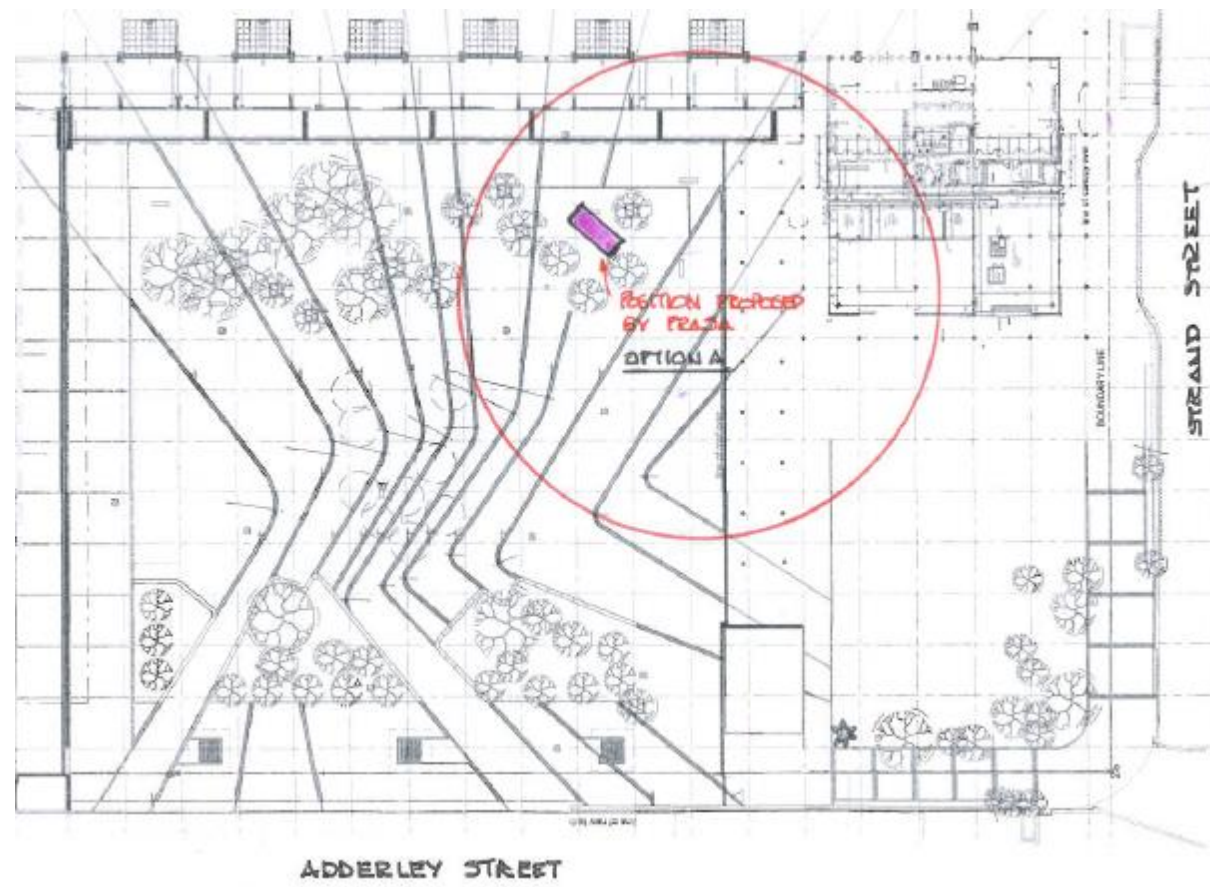
11.2.1.1. Option A1 – PRASA Proposed position and Display enclosure

- 11.2.1.1.1. Good display position and would be in the position already approved by PRASA.
- 11.2.1.1.2. Would not interfere with pedestrian flow.
- 11.2.1.1.3. Display enclosure not suitable.
- 11.2.1.1.4. NOT an acceptable option.

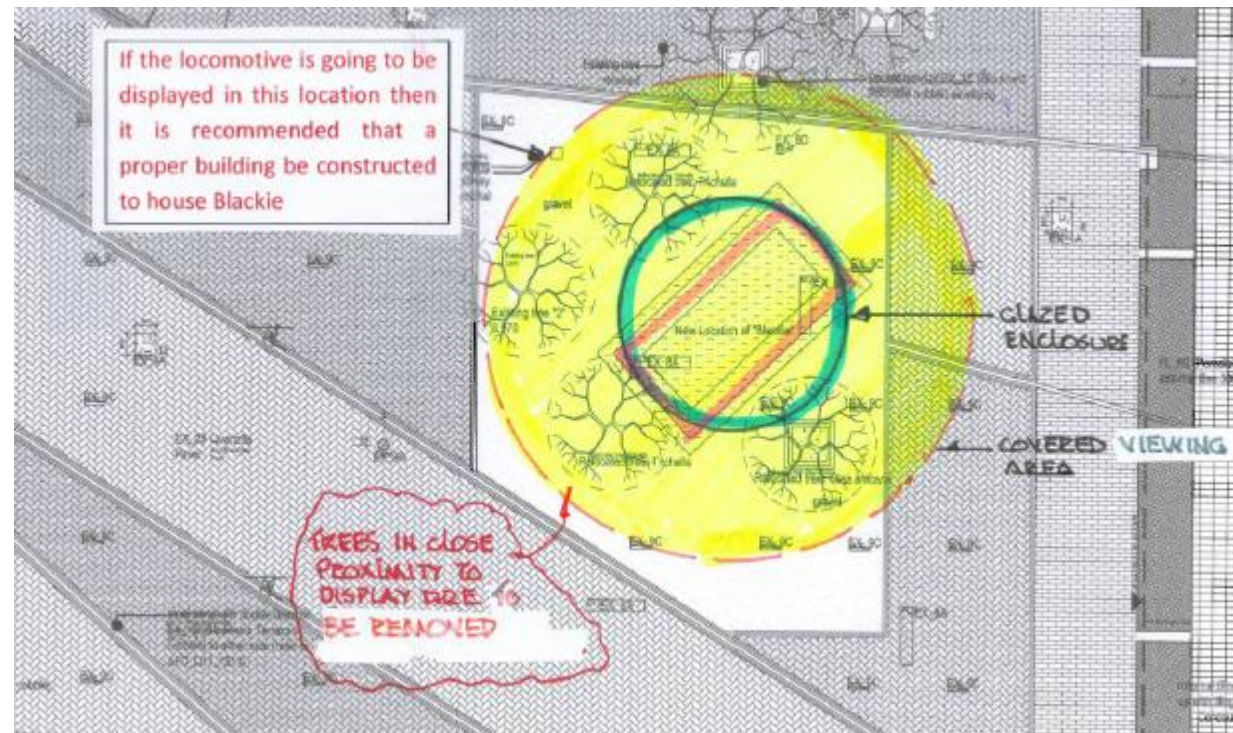
11.2.1.2. Option A2 – PRASA Proposed position but with proper display building to house the locomotive – External access

- 11.2.1.2.1. Good display position and would be in the position already approved by PRASA.
- 11.2.1.2.2. Would not interfere with pedestrian flow.
- 11.2.1.2.3. Special building with external shaded area will have to be built around the display enclosure.
- 11.2.1.2.4. Building will have to be climate controlled.
- 11.2.1.2.5. Viewing of locomotive will be through glazing.
- 11.2.1.2.6. Costs could be a problem.
- 11.2.1.2.7. The costs are likely to be greater than creating a display within the Concourse.
- 11.2.1.2.8. Would be an acceptable option.

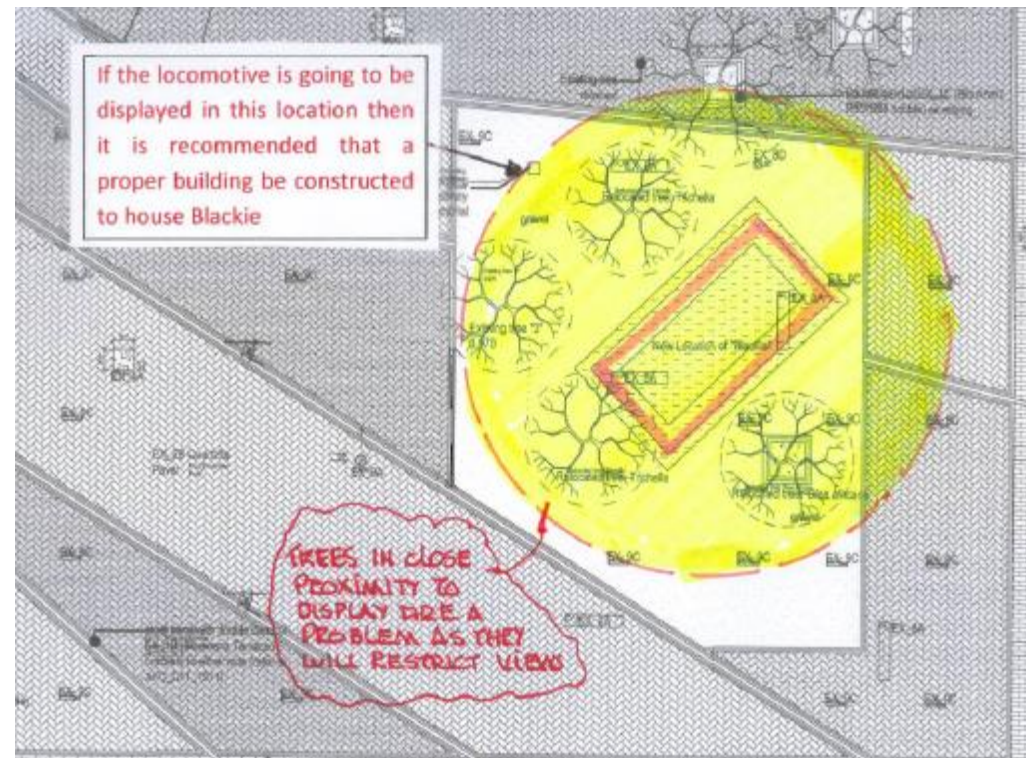
11.2.1.3. Option A3 – PRASA Proposed position but with proper display building to house the locomotive – Internal access

- 11.2.1.3.1. Good display position and would be in the position already approved by PRASA.
- 11.2.1.3.2. Would not interfere with pedestrian flow.
- 11.2.1.3.3. Special building to be built to house “Blackie” within an enclosed viewing area.

- 11.2.1.3.4. Building will have to be climate controlled.
- 11.2.1.3.5. Access to the building would have to be controlled and security systems put in place.

- 11.2.1.3.6. Good viewing conditions - viewing of locomotive will be by entry into the building.
- 11.2.1.3.7. Easy maintenance of the locomotive.
- 11.2.1.3.8. Ability to display other historical artefacts and documents relating to the development of the railways and railway station in Cape Town.

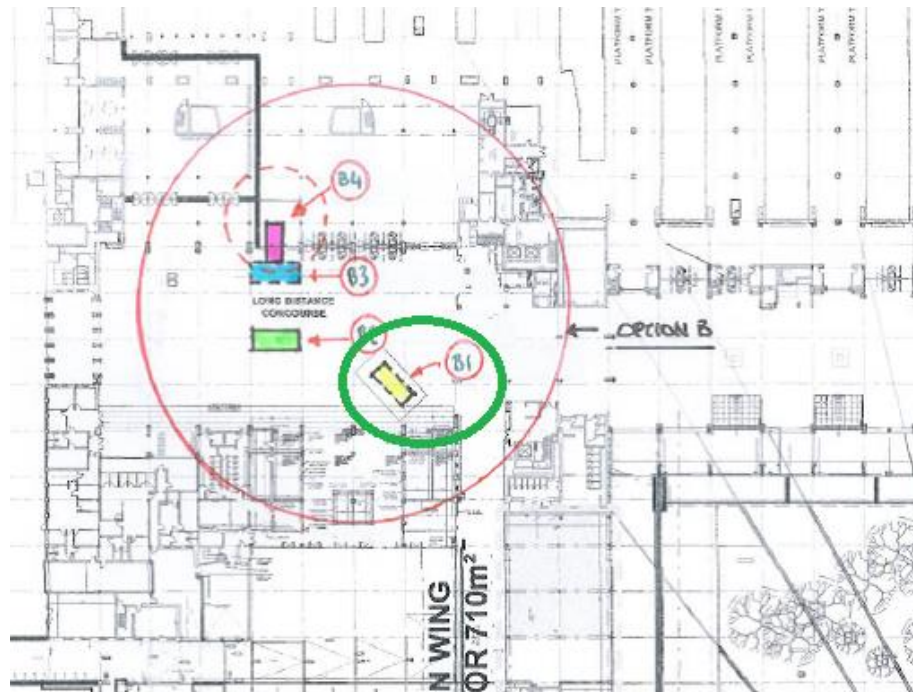
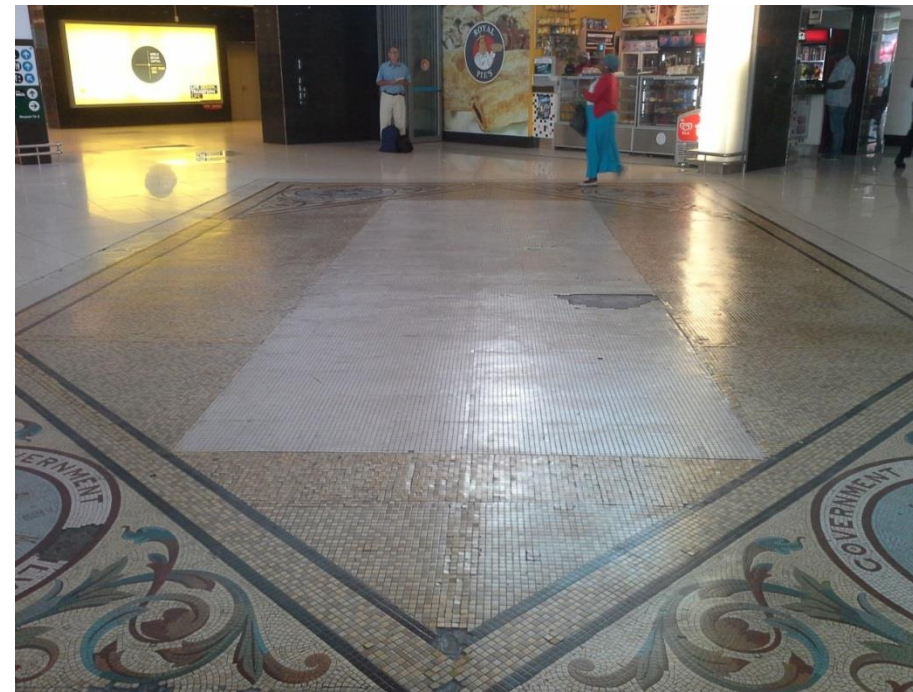
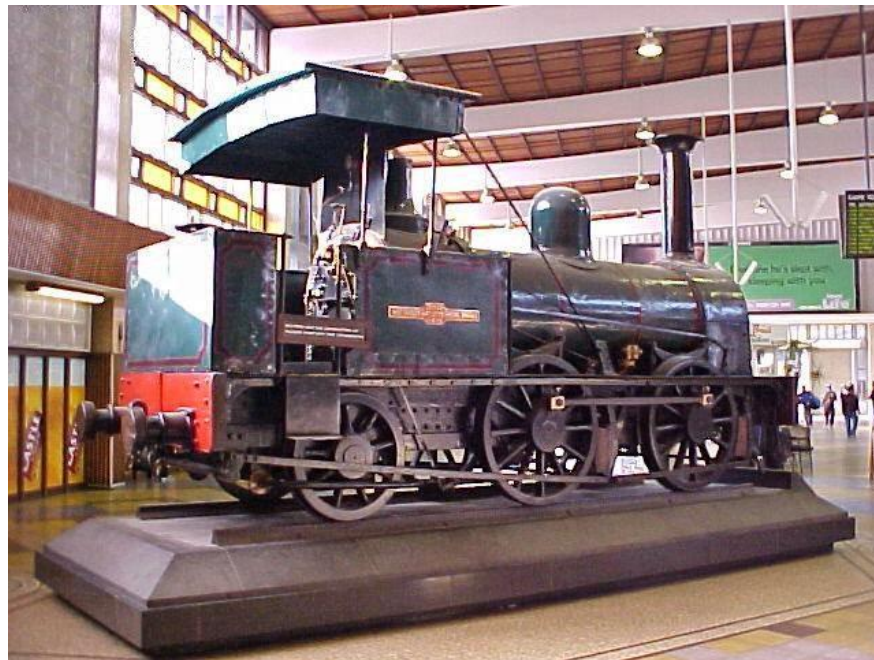
11.2.2.1. Option B1 – Old Position in Main Line Concourse

11.2.2.1.1. Position not acceptable to PRASA - Would interfere with pedestrian flow and access to retail food outlets.

11.2.2.1.2. Mosaic panel can remain in position and be repaired.

11.2.2.1.3. Would NOT be an acceptable option to PRASA.

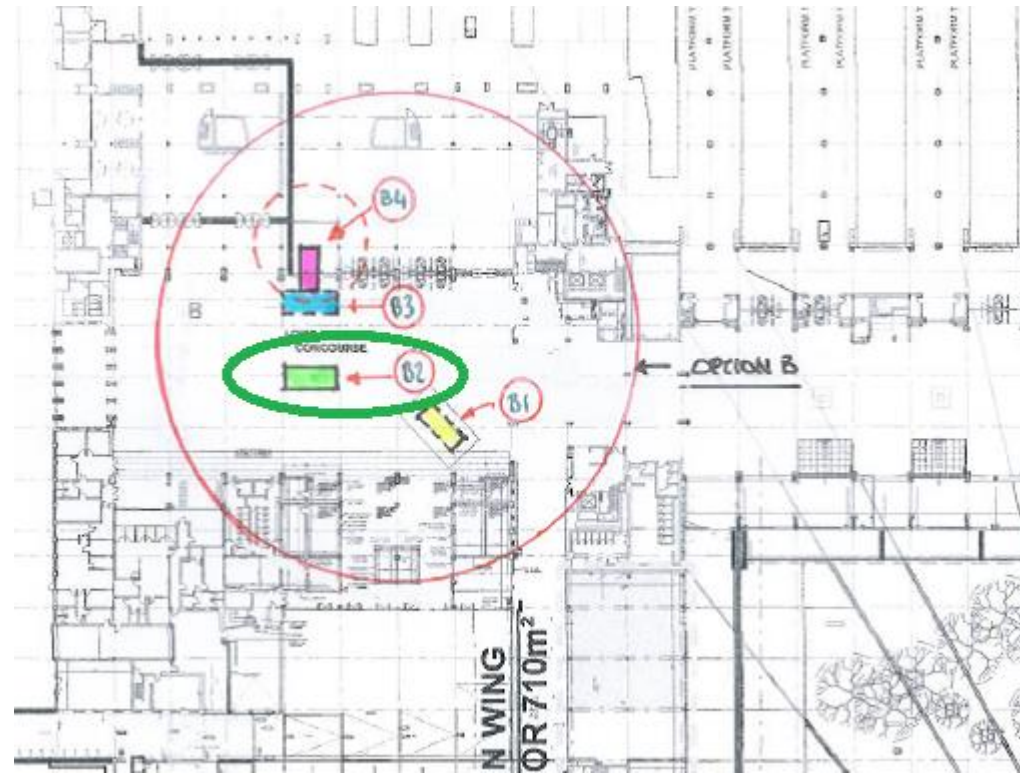
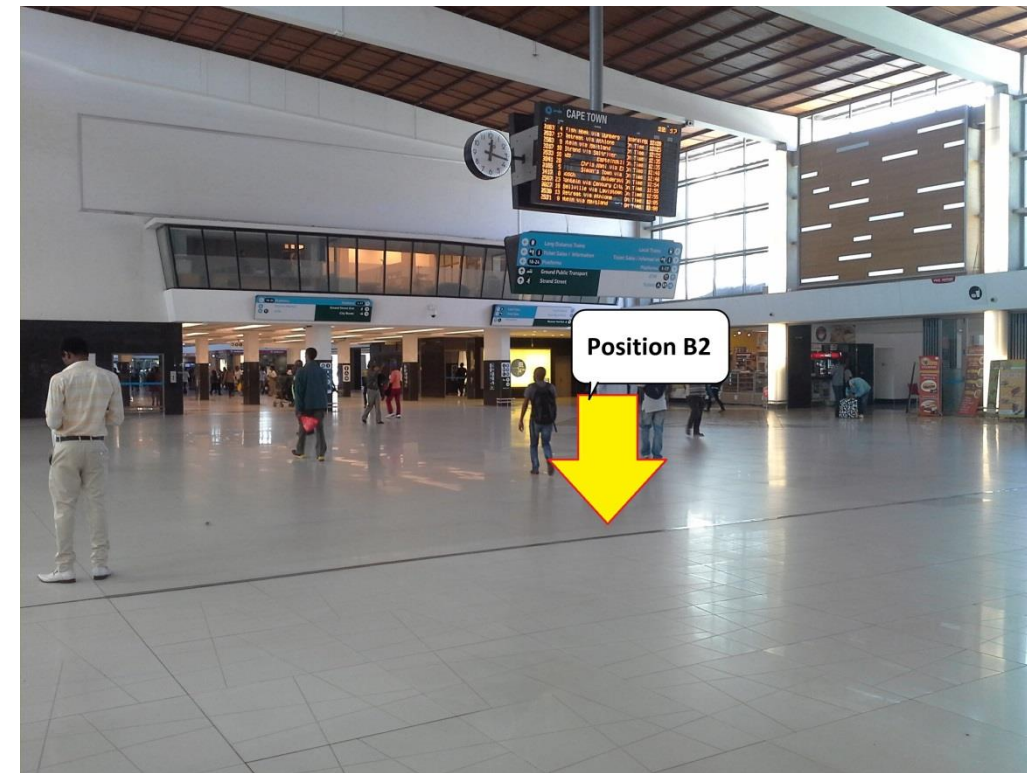
11.2.2.2. Option B2 – Central Position in Main Line Concourse

- 11.2.2.2.1. Mosaic panel will have to be uplifted and relocated.
- 11.2.2.2.2. Readily visible from all sides.
- 11.2.2.2.3. Will have some interference with pedestrian traffic flow in the Concourse but pedestrians can flow around display.
- 11.2.2.2.4. Will interfere with the overhead information boards in the middle of the concourse.
- 11.2.2.2.5. Would NOT be a recommended option.

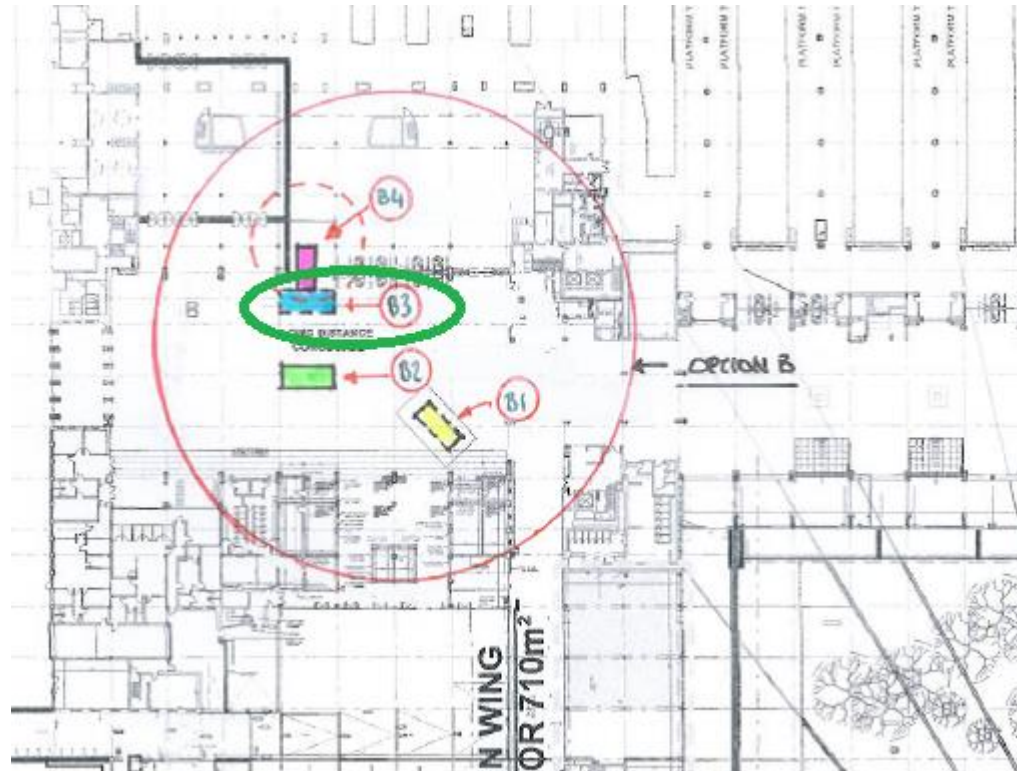
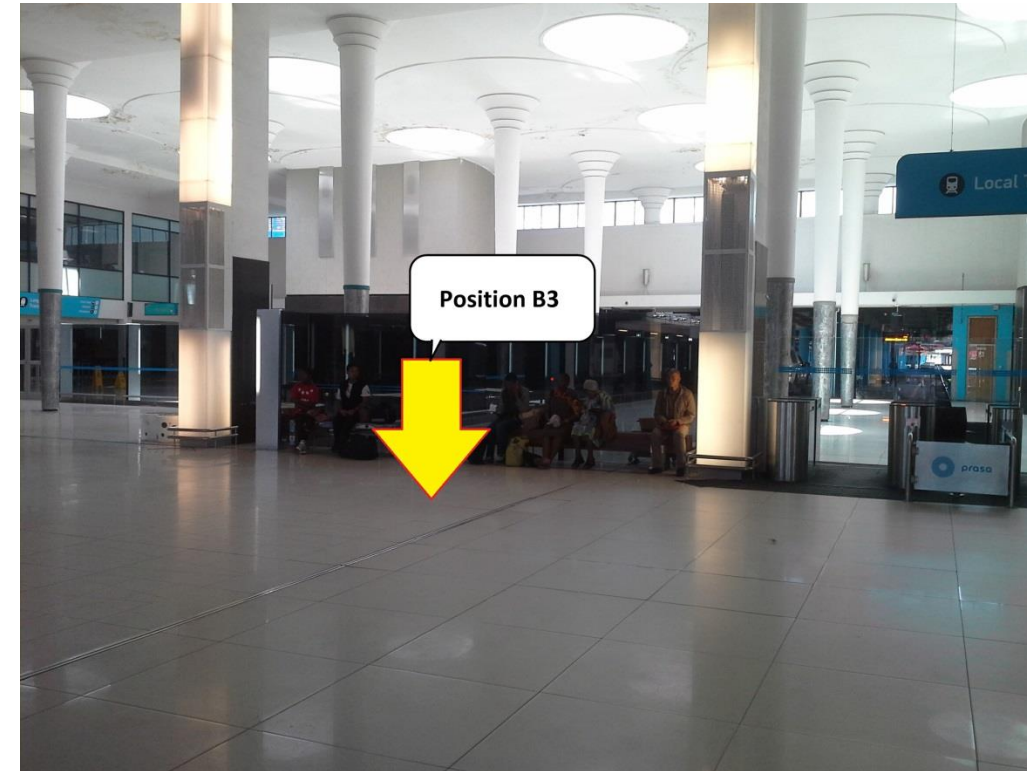
11.2.2.3. Option B3 – Offset towards Main Line platforms in Concourse

- 11.2.2.3.1. Mosaic panel will have to be uplifted and relocated.
- 11.2.2.3.2. Visible from all sides.
- 11.2.2.3.3. Will have minimal interference with pedestrian traffic flow in the Concourse
- 11.2.2.3.4. Position probably acceptable to PRASA.
- 11.2.2.3.5. Not preferred option.
- 11.2.2.3.6. Could be an acceptable option.

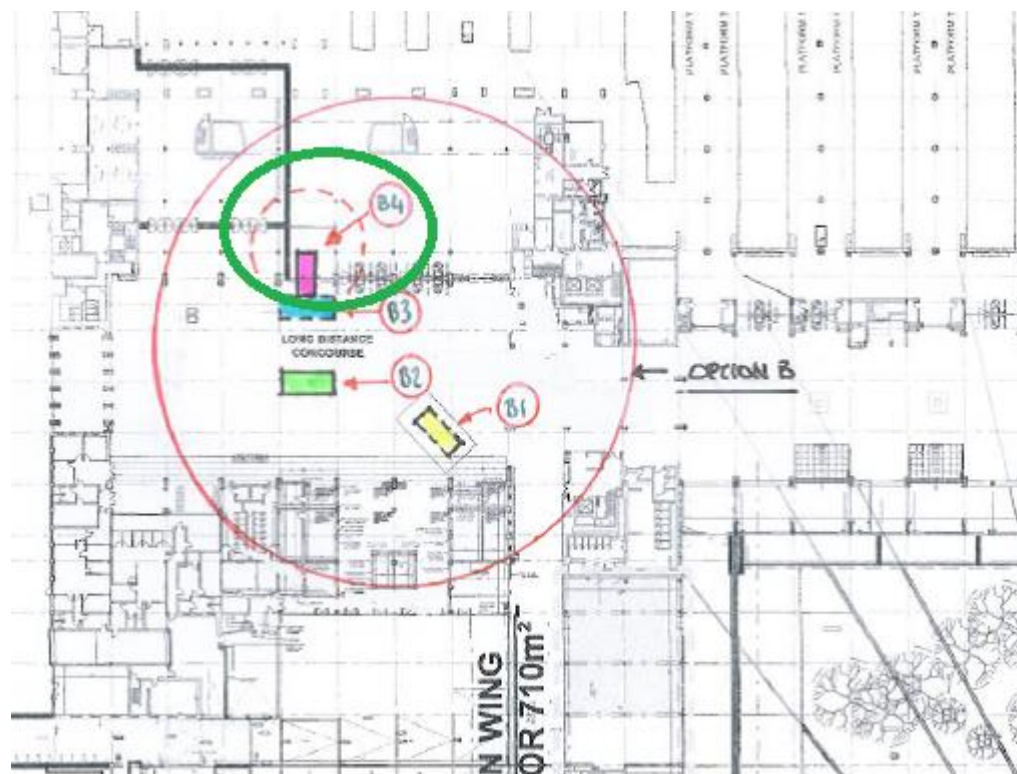
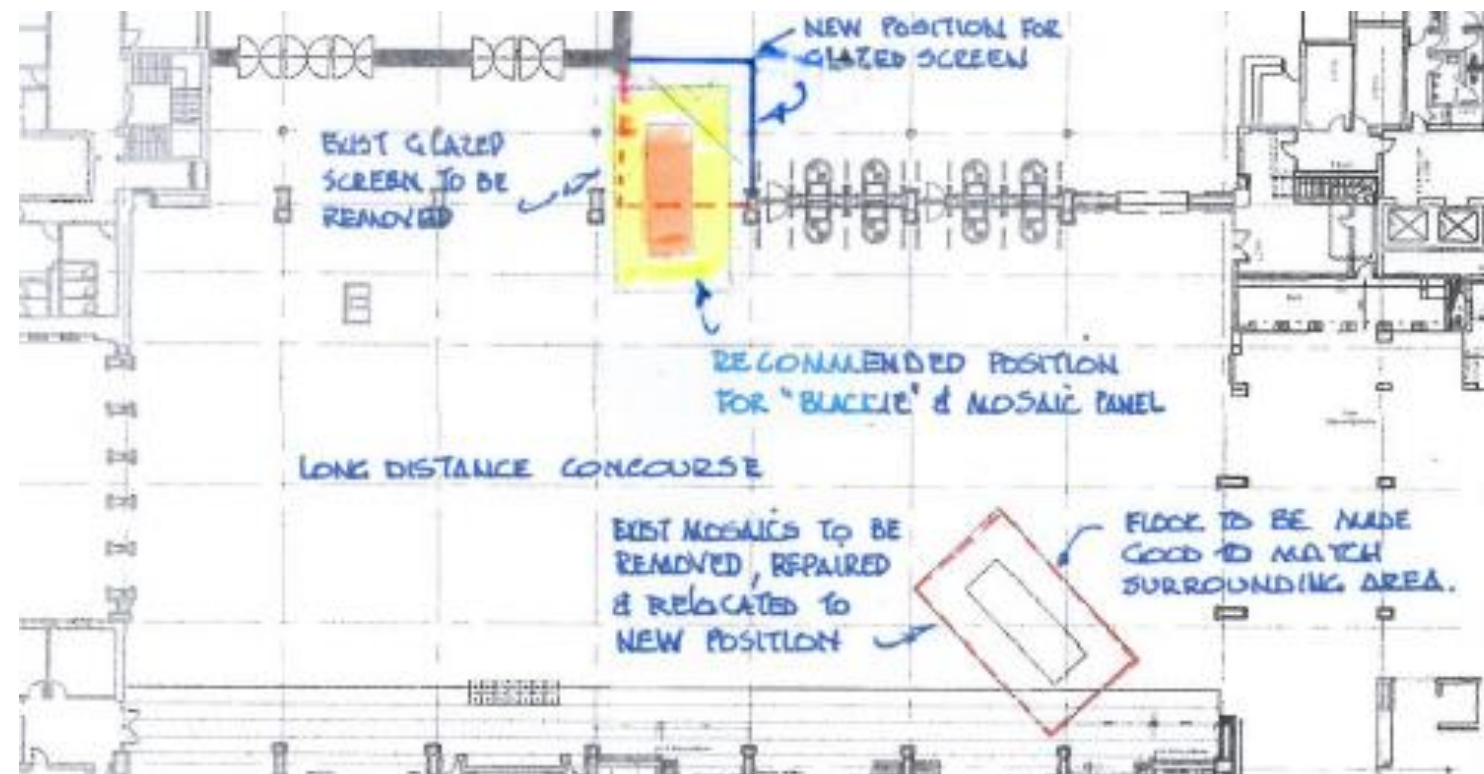
11.2.2.4. Option B4 – Alcove near Main Line platforms in Concourse

- 11.2.2.4.1. Mosaic panel will have to be uplifted and relocated.
- 11.2.2.4.2. Will have no interference with pedestrian traffic flow in the Concourse.
- 11.2.2.4.3. Will require modifications to existing glazed screen between Long Distance and Metro waiting areas.
- 11.2.2.4.4. Visible from all sides - position will provide good display position with minimal interference with other activities within the Concourse.
- 11.2.2.4.5. Ceiling of Concourse will need to be repaired before "Blackie" is placed on display.
- 11.2.2.4.6. Position suggested by PRASA and acceptable to PRASA.
- 11.2.2.4.7. Does have cost implications due to the modifications to the existing glazed screen.
- 11.2.2.4.8. Would be an acceptable option
- 11.2.2.4.9. Preferred location within Concourse.

12.4.1. From a practical and cost perspective we believe that Option B4 should be the preferred option.

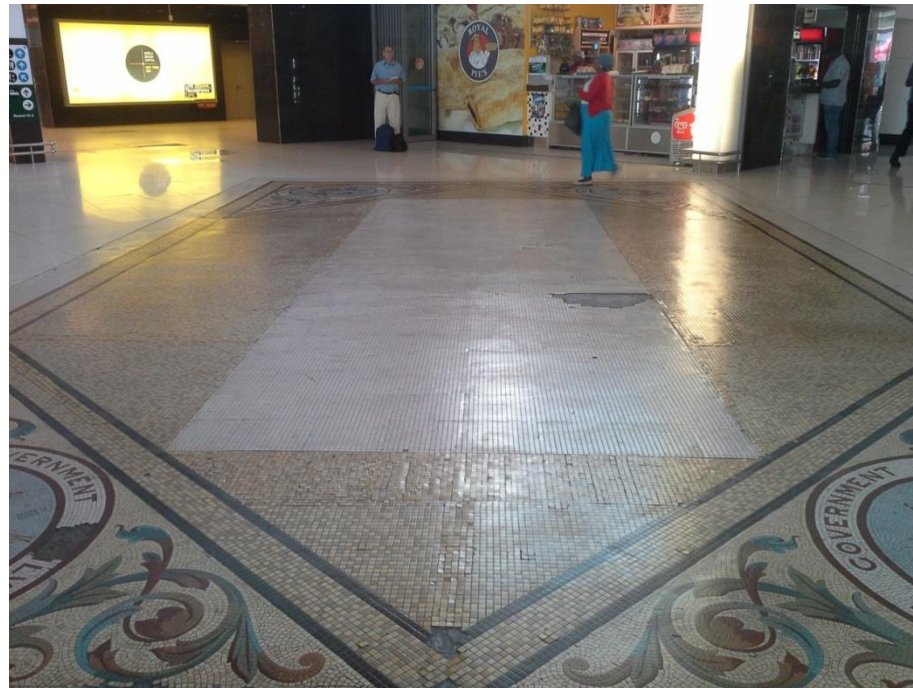
- 13.1. The mosaic panel in the Concourse around the old display area is currently still in place although it has suffered some damage.
- 13.2. There are a number of options to be considered as regards to the future of the panel:

- 13.5. We recommend that the services of a mosaic specialist be engaged by PRASA to carry out the uplifting and relocation of the mosaics.
