**OLD BETHLEHEM FARM 153
DWARS RIVER VALLEY, DRAKENSTEIN**

HOMESTEAD (T-PLAN)

**STRUCTURAL & ARCHAEOLOGICAL INVESTIGATIONS
& ASSESSMENT OF THE WALLS AND FLOORS,
PREPARATORY TOWARDS REHABILITATION**

APRIL 2013

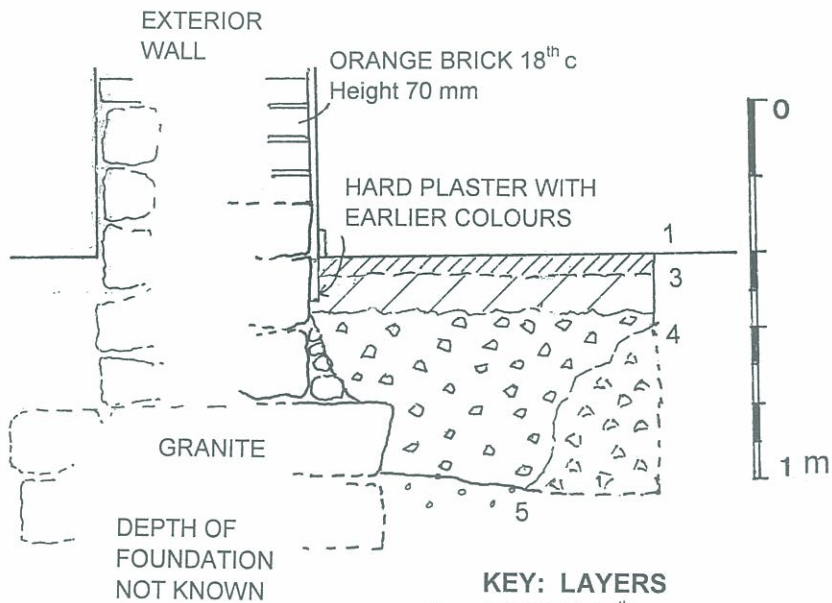
FIG.4.2 Elevation of the excavation B1/4 which reached about 60cm below floor level (Vos 2013).

What is obvious are the unusual wide granite plinths of about 200 mm, with the B4 plinth partially covered in a thin, hard lime plaster. These plinths are surely to support regular joists for boarded floors. The layer 5 appears to be a trampled surface when the house was built in 1770s (FIG.4.2).

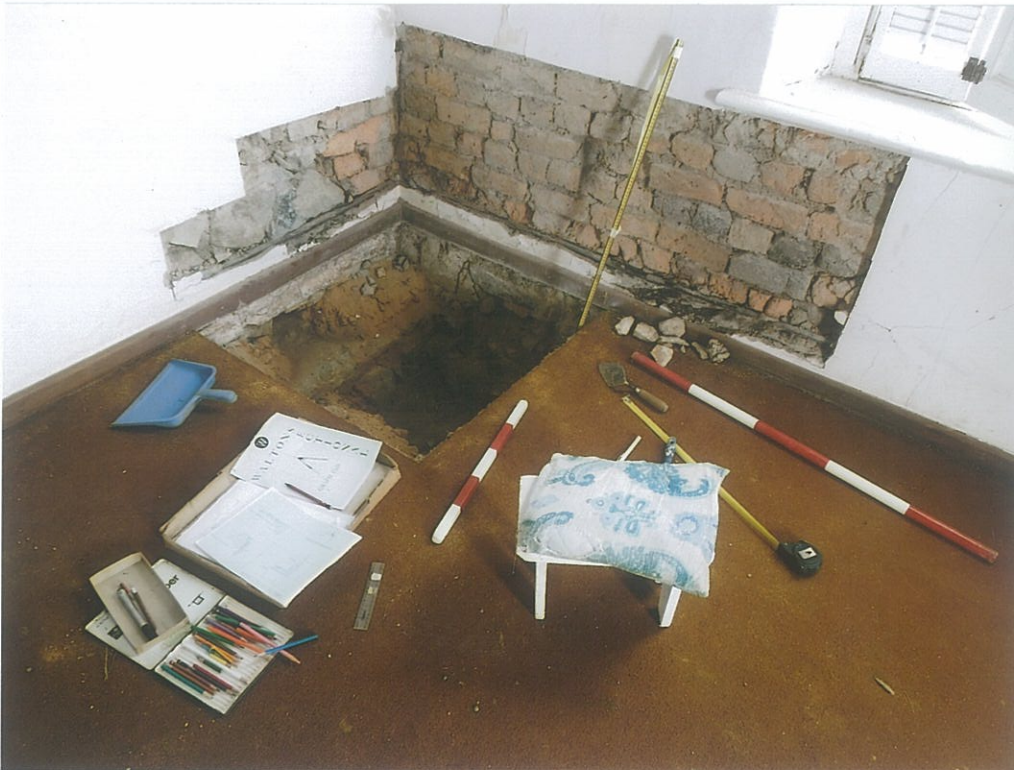
2. In Room B the corner excavation is surrounded by the tools of the trade for documentation (look NW).

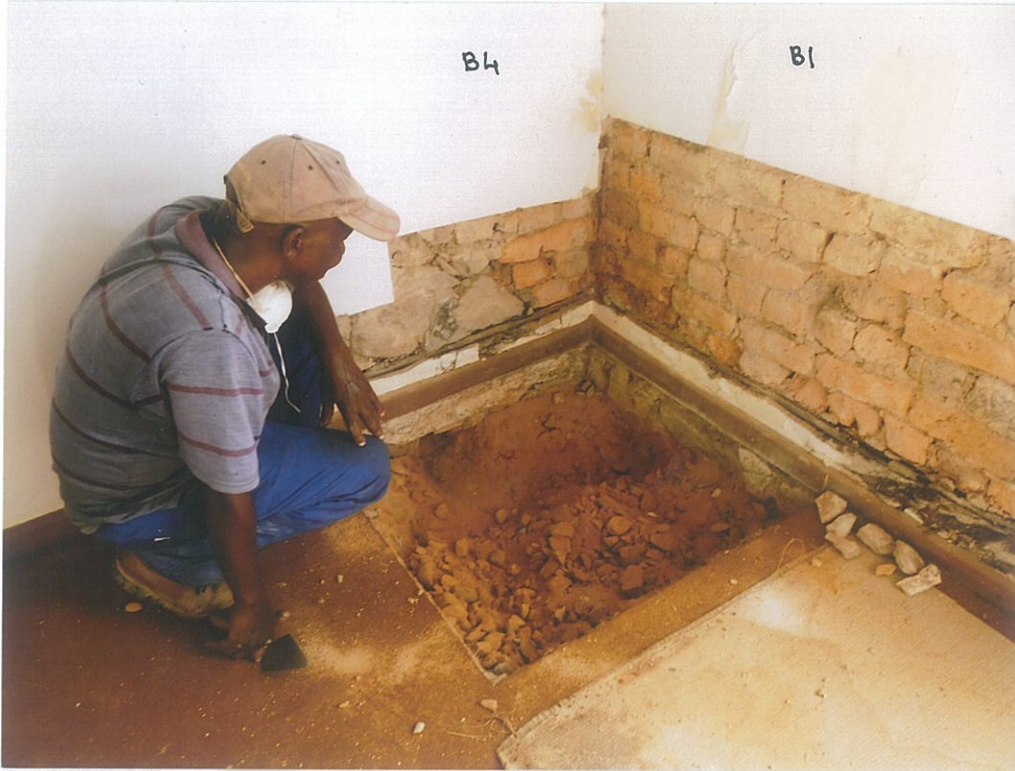
3. Assistant looking at the large volume of gravel excavated from corner section B1/4 (look NW).

4. In this close-up of B1/4, the corner 18th c bricks bond perfectly (1). At wall B4 the earlier plaster band and floor level is visible (2). Note the wide stone plinth (3) (scales 1m, 50 cm) (look N).

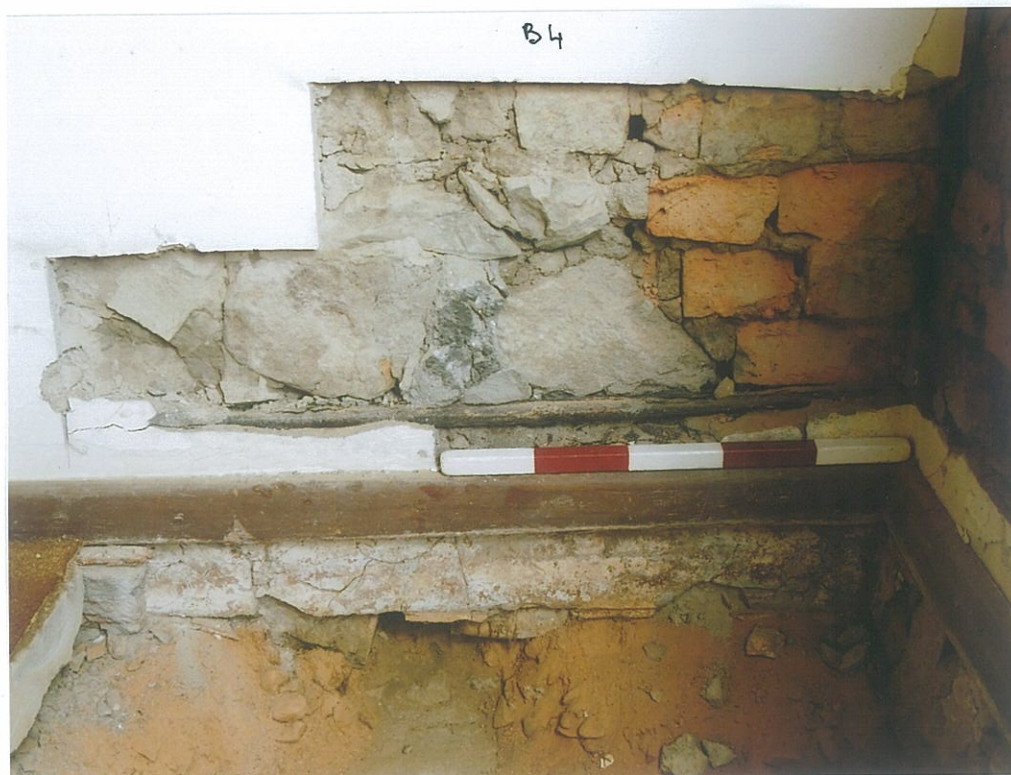
Within the excavation, a 100 mm strip of c.1900 plaster, very hard like cement/lime, showed some early colours. Immediately at its base, are impressions of endboards. This would indicate the Rooms A/B were once at the same level as the Front Rooms C and DE (all 10cm lower). A portion of plaster was stripped above the floor level (carpet), where the cement plaster was already loose. It showed the mid-late 18th century orange brickwork (70 mm high) above the granite footing, the latter for damp proofing.

5, 6. At wall B4 even the interior wall was built-up in stone. Note the earlier floor level (c.1900) with the skirting plaster and the two yellow *in situ* plaster strips below, showing floor board impressions (look W) (scale 50 cm).

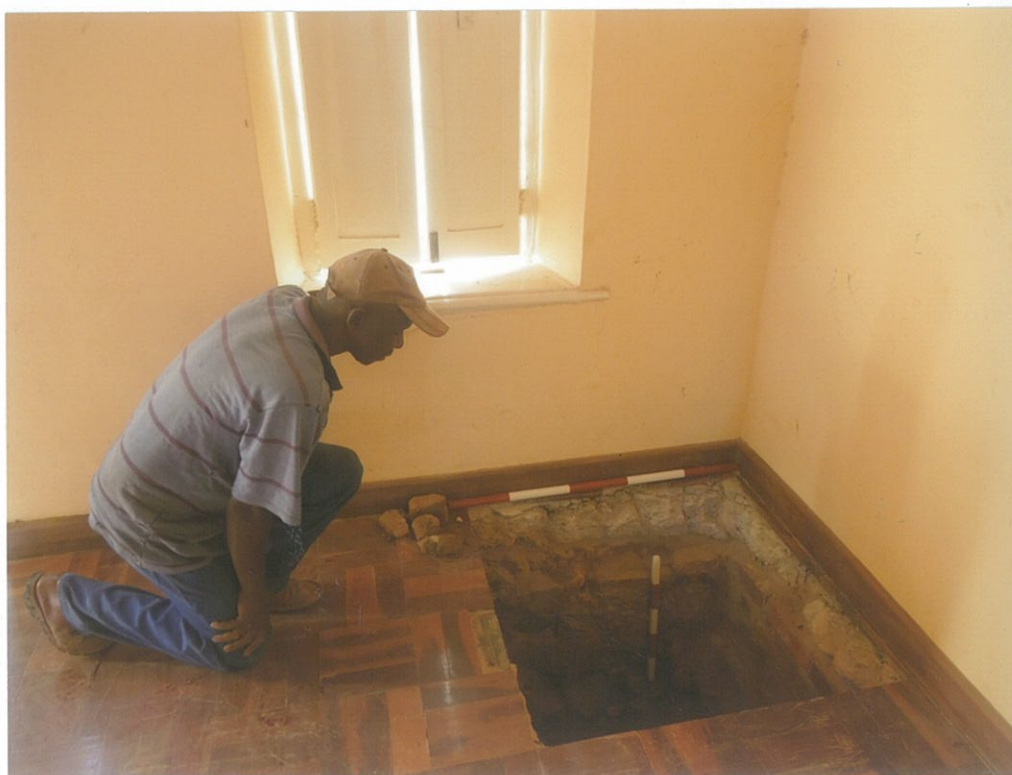
This section was also filled during post-1940s with a concrete bed (for the *blokkiesvloer*) and filled for a depth of 30 cm of fine white sand (**FIG.5.1**). Below wall C2, next to the stone foundation, a layer of modern, hard-fired red brick in cement mortar, prevented any water seepage to the side. Any gravitational water drainage would have gone straight north below the stoep and unto the yard.

7. In Room C, corner section C1/2, is taken fully to the lowest level by assistant Jackson (look N).

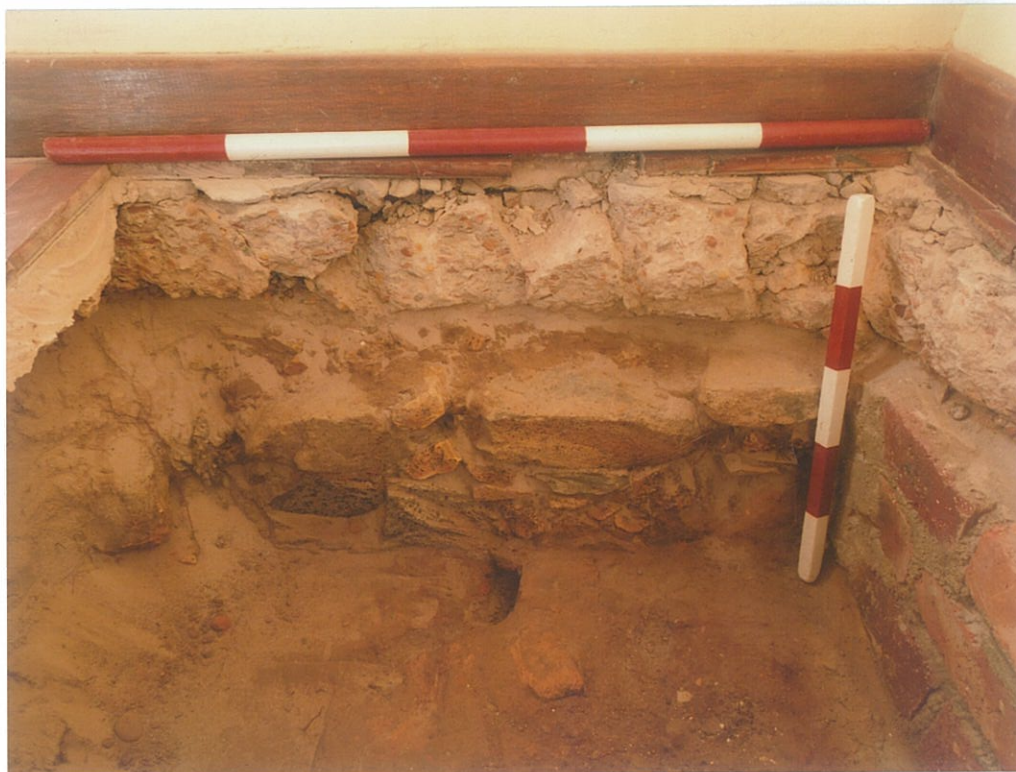
At the façade wall C1, there is again a wide plinth of granite stone, indicating a platform for joists and a boarded floor. Surface 5 shows signs of having been burnt reddish and hard, with charcoal specs and other building rubble present. It may represent the trampled surface when the dwelling was built. Below it (layer 6) still contained some fill of raw brick and then sterile clays followed (**FIG.5.2**).

8. View towards Wall C1, with the volume of white sand removed unto layer 5. Note the upper stone plinth for floor boards (look N) (scales 1m, 50 cm).

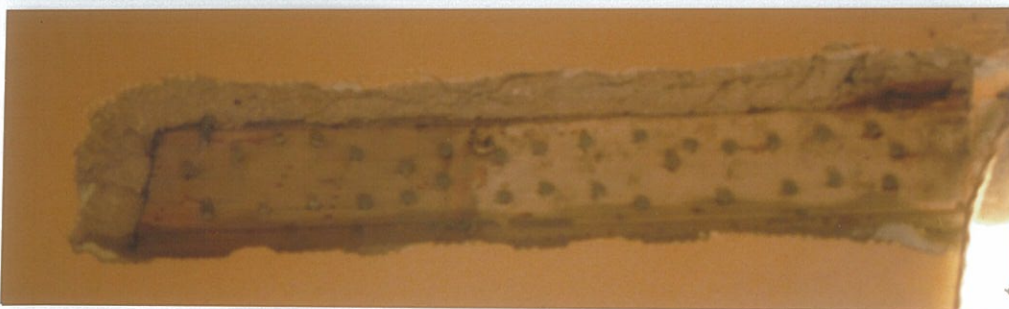
11. The left portion of the lintel shows paint lines. Nails were hammered in afterwards (1900s) to allow plaster to adhere (look N).

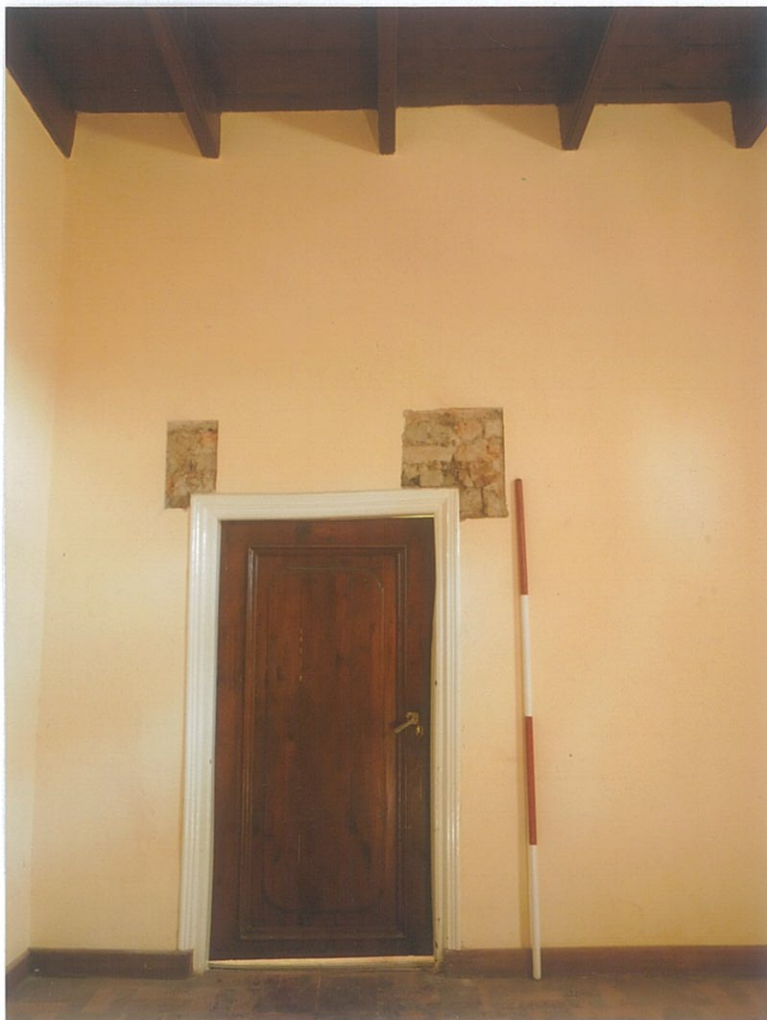
When some plaster was stripped at the lintel level, the brickwork proved to be original with no obvious signs of alteration. At present the lower board was unceremoniously halved to accommodate it above the raised floor (post-1900). As the *Voorhuis* C is already prone to water infiltration from the stoep (same level), it would be functional to raise the floors of Rooms C and D/E to those of the rest of the house. At the back of Room DE3 the veranda stoep is already 10 cm higher!

13. View towards wall C4 with the oldest door (mid-18th) with its surrounding architrave. Note its low position and the c.1880 beams overhead (scale 2m) (look W).

When the floors of Rooms CDE are raised, then the old Door C4 should be raised a mere 20 cm, which would allow its lower board to be "restored" to its correct dimensions. Architectural mouldings at the reveals can also be restored.

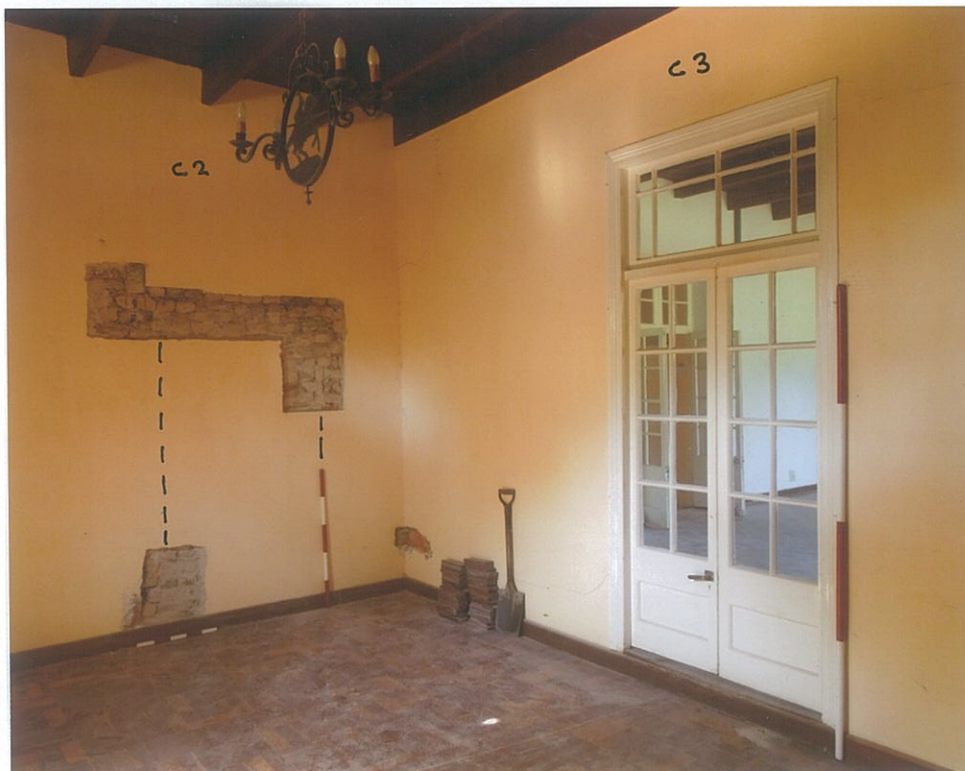
16. View in Room C2/3, where the earlier, blocked-up door is on the left (scales 2m, 1m, 50 cm) (look E).

Note that the *Voorhuis* side doors C2 and C4 are situated central unto the demolished wall/screen in *Agterhuis* F (see FIG.2). Minimum plaster was stripped to show the distinction between the *in situ* orange brick, and the filled-in-door, already done during the 19th century. It is recommended that the old door C4 be reproduced and fitted at door C2 to complete the old *Voorhuis* interior.

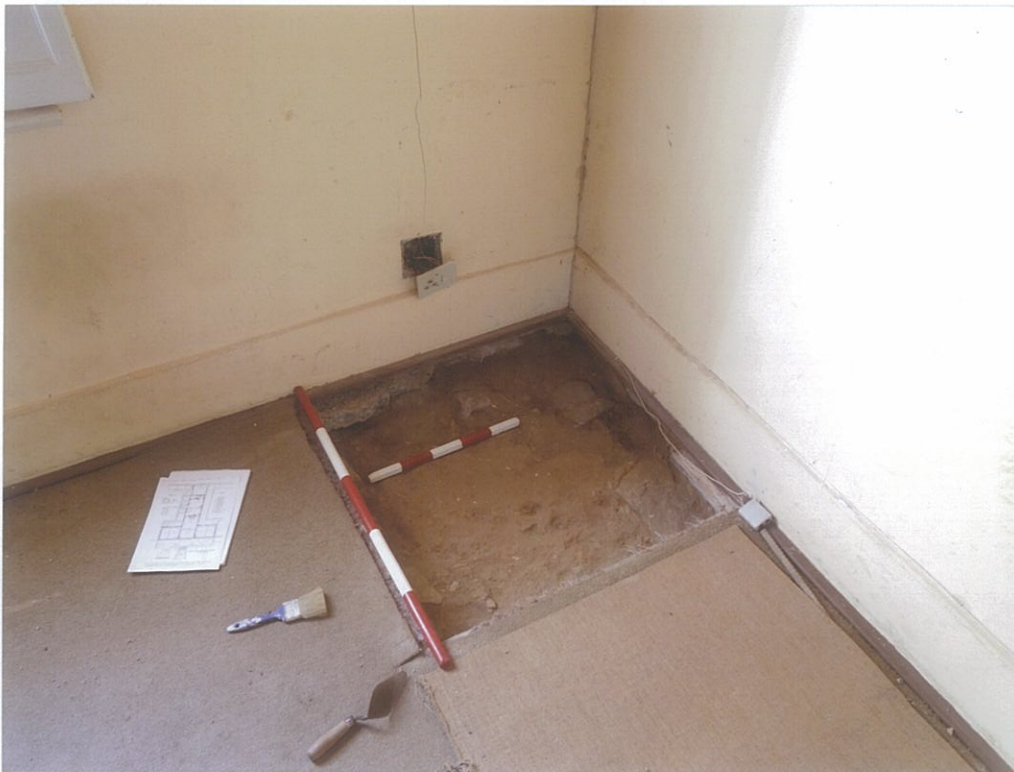
In Rooms DE only one floor corner section D 1/2 was dug, which appeared to contain more fill than the other two front rooms (**FIG.6.1**). Note layer 4 with brick rubble (19th c), layer 5 with yellow raw bricks, lens 6 with charcoal and layer 7 with initial fine rubble, both layers of the 18th century (**FIG.6.2**). Note that Section D1/2 and Section B1/4 have similar wide plinth platforms for joists supporting boarded floors. The exterior façade wall is depicted in elevation till window-sill height. The depth of all the foundations was not determined due to a lack of space for digging, which would have destroyed all layers.

18, 19. View of the corner section D1/2, where an early, filled-in layer (4) lies at the top. Lower down, layer 5 with its brown raw brick pieces, is evident. Note again the two wide stone plinths for joists of boarded floors (scales 1m, 50 cm) (look N).

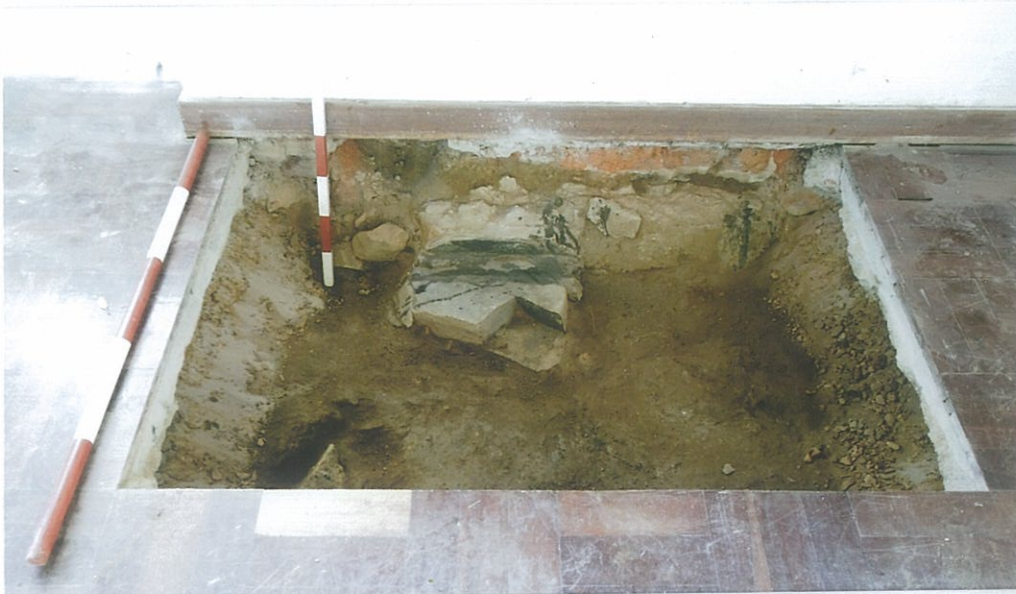
Black creosote oil drippings were present over the slate and the lime plaster (see drawing & photos). The slate bedstone, with no foundations, the black oil drippings and pilaster columns are indicative of a timber screen, with folding doors, probably stretching to the ceiling timbers. The present yellowwood beams have a beading of early 1800, which probably replaced the earlier $\frac{1}{4}$ mould beams. A fire of early 1800 probably razed the floorboards, screen and beams and roof structure. On the surface of layer 5 charcoal specs were also encountered on the burnt surface.

21. A view of excavation F4 with the blocked-floor on the cement bed in the surround (scale 1m, 50 cm) (look W).

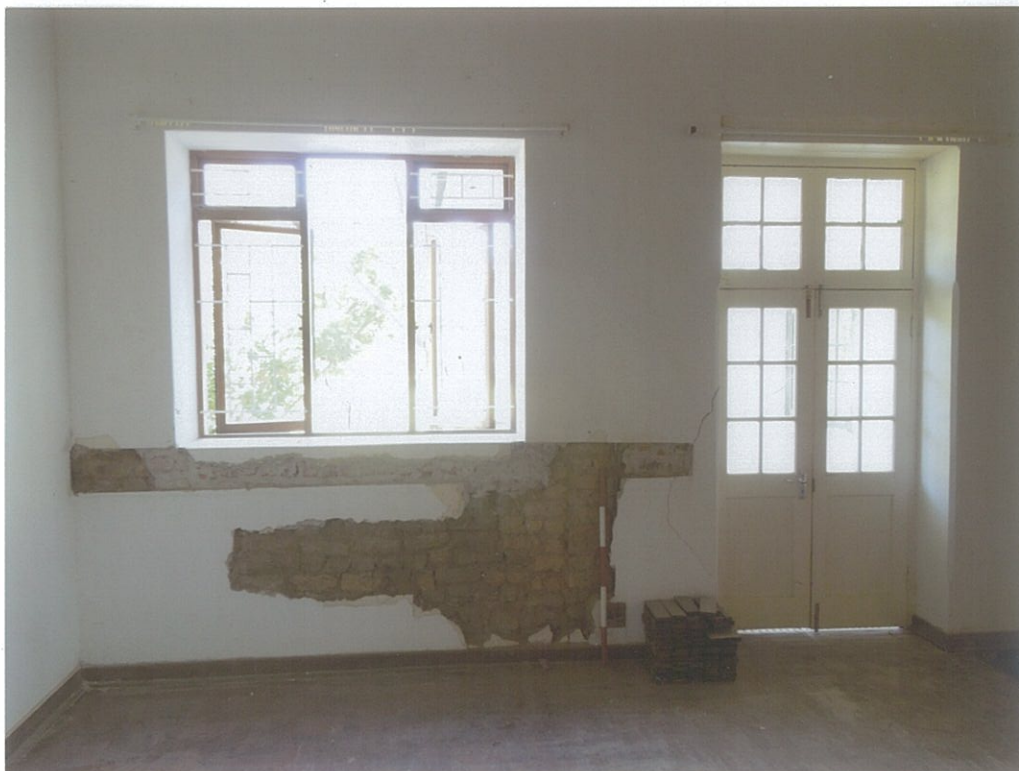
23. View in Room F (*Agterhuis*) towards wall F4, with its window and glazed doors. Compare with FIG.8 above (look W) (scale 1m).

As much of the plaster was loose below modern window F4, a large portion broke away, facilitating searching for earlier openings (FIG.8).

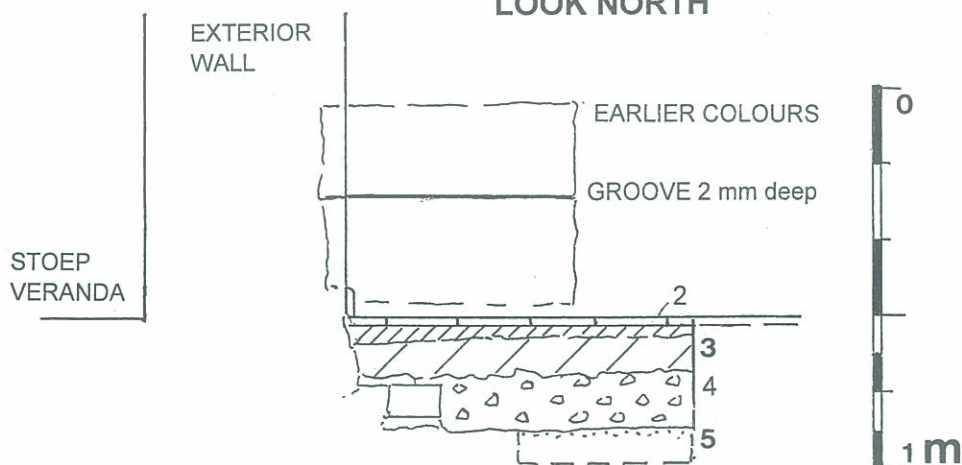
**ROOM I
CORNER SECTION I 1/4
CROSS-SECTION
LOOK NORTH**

FIG.9.1 Ground plan of the excavation I1/4 in old Kitchen I. Ribbed red brick of >1940s to waterproof the left exterior wall.

This excavation revealed completely different information than the other rooms (**FIG.9.1**). Below the blocked-floor the usual c.1940 concrete beds were encountered and also the small sized gravel fill of the same period. It ended upon a layer of pick-hard black loam that is imported and not natural to the Bethlehem site. A small section was deepened by means of a pick, but extremely difficult to break up (**FIG.9.2**).

I interpret this black loam layer, impervious to water penetration, as an 18th century technique to waterproof a floor layer of Cape tiles (28 cm²). Tiles are the general floor covering for this period. It appears that during 1940s the loam floor was also lowered for the gravel and concrete insertion. Water penetration from the exterior stoep courtyard probably played a major role with water infiltration. Note the red-ribbed, brick line in cement parallel to wall I4 to obstruct damp. No wonder many of the walls were replastered in cement.

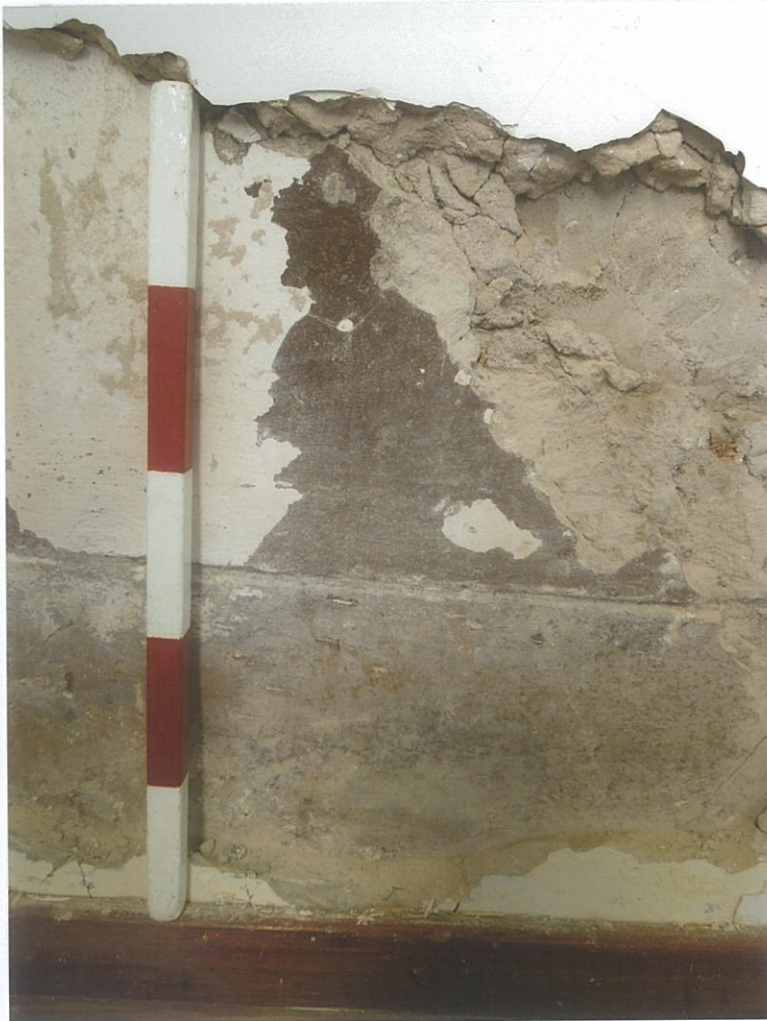
Above the corner Section I 1/4 a portion of the earlier paint layers (1900 or earlier) were encountered. The dark brown layers are more typical of the 19th century and later. Note the grooved line (2 mm deep) at a height of 20 cm. In the *Voorhuis C*, Wall 2, something similar is to be seen. The grooved line probably represents a technique to facilitate structuring paint layers, or indicative of an earlier high skirting or dashboard.

33, 34. A close-up of the corner section I1, where the two lower portions of the painted dado is separated by a horizontal groove (scale 1m) (look N).

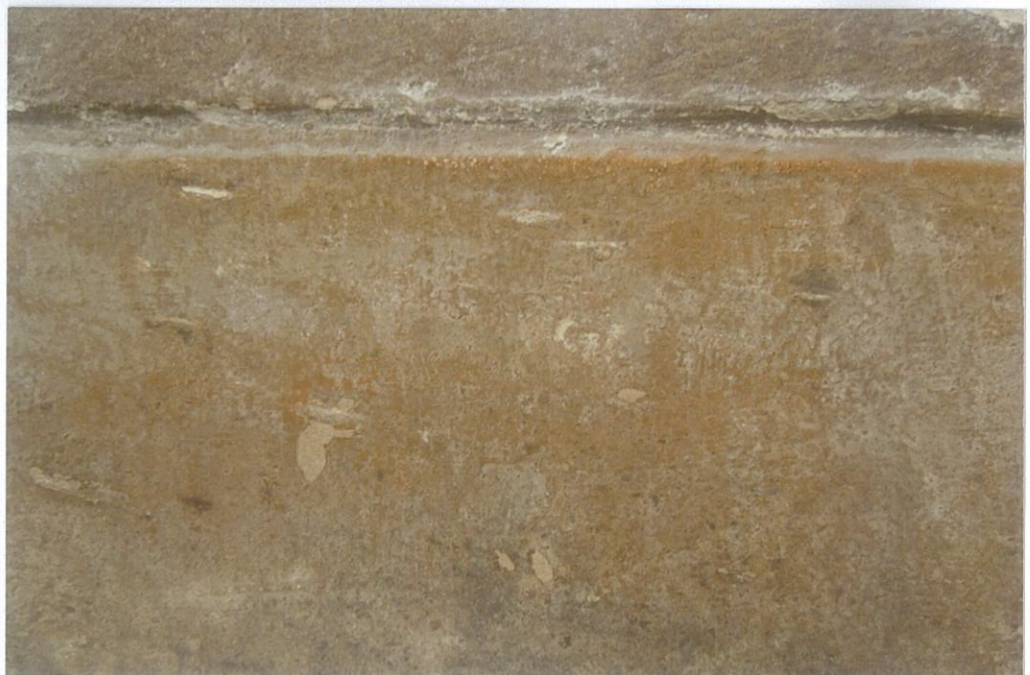
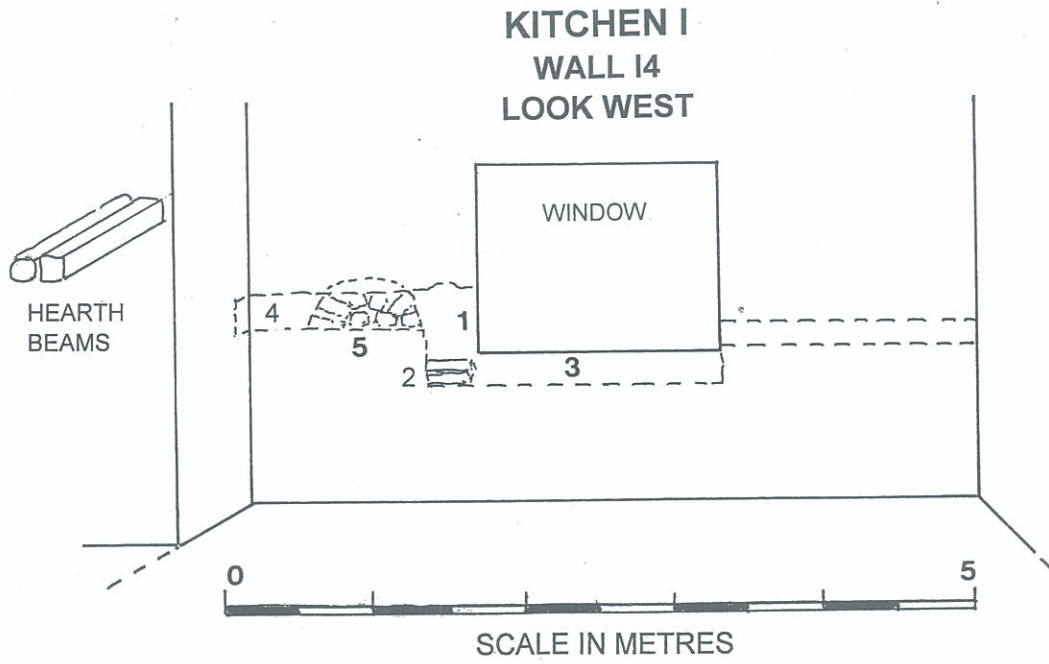
FIG.10 Elevation of Wall I4 of the old Kitchen I. Note the filled-in arch (oven) and black soot of earlier hearth (mid 18th?).

A continuous 20 cm band of plaster stripped horizontally across the whole of Wall I4, revealed some interesting data (**FIG.10**). The hard-fired orange brickwork (66 mm in height = mid-18th century) was laid in a light yellow mortar, and not the usual grey mortar of the 18th century. This would indicate the reuse of older brickwork in reconstruction.

The portion between the modern window and the hearth beam wall brought another surprise. A thin black soot layer adhered to mortar and to orange bricks (60 mm height), laid in dark grey clay mortars. The architect first noticed that a portion of an arched, fill-in brickwork was also extant. All indications are that an earlier hearth (1760-70) was once situated against wall I4, with an oven opening. Finally, coarse brownish brickwork (230 x 120 x 75 mm), rather low-fired and laid in grey mortars, completed the stretch to the corner. They may date to the late 18th century, but is rather enigmatic.

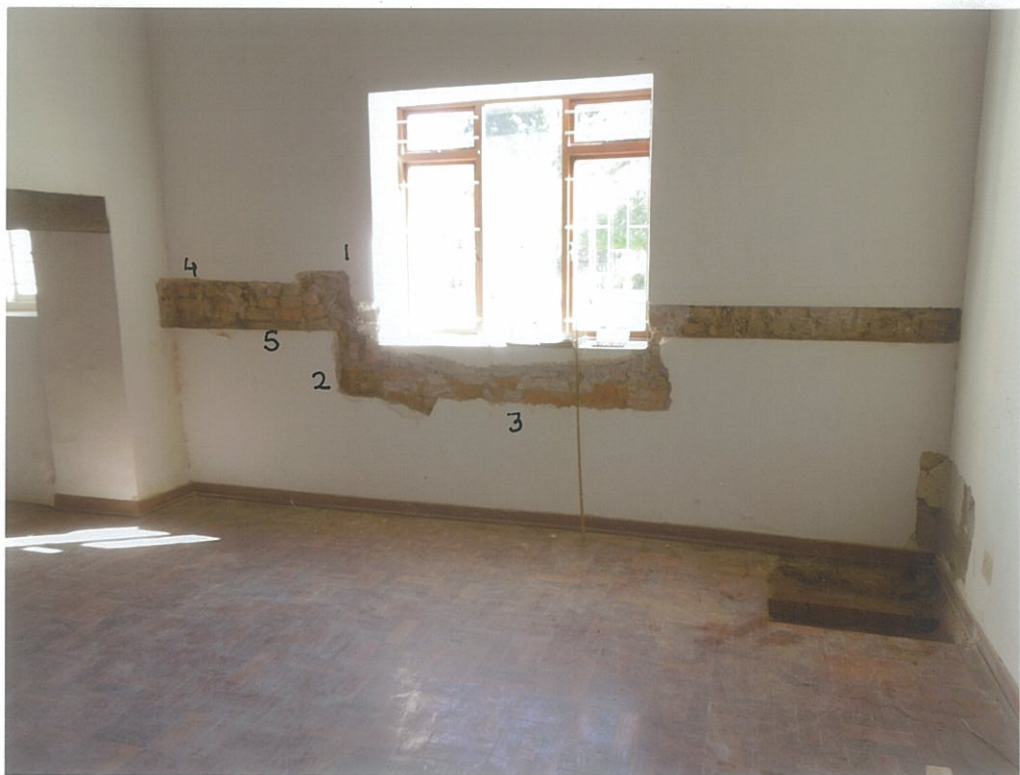
35. View within Kitchen I of Wall 4 where plaster was stripped in bands. The excavation is on the right (look W). The next photo (36) is of the left-hand corner.

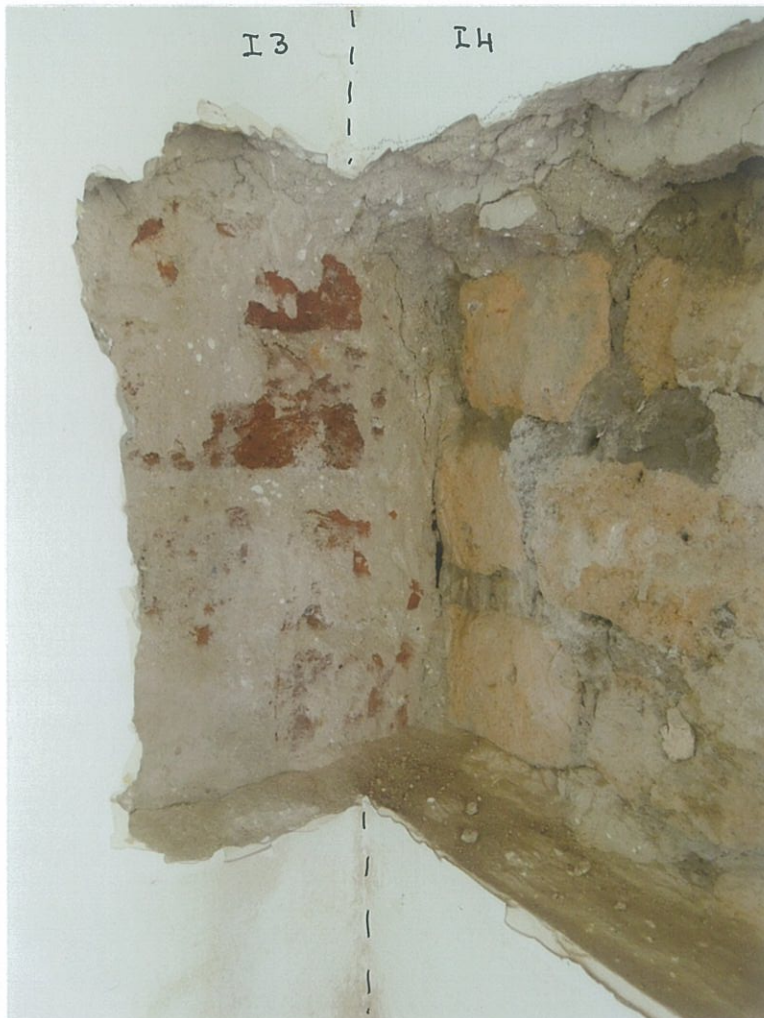
36. Corner section, where the hearth wall I3 shows modern brickwork on the left (look S).

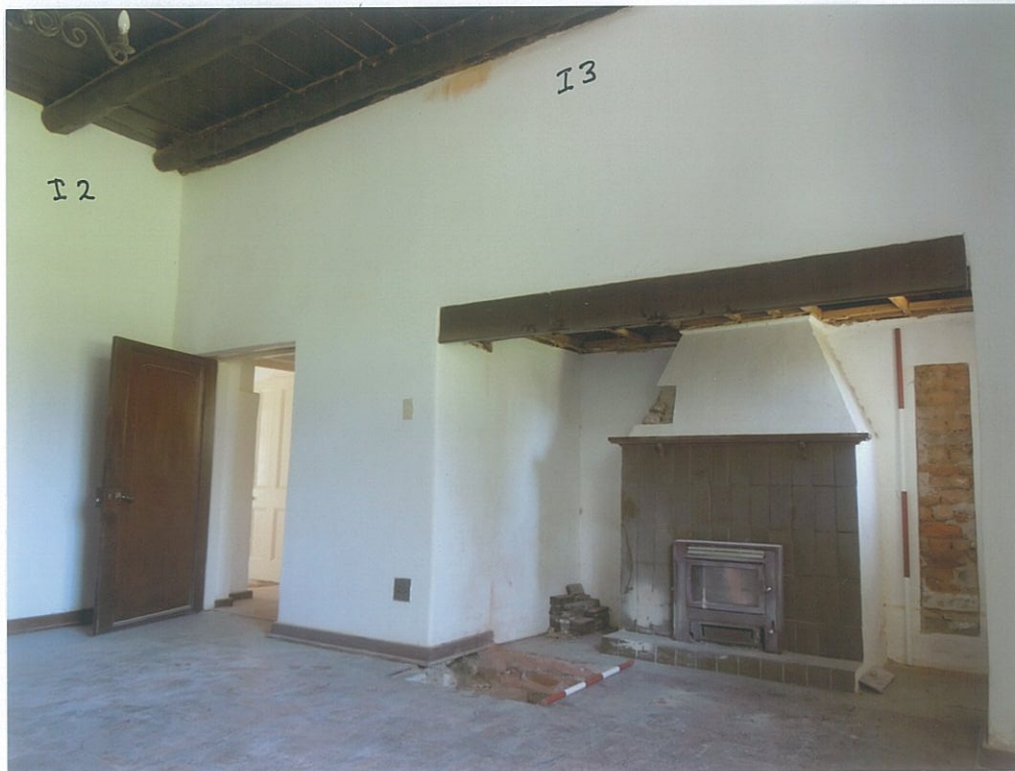
39. Wide-angled view of Kitchen, wall I3 of the hearth, the excavation (scale 1m) and the vertical band on the right (scale 2m) (look S).

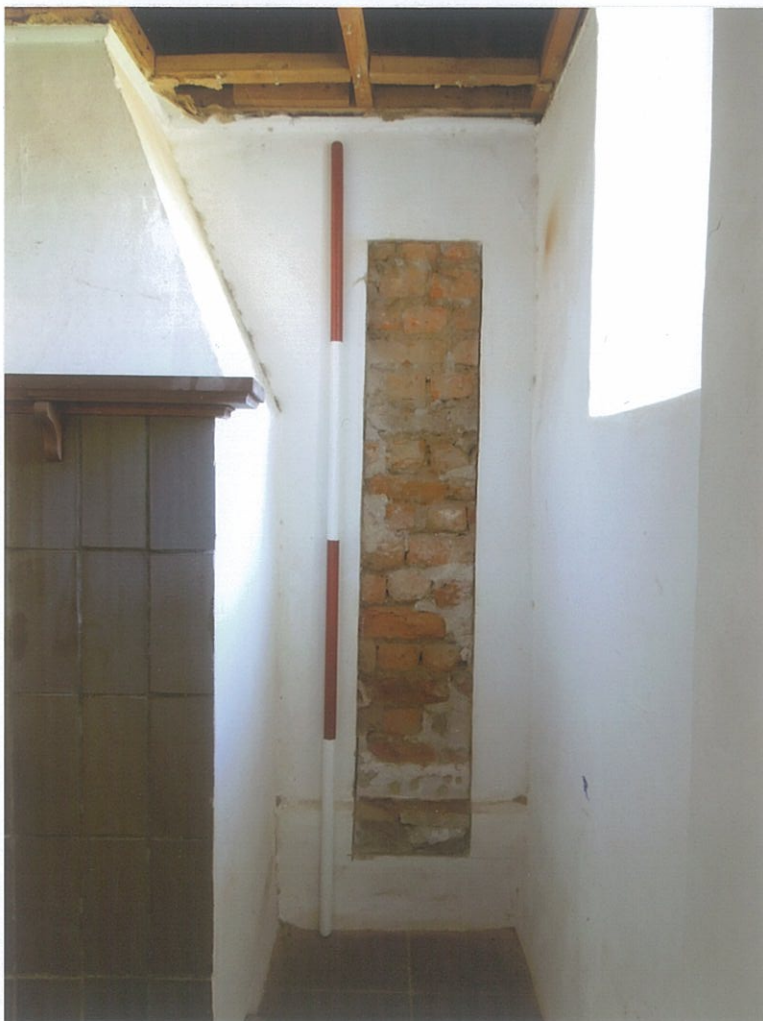
40. The band at the back shows homogeneous, well-fired orange brick with a stone plinth 35 cm high (scale 2m) (look S).

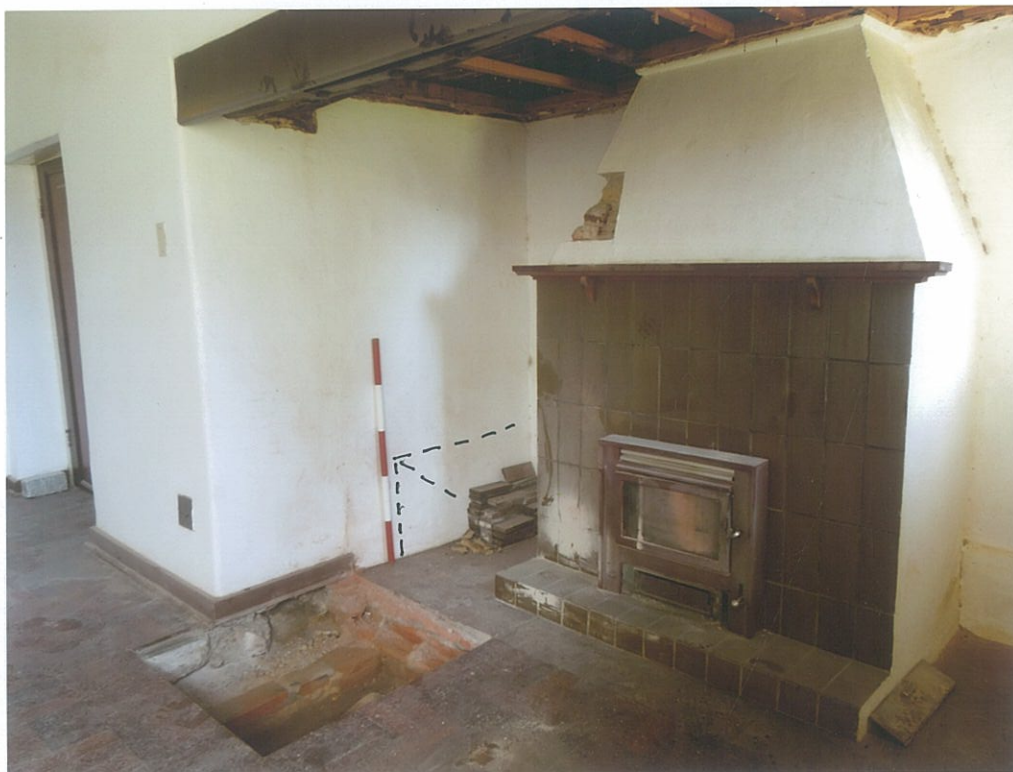
The height of the original flat hearth (destroyed 1940s) can be determined from the height of the oven opening (Room K4) and so also its width. The present intrusion of "kitchen chimney" with c.1940 oven would have to be demolished, but the metal grate could be reused somewhere else in the complex.

41. Another view of the c.1940 grate, hood and sloping chimney built-in position of the earlier hearth. The 1m scale stands about where the low original hearth would begin and raised about 45 cm (look SE).

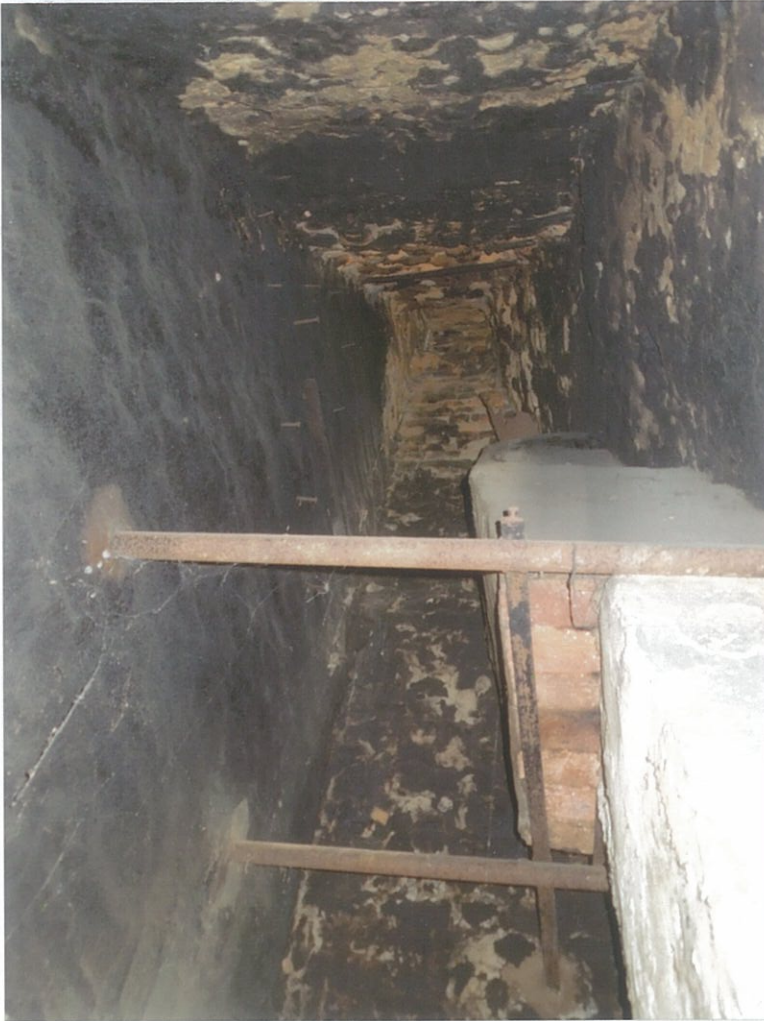
Two adjacent hearth beams were exposed. The front one, possibly reused and mended with iron hardware, also showed signs of being carbonized towards wall J4 (exterior, west). A second circular, blackened beam (poplar) was inserted to strengthen the upper wall of the hearth chimney. When a portion of the hearth ceiling was removed, the chimney stack looked fully intact.

44. A view up the chimney, blackened by soot since 1800s. The structure on the right and the iron bars, date from the 1940s.

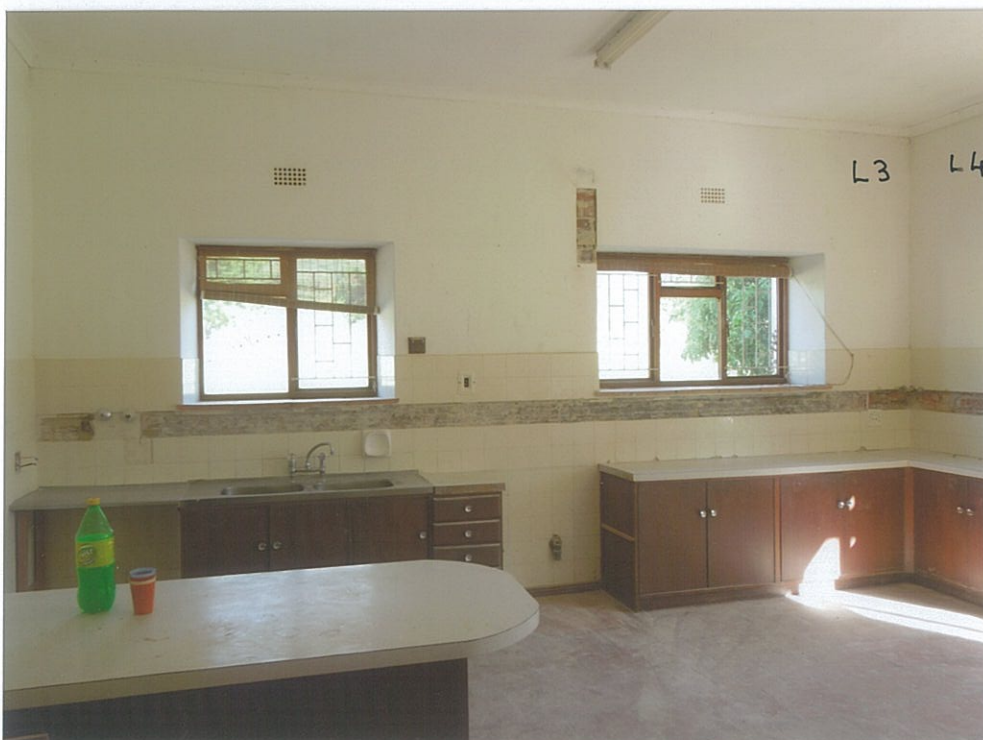
45.1/2 The walls of the modernized Kitchen L were fully tiled. Though a narrow band was cut along the walls, little new information was gained (look W & S).

Due to its many alterations, it is recommended that the (mid to) late Victorian period furniture (glazed doors and sash-windows), in the style of the *Voorhuis* façade be incorporated to harmonizing with the rest of the dwelling. The c.1940 tiled floor is still adequate and suitable. Something very similar would have been in the old Kitchen I.

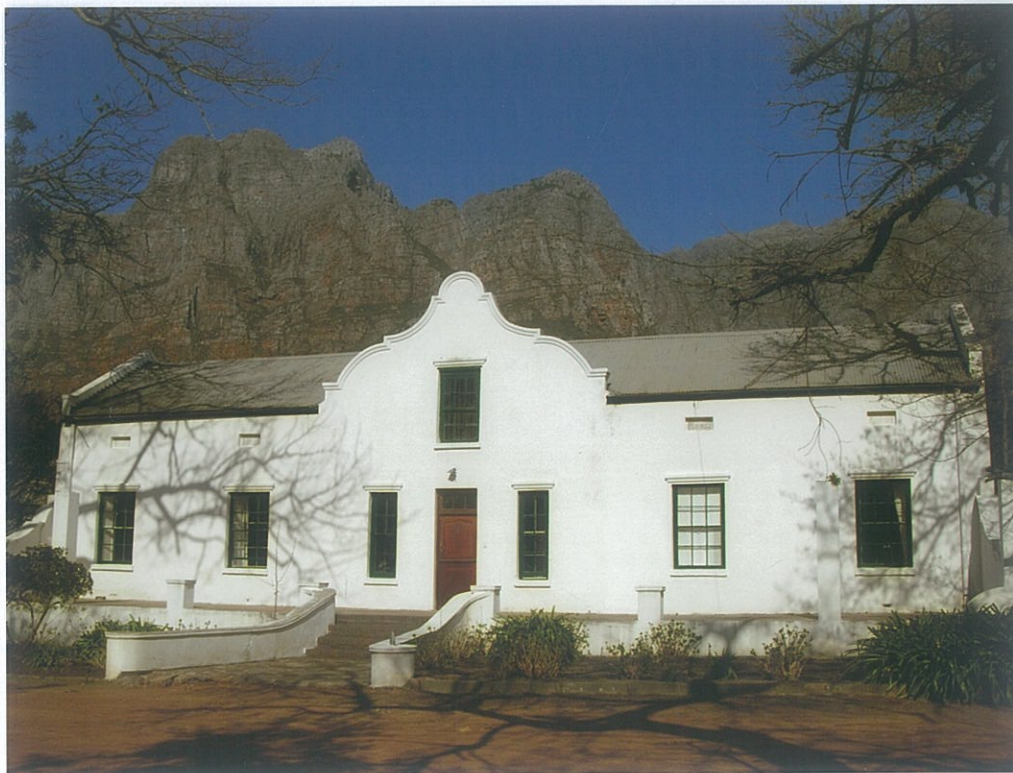
48. View of the Homestead, where the broad stoep and entrance staircase lend some status to the plain facade (look S).

My recommendation is that the c.1920 stoep be retained, but tiled up to the 1920 nose brick, which should be reinstated. The correct stoep incline would also drain water away from the house façade, which is presently not the case.

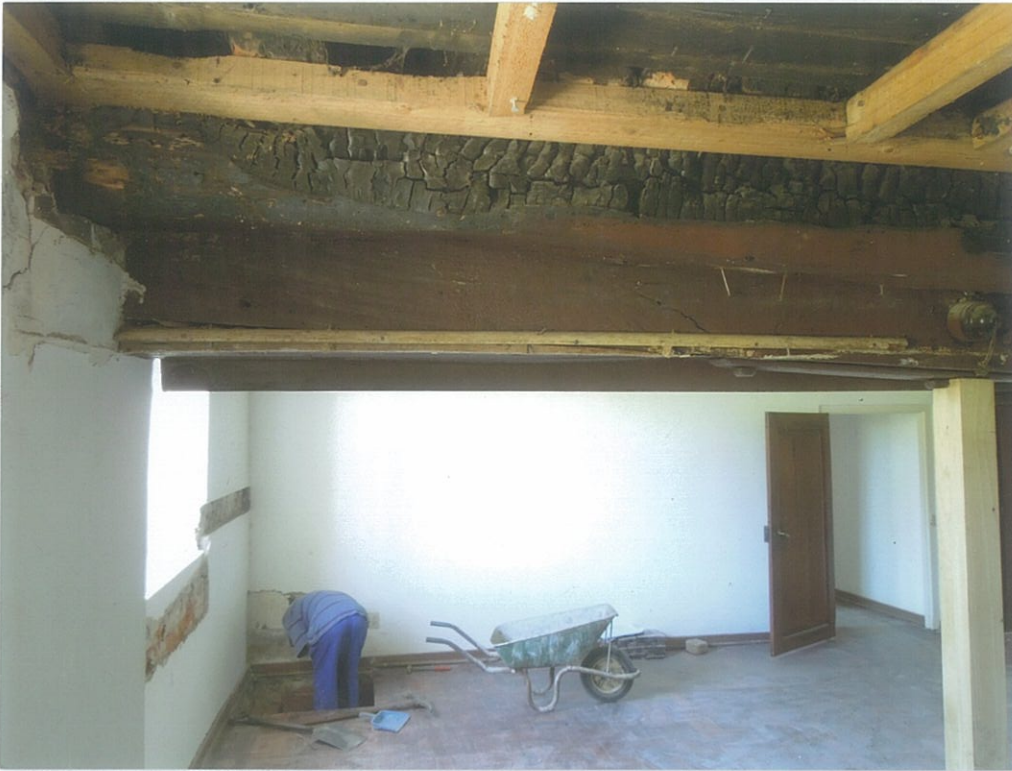
51. The old Kitchen I reflects most of the late 18th/early 19th century features of doors, ceilings, beams and hearth. The floor would certainly have been tiled with at least a sash-window in wall I4. The excavation is in progress (look N).

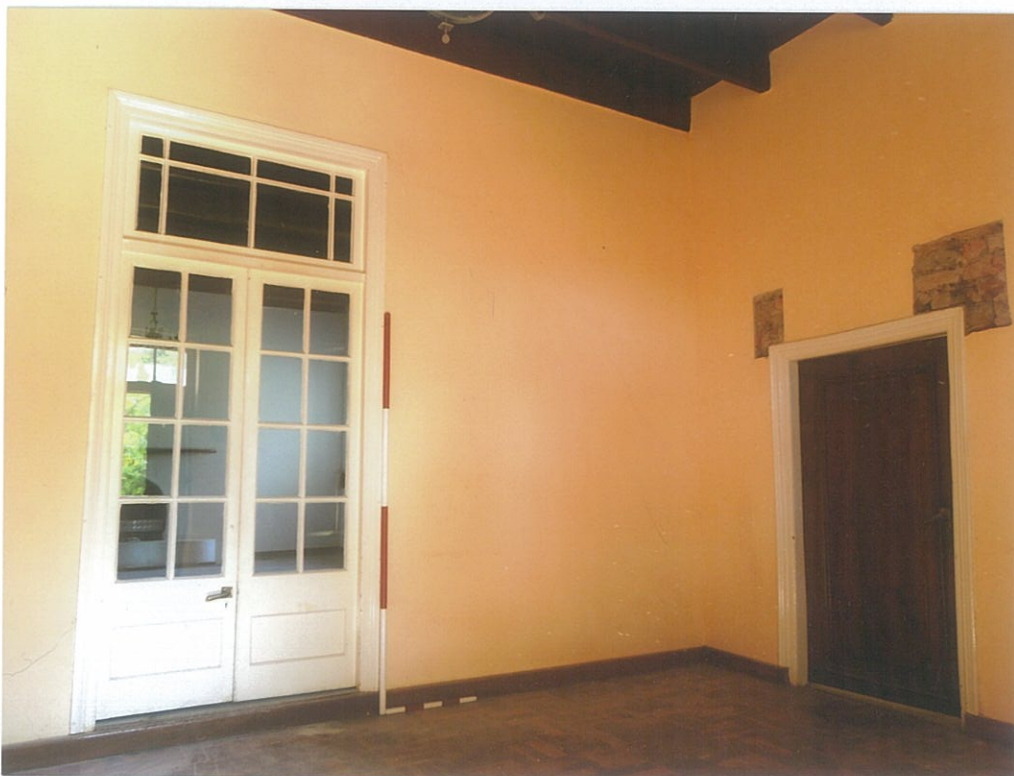
53. In the Voorhuis C, the glazed doors leading to the *Agterhuis* can be used as a stylistic marker (scale 2m) (look S).
