GEOHYDROLOGICAL ASSESSMENT OF THE AQUACULTURE DEVELOPMENT ZONE, AMATIKULU

PROJECT No: LL3224
REPORT VERSION: 1
DATE: November 2018
PREPARED BY: P.G. Hansmeyer *Pr.Sci.Nat.*

Report Type: GEOHYDROLOGICAL ASSESSMENT

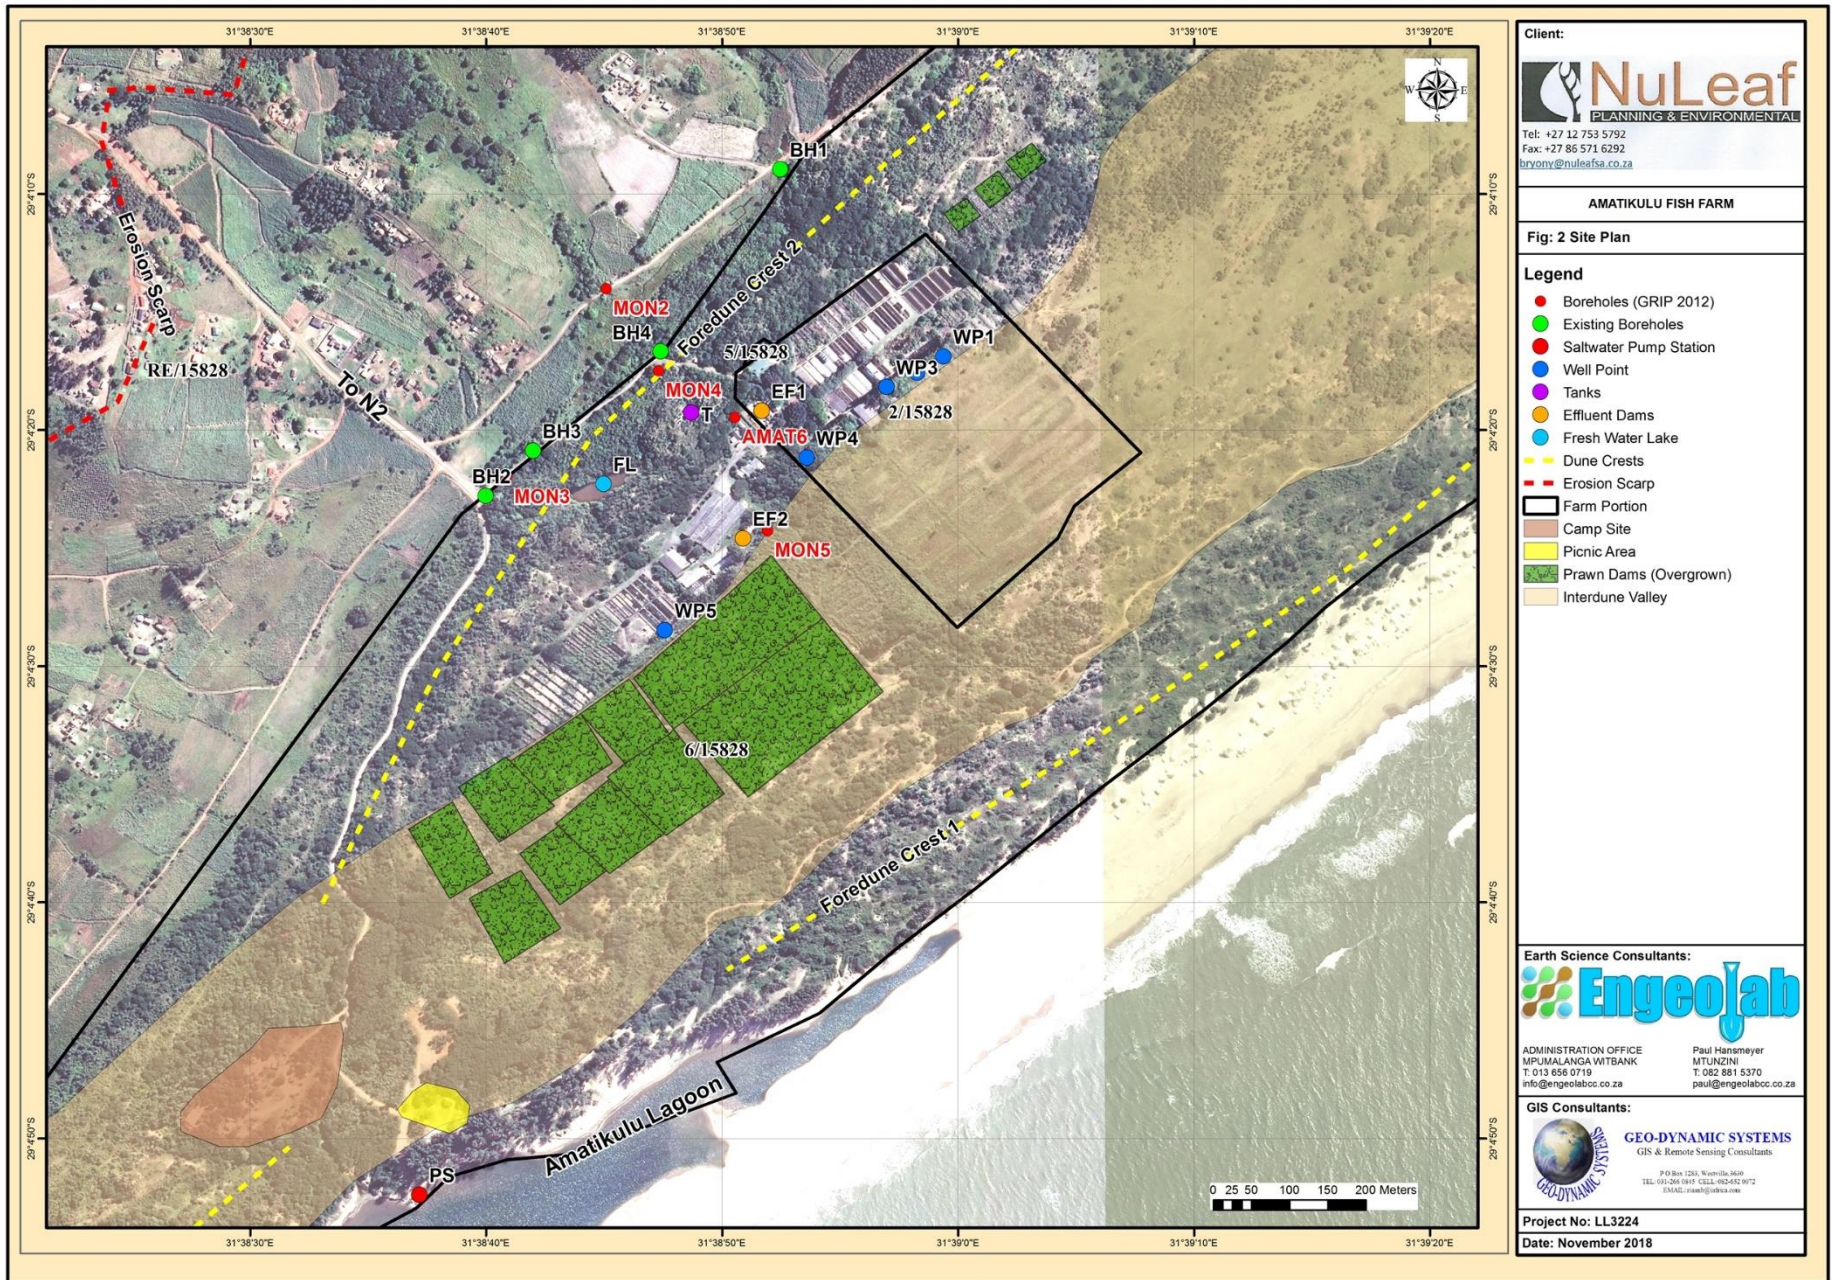
Figure 2. Site Plan

The site was viewed on Friday 16 November 2018 and a walk- and drive-over survey was conducted. Besides examining the site and the Amatikulu lagoon, the boreholes drilled in vicinity were also recorded – refer to Plate 5 below. A summary of sites that were recorded is attached as TABLE A and the various sites recorded are indicated on the Site Plan, Figure 2.

- Unfortunately, the coordinates of the appended borehole are incorrect and although being drilled more than 20 years ago, the profile was recognised but it's position could not be confirmed correctly on site;
- The 'MON' boreholes indicated on the Site Plan, Figure 2 were obtained from the NGDB and were not verified.

As a pollution control measure, the effluent from the Amatikulu Pet Food section is pumped into an effluent dam (EF2) near the factory where it is aerated and filtered and then pumped to a settling pond (EF1) from where it seeps into the ground – refer to Plate 6 below and EF1 and EF2 on the Site Plan, Figure 2. During the walk-over survey and an inspection of the dam and surroundings, the pollution control measures were seemingly dysfunctional as the effluent dam was filled to capacity and a pungent odor pervaded the surroundings.

The perennial fresh water lake (FL) indicated on the Site Plan, Figure 2 is located about 200m to the west of the tank stand and has never been exploited as a source of fresh water and should be investigated as a potential supply.

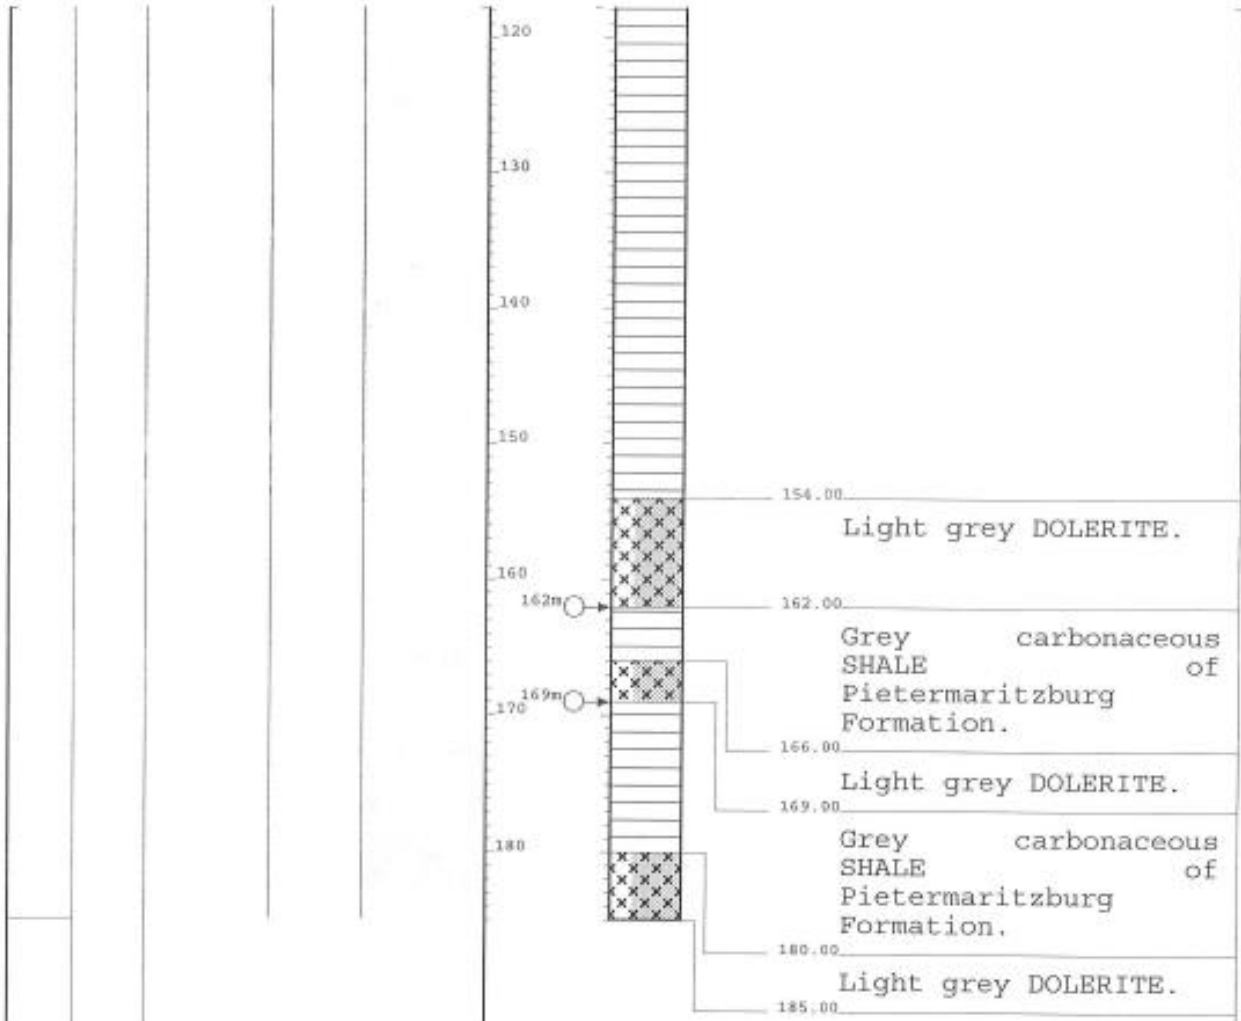
HOLE No: AMAT 5
Sheet 2 of 2

- 1) Water strikes at 10m, 68m, 86m, 162m, 169m.
- 2) Blow yield 3000 litres per hour.
- 3) Pumpset Depth 120m.
- 4) Galvanized CAP.
