*Ref. No. GEOM13-2019-003*

## **ELANDSFONTEIN COLLIERY EXISTING UNDERGROUND WORKINGS SUBSIDENCE INVESTIGATION REPORT**

**DECEMBER 2020**

Report Compiled by:  
**Mr. D. Lees**  
**Senior Rock Engineer**

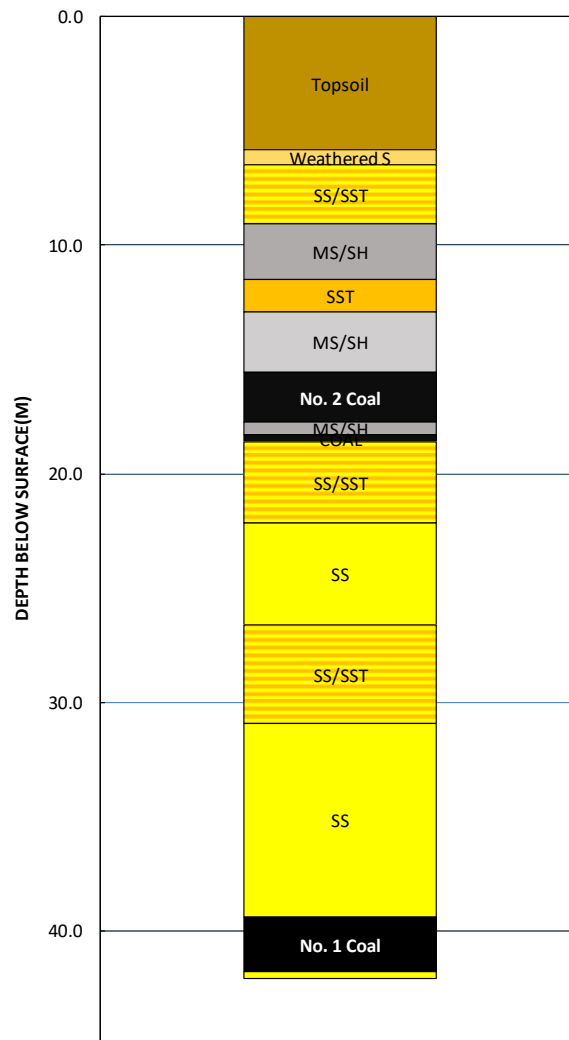
**Figure 2 - Generalised Stratigraphic Column for the Elandsfontein Mining Area**

As can be seen from the information included in **Figure 2** below, the No. 1 Seam (underground mining seam) is usually overlain by a Sandstone layer which is typically between 1.0 m and 14 m thick and has been found based on the available borehole information as well as routine visits to the opencast mining operations at Elandsfontein Colliery over the past Three (3) years to be competent and massive. A thin Coal / Shale layer has however been observed in some areas within the Sandstone later immediately above the No. 1 Seam which could be expected to result in localised roof instability in certain areas but would not be expected to result in extensive failures of the roof across large mining spans.

The Sandstone which overlies the No. 1 Seam is typically overlain by alternating layers of Siltstone / Sandstone and Sandstone which are in turn overlain by the No. 2 Seam. Generally, competent Sandstone layers have been found to constitute between 30 % and 50 % of the No. 1 Seam's overburden within the Elandsfontein mining area.

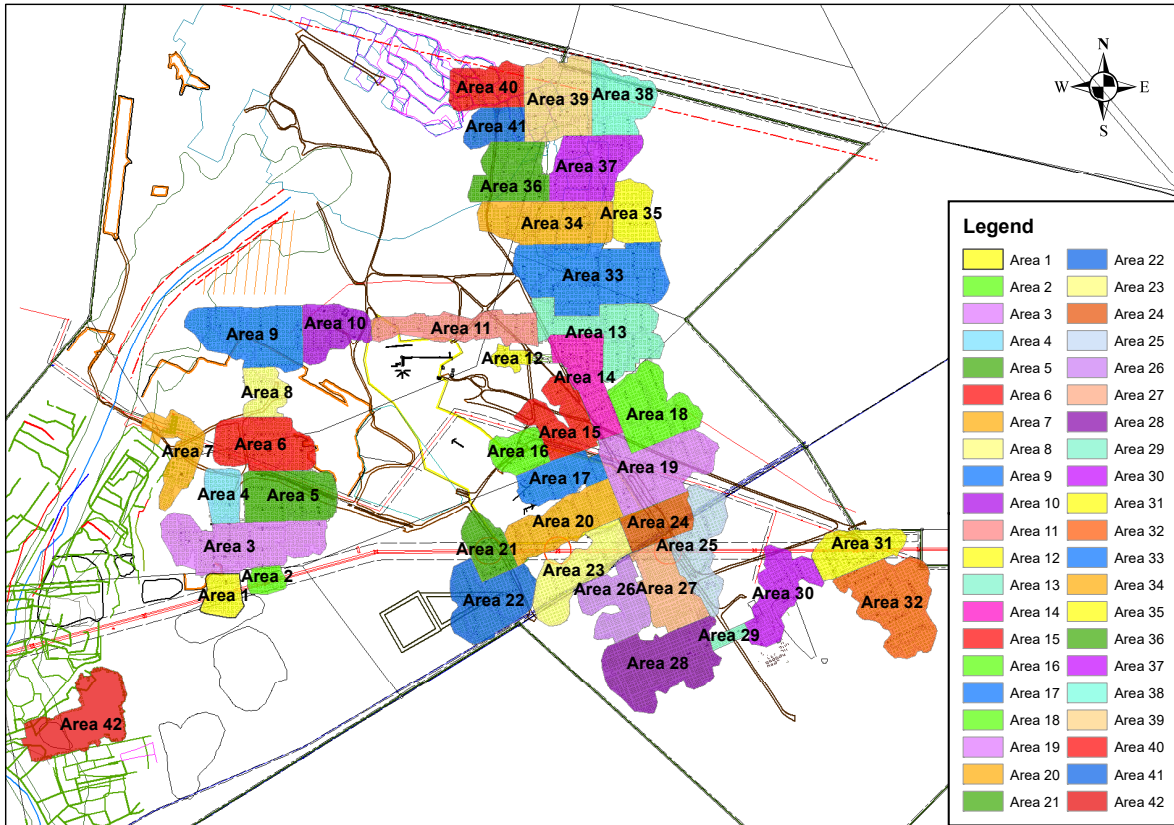
**Figure 3 - Identified Investigation Areas at Elandsfontein Colliery.**

For the purposes of this investigation, due to the geographical extent of the existing underground workings and the variability in pillar centres and mining depth, the existing underground workings within the Elandsfontein mining area have been sub-divided into a total of Forty-Two (42) individual areas based on the geology in each area in conjunction with the underground mining layouts (pillar and bord width dimensions). These areas are illustrated in **Figure 3** below and were generally named from South-West to North-East.

Area 42 is an area in the South-Western portion of the mining area for which there was no underground survey information (mining layouts) available at the time of the assessment. The No. 1 Seam in the area is believed to have initially been mined via underground mining methods before the No. 2 Seam above it was mined via opencast mining methods. This area has been excluded from the subsequent investigations in this report due to the lack of available information for it however, given the mining depth and the apparent thickness of the No. 1 Seam in this area it is recommended that it be classified and managed as a “High Risk” area when it comes to the possibility of surface subsidence and sinkhole formation until such time as additional information has been obtained for it and these risks assessed in more detail.

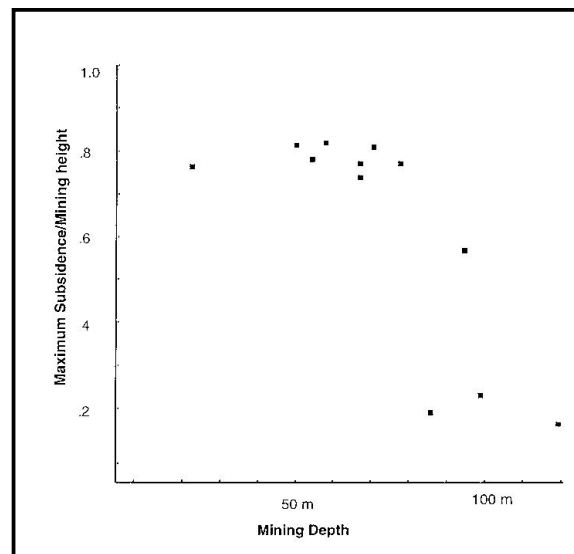
**Figure 4 - Estimated Factor to be applied to the Maximum Amounts of Expected Subsidence based on Mining Depth.**

According to van der Merwe and Madden (2010) **Figure 4** below can be used to adjust the expected maximum amounts of subsidence based on the depth at which mining is taking place.

In the panels under investigation mining took place close to boreholes in which the depth to the coal seam ranged from 13.9 m to 77.6 m.
