## **CONCEPT DESIGN REPORT**

Project Name: Restoration of ZK Matthews House  
Alice, Eastern Cape  
Project Number: TBA

Release Date:  
Print Date: 08/11/2016  
Template Date: 01/01/2012  
Document No: RPT-0001

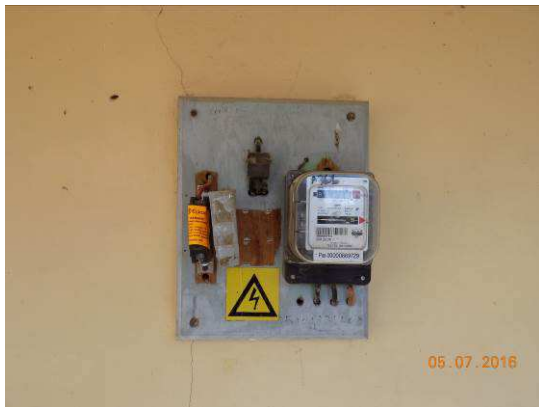
The existing site has a power supply via overhead conductor.

**Figure 26: Existing power distribution**
