**ANNUAL REPORT FOR THE TRONOX KZN SANDS  
(PTY) LTD FAIRBREEZE MINE**

**FOR TRONOX KZN SANDS  
DATE: 30 JANUARY 2019**

**Umlando: Archaeological Surveys and Heritage  
Management**

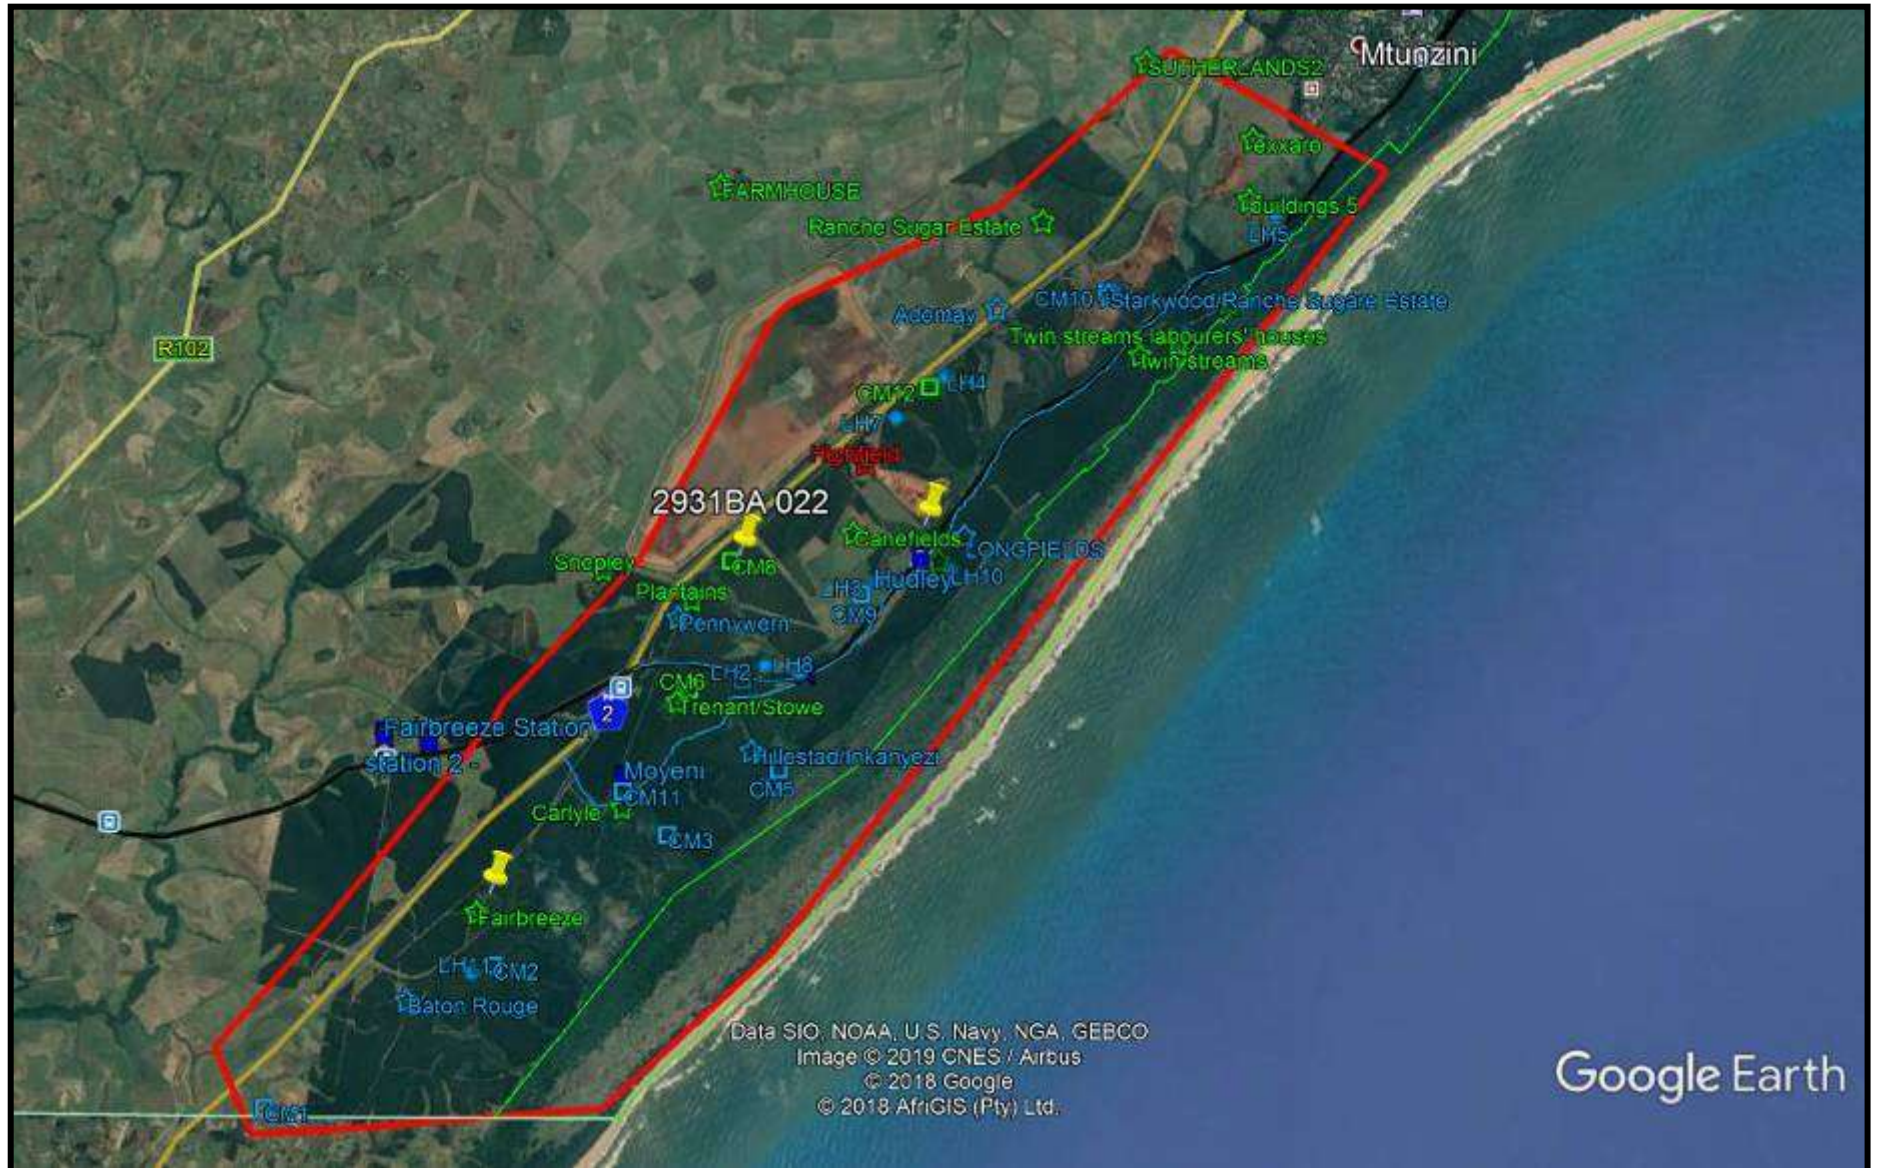
FIG. 8: LOCATION OF GRADED HERITAGE SITES IN THE MINING LEASE

Similarly, some buildings require permits to be destroyed, or parts of the building requires further mitigation. These were noted in the final HIA report. The locations of all heritage features have been submitted to the mine in Google Earth format. Figure 8 shows these sites according to significance:

- Red = very high significance
- Green = significant and needs mitigation, monitoring and possible additional permits
- Blue: low significance, might need monitoring
