**SPECIALIST REPORT ON THE DE WITTEKRANS ROCK ART SITE COMPLEX:  
DE WITTEKRANS PROJECT – MASHALA HENDRINA COAL MINE (PTY) LTD,  
LOCATED NEAR HENDRINA, MPUMALANGA PROVINCE**

**September 2023**

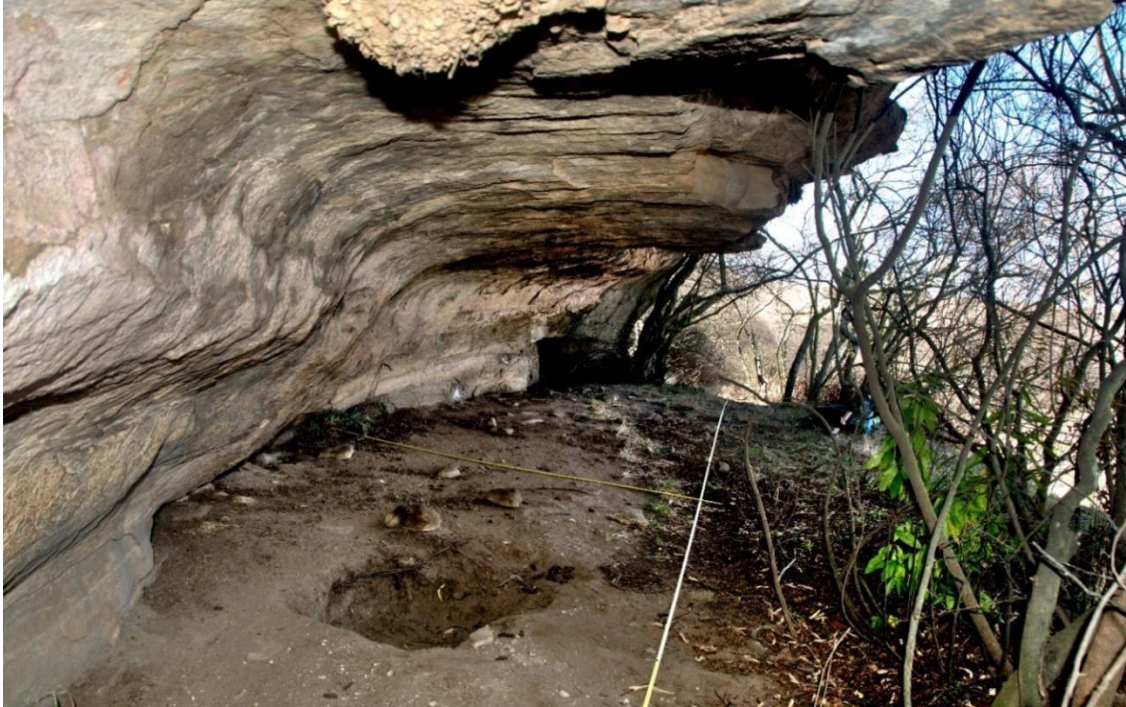
The first of the six painted sites, Site 9a (**Figure 3**), is a small shelter with not many images. It measures 11.5 metres along the dripline. The paintings here (though sparse), cover 10 metres across. There is a protruding step on the left-most part of the shelter, at about 1 metre high – the first few paintings are placed above this step. The most striking image on this part of the shelter is a depression on the rock which has

*Figure 3: Site 9a - photo taken from the left side of the shelter.*

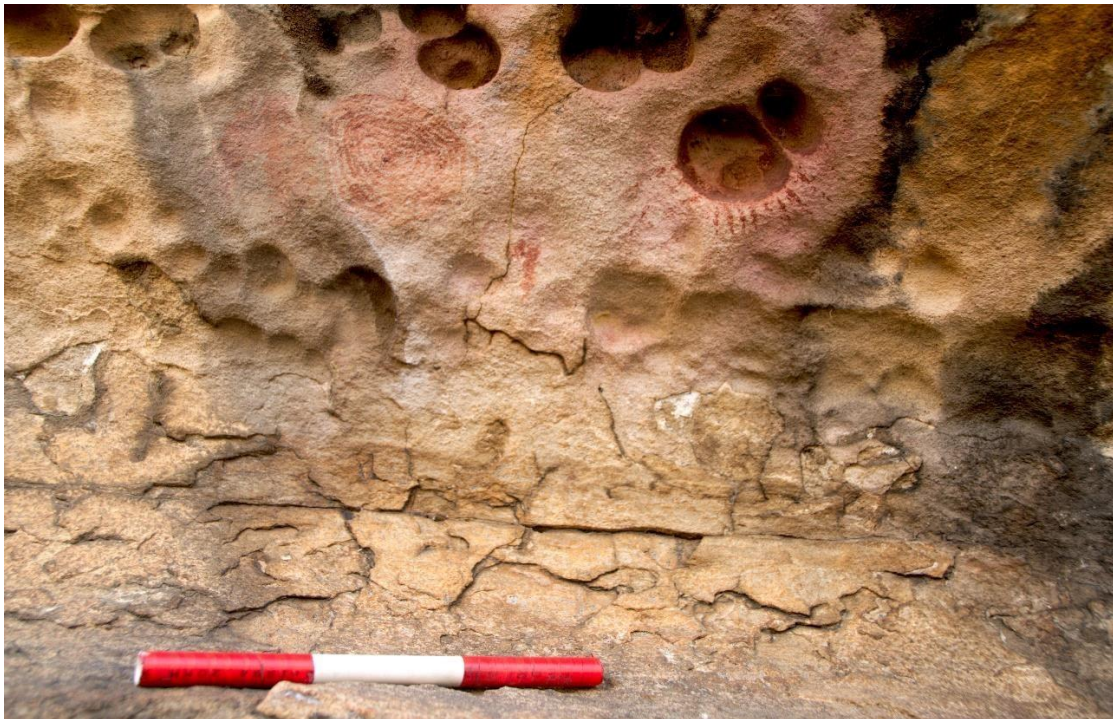
been filled with red paint, with 'rays' coming out of it as if to resemble sunrays or something similar (see **Figure 4**).

*Figure 4: Images on the left-most part of Site 9a.*

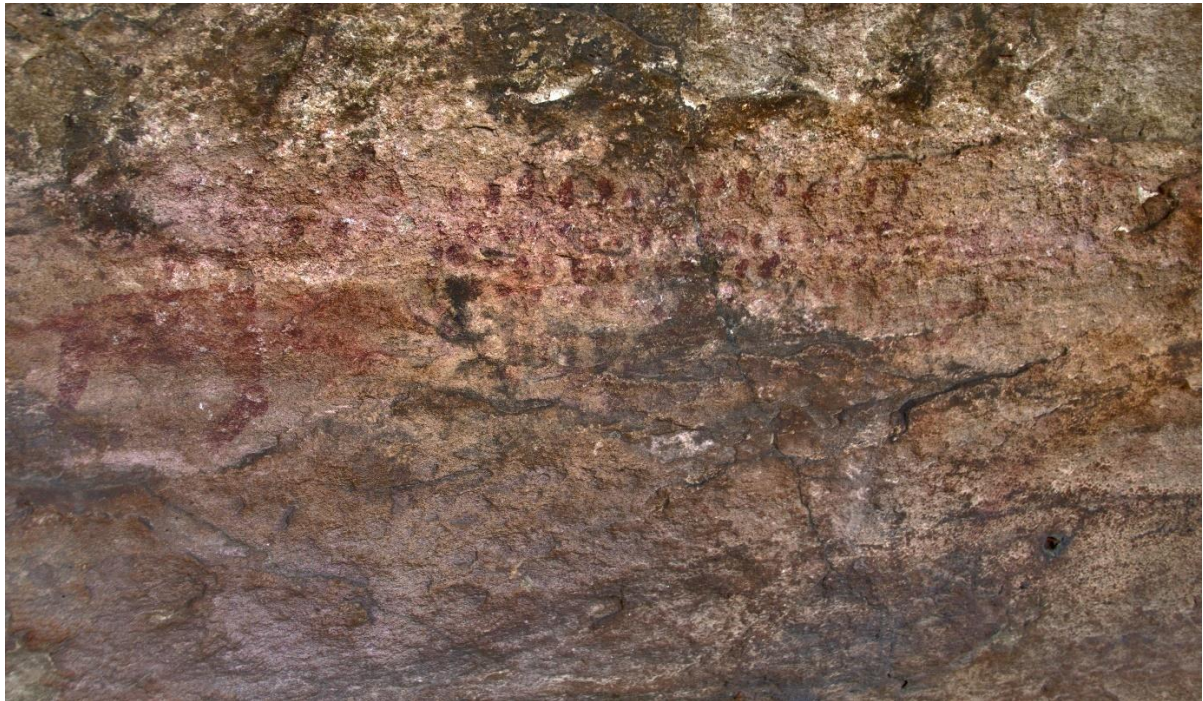
Other images at 9a are on a lower panel, to the right (**Figure 5**) - these are faded red finger dots (in a cluster of four rows of dots) and one dark-red abstract image in a slightly thicker and coarser pigment from the rest of the paintings on this panel. An identifiable object (perhaps a bag?) is painted to the left of the finger-dot cluster, in the same red pigment (see **Appendix 2**).

*Figure 5: Main panel at 9a. Image enhanced using GIMP to clearly show the paintings.*

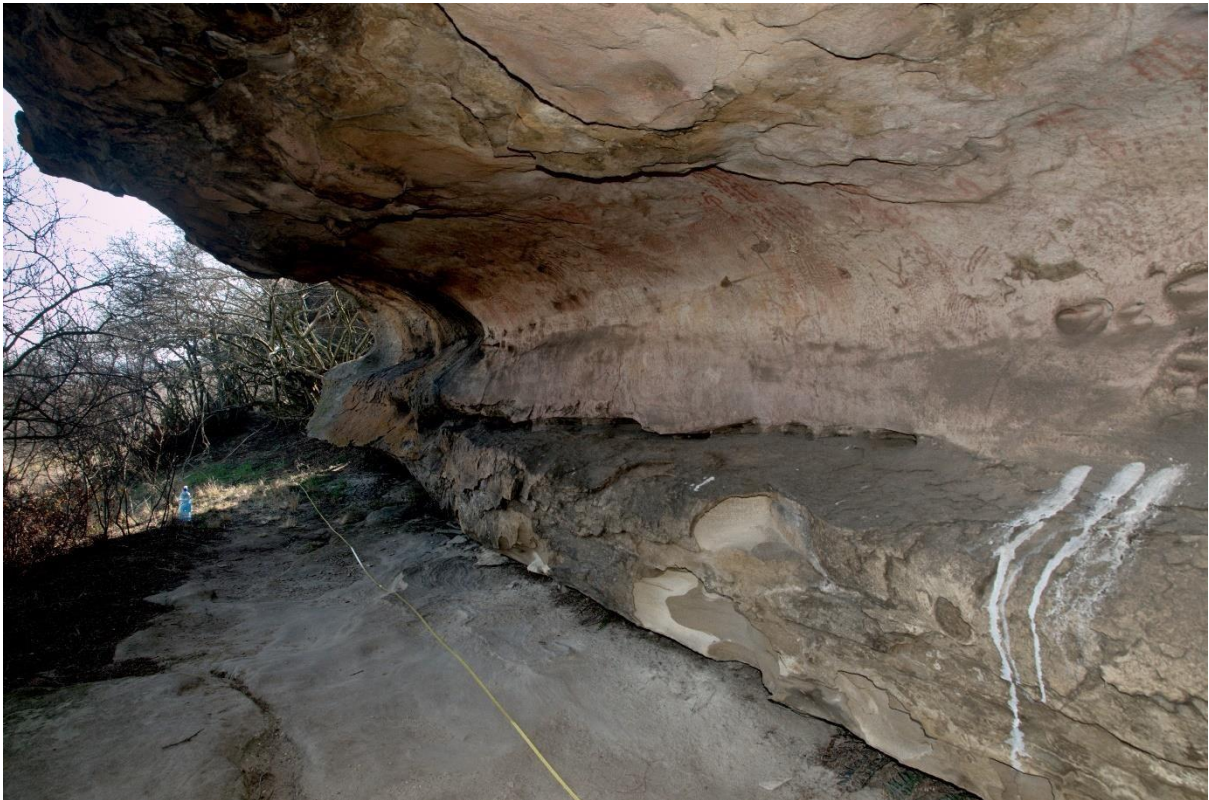
12.4 metres wide, with variable heights across from the ground to the ceiling. At the left-most opening, the shelter ceiling is 2.14 metres high, and 1.96 metres at the right most part of the shelter. In the middle part of the shelter, the ceiling is 1.69 metres high. The overhang curves in for up to 2.2 metres deep, with a sloping ceiling (**Figure 6**).

*Figure 6: The overhang shelter at Site 9b.*

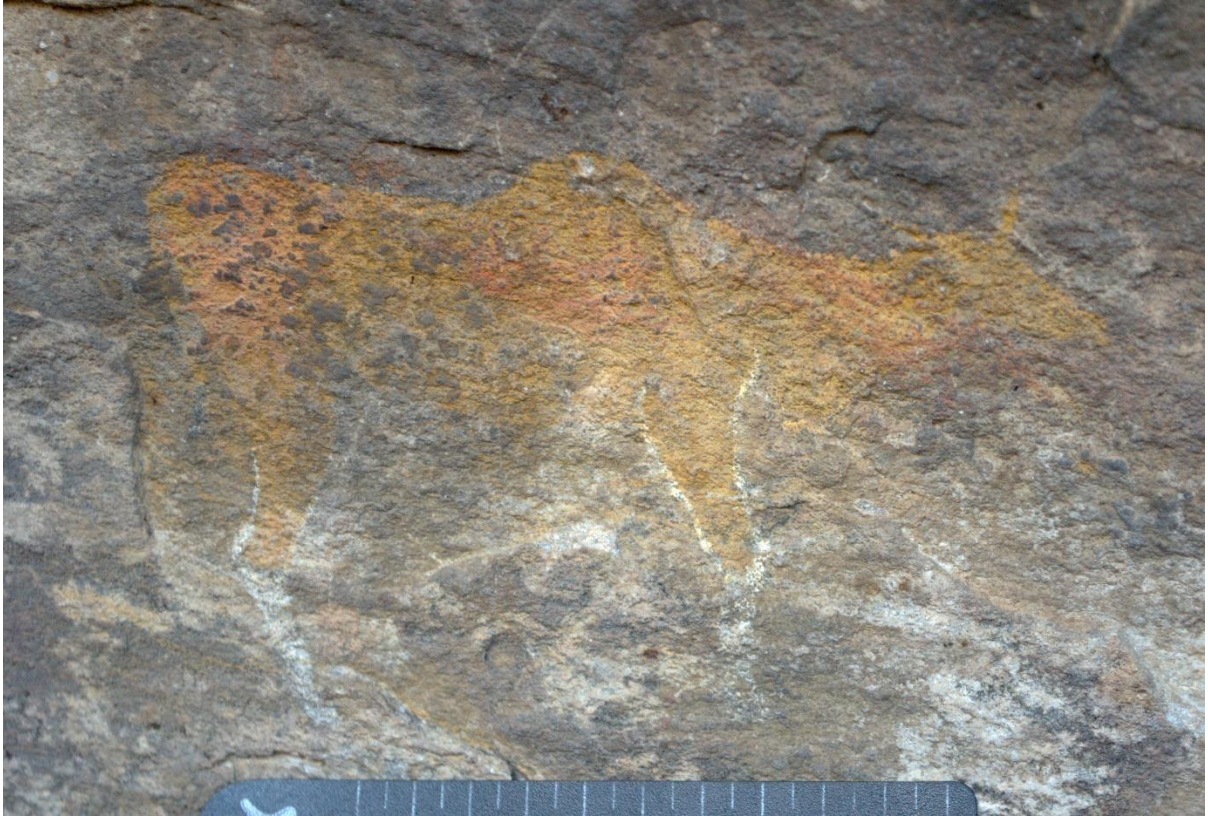
miniature. On the ceiling are two animal figures (bovid-like) which are painted in a thin, yellow pigment and in a depression on the rock surface. On the left-most part of the shelter are two bichrome eland, painted in a yellow and white, chalky pigment (**Figure 8**).

*Figure 8: Bichrome eland at Site 9c.*

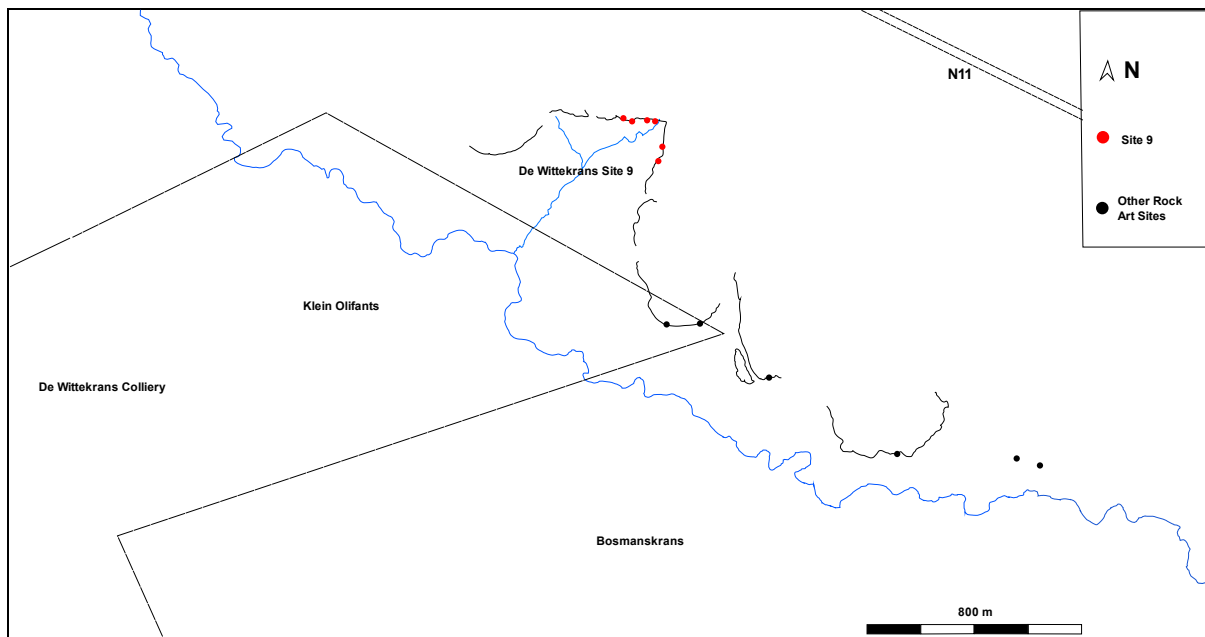
Two more rock painting sites are located across the river from 9d. They are small overhangs along the krans line, and at each site is a 'geometric' image executed in orange pigment and by the finger technique. 9e consists of only one small cluster of finger dots, to make a circular image/pattern. At 9f is painted a 'geometric' shape that resembles 'apron-like' images painted at 9b and 9d.

Figure 11: Distribution of rock art sites at De Wittekrans and along the Klein Olifants River.
