# **DU TOIT FARMSTEAD**

Portion 7 of the farm Steenkoolspruit 18-IS, Mpumalanga Province.

**Architectural Historical Assessment**

**Issue Date:** 3 December 2012

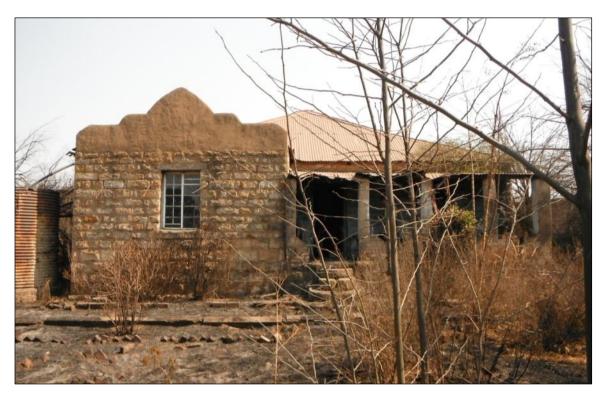
Figure 5 – General view of eastern facade of the dwelling. Note the porch on the right and gabled wing on the left.

This is the building with the most architectural detailing on the site. However, these details are crude and many of the fixtures and fittings in the building have been removed. Only one or two original windows have remained intact while the others have been replaced with steel frame products.

On the condition that the following recommendations are adhered to, no heritage reasons can be given for the building not to be demolished. The conditions to this recommendation are:

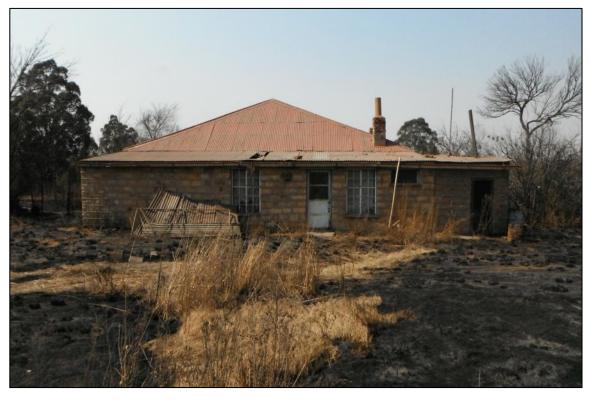
Figure 6 – Western facade of Building A. The annex in the front includes a bathroom.

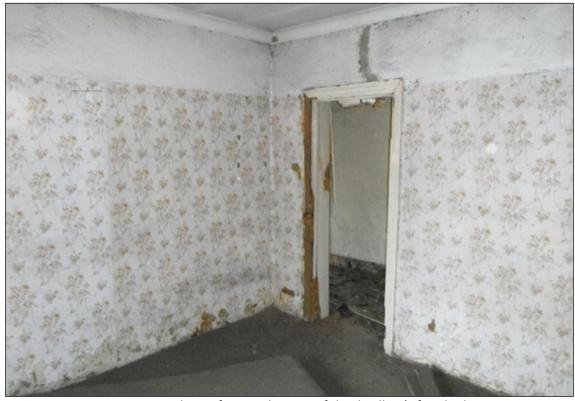
It is therefore apparent that from construction to the present day the farm dwelling was resided in by only members of the Du Toit family. However, in more recent years sections of the house appears to have been used as shelter by squatters. The remains of old mattresses and informal fireplaces inside some of the rooms could be observed during the site visit.

Figure 8 – General view from within one of the dwelling's four bedrooms.

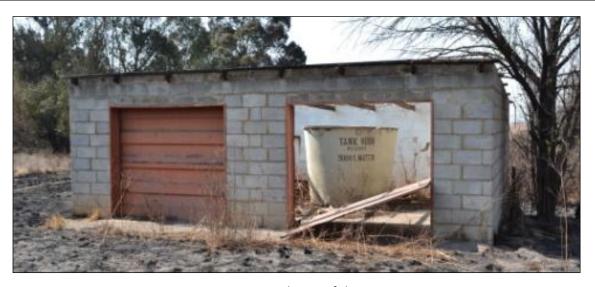
Building 2 is a garage that was constructed with cement bricks and would have had a corrugated iron roof. At the time of the site visit the roof was missing.

Figure 9 – General view of the garage.

No mitigation measures are required for this building.

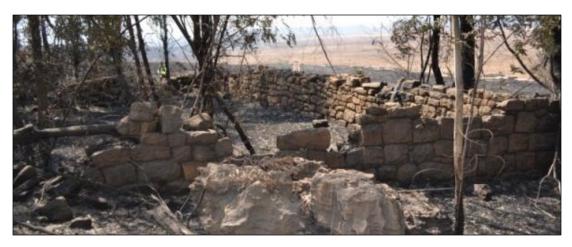
Figure 11 – General view of the kraal as seen from the south.

The kraal walls were constructed applying the double-row-method with filling in between. Stone was selected on site and roughly chipped into square cubes prior to construction. Construction commenced directly on the surface without foundations and the walls have retained their stability over time reflecting the quality of the masonry work.

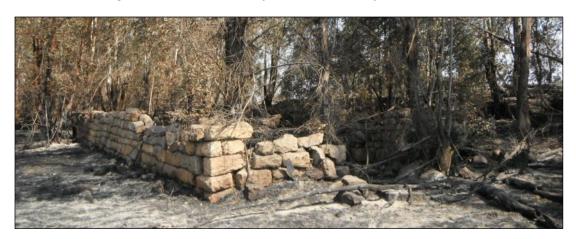
Figure 12 – Another view of the structure, in this instance from the north.
