HERITAGE STATEMENT ALPHA ONE AND PUMP HOUSE.

INTRODUCTION.

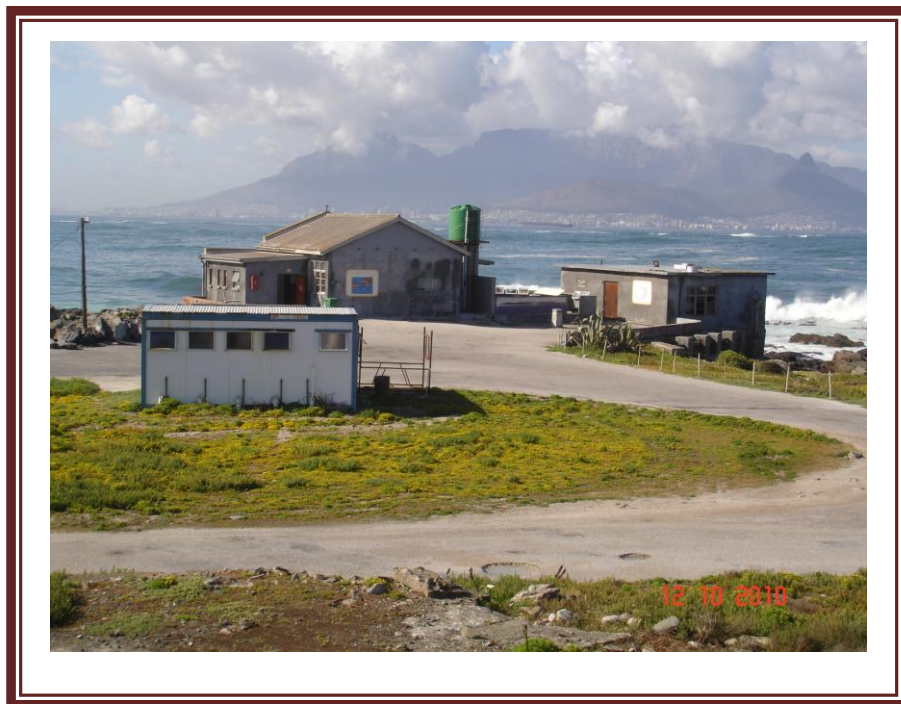
Situated on the south eastern corner of the island overlooking Table Bay towards signal hill. Consists of a number of structures and an associated, although disjointed, cultural landscape. A structure known as the pump house, a bar area with open patio, water tank attached to bar area, vehicle turning circle, toilets added later as a temporary measure as well as septic tank. Prominent and very visible foundations and ruins immediately opposite vehicle turning circle, disused sewer outfall pipe, stainless steel inflow pipe for pumping sea water to desalination plant. Pumping equipment.
