Biodiversity Management Plan

Jagersfontein Developments (Pty) Ltd

March 2013

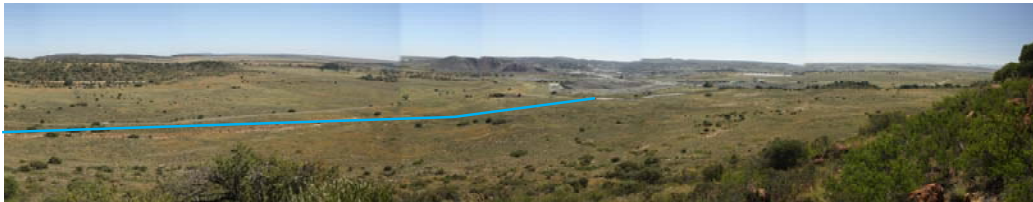
Figure 2: Panorama of the same drainage line as depicted in Fig. 1. The drainage line is indicated in blue.

Figure 3: A close-up of the drainage line as depicted in Fig. 2. The erosion of this drainage line is unnatural and considered a large disturbance. The erosion is caused by increased runoff from a mine dump to the south of the drainage line.

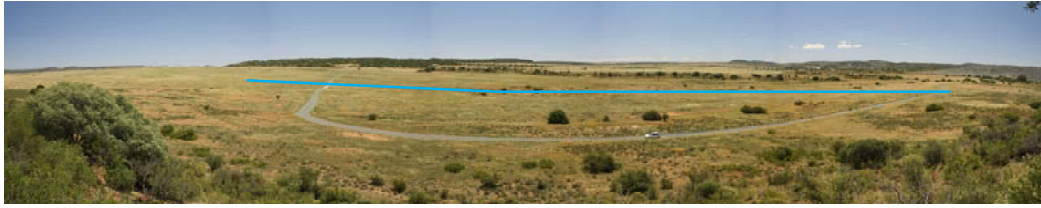
Figure 4: Panorama of another drainage line further west than the one depicted in Fig. 2. The drainage line is indicated in blue.

Figure 5: Close-up of the drainage line depicted in Fig. 4 (indicated by blue line). Note the sheet erosion. The drainage line itself also exhibits moderate gully erosion.

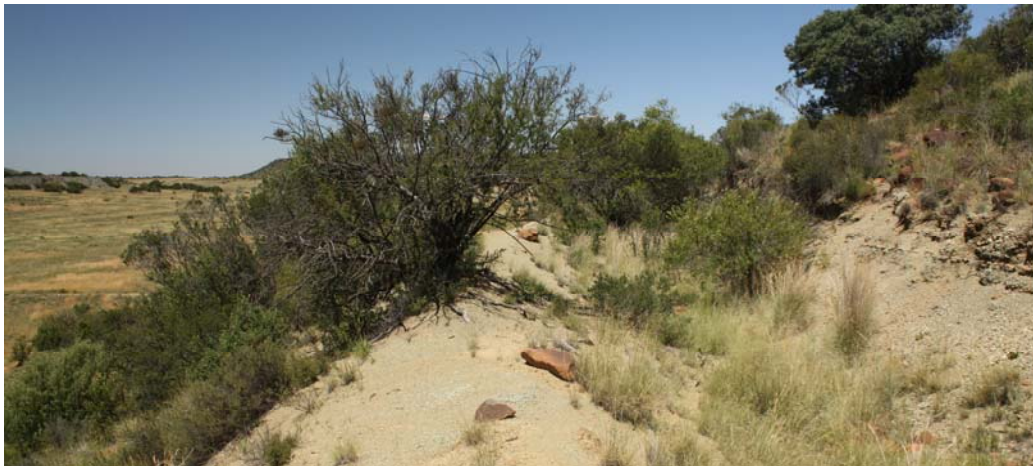
Figure 8: The surface runoff drain along the slopes of the large southern hill formation in the mining area. The drain was most probably constructed during the late 19th century.

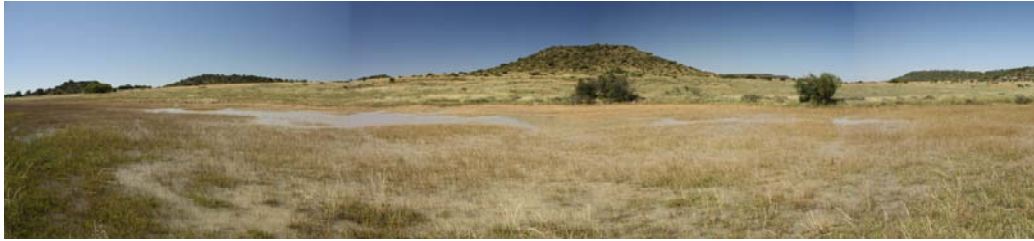
Figure 14: Panorama of the mine sump situated to the south of the processing plant. This is the same dump as depicted in Fig. 1 which obstructs a drainage line and leads to the formation of an artificial wetland (blue figure).

Figure 15: A close-up panorama of the above depicted wetland.

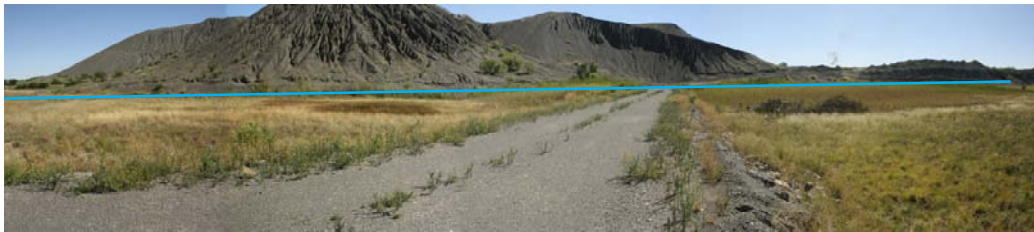
As the seasonal stream flows past the large mine dump the sediment load of the stream is increased drastically. As a consequence the stream is severely degraded in this portion. A small portion of the mine dump is also situated within the seasonal stream and this further transforms and degrades the stream. In this area the main channel of the stream is dominated by *Typha capensis* (Bulrush). The floodplain is dominated by several riparian grass and sedge species with a fair amount of dwarf karroid shrubs also present. Isolated trees are also present. The soil surface is covered by a thick layer of sediment and this causes suffocation of much of the vegetation and aquatic- and soil fauna. As a result the vegetation is in a severely degraded condition and the fauna in this area is very low in diversity.

As the seasonal stream flows east a large dirt roadway crosses the stream. The culverts and drainage underneath this roadway is inadequate to allow drainage of the seasonal stream. In addition to the inadequate drainage the large amounts of sediment as mentioned above cause blocking of the culverts. The culmination of the above causes the water flow to dam up in this area. The condition of the seasonal stream is severely degraded in this area. The area contains only limited vegetation with most of the vegetation suffocated and the faunal component severely degraded.

Figure 16: Panorama of the large main, central mine dump as well as a portion of the seasonal stream (stream indicated in blue). A roadway also crosses this seasonal stream.

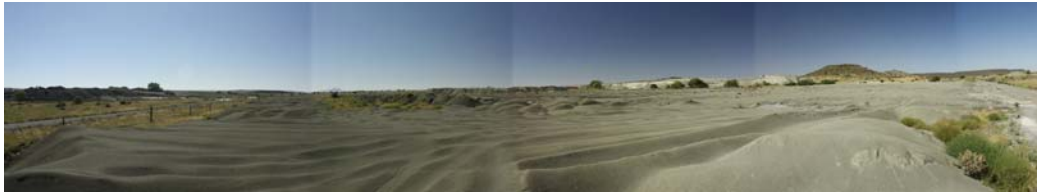
Figure 24: Extensive screened sand dumping south of the seasonal stream. These sand dumps cause severe disturbance of the adjacent seasonal stream. The sand dumps act as a surface runoff barrier and cause ponding of surface water. The sand dumps also cause severe sedimentation of this stream.

Figure 25: A close-up panorama of the screened sand dumps. The extensive nature of these dumps are evident.

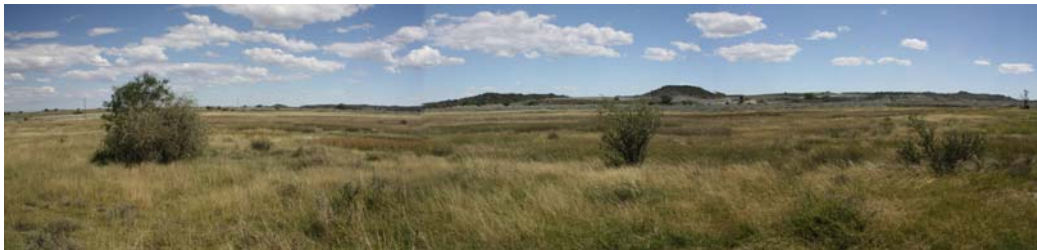
The stream is severely retarded at the above road crossing. Consequently on the eastern side of the road crossing the stream is starved of water flow and is consequently severely degraded. In addition, extensive areas of dumped screened sand occur in the floodplain of the stream. This also adds high volumes of sediment to the stream and further degrades its condition.

Figure 26: Panorama of the seasonal stream near the eastern border of the mining area.

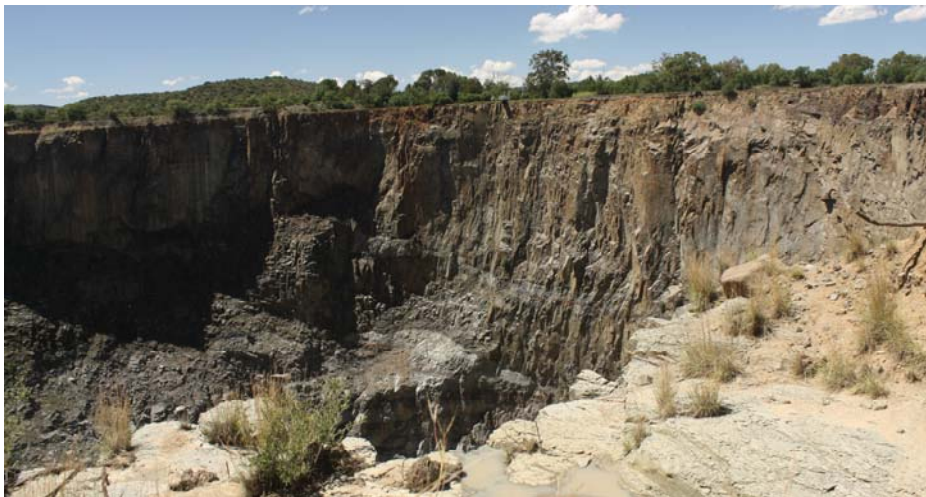
Figure 35: The Jagersfontein Kimberlite Pit.

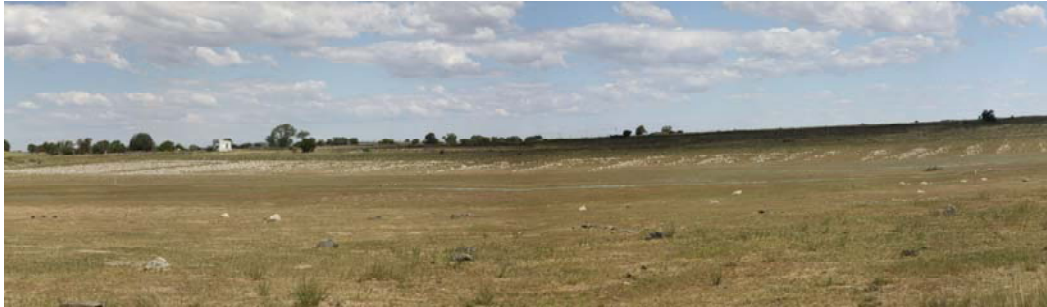
Figure 39: A portion of the historical kimberlite fields on the southern side of Dam 10. These fields are considered to be disturbed areas. The rows of kimberlite boulders are clearly visible.

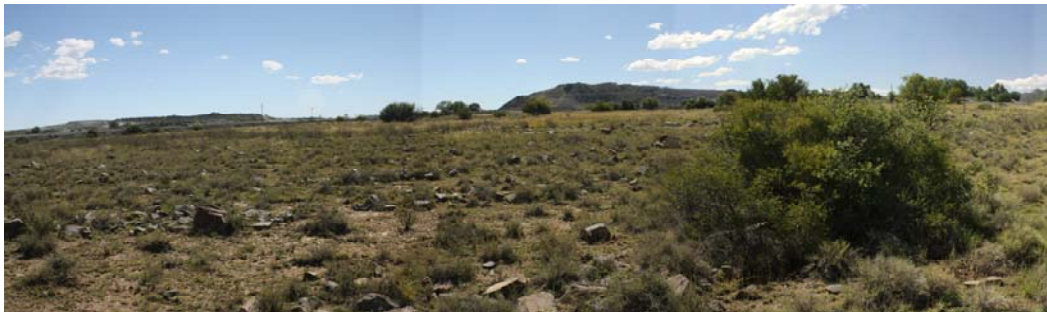
Figure 40: A portion of the historical kimberlite fields on the northern side of Dam 10. The strewn kimberlite boulders are clearly visible. The vegetation in this area is transformed from the natural but is in a stable condition.
