REPORT BY EDWARD MATENGA AUGUST 2004

APPENDIX I

BLUE STONE QUARRY WALL CONDITION SURVEY REPORT

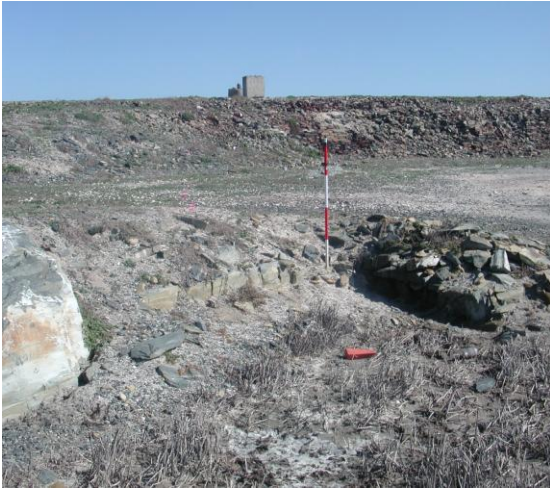
Wall 3

They end against either side of the same boulder forming a soil-retaining platform from which quarried stones were loaded into lorries.
