**OLD BETHLEHEM FARM 153
DWARS RIVER VALLEY, DRAKENSTEIN
STRUCTURAL & RESCUE INVESTIGATIONS DURING
WINE-CELLAR RENOVATIONS 2012**

JANUARY 2013

**Report prepared for
RESIDE PROPERTIES (PTY) LTD**

**H. N. VOS (BA, MA Arch., US)
Historical Archaeologist & Consultant
ARCape Consultancy PO Box 379 Stellenbosch 7599**

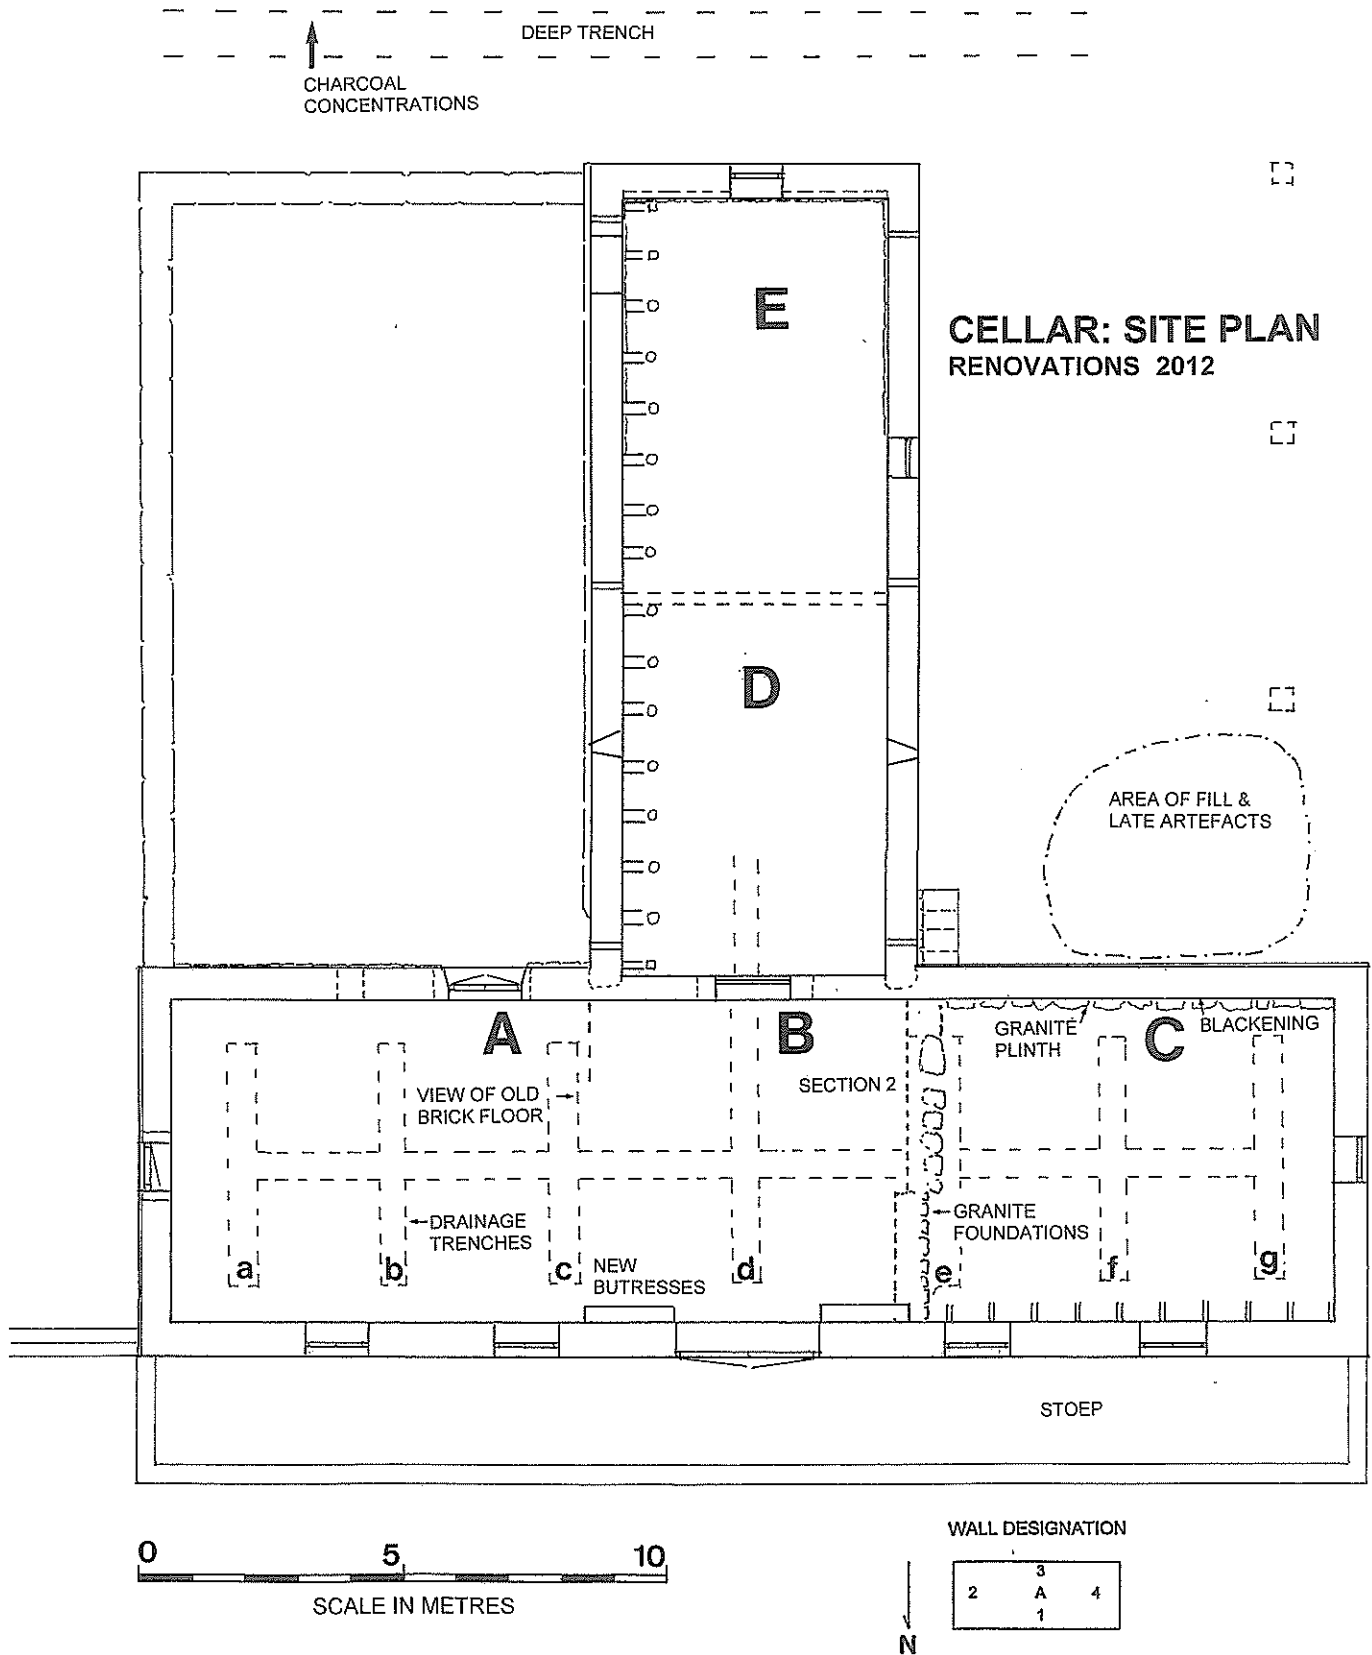
FIG.5.2 Groundplan of the Cellar showing the position of the demolished wall B/C (Trench e), the drainage Trench c with its floor layer, the southern trench at back (yellow clay stratigraphy) and yard area of Fill with 18/19th century artefacts (Vos 2013).

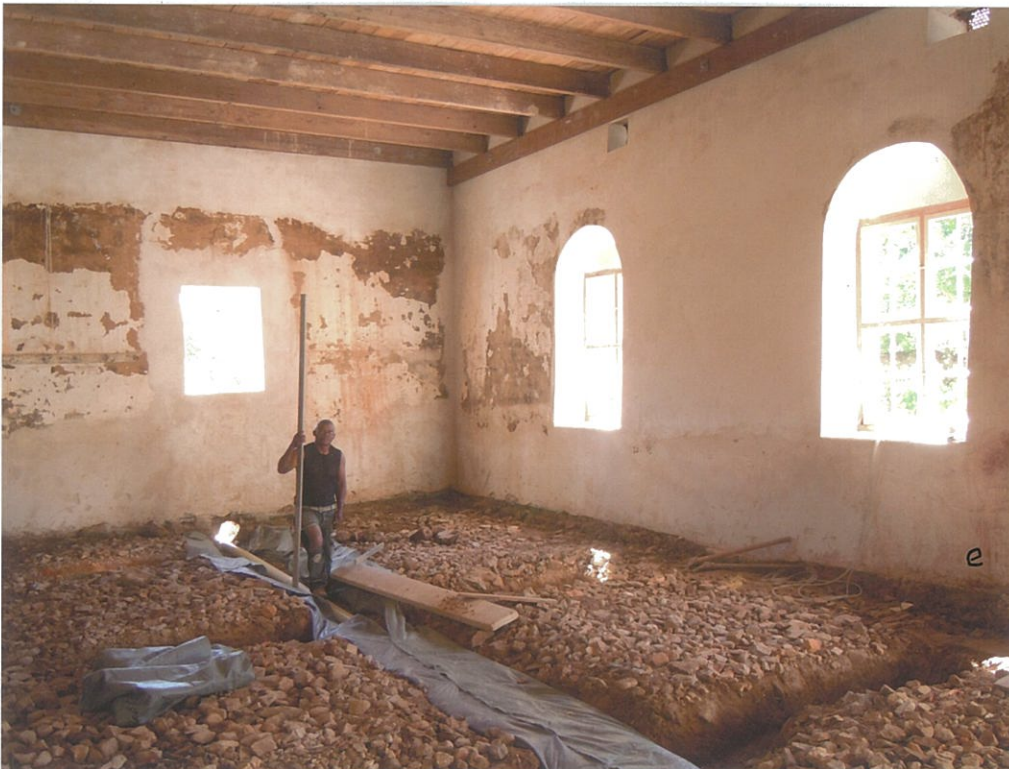
7. View towards Room C façade, with Trench e on the right (look W).

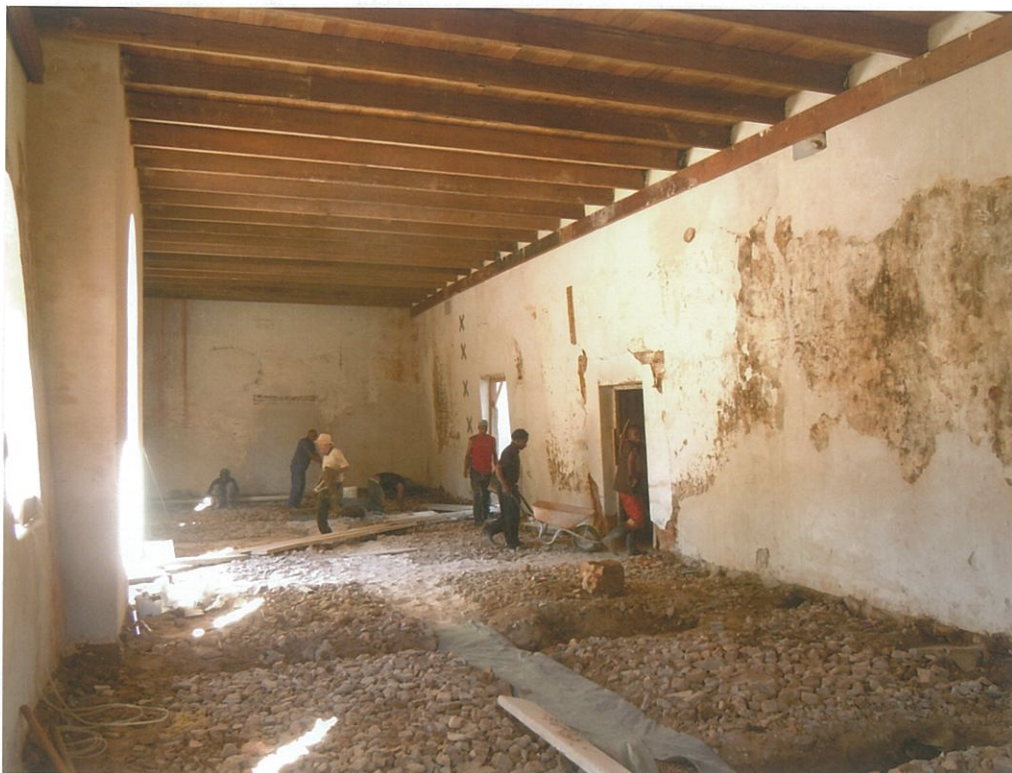
8. View from Room C towards Rooms AB on the interior. Note the new ceiling beams and the buttress on the left. The two men on the right are standing near Trench c, which is recorded in the following photos (look E).

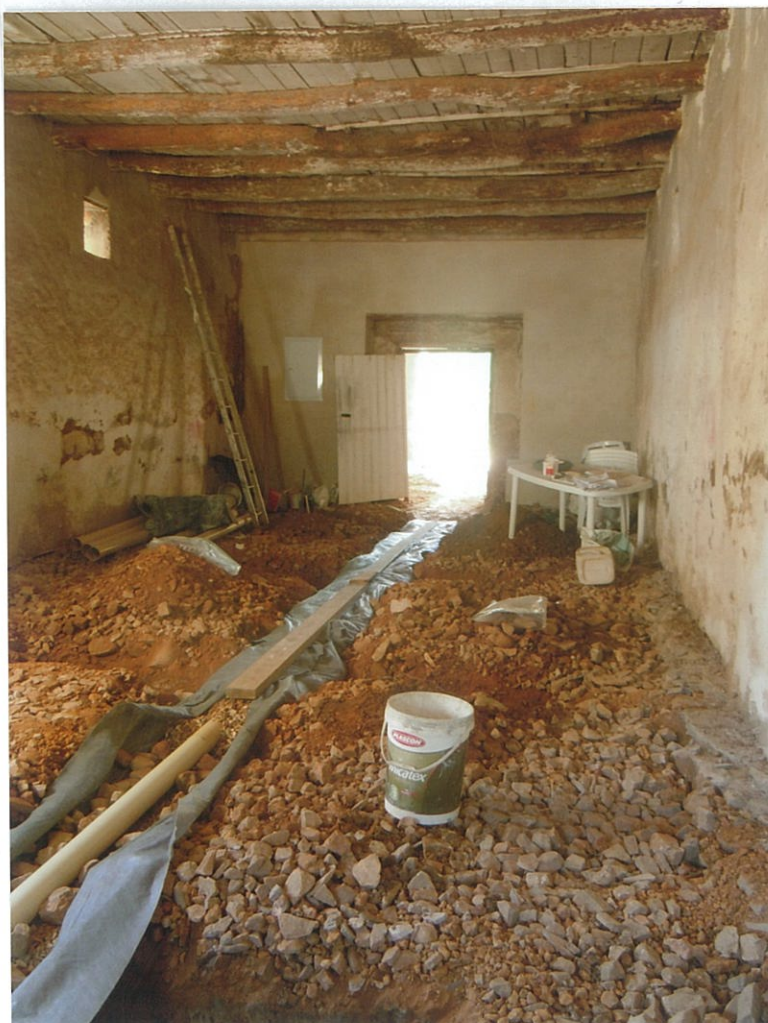
13. Opposite view in the T-wing (look N), with the entrance opening towards the front wing. Note the old poplar beams (early 19th) still in position.

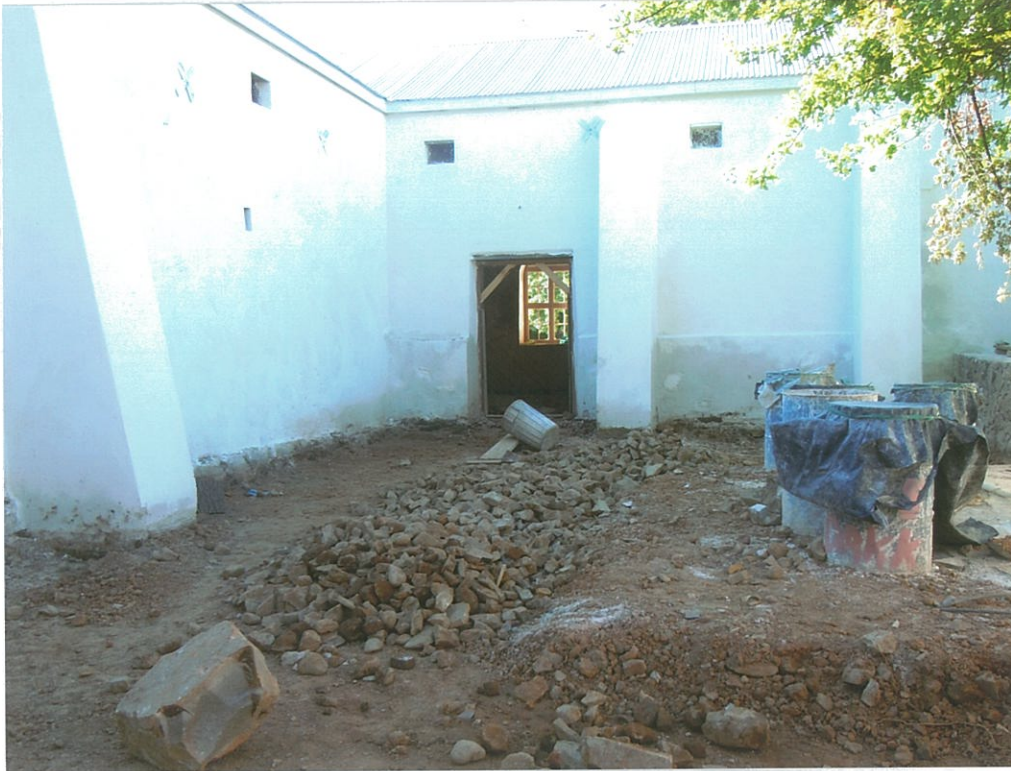
16. View of the eastern enclosure yard. The cement floor has been removed to be replaced with cast concrete. Note the position of the stabilizing buttresses (look N).

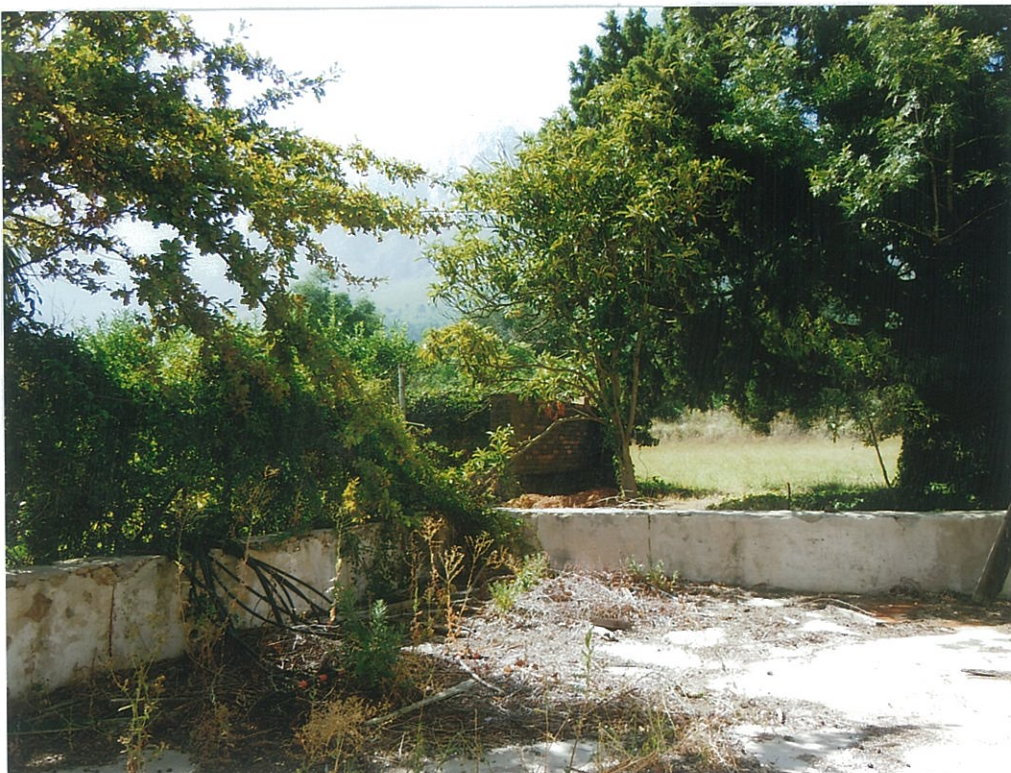
17. An earlier view of the backyard (look S).

At the rear of the Wine-Cellar a deep trench for drainage and a wall were dug. Directly behind the low stone wall of the eastern yard, the soil stratigraphy was exposed (FIG.2). Note the 18-20th century upper clayey soils and brown surface. Lenses of 18th century brick indicate the period when the Cellar was built. Immediately below the brick pieces stretch the yellow clays, studded with charcoal specs. It is now evident that these thick clay deposits date millennia earlier. The Cellar was dug into these sloping clay banks, which were used as sun-dried bricks that were fired orange and shades of cream.

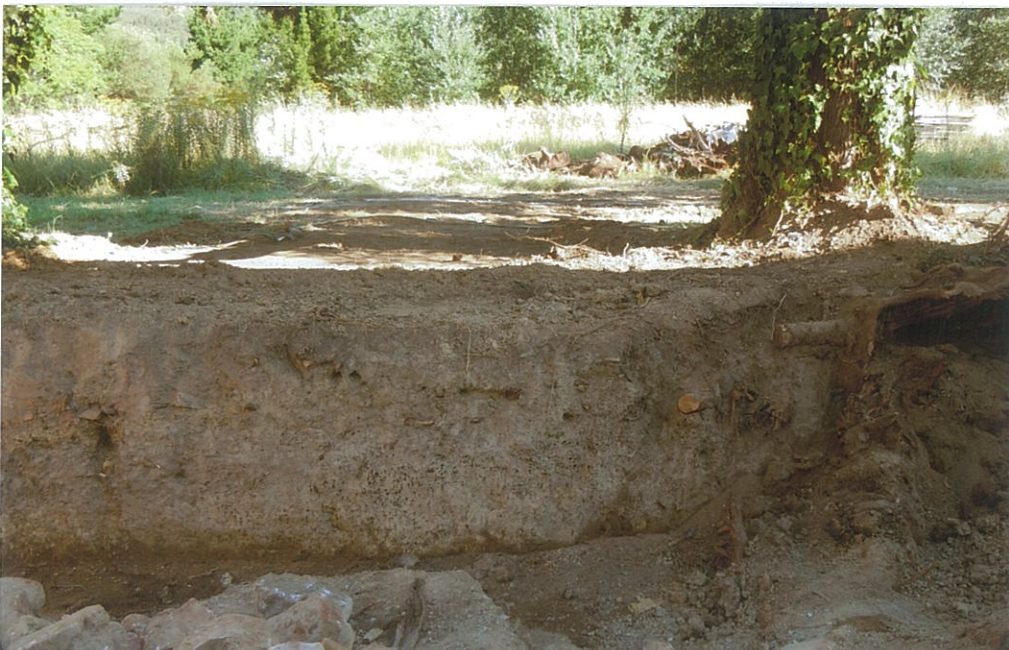
19. View of the trench (110 cm deep) behind the eastern enclosure of the courtyard of the Cellar. Sharp contrasts of light and shadow obscure detail (look S).

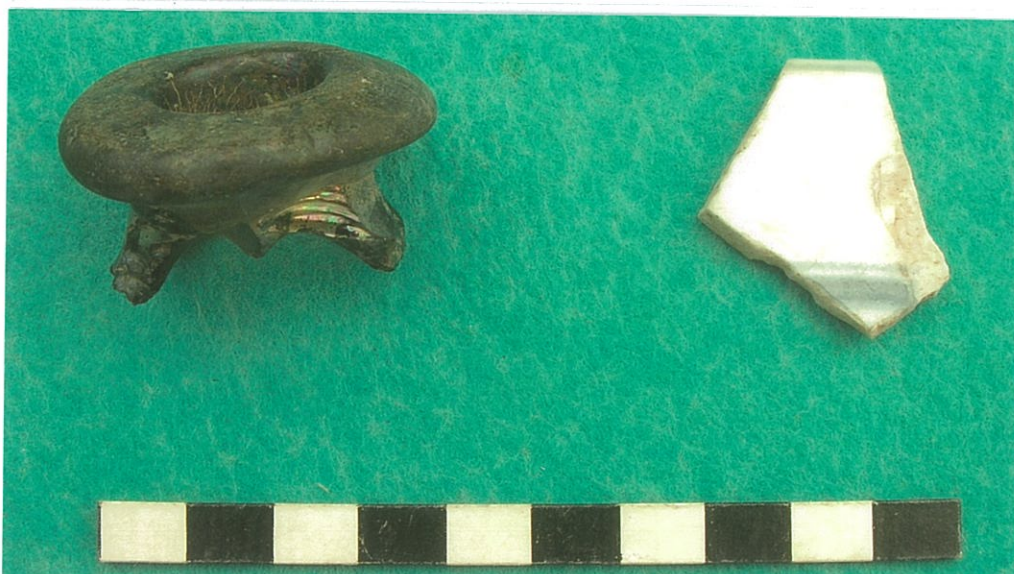
Only two broken artefacts were found. They include a black-green, bottle rimtop of the early 18th century, representative of the so-called onion-shaped bottles. At the Cape bottles were highly prized and reused over many decades. A rim portion of a coarse (South Provincial) Chinese dish / plate represents the porcelain imports to the far reaches of the Cape. Both these finds indicate the Cellar's age of the 18th century.

23. Close-up of the two 18th century artefacts: Bottle top and Chinese porcelain dish fragments (scale 10 cm).

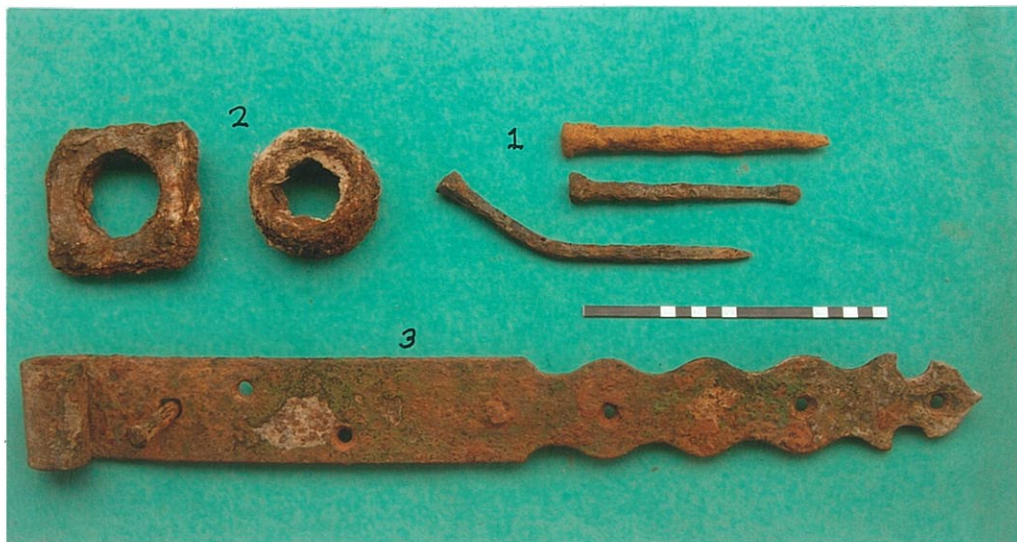
24. Artefacts from the western side next to the Cellar (scale 20 cm).
1. Iron pegs (18th / 19th century)
 2. Iron machinery (late 19th)
 3. Iron straphinge with green paint adhering (c.1900)

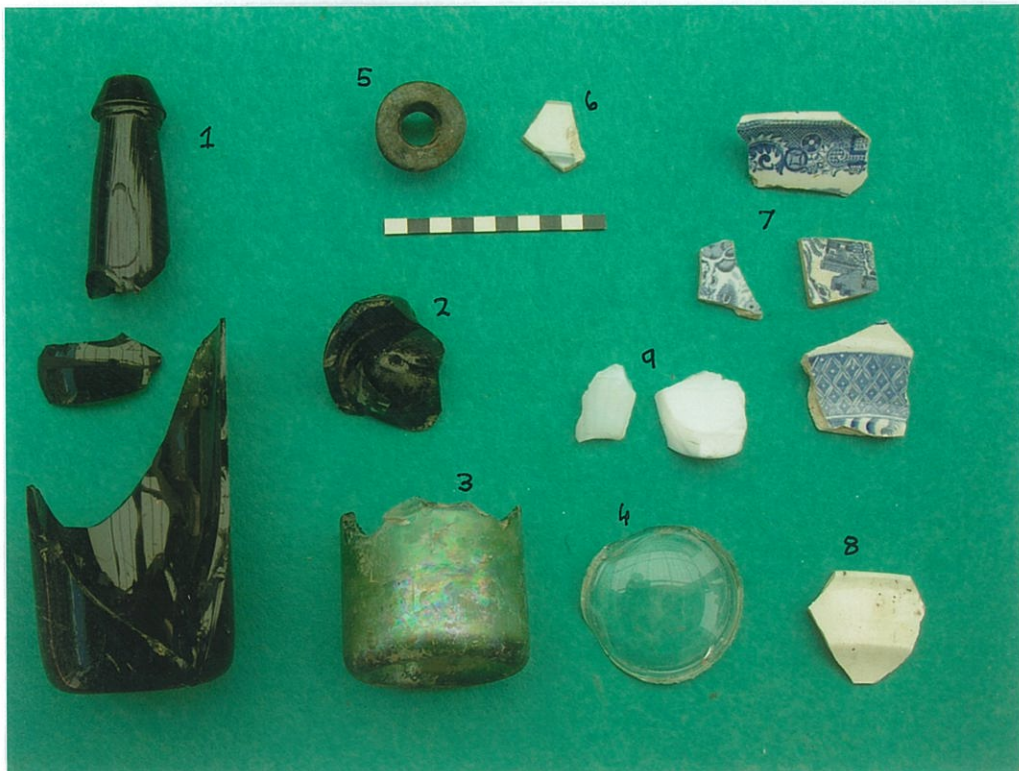
25. Contextual artefacts included (scale 10 cm):
1. Dark wine bottle (British) (mid-late 19th)
 2. Base of small wine/beer bottle (do.)
 3. Marine glass base of bottle (British) (late 19th to 1900)
 4. Base of clear glass flask (20th)
 5. Dark green bottle top (early 18th)
 6. Chinese porcelain rim of plate (18th)
 7. B & W English fine-grained earthenware fragments (dish lid, plates) Willow pattern (late 19th to early 20th)
 8. Plain English *fge* portion of plate (late 19th)
 9. Milk glass fragments of ointment jars (c.1900)

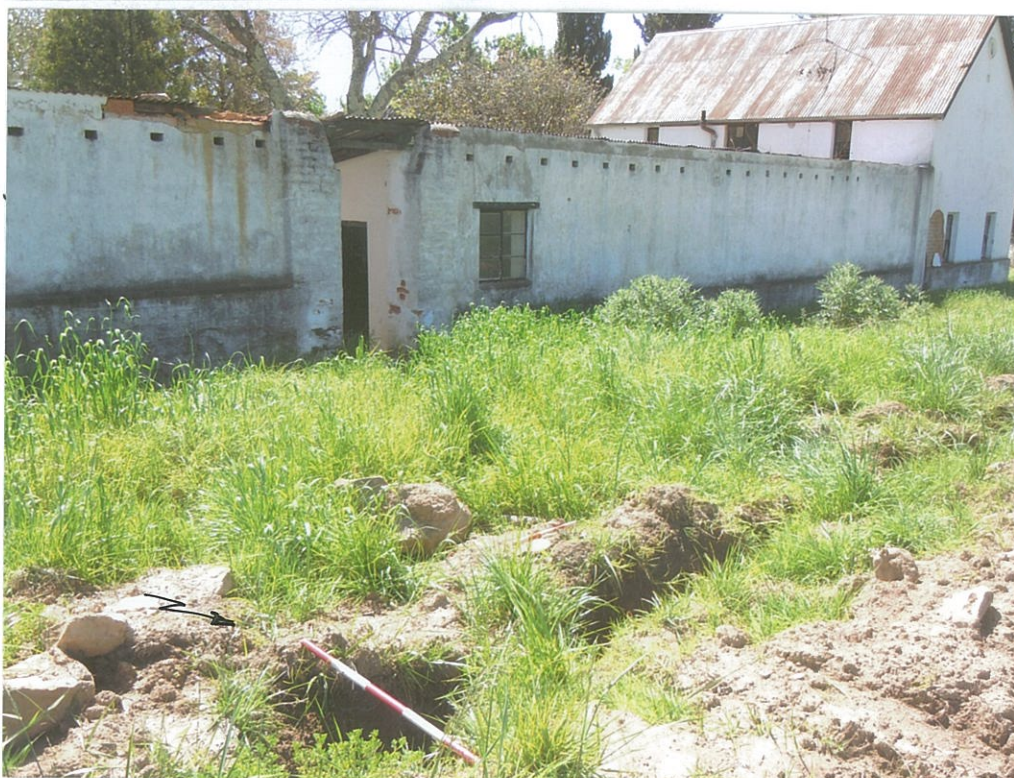
29. View towards the rear of the Homestead and modern kitchen on far left. The area of potential refuse is indicated (look NW) (Vos 2011).
