PROGRESS REPORT 05: April 18 – May 08, 2012

Towers 198 - 32

PROPOSED 400KV TABOR-WITKOP TRANSMISSION LINE, LIMPOPO PROVINCE

For: Stefanutti Stocks Power

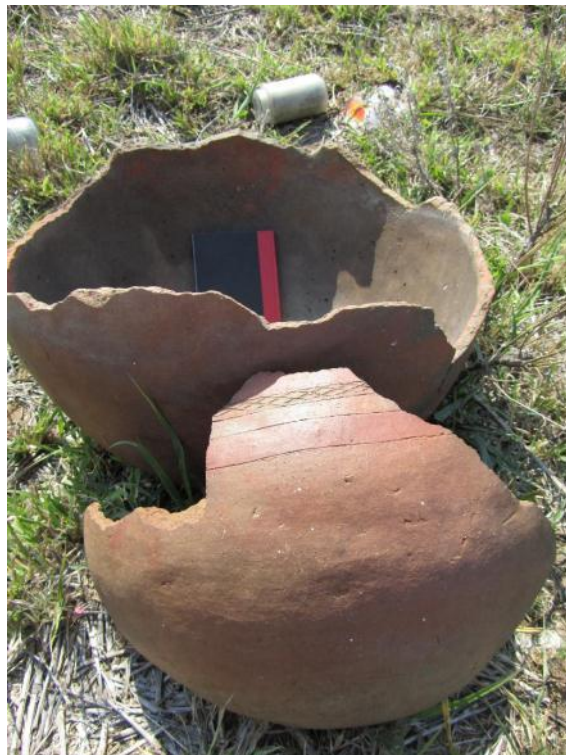
Figure 12. A clay pot and several pottery sherds were located on the surface. The pot, however, is of recent origin and was probably utilised by farm workers who recently left the farm. The decoration on the pot is interesting since it is similar to the Letaba style pottery and was of late still used by the Ndebele.

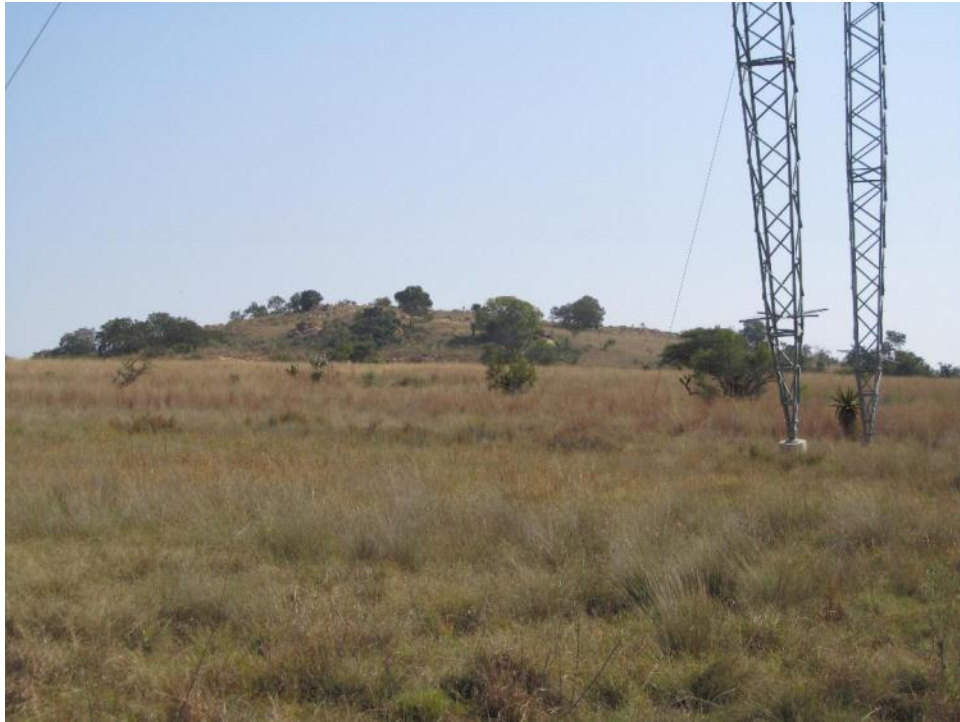
Figure 13. The hill in the background had been dug in several places. It is possible that clay, rather than gold, was mined here, since the excavations did not penetrate the stone bed below and only the soil was removed.

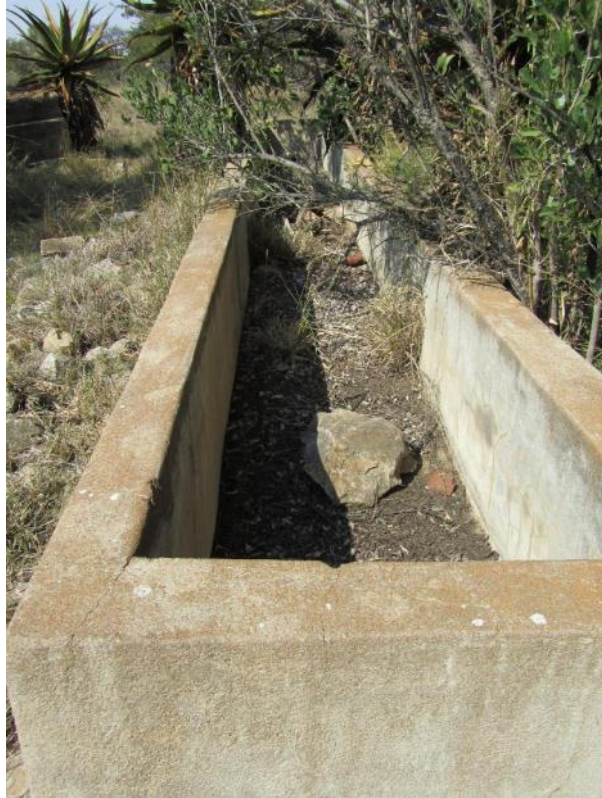
Figure 15. A concrete water trough next to the reservoir.

Recommendations for structures represented in Figs 14 - 17: The reservoir and accompanying structures are close to the transmission line and could be endangered by the activities and traffic related to the transmission line. Avoid and demarcate a clear access route. Demarcate the three depressions for they are a great risk.

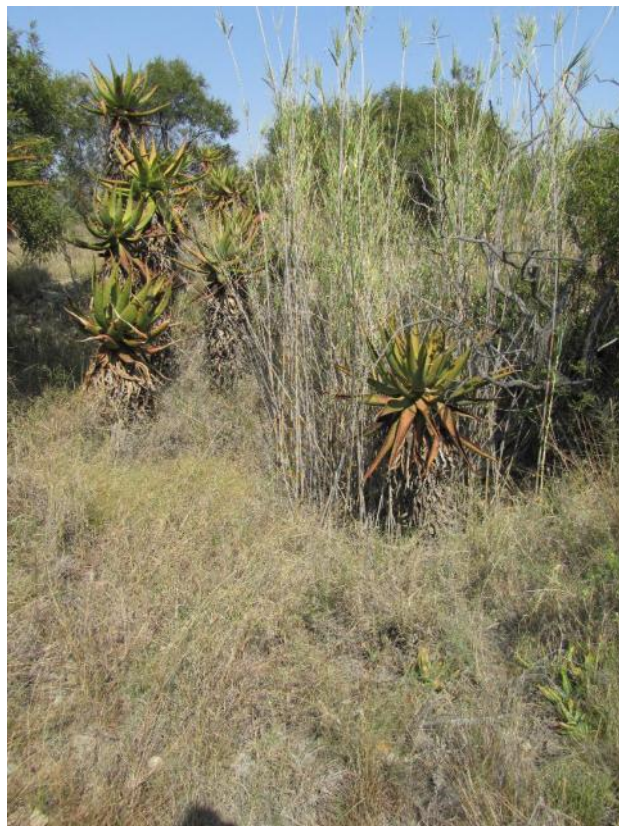
Figure 16. Three deep depressions in the vicinity of the reservoir and water trough. The purpose of these is unknown.

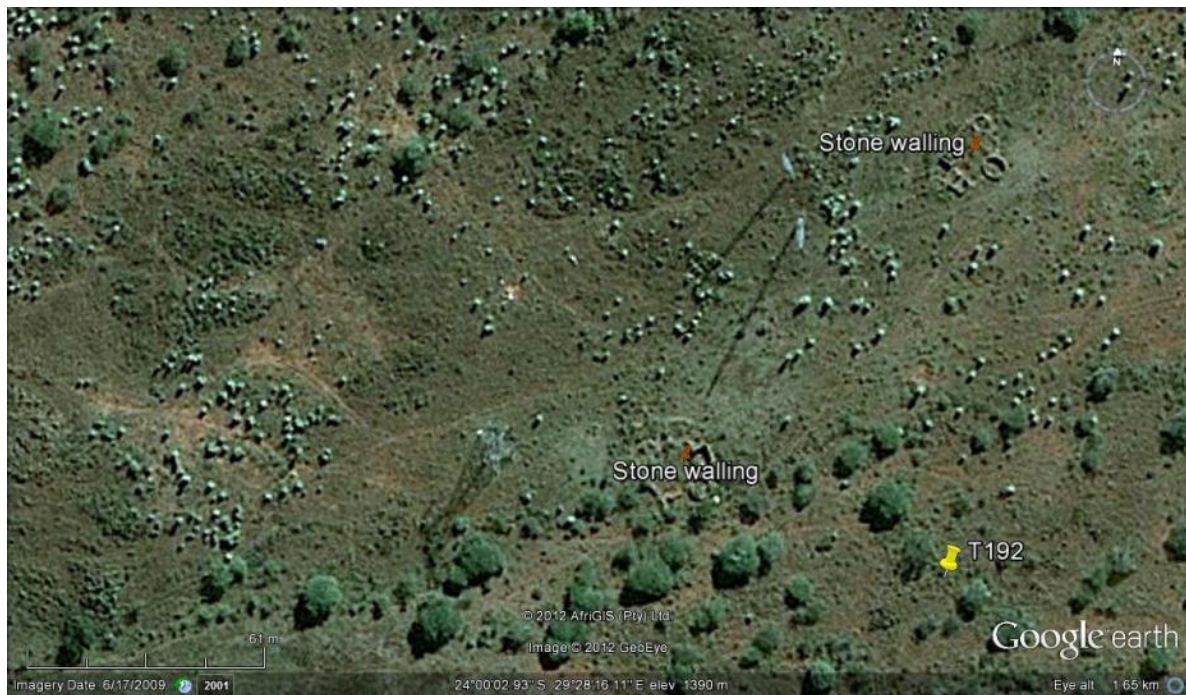
Figure 23. Google map of stone walled structures at Tower 192, respectively at coordinates S24°00'03.8" E29°28'19.35" and S24°00'1.2" E29°28'19.35".

Recommendations: Neither of these structures will be directly affected by the construction of the transmission line. However, the structure closest to the tower might be impacted on by the access road and spanning of the line. An archaeologist should indicate the position of the access route. Demarcate.

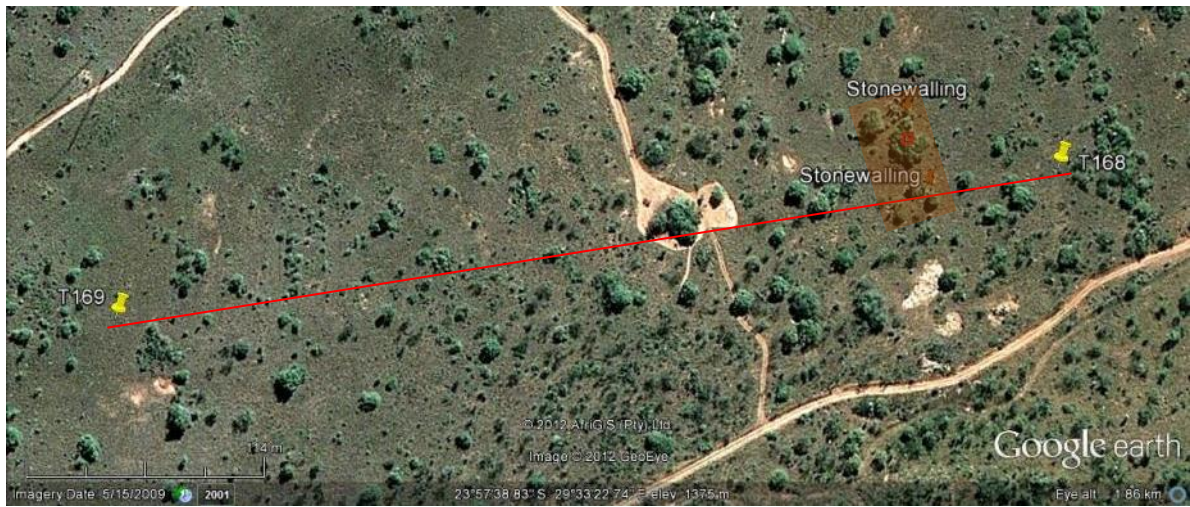
Figure 27. The stone walled structures are in the vicinity of Tower 168, respectively at co-ordinates S23°57'39.0" E29°33'28.2" and S23°57'37.9" E29°33'27.8". It is clear that one of the structures will be impacted on during construction of the line.

The two units, most likely built by farm workers during the historical period, are separated by a rocky outcrop and probably accommodated an extended family. Although not visible on the map, other activity areas will be in close proximity to the homestead, such as a midden and a cattle byre. These could contain human burials (usually those of the male relatives) while the women and children could be buried within the walled areas of the residential area. Until quite recently indigenous people retained this tradition.

Recommendations: The tower will not impact upon the site, but the line will cross the one structure. An archaeologist should be present during the *initial* excavation of the foundations for Tower 168, since the area could contain cultural material and again when the line is spanned.

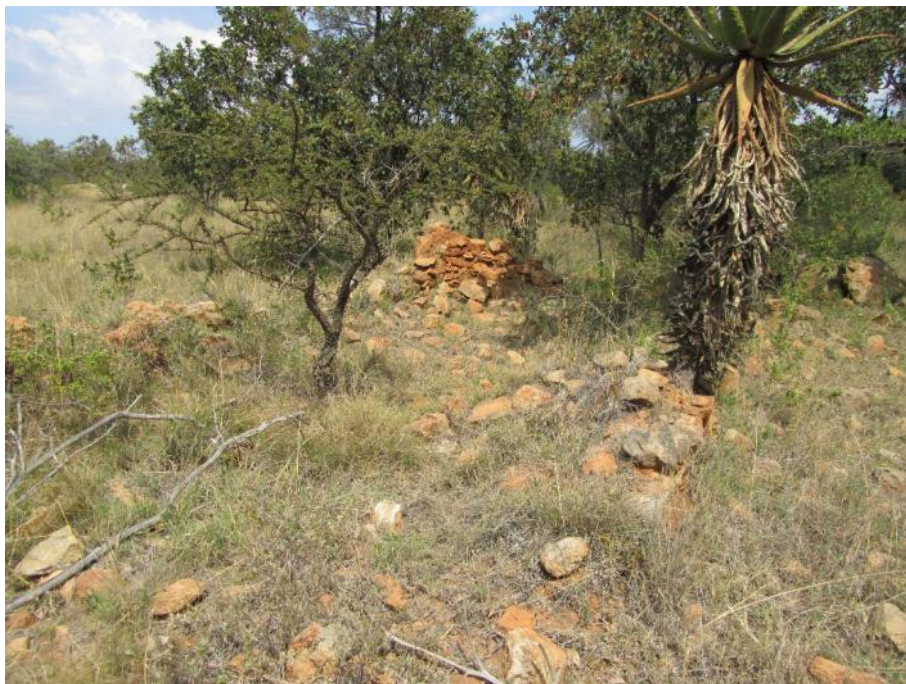
Figure 28. The few remains of the one residence. The rectangular shape is indicative of an historical date for its construction.

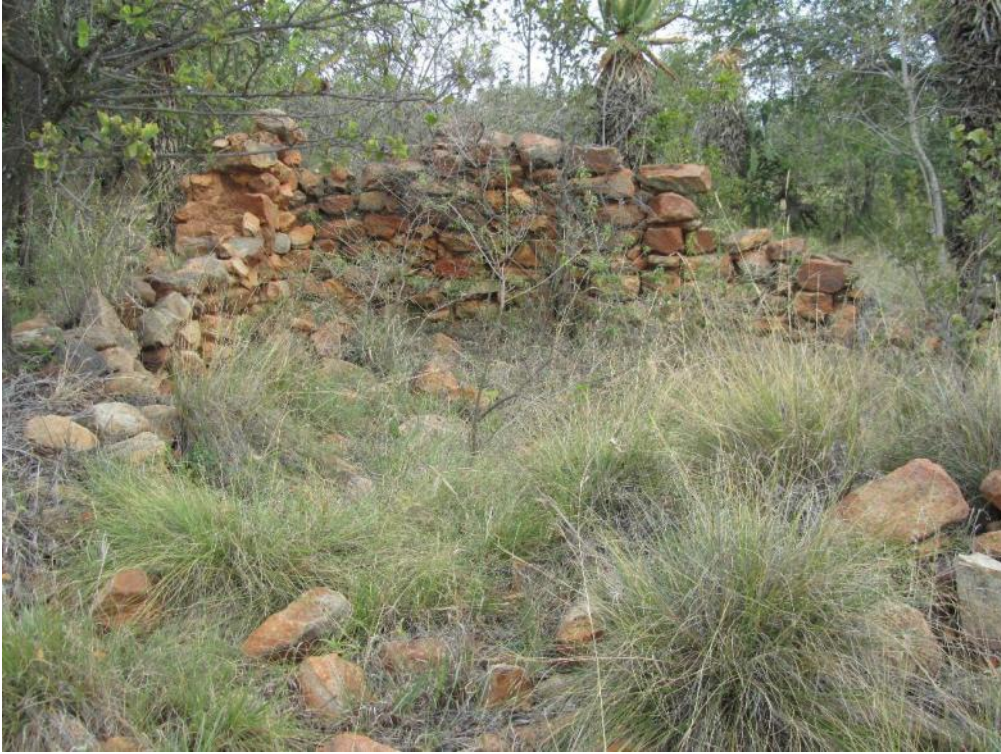
Figure 29. The second unit.

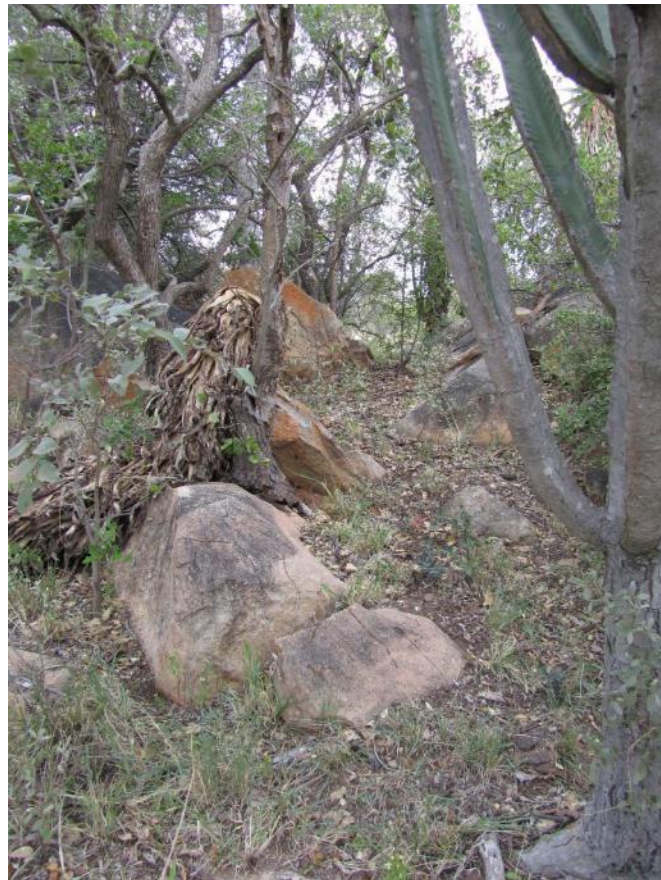
Figure 30. The rocky outcrop between the two units, with a footpath which was probably also used during occupation.

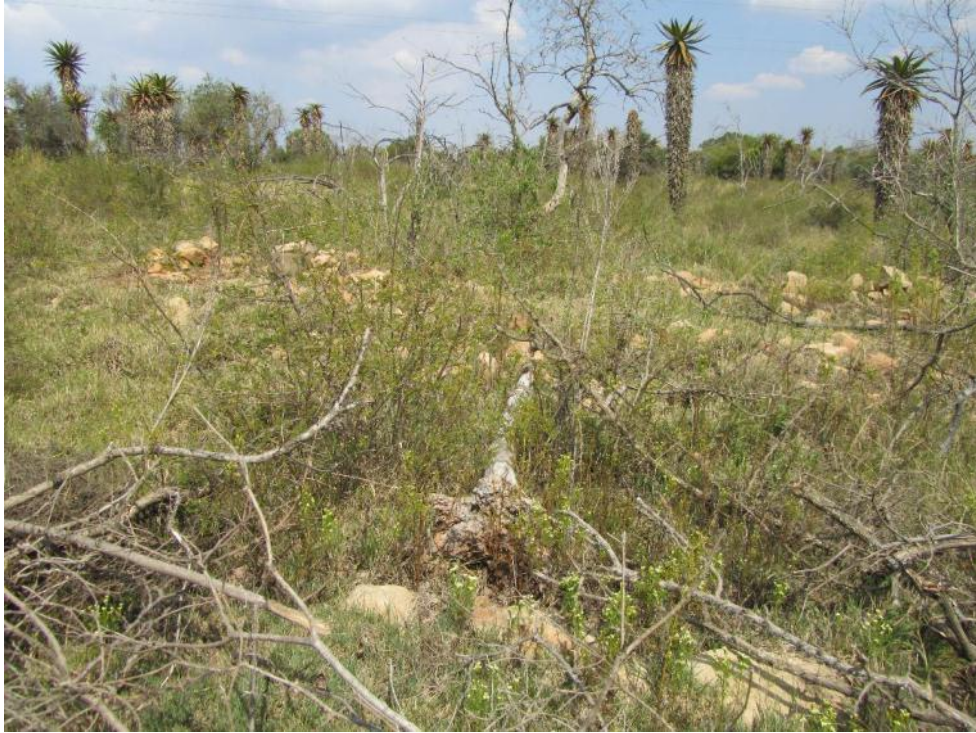
Figure 34. The foundation walls of the smaller, inner circle are clearly visible.

Recommendations: The position of Tower 167 as well as the access road should be relocated or a Phase 2 should be implemented. A SAHRA permit and excavation should be conducted prior to construction. If the tower is relocated, an archaeologist should be in attendance during excavation and construction.

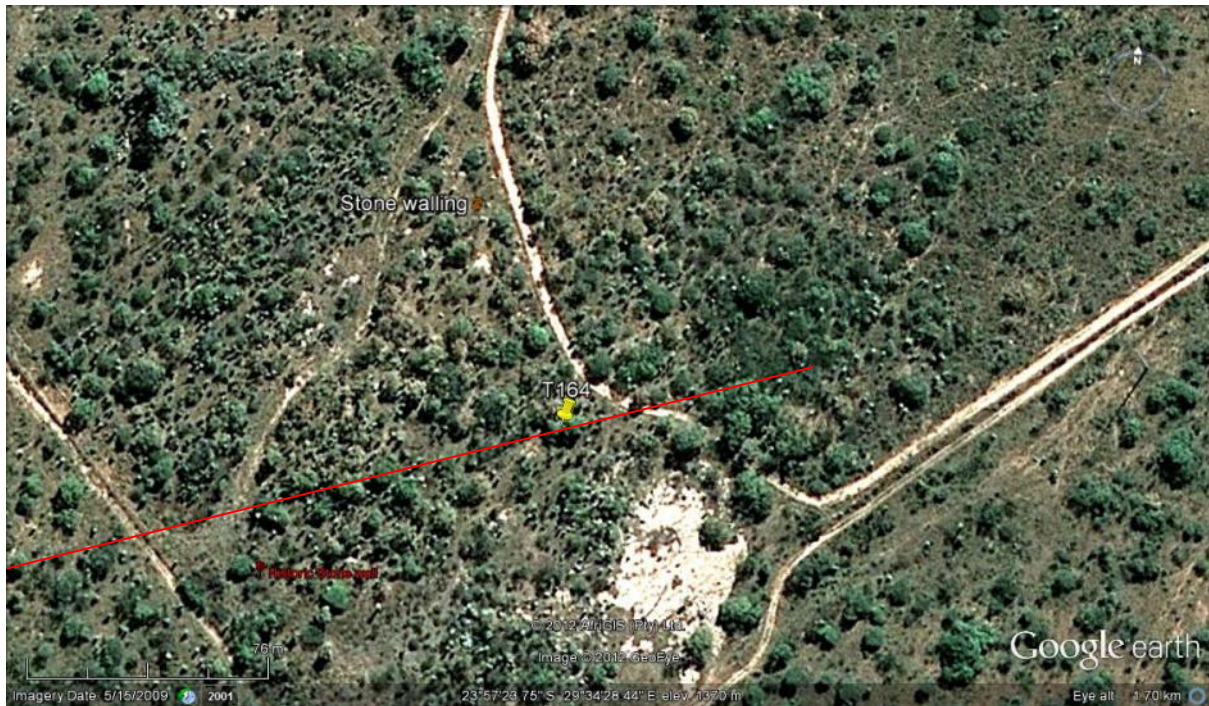
Figure 36. Neither of the historic stone walled sites at the foot of the hill will be affected by the transmission line or its construction.

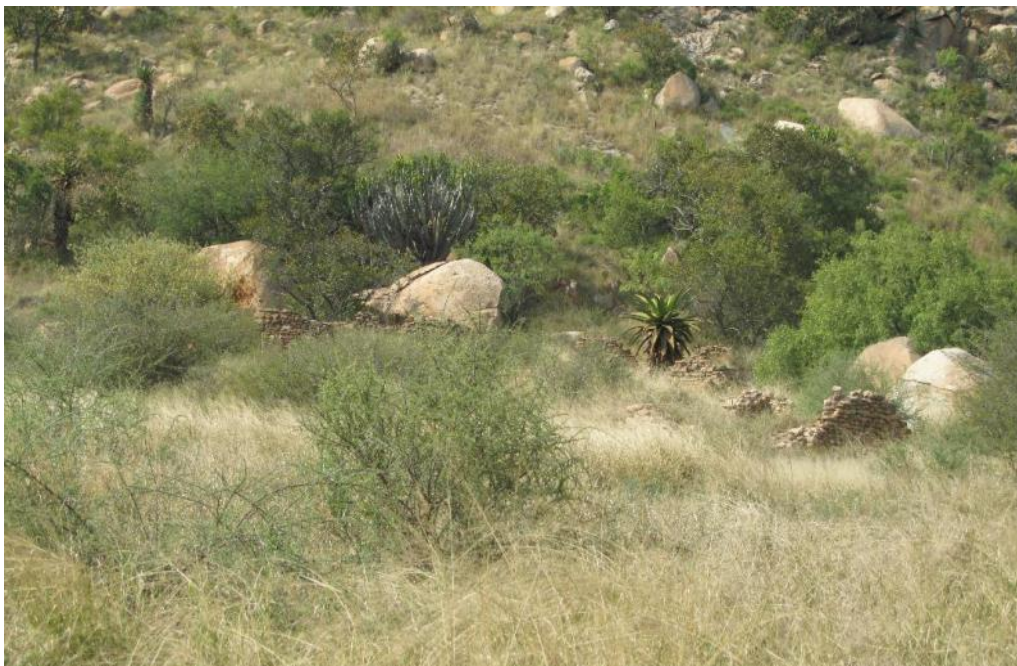
Figure 37. The site (S23°57'22.33" E29°34'26.84") marked as "*Stone walling*" on the Google Earth map. Rectangular structures suggest that it is an historical structure and were probably built by farm labourers.

Recommendations: No action needs to be taken.

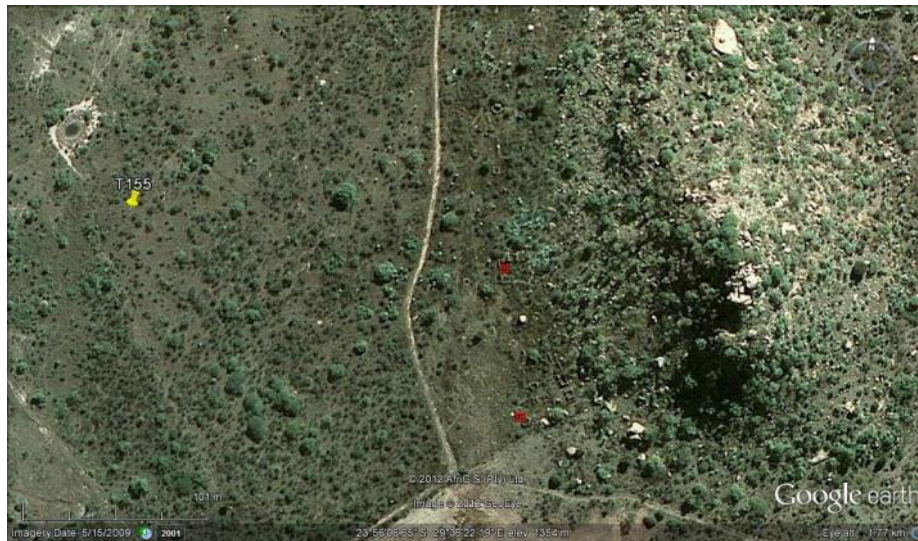
Figure 39. Neither of these historical labourer homesteads will be impacted upon by the development.

Recommendations: No action is required.

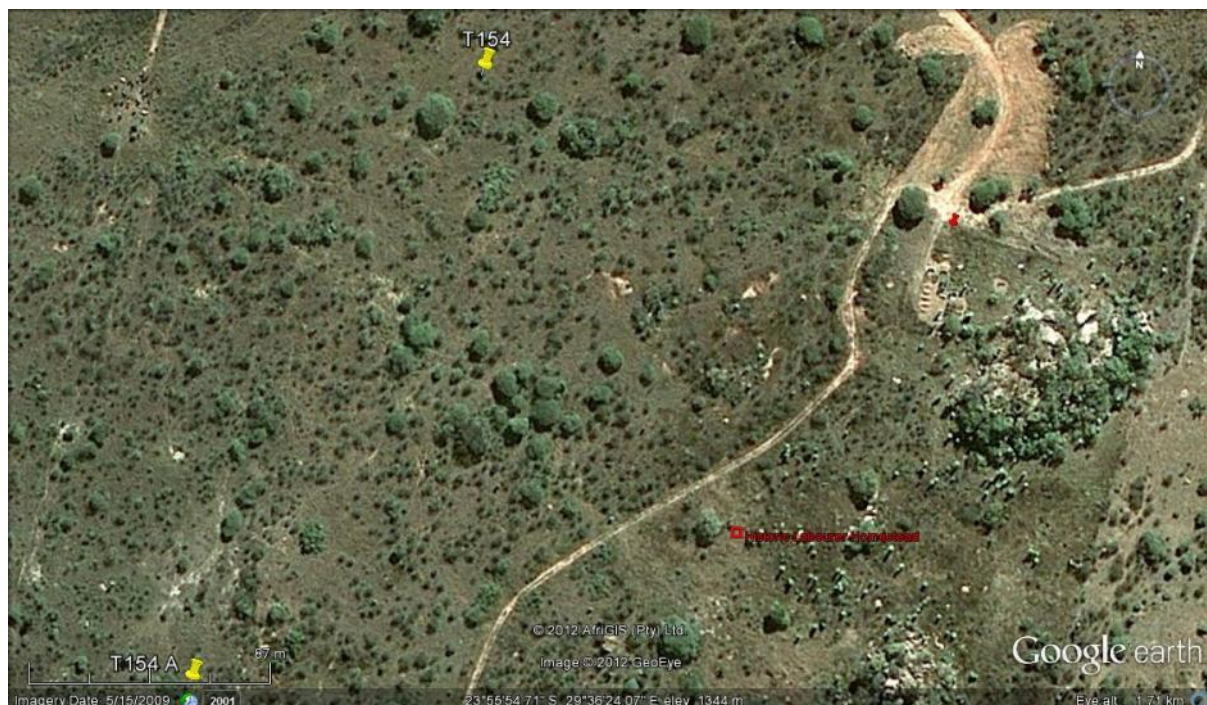
Figure 38. Neither the “Historic Labourer Homestead” nor the cemetery will be impacted on by the transmission line.

Recommendations: No action is required.

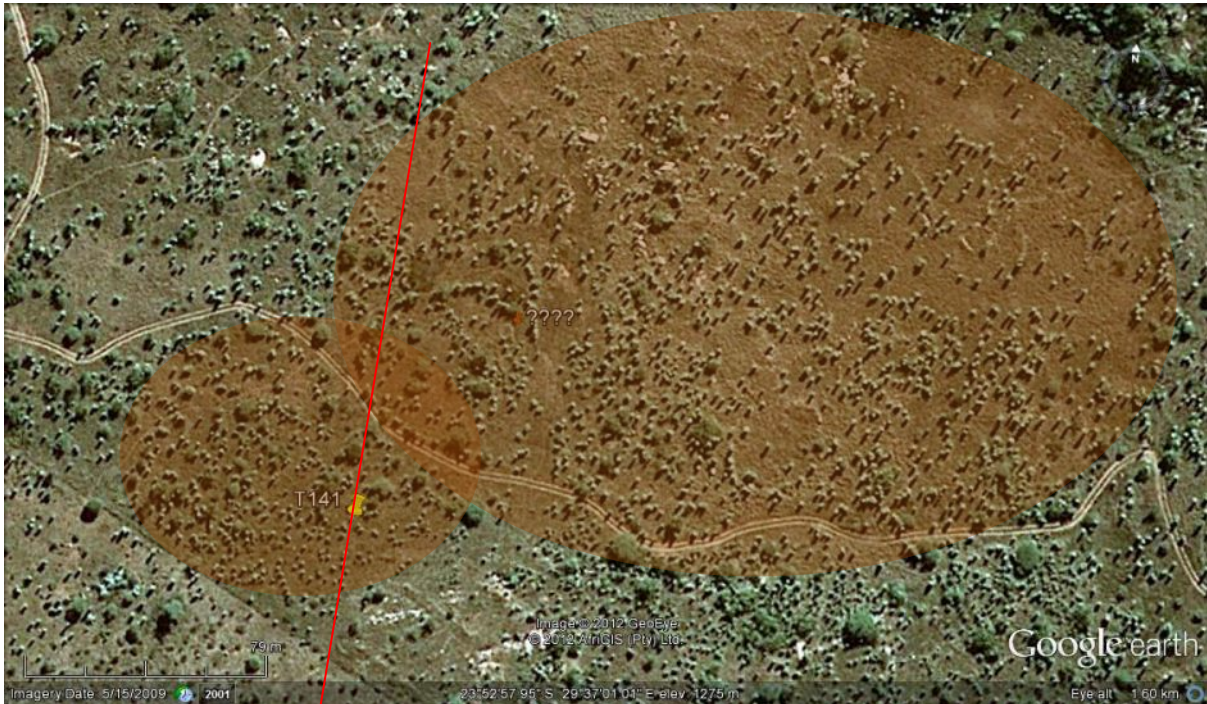
Figure 40. An extensive area contains various stone walling units which form a cluster, here roughly indicated by the brown coloured areas. The stone walling is only vaguely visible since the stone had been robbed, the foundations remaining only in some places.

Recommendations: The historic multi-component site needs no mitigation, but the extensive site at Tower 141 needs protection since the tower foundations and access road will impact upon it. Human burials will not necessarily be visible on the surface and could be located practically anywhere on the site, especially in the cattle byres, of which there are several. None of the hut floors had been located. These clay floors would only have been preserved if the place had burned down. Women and children were often buried under the hut floor or next to the hut.

It is recommended that an archaeologist be present during the excavation of the tower foundations and when the line is brought in.

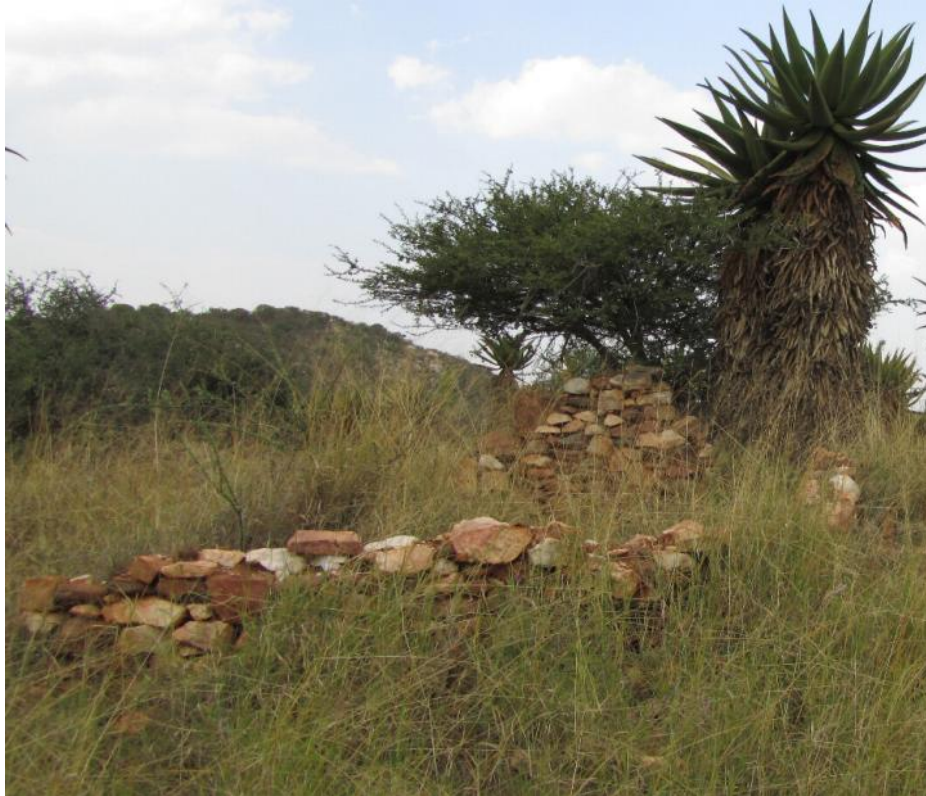
Figure 42. The historic multi-component site on the hill. It is quite possible that some of the stone was robbed from the older, Late Iron Age site in the vicinity of Tower 141. This site will not be affected by the development.

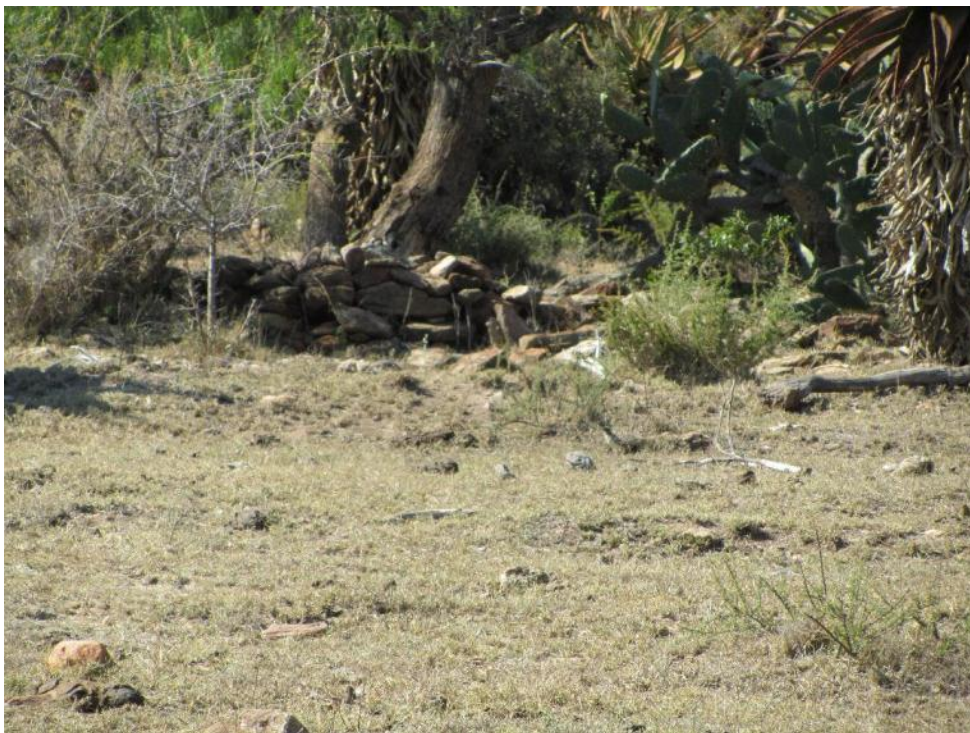
Figure 43. S23°53'08.4" E29°37'03.1". Some better preserved stone walling on the LIA site. It could also signify that the site was again/still occupied during historical times.

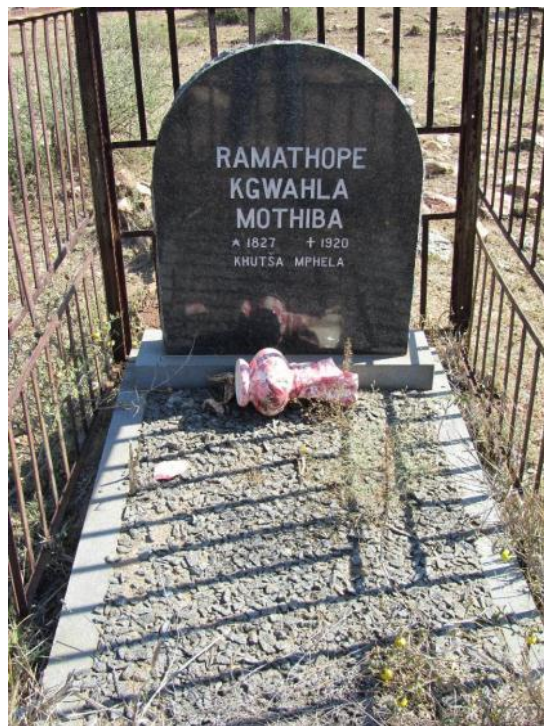
Figure 45. The grave of *Ramathope Kgwahla Mothiba*. The fact that a modern headstone was erected here shows that the place still has some relevance and that Mothiba is probably revered as an important ancestor since he is still remembered since his death in 1920. His burial here could indicate that he was buried on this LIA site either because he still had links to it or that the site was reoccupied at a later date during historical times.

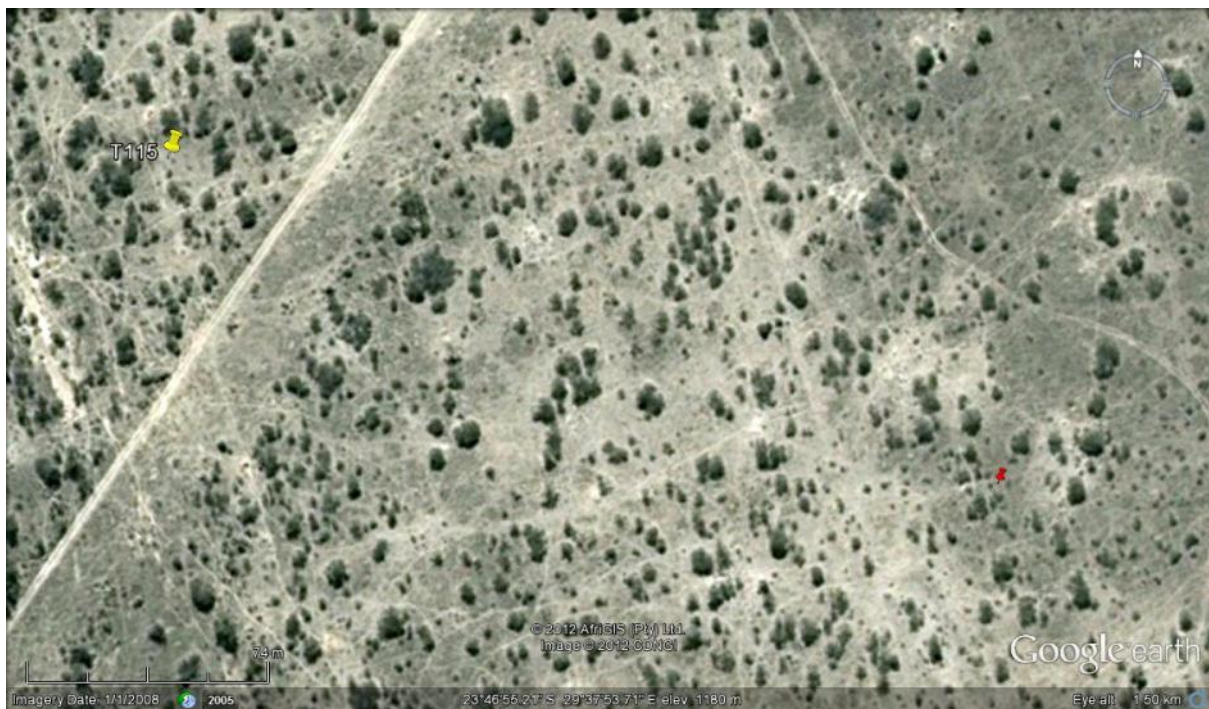
Figure 46. Van Schalkwyk identified a historic cemetery. This will not at all be impacted by the transmission line. This site was not inspected by the current archaeologist since it is far removed from the proposed transmission line.

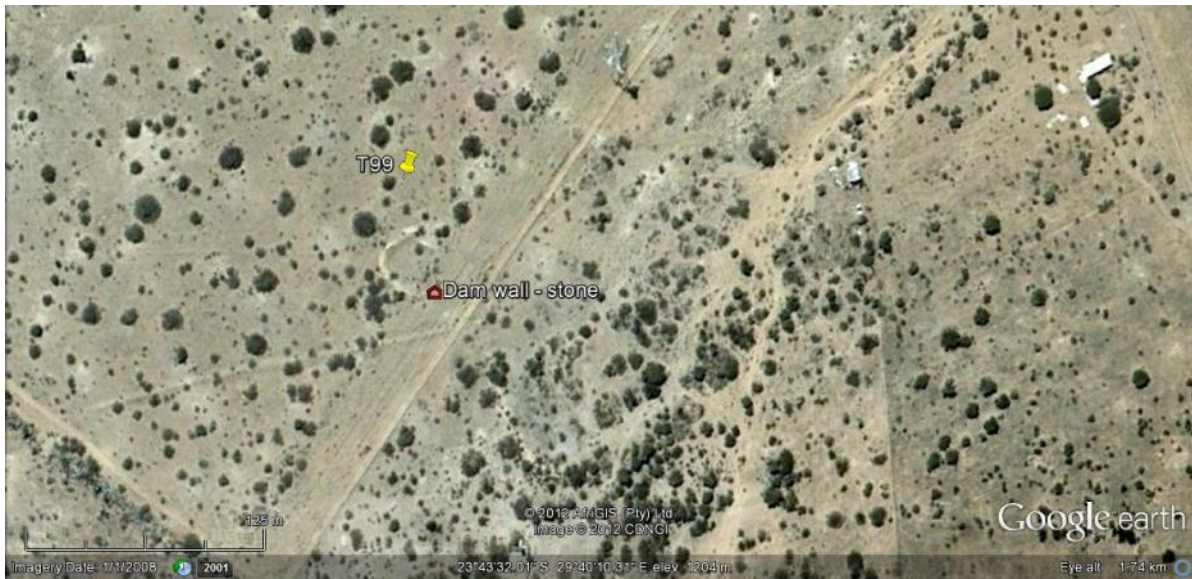
Figure 47. S23°43'33.3" E29°40'07.3". The dam wall is clearly visible in the above image. Within visible distance are two historic farmsteads as well as an old windmill.

Recommendations: Although this structure is historic, its significance on the regional level is low (HIA Report, Van Schalkwyk, 2010) and it is not necessary to relocate the tower foundation. However, care should be taken not to cause any further damage.

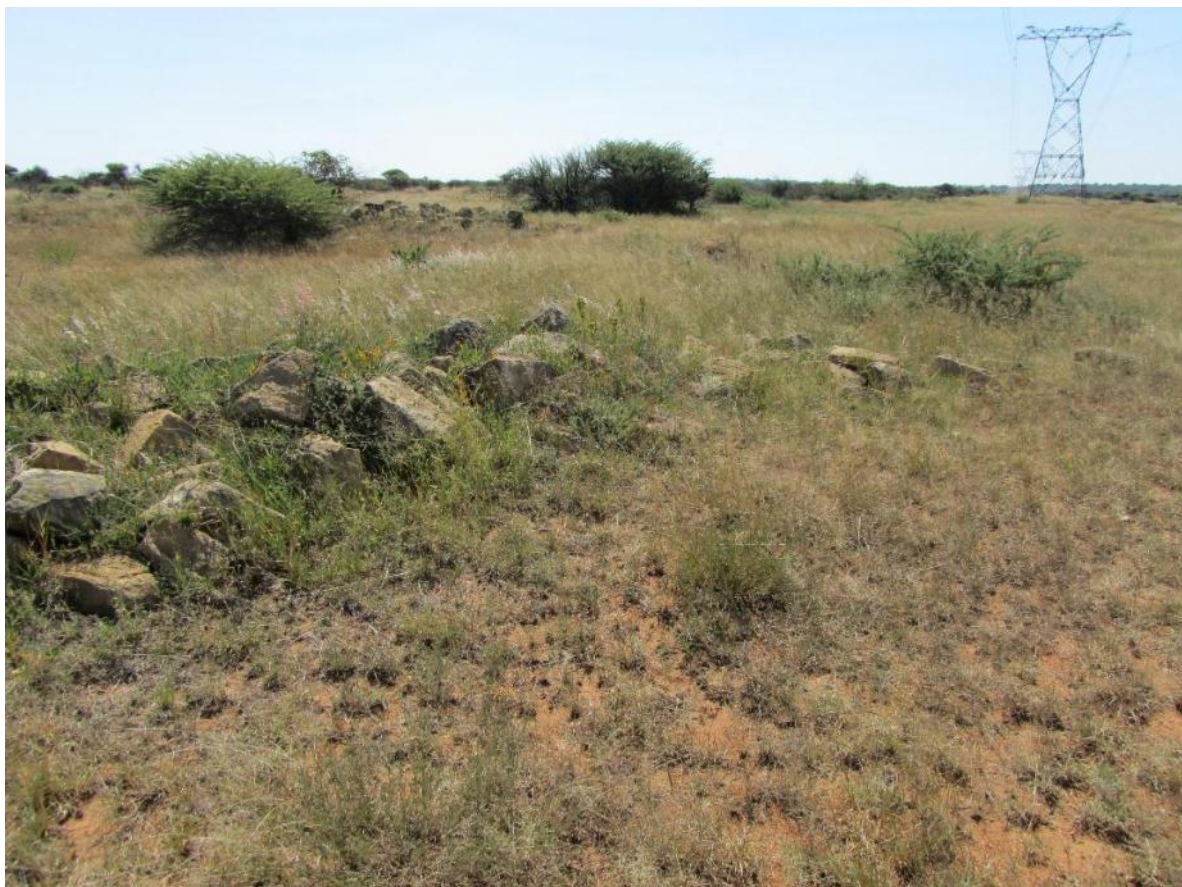
Figure 48. This was a farm dam built with stone.

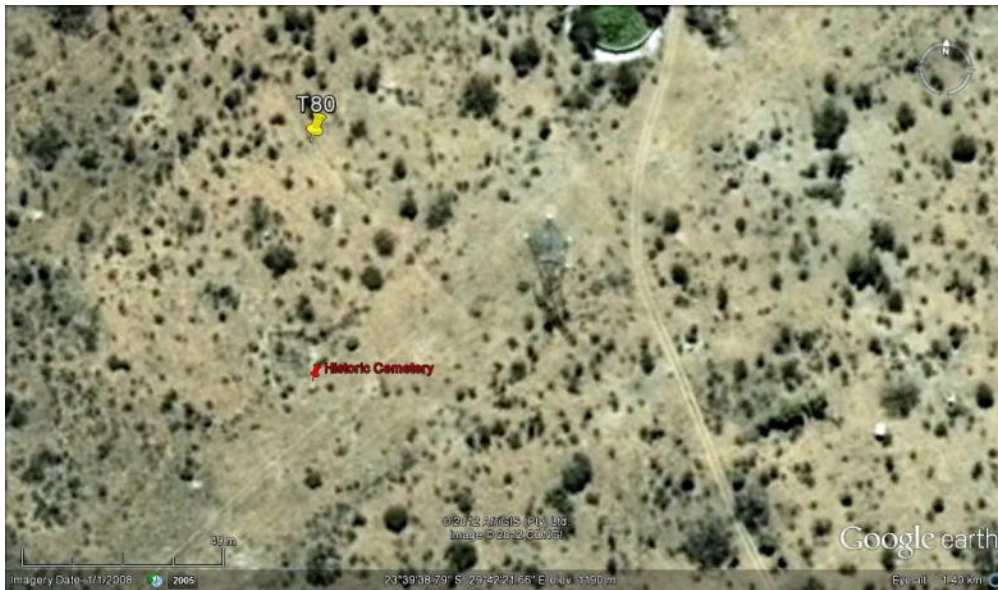
Figure 50. Close to the historic cemetery is a residence, a modern cement dam and a windmill.

Recommendations: None of these structures will be affected by the transmission line. Nevertheless, care should be taken to avoid these and if necessary should be demarcated.

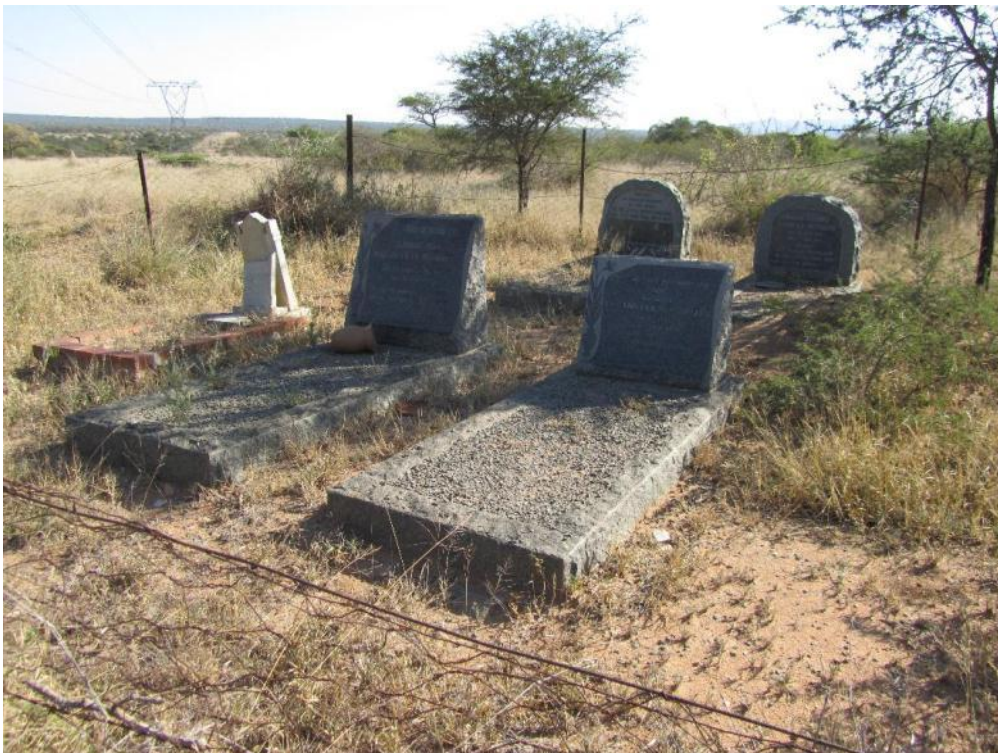
Figure 51. The cemetery of the Van der Westhuizen family. The oldest of the graves date from 1931.

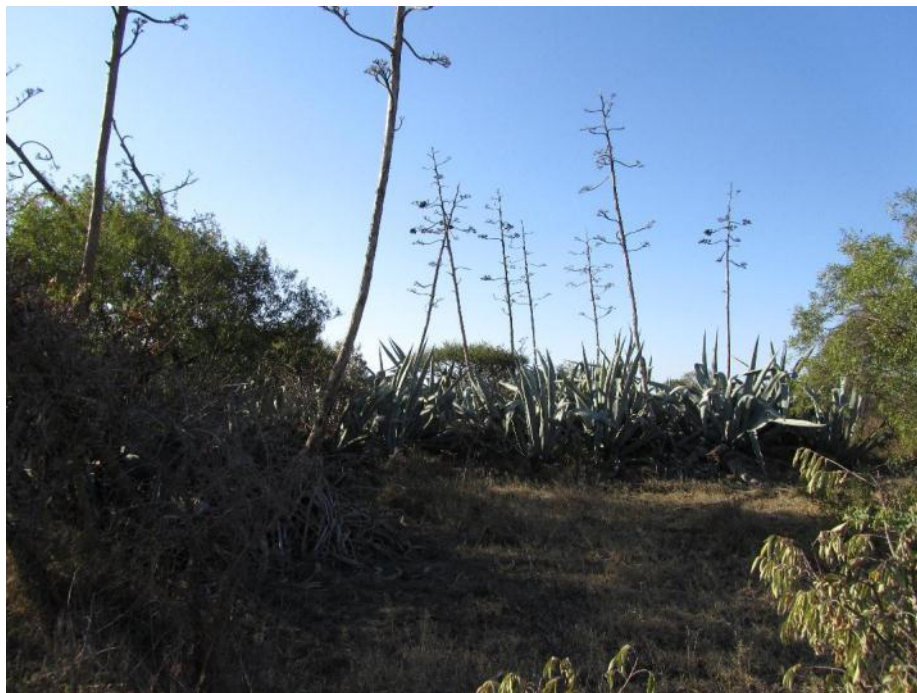
Figure 53. A clump of *Agave sisalana* (American agave or sisal). These plants have become naturalised in South Africa. It forms an impenetrable barrier and is still used for that purpose around cattle byres.

Recommendations: The tower is not located on these sites, however, the transmission line will cross it and the access road will pass through it. Care should be taken not to damage the structures when the line is being spanned. Access routes should preferably avoid these areas and its location should be mitigated with the archaeologist.

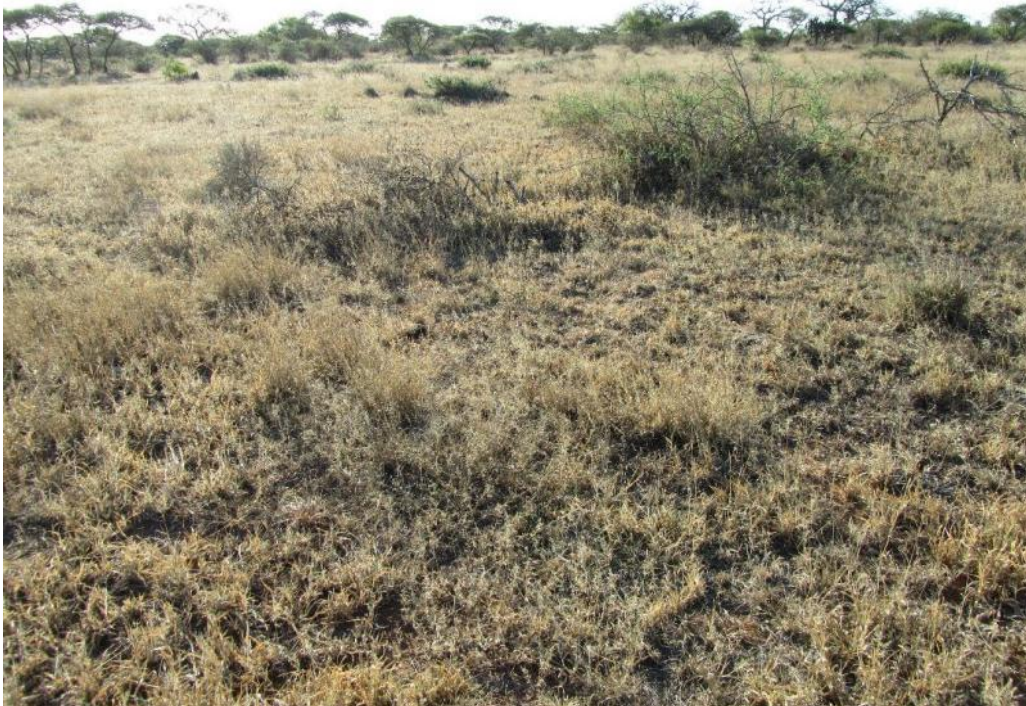
Figure 54. The area indicated with a “B” on the map. It is covered in grass and surrounded by trees in a circular shape. The slight rise in the foreground could be due to dung or midden accumulation.

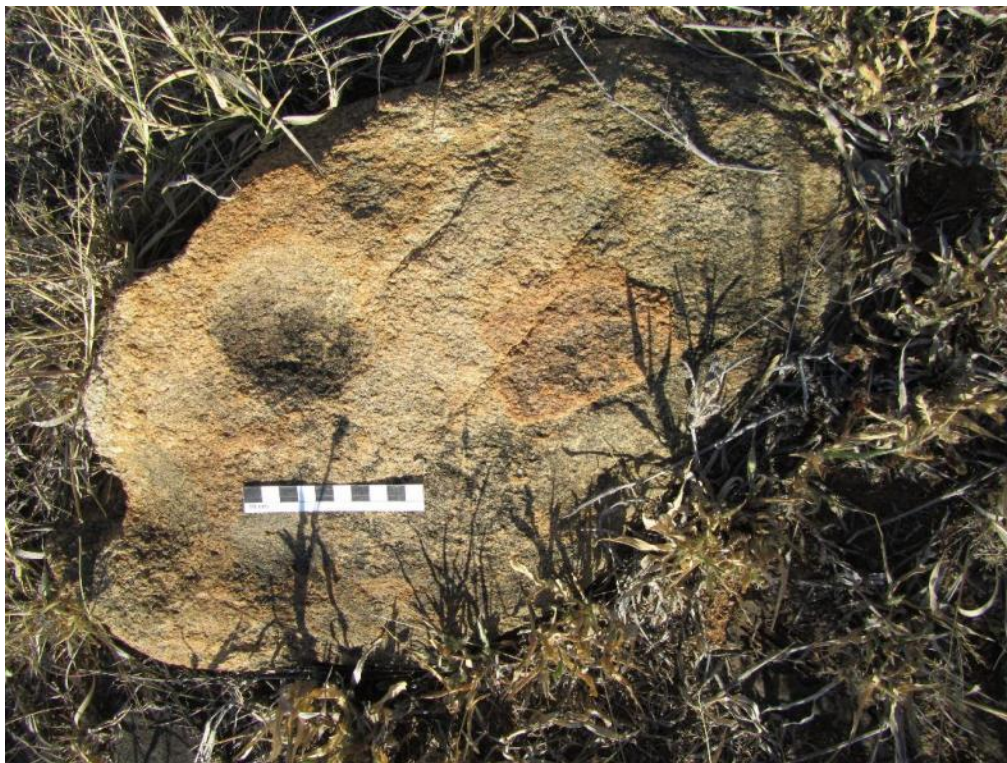
Figure 55. A flat stone with several indentations on its upper surface. Its function is unknown, but it shows human skill and activity.

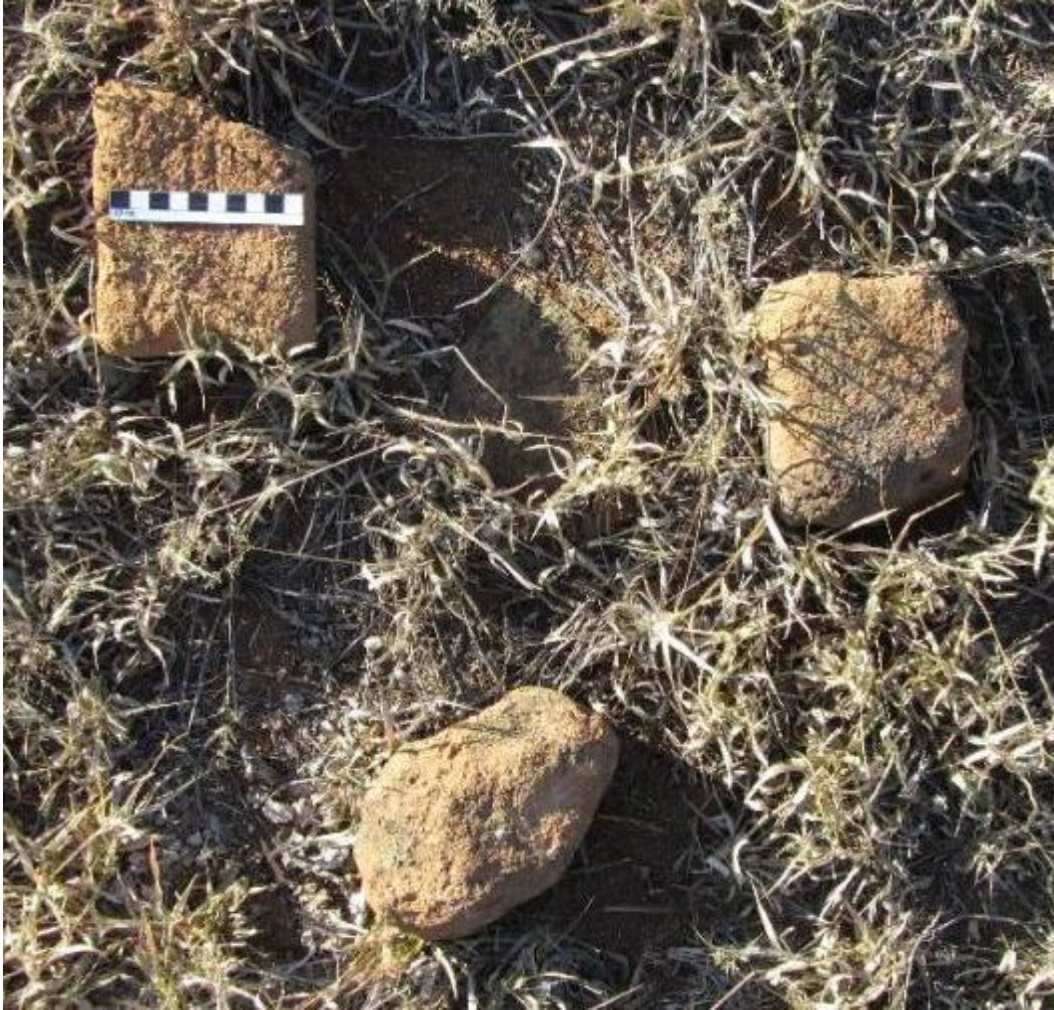
Figure 56. Some fragments of rectangular bricks were also recovered not far from the indented stone (*Fig 55*) which indicates recent historical presence.

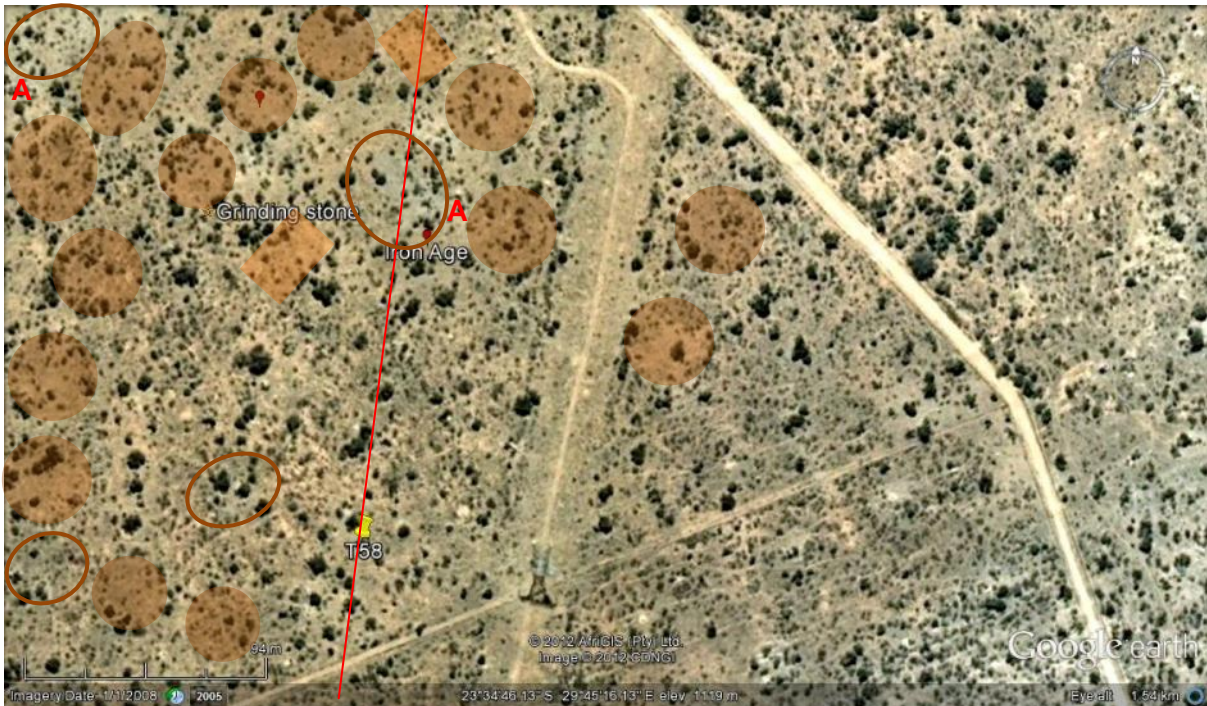
Figure 57. The scalloped pattern that can still be vaguely distinguished, and attests to the site being utilised during the Late Iron Age. The brown circles (“A”) are cattle byres, characterised by the grey colouring. The circular and oval shapes are residential units which clearly forms the scalloped pattern. Not all the units are clearly seen on the map and therefore they have not all been indicated. At least two rectangular units are also distinguishable: these were probably utilised during historical times after contact with the Europeans and/or could have been used by the farm labourers.

Recommendations: It is recommended that the archaeologist should be present when the foundations of Tower 58 are excavated, since human skeletal material could be retrieved. Great care should also be taken not to damage cultural remains when the transmission line is spanned. Since the previous access route has already damaged the site, it is advised that this route should also be utilised for the Tabor-Witkop transmission line and that the shortest possible access route or a route which will cause the least disturbance should be demarcated from the original access.

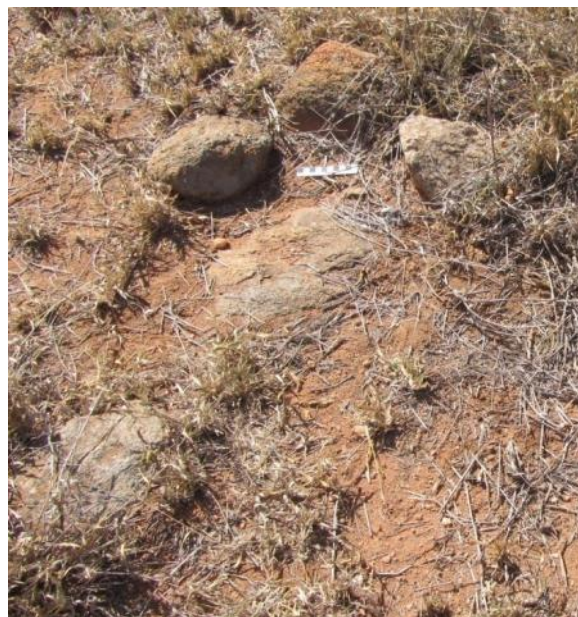
Figure 58. Part of a foundation which is still visible.
