PROGRESS REPORT 05: April 18 – May 08, 2012

Towers 198 - 32

PROPOSED 400KV TABOR-WITKOP TRANSMISSION LINE, LIMPOPO PROVINCE

For: Stefanutti Stocks Power

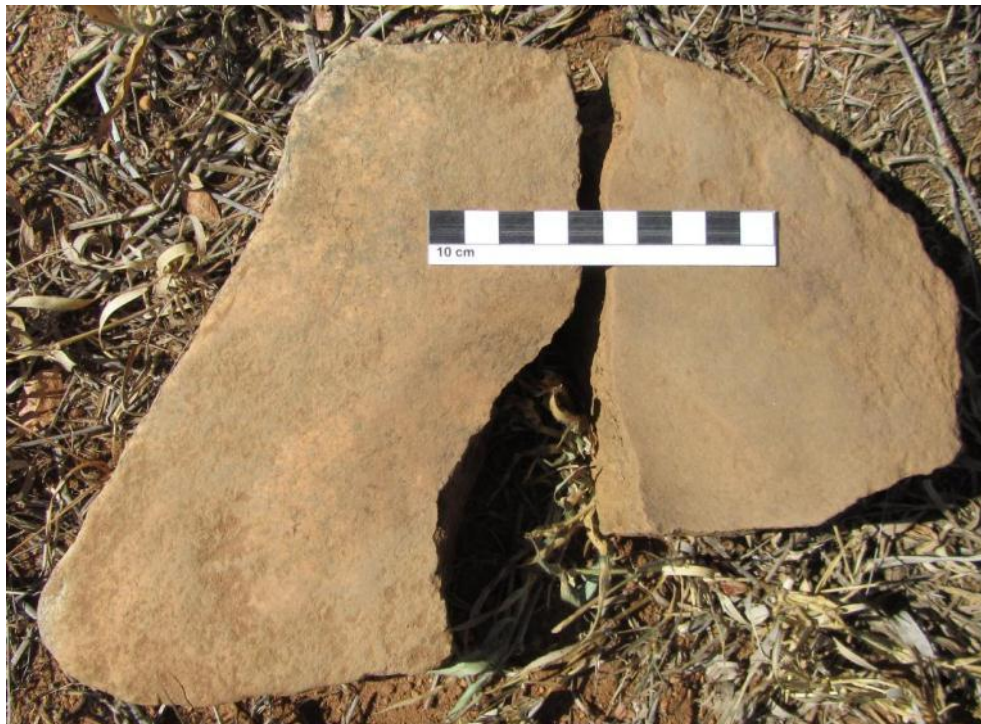
Figure 60. A broken grinding stone was recovered from the site at co-ordinates S23°34'44.5" E29°45'10.5". This would relate to female activities.

Recommendations: It is recommended that the archaeologist should be present when the foundations of Tower 58 are excavated, since human skeletal material could be retrieved. Great care should also be taken not to damage cultural remains when the transmission line is spanned. Since the previous access route has already damaged the site, it is advised that this route should also be utilised for the Tabor-Witkop transmission line and that the shortest possible access route or a route which will cause the least disturbance should be demarcated from the original access.

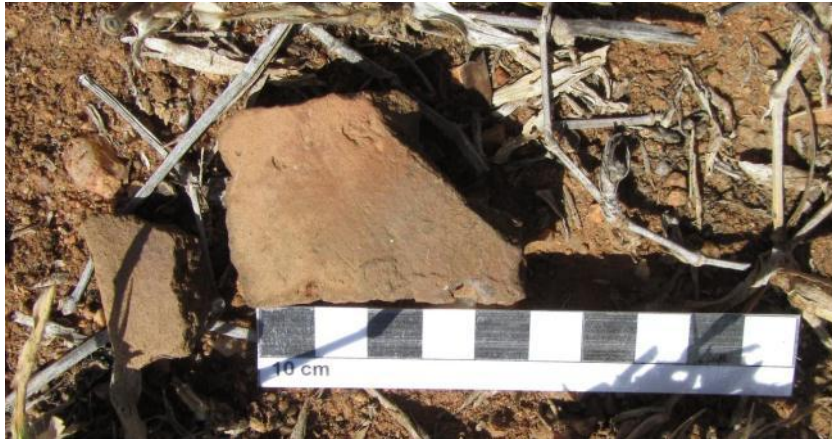
Figure 61. Pottery sherds are scattered across the site.

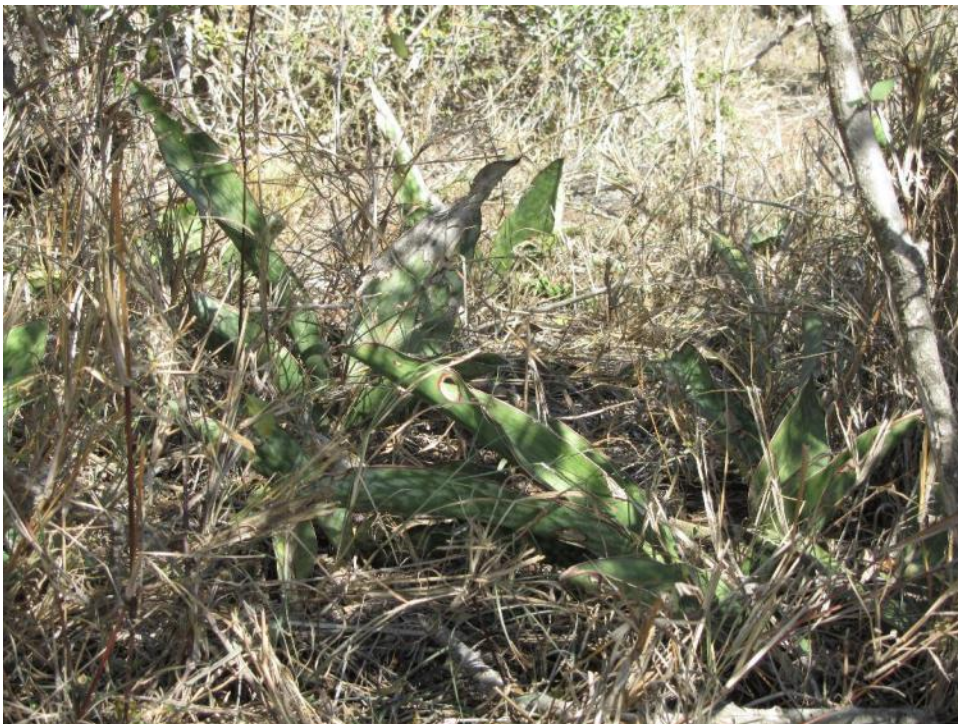
Figure 62. A few clusters of *Sansevieria hyacinthoides* (piles root) has been located on the site. It is a popular remedy for ear infection, ear- and toothache. Traditionally it is used to treat haemorrhoids, ulcers and intestinal worms as well as stomach disorders and diarrhoea. *S hyacinthoides* occurs naturally in the eastern and northern parts of South Africa. It replants easily. Its presence on the site could be due to its many medicinal uses.

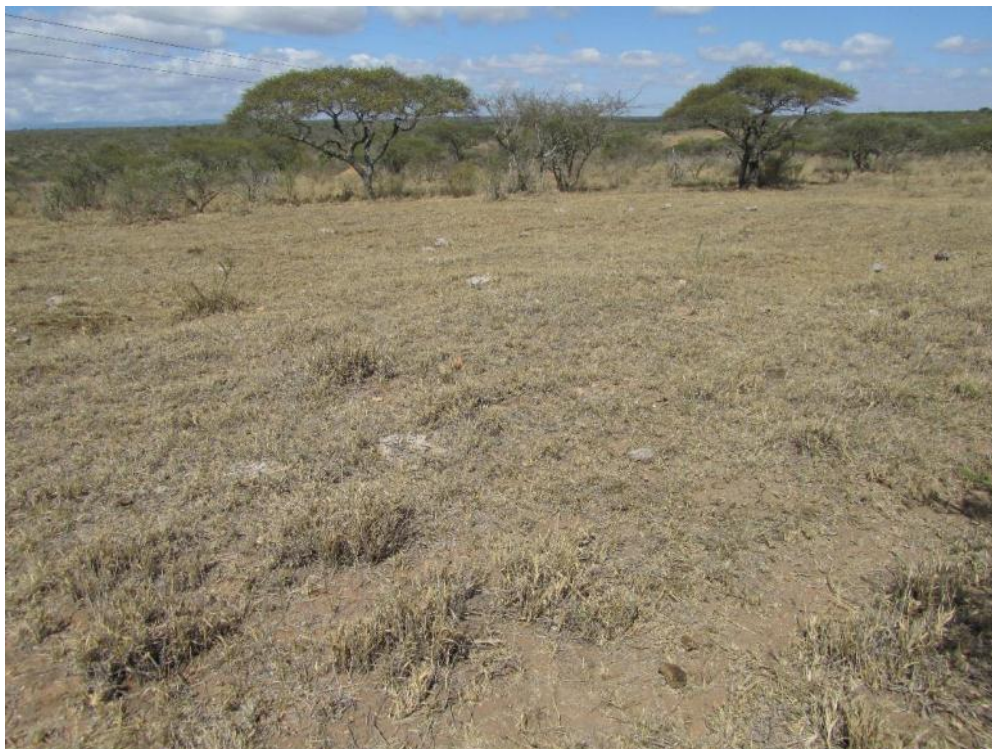
Figure 64. The grey ashy composition and colouring of the soil is clear in the image.

Recommendations: The same as for Tower 58: The archaeologist should be present when the foundations for Tower 56 are excavated, since human skeletal material could be retrieved. Great care should also be taken not to damage cultural remains when the transmission line is spanned. Since the previous access route has already damaged the site, it is advised that this route should also be utilised for the Tabor-Witkop transmission line and that the shortest possible access route or a route which will cause the least disturbance should be demarcated from the original access.

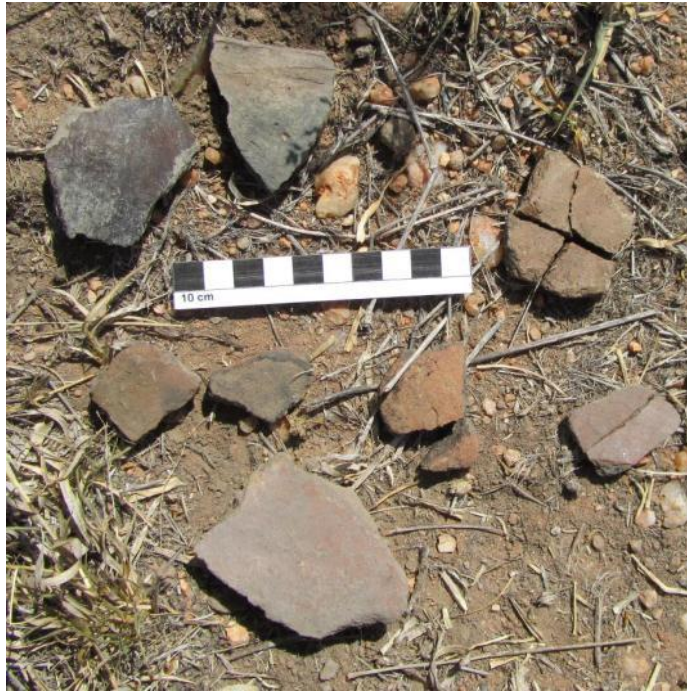
Figure 65. A cluster of pottery sherds were located on the surface at co-ordinates S23°34'14.8" E29°45'18.6". The rest of the site would undoubtedly relinquish more and similar samples.

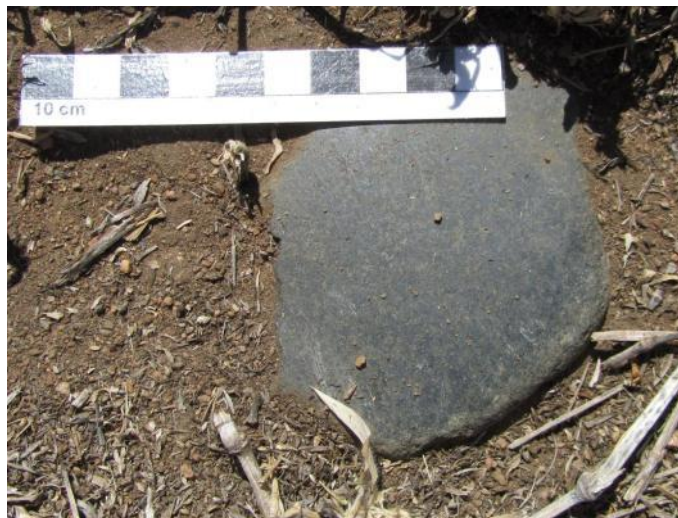
Figure 66. A grinder or polishing stone was recovered from co-ordinates S23°34'13.7" E29°45'18.4" together with more pottery sherds.

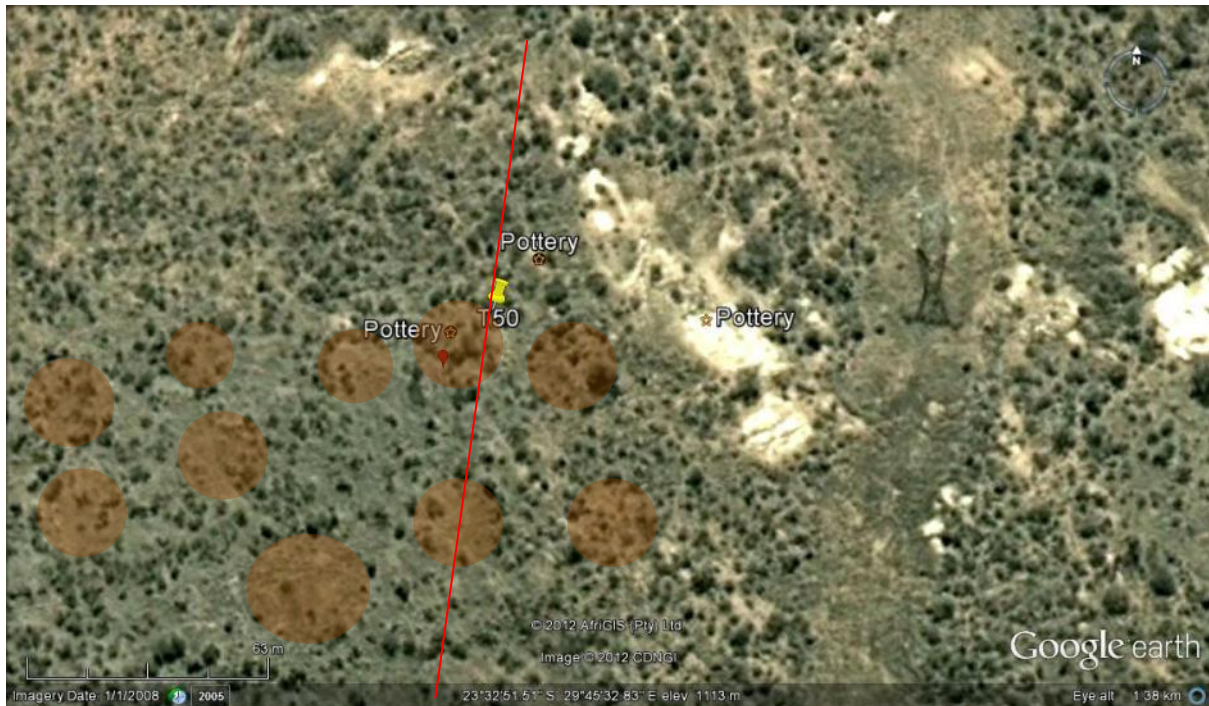
Figure 67. Another archaeological site not previously identified. Again vegetation delineating circular “open areas”. Interestingly most of these circles seem to be more-or-less the same size and definitely form a pattern. Some pottery sherds were located in various places on the site, but where the soil was disturbed by the soil nomination, many sherds were seen.

Recommendations: The same as for Towers 58 and 56: The archaeologist should be present when the foundations for Tower 56 are excavated, since human skeletal material could be retrieved. Great care should also be taken not to damage cultural remains when the transmission line is spanned. Since the previous access route has already damaged the site, it is advised that this route should also be utilised for the Tabor-Witkop transmission line and that the shortest possible access route or a route which will cause the least disturbance should be demarcated from the original access.

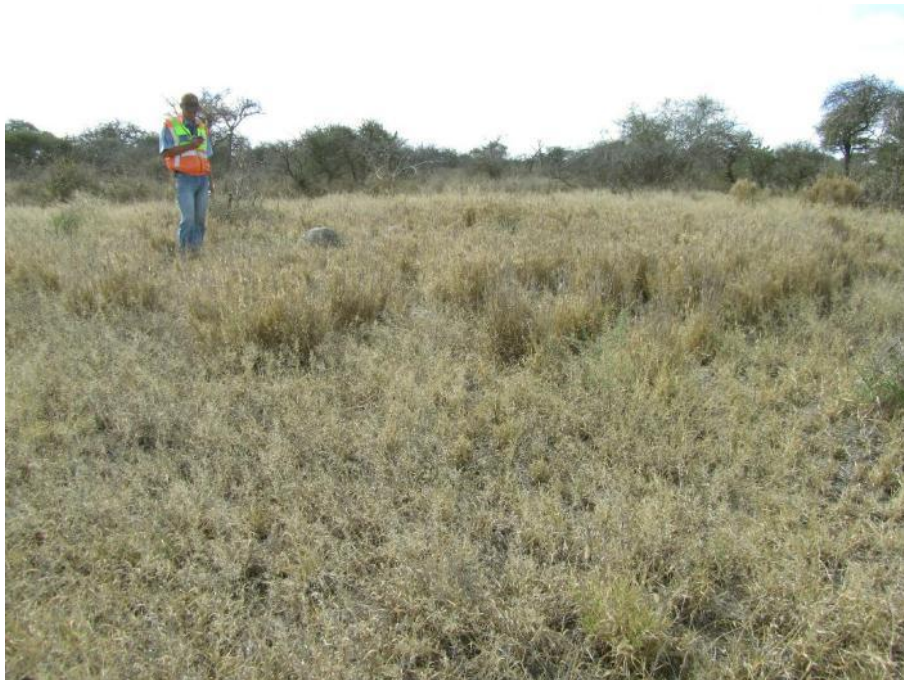
Figure 68. The appearance of the site in general: roughly circular, open, grass areas surrounded by trees.

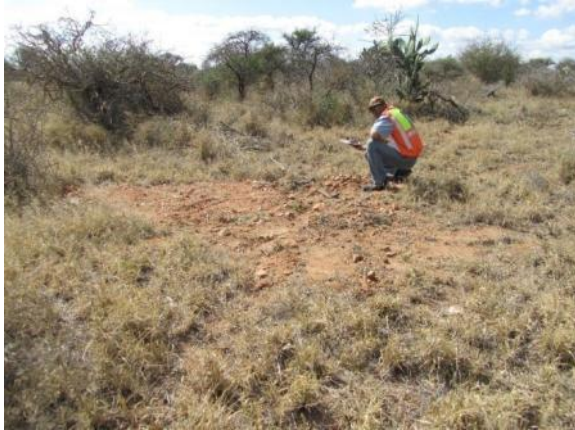
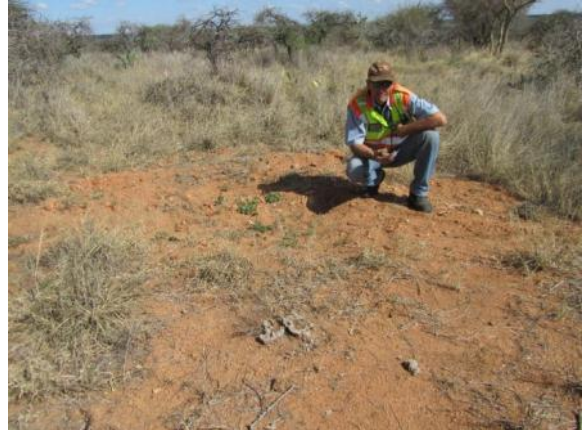
Figures 69 & 70. At both soil nominations (S23°32'51.3" E29°45'31.4" and S23°32'50.7" E29°45'32.2") the presence of pottery was noted.

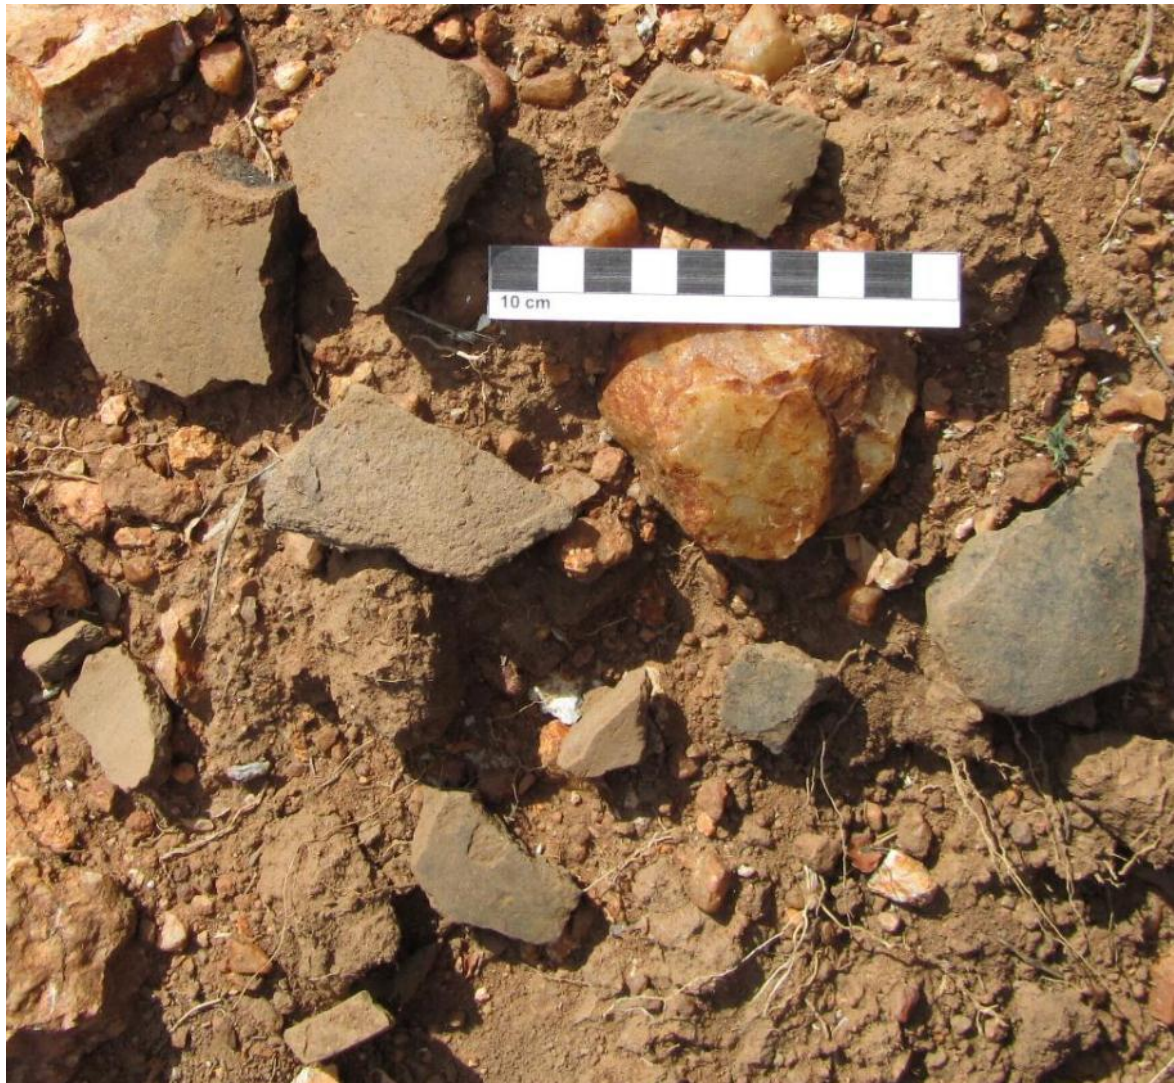
Figure 71. Some decorated pottery and lipped sherds were also revealed by the soil nominations. The pattern on the sherd above the scale is typical of the Letaba style which were used by the Ndebele.

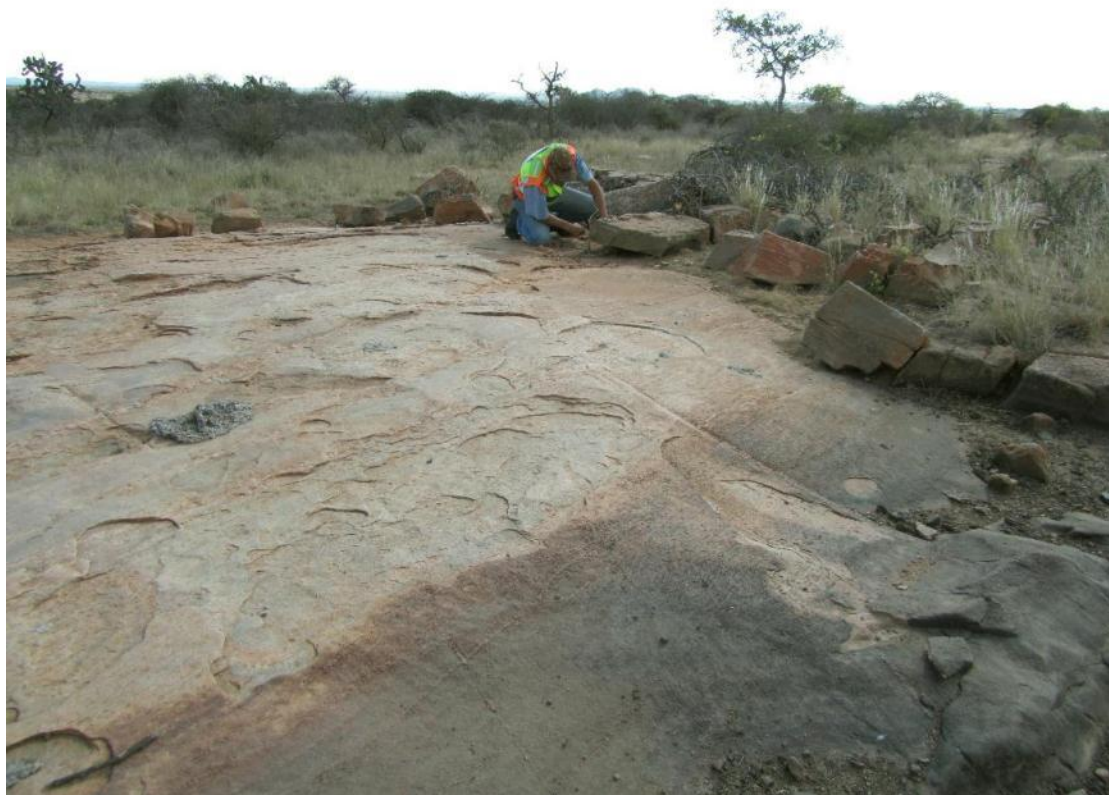
Figure 72. Pottery sherds were also found among the crevices and in the soil depressions on this rock outcrop (S23°32'51.2" E29°45'33.7").

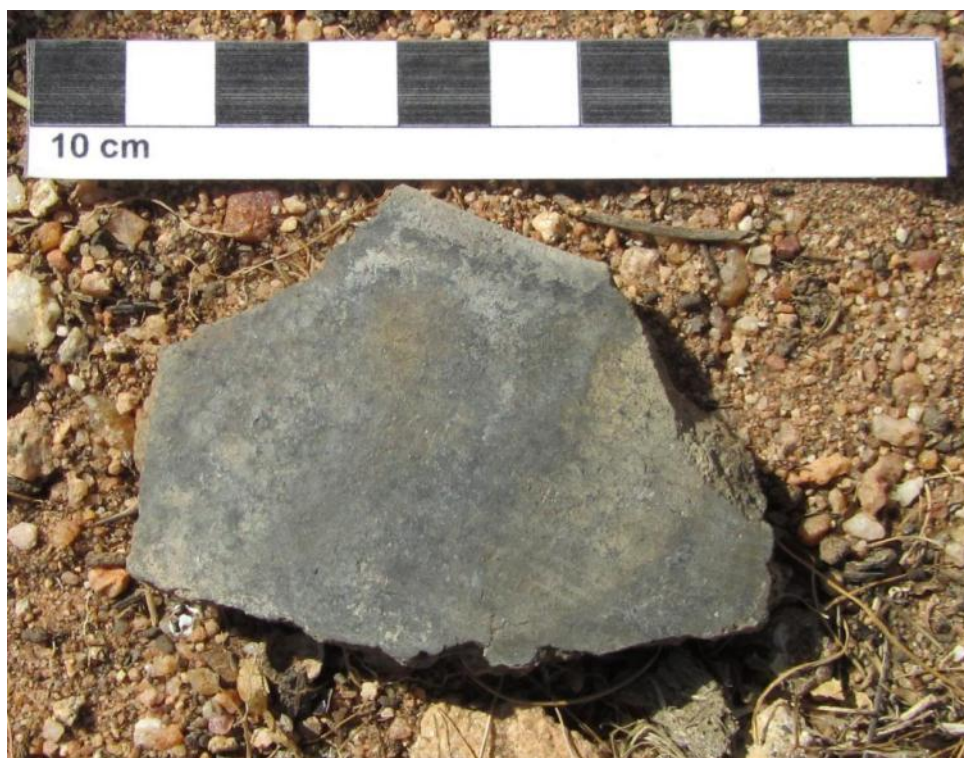
Figure 73. One of the diagnostic pottery lips was found on the stone outcrop.

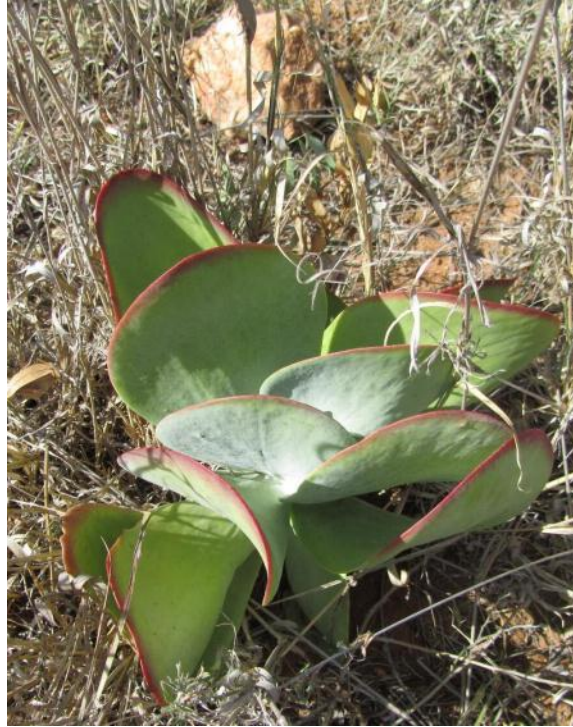
Figure 74. A few *Cotyledon orbiculata* (pig's ear) has been located at this site. It is widely distributed over practically the whole of southern Africa and is widely used for medicinal purposes. It is used to treat corns and warts, and as a vermifuge. It also cures ear- and toothache, treats boils and inflammation. Apparently it is also used to treat epilepsy. *C orbiculata*'s multiple medicinal uses could explain its presence on the archaeological sites.
