PARLIAMENT PRECINCT: OLD ASSEMBLY BUILDING

**PERMIT APPLICATION : ENTRANCE HALL / NCOP LINK CORRIDOR – GROUND AND
FIRST FLOORS – STRIPPING OF EXISTING COLUMNS**

DATE: 29 – 11 – 2022

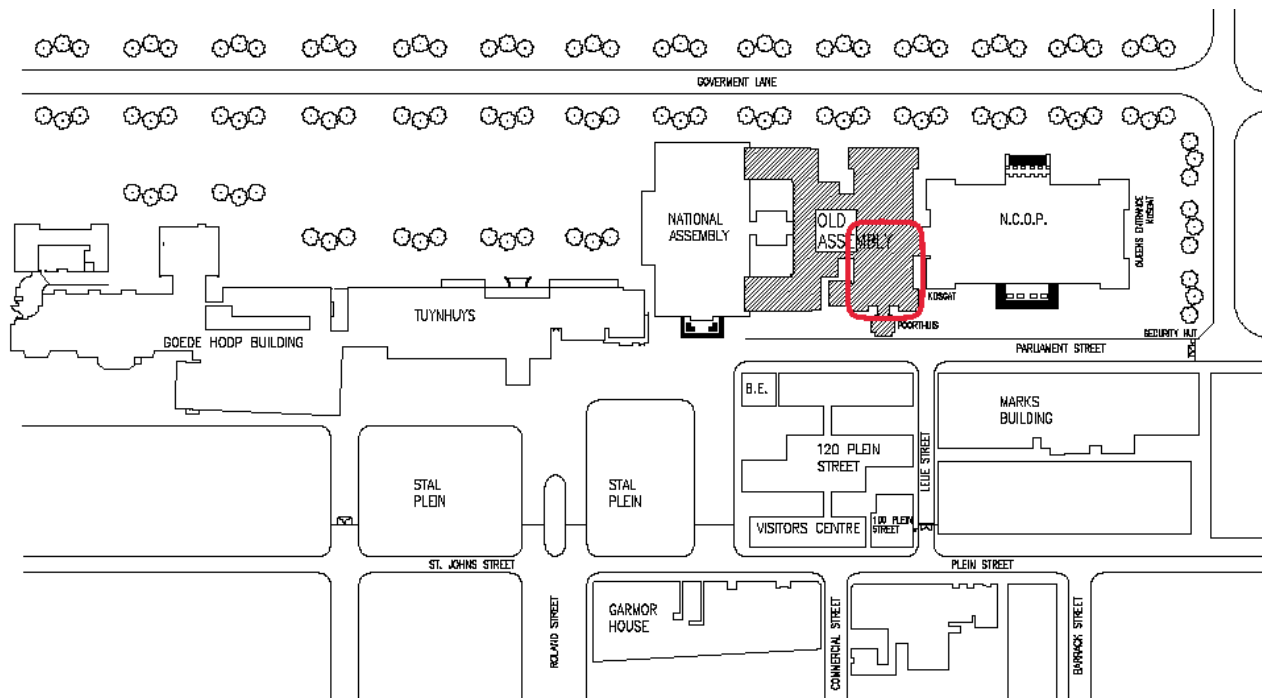
Fig 1 : Site plan – Parliament Precinct

The January 2022 fire caused damages to the second floor on the South East as indicated below on the site plan.

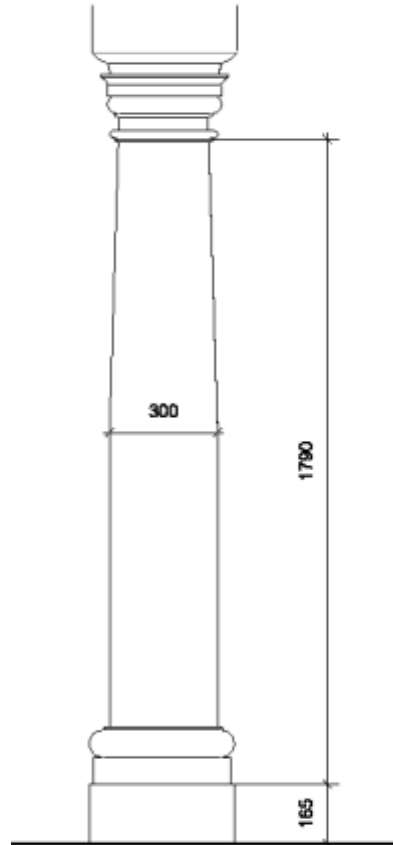
Fig 10 : Typical column in the Entrance Hall/NCOP link corridor

- 1.3 The columns are made out of circular concrete columns, wrap in a plaster/gypsum coating. It is currently the latter that has been damaged by water ingress, causing the coating to crack open, bulged and pop-off.

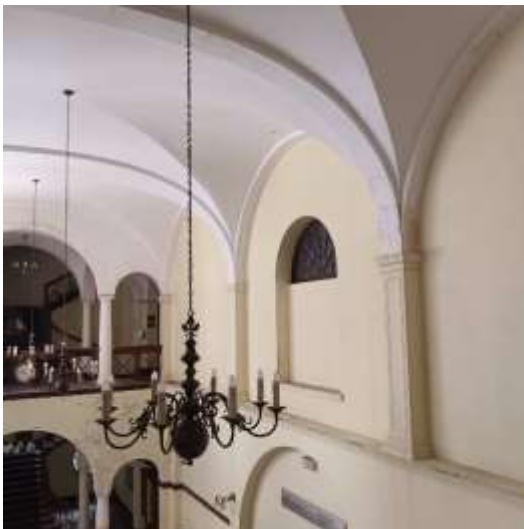
Fig 15 : Hall – ‘Blank’ Wall

5.1.2.1 Shows signs of water stains, cracks in some areas and water ingress (peeling, flaking and bubbling of paint etc).

5. 1.2.2 Water ingresses into the walls from above, find their way downwards, settling in the columns and walls, resulting in the damages now experienced.
