RECORDING OF HISTORIC BUILDING AT STEENKOOLESPRUIT IMPUNZI MINE (WITBANK – MPUMALANGA PROVINCE)

Recording: M. Naude & C.M. Naude
Date: October - November 2014

RECORDING OF THE FLOOR PLAN AND ELEVATIONS OF THE DWELLING.

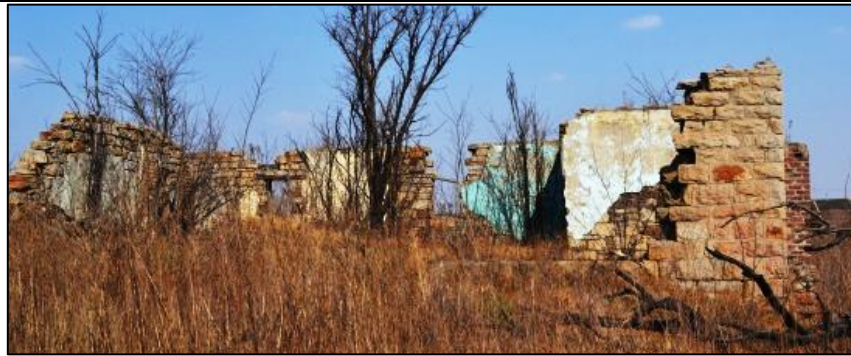
<p data-bbox="800 1040 1058 1065">North-western elevation</p>

1.	<p data-bbox="279 537 554 561">North western elevation</p> <p data-bbox="279 597 1535 654">The building is not orientated according to the exact north-south axis but is set slightly off this coordinate. Almost the entire façade has been demolished and no evidence is available in the structure in order to reconstruct the elevation.</p>

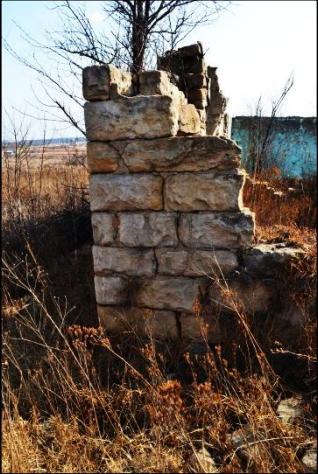
4.	<p><u>Walls</u></p> <p>The exterior walling of the original dwelling was constructed with sandstone and the walls are about 600mm in diameter. The interior walling was constructed with sundried bricks of about 200mm in diameter. The stone masonry walling was left unplastered on the exterior while plastered along the interior. Some sections still have the original mud plaster while other sections were plastered with a sand and cement mixture.</p> <p>All the later additions were done in brick and they were plastered. The most significant brick addition was added to the front façade of the dwelling and left unplastered.</p> <p>All the walls are badly damaged as the building has no roof to protect them.</p>
