HARBOUR MAINTENANCE CHECKLIST FOR SUBMISSION TO DEA GANSBAAI HARBOUR

Gansbaai Harbour

Pieter Badenhorst Professional Services CC

Date: 24 February 2017

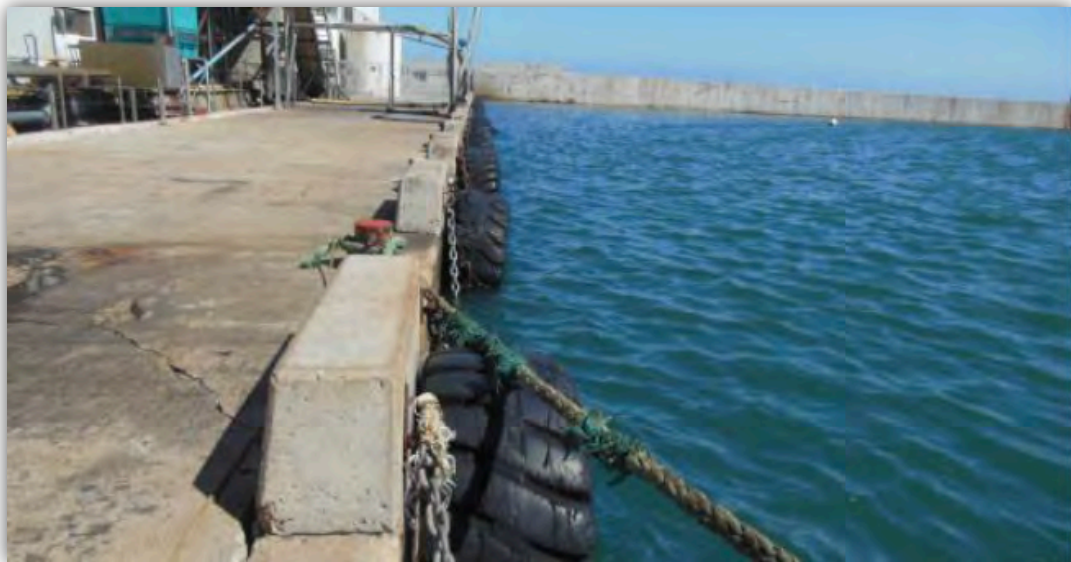
Figure 1.2.3.1a: Quay wall

This 162m long concrete caisson quay wall consists of a 90m long suspended reinforced concrete slab structure and a 72m long concrete block structure as shown in Figure 1.2.3.1a.

Concrete fender blocks where tyres are attached have structural cracks and concrete spalling. Reinforcing is exposed and is corroding. The reinforced slab deck has structural cracking and previous repair methods have failed (see Figure 1.2.3.1b).

Maintenance and concrete repair work to concrete fenders and reinforced concrete slabs. Examples of damage shown in Figure 1.2.3.1b.

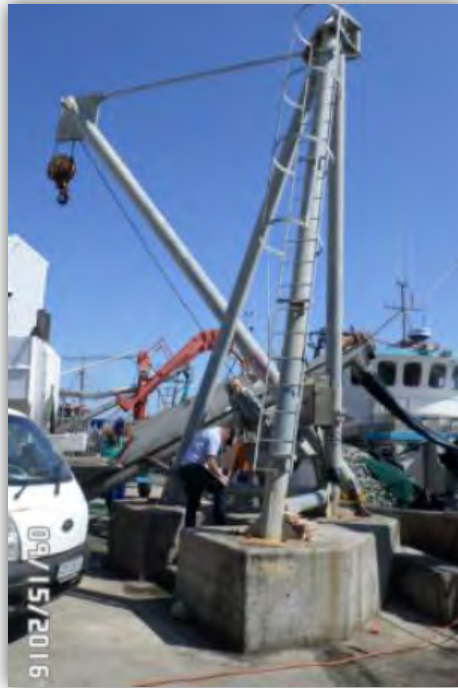
Figure 1.2.3.1c: Structural cracks to be repaired

The derrick crane is rated as a 7.5 SWL ton crane used for ship to shore lifting as shown below in Figure 1.2.3.1c.

Corrosion is evident throughout the structure as shown in Figure 1.2.3.1d. However, there were no immediate indications of duress to the steel structure.

For its operational requirements, the crane is deemed to be adequate. In conversation with the Doc Master, he gave no indication that the crane is negatively affecting the harbour operations. It is anticipated that only rehabilitation is required by providing maintenance through sand-gritting and recoating with corrosive protection paint.

It is however recommended that a specialist service provider do a full diagnostic to verify the operational capability of the crane and inform on the way forward.

- Worst case scenario to replace crane with “like to like” (further site investigations to take place)
- If not replaced repair and maintenance. Grit blasting and recoating with non-corrosive paints where required.
