**Professional Consultancy Services for Coastal Engineering Infrastructure  
Proclaimed Fishing Harbours Western Cape**

# **HARBOUR MAINTENANCE CHECKLIST FOR SUBMISSION TO DEA STILBAAI HARBOUR**

## **Stilbaai Harbour**

**Date: 7 February 2017**

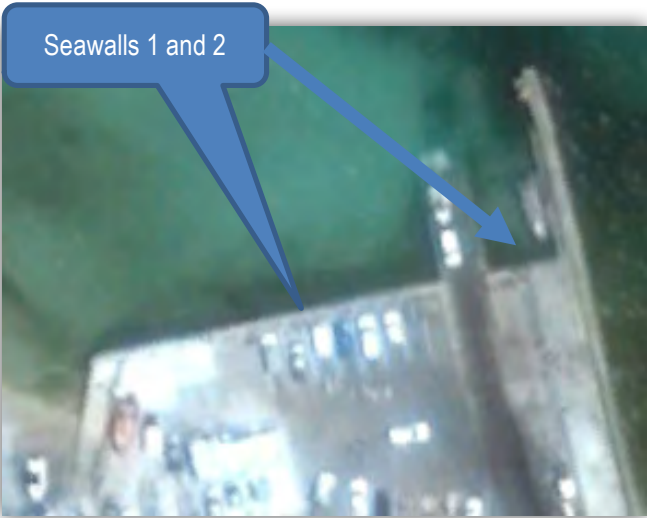
Figure 1.2.3.1a: Seawalls 1 and 2

The integrity of the toe of the seawall could not be viewed for scour, but it is assumed that the cause of the settlement behind the wall is most likely due to loss of backfill material leaching through the wall.

Abrasion of concrete was noted on the lower blocks, below the high water mark. Significant staining, minor cracking and spalling is evident throughout.

**Seawall 2:** The seawall above the high water mark is in good condition, however the lower section in the tidal zone indicates that abrasion is taking place. There is visible settlement, unevenness, and collapse of the paving blocks behind the seawall. There is a void under the paving, probably caused by a loss of fill material leaching out under the seawall and/or alternatively through the joints. The integrity of the toe of the seawall with regards to scour is not confirmed,

However, the surface landward of the walls require maintenance as shown in Figure 1.2.3.2 as well as improved toe protection within the existing footprint.

**Seawall 1:** Repair works is required to resolve the continuing settlement behind the seawall. Further investigation is required to establish whether settlement is continuing or has been arrested. This is to done through site investigations by excavating behind the seawall and analysing the toe of the structure.

The envisaged extent of the repair works required is likely to include the following: repair of toe protection, replacement of backfill material, sealing of joints between concrete blocks and concrete paving slab.

Repair works envisaged: repair of toe protection, sealing of backfill against leaching paths, replacement of backfill material and reinstatement of paving.

- Excavate landside of seawall
- At joints in seawall add geotextile layer
- Backfill with rock, and layer works
- Replace existing paving as required
- Rehabilitate toe of the structure
- Provide new wheepholes

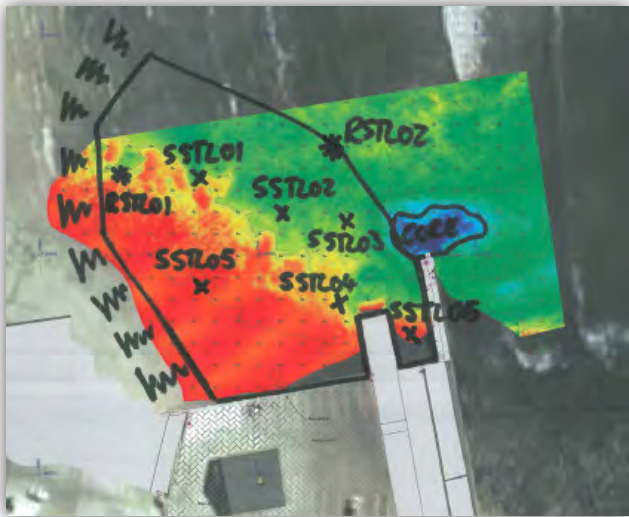
**Figure 1.2.5.1: Proposed area for dredging in Stilbaai harbour**

The proposed area for dredging is shown in Figure 1.2.5.1. It is estimated that approximately 4000m<sup>3</sup> dredging will be required and to be deposited outside the harbour area. The actual deposit position must still be finalised. For these small volumes the cost for depositing on a beach south of the harbour compared with containment and re-use on the land (see Figure 1.2.5.2) will have to be evaluated.
