**Proclaimed Fishing Harbours – Work Package 3**

29-31 August Site Visit

**Coega Development Corporation**

26 September 2016

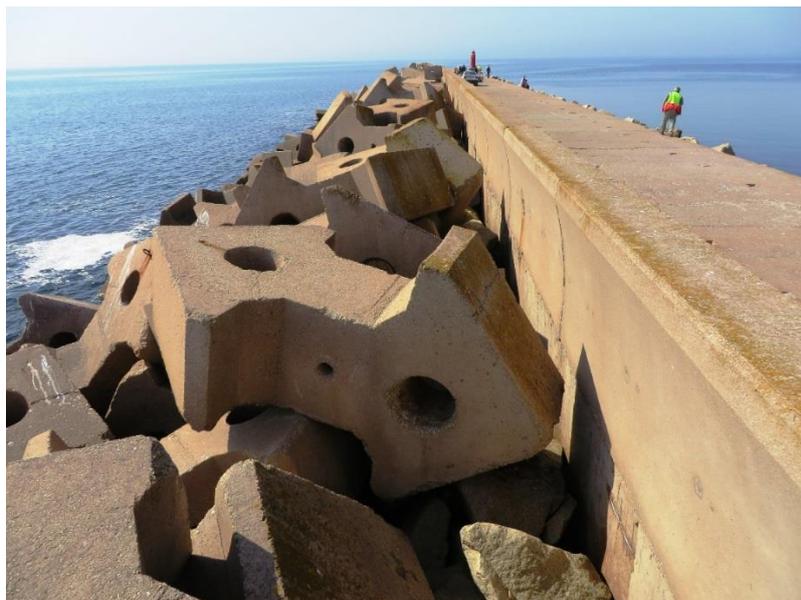
In general, the main breakwater is in good condition (including the concrete structural elements, concrete causeway/deck, concrete crest wall and the outer armour units). However, beyond the 'Coastal Quay' there is evidence that the concrete deck has deteriorated somewhat and may, at some stage, require remedial works – primarily patch repairs. This could be attributed to higher exposure of the deeper section to waves and potential overtopping.

Figure 3: St Helena Bay Harbour main breakwater (western face)

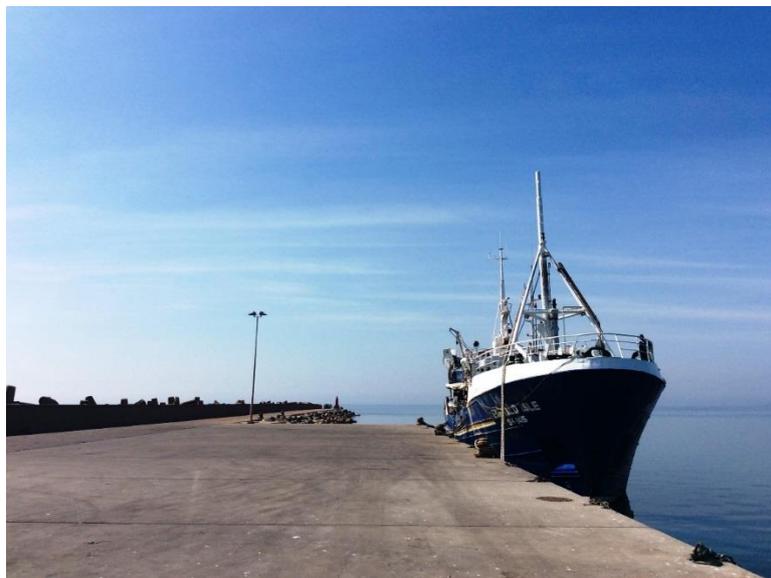
The 'Coastal Quay' is in good condition with no immediate remedial works to the concrete elements required. However, the following was noted:

Figure 4: Coastal quay along the breakwater

- Bollards – require general clean (sand blasting) and painting.
- Fenders – service all the tyre fenders, chain supports and fastenings.
- Potable water supply – extend the fresh water supply from the existing HDPE pipe to suitable points along the quay.

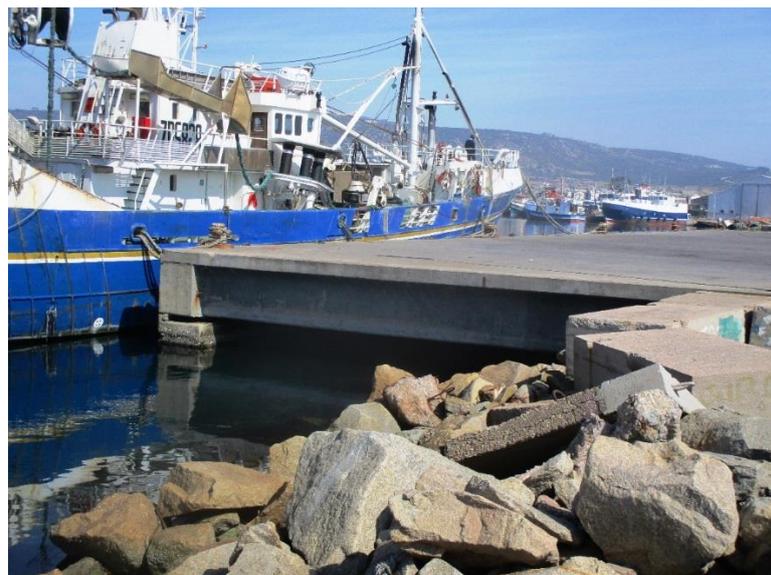
Figure 5: Coastal quay

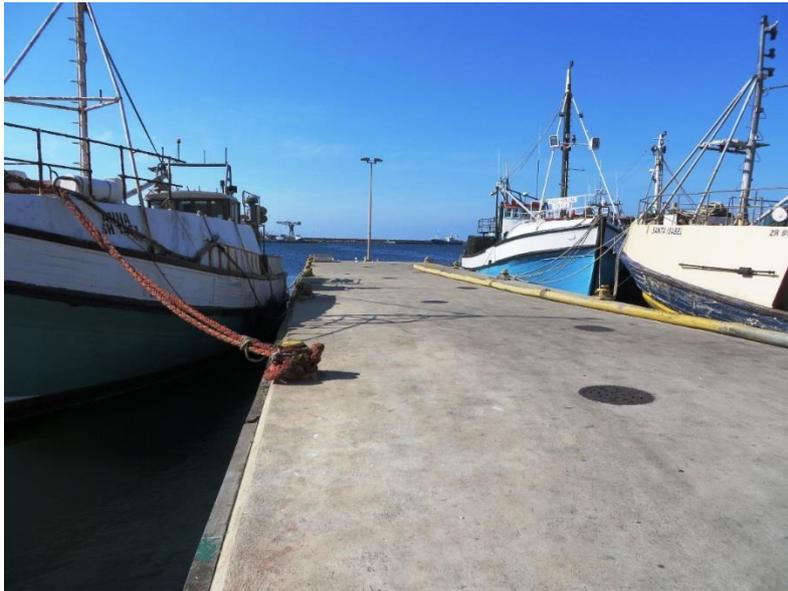
The concrete jetty structure is generally in good condition.

The fendering system, comprising tyres, chain supports and fastening, requires a general service. Approximately 8 tyre fenders need to be replaced. The bollards along the jetty require cleaning and repainting.

Figure 6: Jetty 1

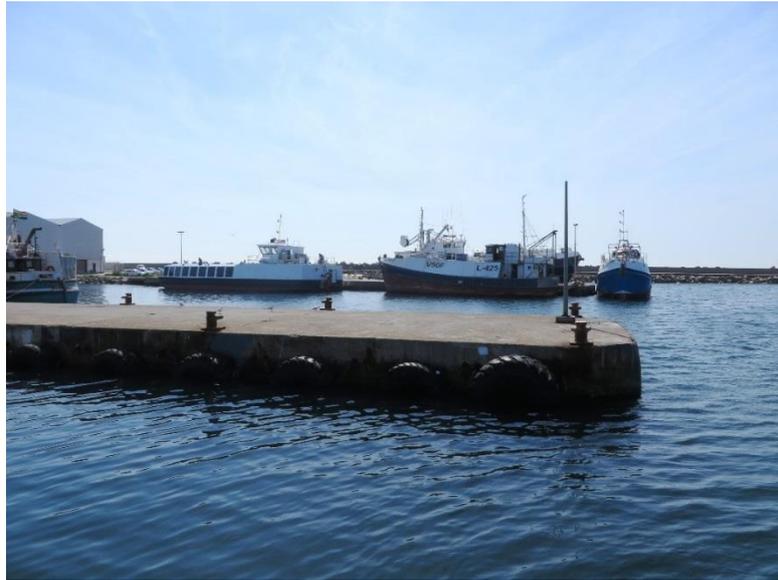
The concrete jetty structure is generally in good condition. However, it was noted that there is a crack below one of the bollards near the head of the jetty, which will require repair. A general service of the tyre fenders, chain supports and fastening is required. The bollards along the jetty require cleaning and repainting.

Figure 10: Jetty 3

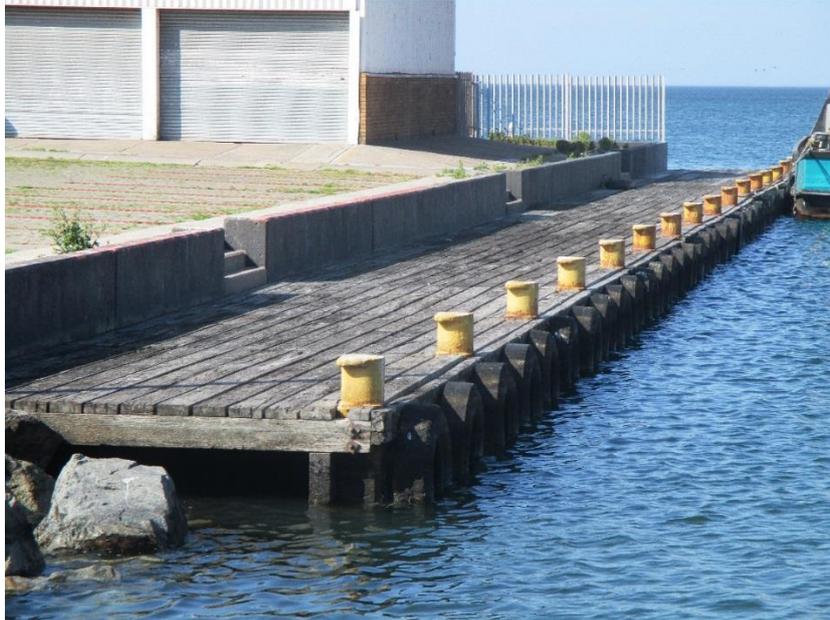
Timber Quay 1 shows evidence of deterioration of the timber deck with the majority of the deck panels needing replacement. The condition of the supporting reinforced concrete piles are still to be ascertained as it requires an inspection by divers.

As with the above jetties, a number of the tyre fenders need replacement, whilst a general service of the remaining fenders, chain supports and fastenings is required. The bollards along the jetty require cleaning and repainting.

Figure 14: Timber Quay 1

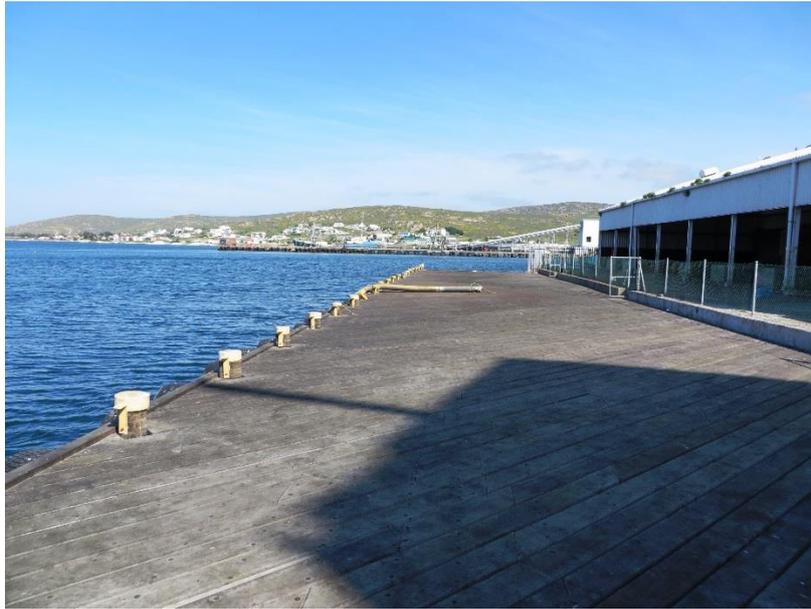
Timber Quay 2 has recently been refurbished and is in good condition. It was noted that two tyre fenders are missing whilst one of the bollards requires repair. Apart from the repair needs, the bollards along the jetty require cleaning and repainting.

Figure 16: Timber Quay 2

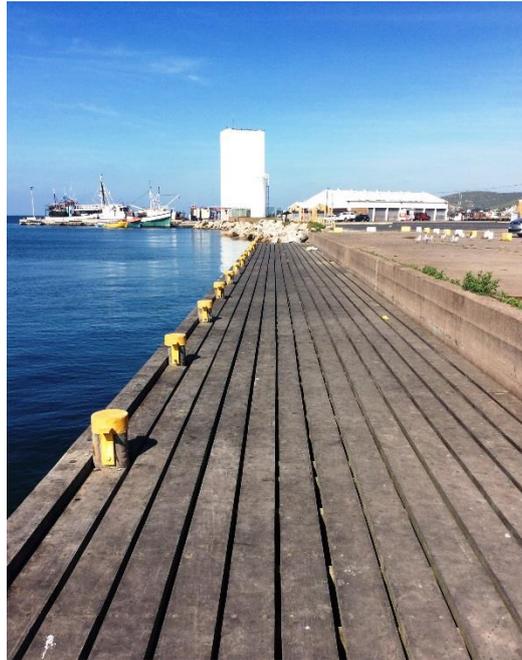
Timber Quay 3 has also recently been refurbished and is in good condition. The bollards along the jetty require cleaning and repainting.

Figure 18: Timber Quay 3

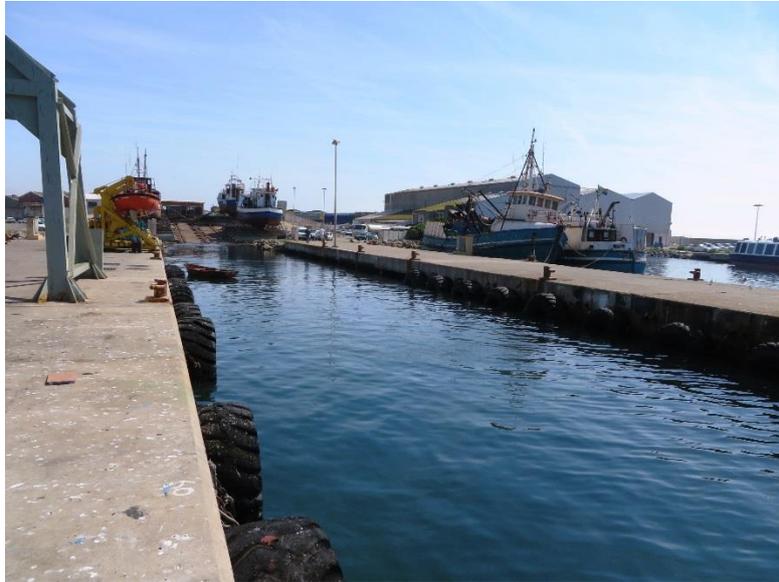
The main repair slipway is located between Jetties 2 and 3. The slipway layup area has capacity to accommodate 4 vessels at a time. However, the presence of an abandoned wreck, which has been lying at the SE repair bay for approximately 13 years (according to the harbour staff), has reduced this capacity to 3. The existing cradle/lift is said to work adequately with no issues raised or identified pertaining to the rail system. However, the use of divers to investigate the portion of the rail below the low water mark is recommended.

- Firewater pumps not operational (discussed in section 3.9). This raised a concern with the project team over the safety of the overall slipway operation, given the inherent hazard of fire due to the flammable and combustible items such as timber hulls, ship diesel, LPG gas canisters etc.

**Figure 19: Entrance to the slipway repair facility**

Based on the above, an investigation into improving the current operations of the slipway facility is suggested with specific focus on automating the cradle arms, the horizontal movement and positioning of vessels and upgrading of the main winch capacity.

The provision of potable water to the slipway is also required.

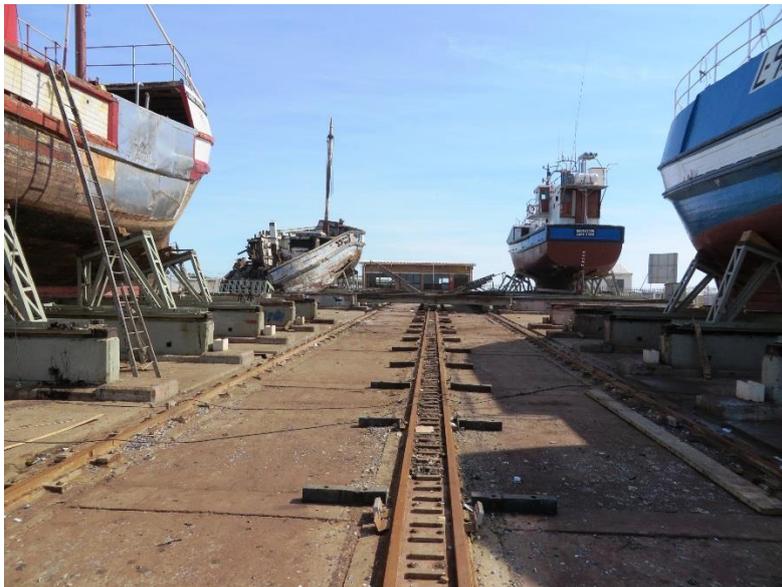
**Figure 20: Slipway cradle rail**

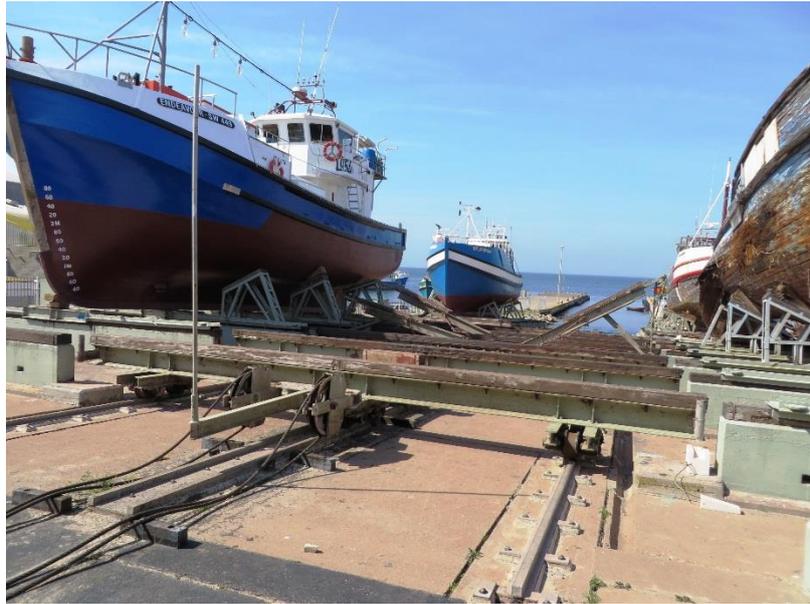
Figure 21: Slipway cradle

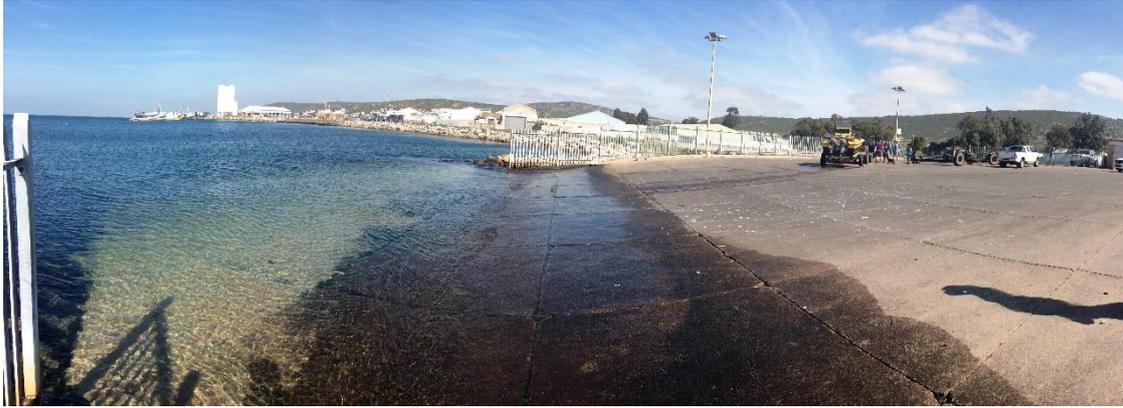
The boat launch is generally in a good condition. However, the winch requires general maintenance and an overall service. The supply of water to the facility is required for the cleaning of the vessels.

Figure 23: Boat launch ramp

A bathymetric survey in the vicinity of the launch ramp is recommended to assess the possibility of extending the ramp to deeper depths in order to cater for deeper draft vessels.

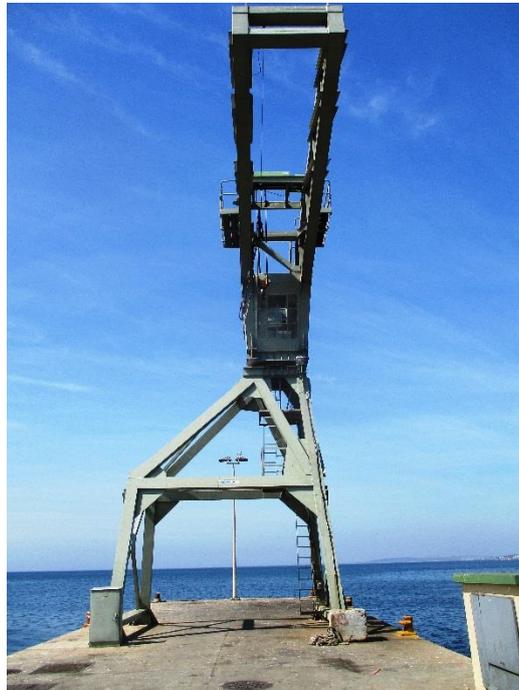
Figure 24: Shore crane on Jetty 2

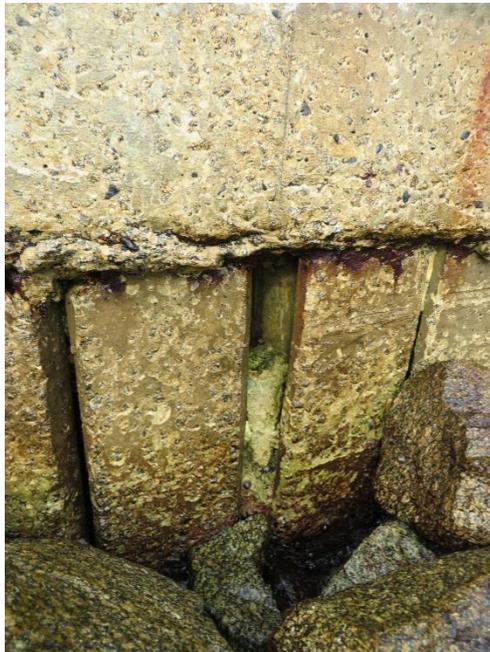
Along the eastern breakwater, which was constructed in the late 1960's / early 1970's, there is evidence that the concrete sheet pile wall sections have separated at certain locations. This has resulted in significant loss of sand fill from the breakwater. In turn, this has led to the surface bed concrete slabs settling and severe distress is now evident in many places. Cracking and spalling of

**Figure 27: Separation of the concrete sheet pile walls**

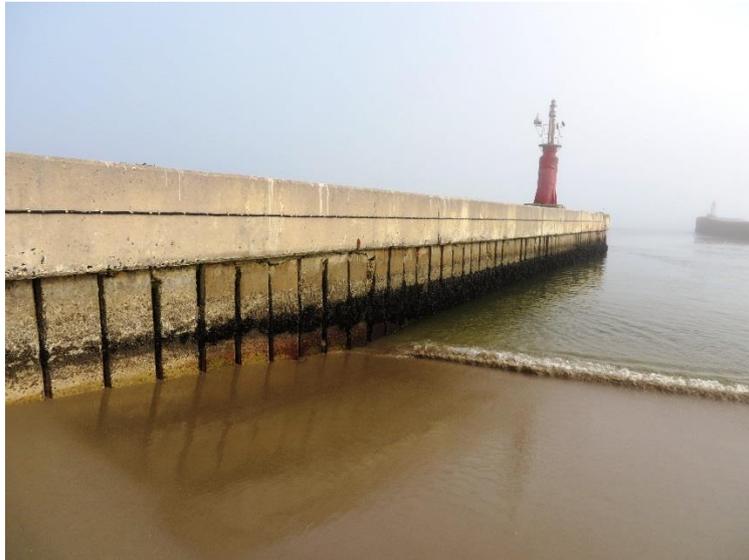
Similar to the eastern breakwater, the middle breakwater shows evidence of the concrete sheet pile walls separating and deflecting. As a result, the sand fill has been lost and the concrete deck shows evidence of distress, albeit not as significant as the eastern breakwater.

The channel marker at the head of the middle breakwater requires maintenance.

Figure 28: Middle breakwater

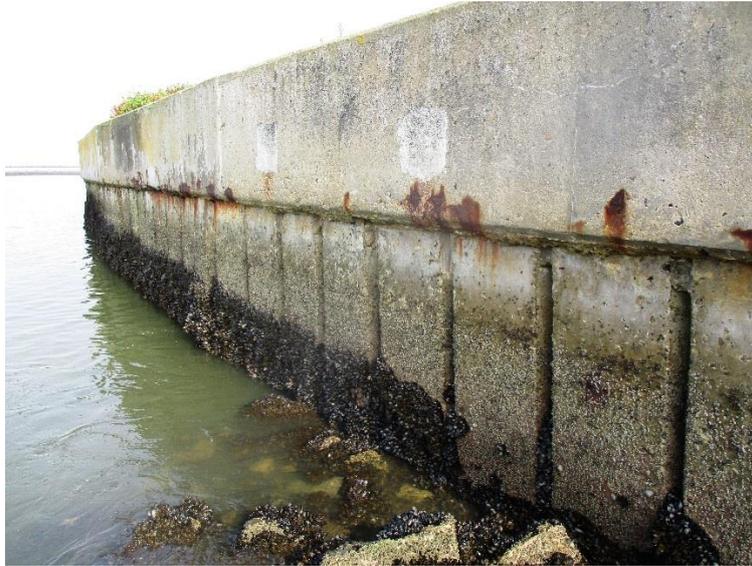
The middle training wall, which extends from the middle breakwater and along the Berg River to the Laaiplek Harbour boat launch ramp, was also constructed with the use of concrete sheet piles. At certain sections along the wall the sheet piles have separated, once again resulting in sand fill being lost from behind the wall. As a result, sinkholes/cavities have formed behind the training wall. In an attempt to remediate this, evidence suggests that ground anchors were installed to tie back the walls and concrete was placed behind the walls to fill in the gaps in the sheet pile wall. In some areas it is apparent that sand fill is still being lost.

Figure 30: Middle training wall

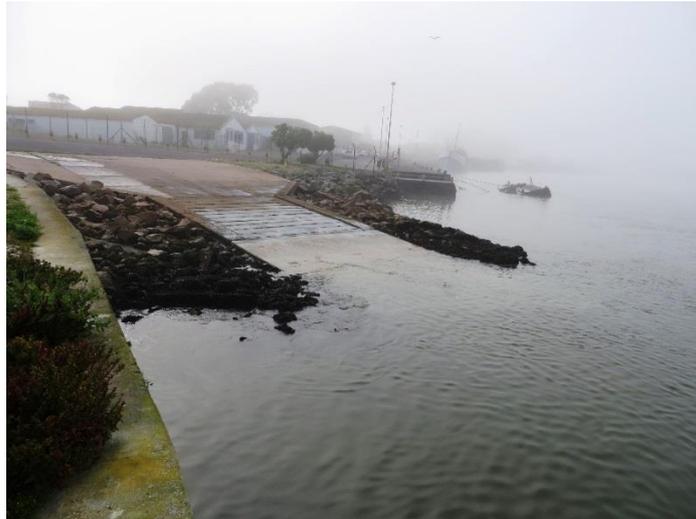
The existing boat launch ramp is generally in good condition with no alarming concerns. However, the harbour officials would like to expand the boat launch to allow for more than one boat to be launched or landed simultaneously.

Figure 32: Boat launch ramp

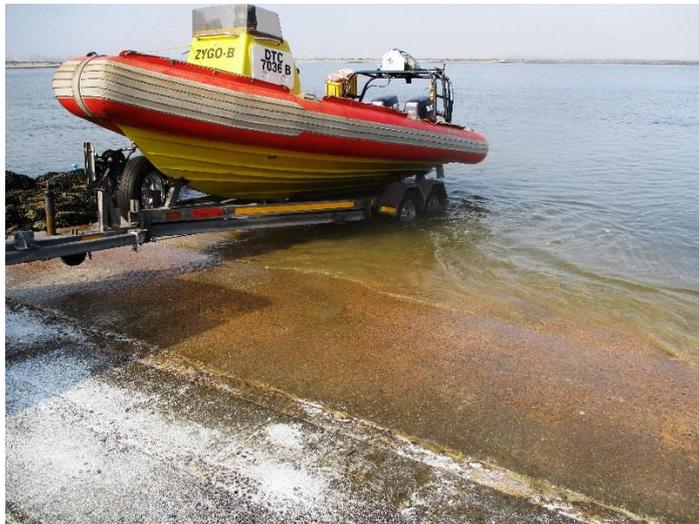
Figure 33: Boat being launched from the ramp

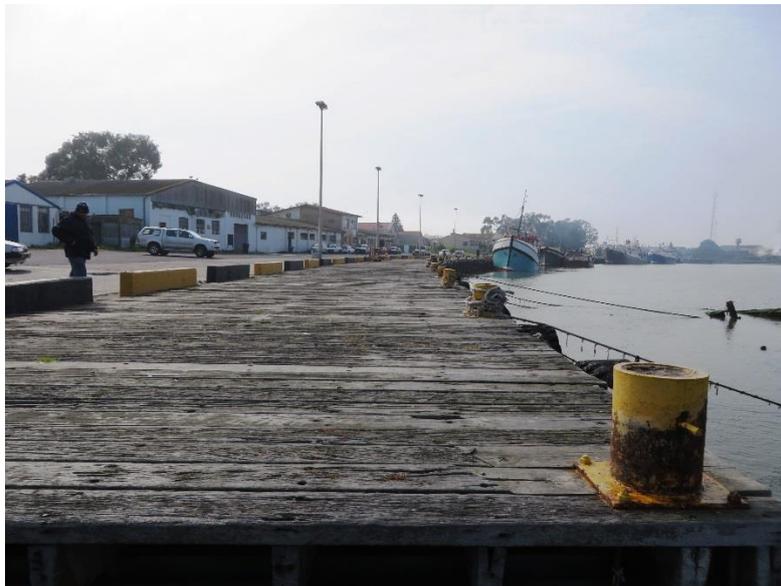
The entire timber deck is in a relatively poor condition, as may be expected due to the minimal maintenance done on it since its construction in the 1960's/70's. A number of the timber deck panels are loose and rotten. The piling will require further investigation by divers to determine the condition of these elements.

- Vessels larger than the original design vessel are currently utilising the quay.
- During northerly winds, the mooring of larger vessels results in the timber quay swaying back and forth due to increased mooring loads applied to the structure.
- There are only 2 or 3 potable water supply points along the entire length of the quay, which makes the provision of water to all moored vessels difficult.

Figure 34: Timber quay

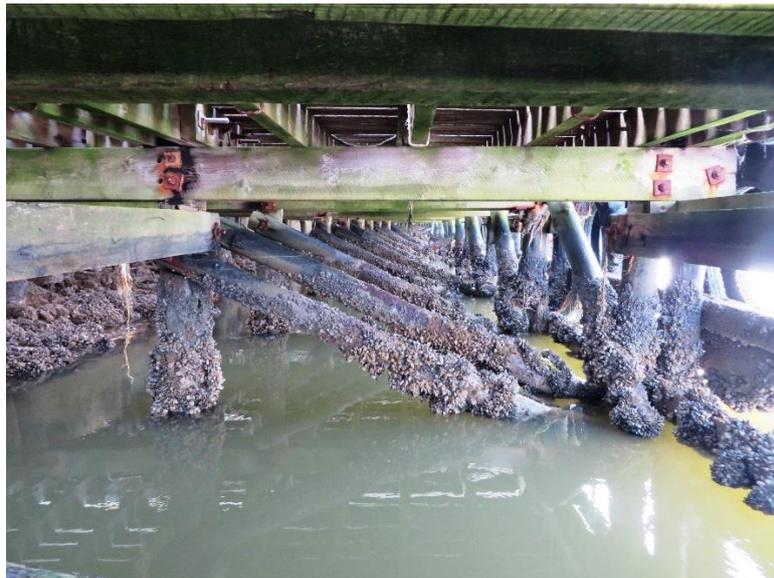
- The electrical cables run along the underside of the timber deck, across the support beams without being fastened to the structure.
- The electrical kiosks located along the quay are often out of service due to leaking during periods of rain.
- There is evidence of damage to the concrete barriers which block vehicle access onto the quay.
- On the far eastern end of the quay, near the shore crane, steel plates have been placed on top of the wooden deck, presumably to reinforce the deck to allow vehicles onto this area. It is believed that piles are arranged at closer spacing in this area to support this and that this area has therefore been designed for higher loadings.

Figure 35: Sub-structure below the quay deck

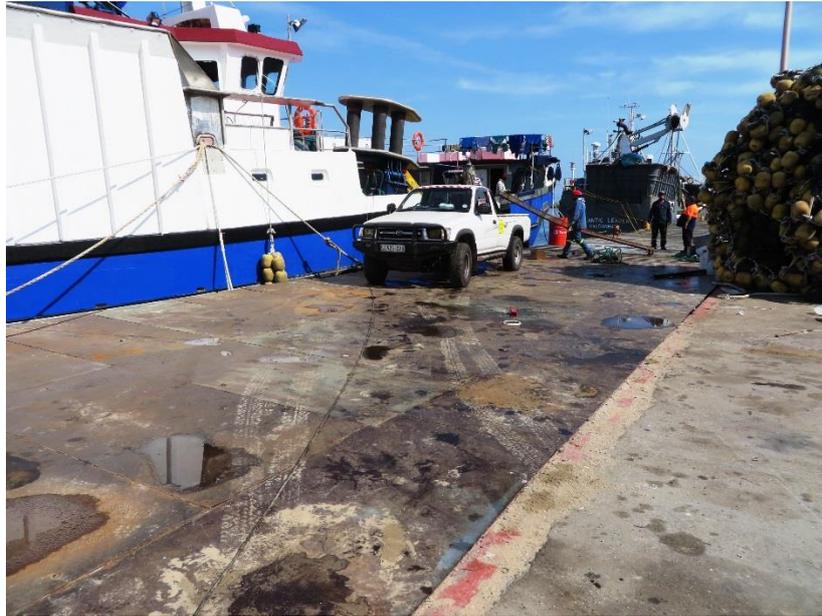
Laaiplek Harbour has a fixed shear-leg crane at the eastern end of the quay. Currently, it is out of order and in poor condition, most likely requiring replacement. Alongside the crane is a makeshift loading area constructed out of steel plates placed on top of the timber deck. It was raised that a better arrangement would be beneficial, possibly formalising this setup with a concrete deck and loading/unloading area.

Figure 42: Steel loading platform at eastern end of timber quay

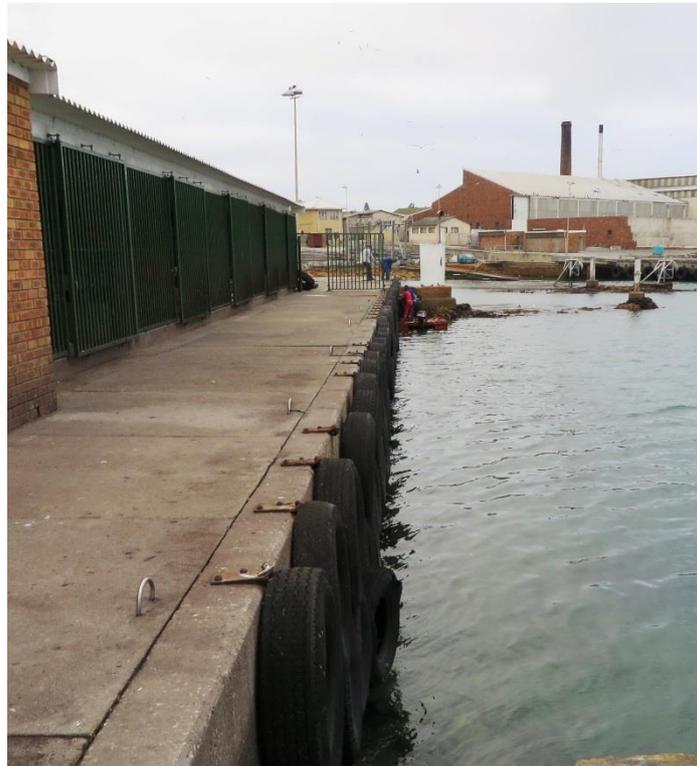
The Snoek Quay appeared to be in good condition. During the site visit maintenance works were being carried out on the tyre fenders.

Figure 49: Snoek Quay

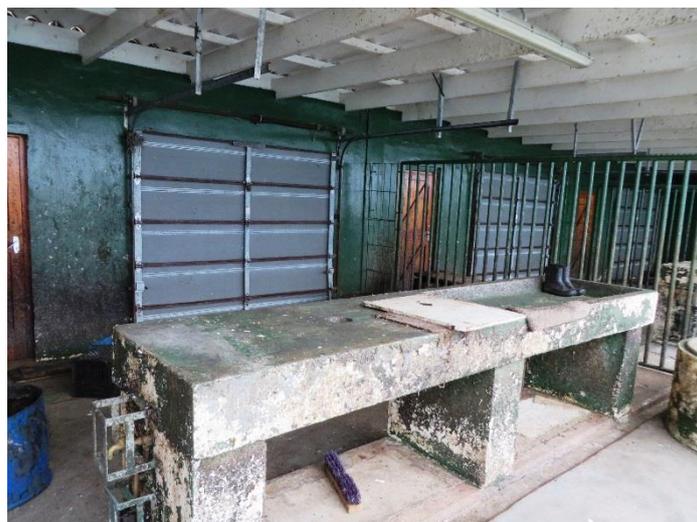
The fish cleaning facility was in adequate condition, but the roller doors for access to the cleaning benches from the parking area require replacement. The harbour master also suggested that an additional potable water supply point be placed at each cleaning bench. An additional high mast for lighting purposes was requested at the northern end of the cleaning facility along the quay to provide additional light as the lighting along that portion of the quay is poor.

Figure 50: Fish cleaning facility along Snoek Quay

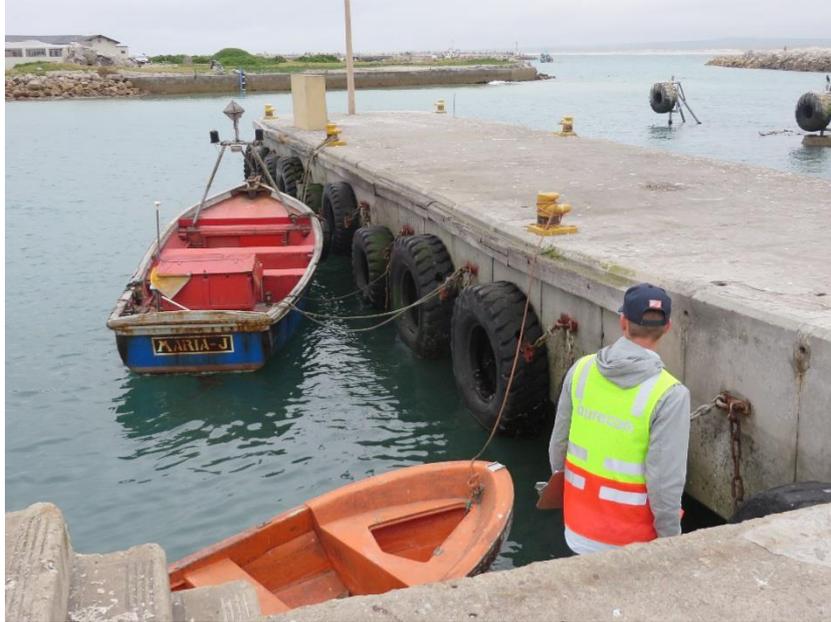
The finger jetty, located alongside the slipway facility, is generally in good condition with some general cleaning and maintenance required along the concrete deck. The bollards along the jetty require

cleaning and repainting. A general service of the tyre fenders, chain supports and fastenings is required with the possible replacement of two fenders.

Figure 51: Finger Jetty

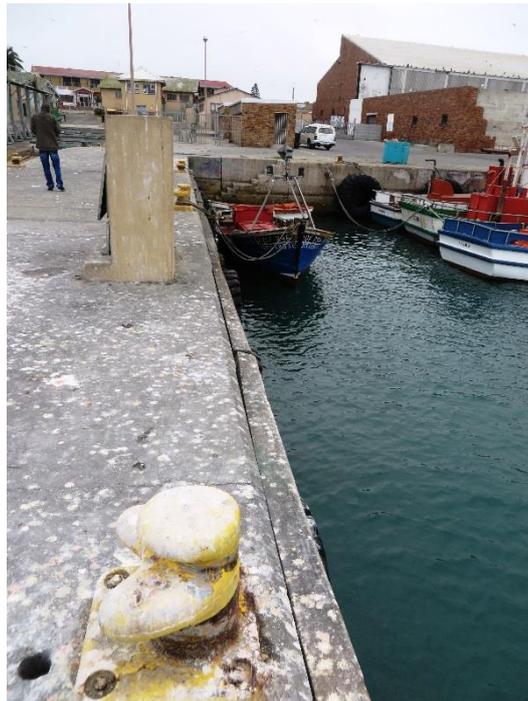
Figure 52: Bollard and electrical supply point on Finger Jetty

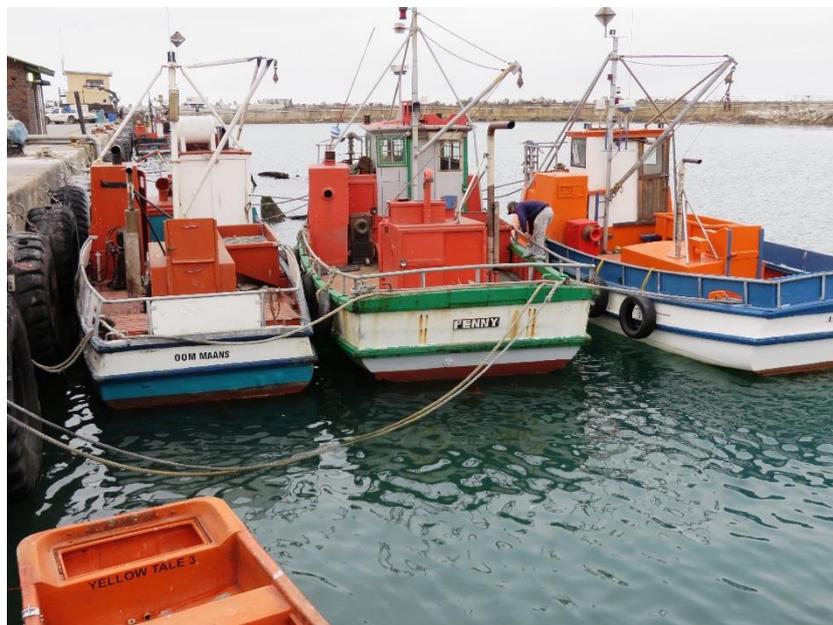
The concrete gravity quay structure is in good condition with evidence of expected wear and tear from prolonged use. There is one missing bollard whilst the majority of the bollards along the quay require cleaning and repainting. Roughly 10 tyre fenders may require replacement with the remaining fenders are in need of a general service of the tyres, chain supports and fastenings.

Figure 53: Fishing vessels moored alongside main quay

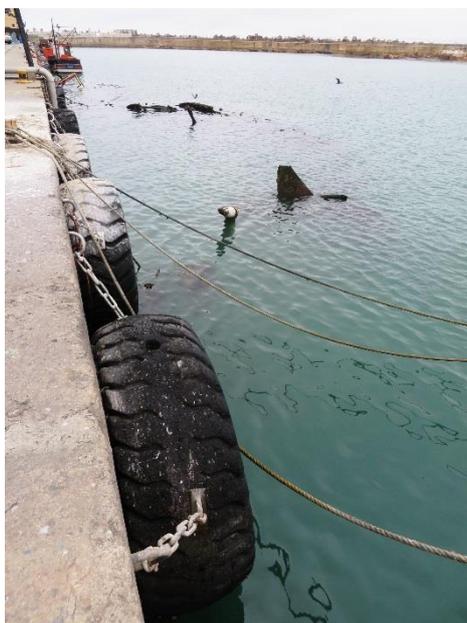
Located alongside the main quay are two sunken vessels which take up approximately 50 to 55m of quay length and interfere with the efficient use of the shear-legs crane.

Figure 54: Sunken vessels alongside main quay occupying quay space

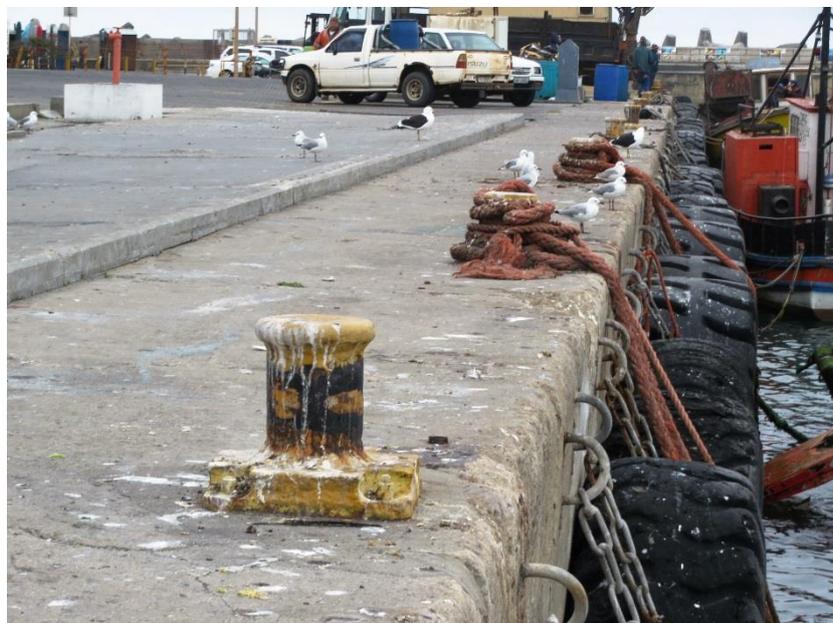
Figure 56: Tyre fenders and bollards along the main quay

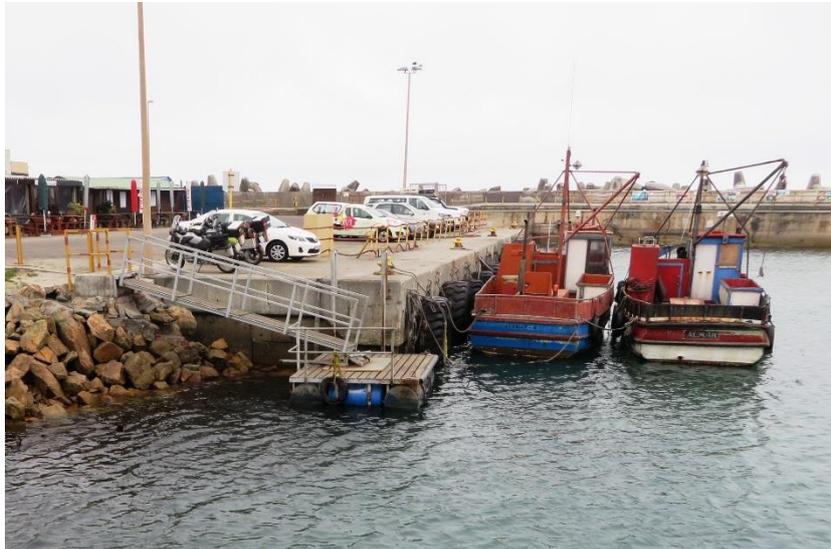
The secondary quay, in front of Isabella's Restaurant, consists of concrete gravity blocks. Overall, the quay structure is in good condition with a couple of the tyre fenders in need of replacement. The remaining fenders require a general service. The bollards along the quay are in good condition but minor maintenance works may be necessary.

The back of the quay is open to the public and used as parking for visitors to Isabella's Restaurant. To accommodate this, a handrail has been erected. However, this handrail requires refurbishment and possibly replacement with a more robust solution.

Figure 57: Secondary quay

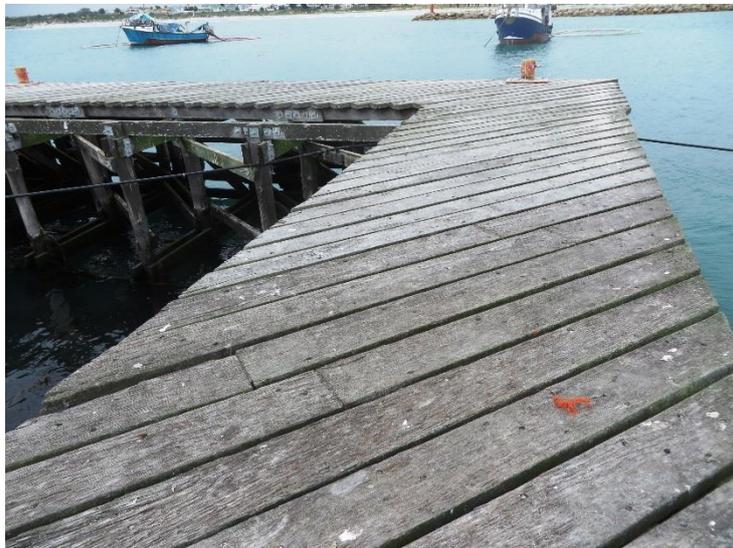
The timber quay or landing platform located along the western breakwater is in relatively good condition. There is evidence of additional bracing provided to further secure the quay (cable bracing attached to the front corner piles). The tyre fenders are in good condition, but the bollards require cleaning and repainting.

Figure 58: Timber quay deck

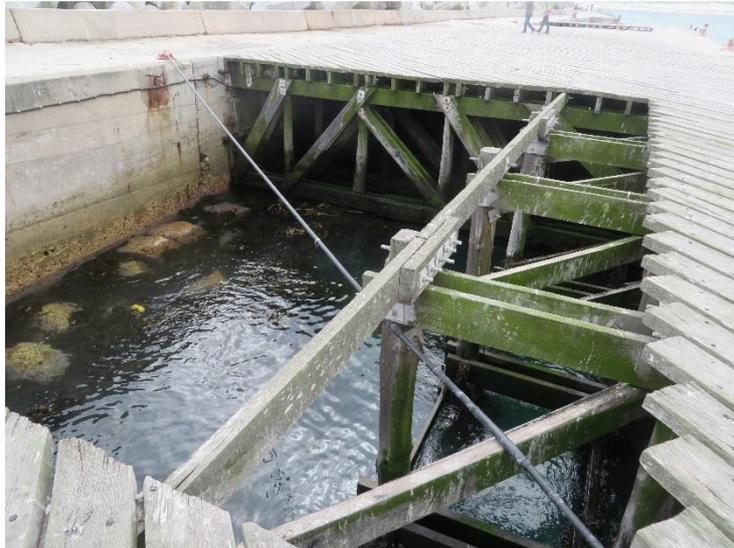
Figure 59: Sub-structure and additional bracing cable of the timber quay

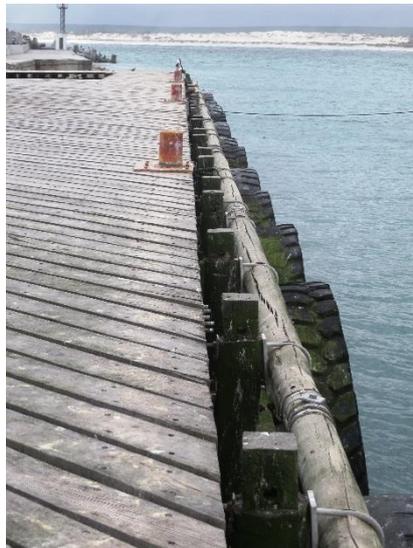
Figure 60: Bollard and tyre fender system on the timber quay

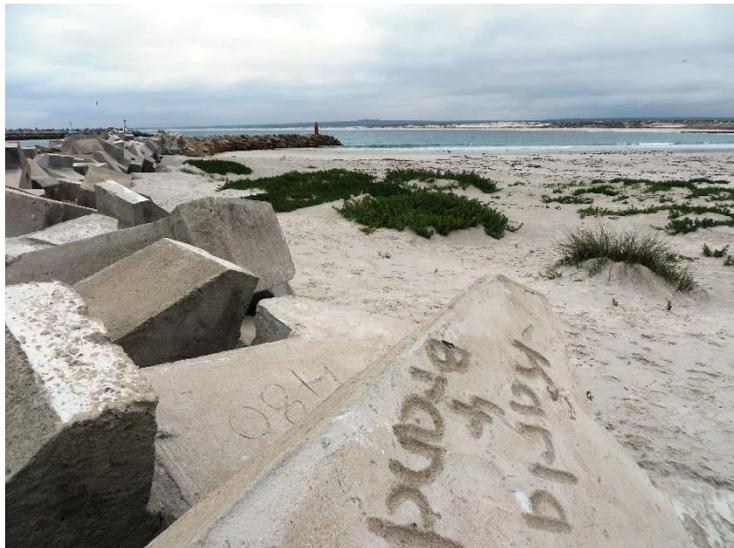
The eastern breakwater structure is in good condition with the navigation aid at the head of the breakwater being fully functional. It was noted that there is a large amount of windblown sand which has accumulated alongside as well as on the breakwater structure, due to north / north-easterly winds.

Figure 62: Sand build-up along the armour units of the eastern breakwater

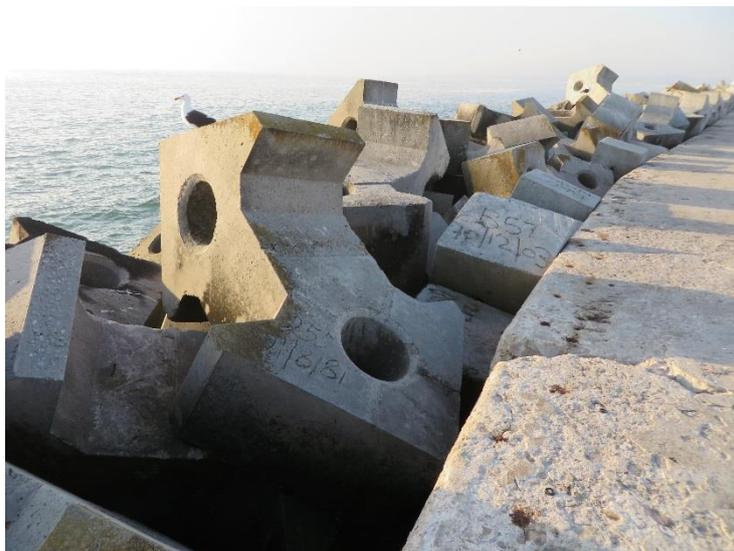
Figure 66: Concrete armour units along the western breakwater

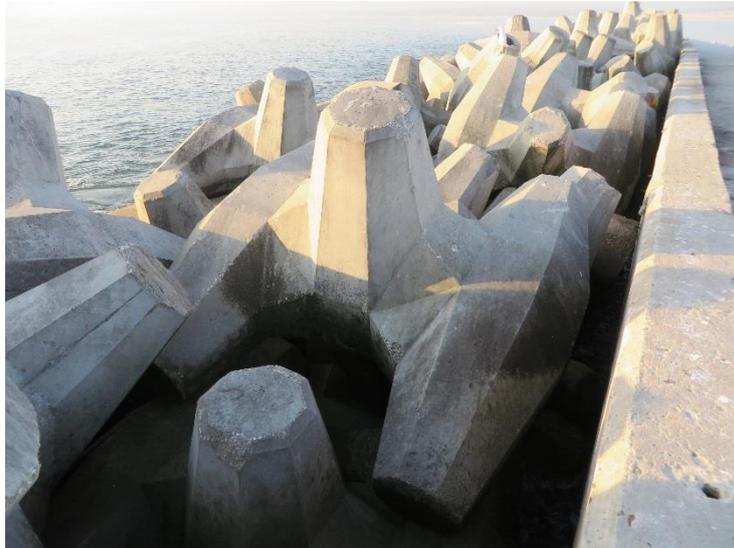
Figure 67: Different type of armour units used along the western breakwater

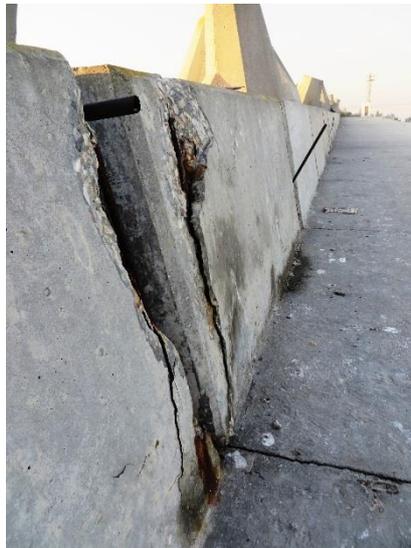
The concrete deck of the western breakwater shows evidence of concrete and reinforcement degradation. There are locations where the reinforcement is exposed and severe spalling of concrete has already taken place. It is recommended that a thorough investigation be undertaken to ascertain the condition of the materials and that proper concrete repairs be carried out, ideally within the next two years.

Figure 68: Reinforcement exposed along the western breakwater crest wall

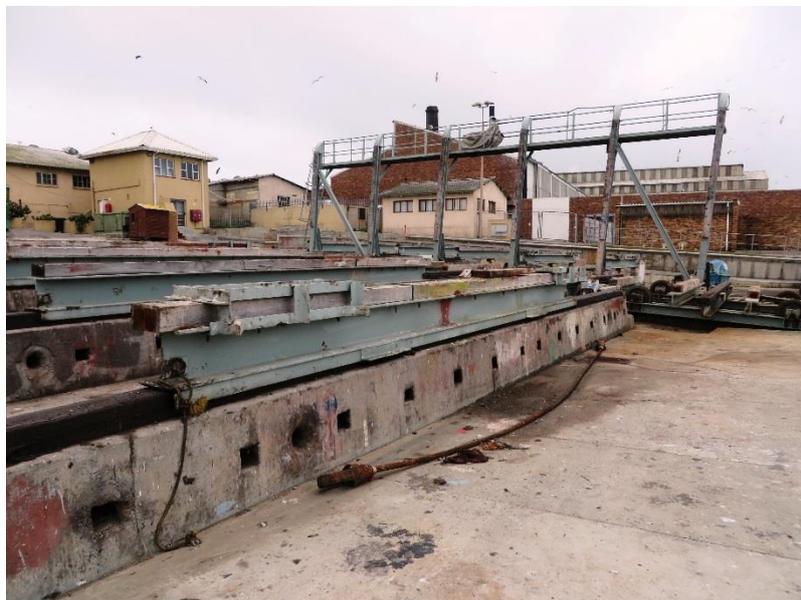
- The main winch which pulls the cradle requires a service as its last service took place over 10 years ago.
- The side pulleys (horizontal winches) are currently being used at St Helena Bay Harbour and are required back in Lambert's Bay with two vessels scheduled for repairs at the slipway during the month of September.

Figure 71: Slipway support beams and cradle

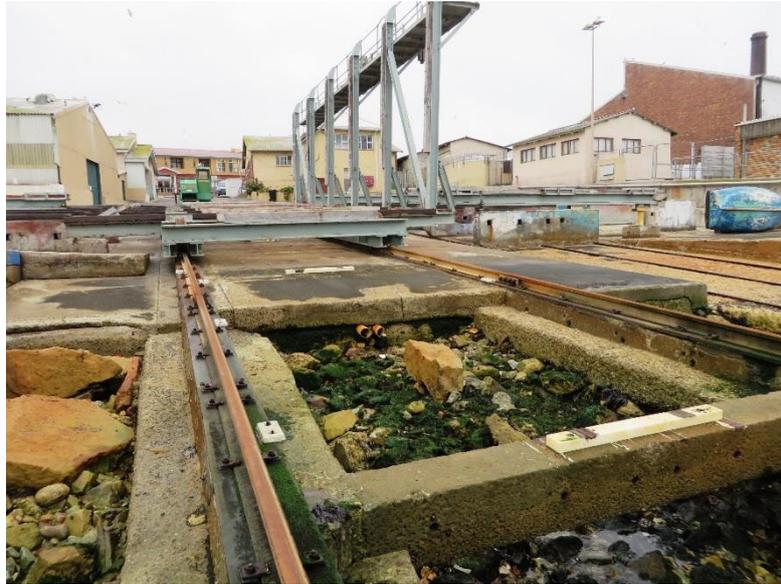
**Figure 72: Slipway cradle and rail system**

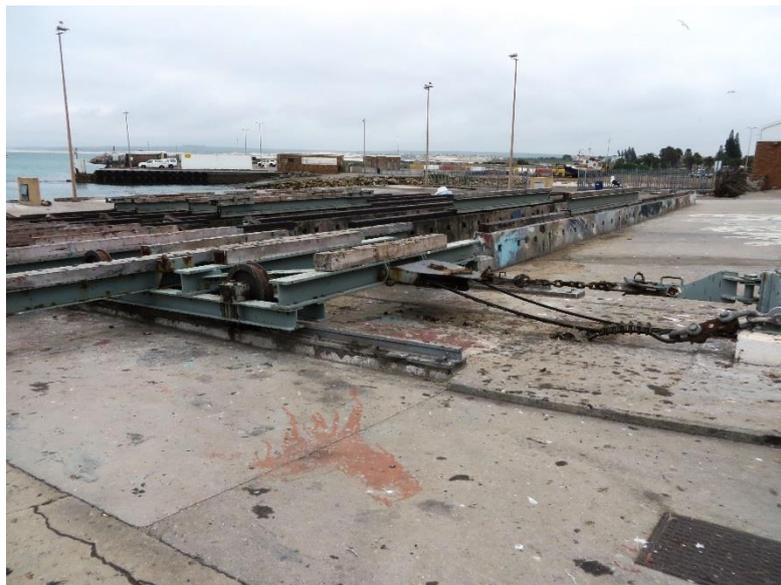
**Figure 73: Slipway vessel support beams**

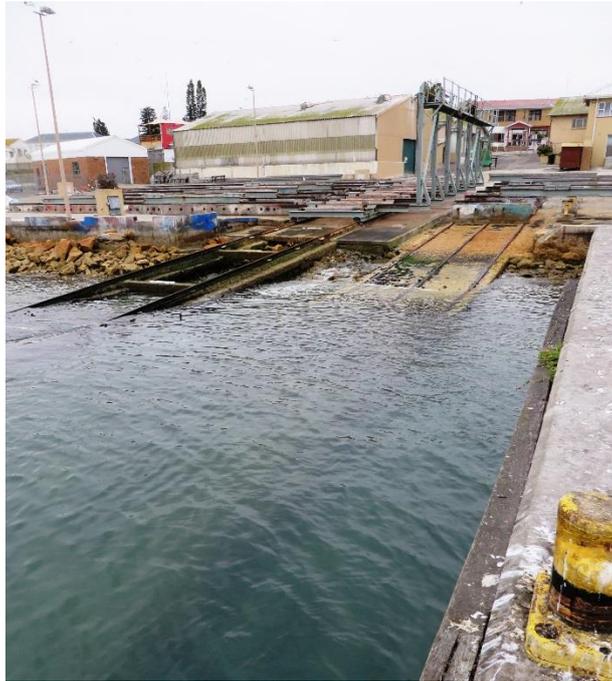
- Dredging of the harbour basin adjacent to the slipway is required as the majority of vessels can only use the slipway during high tide due to limited depth.

Figure 74: Slipway ramps – old slipway (right), and new slipway with facility (left)

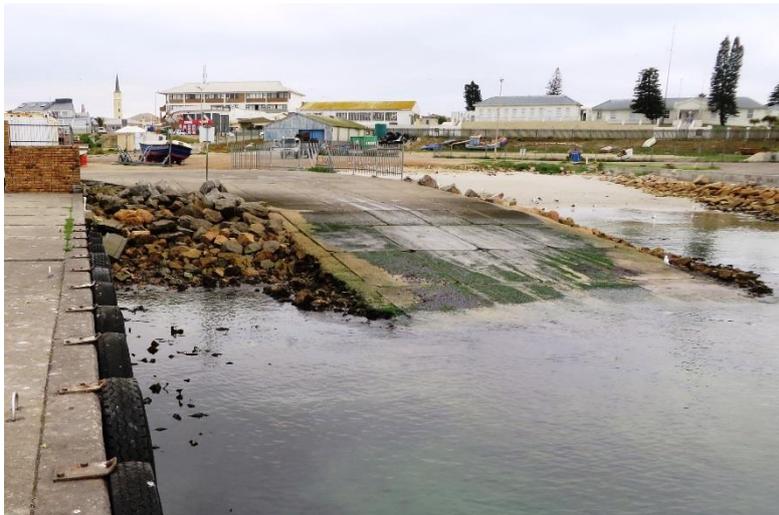
In general, the concrete boat launch ramp is in adequate condition with cleaning works required. The removal of some fallen fenders from the adjacent Snoek Quay is required to eliminate any potential navigation hazards.

Figure 75: Boat launch ramp

The harbour master expressed his desire to widen the existing boat launch ramp to cater for more boats at a time. Currently, two boats and trailers can be accommodated on the ramp simultaneously. The widening of the ramp also assist in reducing the congestion generated during “the snoek run”, which not only impacts the harbour but also the town.

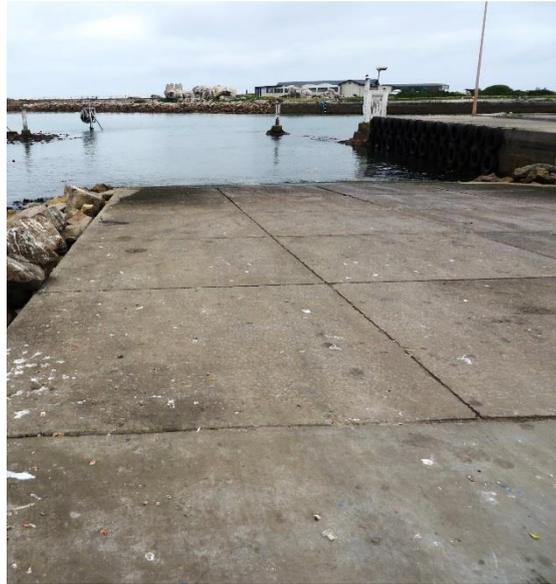
Figure 76: Concrete slabs at the boat launch ramp

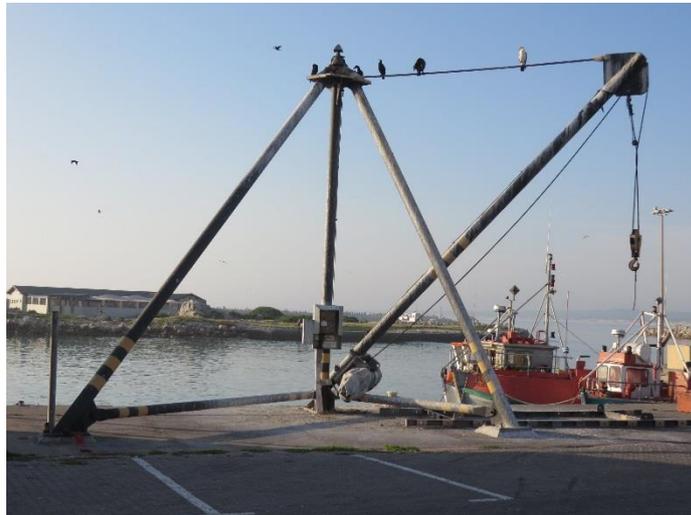
The shore crane at Lambert's Bay Harbour is a shear-leg crane, similar to that at Laaiplek Harbour. The crane cable was apparently shortened/cut when it got stuck in the winch. As a result, the cable is has insufficient length for all its desired application of loading/unloading of vessels. Therefore a new full length cable is required. Apart from the cable the crane works well.

It was noted that the presence of a sunken vessel in the immediate berth alongside the crane further reduces the usability of the crane.

Figure 77: Shear-leg shore crane

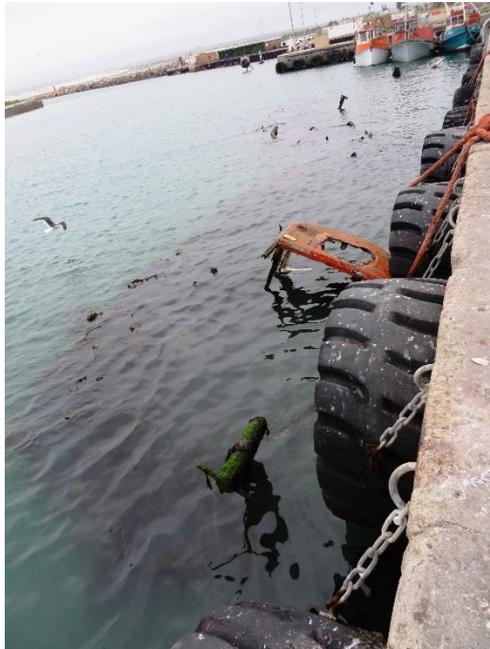
Currently, there are two sunken vessels located along main quay with one of these vessels having broken into two parts. It is currently unknown if the vessels still contain any diesel or other possible contaminants in their tanks.

Figure 79: Sunken vessel moored along main quay

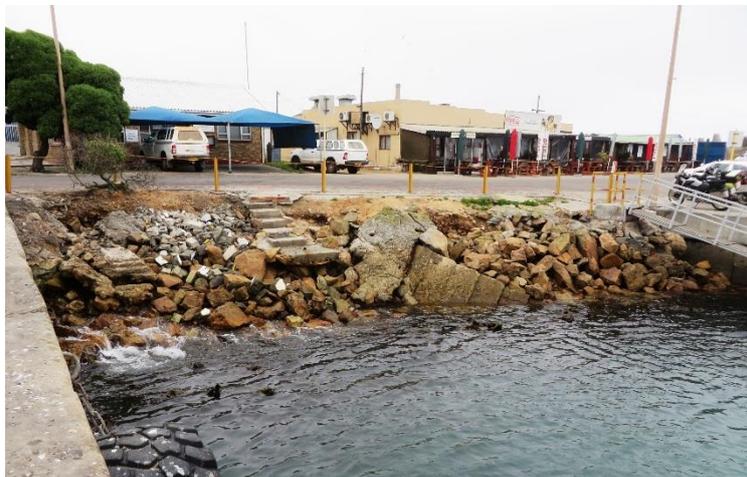
- The navigation aid, also referred to as the “Lighthouse” structure at the southern end of Snoek Quay has been displaced off its plinth foundation. It is significantly damaged and requires repairs.
- Revetment – the revetment in front of Isabella’s Restaurant (between main and secondary quay) requires repairs. It is evident that, although rubble is being dumped on this revetment, there is continued erosion of the slope, which will lead to the undermining of the adjacent roadway. This will significantly hamper access to main quay and create a safety hazard.

**Figure 83: Rubble revetment between main and secondary quays**
