16 BROWNS ROAD / 8 ALBERT ROAD RESTORATION AND STATUS QUO REPORT

2.3 ARCHITECTURAL ASSESSEMENT OF CONDITIONS OF PROPERTY

Inspected in November 2007 and September 2013.

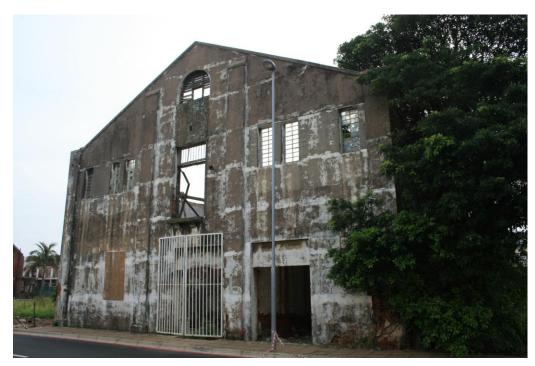
In 2007, this building was substantially intact. The building had timber posts supporting a mezzanine floor and was roofed with corrugated sheeting on king post timber trusses. There was a fig tree growing along the east facing wall. In 2009 a decision was made to convert the building into 21 units. The fig tree was removed (it had damaged the structural stability of the wall). An opening was made in the north facing wall for the piling rig to access the interior of the building. The development did not go ahead. A portion of the east facing wall collapsed, followed by a portion of the west facing wall, the north façade and finally the south facing façade. The new development will use the piles for support. The crumbling brickwork will be retained as a ruin with a concrete edge to the brickwork. A contemporary building will be built inside the ruin.
