## Site Management Plan (SMP)

**Robben Island**

*Reference: Irish Graveyard*

# **Draft outline of Site Management Plan**

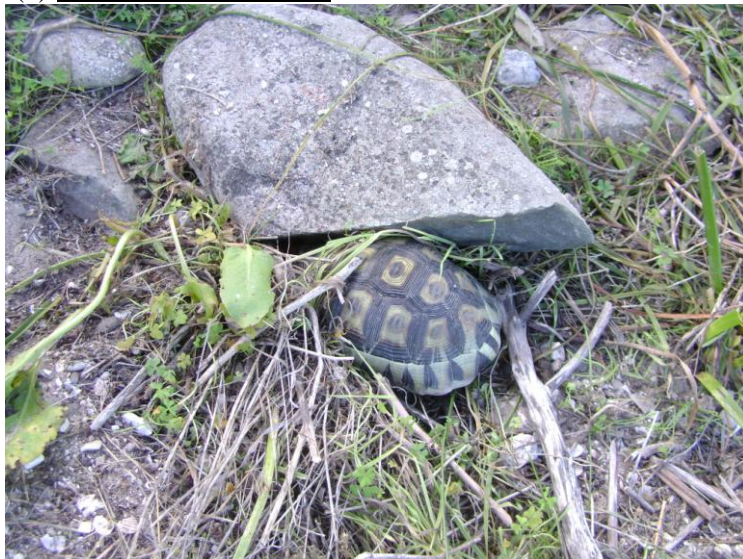
Also trying remove away the vegetation would assist but anyone doing this maintenance should be observant of the animals and not harm them as the site has become their habitat.

(c) Tortoise in its shelter

This being the site of great significance mostly to the effected families, it is likely that people will be emotional when visiting the site so it think to create some privacy it would be right to fence the site as people would not want to be disturbed by animals

which may run around, hence its close to the scrubs and trees. Fencing the site will be beneficial both to the visitors and the site itself e.g. the wont be running around of stray animals which could bump the tombstones off hence the springboks. With signage in place there should be rules and regulations put in place so that the visitor sees the instructions for the site e.g. *No Littering. Do not interfere with the site. Further enquiries as the tour guide.* The site should be incorporated in the site-tour of Robben Island when the tourists are taken around RIM by bus because it has some significant value too as mentioned before.
