Rim Restoration Work

Sample Images & Paint Specs

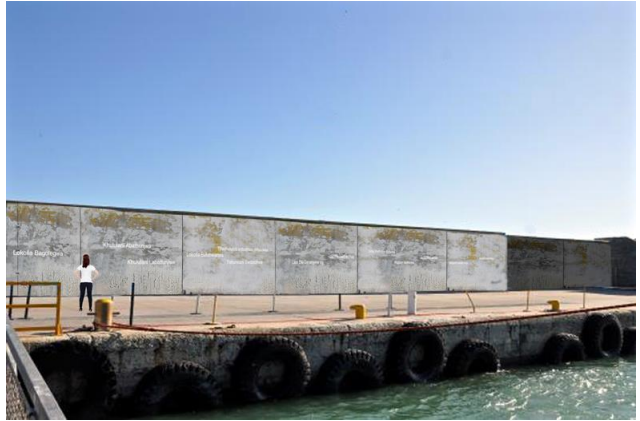
The current wall showing billboards to be removed.

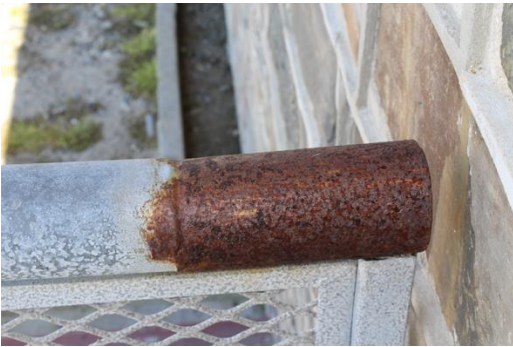
Galvanised rail detail

ed rail is in good condition except for two areas of the rails that show some rusting. The rusted areas will be ground away and the metal treated with cold galvanising paint.
