Mr Phillip Hine
SAHRA

31 October 2016

Re: PERMIT APPLICATION FOR THE PROPOSED REHABILITATION OF SITE 2, VELE COLLIERY

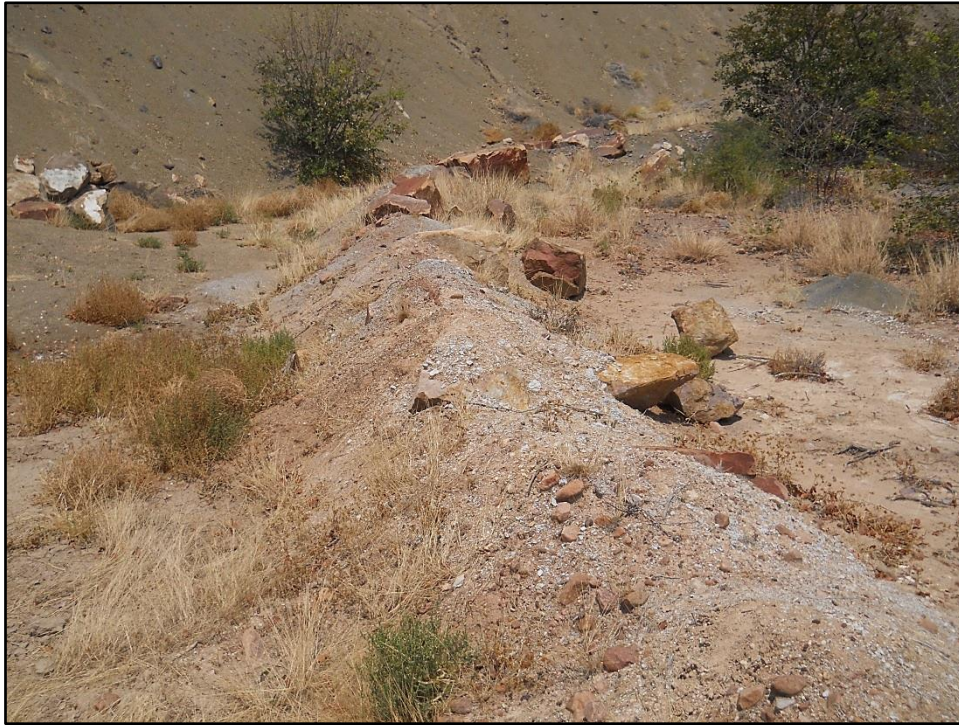
Figure 8. Example of a toe berm.

- The use of a TLB to create a toe berm, at the foot of the Overburden dump (see figure 4 – line indicating edge of dump) to redirect any water flow from the dump in an easterly direction and this would also facilitate the collection of silt and overburden material. The berm would be built from material on the site and would be situated some 5m from the toe of the dump and be approximately 3m high.
