**REPORT OF SITE VISIT AT JAGERSFONTEIN, FREE STATE
TO ASSESS THE PROPOSED INFILLING OF THE MINE PIT
FROM JAGERSFONTEIN DEVELOPMENT INC.**

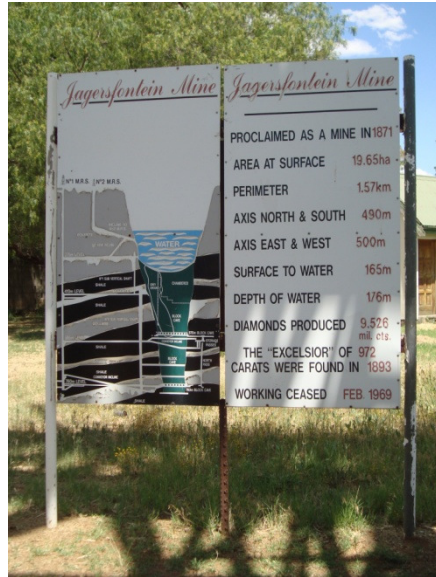
The viewing platform on the pit was closed down about a year ago because of safety issues. The engineering report identified that the platform was not safe enough for people to visit (Fig. 4). During the site visit we did, however, walk on the viewing platform and along the edge of the pit. Some sections along the perimeter of the pit are more fragile than others and cracks are clearly visible in a few spots (Figs. 5-7).

Figure 3. Description of the mine pit
