**Aquatics Assessment**  
**(Vlakkeland, Paarl, Western Province)**

**DHEC Report 622/2013**

## **AMENDMENT NOTE TO REPORT DHEC 622 (2013): VLAKKELAND (PAARL)**

### **Vlakkeland Soil investigation**

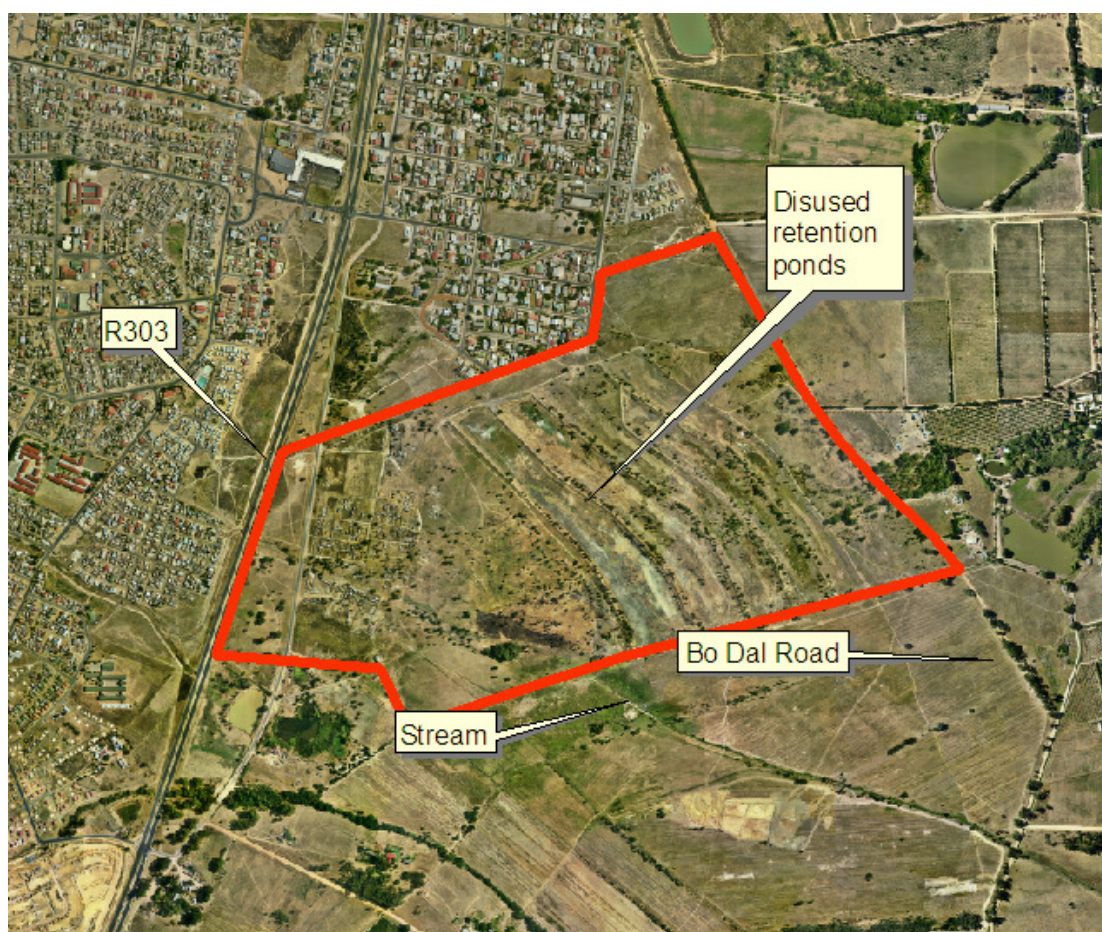
**Figure 2:** The Vlakkeland site (2009 image) (Source: Drakenstein Municipality).

The site slopes steeply down from the Do Bal Road and the gently from the east to the west (**Appendix B, Figures 1 and 2**). The greater portion of the site is taken up by a series of wastewater effluent retention ponds utilized by the Paarl Municipality for several decades until circa 1997 (Mr Cedric Morkel, pers. comm.). Effluent was pumped to the ponds and chlorinated. Overflow from the ponds was conveyed via a pipeline from the south-western corner of the ponds to the Berg River. When use of the ponds was terminated, the pond walls were breached and the site vacated (**Appendix B, Figure 8**).

The western boundary of the site is occupied by an informal settlement.
