## **THE STRACHAN MEMORIAL HALL, MAIN STREET, UMZIMKULU – PHOTOGRAPHS TAKEN ON SATURDAY THE 18 APRIL 2015 BY AMAFA STAFF:**

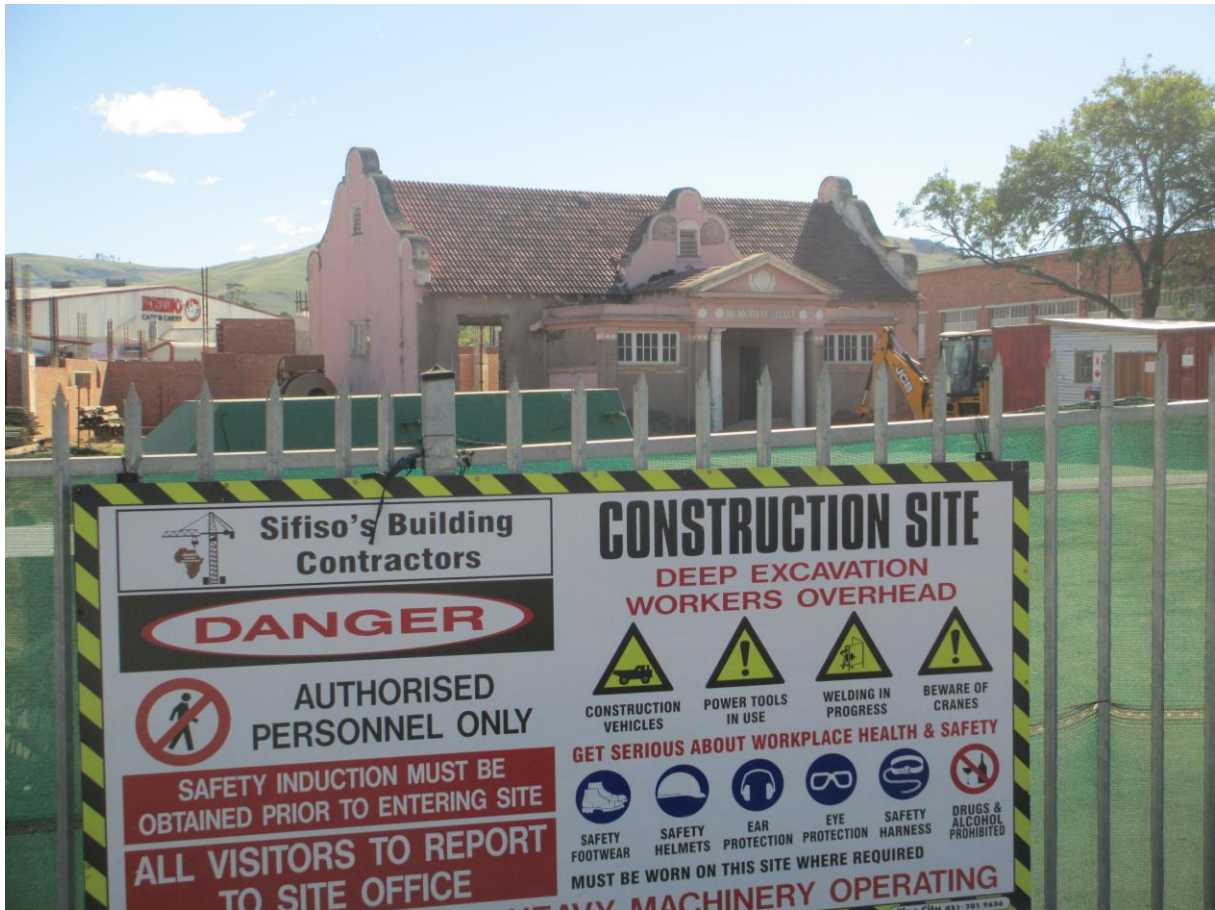
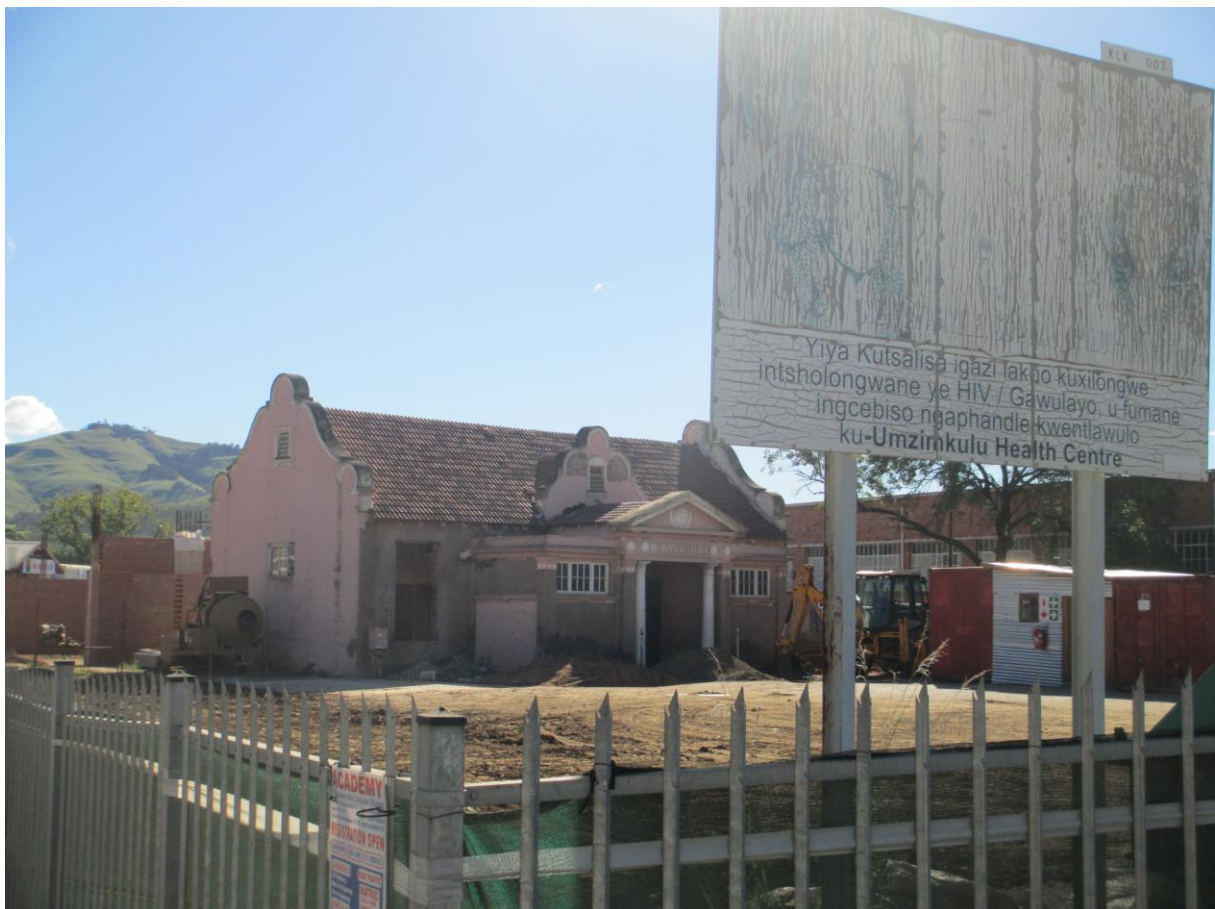
The photographs show that some work had been undertaken on the hall, most of which was reversible if proven incorrect: some windows had been removed; plaster had been removed and replaced; gutters and downpipes had been removed, and roof tiles were in the process of being replaced. While some of this work can be seen as maintenance and the exact like for like replacement of existing material, the definition of “Alter” in the National Heritage Resources Act includes any work that may affect the structural integrity of the site and any decoration, including plastering and painting. This work was, therefore, in contravention of the KZN Heritage Act (4/2008) as no application to carry out any work on this building other than the removal of the additions had been received or processed by Amafa and the work was not covered by the “in principle” decision to allow the demolition of the extension to the hall and the construction of a new auditorium, gymnasium, and coffee shop facing on to the R56.
