**WETLAND DELINEATION IN THE RUSTENBURG
PLATINUM MINE PROJECT AREA AND A HIGH
LEVEL ASSESSMENT OF SELECTED RIVER
CROSSINGS, NORTH-WEST PROVINCE**

Prepared for

SRK Consulting (Pty) Ltd

May 2015

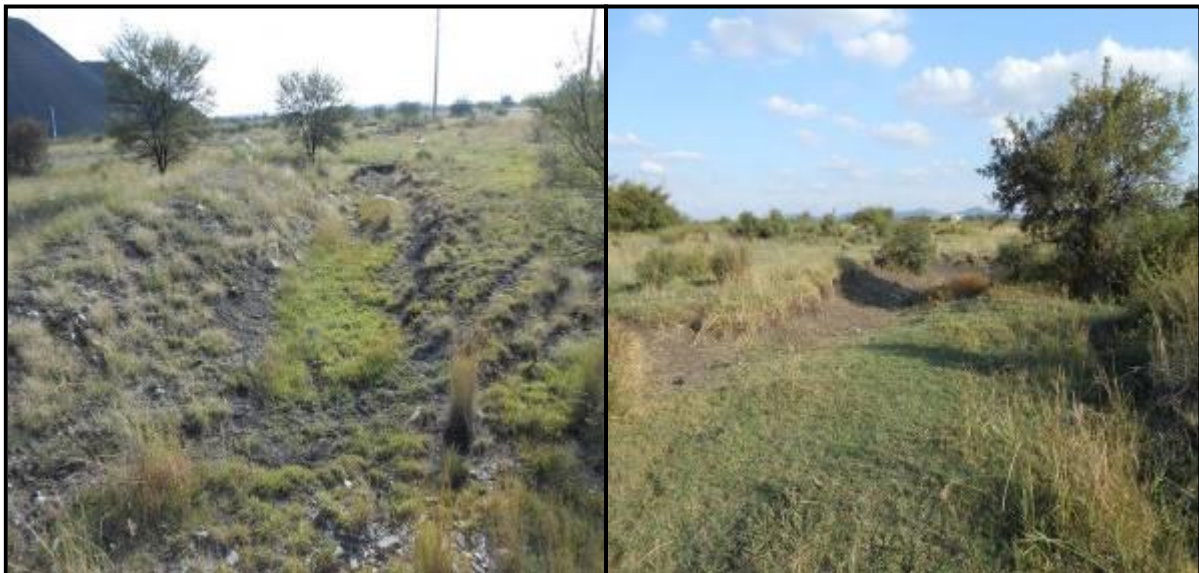
Brakspruit: South of Siphumelele 2

The WET-IHI calculations for the Brakspruit indicates that the system has been moderately/largely modified, and that loss and change of natural habitat and biota have occurred, but the basic ecosystem functions are still predominantly unchanged. The feature has been disturbed by erosion which has occurred as a result of increased water input as well as heavy grazing and trampling by livestock. These activities have resulted in the moderate modification of the geomorphology of the feature. Furthermore alien vegetation invasion has occurred especially along these structures since the soil profile has been altered. The constructions of road crossings and pipelines along this system has resulted in a large modification of the hydrology of the system. Stockpiling in mining areas might lead to sediment deposition within systems if located within 100m of the floodline, and as a result water quality might be altered. However, no soil dumping or stockpiling was evident within the feature. The figures below represent the disturbance observed within the system.

Figure 9: Representative photographs of erosion disturbances within the Brakspruit system.

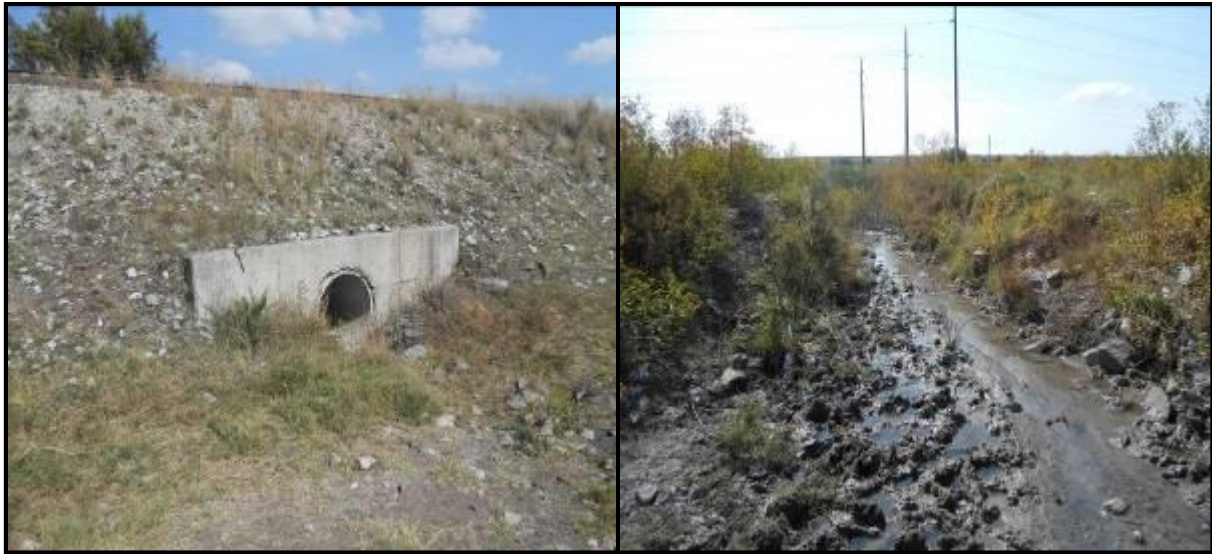
Hoedspruit: South of Hoedspruit Tailings Dam

The feature obtained an average percentage that places the feature within category D which implies that the feature has been largely modified, and large loss of natural habitat, biota and basic ecosystem functions has occurred: 20-40% seriously modified. Most of the vegetation within this feature has been cleared during the construction of a railway crossing and development of a road that traverses the feature below the railway crossing. As a result the area has been largely eroded and alien species such as *Flaveria bidentis* have invaded. This species was identified along the edges of the feature and has led to the destabilization of soils within the feature. Due to the road there is increased water input within feature as well

as sediment deposition which moderately altered the geomorphology of the area. The figure below represents the Hoedspruit system.

Figure 10: Representative photographs of the Hoedspruit system.

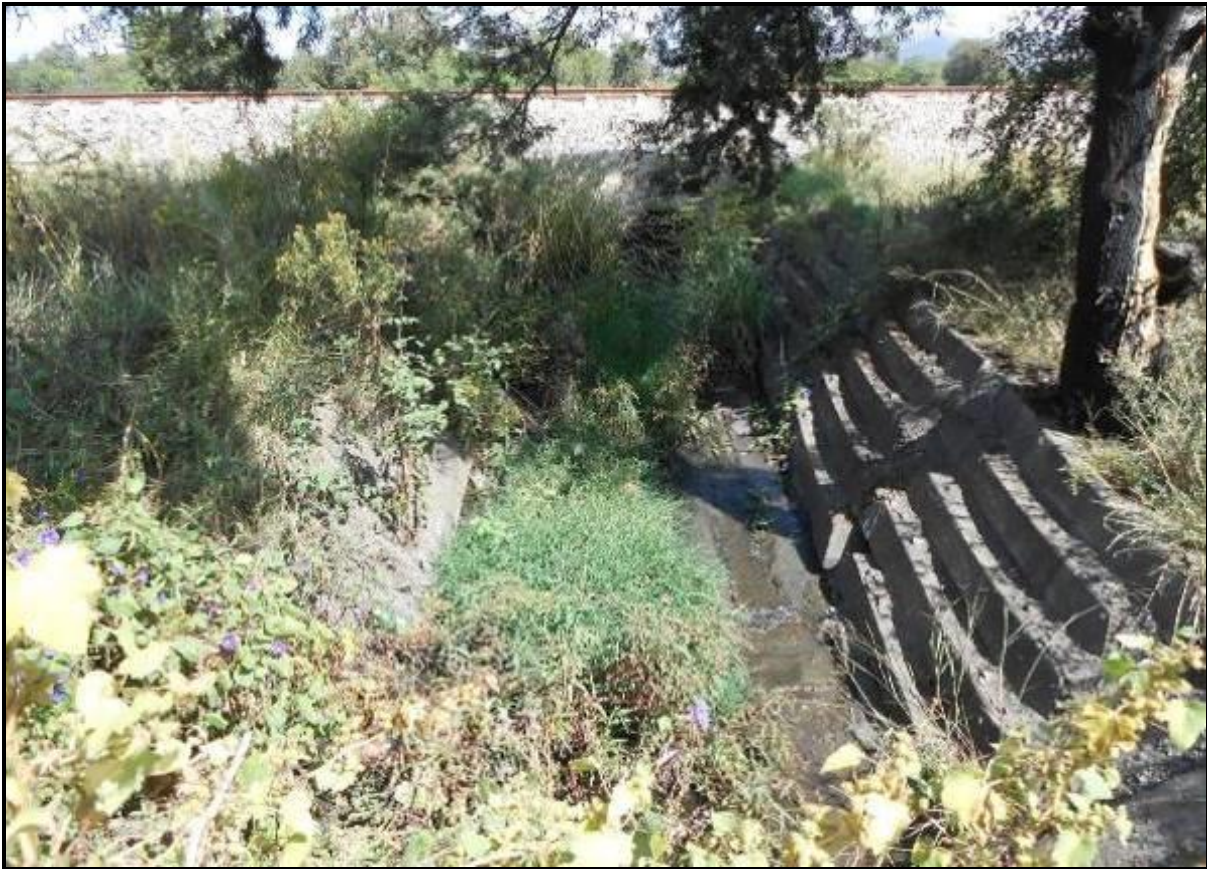
The feature (where Site 33 and Site 34 are located) consists of an artificial canal, created to convey water from the open flooded pit into the nearby watercourse, and it was mainly encroached and dominated by alien vegetation such as *Melia azedarach*, *Datura stramonium*, *Ipomoea purpurea*, and *Flaveria bidentis*. There were soil stockpiling observed adjacent to the upper portions of the feature which deposits sediment into the feature and also reduces the quality of water passing through the channel. Since this feature was

artificially constructed it did not indicate any wetland characteristics and cannot be considered to be a natural watercourse. The figure below represent the artificial channel that forms part of the system.

Figure 12: Representative photograph of the Wildebeesfonteinspruit (North-west of Khuseleka 1)

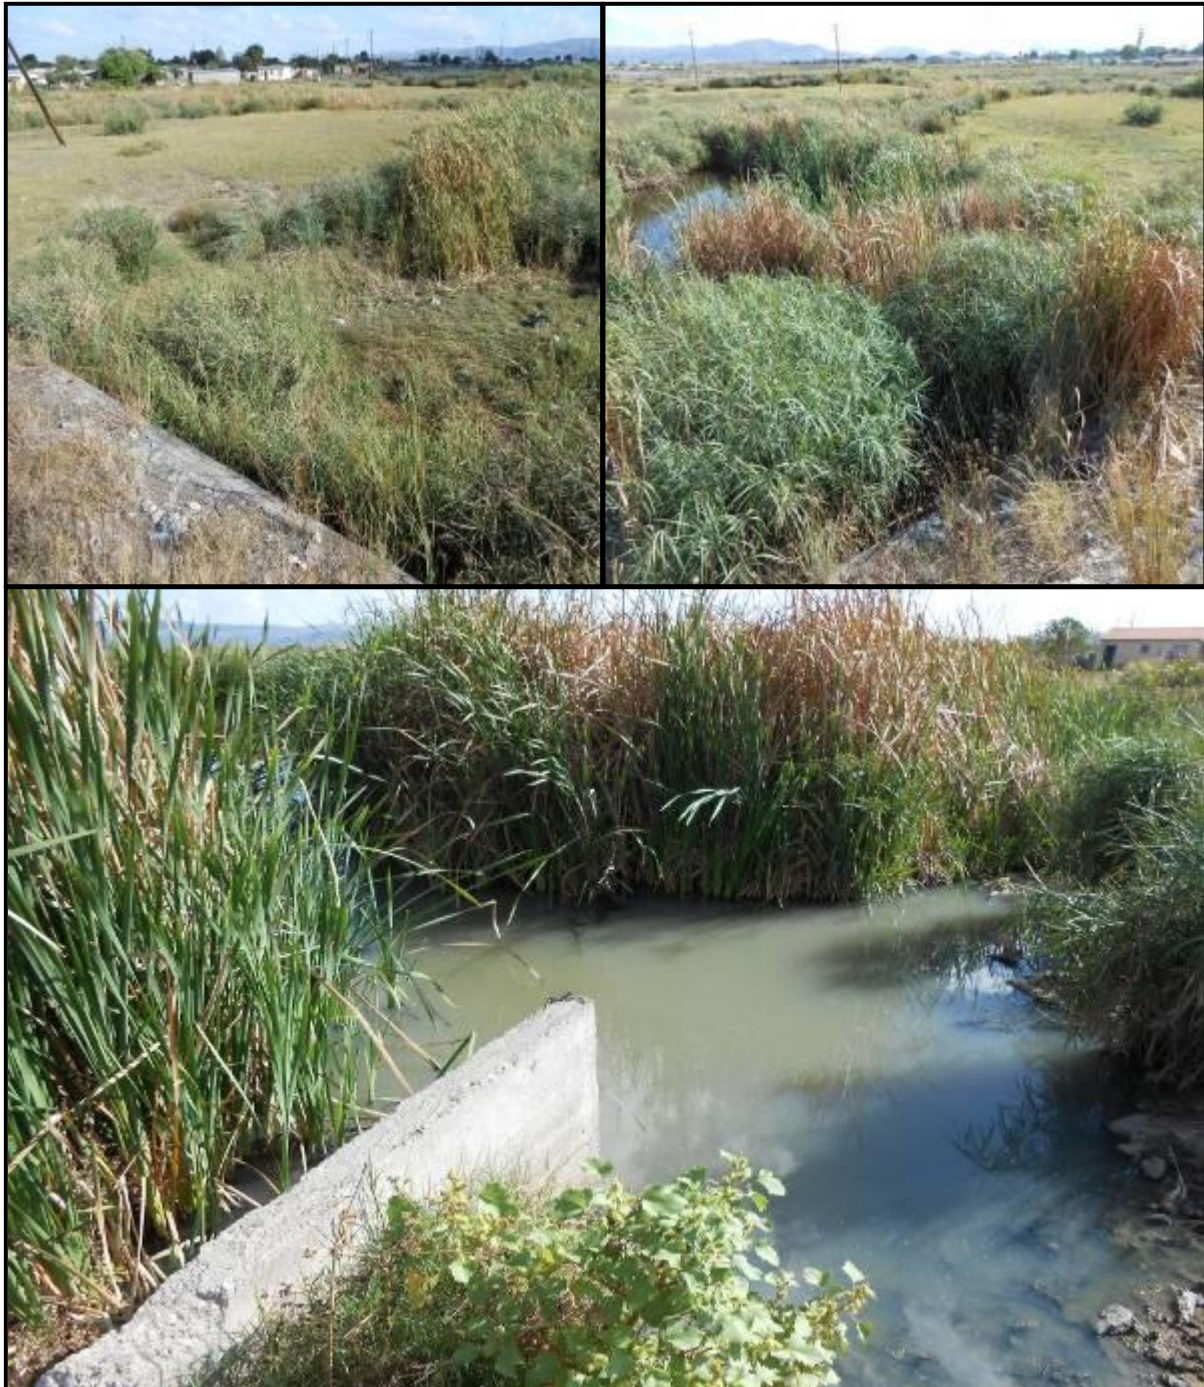
Wildebeesfonteinspruit: Site 34f, 34g, 34h

The system obtained an average score that places the system within category B/C. the entire system appears to be in good condition, apart from the presence of structures such as roads and culverts. The vegetation component of this feature was in a largely natural condition with only a few eroded areas along the road crossings. The water quality was largely modified by potential sources such as sedimentation and runoff from the neighbouring communities as well as deposition of untreated sewage effluent from leaking pipes in the upstream areas of the system. The hydrology of the feature is moderately modified by increased water input within the feature as a result of hardened surfaces within the catchment. Increased runoff from the tarred road has led to increased water input, whereas dirt roads traversing the feature have increased the availability of sediment, thus modifying the geomorphology of the feature. The figure below represents the vegetation and sewage effluent that is being discharged within the system.

Figure 13: Representative photographs of the Wildebeesfonteinspruit.

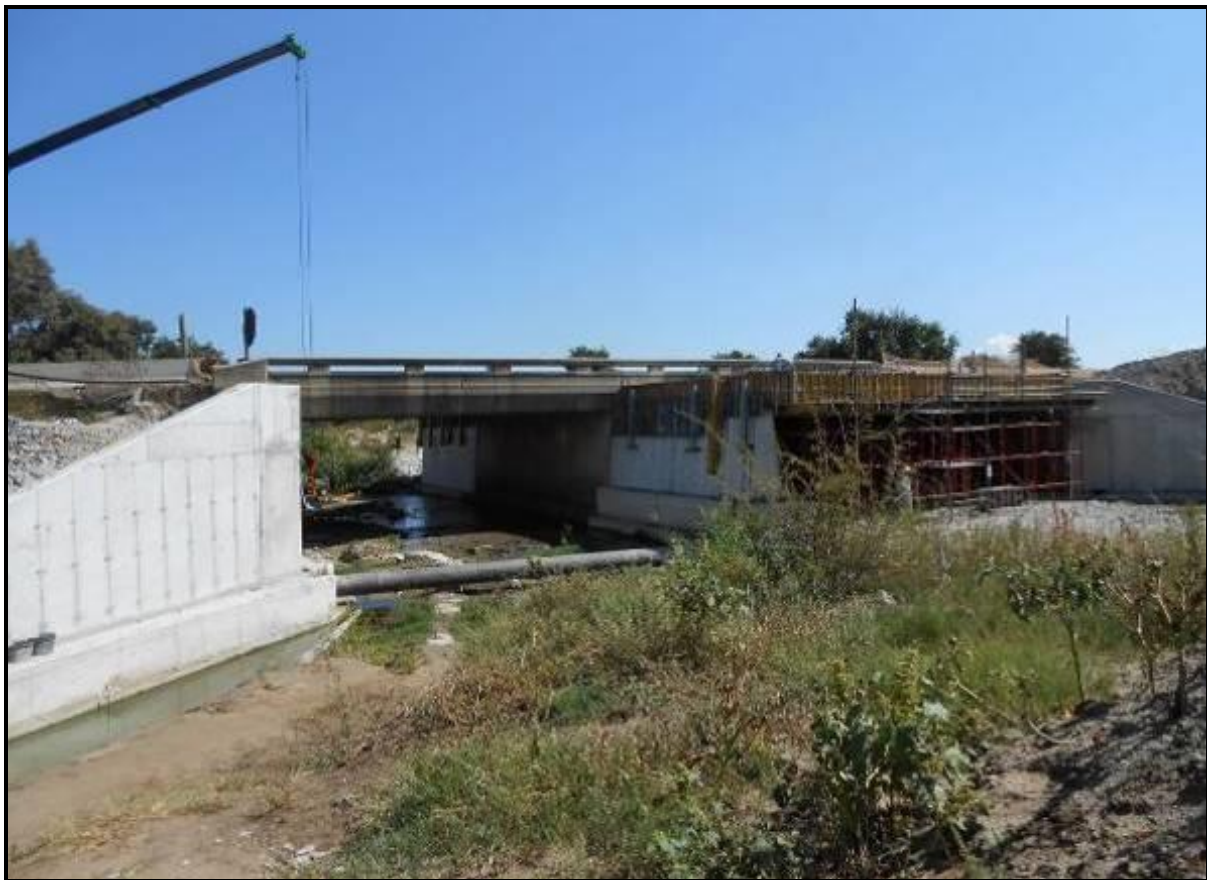
Dorpspruit River: South-east of Khuseleka 1 shaft (Site 32a & 32b)

The feature obtained an average score that places the feature within category D which implies that the feature has been largely modified, and large loss of natural habitat, biota and basic ecosystem functions has occurred. The loss of natural habitat, biota and basic ecosystem functions is extensive, and this is mainly due to the road bridge construction activities that are currently taking place within the feature. The system experienced low flow at the time of the assessment therefore there was limited disturbance on stream flow. The

feature has been subjected to vegetation clearing and as a result, alien vegetation species have established. The geomorphology of the feature has been largely modified by the excavations as well as sediment deposition and infilling from the construction. The catchment area will have increased water input as a result of runoff from the road and paved surfaces. Since the feature is hydrologically linked to an upstream dam, in which sewage effluent is being discharged, the water quality of the feature was largely modified and falls within category D. Potential influences on water quality are sedimentation and runoff from the neighbouring communities. The figure below represent the construction activities that are currently taking place within the system.

Figure 14: Representative photograph of the construction activities within the Dorpspruit

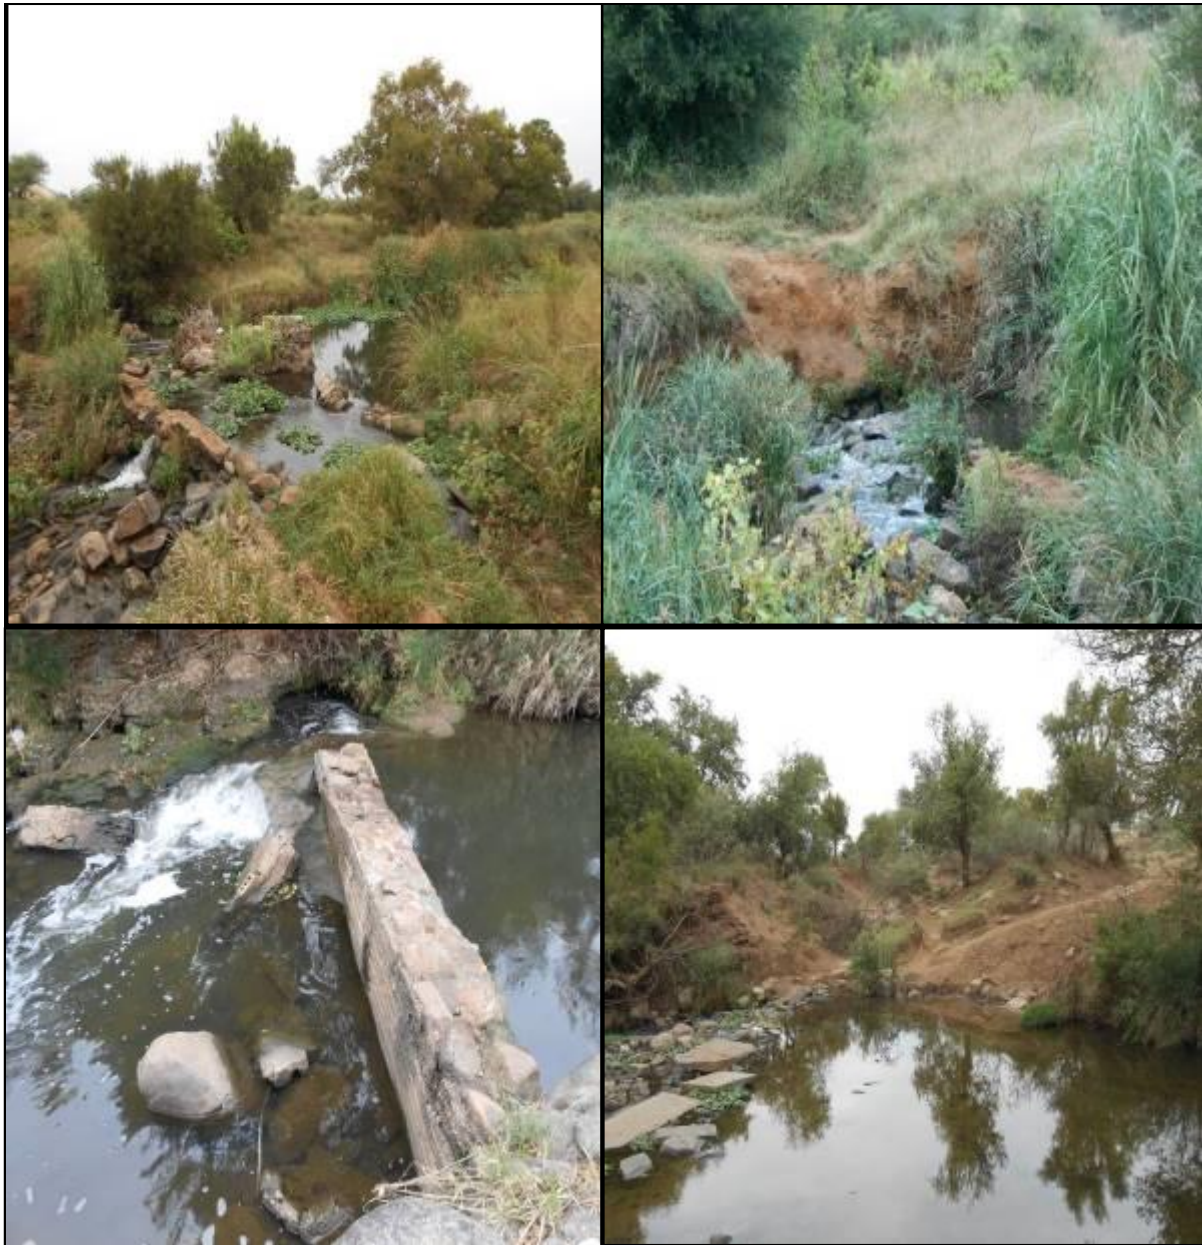
Dorpspruit River (Site 32d, 32e & 32f) East of Khuseleka 1 and West of Paardekraal Return Water Dam (RWD)

The system has been largely modified by the collapsing of a road crossing and a weir at Site 32e and Site 32f as observed during the site visit. This activity has led to the formation of erosion gullies and sedimentation within the system and increased channel depth and width. As a result, the geomorphology of the system has been seriously modified.

The hydrology of the system has been largely modified and this has resulted in the alteration of water flow patterns. Furthermore, the collapsed structures will eventually cause migration

barriers for aquatic species. Due to erosion, vegetation has been modified especially along the river banks and where the crossings/roads occur along the river. Alien vegetation species have established including *Eichhornia crassipes*. This plant can block sunlight from reaching native aquatic plants, and removes oxygen from the water eventually killing aquatic species. The water quality within the system has been modified, and potential influences on water quality are sedimentation and runoff from the neighbouring communities.

Figure 15: Dorpspruit East of Khuseleka 1 and West of Paardekraal Return Water Dam (RWD)

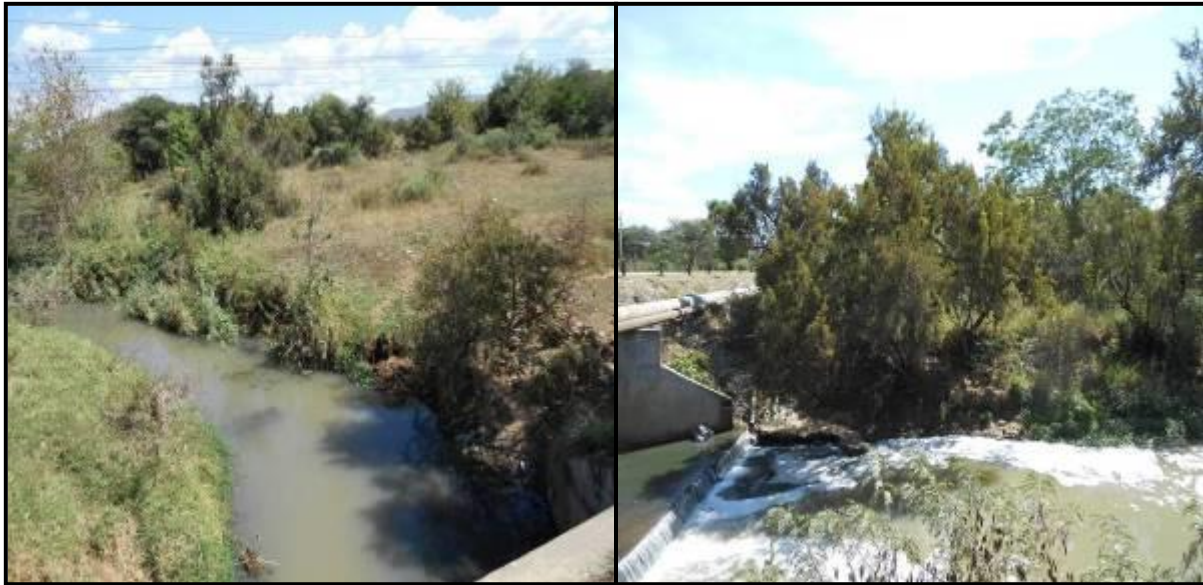
Figure 17: A weir and road crossing as modifications to the hydrology of the stream.

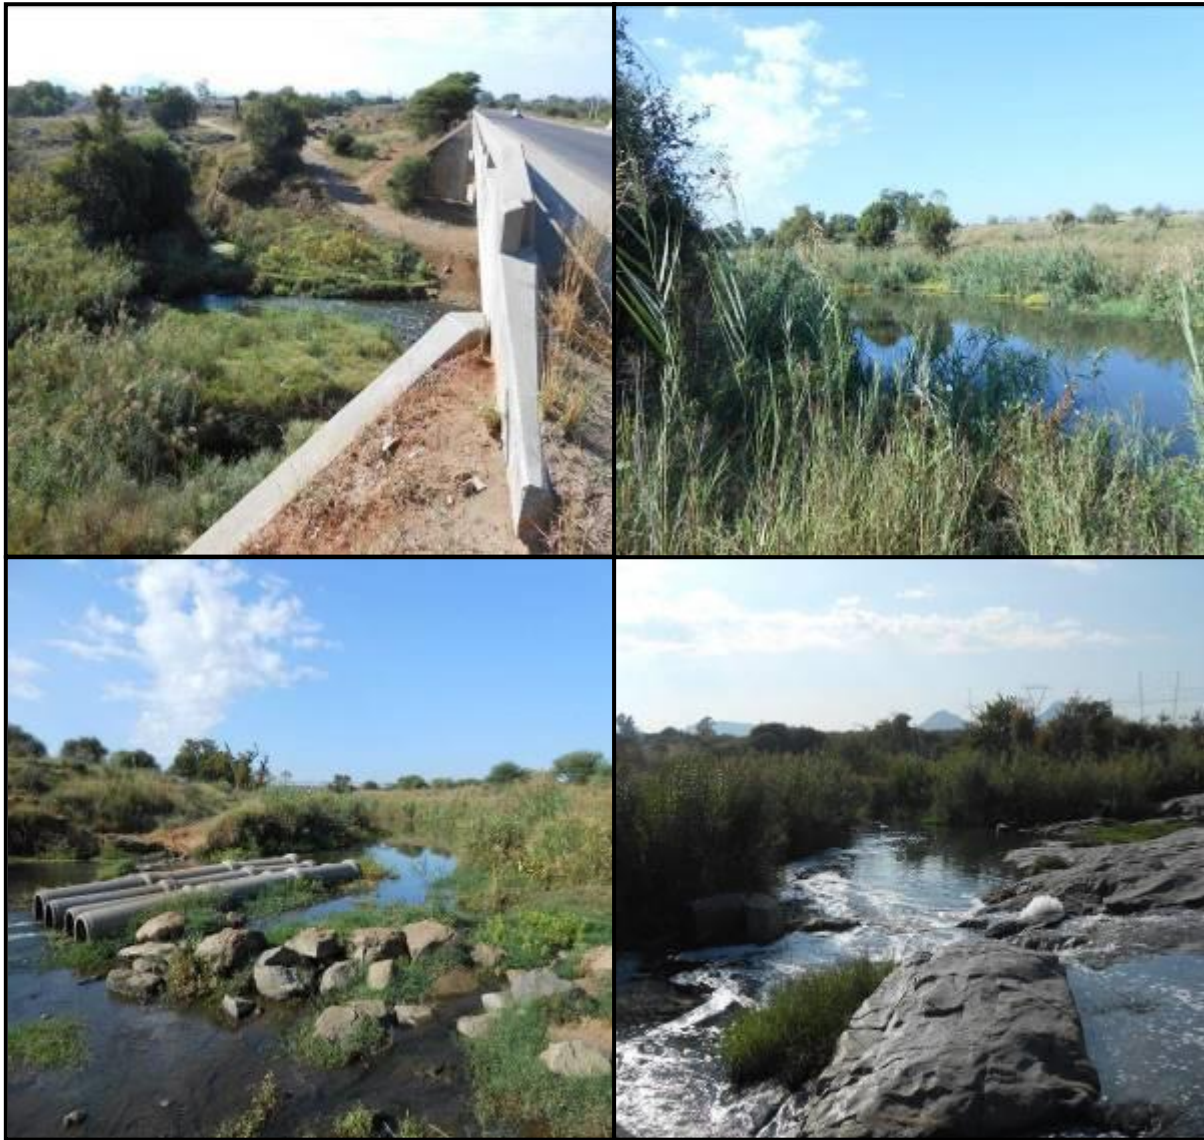
Hex River: North of Paardekraal RWD (Sites: 28, 28a, 28b, 28c)

The river obtained an overall score that indicates that the feature falls within the PES Category C (moderately modified), this implies that there has been loss and change of natural habitat and biota, but the basic ecosystem functions are still predominantly unchanged. A few structures such as road bridge crossings and pipelines have resulted in the moderate modification of the feature. Algal proliferation has been observed in a few areas which implies that the water has an overabundance of nutrients such as nitrate and phosphate. Soil stockpiling along with construction rubble as well as litter were observed adjacent to **Site 28** where there is a road crossing. It is anticipated that during heavy rainfall, runoff from the stockpiling area will result in erosion as well as sediment deposition within the feature, which would potentially alter the water quality. In the upper portions of the system the water quality seemed to be moderately modified as opposed to the largely modified portions upstream (Site 28). The hydrology as well as morphology of the feature has also been moderately modified by the presence of the pipes and roads. In some cases these pipes cause a migration barrier and traps debris since they are placed within the river bed and not elevated on plinths. In addition, the water flow pattern changes due to the presence of these pipes, thus resulting in erosion of the river banks. Vegetation removal has occurred in the vicinity of the road crossings, and although alien species were observed on site, indigenous vegetation still occurs in some areas where anthropogenic activity has been less. The figures below represent the Hex River.

Figure 18: Representation of the Hex River.

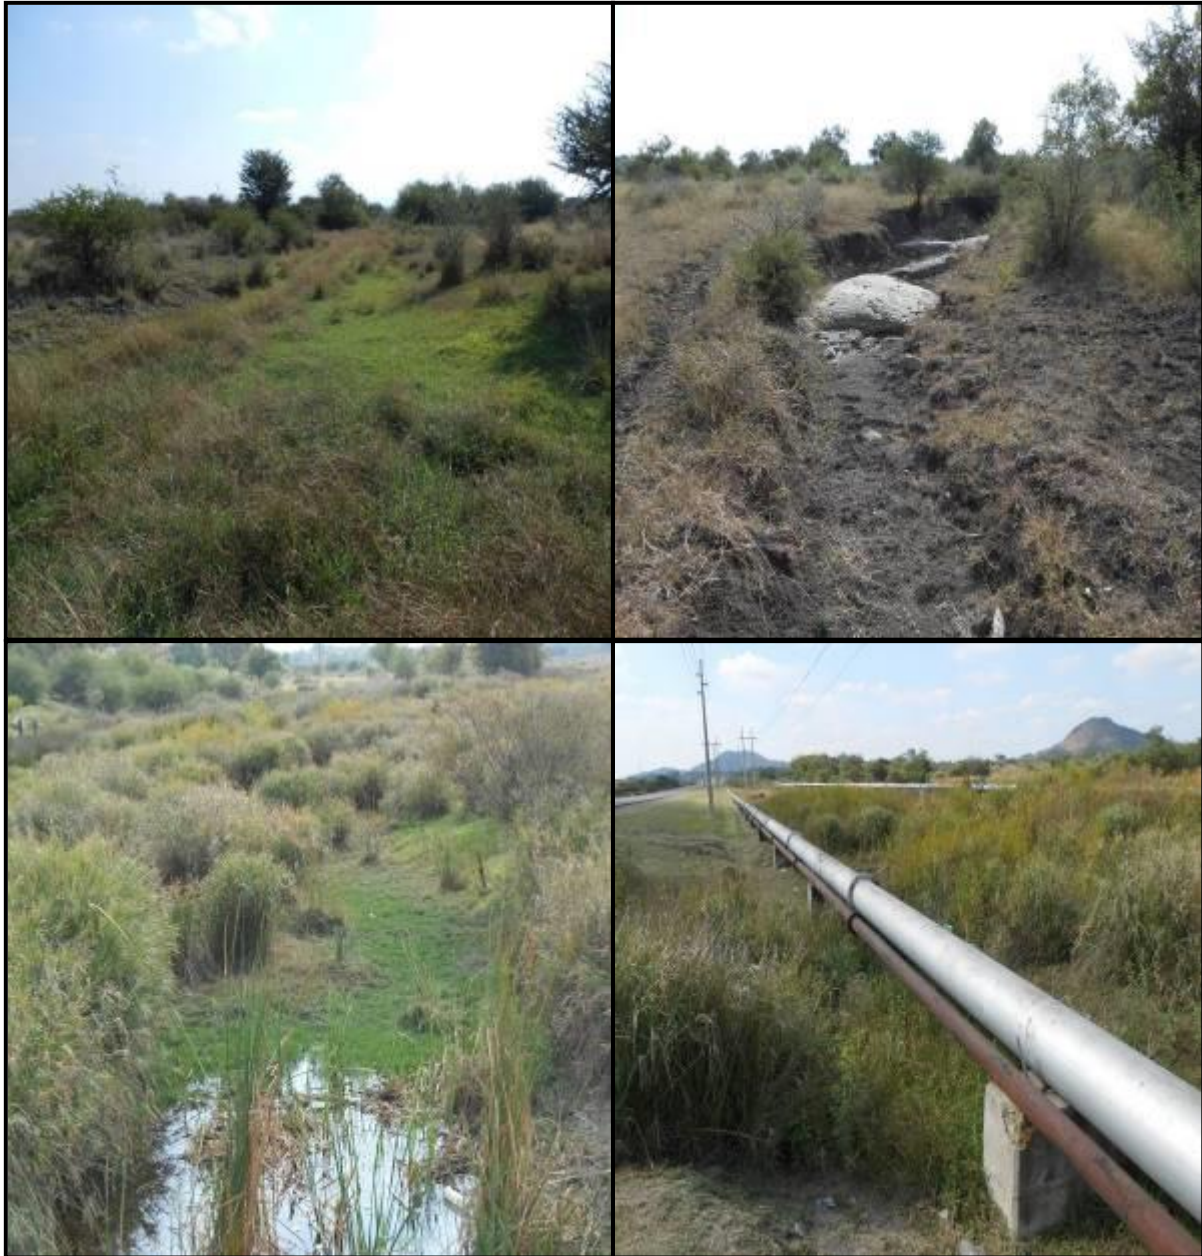
The river obtained an overall score that indicates that the feature falls within the PES Category C (moderately modified), this implies that there has been loss and change of natural habitat and biota, but the basic ecosystem functions are still predominantly unchanged. The hydrology of the feature has been moderately modified by the construction of road crossings/bridges as well as surface hardening within the catchment which causes increased water input within the feature. Furthermore, canals have been created to decrease water retention on the floodplain surface, however, flow capture and removal is ineffective. Mowing along the edges of the road and pipeline as observed at Site 3 has led to the modification of the vegetation structure of the system. In some portions, indigenous

vegetation still persists although alien species proliferation has occurred and was observed throughout the system; *Flaveria bidentis* was the dominant species. Erosion observed was mainly within community areas, and is attributed to cattle trampling and grazing. In addition, waste dumping was observed beneath the road crossings, which alters water quality of the system.

Figure 21: Photographs representing Klipfonteinspruit.

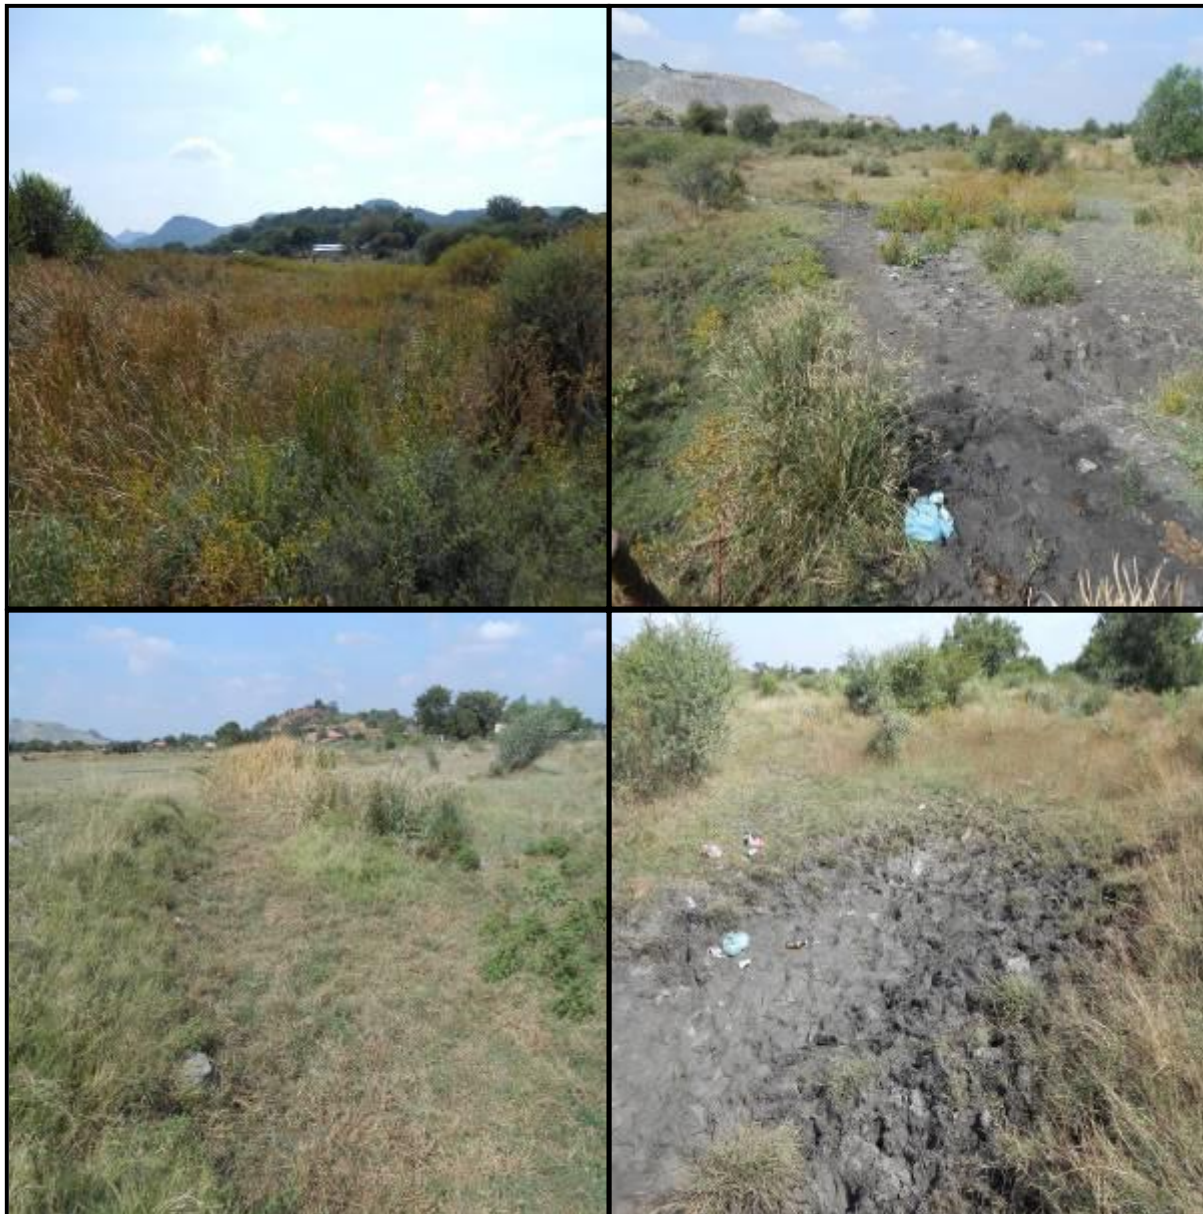
Paardekraalspruit: North-west of Siphumelele 3 Waste Rock Dump (Site 15, 16, 17)

The river obtained an overall score that indicates that the feature falls within the PES Category C/D (moderately to largely modified), this implies that there has been loss and change of natural habitat and biota, but the basic ecosystem functions are still predominantly

unchanged. The feature is located in an urbanised area, and due to hardened surfaces, there is increased water input into the feature. Vegetation clearing within the catchment and around the feature decreases surface roughness, which leads to an increased erosion risk to the feature. Extensive livestock grazing and trampling has also contributed to erosion within the feature and this has led to alien invasion as presented in the figures below.

Figure 22: Alien invasion and erosion within Paardekraalspruit.

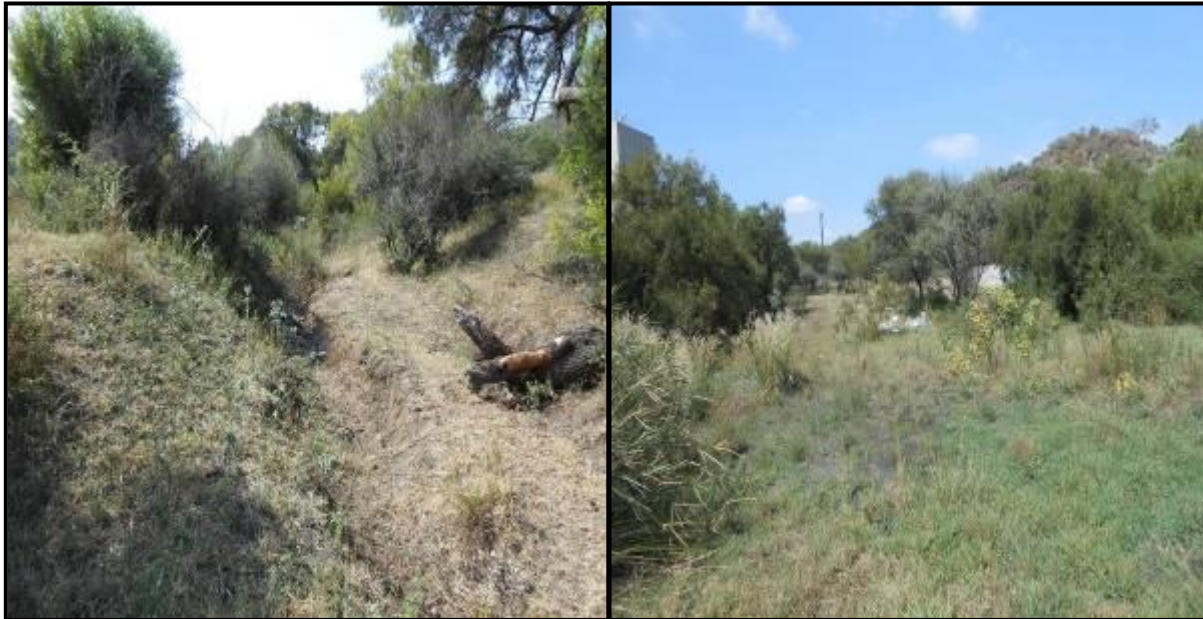
Paardekraalspruit: North of Siphumelele 1 Waste Rock Dump (Site 18, 19)

The river obtained an overall score that indicates that the feature falls within the PES Category C (moderately modified). The feature seems to be in moderate condition apart from the waste and debris accumulation below the bridge which obstructs water flow. Vegetation has been disturbed along the road crossing, with clearings and alien invasion

visible. However, the vegetation cover within the feature was moderately low, which plays a significant role in protecting the area against erosion. Due to the feature being located in an urbanised location, it will definitely receive increased runoff and will be affected by altered runoff peaks during heavy rainfall events. Waste dumping observed in the lower portions of the feature, is likely to modify the water quality within this feature. In addition, runoff from the mining area and sediment deposition will further deteriorate the water quality. The figure below represents the Paardekraalspruit system.

Figure 23: Representation of Paardekraalspruit.

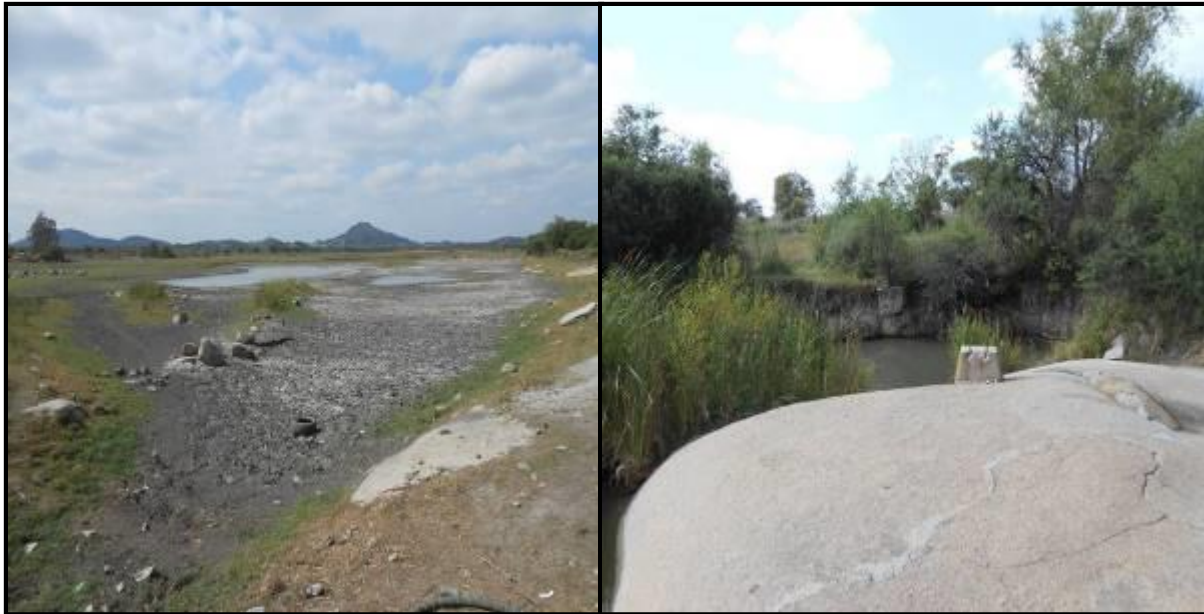
Klipfonteinspruit: South of Siphumelele 3 and East of PMR (Site 3a, 3b, 3c, 3d, 4, 4a, 5)

The river obtained an overall score that indicates that the feature falls within the PES Category C/D (moderately to largely modified), this implies that there has been loss and change of natural habitat and biota, but the basic ecosystem functions are still predominantly unchanged. The feature has been modified by the presence of road crossings/culverts as a result, runoff from the road increases water input within the feature. The dam upstream captures sediment before it enters the stream, hence there was less sediment deposition observed. The vegetation has been disturbed by the invasion of alien species which seems to inhibit natural vegetation especially along the culvert.

Figure 26: Representation of Klipfonteinspruit.

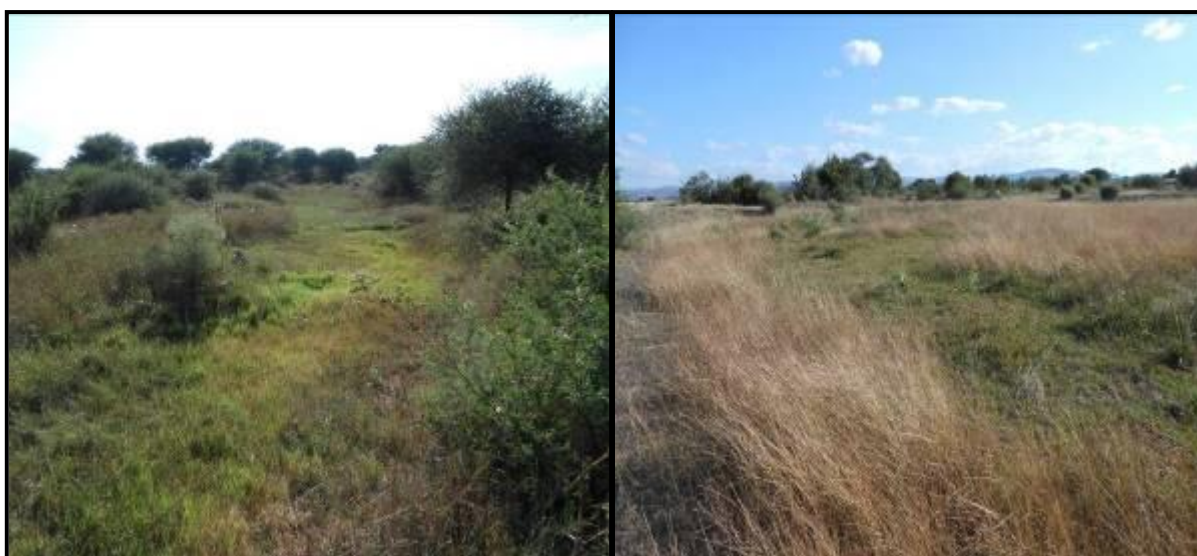
Drainage lines

The features obtained an average score that falls within category A/B which implies that the features are largely natural with few modifications. The hydrology of the drainage lines has been slightly modified by the increased water input as a result of runoff from surface hardening within the catchment. In addition vegetation has been slightly modified by livestock grazing as well as minor invasion of alien species such as *Xanthium strumarium* and *Flaveria bidentis*. The geomorphology of the feature was natural but modified by livestock trampling to a limited extent.

Figure 28: Representation of the drainage lines.

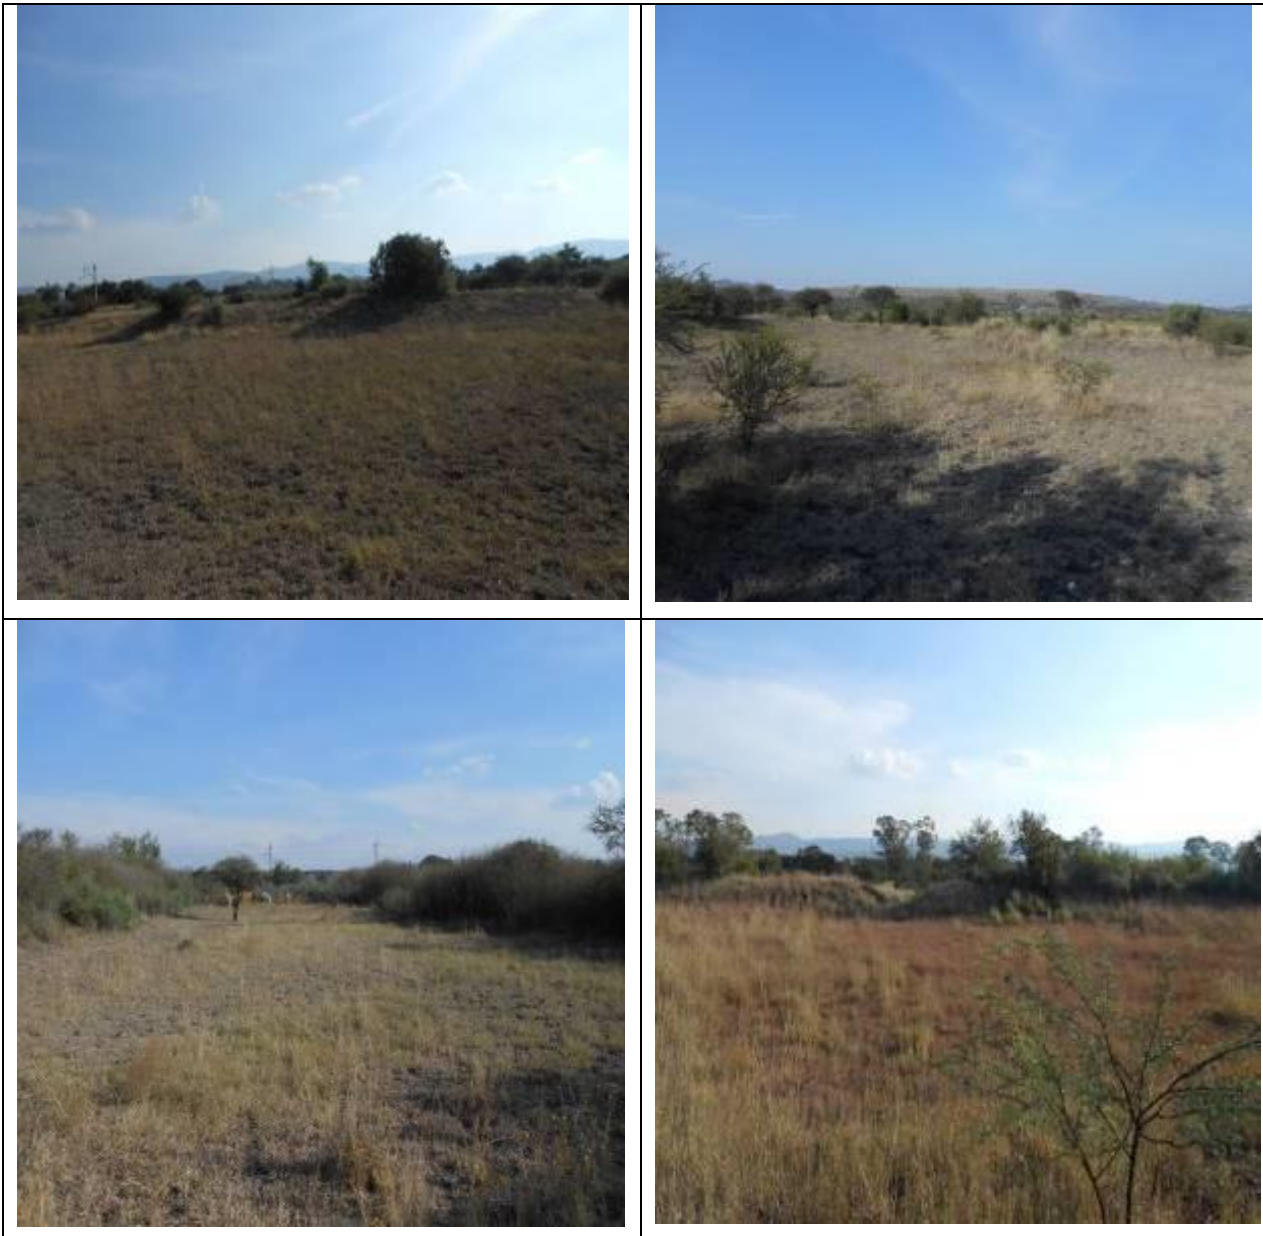
The dams were in a good state at the time of the assessment and were not affected by the current disturbances within the catchment. This may be due to their hydrological isolation from other wetland/riparian features. The hydrology of the features was largely natural with a few modifications. In addition, the geomorphology was slightly modified by compaction as a result of livestock trampling and grazing. The vegetation cover was moderately modified and this is mainly due to livestock grazing.

Figure 29: Representation of the dams observed during site visit.

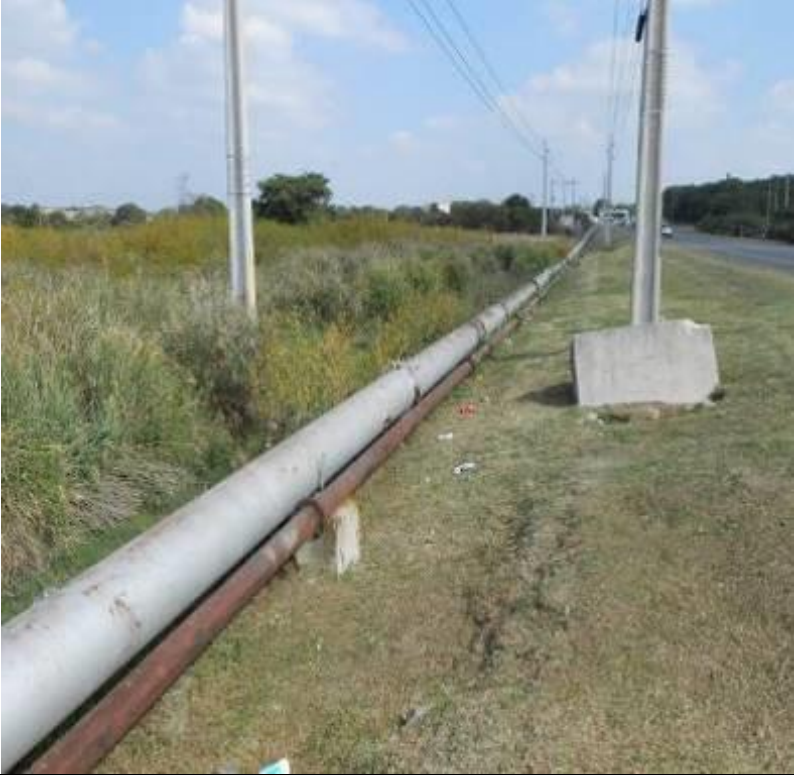
Site number: 3a	Coordinates: 25°41'41.32"S 27°22'06.46"E
Crossing Type: Pipeline	
Site Photo:

Present Ecological State	C
Wetland type	River
Morphology	Wide, relatively shallow channel.
Riparian and in Stream Habitat	Instream ecology: dominated by <i>Cyperus sexangularis</i>
Vegetation	The stream is dominated by <i>Sexangularis</i> and <i>Flaveria bidentis</i> .
System Modifiers	Mowing.
Potential impacts of water use on environment	The pipeline will not significantly negatively impact on the receiving environment; provided it is adequately maintained and there are no leaks detected during monitoring.
Socio-economic impacts of water use	The pipeline will not significantly negatively impact on any water users.
Socio-economic advantages of water use	The sewer line is necessary for the safe disposal of sewage.
Potential impacts of water use on water resource	The support structures within the channel will result in some but not major alterations to streamflow patterns; however these are not deemed to have a significant impact on downstream resources.

Summary of proposed impact on water use will have on other users	The pipeline crossing will not impact significantly on other water users.
Mitigation and Rehabilitation plan	Minimize the extent of vegetation clearing (curb side maintenance/grass mowing) next to the road to reduce runoff.

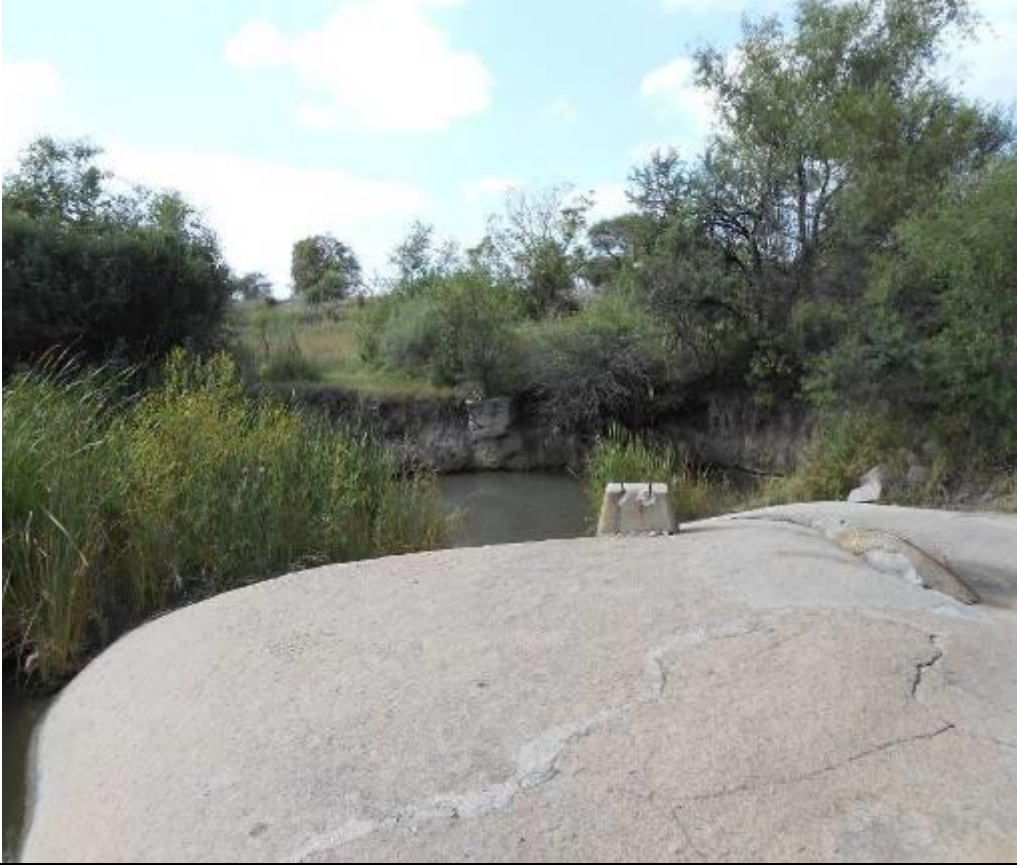
Site number: 3c	Coordinates: 25°41'33.32"S 27°21'23.65"E
Crossing Type: Culvert	
Site Photo:

Present Ecological State	C
Wetland type	River
Morphology	Wide, deeply incised channel.
Riparian and in Stream Habitat	<i>Acacia</i> spp. dominated bushveld vegetation. Instream ecology: lowered water level during assessment, exposed bedrock.
Vegetation	<i>Typha capensis</i> , dominated and alien species such <i>Asparagus larycinus</i> and <i>Conyza bonariensis</i> were observed.
System Modifiers	Encroachment.
Potential impacts of water use on environment	The culvert has been broken or removed on purpose since there is no obstruction of waterflow.
Socio-economic impacts of water use	The culvert will not significantly negatively impact on any water users.
Socio-economic advantages of water use	The culvert will not significantly negatively impact on any water users
Potential impacts of water use on water resource	The culvert will not significantly negatively impact on the water resource.

Summary of proposed impact on water use will have on other users	The culvert will not impact significantly on other water users.
Mitigation and Rehabilitation plan	Control alien vegetation.

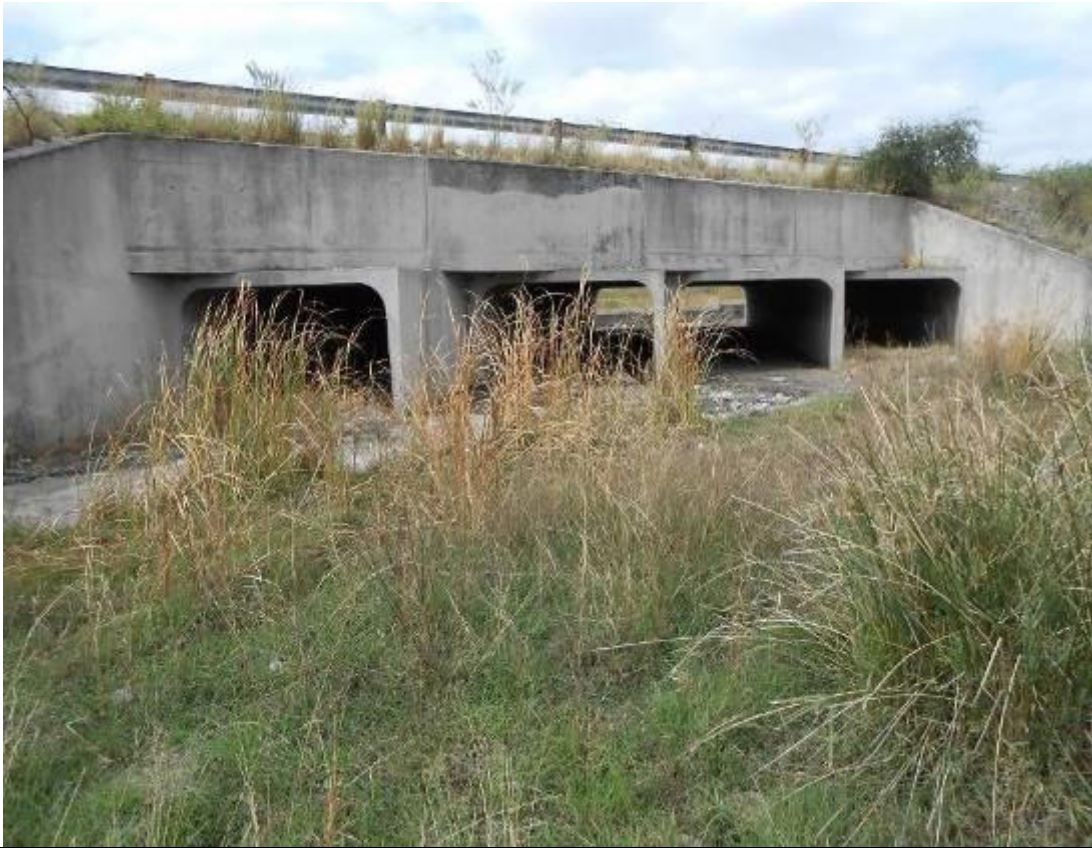
Site number: 4/4a	Coordinates: 25°41'26.54"S 27°21'10.01"E
Crossing Type: Road crossing	
Site Photo:

Present Ecological State	C
Wetland type	River
Morphology	Wide, relatively shallow channel. Dry river bed.
Riparian and in Stream Habitat	Instream ecology: riverbed dry at the time of the study.
Vegetation	<i>Typha capensis</i> and <i>Cyperus sexangularis</i> dominated. Alien species such as <i>Tagetes minuta</i> and <i>Bidens pilosa</i> were observed on site.
System Modifiers	Culvert. Increased runoff from road.
Potential impacts of water use on environment	The road crossing will not significantly negatively impact on any water users.
Socio-economic impacts of water use	The road crossing will not significantly negatively impact on any water users.
Socio-economic advantages of water use	The road crossing plays an important role in providing connectivity in the area thereby allowing economic activity in the area

Potential impacts of water use on water resource	The road crossing is well constructed and berms are constructed to prevent erosion.
Summary of proposed impact on water use will have on other users	The road crossing will not impact significantly on other water users.
Mitigation and Rehabilitation plan	Control alien vegetation
