**WETLAND DELINEATION IN THE RUSTENBURG
PLATINUM MINE PROJECT AREA AND A HIGH
LEVEL ASSESSMENT OF SELECTED RIVER
CROSSINGS, NORTH-WEST PROVINCE**

Prepared for

SRK Consulting (Pty) Ltd

May 2015

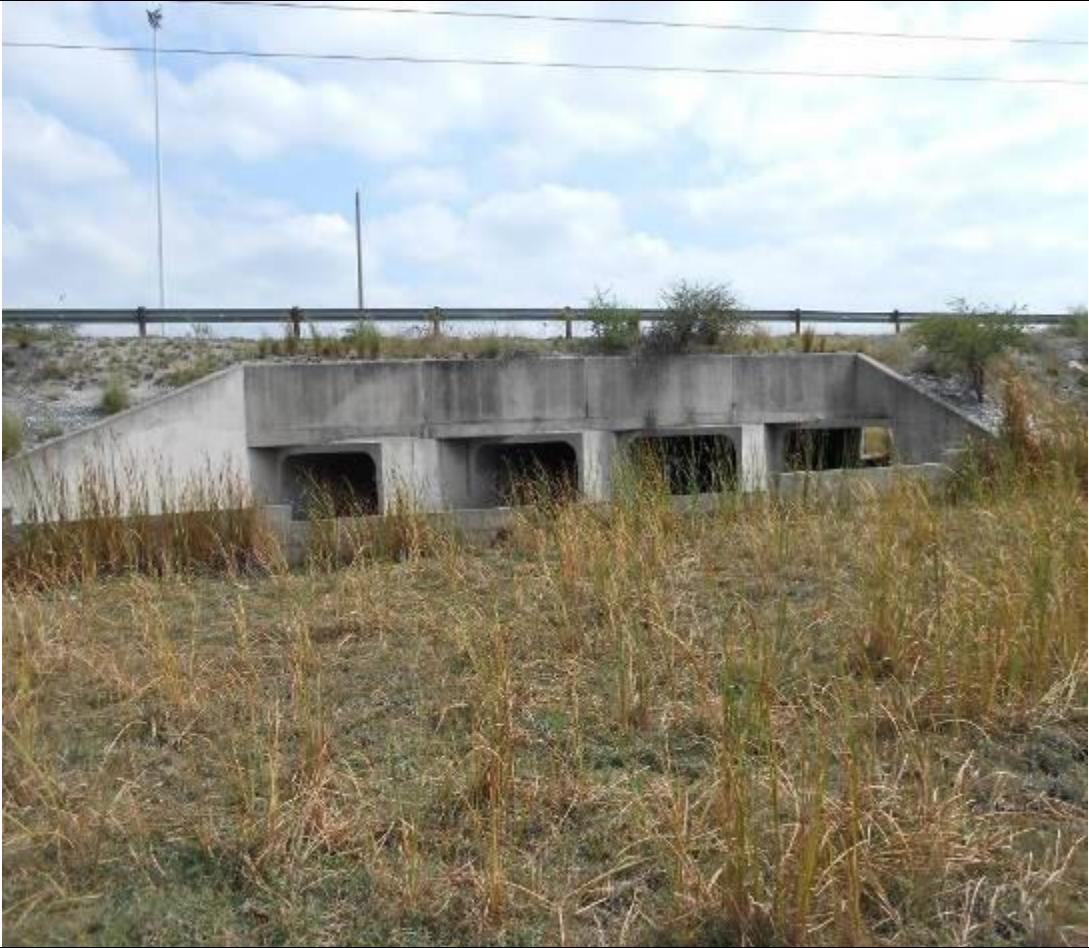
Site number: 05	Coordinates: 25°41'26.59"S 27°21'11.30"E
Crossing Type: Road crossing

Present Ecological State	C
Wetland type	River
Morphology	Wide, relatively shallow channel. Dry river bed.
Riparian and in Stream Habitat	Instream ecology: riverbed dry at the time of the study.
Vegetation	<i>Typha capensis</i> dominated.
System Modifiers	Culvert. Increased runoff from road. Stock piling
Potential impacts of water use on environment	The road crossing will not significantly negatively impact on any water users.
Socio-economic impacts of water use	The road crossing will not significantly negatively impact on any water users.
Socio-economic advantages of water use	The road crossing plays an important role in providing connectivity in the area thereby allowing economic activity in the area
Potential impacts of water use on water resource	The road crossing is well constructed. However stock piling adjacent the stream will result in sediment deposition.

Summary of proposed impact on water use will have on other users	The road crossing will not impact significantly on other water users.
Mitigation and Rehabilitation plan	Control alien vegetation. Remove stock piled adjacent the feature to avoid sediment deposition and further erosion of the area.

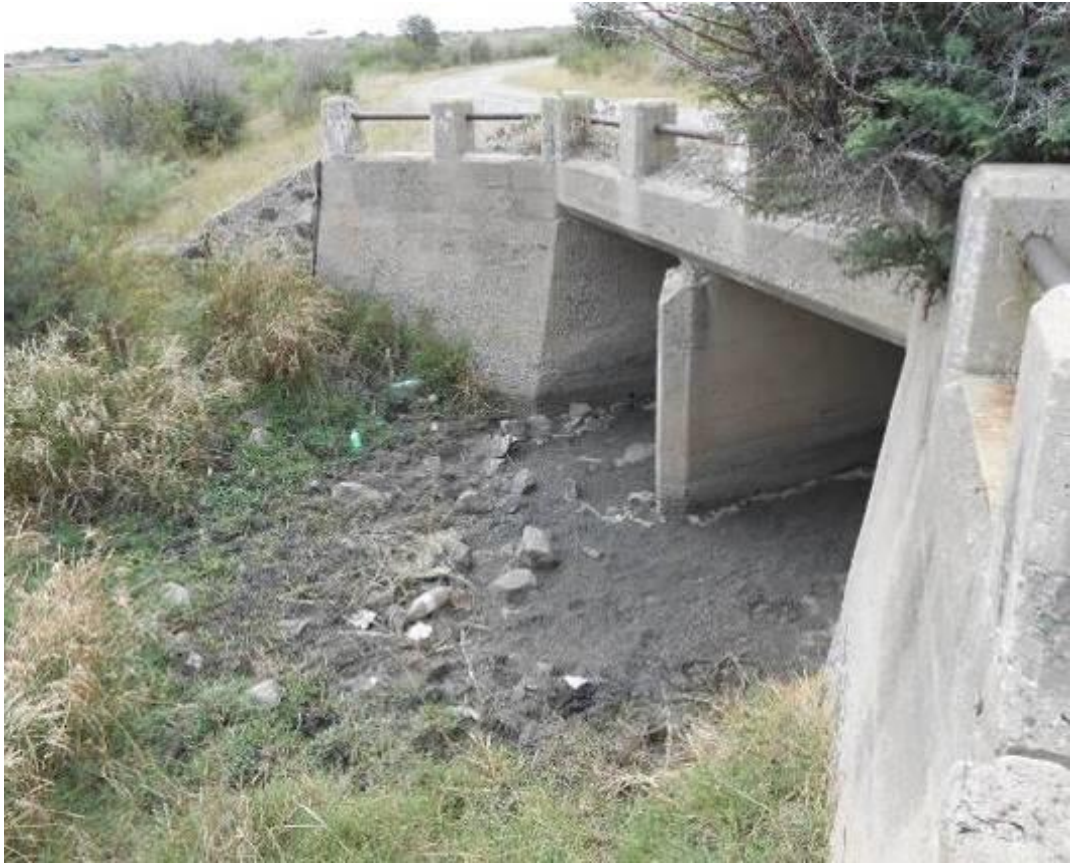
Site number: 06	Coordinates: 25°40'52.34"S 27°20'25.70"E
Crossing Type: Road crossing	
Site Photo:

Present Ecological State	C
Wetland type	River
Morphology	Wide, shallow banks. Dry river bed.
Riparian and in Stream Habitat	Riparian vegetation dominated by <i>Asparagus larycinus</i> and <i>Acacia</i> spp. In-stream ecology: riverbed dry at the time of the study.
Vegetation	<i>Hyperhenia hirta</i> , <i>Eragrostis curvula</i> , and <i>Cyperus sexangularis</i> dominated.
System Modifiers	In-stream flow altered moderately due to infrastructure (old bridge) within macro-channel. Some alien vegetation present. Trampling by livestock resulting in erosion and sedimentation.
Potential impacts of water use on environment	The bridge will not significantly negatively impact on any water users.
Socio-economic impacts of water use	The bridge will not significantly negatively impact on any water users.
Socio-economic advantages of water use	The bridge plays an important role in providing connectivity in the area thereby allowing economic activity in the area

Potential impacts of water use on water resource	The bridge is likely to have moderately altered streamflow patterns.
Summary of proposed impact on water use will have on other users	The bridge does not impact significantly on other water users.
Mitigation and Rehabilitation plan	Monitor erosion, alien vegetation control programme.

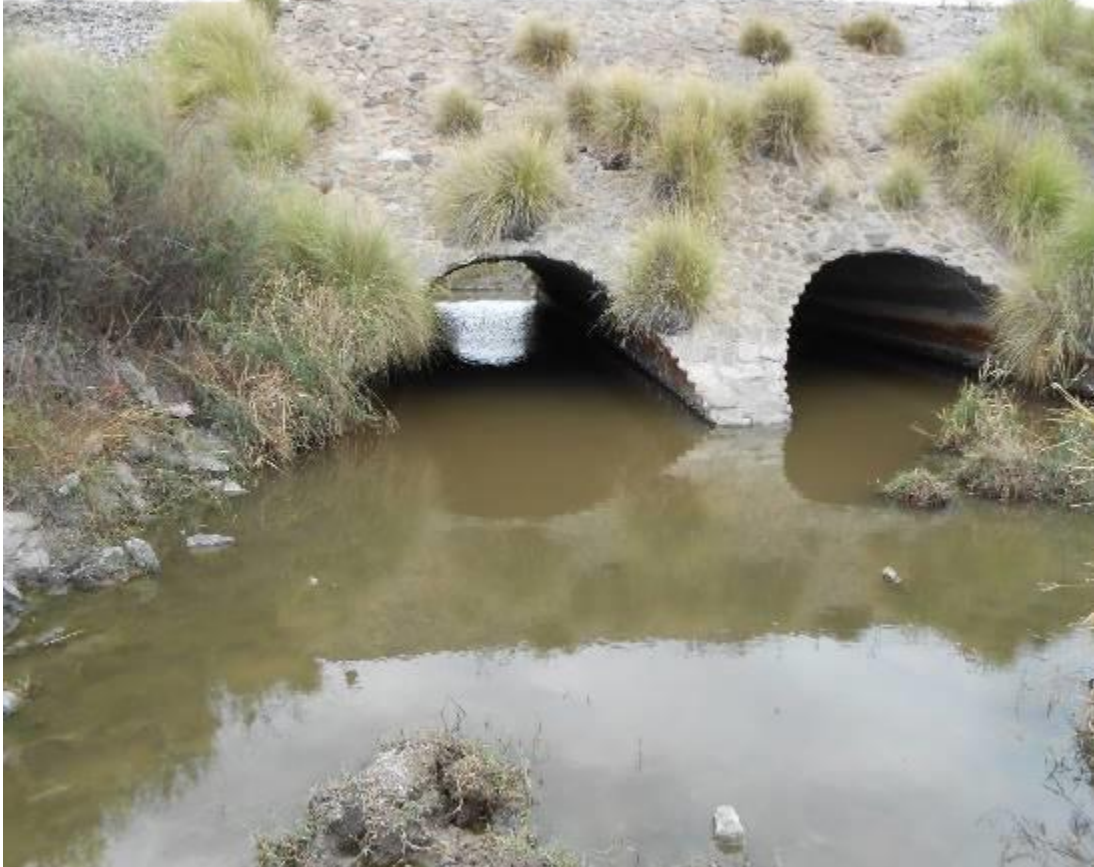
Site number: 07	Coordinates: 25°40'45.84"S 27°20'01.63"E
Crossing Type: Railway/Culvert	
Site Photo:

Present Ecological State	C
Wetland type	River
Morphology	Trampling by livestock and resulting erosion.
Riparian and in Stream Habitat	<i>Cyperus sexangularis</i> dominated.
Vegetation	<i>Asclepias fruiticosa</i> , <i>Xanthium strumarium</i> , <i>Asparagus loricinus</i> , <i>Flaveria bidentis</i> , <i>Conyza bonariensis</i> , <i>Cyperus sexangularis</i>
System Modifiers	Trampling and overgrazing by livestock.
Potential impacts of water use on environment	The culvert has changed the geomorphology as well as vegetation on site.
Socio-economic impacts of water use	The culvert will not significantly impact negatively on any water users.
Socio-economic advantages of water use	The bridge plays an important role in providing connectivity in the area thereby allowing economic activity in the area.
Potential impacts of water use on water resource	The culvert has altered water flow patterns line on the water resource.

Summary of proposed impact on water use will have on other users	The culvert will not significantly impact negatively on any water users.
Mitigation and Rehabilitation plan	Erosion monitoring and control

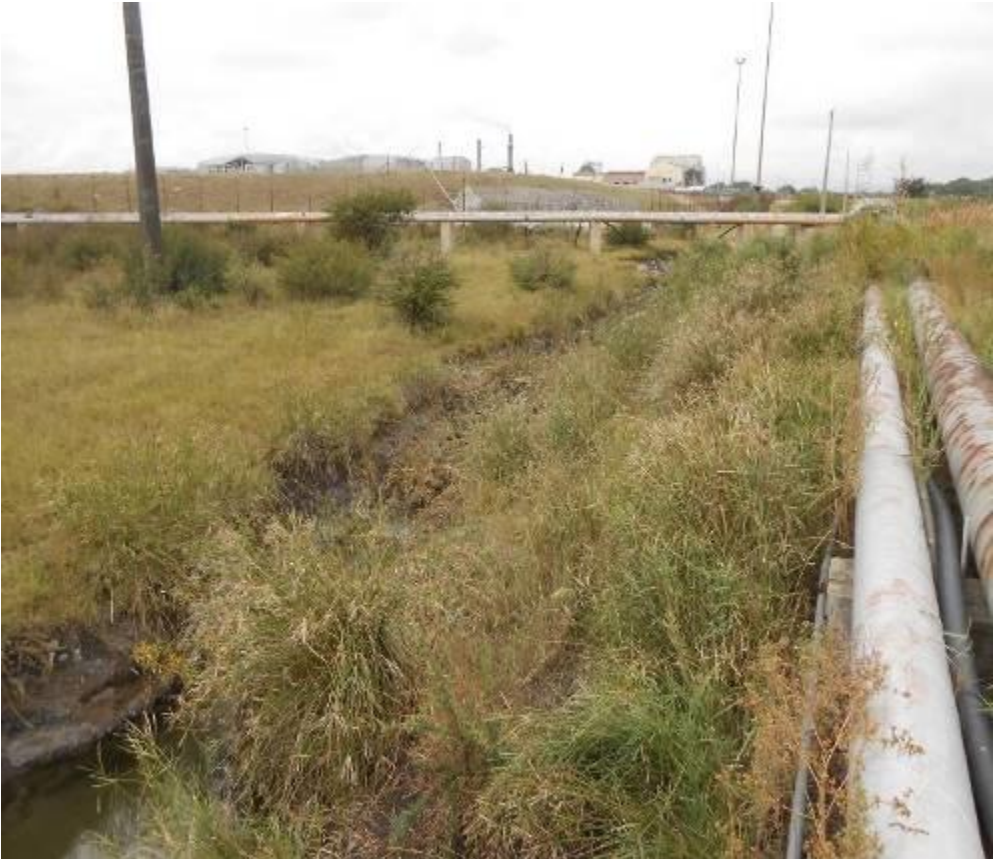
Site number: 8a	Coordinates: 25°40'43.43"S 27°19'36.40"E
Crossing Type: Pipeline	
Site Photo:

Present Ecological State	D
Wetland type	River
Morphology	Narrow, ephemeral channel.
Riparian and in Stream Habitat	Riparian habitat dominated by pioneer graminoid species. Instream ecology: riverbed dry at the time of the study; terrestrial plants found in the channel.
Vegetation	<i>Hyparrhenia hirta</i> , <i>Phragmites australis</i> , <i>Flaveria bidentis</i> , <i>Coenzya bonariensis</i> , <i>Cynodon dactylon</i> , <i>Sesbania sesban</i>
System Modifiers	Erosion. Grazing and trampling by livestock has altered the vegetation. Sediment deposition. Berm not functioning well.
Potential impacts of water use on environment	The pipeline will not significantly negatively impact on any water users.
Socio-economic impacts of water use	The pipeline will not significantly negatively impact on any water users.
Socio-economic advantages of water use	The pipeline will not significantly negatively impact on any water users.

Potential impacts of water use on water resource	The pipeline will not significantly negatively impact on any water users.
Summary of proposed impact on water use will have on other users	The road crossing will not impact significantly on other water users.
Mitigation and Rehabilitation plan	Invasive vegetation control. Fix berm where the other canal enters the stream. Monitor erosion.

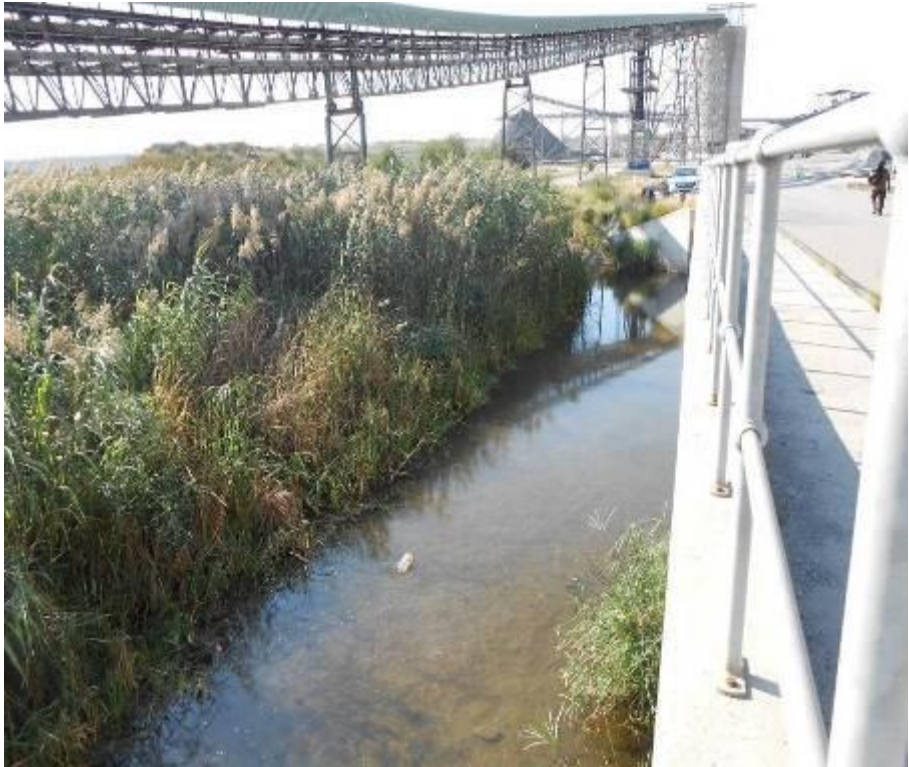
Site number: 09	Coordinates: 25°40'31.53"S 27°18'46.76"E
Crossing Type: Pipeline & conveyer belt	
Site Photo:

Present Ecological State	C
Wetland type	River
Morphology	Moderately incised channel.
Riparian and in Stream Habitat	Inundation below the bridge. Well vegetated in-stream habitat.
Vegetation	<i>Sporobolus pyramidalis</i> ,, <i>Cynodon dactylon</i> , <i>Phragmites australis</i> , <i>Melinis repens</i>
System Modifiers	Erosion along culvert due to grazing and trampling
Potential impacts of water use on environment	The conveyor line crossing will not significantly negatively impact on any water users, provided it is well maintained.
Socio-economic impacts of water use	The conveyor line crossing will not significantly negatively impact on any water users, however, the bridge will alter water flow patterns.
Socio-economic advantages of water use	The conveyor line as well as the road/bridge crossing is essential for continued mining operations, thus continuing economic development in the area.

Potential impacts of water use on water resource	The conveyor line crossing plinths do not pose any significant risk to the resource. Due to inherent erodability of the soils, bank incision during high-flow events and sedimentation of downstream resources is anticipated; however this is not as a direct consequence of the support structures.
Summary of proposed impact on water use will have on other users	The conveyor line crossing will not impact significantly on other water users.
Mitigation and Rehabilitation plan	Control erosion if possible (The activity may be out of RPM control as the feature is used by livestock for regular watering and crossing point)

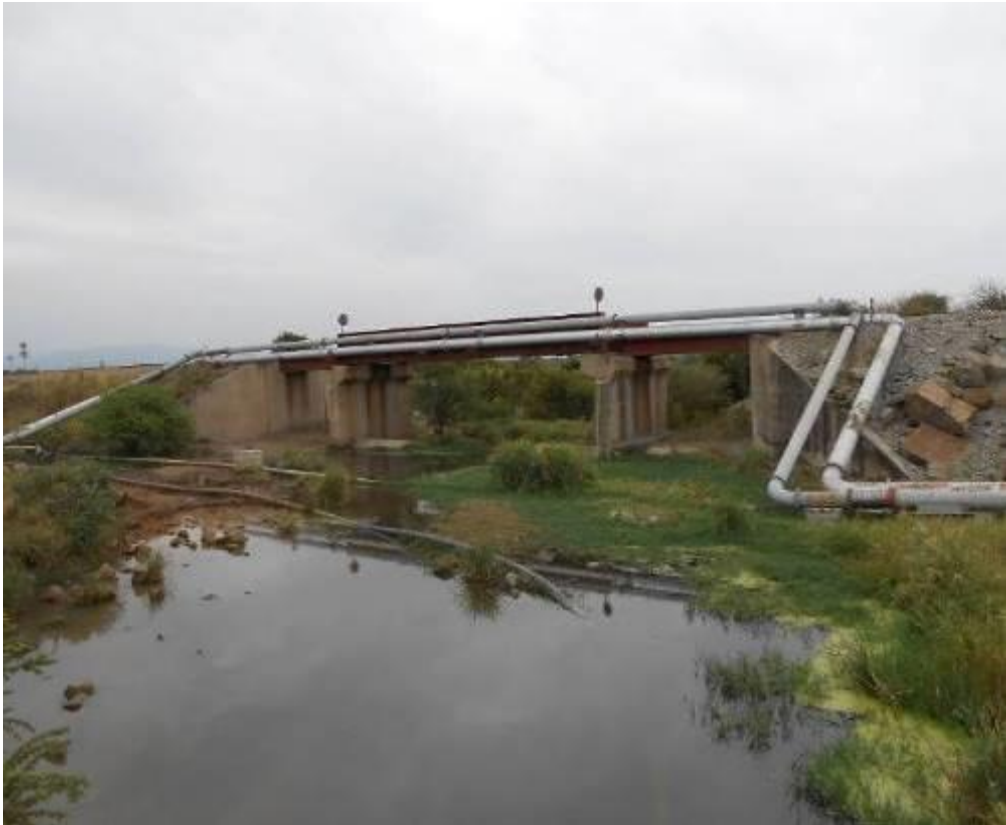
Site number: 11/a/b	Coordinates: 25°39'28.41"S 27°17'47.97"E
Crossing Type: Railway/Weir/Pipeline	
Site Photo:

Present Ecological State	D
Wetland type	River
Morphology	Shallow, wide channel.
Riparian and in Stream Habitat	Predominantly terrestrial, alien floral species.
Vegetation	<i>Cyperus sexangularis</i> , <i>Tagetes minuta</i> , <i>Melinis repens</i> , <i>Hypparrhenia hirta</i> , <i>Brachiaria brizantha</i> , <i>Rhus lancea</i> , <i>Typha capensis</i> , <i>Phragmites australis</i> , <i>Aloe spp</i> , <i>Asparagus larcinus</i> , <i>Coenyzia bonariensis</i> , <i>Asclepias fruticosa</i> , <i>Eragrostis curvula</i>
System Modifiers	Erosion. Livestock grazing and trampling. Leaking pipes. Weir altering water flow patterns
Potential impacts of water use on environment	The weir and the culvert will alter water flow pattern. However the railway line and the pipeline will not significantly negatively impact on any water users.

Socio-economic impacts of water use	The structures will not significantly negatively impact on any water users.
Socio-economic advantages of water use	The railway line is utilised for the mining operations.
Potential impacts of water use on water resource	Alteration to streamflow patterns during flow periods is anticipated due to the presence of the culvert and the weir.
Summary of proposed impact on water use will have on other users	The railway crossing will not impact significantly on other water users, in addition, the pipeline will not have any significant impact provided it is well maintained.
Mitigation and Rehabilitation plan	Monitor erosion. Monitor pipes for leaks. Insert erosion control berms.

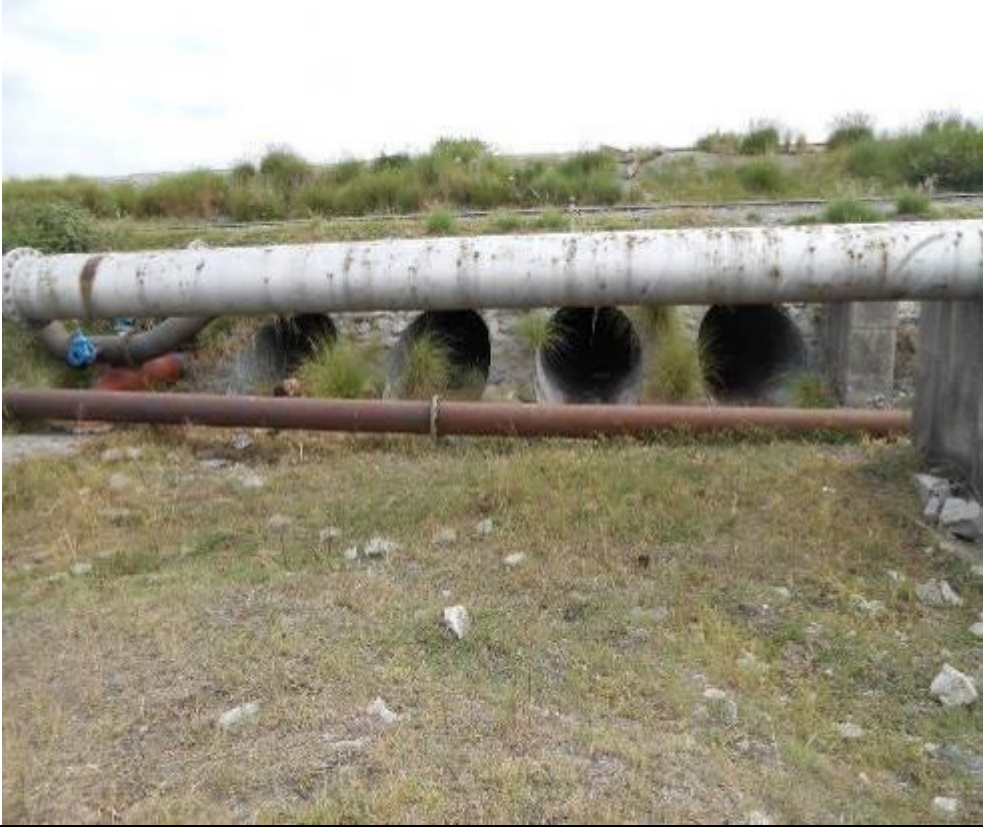
Site number: 12/12a	Coordinates: 25°39'56.50"S 27°20'07.59"E
Crossing Type: Road crossing culvert & pipeline	
Site Photo:

Present Ecological State	C
Wetland type	River
Morphology	Wide, relatively shallow channel. Dry river bed.
Riparian and in Stream Habitat	<i>Dichrostachys</i> spp. dominated bushveld vegetation. Instream ecology: riverbed dry at the time of the study.
Vegetation	<i>Cyperus sexangularis</i> , <i>Hyparrhenia hirta</i> , <i>Acacia</i> spp, <i>Coeniza bonariensis</i> , <i>Cynodon dactylon</i> , <i>Verbena bonariensis</i> , <i>Setaria sphacelata</i> , <i>Helichrysum</i> spp, <i>Typha capensis</i>
System Modifiers	Livestock grazing. Erosion.
Potential impacts of water use on environment	The road crossing will not significantly negatively impact on the receiving environment.
Socio-economic impacts of water use	The road crossing will not significantly negatively impact on any water users.

Socio-economic advantages of water use	The pipeline will not significantly negatively impact on the receiving environment provide it is well maintained
Potential impacts of water use on water resource	The road crossing as well as the pipeline plinths within the channel will result in some alterations to streamflow patterns during flow periods; however these are not deemed to have a significant impact on downstream resources.
Summary of proposed impact on water use will have on other users	The pipeline will not impact significantly on other water users.
Mitigation and Rehabilitation plan	Monitor erosion.

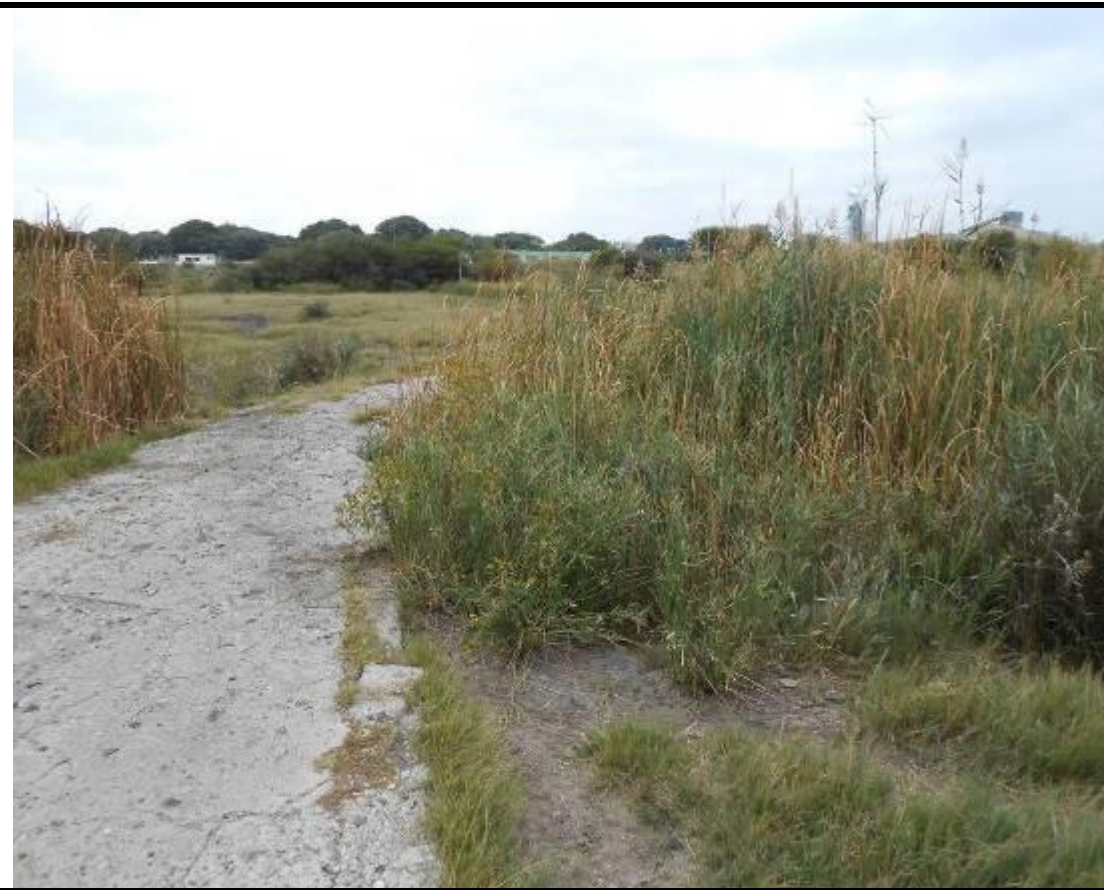
Site number: 12b	Coordinates: 25°39'30.67"S 27°19'16.36"E
Crossing Type: Road crossing

Present Ecological State	C
Wetland type	River
Morphology	Wide, relatively shallow channel, mixture of alluvial sand and bedrock. Dry river bed.
Riparian and in Stream Habitat	<i>Dichrostachys</i> spp. dominated bushveld vegetation. Instream ecology: riverbed dry at the time of the study.
Vegetation	<i>Phragmites australis</i> , <i>Cynodon dactylon</i> , <i>Conyza bonariensis</i> , <i>Panicum maxima</i> , <i>Cyperus sexangularis</i> , <i>Flaveria bidentis</i> , <i>Typha capensis</i> .
System Modifiers	Road traversing feature. Livestock grazing and trampling. Erosion.
Potential impacts of water use on environment	The road crossing will not significantly negatively impact on the receiving environment.
Socio-economic impacts of water use	The road crossing will not significantly negatively impact on any water users.

Socio-economic advantages of water use	The road crossing is necessary to connect the mining area to the neighbouring community.
Potential impacts of water use on water resource	The road crossing will not significantly negatively impact on any water users.
Summary of proposed impact on water use will have on other users	The road crossing will not impact significantly on other water users.
Mitigation and Rehabilitation plan	Monitor erosion. And control alien vegetation.

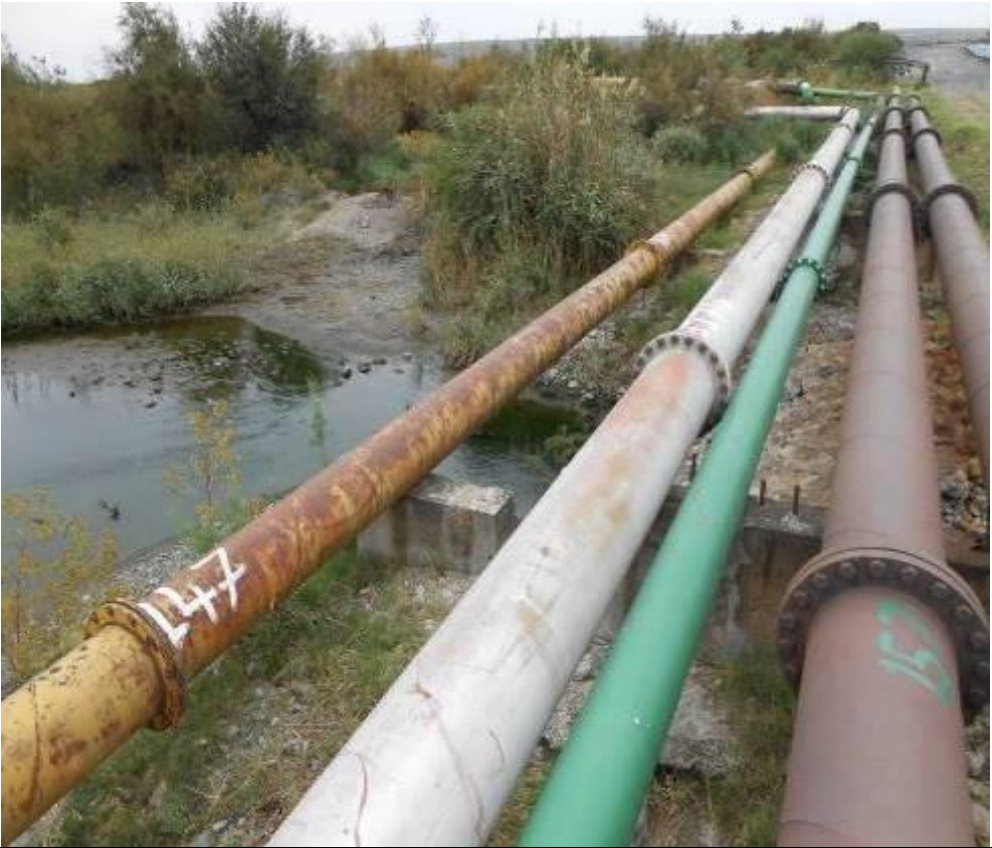
Site number: 13/13a	Coordinates: 25°39'30.18"S 27°19'15.73"E
Crossing Type: Culvert and pipeline	
Site Photo:

Present Ecological State	D
Wetland type	River
Morphology	Wide, relatively shallow channel, mixture of alluvial sand and bedrock. Dry river bed.
Riparian and in Stream Habitat	<i>Acacia</i> spp. dominated bushveld vegetation. Instream ecology: flowing water
Vegetation	<i>Phragmites australis</i> , <i>Cyperus sexangularis</i> , <i>Asparagus larinus</i> , <i>Conyza bonariensis</i> , <i>Tagetes minuta</i> , <i>Melinis repens</i> , <i>Eragrostis curvula</i> , <i>Panicum maxima</i>
System Modifiers	Sedimentation. Erosion. Alien invasion.
Potential impacts of water use on environment	The pipeline will not significantly negatively impact on the receiving environment; provided it is adequately maintained.
Socio-economic impacts of water use	The pipeline will not significantly negatively impact on any water users.

Socio-economic advantages of water use	The pipeline is necessary for the safe disposal of sewage.
Potential impacts of water use on water resource	The plinths within the channel will result in some alterations to streamflow patterns during flow periods. The culvert is very narrow and low and will cause a constriction on water flow.
Summary of proposed impact on water use will have on other users	The pipeline will not impact significantly on other water users.
Mitigation and Rehabilitation plan	Monitor pipes for leakage. Control alien vegetation. redesign and reconstruct the culvert

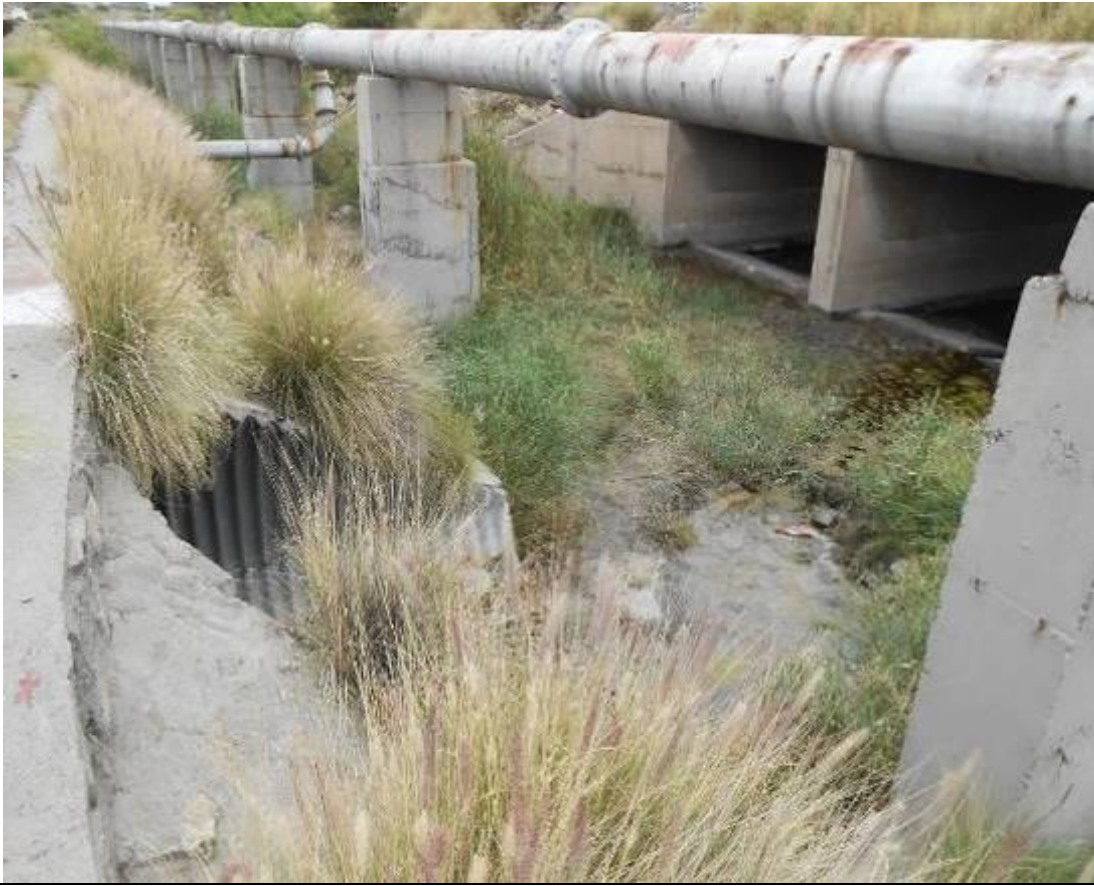
Site number: 14/a/weir	Coordinates: 25°39'03.71"S 27°18'45.09"E
Crossing Type: Culvert & pipeline & weir	
Site Photo:

Present Ecological State	C
Wetland type	River
Morphology	Wide, relatively shallow channel.
Riparian and in Stream Habitat	Instream ecology: there is water within the channel.
Vegetation	<i>Cyperus sexangularis</i> , <i>Melinis repens</i> , <i>Typha capensis</i> , <i>Phragmites australis</i> , <i>Acacia</i> spp., <i>Cynodon dactylon</i> .
System Modifiers	Culvert. Erosion. Cattle trampling. Increased water input due to runoff from road.
Potential impacts of water use on environment	The pipeline crossing will not significantly negatively impact on the receiving environment; provided it is adequately maintained. The culvert and the weir will alter water flow patterns.
Socio-economic impacts of water use	The pipeline and culvert will not significantly negatively impact on any water users.

Socio-economic advantages of water use	The pipeline and culvert will not significantly negatively impact on any water users.
Potential impacts of water use on water resource	The plinths within the channel will result in some alterations to streamflow patterns during flow periods; however these are not deemed to have a significant impact on downstream resources.
Summary of proposed impact on water use will have on other users	The structures will not impact significantly on other water users.
Mitigation and Rehabilitation plan	Monitoring of erosion. Monitor pipes for leaks

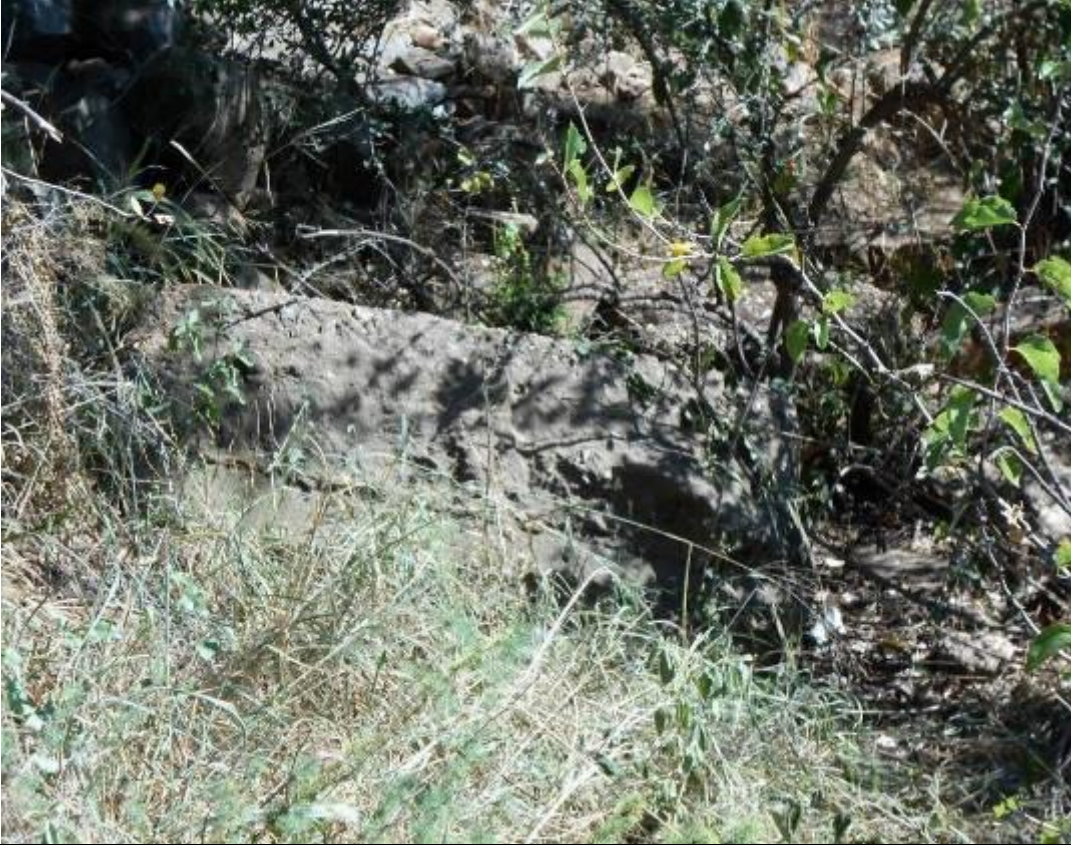
Site number: 14b/c	Coordinates: 25°38'0.36"S 27°17'39.04"E
Crossing Type: Road crossing	
Site Photo:

Present Ecological State	C
Wetland type	River
Morphology	Wide, relatively shallow channel, mixture of alluvial sand and bedrock. Dry river bed.
Riparian and in Stream Habitat	<i>Dichrostachys</i> spp. dominated bushveld vegetation. Instream ecology: riverbed dry at the time of the study.
Vegetation	<i>Cyperus sexangularis</i> , <i>Melinis repens</i> , <i>Typha capensis</i> , <i>Phragmites australis</i> , <i>Acacia</i> spp. <i>Cynodon dactylon</i> .
System Modifiers	Culvert. Erosion. Cattle trampling. Increased water input due to runoff from road.
Potential impacts of water use on environment	The sewer line crossing will not significantly negatively impact on the receiving environment; provided it is adequately maintained.
Socio-economic impacts of water use	The sewer line crossing will not significantly negatively impact on any water users.

Socio-economic advantages of water use	The sewer line is necessary for the safe disposal of sewage.
Potential impacts of water use on water resource	The support structures within the channel will result in some alterations to streamflow patterns during flow periods; however these are not deemed to have a significant impact on downstream resources.
Summary of proposed impact on water use will have on other users	The sewer line crossing will not impact significantly on other water users.
Mitigation and Rehabilitation plan	Monitoring of erosion. Monitor pipes for leaks

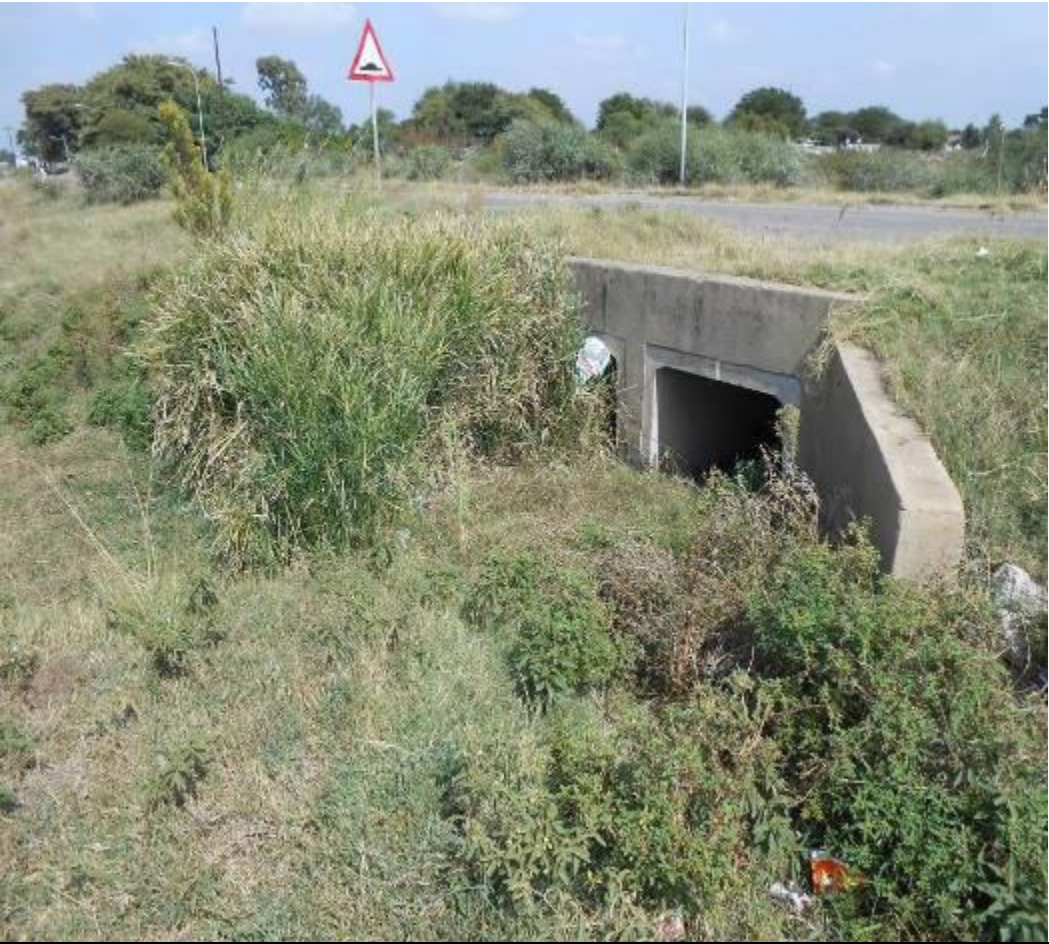
Site number: 16	Coordinates: 25°39'09.61"S 27°22'09.61"E
Crossing Type: Road crossing	
Site Photo:

Present Ecological State	C
Wetland type	River
Morphology	Shallow channel. Dry river bed.
Riparian and in Stream Habitat	Well vegetated. Instream ecology: riverbed dry at the time of the study.
Vegetation	<i>Chloris gayana</i> , <i>Cyperus sexangularis</i> , <i>Flaveria bidentis</i> , <i>Heteropogon contortus</i> , <i>Asclepias fruticosa</i> , <i>Opuntia ficus-indica</i> .
System Modifiers	Littering. Alien species invasion.
Potential impacts of water use on environment	The road crossing will not significantly negatively impact on the receiving environment; provided it is adequately maintained.
Socio-economic impacts of water use	The road crossing will not significantly negatively impact on any water users.
Socio-economic advantages of water use	The road crossing plays an important role in providing connectivity in the area thereby allowing economic activity in the area

Potential impacts of water use on water resource	The culvert will result in some alterations to water flow patterns during flow periods; however these are not deemed to have a significant impact on downstream resources.
Summary of proposed impact on water use will have on other users	The road crossing will not impact significantly on other water users.
Mitigation and Rehabilitation plan	Clean up litter. Control alien species

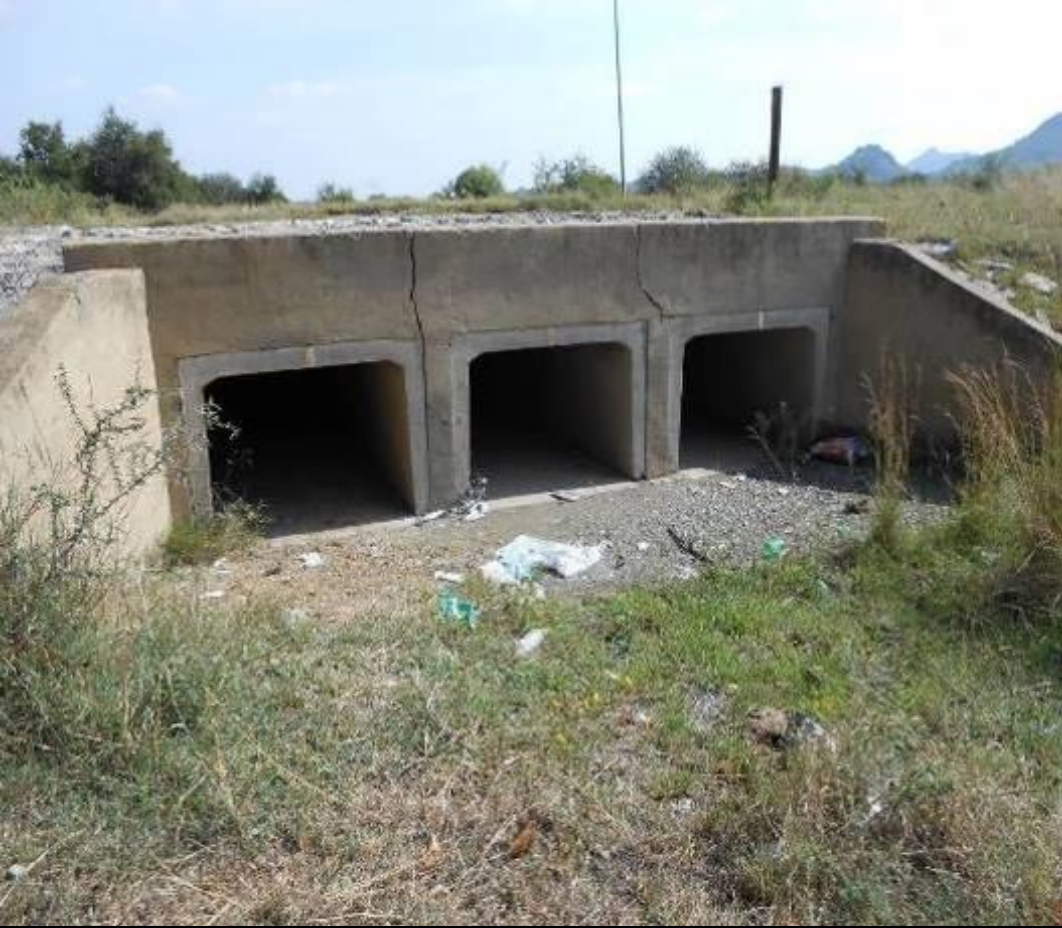
Site number: 17	Coordinates: 25°39'06.22"S 27°22'11.14"E
Crossing Type: road crossing	
Site Photo:

Present Ecological State	C
Wetland type	River
Morphology	Shallow channel. Dry river bed.
Riparian and in Stream Habitat	<i>Acacia</i> spp. dominated bushveld vegetation. Instream ecology: riverbed dry at the time of the study.
Vegetation	<i>Heteropogon contortus</i> , <i>Aslepias fruiticosa</i> , <i>Hyparrhenia hirta</i> , <i>Cynodon dactylon</i>
System Modifiers	Exposed pipe just beneath the culvert. Livestock grazing and trampling.
Potential impacts of water use on environment	The road crossing will not significantly negatively impact on the receiving environment.
Socio-economic impacts of water use	The road crossing will not significantly negatively impact on any water users.
Socio-economic advantages of water use	The road crossing plays an important role in providing connectivity in the area thereby allowing economic activity in the area.

Potential impacts of water use on water resource	The road crossing will result in some alterations to water flow patterns during flow periods; however these are not deemed to have a significant impact on downstream resources.
Summary of proposed impact on water use will have on other users	The road crossing will not impact significantly on other water users.
Mitigation and Rehabilitation plan	Monitor the area for erosion.

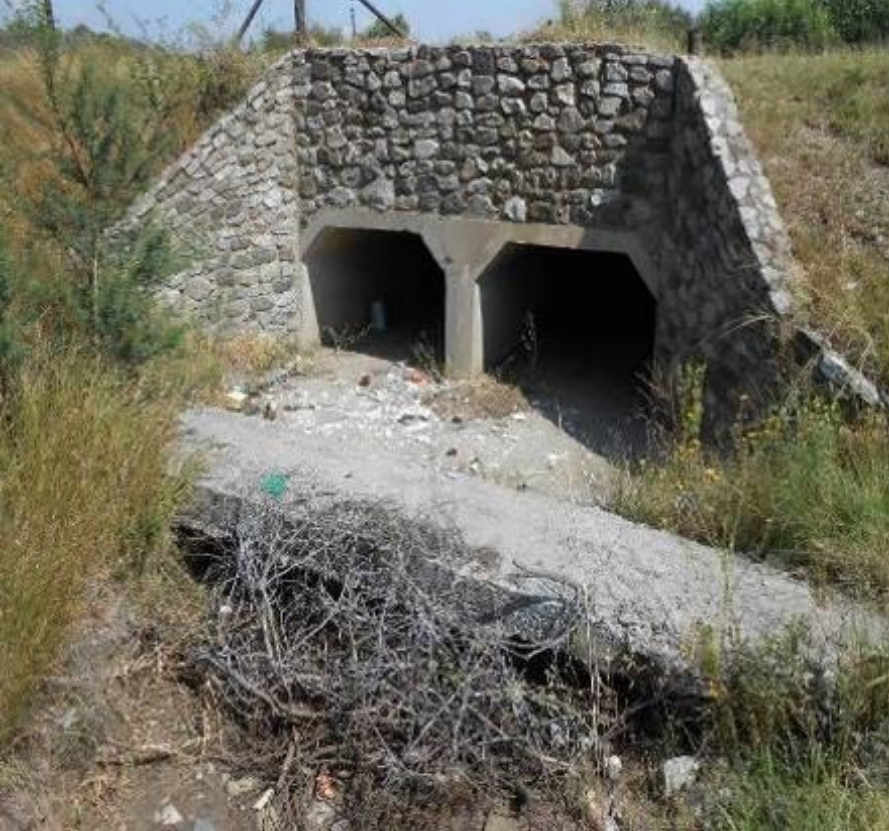
Site number: 18	Coordinates: 25°39'03.03"S 27°22'30.54"E
Crossing Type: Road culvert	
Site Photo:

Present Ecological State	C
Wetland type	River
Morphology	Wide, relatively shallow channel, mixture of alluvial sand and bedrock. Dry river bed.
Riparian and in Stream Habitat	<i>Rhus lancea</i> and <i>Acacia</i> spp. dominated bushveld vegetation. Instream ecology: riverbed dry at the time of the study.
Vegetation	<i>Datura stramonium</i> , <i>Persicaria lapathifolia</i> , <i>Conyza bonariensis</i> , <i>tithonia rotundifolia</i> , <i>Eragrostis curvula</i> , <i>Rhus lancea</i> , <i>Sporobolus pyramidalis</i> , <i>Tagetes minuta</i> , <i>Verbena bonariensis</i> , <i>Acacia</i> spp.
System Modifiers	Increased runoff from the road. Debris blocking water flow and causing a migration barrier. Erosion and river bed scouring. Waste dumping.
Potential impacts of water use on environment	The road culvert crossing will not significantly negatively impact on the receiving environment.

Socio-economic impacts of water use	The road culvert crossing will not significantly negatively impact on any water users.
Socio-economic advantages of water use	The road culvert plays an important role in providing connectivity in the area thereby allowing economic activity in the area
Potential impacts of water use on water resource	The road culvert crossing will result in some alterations to water flow patterns during flow periods. In addition, the eroded culvert will cause a migration barrier during high flow periods.
Summary of proposed impact on water use will have on other users	The road culvert crossing will not impact significantly on other water users.
Mitigation and Rehabilitation plan	Remove waste. Remove a concrete slab that forms a weir as it traps debris and blocks water flow. Remove waste. Monitor erosion.

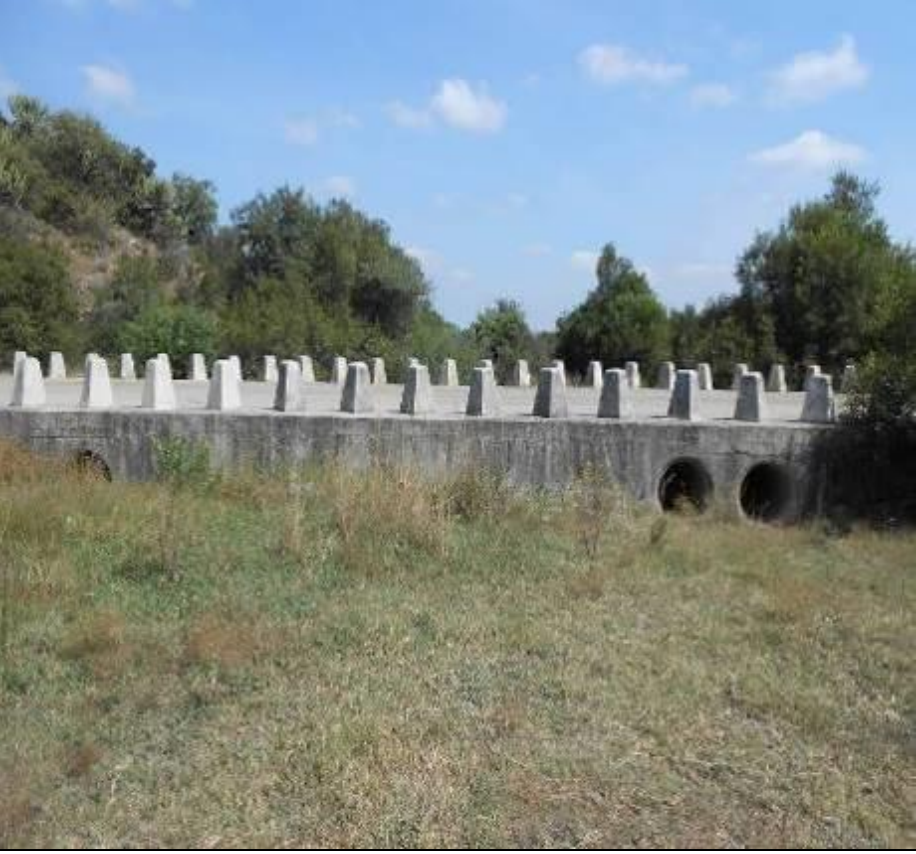
Site number: 19	Coordinates: 25°39'00.83"S 27°22'42.64"E
Crossing Type: Road culvert	
Site Photo:

Present Ecological State	C
Wetland type	River
Morphology	Wide, relatively shallow channel, mixture of alluvial sand and bedrock. Dry river bed.
Riparian and in Stream Habitat	<i>Rhus lancea</i> and <i>Acacia</i> spp. dominated bushveld vegetation. Instream ecology: riverbed dry at the time of the study.
Vegetation	<i>Cyperus sexangularis</i> , <i>Asclepias fruticosa</i> , <i>Sporobolus africanus</i>
System Modifiers	Increased runoff from the road. Littering. Stockpiling. Erosion.
Potential impacts of water use on environment	The road culvert crossing will not significantly negatively impact on the receiving environment.
Socio-economic impacts of water use	The road culvert crossing will not significantly negatively impact on any water users.
Socio-economic advantages of water use	The road culvert plays an important role in providing connectivity in the area thereby allowing economic activity in the area

Potential impacts of water use on water resource	The road culvert crossing will result in some alterations to water flow patterns during flow periods, and increase water input within the water resource.
Summary of proposed impact on water use will have on other users	The road culvert crossing will not impact significantly on other water users.
Mitigation and Rehabilitation plan	Clean up litter. Remove piled soil to prevent sedimentation. Monitor erosion

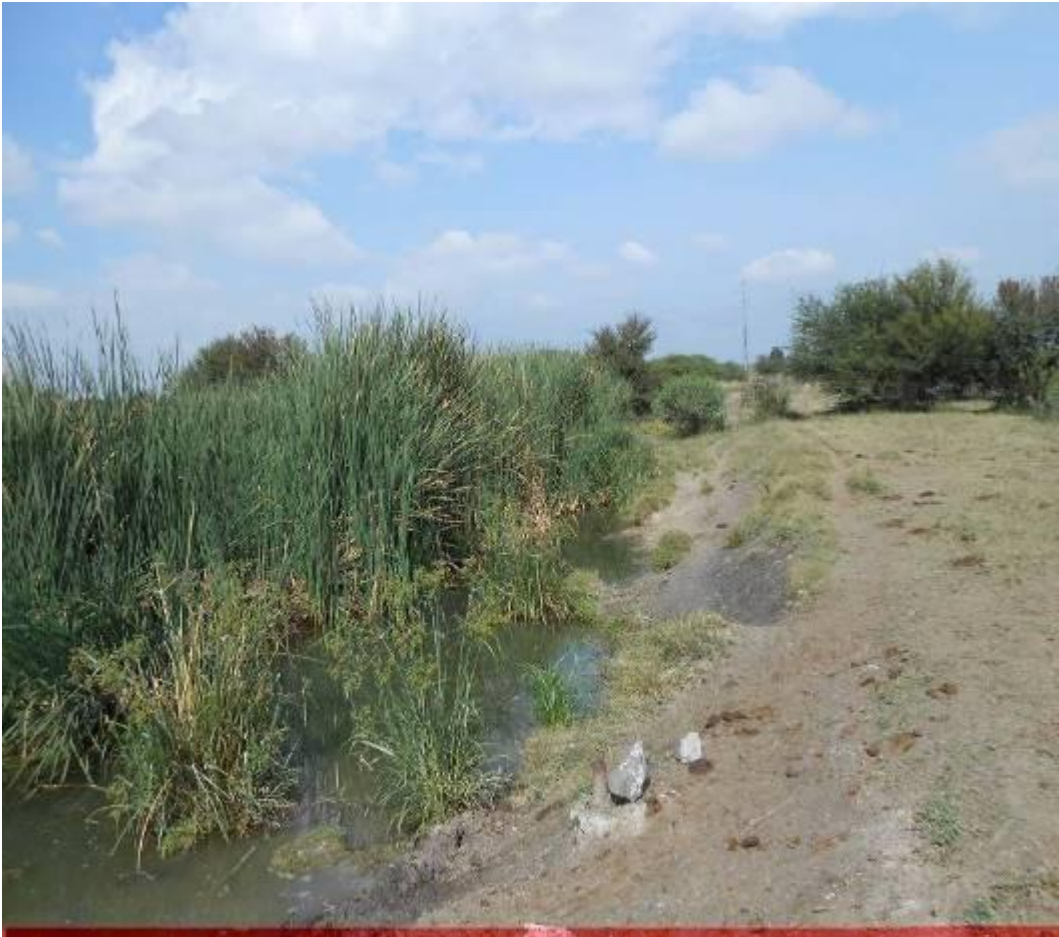
Site number: 19a	Coordinates: 25°38'21.79"S 27°20'53.49"E
Crossing Type: road crossing	
Site Photo:

Present Ecological State	C
Wetland type	Pan
Morphology	Wide, relatively shallow channel, mixture of alluvial sand and bedrock. Dry river bed.
Riparian and in Stream Habitat	<i>Acacia</i> spp. dominated bushveld vegetation. Instream ecology: riverbed dry at the time of the study.
Vegetation	<i>Heteropogon contortus</i> , <i>Typha capensis</i> , <i>Melinis repens</i> , <i>Panicum laetifolium</i> , <i>Themeda triandra</i> , <i>Setaria sphacelata</i> , <i>Tagetes minuta</i>
System Modifiers	Erosion. Livestock grazing and trampling.
Potential impacts of water use on environment	The road crossing is not well constructed and since it is a dirt road there will be sediment deposition during rainfall events.
Socio-economic impacts of water use	The road crossing will not significantly negatively impact on any water users.

Socio-economic advantages of water use	The road crossing will not negatively impact on water users.
Potential impacts of water use on water resource	There will be increase sediment deposition within the water resource since the road is a dirt road.
Summary of proposed impact on water use will have on other users	The road will not impact significantly on other water users.
Mitigation and Rehabilitation plan	Monitor the area for erosion.

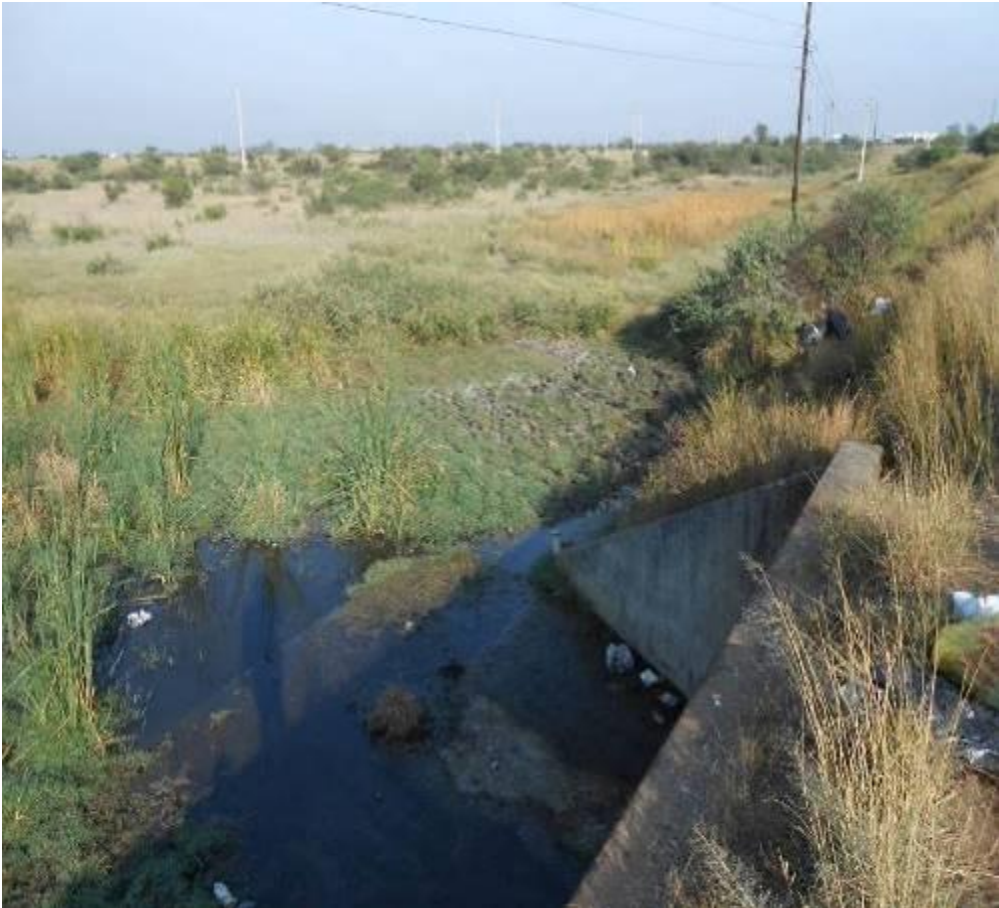
Site number: 21	Coordinates: 25°36'35.53"S 27°18'21.15"E
Crossing Type: Culvert road	
Site Photo:

Present Ecological State	C
Wetland type	River
Morphology	Wide, moderately diffuse channel, inundation below the culvert
Riparian and in Stream Habitat	The stream channel was well vegetated
Vegetation	<i>Heteropogon contortus</i> , <i>Cyperus sexangularis</i> , <i>Typha capensis</i> , <i>Eragrostis curvula</i> , <i>Melinis repens</i> , <i>Xanthium strumarium</i> , <i>Conyza bonariensis</i> , <i>Asclepias fruiticosa</i>
System Modifiers	Livestock grazing and trampling. Littering
Potential impacts of water use on environment	The road crossing will not significantly negatively impact on the environment.
Socio-economic impacts of water use	The road crossing will not significantly negatively impact on any water users.
Socio-economic advantages of water use	The road crossing plays an important role in providing connectivity in the area, particularly to the local community, thereby allowing economic activity in the area.

Potential impacts of water use on water resource	The culvert will result in some alterations to streamflow patterns during flow periods; however these are not deemed to have a significant impact on downstream resources.
Summary of proposed impact on water use will have on other users	The road crossing will not impact significantly on other water users.
Mitigation and Rehabilitation plan	Monitor the area for erosion. Control alien invasion.
