**WETLAND DELINEATION IN THE RUSTENBURG
PLATINUM MINE PROJECT AREA AND A HIGH
LEVEL ASSESSMENT OF SELECTED RIVER
CROSSINGS, NORTH-WEST PROVINCE**

Prepared for

SRK Consulting (Pty) Ltd

May 2015

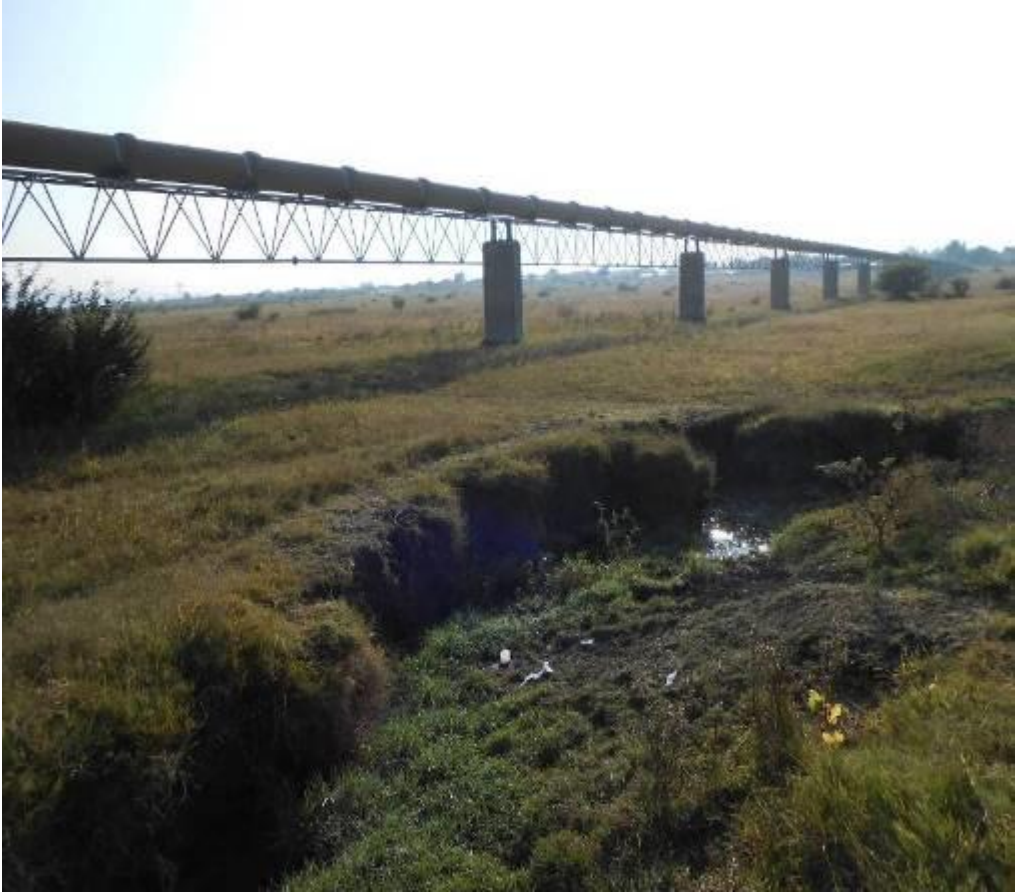
Site number: 21a/b	Coordinates: 25°36'05.18"S 27°18'10.04"E
Crossing Type: Pipeline	
Site Photo:

Present Ecological State	B
Wetland type	River
Morphology	Narrow moderately incised, shallow channel.
Riparian and in Stream Habitat	<i>Acacia karroo</i> dominated bushveld vegetation.
Vegetation	<i>Setaria sphacelata</i> , <i>Flaveria bidentis</i> , <i>Typha capensis</i> , <i>Conyza bonariensis</i> , <i>Cyperus sexangularis</i>
System Modifiers	Livestock grazing
Potential impacts of water use on environment	The pipeline will not significantly negatively impact on the receiving environment; provided it is adequately maintained.
Socio-economic impacts of water use	The pipeline will not significantly negatively impact on any water users.
Socio-economic advantages of water use	The pipeline will not significantly negatively impact on any water users
Potential impacts of water use on water resource	The support structures within the channel will result in some alterations to streamflow patterns during flow periods; however these are not deemed to have a significant impact on downstream resources.

Summary of proposed impact on water use will have on other users	The pipeline will not impact significantly on other water users.
Mitigation and Rehabilitation plan	Monitor pipes for leaks

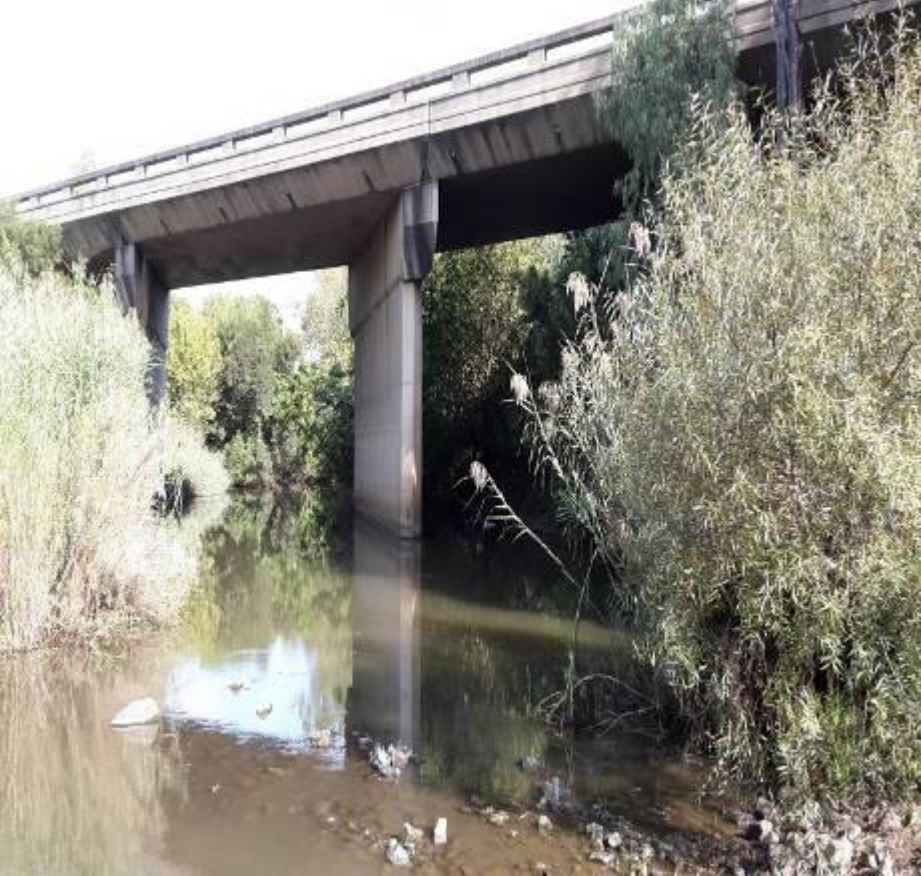
Site number: Site 22 and Site 23	Coordinates: 25°40'34.99"S 27°16'40.43"E
Crossing Type: Road crossing	
Site Photo:

Present Ecological State	B
Wetland type	River
Morphology	Wide, relatively shallow channel, inundation below bridge.
Riparian and in Stream Habitat	<i>Melia azedarach</i> in the terrestrial area. Inundation below bridge.
Vegetation	<i>Phragmites australis</i> , <i>Cyperus sexangularis</i> , <i>Asparagus laricinus</i> <i>Xanthium strumarium</i> , <i>Rhus lancea</i> ,
System Modifiers	Water abstraction. Vegetation clearing. Erosion. Runoff from the road. Livestock grazing.
Potential impacts of water use on environment	The road crossing will not significantly negatively impact on the environment.
Socio-economic impacts of water use	The road crossing will not significantly negatively impact on any water users.
Socio-economic advantages of water use	The road crossing plays an important role in providing connectivity in the area, particularly to the local community, thereby allowing economic activity in the area.

Potential impacts of water use on water resource	The support structures within the channel will result in some alterations to streamflow patterns during flow periods; however these are not deemed to have a significant impact on downstream resources.
Summary of proposed impact on water use will have on other users	The road crossing will not impact significantly on other water users.
Mitigation and Rehabilitation plan	Re-vegetate where necessary. Monitor erosion.

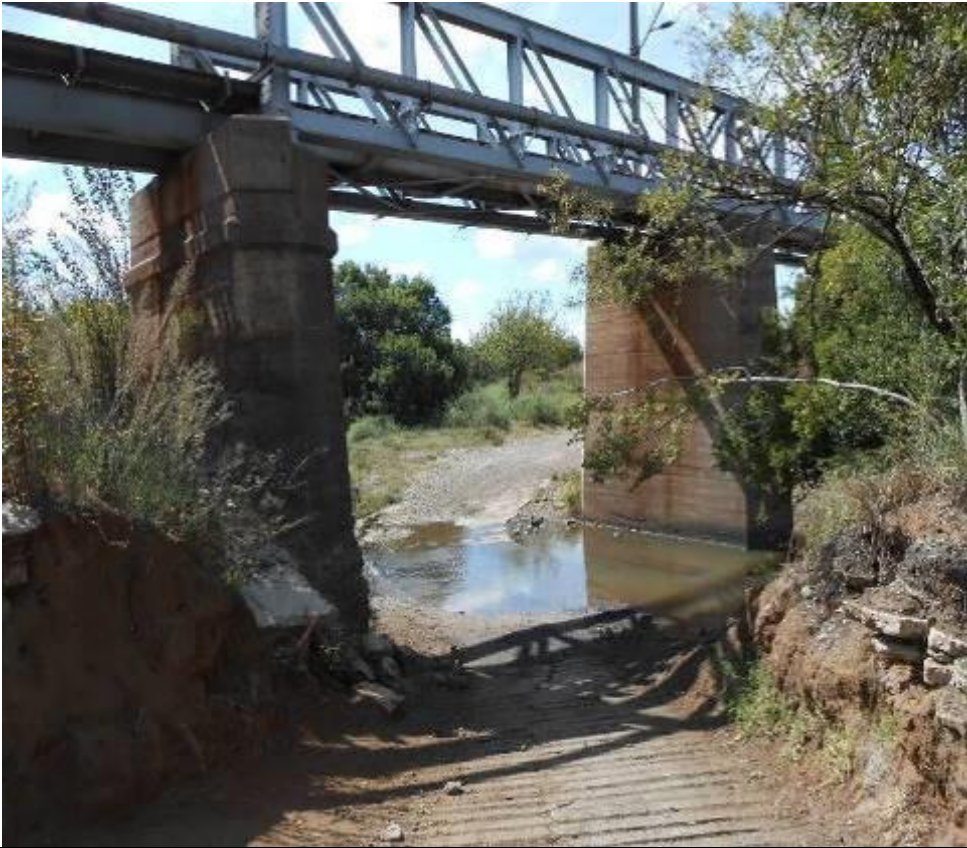
Site number: Site 24	Coordinates: 25°40'05.75"S 27°16'40.08"E
Crossing Type: Railway/Culvert	
Site Photo:

Present Ecological State	C
Wetland type	River
Morphology	Wide, relatively shallow channel. Paved road below the railway crossing reducing infiltration.
Riparian and in Stream Habitat	Inundation below crossing
Vegetation	<i>Rhus lancea</i> , <i>Persicaria lapathifolia</i> , <i>Panicum maxima</i> , <i>Morus alba</i> , <i>Cyperus sexangularis</i> , <i>Phragmites australis</i> , <i>Themeda triandra</i>
System Modifiers	Road beneath the railway traversing the river. Erosion. Cattle trampling and grazing. Leaking pipes.
Potential impacts of water use on environment	The railway crossing will not significantly negatively impact on the environment.
Socio-economic impacts of water use	The railway crossing will not significantly negatively impact on any water users.
Socio-economic advantages of water use	The railway crossing is necessary for transporting mining goods.

Potential impacts of water use on water resource	The support structures within the channel will result in some alterations to streamflow patterns during flow periods; however these are not deemed to have a significant impact on downstream resources.
Summary of proposed impact on water use will have on other users	The railway crossing will not impact significantly on other water users.
Mitigation and Rehabilitation plan	Control alien vegetation. Monitor erosion. Monitor leaking pipes. Re-vegetate the banks.

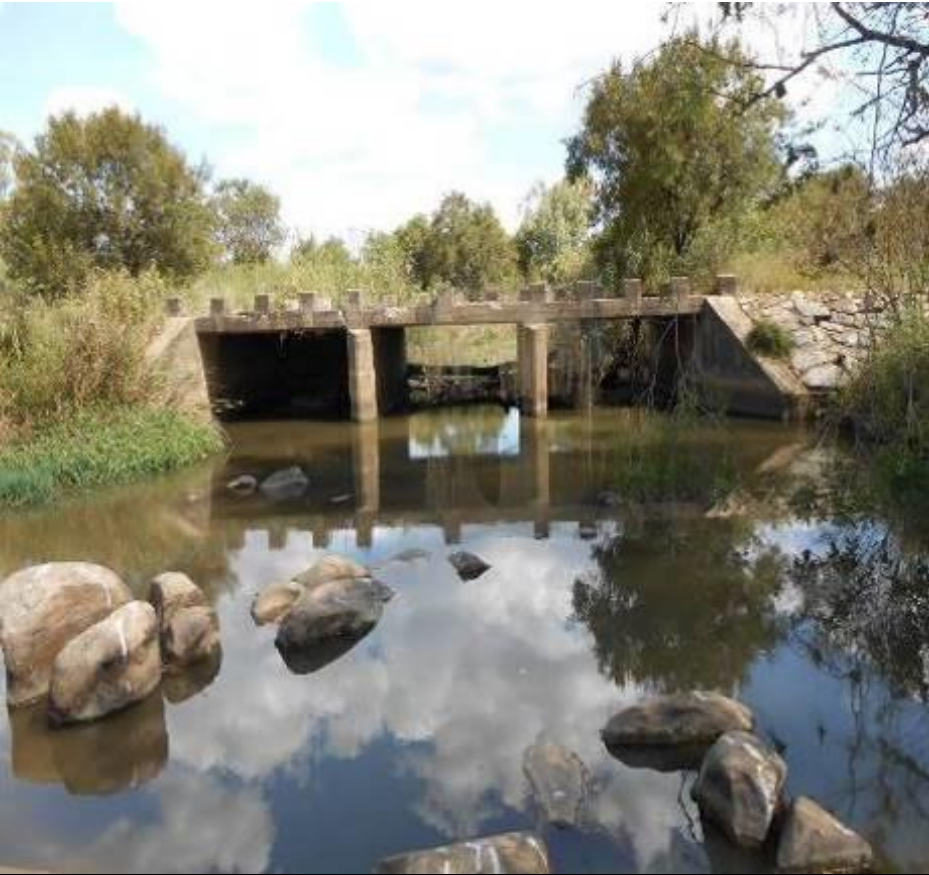
Site number: Site 24a/24b	Coordinates: 25°39'55.43"S 27°16'46.30"E
Crossing Type: Bridge/road crossing	
Site Photo:

Present Ecological State	D
Wetland type	River
Morphology	Wide, relatively shallow channel, mixture of alluvial sand and bedrock. Dry river bed.
Riparian and in Stream Habitat	<i>Dichrostachys</i> spp. dominated bushveld vegetation. Instream ecology: riverbed dry at the time of the study.
Vegetation	
System Modifiers	Weir. Debris within the stream. Cattle trampling and grazing. Water abstraction. Alien vegetation.
Potential impacts of water use on environment	The sewer line crossing will not significantly negatively impact on the receiving environment; provided it is adequately maintained.
Socio-economic impacts of water use	The sewer line crossing will not significantly negatively impact on any water users.
Socio-economic advantages of water use	The sewer line is necessary for the safe disposal of sewage.

Potential impacts of water use on water resource	The support structures within the channel will result in some alterations to streamflow patterns during flow periods; however these are not deemed to have a significant impact on downstream resources.
Summary of proposed impact on water use will have on other users	The sewer line crossing will not impact significantly on other water users.
Mitigation and Rehabilitation plan	Remove debris. Monitor erosion. Control alien vegetation.

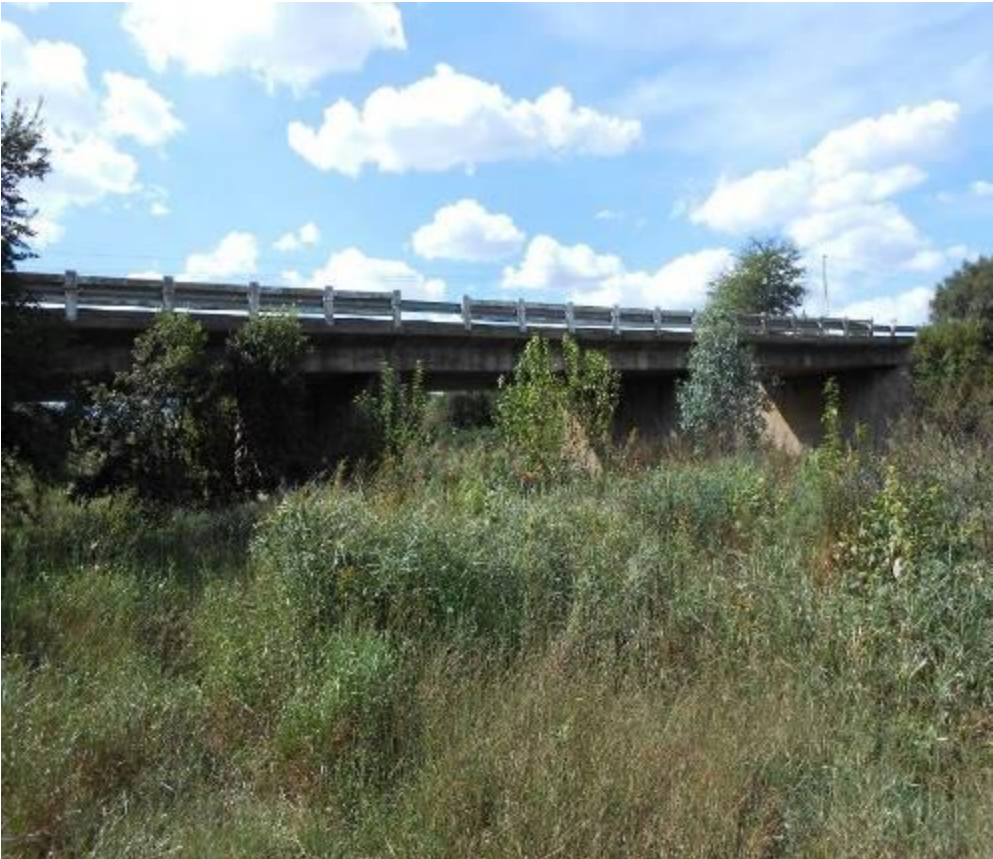
Site number: Site 25	Coordinates: 25°39'53.01"S 27°16'46.74"E
Crossing Type: Road crossing	
Site Photo:

Present Ecological State	C
Wetland type	River
Morphology	Wide, shallow channel.
Riparian and in Stream Habitat	<i>Dichrostachys</i> spp. dominated bushveld vegetation. Instream ecology: riverbed dry at the time of the study.
Vegetation	<i>Lantana camara</i> , <i>Cyperus sexangularis</i> , <i>Tagetes minuta</i>
System Modifiers	Encroachment.
Potential impacts of water use on environment	The road crossing will not significantly negatively impact on the environment.
Socio-economic impacts of water use	The road crossing will not significantly negatively impact on the on any water users.
Socio-economic advantages of water use	The road crossing plays an important role in providing connectivity in the area, particularly to the local community, thereby allowing economic activity in the area.
Potential impacts of water use on water resource	The support structures within the channel will result in some alterations to streamflow patterns during flow periods; however these are not deemed to have a significant impact on downstream resources.

Summary of proposed impact on water use will have on other users	The road crossing will not impact significantly on other water users.
Mitigation and Rehabilitation plan	Control alien vegetation.

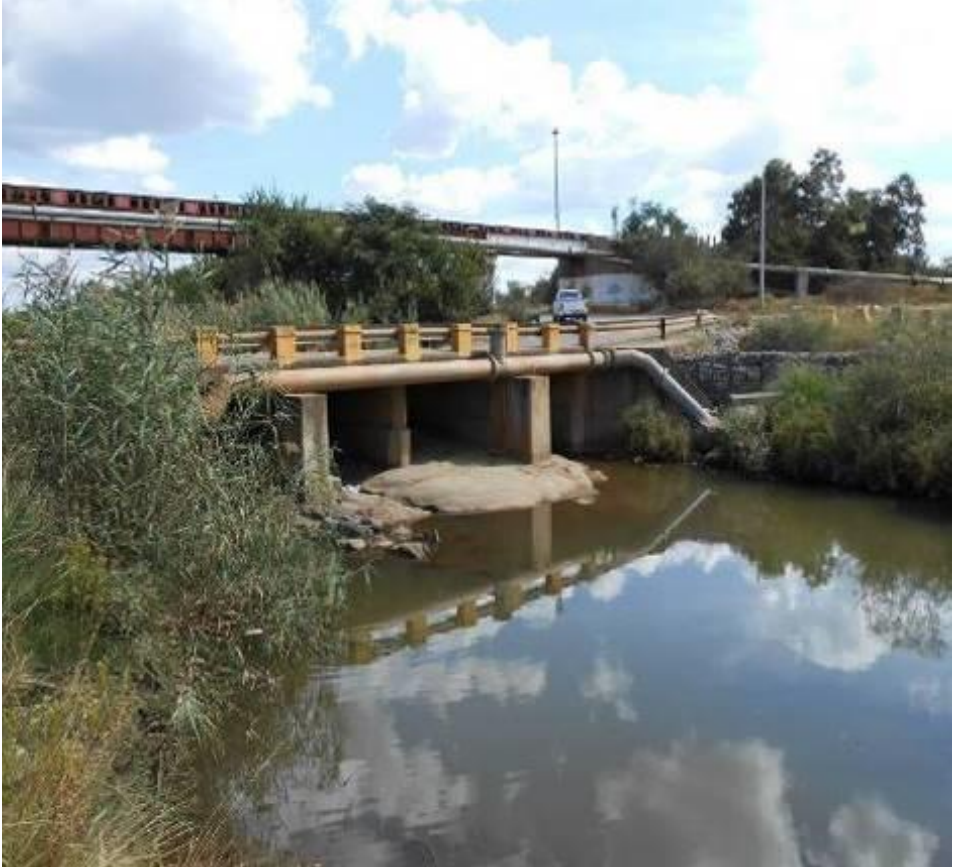
Site number: Site 26/26weir	Coordinates: 25°39'24.47"S 27°17'14.53"E
Crossing Type: Road crossing + weir	
Site Photo:

Present Ecological State	C
Wetland type	River
Morphology	Wide, relatively shallow channel, mixture of alluvial sand and bedrock. Dry river bed.
Riparian and in Stream Habitat	<i>Acacia</i> spp. dominated bushveld vegetation. Instream ecology: inundation underneath the bridge.
Vegetation	<i>Tagetes minuta</i> , <i>Cyperus sexangularis</i> , <i>Phragmites australis</i> , <i>Flaveria bidentis</i>
System Modifiers	Rock dumping. Leaking pipes. Alien vegetation.
Potential impacts of water use on environment	The road crossing will not significantly negatively impact on the environment.
Socio-economic impacts of water use	The road crossing will not significantly negatively impact on any water users.
Socio-economic advantages of water use	The road crossing plays an important role in providing connectivity in the area, particularly to the local community, thereby allowing economic activity in the area.

Potential impacts of water use on water resource	The weir and support structures within the channel will result in some alterations to streamflow patterns during flow periods; however these are not deemed to have a significant impact on downstream resources.
Summary of proposed impact on water use will have on other users	The road crossing will not impact significantly on other water users.
Mitigation and Rehabilitation plan	Control alien vegetation. Monitor pipes for leakages.

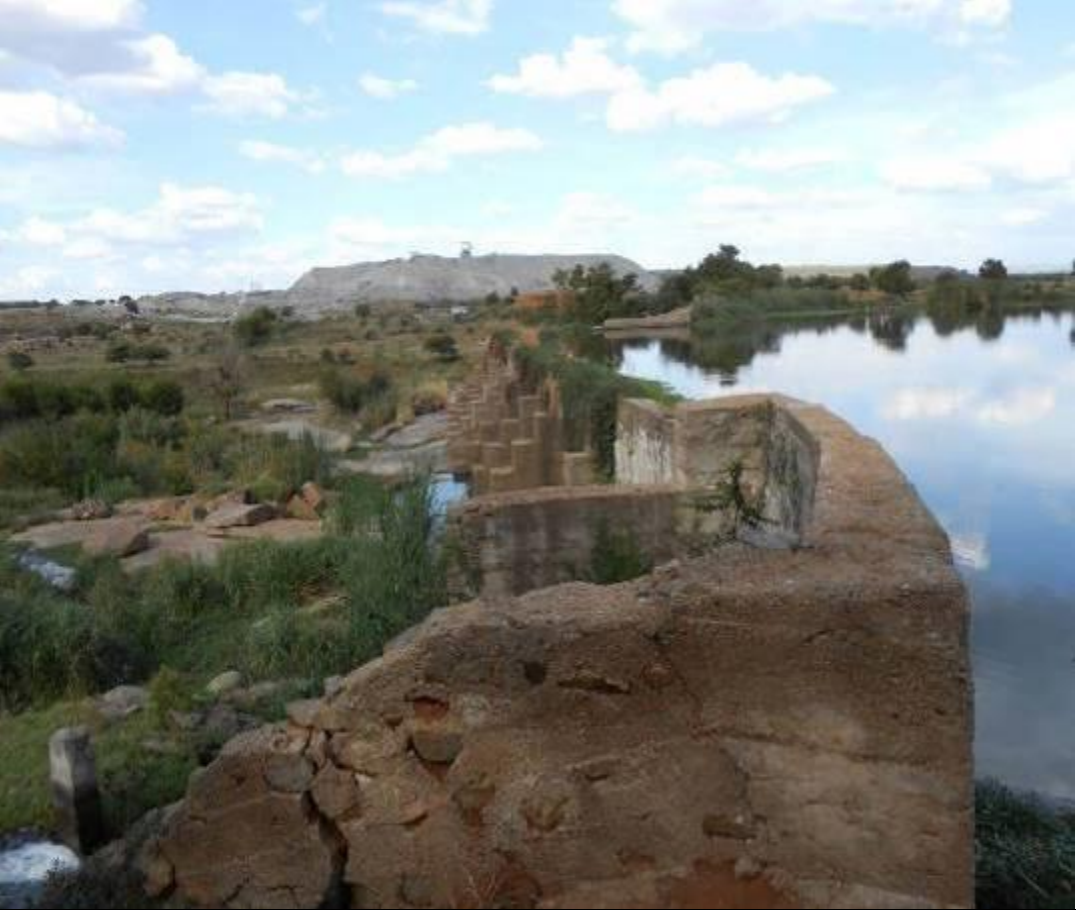
Site number: Site 26a	Coordinates: 25°38'57.41"S 27°17'22.82"E
Crossing Type: Dam crossing	
Site Photo:

Present Ecological State	C
Wetland type	River
Morphology	Wide, relatively shallow channel, inundation behind the dam wall. Flowing water. Exposed bed rock within the stream channel.
Riparian and in Stream Habitat	Exposed bedrock within the stream channel
Vegetation	<i>Typha capensis</i> , <i>Rhus lancea</i> , <i>Cyperus sexangularis</i>
System Modifiers	Weir. Waste dumping. Alien vegetation.
Potential impacts of water use on environment	The dam will not significantly negatively impact on the r environment.
Socio-economic impacts of water use	The dam will capture flow during low flow periods, leading to less water flowing to downstream areas.
Socio-economic advantages of water use	N/A.
Potential impacts of water use on water resource	The support structures within the channel will result in some alterations to streamflow patterns during flow periods.

Summary of proposed impact on water use will have on other users	The dam will capture flow during low flow periods, resulting in less water flowing to downstream areas.
Mitigation and Rehabilitation plan	Clean up litter. Control alien vegetation.

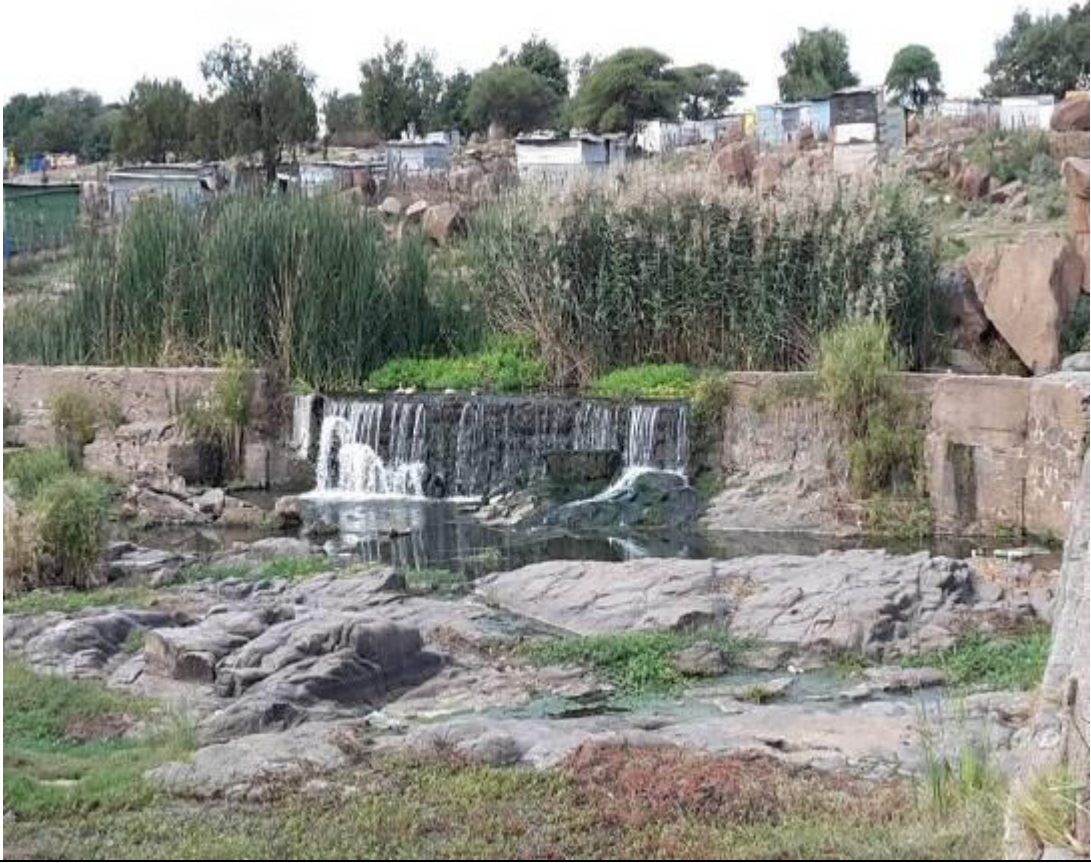
Site number: Site 26b	Coordinates: 25°38'52.20"S 27°17'29.00"E
Crossing Type: Weir	
Site Photo:

Present Ecological State	D
Wetland type	River
Morphology	Wide, relatively shallow channel, mixture of alluvial sand and bedrock. Dry river bed.
Riparian and in Stream Habitat	Exposed bedrock within the stream channel
Vegetation	<i>Persicaria lapathifolia</i> , <i>Cyperus sexangularis</i> , <i>Phragmites australis</i> , <i>Melinis repens</i>
System Modifiers	Weir. Change in water quality due to use for laundry purposes. Alien vegetation.
Potential impacts of water use on environment	The weir will not significantly negatively impact on the environment.
Socio-economic impacts of water use	The weir will not significantly negatively impact on any water users.
Socio-economic advantages of water use	N/A.
Potential impacts of water use on water resource	The weir result in some alterations to streamflow patterns during flow periods; however these are not deemed to have a significant impact on downstream resources.

Summary of proposed impact on water use will have on other users	The weir will not impact significantly on other water users.
Mitigation and Rehabilitation plan	Monitor water quality. Control alien vegetation.

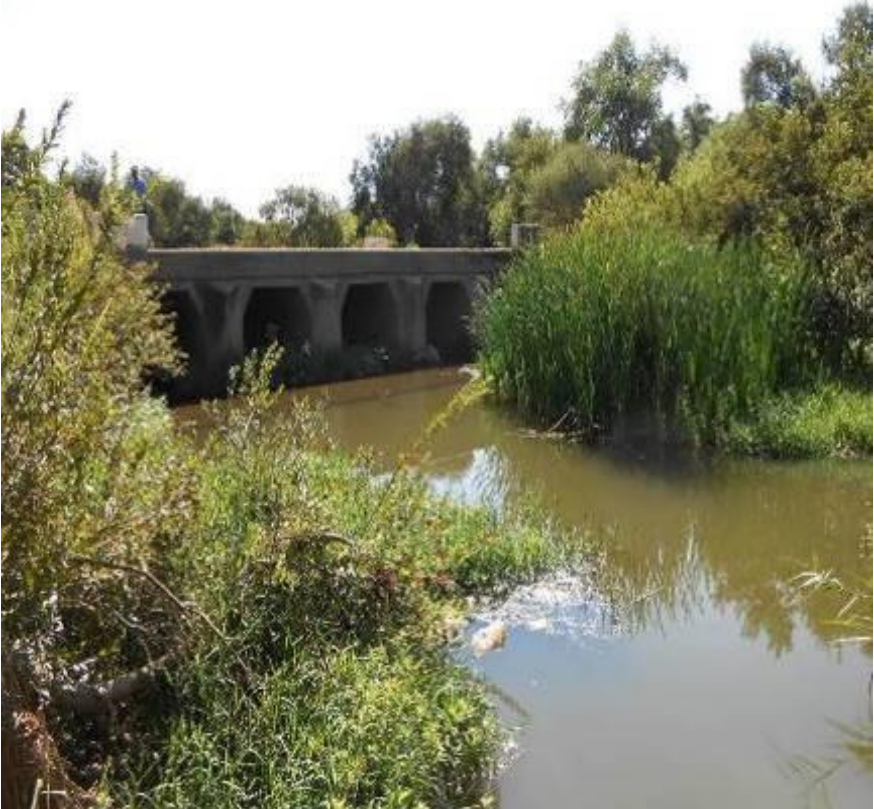
Site number: Site 27a	Coordinates: 25°37'59.54"S 27°17'24.99"E
Crossing Type: Culvert road crossing	
Site Photo:

Present Ecological State	E
Wetland type	River
Morphology	Wide, relatively shallow channel, mixture of alluvial sand and bedrock. Dry river bed.
Riparian and in Stream Habitat	<i>Acacia</i> spp. And asparagus laricinus dominated bushveld vegetation. Inundation below bridge.
Vegetation	<i>Phragmites australis</i> , <i>Typha capensis</i> , <i>Flaveria bidentis</i> , <i>Morus alba</i> , <i>Sesbania sesban</i> , <i>Eucalyptus</i> spp.
System Modifiers	Erosion. Altered water quality due to usage for laundry washing purposes.
Potential impacts of water use on environment	The road crossing will not significantly negatively impact on the environment.
Socio-economic impacts of water use	The road crossing will not significantly negatively impact on any water users.
Socio-economic advantages of water use	The road crossing plays an important role in providing connectivity in the area, particularly to the local community, thereby allowing economic activity in the area.

Potential impacts of water use on water resource	The culvert within the channel will result in some alterations to streamflow patterns during flow periods; however these are not deemed to have a significant impact on downstream resources.
Summary of proposed impact on water use will have on other users	The road crossing will not impact significantly on other water users.
Mitigation and Rehabilitation plan	Control alien vegetation. Monitor erosion.

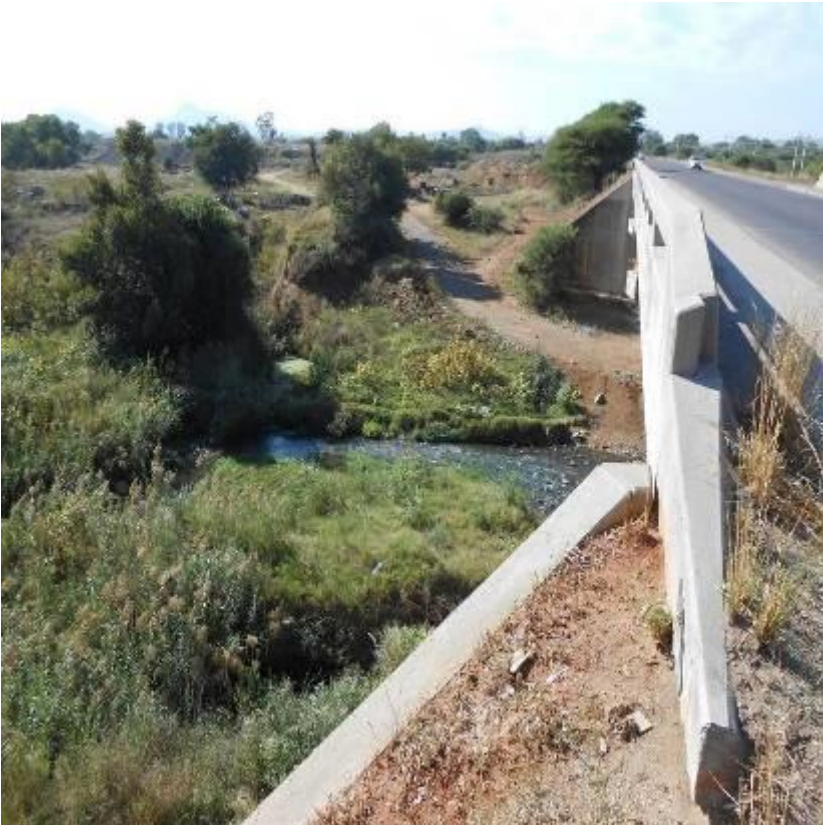
Site number: Site 28	Coordinates: 25°36'29.48"S 27°17'18.84"E
Crossing Type: Road crossing	
Site Photo:

Present Ecological State	C
Wetland type	River
Morphology	Wide, relatively shallow channel flowing water within the channel
Riparian and in Stream Habitat	<i>Acacia</i> spp. dominated bushveld vegetation. Instream ecology: <i>Phragmites australis</i> dominating instream habitat
Vegetation	<i>Phragmites australis</i> , <i>Cynodon dactylon</i> , <i>Cyperus sexangularis</i> , <i>Asclepius fruticosa</i>
System Modifiers	Soil dumping adjacent to feature. Erosion below bridge. Waste dumping. Leaking drain next to the river. Grazing.
Potential impacts of water use on environment	The road crossing will not significantly negatively impact on the environment
Socio-economic impacts of water use	The road crossing will not significantly negatively impact on any water users.
Socio-economic advantages of water use	The road crossing plays an important role in providing connectivity in the area, particularly to the local community, thereby allowing economic activity in the area.

Potential impacts of water use on water resource	The culverts within the channel will result in some alterations to streamflow patterns during flow periods; however these are not deemed to have a significant impact on downstream resources.
Summary of proposed impact on water use will have on other users	The road crossing will not impact significantly on other water users.
Mitigation and Rehabilitation plan	Monitor erosion below the bridge. Clean up litter. Remove soil piles to prevent sedimentation. Monitor drain leakage to prevent contamination of water.

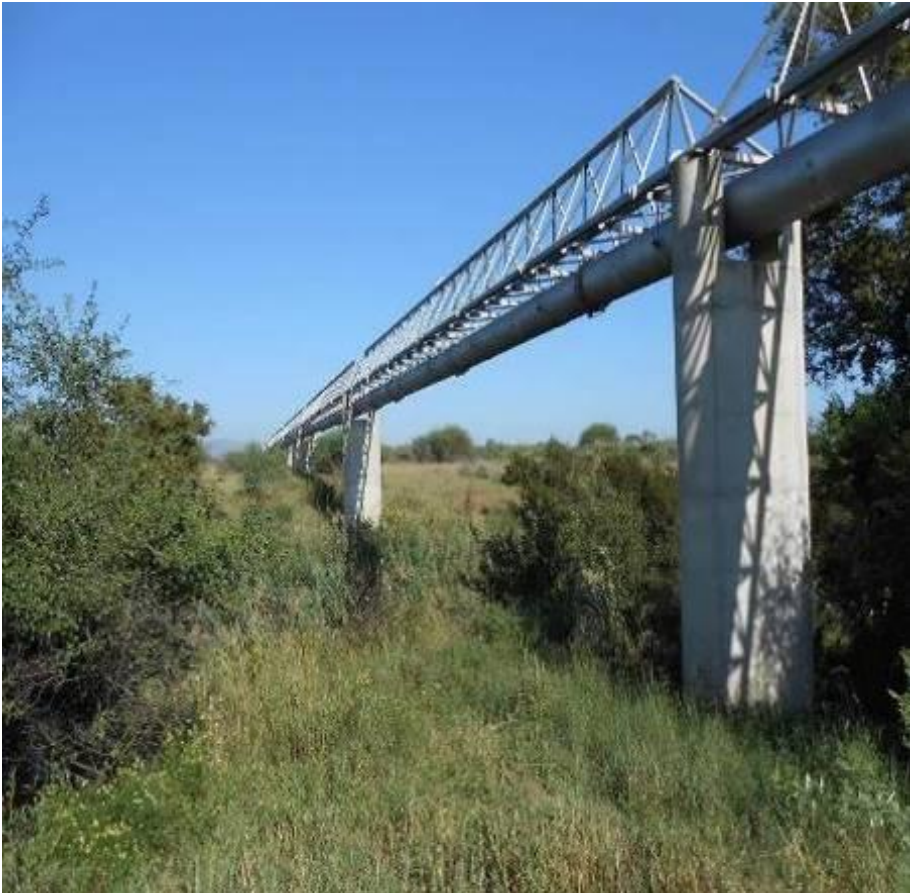
Site number: Site 28a	Coordinates: 25°36'01.36"S 27°17'37.67"E
Crossing Type: Pipeline crossing	
Site Photo:

Present Ecological State	C
Wetland type	River
Morphology	Wide, relatively deep channel.
Riparian and in Stream Habitat	<i>Rhus lancea</i> and <i>Acacia</i> spp. dominated bushveld vegetation. Instream ecology: Water within the channel
Vegetation	<i>Flaveria bidentis</i> , <i>Cyperus sexangularis</i> , <i>Cynodon dactylon</i>
System Modifiers	Water contamination. Algae proliferation.
Potential impacts of water use on environment	The pipeline crossing will not significantly negatively impact on the receiving environment; provided it is adequately maintained.
Socio-economic impacts of water use	The pipeline crossing will not significantly negatively impact on any water users.
Socio-economic advantages of water use	The pipeline is necessary for the safe disposal of sewage.
Potential impacts of water use on water resource	The support structures within the channel will result in some alterations to streamflow patterns during flow periods; however these are not deemed to have a significant impact on downstream resources.

Summary of proposed impact on water use will have on other users	The pipeline crossing will not impact significantly on other water users.
Mitigation and Rehabilitation plan	Monitor water quality

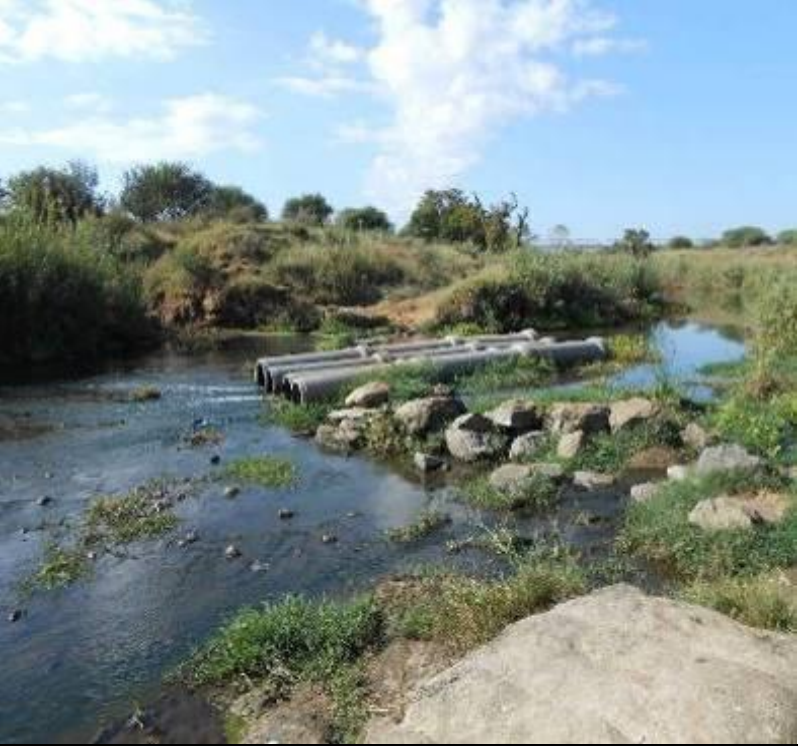
Site number: Site 28b	Coordinates: 25°35'55.85"S 27°17'33.01"E
Crossing Type: Battery of pipes which possibly formed part of a historical road crossing	
Site Photo:

Present Ecological State	C
Wetland type	River
Morphology	Wide, relatively shallow channel, mixture of alluvial sand and bedrock. Flowing water
Riparian and in Stream Habitat	<i>Acacia</i> spp dominated bushveld vegetation.
Vegetation	<i>Conyza bonariensis</i> , <i>Cyperus sexangularis</i> , <i>Phragmites australis</i>
System Modifiers	Erosion. Algae proliferation. Exposed pipes.
Potential impacts of water use on environment	The pipeline crossing will not significantly negatively impact on the environment.
Socio-economic impacts of water use	The pipeline crossing will not significantly negatively impact on any water users.
Socio-economic advantages of water use	N/A
Potential impacts of water use on water resource	The pipes within the channel will result in some alterations to streamflow patterns during flow periods; however these are not deemed to have a significant impact on downstream resources.

Summary of proposed impact on water use will have on other users	The pipeline crossing will not impact significantly on other water users.
Mitigation and Rehabilitation plan	Monitor erosion. Construct a proper crossing and/or make sure the pipes are underground to allow proper flow of water. If crossing is no longer required remove pipes from the watercourse. If crossing is required, construct a proper crossing to enable proper flow of water and movement of biota.

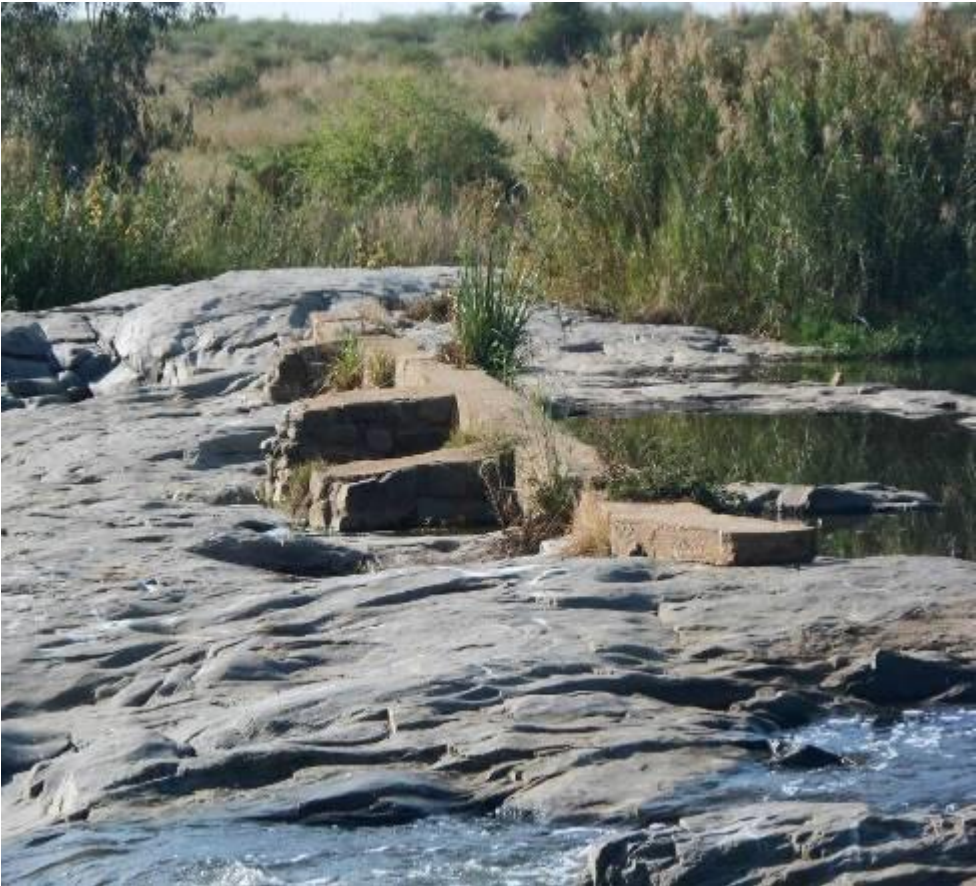
Site number: Site 28c	Coordinates: 25°35'31.42"S 27°17'55.09"E
Crossing Type: Weir crossing	
Site Photo:

Present Ecological State	C
Wetland type	River
Morphology	Wide, relatively shallow channel, exposed bedrock.
Riparian and in Stream Habitat	<i>Eucalyptus</i> spp. dominated bushveld vegetation. Instream ecology: Exposed bedrock.
Vegetation	<i>Phragmites australis</i> , <i>Cyperus sexangularis</i>
System Modifiers	Broken weir. Alien vegetation.
Potential impacts of water use on environment	The weir will not significantly negatively impact on the environment.
Socio-economic impacts of water use	The weir will not significantly negatively impact on any water users.
Socio-economic advantages of water use	The weir will not significantly negative impact on any water users
Potential impacts of water use on water resource	The weir will result in some alterations to streamflow patterns during flow periods; however these are not deemed to have a significant impact on downstream resources.

Summary of proposed impact on water use will have on other users	The weir will not impact significantly on other water users.
Mitigation and Rehabilitation plan	Control alien vegetation.

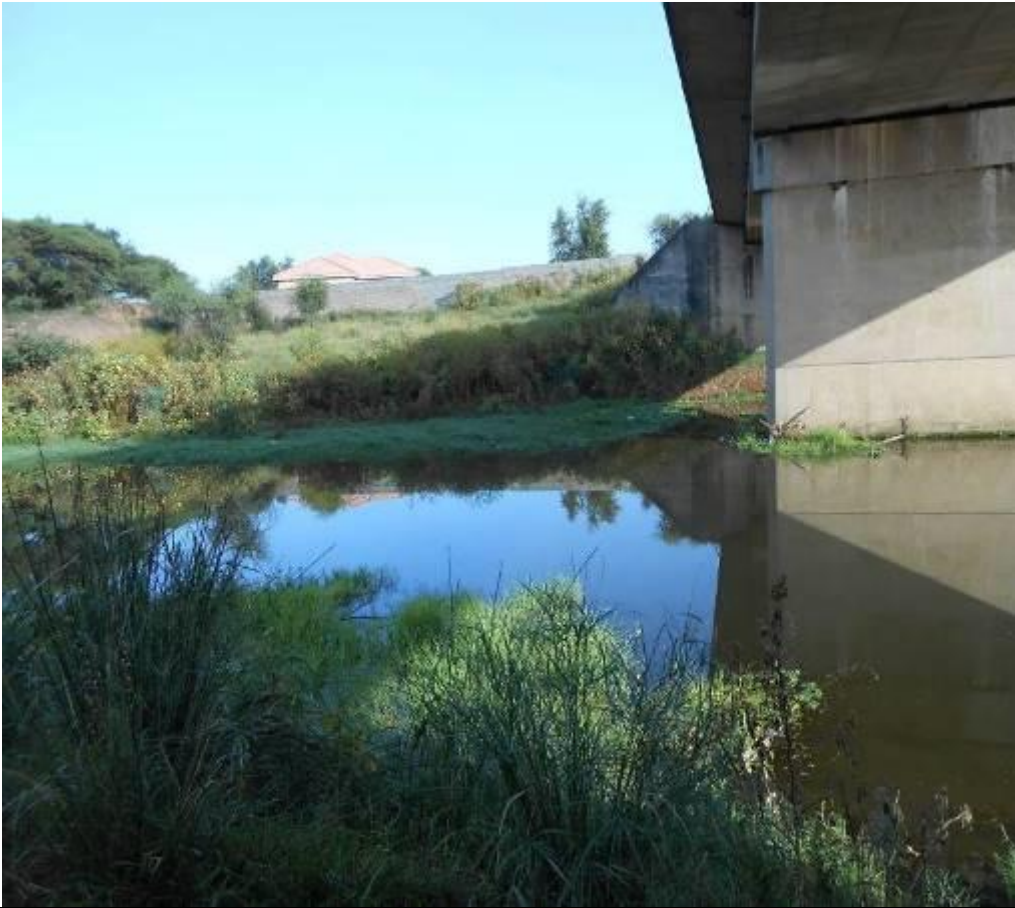
Site number: Site 29	Coordinates: 25°35'07.16"S 27°18'16.92"E
Crossing Type: Road crossing	
Site Photo:

Present Ecological State	C
Wetland type	River
Morphology	Wide, relatively shallow channel, inundation below bridge
Riparian and in Stream Habitat	<i>Acacia</i> spp. dominated bushveld vegetation. Instream ecology: Inundation below dam.
Vegetation	<i>Themeda triandra</i> , <i>Cyperus sexangularis</i> , <i>Phragmites australis</i> , <i>Typha capensis</i>
System Modifiers	Trampling. Erosion. Waste dumping.
Potential impacts of water use on environment	The road crossing will not significantly negatively impact on the environment.
Socio-economic impacts of water use	The road crossing will not significantly negatively impact on any water users.
Socio-economic advantages of water use	The road crossing plays an important role in providing connectivity in the area, particularly to the local community, thereby allowing economic activity in the area.

Potential impacts of water use on water resource	The support structures within the channel will result in some alterations to streamflow patterns during flow periods; however these are not deemed to have a significant impact on downstream resources.
Summary of proposed impact on water use will have on other users	The road crossing will not impact significantly on other water users.
Mitigation and Rehabilitation plan	Control alien vegetation along river banks. Re-vegetate eroded banks.

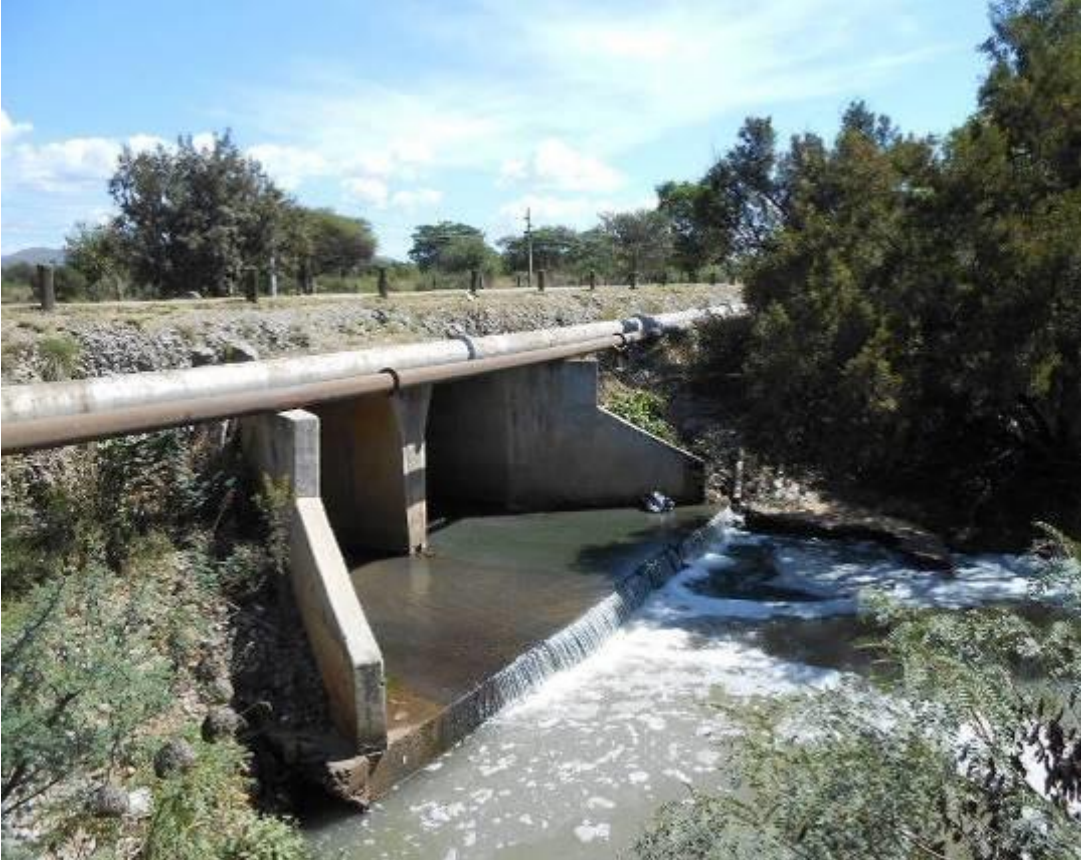
Site number: Site 30	Coordinates: 25°38'50.46"S 27°15'12.10"E
Crossing Type: Road/weir crossing	
Site Photo:

Present Ecological State	C
Wetland type	River
Morphology	Wide, relatively shallow channel.
Riparian and in Stream Habitat	<i>Rhus lancea</i> dominated bushveld vegetation. Instream ecology: flowing water
Vegetation	<i>Tagetes minuta</i> , <i>Datura stramonium</i> , <i>Cynodon dactylon</i> , <i>Coenyzia bonariensis</i>
System Modifiers	Erosion. Waste dumping. Sewage effluent. Road construction.
Potential impacts of water use on environment	The road/weir crossing will not significantly negatively impact on the environment.
Socio-economic impacts of water use	The road/weir crossing will not significantly negatively impact on any water users.
Socio-economic advantages of water use	The road crossing plays an important role in providing connectivity in the area, particularly to the local community, thereby allowing economic activity in the area.

Potential impacts of water use on water resource	The weir will result in some alterations to streamflow patterns during flow periods; however these are not deemed to have a significant impact on downstream resources.
Summary of proposed impact on water use will have on other users	The road crossing will not impact significantly on other water users.
Mitigation and Rehabilitation plan	Monitor erosion. Monitor water quality.

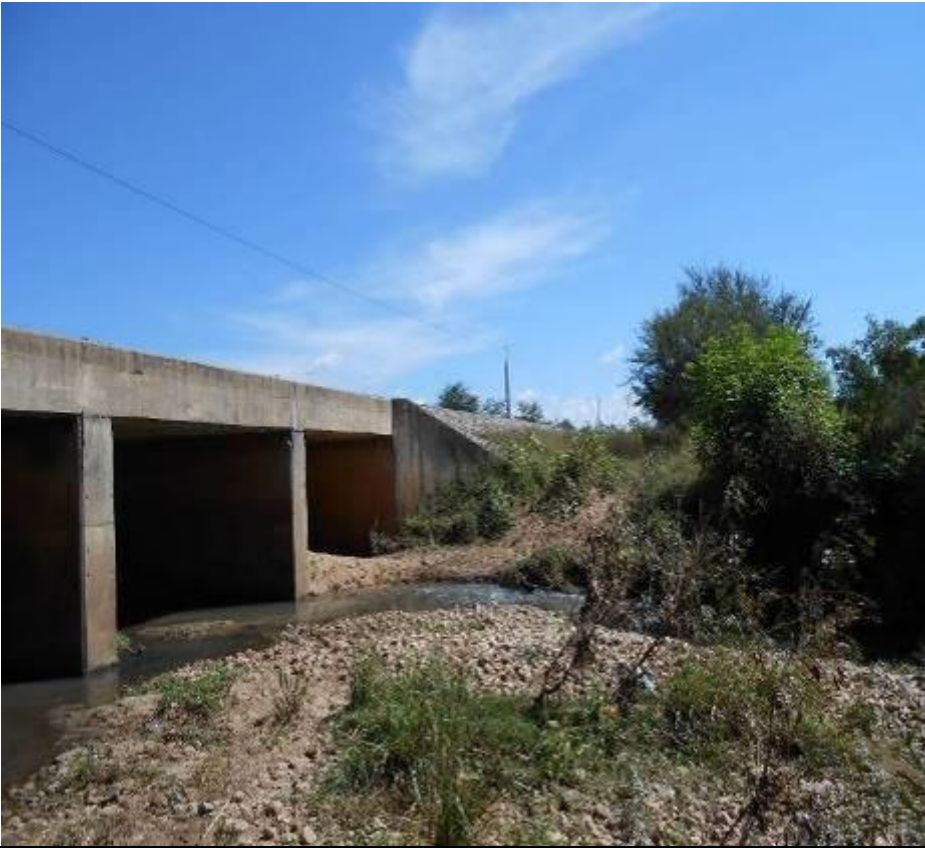
Site number: 31	Coordinates: 25°38'41.89S 27°15'17.04"E
Crossing Type: Railway crossing	
Site Photo:

Present Ecological State	D
Wetland type	River
Morphology	Wide, relatively shallow channel, high sediment load along the culvert
Riparian and in Stream Habitat	<i>Acacia karroo</i> dominate the bushveld vegetation.
Vegetation	<i>Morus alba</i> , <i>Melia azedarach</i> , <i>Tagetes minuta</i> , <i>Rhus lancea</i>
System Modifiers	Sediment and debris deposition causing streamflow diversion and aquatic migratory barrier. Erosion below the bridge and banks. Algae proliferation.
Potential impacts of water use on environment	The road crossing will not significantly negatively impact on the environment.
Socio-economic impacts of water use	The road crossing will not significantly negatively impact on any water users.
Socio-economic advantages of water use	The road crossing plays an important role in providing connectivity in the area, particularly to the local community, thereby allowing economic activity in the area.

Potential impacts of water use on water resource	The support structures within the channel will result in some alterations to streamflow patterns during flow periods; however these are not deemed to have a significant impact on downstream resources.
Summary of proposed impact on water use will have on other users	The road crossing will not impact significantly on other water users.
Mitigation and Rehabilitation plan	Remove debris within the stream. Control erosion by putting berms on the banks below bridge. Desilt the feature.

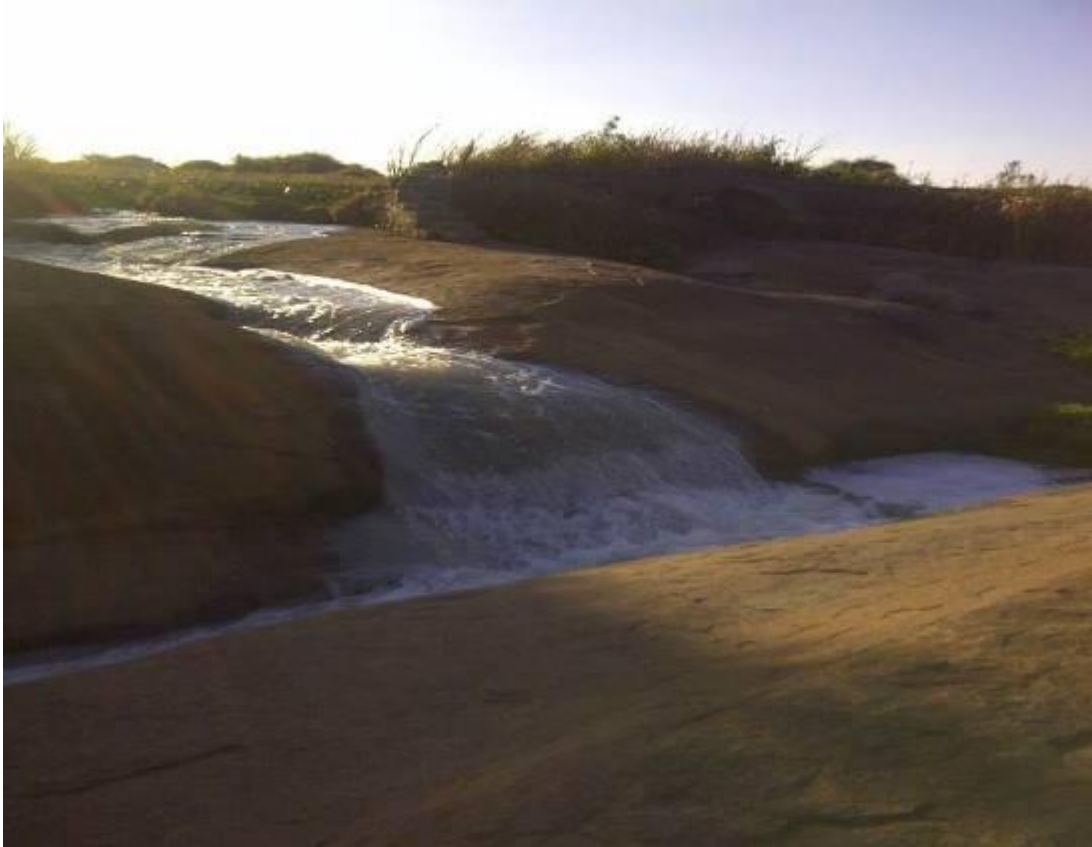
Site number: 31a	Coordinates: 25°37'55.64S 27°15'39.41"E
Crossing Type: Weir	
Site Photo:

Present Ecological State	C
Wetland type	River
Morphology	Exposed bedrock
Riparian and in Stream Habitat	Exposed bedrock
Vegetation	<i>Eichhornia crassipes</i> , <i>Typha capensis</i> , <i>Tagetes minuta</i>
System Modifiers	Sewage effluent.
Potential impacts of water use on environment	The weir crossing will not significantly negatively impact on the environment.
Socio-economic impacts of water use	The weir will not significantly negatively impact on any water users.
Socio-economic advantages of water use	N/A
Potential impacts of water use on water resource	The weir will result in some alterations to streamflow patterns during flow periods; however these are not deemed to have a significant impact on downstream resources.
Summary of proposed impact on water use will have on other users	The weir crossing will not impact significantly on other water users.

Mitigation and Rehabilitation plan	Monitor water quality and implement measures to prevent sewage effluent from entering the system.

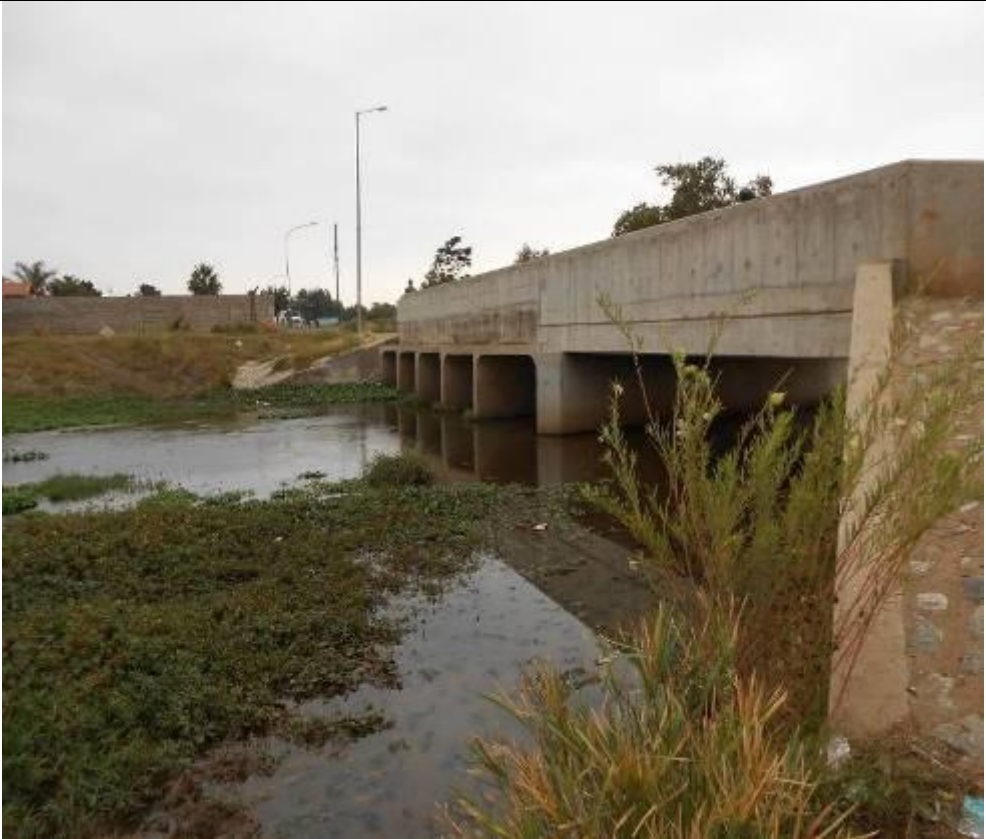
Site number: 32c	Coordinates: 25°37'39.14"S 27°16'24.15"E
Crossing Type: Road crossing

Present Ecological State	C
Wetland type	River
Morphology	Wide, very shallow channel
Riparian and in Stream Habitat	<i>Acacia</i> spp. dominated bushveld vegetation. Instream ecology: <i>Echhornia crassipes</i>
Vegetation	<i>Tagetes minuta</i> , <i>Asclepias fruiticosa</i> , <i>Typha capensis</i> , <i>Conyza bonariensis</i> , <i>Cyperus sexangularis</i> , <i>Persicaria lapathifolia</i> , <i>Datura stramonium</i> , <i>Asclepias fruiticosa</i> , <i>Sesbania sesban</i> , <i>Sporobolus pyramidalis</i> , <i>Verbena bonariensis</i> , <i>Bidens pilosa</i>
System Modifiers	Waste dumping. Increased water input from the road. Livestock grazing.
Potential impacts of water use on environment	The road crossing will not significantly negatively impact on the environment.
Socio-economic impacts of water use	The road crossing will not significantly negatively impact on any water users.

Socio-economic advantages of water use	The road crossing plays an important role in providing connectivity in the area, particularly to the local community, thereby allowing economic activity in the area.
Potential impacts of water use on water resource	The support structures within the channel will result in some alterations to streamflow patterns during flow periods; however these are not deemed to have a significant impact on downstream resources.
Summary of proposed impact on water use will have on other users	The road crossing will not impact significantly on other water users.
Mitigation and Rehabilitation plan	Monitor water quality. Control alien vegetation. Clean up litter
