**WETLAND DELINEATION IN THE RUSTENBURG
PLATINUM MINE PROJECT AREA AND A HIGH
LEVEL ASSESSMENT OF SELECTED RIVER
CROSSINGS, NORTH-WEST PROVINCE**

Prepared for

SRK Consulting (Pty) Ltd

May 2015

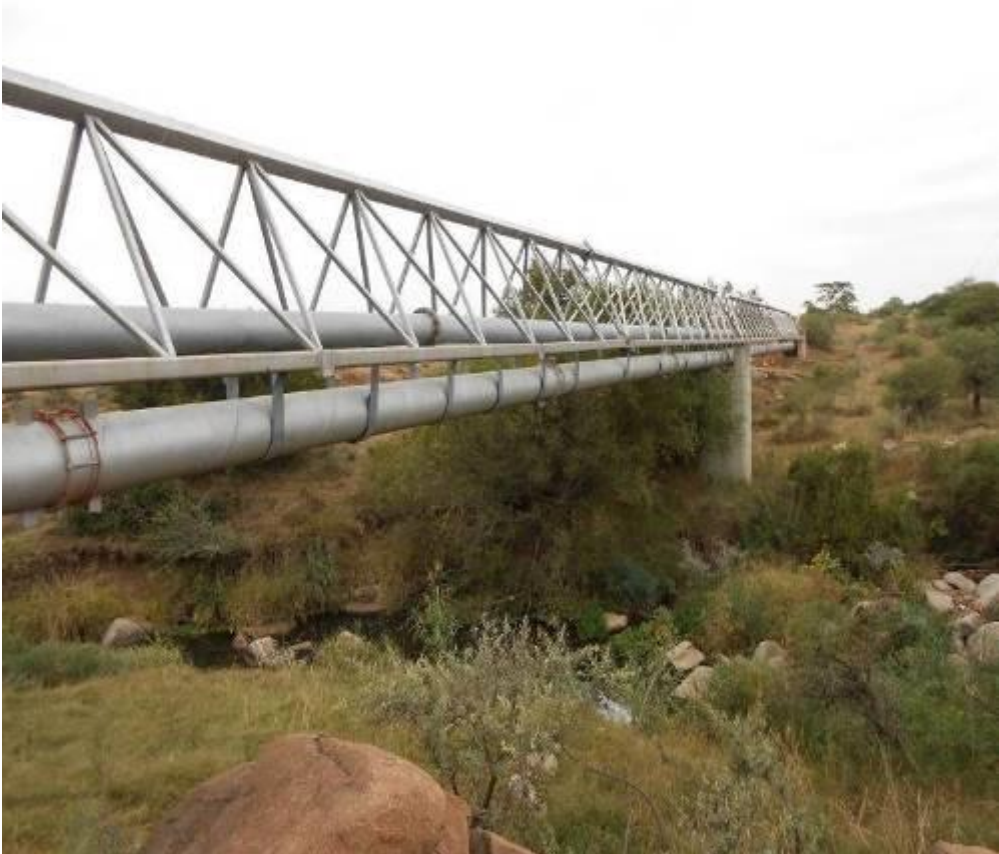
Site number: 32d	Coordinates: 25°36'28.67"S 27°13'12.66"E
Crossing Type: Pipeline	
Site Photo:

Present Ecological State	C
Wetland type	River
Morphology	Wide, relatively shallow, incised channel.
Riparian and in Stream Habitat	<i>Acacia karroo</i> . Dominated bushveld vegetation. Instream ecology: flowing water.
Vegetation	<i>Cynodon dactylon</i> , <i>Lantana camara</i> , <i>Asclepias fruticosa</i> , <i>Phragmites australis</i> , <i>Senecio cinerascens</i>
System Modifiers	Sedimentation. Erosion. Encroachment
Potential impacts of water use on environment	The pipeline crossing will not significantly negatively impact on the receiving environment; provided it is adequately maintained.
Socio-economic impacts of water use	The pipeline crossing will not significantly negatively impact on any water users.
Socio-economic advantages of water use	N/A
Potential impacts of water use on water resource	The support structures within the channel will result in some alterations to streamflow patterns during flow periods; however these are not deemed to have a significant impact on downstream resources.

Summary of proposed impact on water use will have on other users	The pipeline crossing will not impact significantly on other water users.
Mitigation and Rehabilitation plan	Monitor erosion. Control alien vegetation.

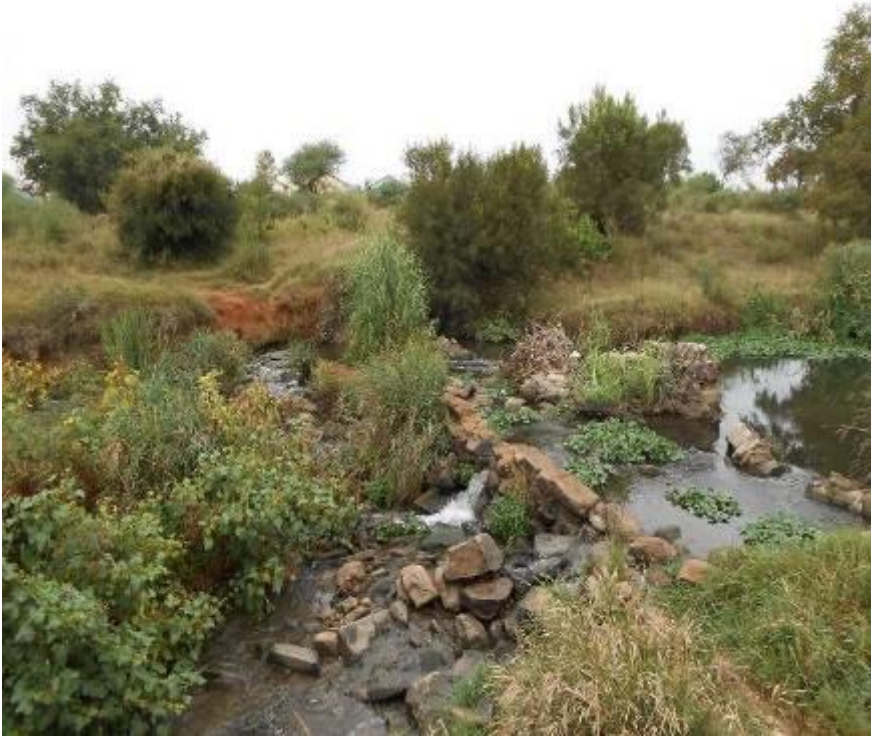
Site number: 32e	Coordinates: 25°37'31.96"S 27°17'02.40"E
Crossing Type: Road crossing	
Site Photo:

Present Ecological State	C
Wetland type	River
Morphology	Wide, relatively shallow incised channel.
Riparian and in Stream Habitat	<i>Rhus lancea</i> dominated bushveld vegetation. Instream ecology: Flowing water with vegetation such as <i>Cyperus sexangularis</i> in stream
Vegetation	<i>Asclepias fruiticosa</i> , <i>Typha capensis</i> , <i>Conyza bonariensis</i> , <i>Cyperus sexangularis</i> , <i>Persicaria lapathifolia</i> , <i>Asclepias fruiticosa</i> , <i>Sporobolus pyramidalis</i> , <i>Eichhornia crassipes</i> , <i>Xanthium strumarium</i> , <i>Phragmites australis</i> , <i>Asparagus laricinus</i> , <i>Conyza bonariensis</i> , <i>Cynodon dactylon</i> , <i>Parthenium hysterophorus</i>
System Modifiers	Erosion. Broken informal small weir.
Potential impacts of water use on environment	The road crossing will not significantly will further increase erosion along the banks.

Socio-economic impacts of water use	The road crossing will not significantly negatively impact on any water users.
Socio-economic advantages of water use	The road no longer serves its purpose of connectivity within the area.
Potential impacts of water use on water resource	The collapsed road will result in some alterations to streamflow patterns during flow periods; however these are not deemed to have a significant impact on downstream resources.
Summary of proposed impact on water use will have on other users	The road crossing will not impact significantly on other water users.
Mitigation and Rehabilitation plan	If the road is no longer required, remove collapsed structure. Insert berms to control erosion.

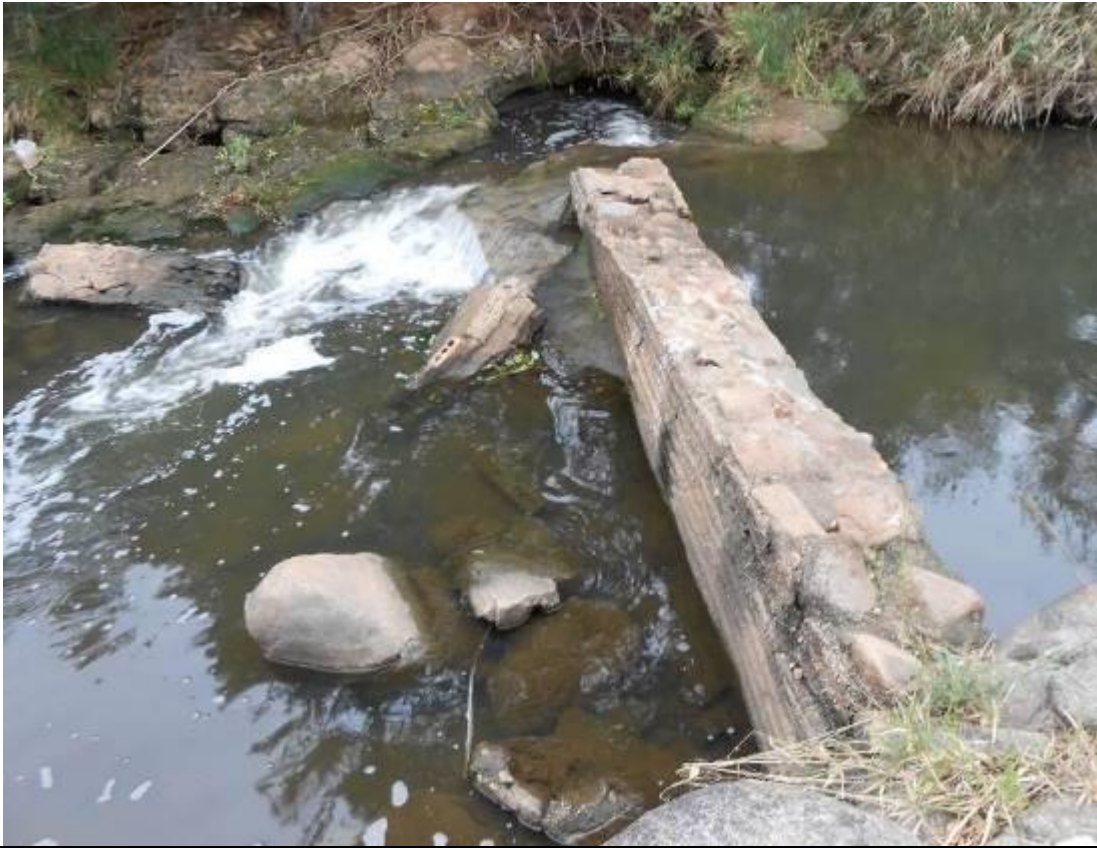
Site number: 32f	Coordinates: 25°37'31.44"S 27°17'07.71"E
Crossing Type: Road crossing	
Site Photo:

Present Ecological State	C
Wetland type	River
Morphology	Wide, relatively shallow channel, exposed rocks along the banks due to erosion.
Riparian and in Stream Habitat	Instream ecology: flowing water
Vegetation	<i>Cyperus sexangularis</i> , <i>Sporobolus pyramidalis</i> , <i>Xanthium strumarium</i> , <i>Phragmites australis</i> , <i>Asparagus larycinus</i> , <i>Conyza bonariensis</i> , <i>Panicum ecklonii</i> , <i>Rhus lancea</i> , <i>Tagetes minuta</i> , <i>Hyparrhenia hirta</i> .
System Modifiers	Weir altering water flow. Erosion
Potential impacts of water use on environment	The road crossing will not significantly negatively impact on the environment.
Socio-economic impacts of water use	The road crossing will not significantly negatively impact on any water users.
Socio-economic advantages of water use	The road is not efficiently providing connectivity due to the fact that it is very narrow and not well constructed.

Potential impacts of water use on water resource	The road will result in some alterations to streamflow patterns during flow periods; however these are not deemed to have a significant impact on downstream resources.
Summary of proposed impact on water use will have on other users	The road crossing will not impact significantly on other water users.
Mitigation and Rehabilitation plan	Control erosion. Construct a proper bridge crossing or remove the collapsed structure if crossing is no longer needed.

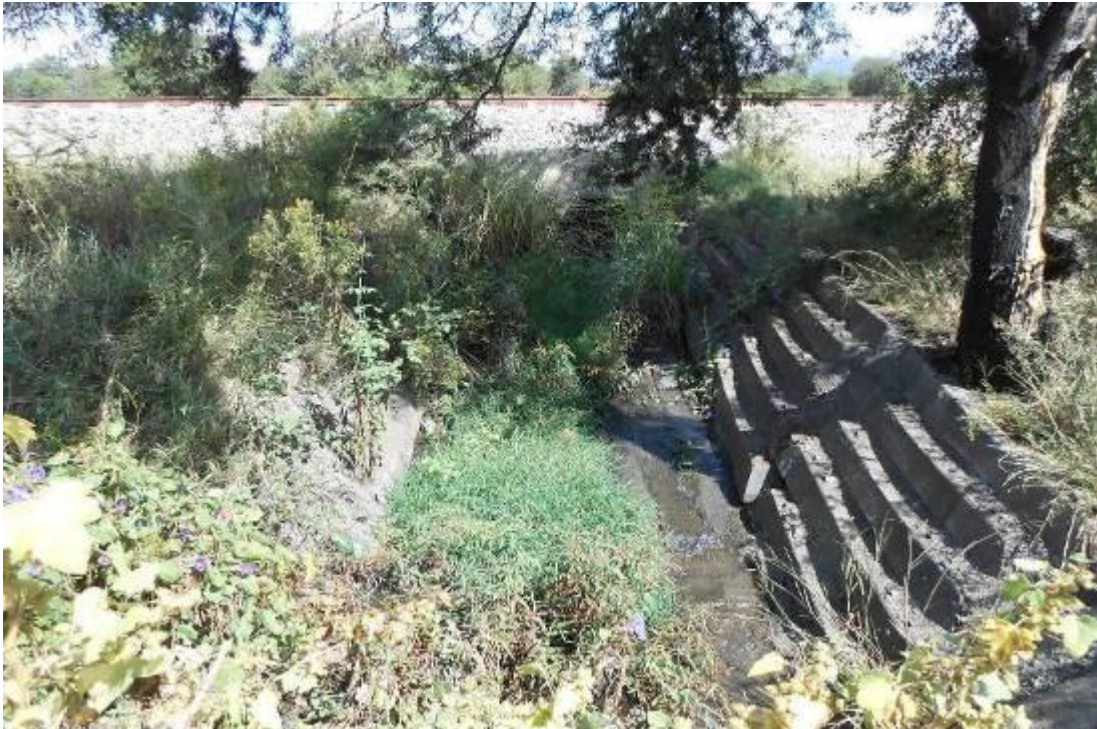
Site number: 34	Coordinates: 24°37'04.04"S 27°13'40.26"E
Crossing Type: Railway line/bridge crossing	
Site Photo:

Present Ecological State	D
Wetland type	Artificial channel
Morphology	Relatively narrow artificial channel. Some water present during the study, unlikely to support any aquatic macro-invertebrates. Overgrown instream vegetation.
Riparian and in Stream Habitat	Dominated by bushveld grasses. Instream ecology: limited flow present at the time of the assessment. Overgrown instream vegetation.
Vegetation	<i>Xanthium strumarium</i> , <i>Acacia karroo</i> , <i>Datura stramonium</i> , <i>Asclepias fruiticosa</i> , <i>Themeda triandra</i> , <i>Persicaria lapathifolia</i> , <i>Ipomoea purpurea</i> , <i>Tagetes minuta</i> , <i>Rhus lancea</i> , <i>Tithonia rotundifolia</i>
System Modifiers	Sedimentation. Erosion. Encroachment.
Potential impacts of water use on environment	Loss of natural instream habitat.

Socio-economic impacts of water use	The railway crossing will not significantly negatively impact on any water users.
Socio-economic advantages of water use	The railway crossing plays an important role in providing connectivity in the area, particularly in the industrial sector, thereby allowing economic activity in the area.
Potential impacts of water use on water resource	The railway crossing has been well-constructed with little to no incision evident. Moderate alteration to streamflow is anticipated as a result of the artificial nature of the channel, however since the system is ephemeral, no significant impact on downstream resources is anticipated as a result of this.
Summary of proposed impact on water use will have on other users	The railway crossing will not impact significantly on other water users.
Mitigation and Rehabilitation plan	Monitoring of erosion. Alien vegetation removal and monitoring within the channel.

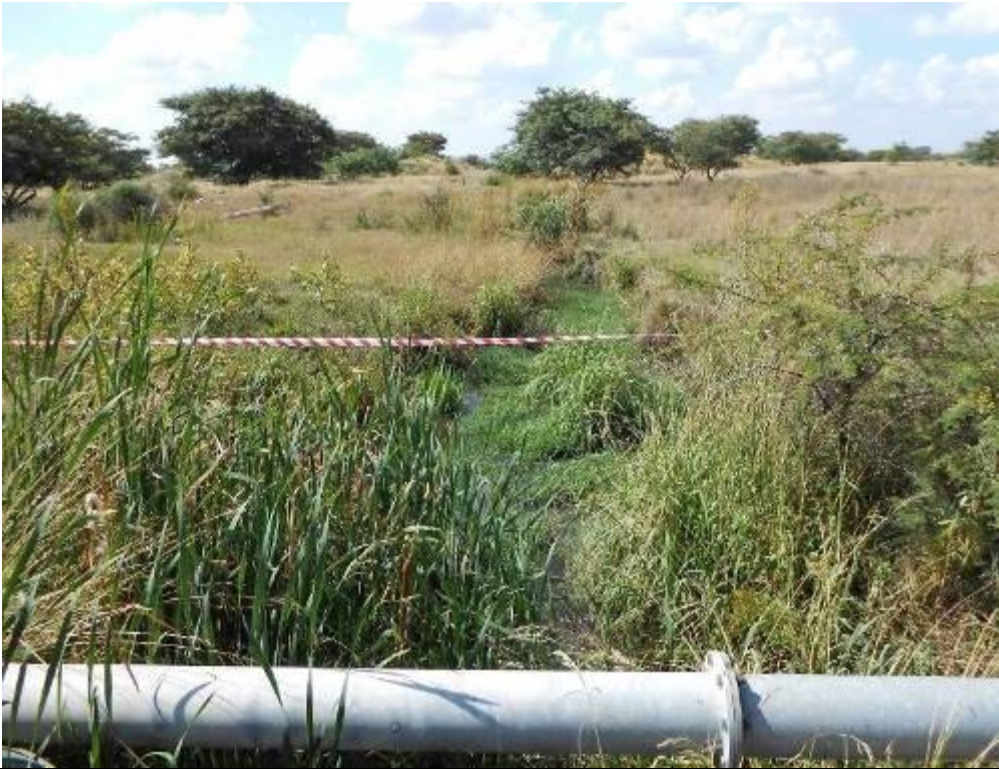
Site number: 34a	Coordinates: 25°37'29.34"S 27°13'54.70"E
Crossing Type: Pipeline	
Site Photo:

Present Ecological State	B
Wetland type	River
Morphology	Relatively narrow, shallow channel, mixture of alluvial sand and mud. Limited flow present at the time of the study.
Riparian and in Stream Habitat	<i>Cymbopogon</i> dominated bushveld vegetation; alien vegetation component moderate. Instream ecology: limited flow present at the time of the assessment, dominated by <i>Typha</i> .
Vegetation	<i>Tagetes minuta</i> , <i>Typha capensis</i> , <i>Cymbopogon validus</i> , <i>Flaveria bidentis</i>
System Modifiers	Invasive alien vegetation.
Potential impacts of water use on environment	Possible flow impedance during high flow periods.
Socio-economic impacts of water use	The pipeline will not significantly negatively impact on any water users.
Socio-economic advantages of water use	The pipeline will not significantly negatively impact on any water users.

Potential impacts of water use on water resource	The support structures within the channel will result in some alterations to streamflow patterns during flow periods; however these are not deemed to have a significant impact on downstream resources.
Summary of proposed impact on water use will have on other users	The pipeline will not impact significantly on other water users.
Mitigation and Rehabilitation plan	Implement alien vegetation control programme. Monitor the pipeline for leaks.

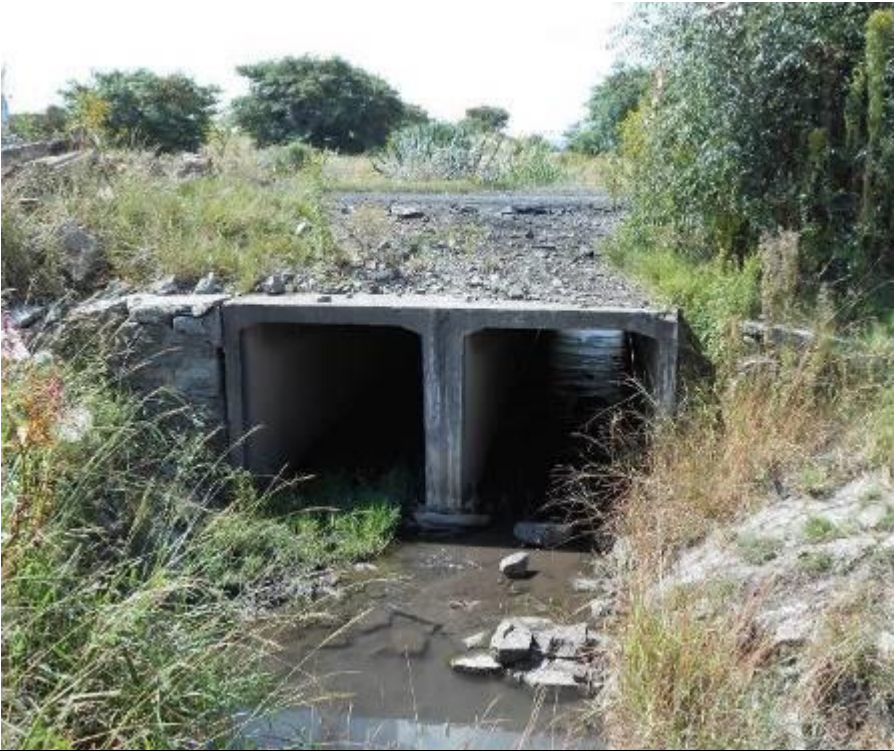
Site number: 34b	Coordinates: 25°37'29.82"S 27°13'54.76"E
Crossing Type: Road crossing/culvert	
Site Photo:

Present Ecological State	C
Wetland type	River
Morphology	Wide, relatively deep channel, mixture of alluvial sand and rocky substrate. Low flow present at the time of the study.
Riparian and in Stream Habitat	Dominated by bushveld grass, alien vegetation component moderate. Instream ecology: low flow present, no instream vegetation present at the time of the study.
Vegetation	<i>Verbena bonariensis</i> , <i>Tagetes minuta</i> , <i>Persicaria lapathifolia</i> , <i>Bidens pilosa</i> , <i>Cynodon dactylon</i> , <i>Datura stramonium</i> ,
System Modifiers	Erosion. Construction. Waste dumping.
Potential impacts of water use on environment	Increased water input from the road. Further erosion and sedimentation of the system.
Socio-economic impacts of water use	The bridge will not significantly negatively impact on any water users.

Socio-economic advantages of water use	The bridge plays an important role in providing connectivity in the area, thereby allowing economic activity in the area
Potential impacts of water use on water resource	Some erosion and incision apparent at the bridge tie-ins. Moderate alteration to streamflow patterns is anticipated as a result of the culvert.
Summary of proposed impact on water use will have on other users	The bridge will not impact significantly on other water users.
Mitigation and Rehabilitation plan	Invasive vegetation control. Erosion monitoring.

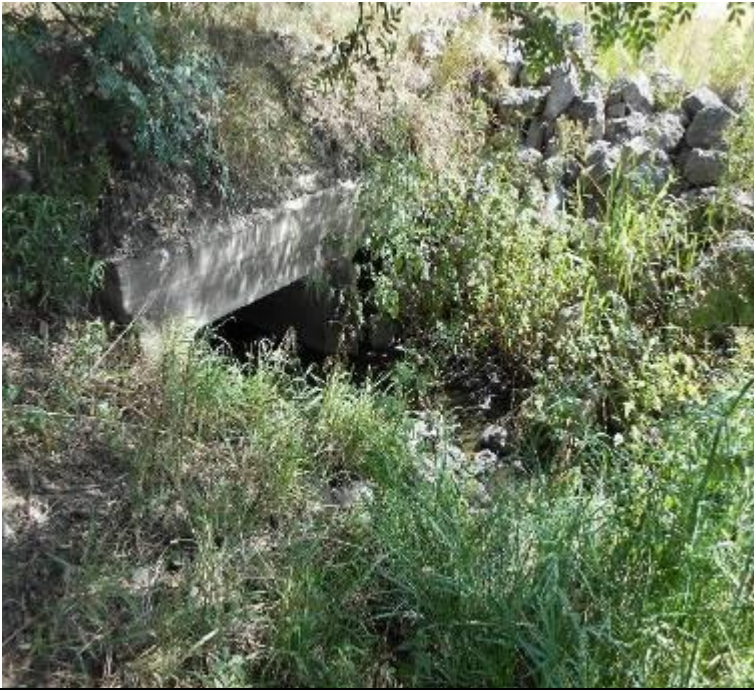
Site number: 34c	Coordinates: 25°37'24.04"S 27°13'59.50"E
Crossing Type: Culvert/Road	
Site Photo:

Present Ecological State	C
Wetland type	River
Morphology	Narrow, relatively shallow channel, with a mixture of alluvial sand. Dry river bed at the time of the assessment.
Riparian and in Stream Habitat	Dominated by bushveld grass; alien vegetation component moderate. Instream ecology: riverbed dry at the time of the study.
Vegetation	<i>Leonotis dysophylla</i> , <i>Tagetes minuta</i> , <i>Asparagus larycinus</i> , <i>circium vulgare</i> , <i>Cyperus sexangularis</i> , <i>Bidens pilosa</i> , <i>Persicaria lapathifolia</i> , <i>Xanthium strumarium</i>
System Modifiers	Erosion. Rock dumping. Alien invasion. Encroachment
Potential impacts of water use on environment	The culvert will not significantly negatively impact on the environment due to the ephemeral nature of the stream.
Socio-economic impacts of water use	The culvert will not significantly negatively impact on any water users.

Socio-economic advantages of water use	The culvert will not significantly negatively impact on any water users, but does not serve as an important socio-economic advantage due to its remote location.
Potential impacts of water use on water resource	The culvert has been well-constructed with little to no incision apparent at the tie-ins. Moderate alteration to streamflow patterns is anticipated as a result of the overgrown instream habitat; however since the system is ephemeral, no significant impact on downstream resources is anticipated as a result of this.
Summary of proposed impact on water use will have on other users	The culvert will not impact significantly on other water users.
Mitigation and Rehabilitation plan	Invasive vegetation control especially within the river channel. Insert proper berms along the culvert, instead of rocks. Erosion monitoring. Remove rocks.

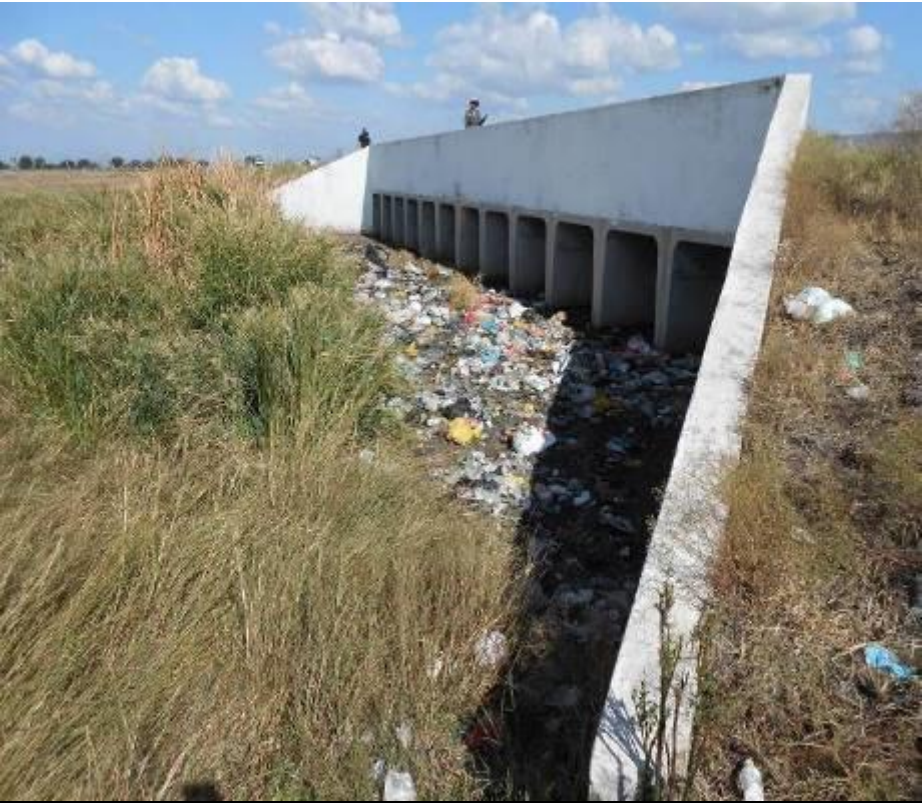
Site number: 34e	Coordinates: 25°36'57.65"S 27°14'30.30"E
Crossing Type: Road crossing	
Site Photo:

Present Ecological State	D
Wetland type	River
Morphology	Wide, relatively shallow channel, mixture of alluvial sand. Dry river bed at the time of the study.
Riparian and in Stream Habitat	Dominated by bushveld vegetation; alien vegetation component moderate. Instream ecology: riverbed dry at the time of the study and dominated by <i>Typha capensis</i> .
Vegetation	<i>Typha capensis</i> , <i>Cyperus sexangularis</i> , <i>Cynodon dactylon</i>
System Modifiers	Increased water input from the road. Dumping of general waste.
Potential impacts of water use on environment	The bridge will not significantly negatively impact on the environment due to the ephemeral nature of the stream.
Socio-economic impacts of water use	The bridge will not significantly negatively impact on any water users.
Socio-economic advantages of water use	The bridge plays an important role in providing connectivity in the area, particularly to the local community, thereby allowing economic activity in the area

Potential impacts of water use on water resource	The bridge has been well-constructed with little to no incision apparent at the bridge tie-ins. Moderate alteration to streamflow patterns is anticipated as a result of the culverts; however since the system is ephemeral, no significant impact on downstream resources is anticipated as a result of this.
Summary of proposed impact on water use will have on other users	The bridge will not impact significantly on other water users.
Mitigation and Rehabilitation plan	Remove general waste from bridge crossing.

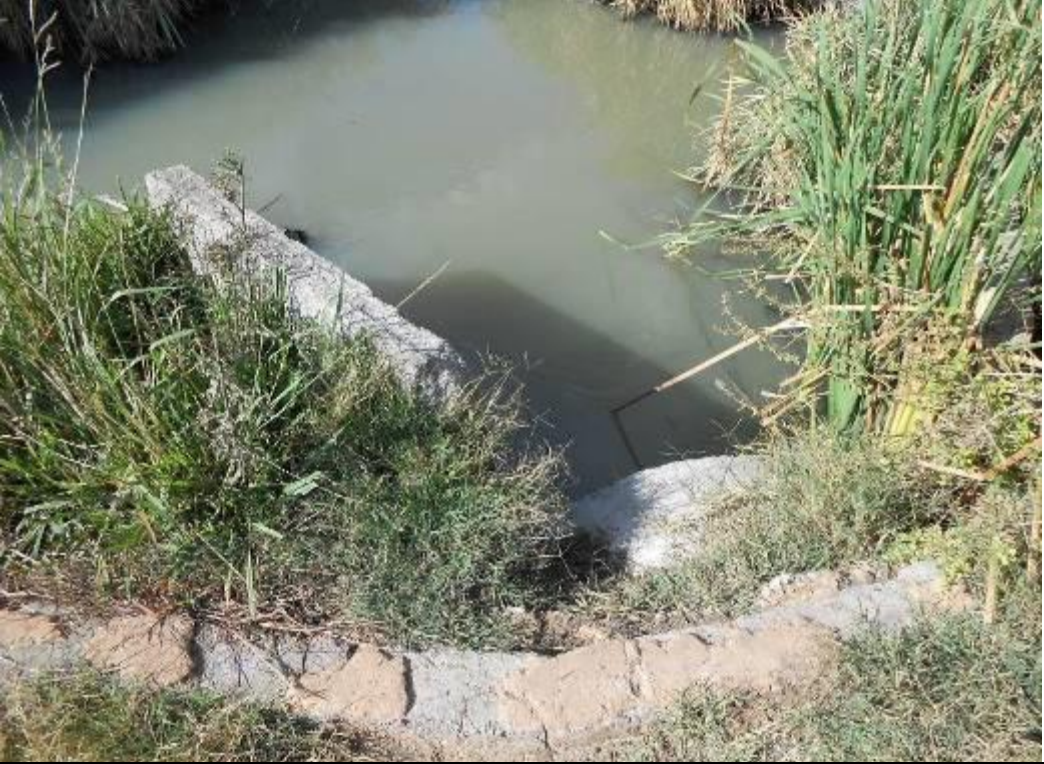
Site number: 34f	Coordinates: 25°36'04.22"S 27°15'20.27"E
Crossing Type: Pipe crossing	
Site Photo:

Present Ecological State	D
Wetland type	River
Morphology	Wide, relatively shallow channel, mixture of alluvial sand. Slow flowing water present at the time of the assessment.
Riparian and in Stream Habitat	Instream ecology: dominated by <i>Typha capensis</i> .
Vegetation	<i>Conyza bonariensis</i> , <i>Cyperus sexangularis</i> , <i>Typha capensis</i> , <i>Bidens pilosa</i> , <i>Urochloa mosambicensis</i> , <i>Tithonia rotundifolia</i>
System Modifiers	Sewage effluent altering water quality. Burst pipe traversing the road and the feature. Trampling. Erosion.
Potential impacts of water use on environment	At the moment sewage is entering the system due to the broken pipe at the time of the assessment. The pipeline crossing will not significantly negatively impact on the receiving environment; provided it is adequately maintained.

Socio-economic impacts of water use	At the moment sewage is entering the system due to the broken pipe at the site. The pipeline crossing will not significantly negatively impact on any water users, provided it is adequately maintained.
Socio-economic advantages of water use	The sewer line is necessary for the safe disposal of sewage.
Potential impacts of water use on water resource	The pipeline crossing has been poorly-constructed with some erosion present at the site. The pipeline present at the site has been damaged, this will alter the flow of the system with increased flow entering the system.
Summary of proposed impact on water use will have on other users	At the moment the pipeline crossing is having a negative impact due to the damaged pipe and sewage entering the system. The crossing will not impact significantly on other water users if it is properly maintained.
Mitigation and Rehabilitation plan	Monitor erosion. Construct a proper road crossing. Install proper sewage pipes.

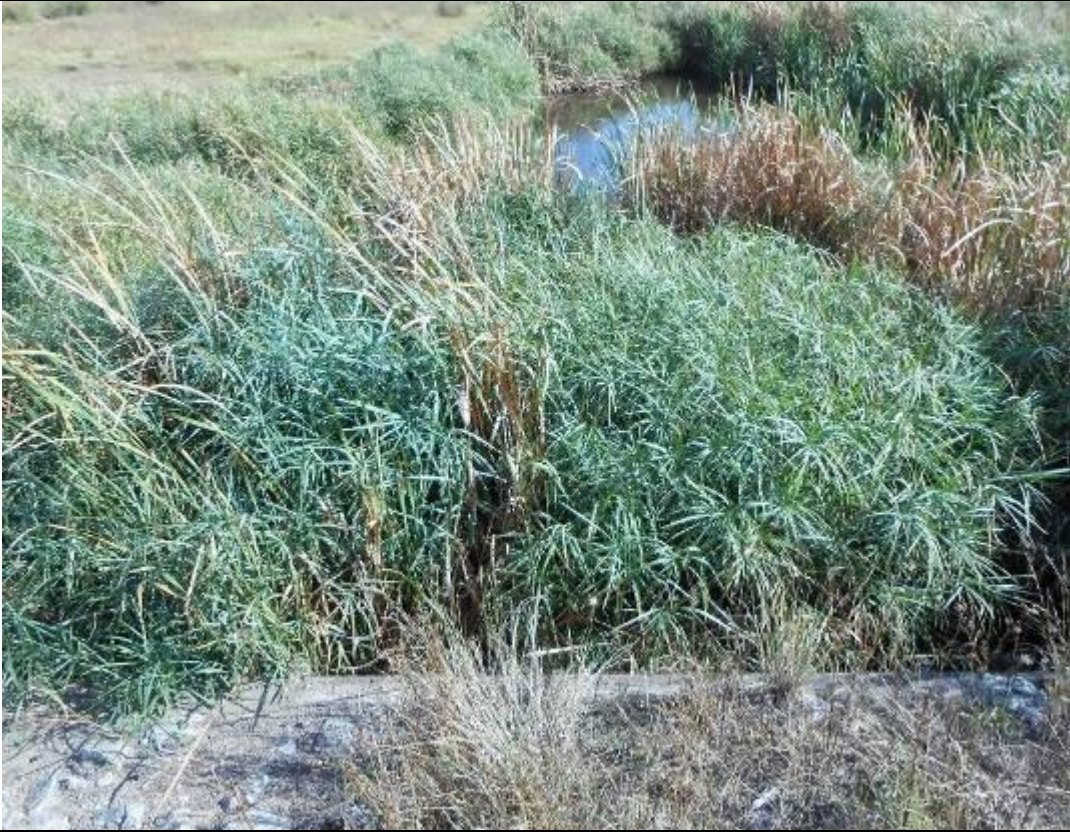
Site number: 34g	Coordinates: 25°56'44.93"S 27°15'41.10"E
Crossing Type: Road crossing

Present Ecological State	C
Wetland type	River
Morphology	Wide, relatively shallow channel. Slow flowing water present at the site.
Riparian and in Stream Habitat	Instream habitat dominated by <i>Cyperus sexangularis</i> and <i>Typha capensis</i> .
Vegetation	<i>Conyza bonariensis</i> , <i>Cyperus sexangularis</i> , <i>Typha capensis</i> , <i>Bidens pilosa</i> , <i>Urochloa mosambicensis</i> , <i>Tithonia rotundifolia</i>
System Modifiers	Sewage effluent. Increased water input from the road. Waste dumping.
Potential impacts of water use on environment	The bridge crossing will not significantly negatively impact on the receiving environment.
Socio-economic impacts of water use	The bridge crossing will not significantly negatively impact on any water users.
Socio-economic advantages of water use	The bridge plays an important role in providing connectivity in the area, particularly to the local community, thereby allowing economic activity in the area

Potential impacts of water use on water resource	The bridge has been well-constructed with little to no incision apparent at the bridge tie-ins. Moderate alteration to streamflow patterns is anticipated as a result of the culverts and overgrown instream vegetation.
Summary of proposed impact on water use will have on other users	The bridge will not impact significantly on other water users.
Mitigation and Rehabilitation plan	Monitoring of erosion.

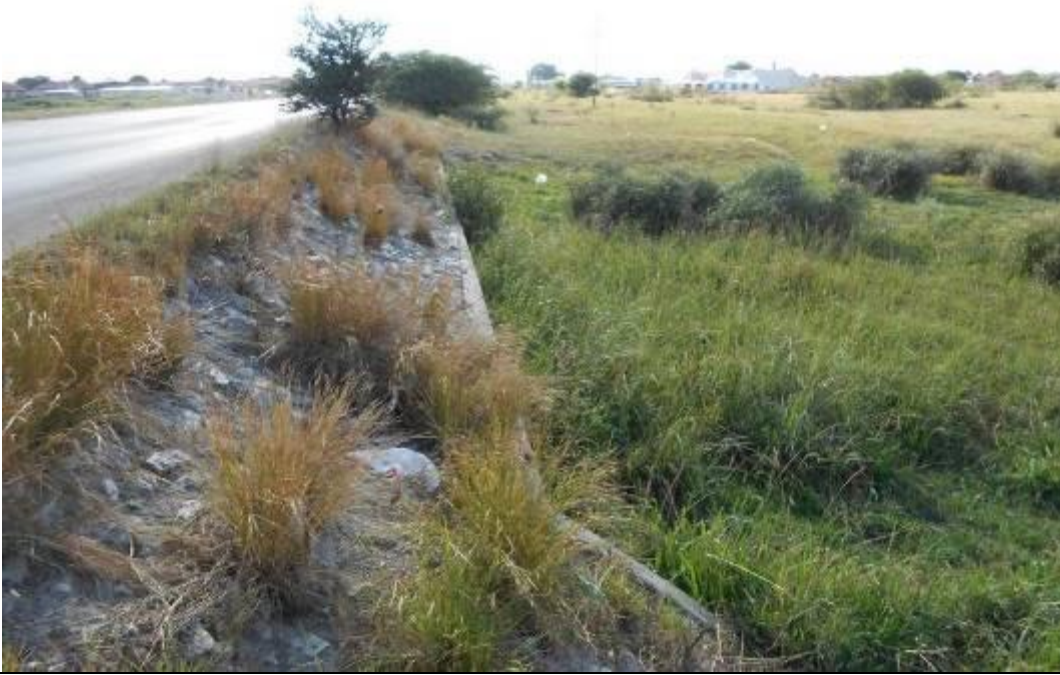
Site number: 34h	Coordinates: 25°35'43.76"S 27°15'40.05"E
Crossing Type: Road crossing culvert	
Site Photo:

Present Ecological State	C
Wetland type	River
Morphology	Wide, relatively shallow channel, mixture of alluvial sand. Dry river bed at the time of the study.
Riparian and in Stream Habitat	Dominated by bushveld vegetation. Instream ecology: riverbed dry at the time of the study and dominated by terrestrial species.
Vegetation	<i>Typha capensis</i> , <i>Cyperus sexangularis</i> , <i>Bidens pilosa</i> , <i>Persicaria lapathifolia</i>
System Modifiers	Increased water input due to the road crossing.
Potential impacts of water use on environment	The bridge crossing will not significantly negatively impact on the receiving environment.
Socio-economic impacts of water use	The bridge crossing will not significantly negatively impact on any water users.
Socio-economic advantages of water use	The bridge plays an important role in providing connectivity in the area, particularly to the local community, thereby allowing economic activity in the area

Potential impacts of water use on water resource	The bridge has been well-constructed with little to no incision apparent at the bridge tie-ins. Moderate alteration to streamflow patterns is anticipated as a result of the culverts and overgrown instream vegetation, however due to the ephemeral nature of the system, limited impact on the downstream users is expected.
Summary of proposed impact on water use will have on other users	The bridge will not impact significantly on other water users.
Mitigation and Rehabilitation plan	Monitoring of erosion.

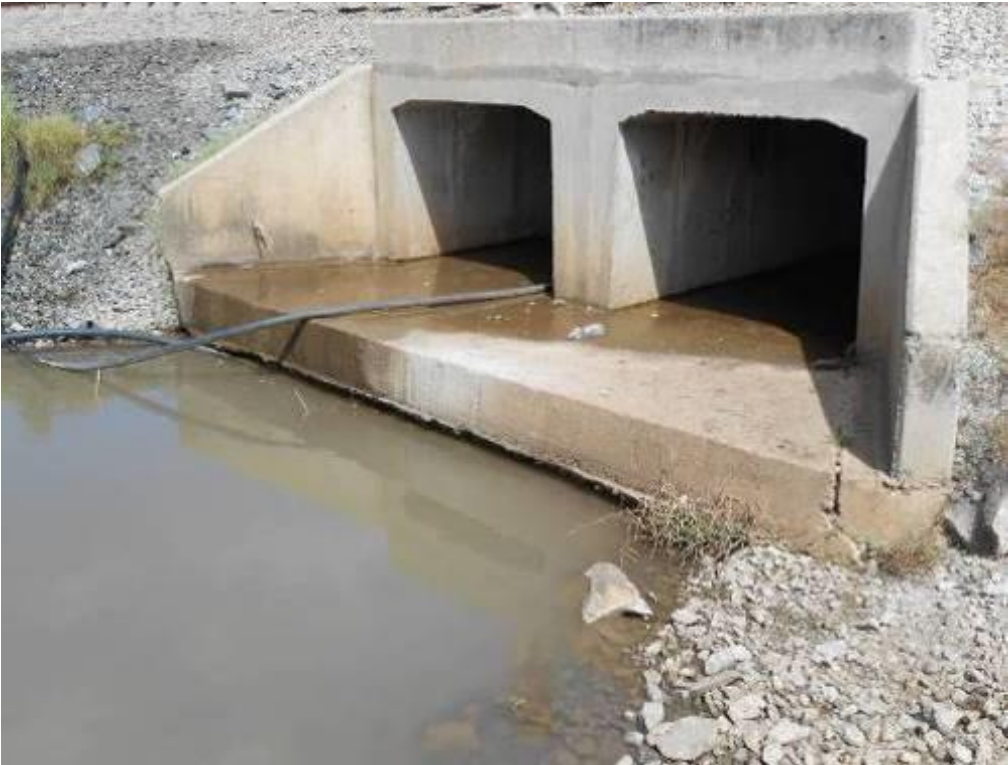
Table 84: Summary of the assessment undertaken at site 35.

Present Ecological State	C
Wetland type	Non-perennial drainage line
Morphology	Wide, relatively deep channel, mixture of alluvial sand and gravel. Shallow pool present at the time of the assessment, unlikely to support any aquatic macro-invertebrates. .
Riparian and in Stream Habitat	Dominated by bushveld vegetation; alien vegetation component moderate. Instream ecology: shallow pool present at the time of the study with no instream vegetation present.
Vegetation	<i>Setaria sphacelata</i> , <i>Bidens pilosa</i> , <i>Cynodon dactylon</i> , <i>Acacia karroo</i>
System Modifiers	Burst leaking pipes. Erosion. Grazing. Alien invasion.
Potential impacts of water use on environment	Aquatic migratory barrier- during low flow periods.
Socio-economic impacts of water use	The railway culvert will not significantly negatively impact on any water users.

Socio-economic advantages of water use	The railway culvert plays an important role in providing connectivity in the area, particularly to the industrial sector, thereby allowing economic activity in the area
Potential impacts of water use on water resource	The railway culvert has been poorly-constructed with incision and erosion apparent at the bridge tie-ins. Moderate alteration to streamflow patterns is anticipated as a result of the culverts; scouring of the streambed evident.
Summary of proposed impact on water use will have on other users	The railway culvert will not impact significantly on other water users.
Mitigation and Rehabilitation plan	Invasive vegetation control. Erosion monitoring. Monitor pipes for leaks.

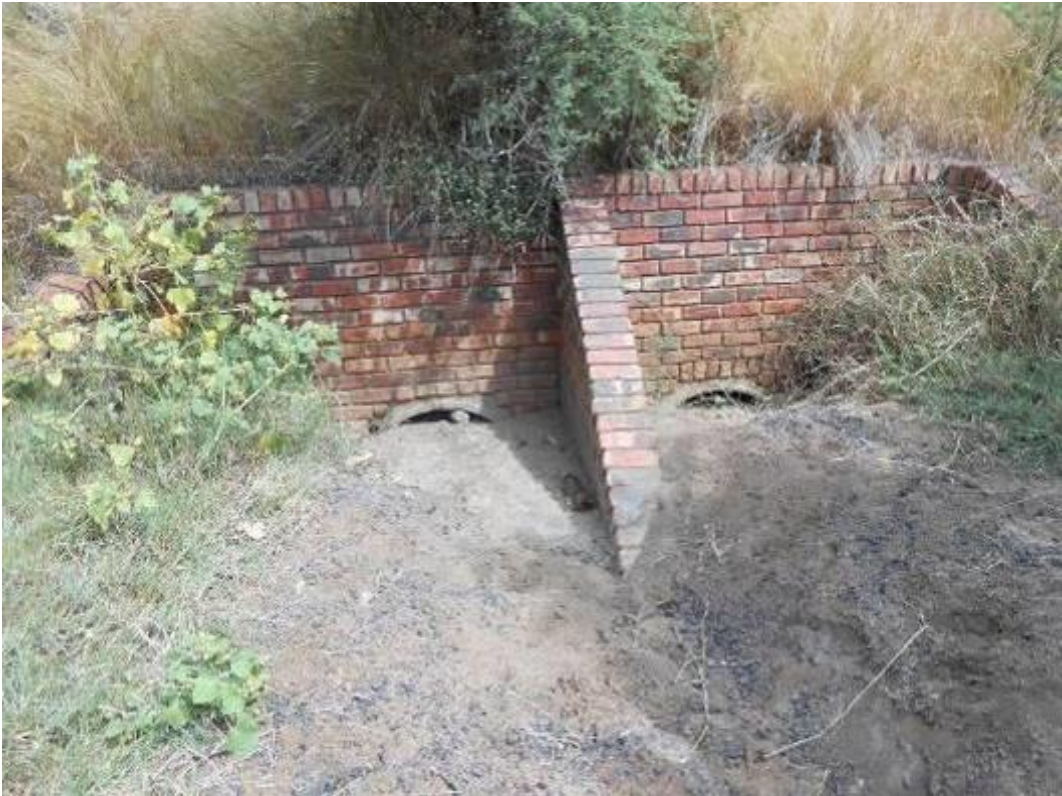
Table 85: Summary of the assessment undertaken at site 35a.

Present Ecological State	E
Wetland type	Non-perennial drainage line
Morphology	Wide, relatively shallow channel, mixture of alluvial sand. Dry stream bed at the time of the assessment.
Riparian and in Stream Habitat	Dominated by bushveld vegetation. Instream ecology: streambed dry at the time of the study. Excessive sedimentation of the system.
Vegetation	<i>Asclepias fruticosa</i> , <i>Xanthium strumarium</i> , <i>Tagetes minuta</i> , <i>Melinis repens</i> , <i>Bidens pilosa</i> , <i>Cynodon dactylon</i>
System Modifiers	Clogged pipes. Erosion. Encroachment. Trampling by livestock, some alteration to streamflow patterns is anticipated due to the support structures placed in the channel.
Potential impacts of water use on environment	Unclog pipes to in order to restore instream flow patterns. The culvert will not significantly negatively impact on the environment, if the culvert is properly maintained.

Socio-economic impacts of water use	The culvert will not significantly negatively impact on any water users.
Socio-economic advantages of water use	The culvert will not significantly negatively impact on any water users.
Potential impacts of water use on water resource	Some streamflow alteration is anticipated high flow periods, however, due to the ephemeral nature of the stream it is unlikely to have a significant impact on downstream resources.
Summary of proposed impact on water use will have on other users	The culvert will not significantly negatively impact on any water users.
Mitigation and Rehabilitation plan	Erosion monitoring, alien vegetation monitoring. Unclog pipes to in order to restore instream flow patterns.

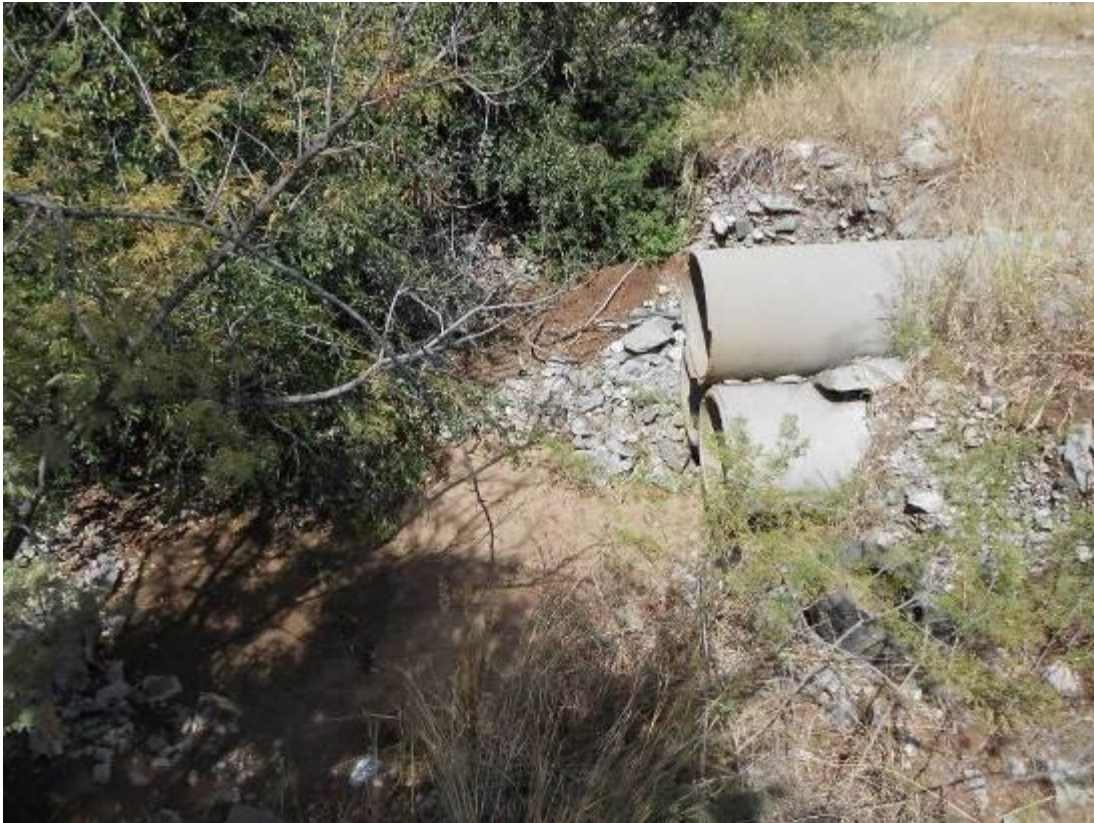
Table 86: Summary of the assessment undertaken at Site 35b.

Present Ecological State	D
Wetland type	Non-perennial drainage line
Morphology	Wide, relatively shallow channel, mixture of alluvial sand and bedrock. Dry riverbed at the time of the study.
Riparian and in Stream Habitat	Dominated by bushveld vegetation. Instream ecology: dry riverbed at the time of the assessment dominated by terrestrial species.
Vegetation	<i>Tagetes minuta</i> , <i>Melinis repens</i> , <i>Hyparrhenia hirta</i> . <i>Rhus lancea</i>
System Modifiers	Erosion. Encroachment
Potential impacts of water use on environment	The crossing will not significantly negatively impact on the environment.
Socio-economic impacts of water use	The culvert will not significantly negatively impact on any water users.
Socio-economic advantages of water use	The culvert plays an important role in providing connectivity in the area, particularly to the industrial sector, thereby allowing economic activity in the area

Potential impacts of water use on water resource	Some streamflow alteration may occur during high flow periods, however due to the ephemeral nature of the stream it is unlikely to have a significant impact on downstream resources.
Summary of proposed impact on water use will have on other users	The culvert will not significantly negatively impact on any water users.
Mitigation and Rehabilitation plan	Erosion monitoring. Alien vegetation monitoring. Build a proper culvert.

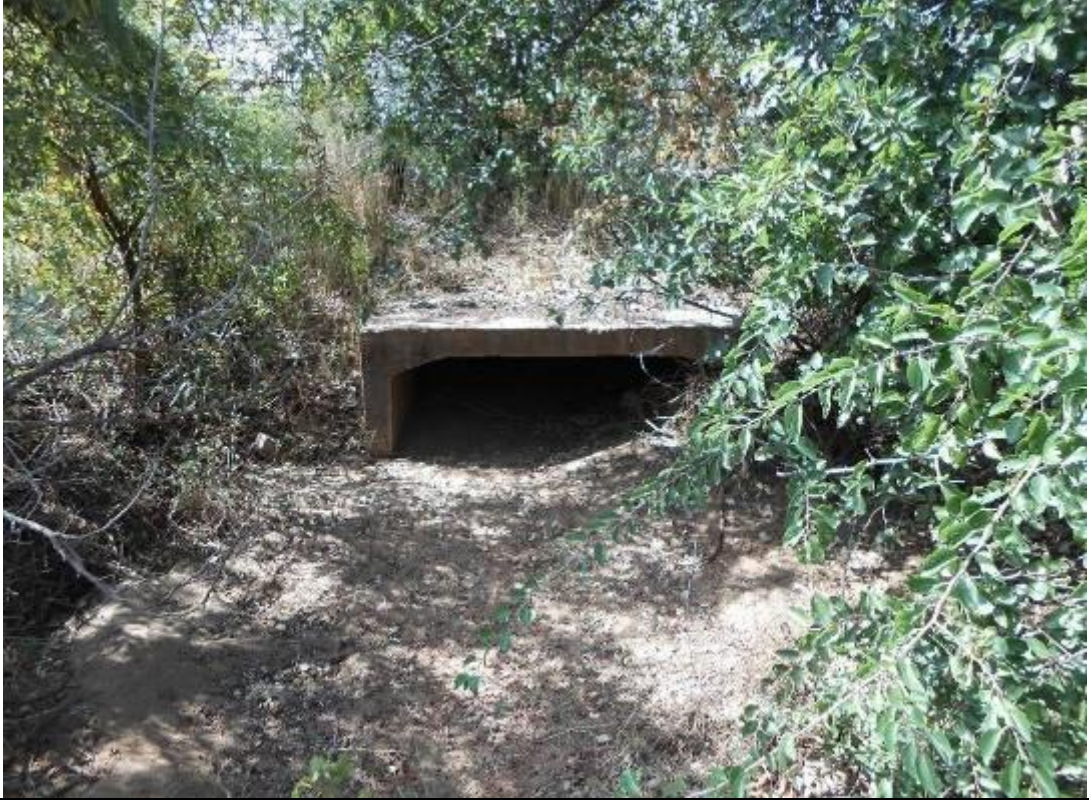
Table 87: Summary of the assessment undertaken at Site 36.

Present Ecological State	C
Wetland type	Non-perennial drainage line
Morphology	Wide, relatively shallow channel, mixture of alluvial sand. Dry river bed at the time of the assessment.
Riparian and in Stream Habitat	Dominated by bushveld vegetation. Instream ecology: riverbed dry at the time of the study. Excessive sedimentation of the system.
Vegetation	<i>Xanthium strumarium</i> , <i>Acacia karroo</i> , <i>Datura stramonium</i> , <i>Asclepias fruiticosa</i> , <i>Themeda triandra</i>
System Modifiers	Sedimentation. Erosion. Encroachment
Potential impacts of water use on environment	Unclog pipes to in order to restore instream flow patterns. The culvert will not significantly negatively impact on the environment, if the culvert is properly maintained.
Socio-economic impacts of water use	The culvert will not significantly negatively impact on any water users.

Socio-economic advantages of water use	The culvert plays an important role in providing connectivity in the area, particularly to the industrial sector, thereby allowing economic activity in the area.
Potential impacts of water use on water resource	Some streamflow alteration is anticipated high flow periods, however, due to the ephemeral nature of the stream it is unlikely to have a significant impact on downstream resources.
Summary of proposed impact on water use will have on other users	The culvert will not significantly negatively impact on any water users.
Mitigation and Rehabilitation plan	Monitoring of erosion. Alien vegetation monitoring. Unclog sediment from the culvert.

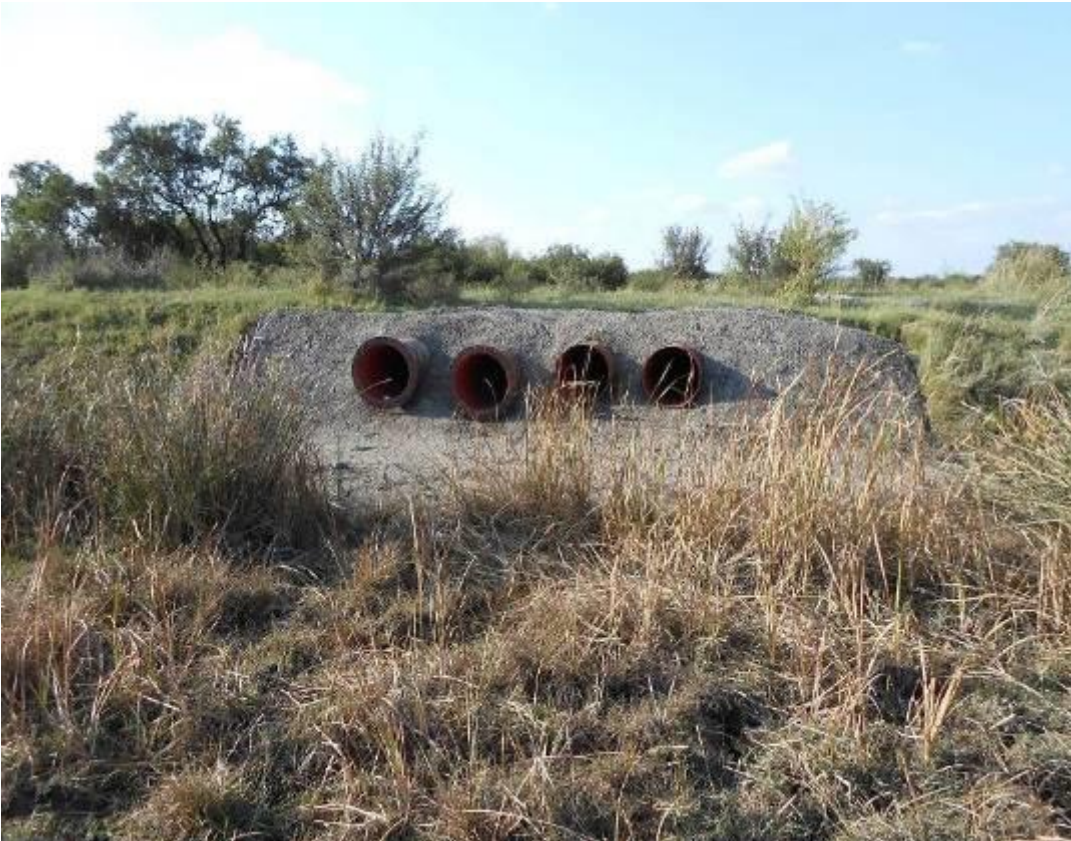
Table 92: Summary of the assessment undertaken at Site 38c.

Present Ecological State	C
Wetland type	River
Morphology	Wide, relatively shallow channel, Dry river bed.
Riparian and in Stream Habitat	<i>Acacia karroo</i> dominated the bushveld. Dry at the time of the assessment.
Vegetation	<i>Cyperus sexangularis</i> , <i>Conyza bonariensis</i> , <i>Melinis repens</i> , <i>Setaria sphacelata</i> , <i>Sesbania sesban</i> , <i>Verbena bonariensis</i> , <i>Themeda triandra</i> , <i>Acacia karroo</i>
System Modifiers	Road/pipeline increasing water input. Alien vegetation
Potential impacts of water use on environment	The road/pipeline crossing will not significantly negatively impact on the receiving environment.
Socio-economic impacts of water use	The road/pipeline will not significantly negatively impact on any water users.
Socio-economic advantages of water use	The road crossing is necessary for connectivity.

Potential impacts of water use on water resource	Since the road/pipeline is located adjacent a stream there will be no obstruction or impact on water flow. However, there might be increased water input coming through the pipes into the stream.
Summary of proposed impact on water use will have on other users	These structures will not impact significantly on other water users.
Mitigation and Rehabilitation plan	Control alien vegetation species.

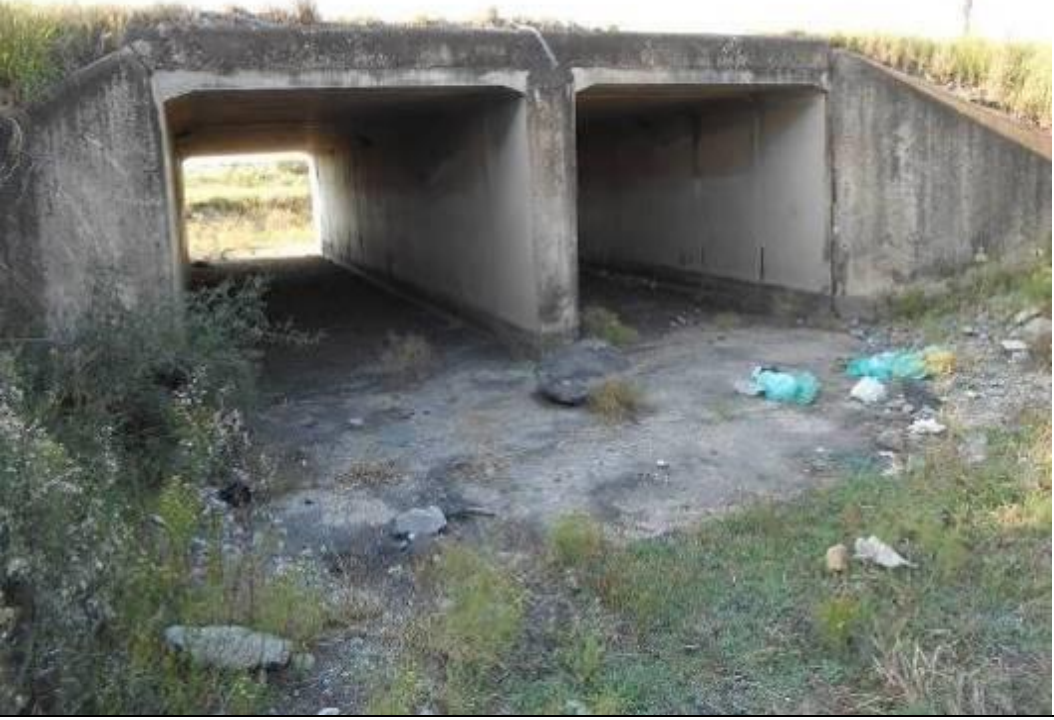
Table 93: Summary of the assessment undertaken at Site 39.

Present Ecological State	C
Wetland type	River
Morphology	Wide, and diffuse. Dry river bed.
Riparian and in Stream Habitat	Dry at the time of the assessment.
Vegetation	<i>Sesbania sesban</i> , <i>Sporobolus pyramidalis</i> , <i>Helichrysum spp</i> , <i>Persicaria lapathifolia</i> , <i>Tagetes minuta</i>
System Modifiers	Culvert. Livestock grazing and trampling. Erosion.
Potential impacts of water use on environment	The road crossing will not significantly negatively impact on the environment.
Socio-economic impacts of water use	The road crossing will not significantly negatively impact on any water users.
Socio-economic advantages of water use	The road crossing plays an important role in providing connectivity in the area.
Potential impacts of water use on water resource	The road will result in increased runoff, the culvert will result in some alterations to streamflow patterns during flow periods; however these are not deemed to have a significant impact on downstream resources.

Summary of proposed impact on water use will have on other users	The road crossing will not impact significantly on other water users.
Mitigation and Rehabilitation plan	Control erosion, remove litter.

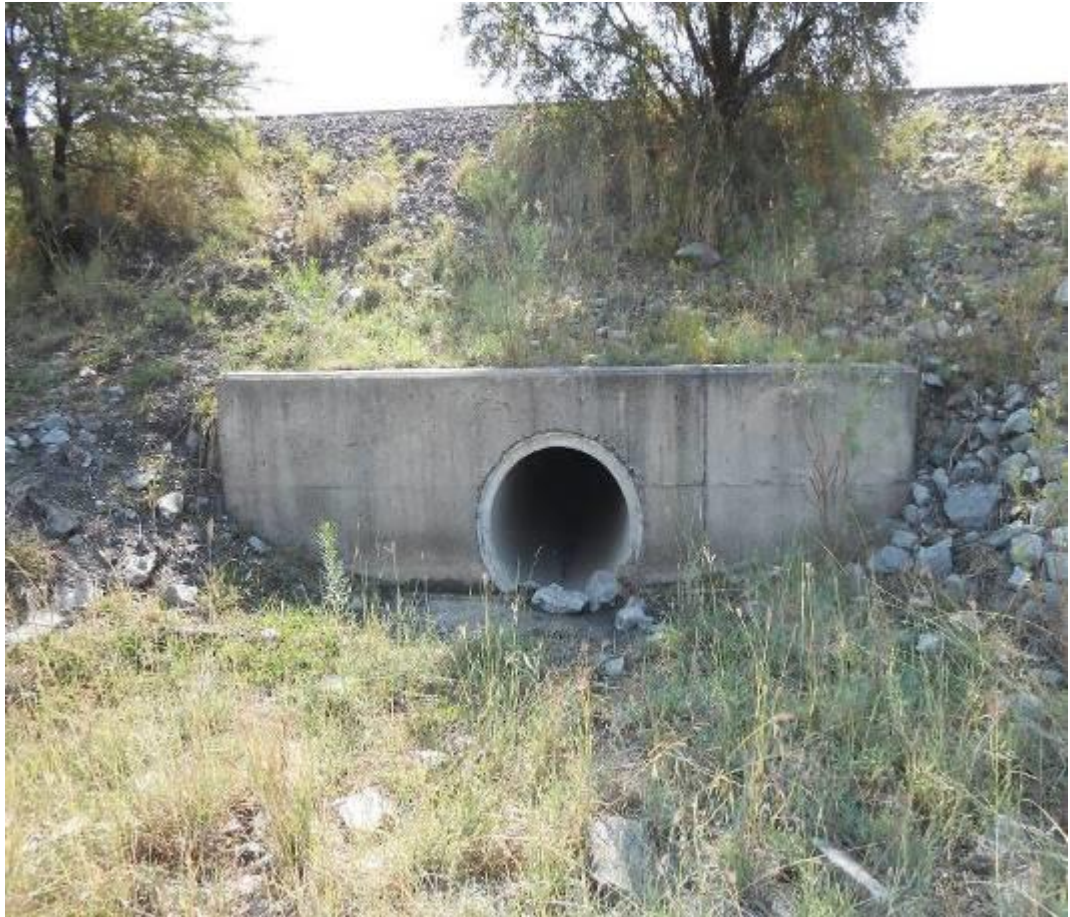
Table 94: Summary of the assessment undertaken at Site 40a.

Present Ecological State	C
Wetland type	River
Morphology	Very diffuse area. Dry river bed.
Riparian and in Stream Habitat	Mostly grass species dominating the area. Instream ecology: riverbed dry at the time of the study.
Vegetation	<i>Chloris virgata</i> , <i>Melinis repens</i> , <i>Setaria sphacelata</i> , <i>Asclepias fruticosa</i>
System Modifiers	Erosion.
Potential impacts of water use on environment	The railway crossing will not significantly negatively impact the environment.
Socio-economic impacts of water use	The railway crossing will not significantly negatively impact on any water users.
Socio-economic advantages of water use	The railway crossing will not significantly negatively impact on any water users.
Potential impacts of water use on water resource	Alterations to water flow patterns during flow periods; however these are not deemed to have a significant impact on downstream resources.

Summary of proposed impact on water use will have on other users	The railway crossing will not impact significantly on other water users.
Mitigation and Rehabilitation plan	Monitor erosion.
