**WETLAND DELINEATION IN THE RUSTENBURG
PLATINUM MINE PROJECT AREA AND A HIGH
LEVEL ASSESSMENT OF SELECTED RIVER
CROSSINGS, NORTH-WEST PROVINCE**

Prepared for

SRK Consulting (Pty) Ltd

May 2015

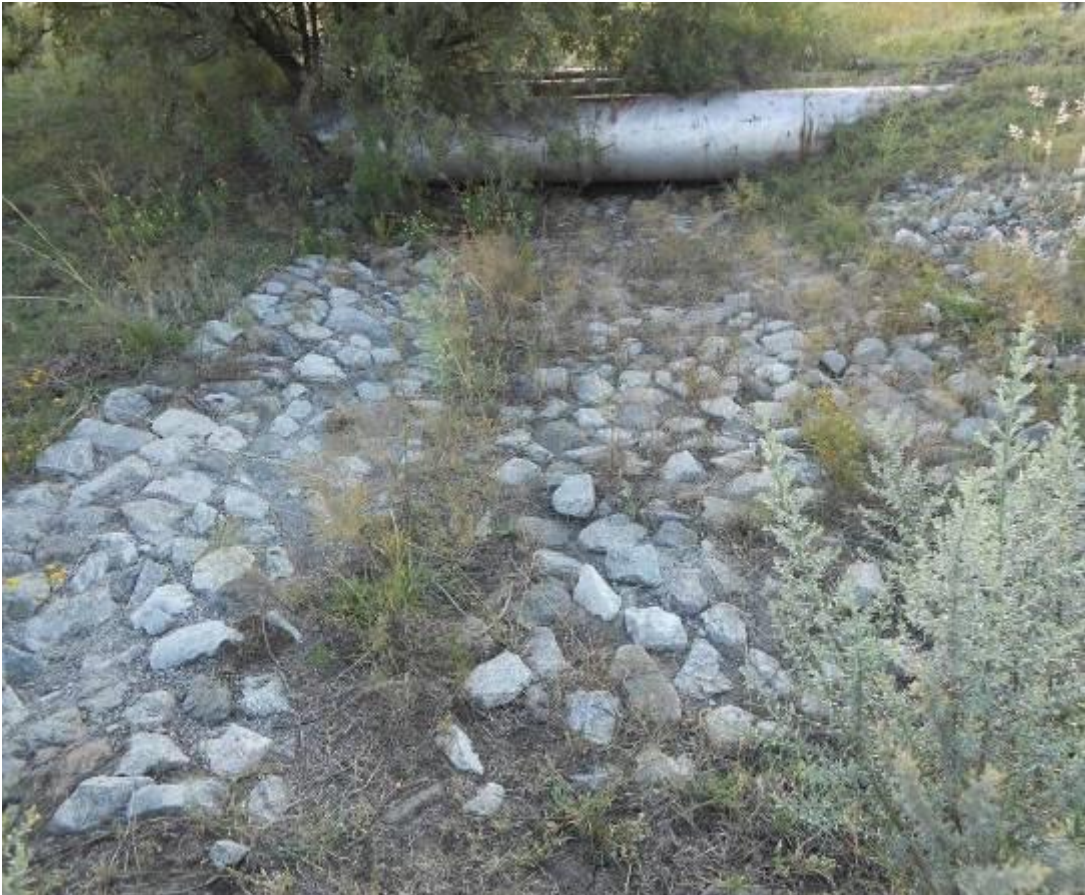
Table 95: Summary of the assessment undertaken at Site 40c.

Present Ecological State	C
Wetland type	River
Morphology	Narrow, shallow channel. Dry river bed.
Riparian and in Stream Habitat	Dry at the time of the assessment. Alien vegetation within the stream channel.
Vegetation	<i>Flaveria bidentis</i> , <i>Conyza bonariensis</i> , <i>Hyparrhenia hirta</i> , <i>Asclepias fruiticosa</i>
System Modifiers	Pipes obstructing water flow
Potential impacts of water use on environment	The pipeline will not significantly negatively impact on the receiving environment; provided it is adequately maintained.
Socio-economic impacts of water use	The pipeline is very low/ close to the ground, therefore it will obstruct water flow during heavy rainfall events.
Socio-economic advantages of water use	The pipeline will not significantly negatively impact on water users.
Potential impacts of water use on water resource	The presence of the pipeline as well as rocks within the channel will alter water flow patterns during flow periods.

Summary of proposed impact on water use will have on other users	The pipeline will not impact significantly on other water users.
Mitigation and Rehabilitation plan	The pipes should in fact be underground so that it doesn't inhibit the flow of water.

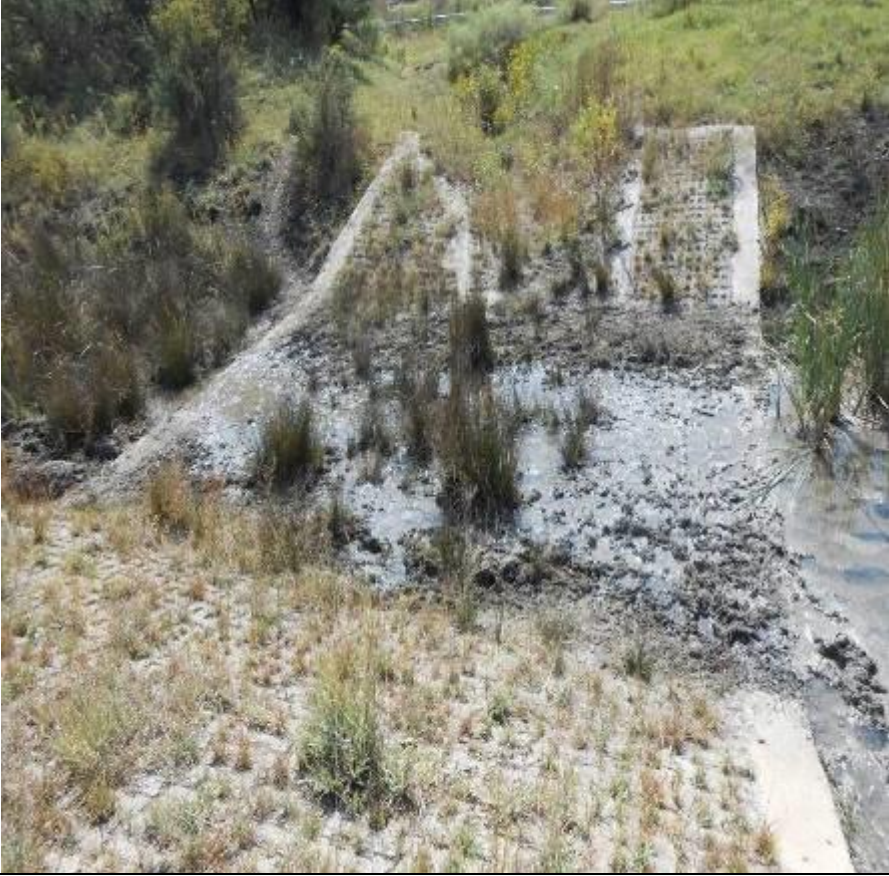
Table 96: Summary of the assessment undertaken at Site 40d-40h.

Present Ecological State	C
Wetland type	River
Morphology	Wide, shallow paved channel
Riparian and in Stream Habitat	Acacia spp dominated the bushveld.
Vegetation	<i>Heteropogon contortus</i> , <i>Bothriochloa insculpta</i> , <i>Andropogon eucomus</i> , <i>Themeda triandra</i> , <i>Setaria sphacelata</i> , <i>Conyza bonariensis</i> , <i>Asclepias fruiticosa</i> ,
System Modifiers	Eroded banks where there's a culvert. Trampling and grazing.
Potential impacts of water use on environment	The diversion will redirect the flow of water and cause drying up in areas where there used to be flowing water or water available to users.
Socio-economic impacts of water use	The diversion will result in lack of water in certain areas as a result of water not being able to flow to those areas.

Socio-economic advantages of water use	The diversion will not significantly negatively impact on any water users
Potential impacts of water use on water resource	Alterations to streamflow patterns during flow periods.
Summary of proposed impact on water use will have on other users	The diversion will impact water supply on other water users.
Mitigation and Rehabilitation plan	Monitor erosion.

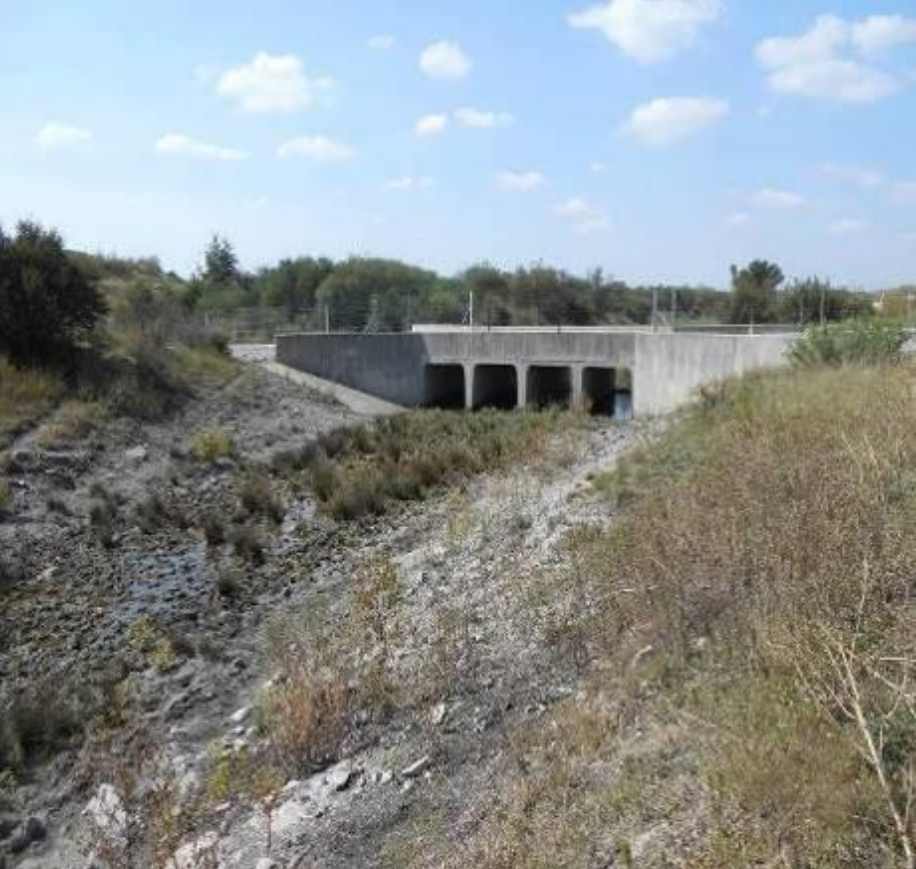
Table 97: Summary of the assessment undertaken at Site 40e.

Present Ecological State	C
Wetland type	River
Morphology	Wide, shallow channel. Dry river bed. The channel has been artificially paved.
Riparian and in Stream Habitat	<i>Dichrostachys</i> dominated bushveld vegetation. Instream ecology: riverbed dry at the time of the study.
Vegetation	<i>Sesbania sesban</i> , <i>Flaveria bidentis</i> , <i>Setaria sphacelata</i> , <i>Asclapias fruiticosa</i> , <i>polygala hottentota</i> , <i>Themeda triandra</i> , <i>Melinis repens</i> , <i>Brachiaria brizantha</i>
System Modifiers	Erosion. Runoff from the adjacent development deposits sediment into the feature since the banks are unvegetated.
Potential impacts of water use on environment	The road crossing will not significantly negatively impact on any water users.
Socio-economic impacts of water use	The road crossing will not significantly negatively impact on any water users.

Socio-economic advantages of water use	The road crossing is necessary for providing connectivity in the area.
Potential impacts of water use on water resource	The paved channel as well as the culvert have altered water flow patterns.
Summary of proposed impact on water use will have on other users	The road crossing will not impact significantly on other water users.
Mitigation and Rehabilitation plan	Monitor erosion.

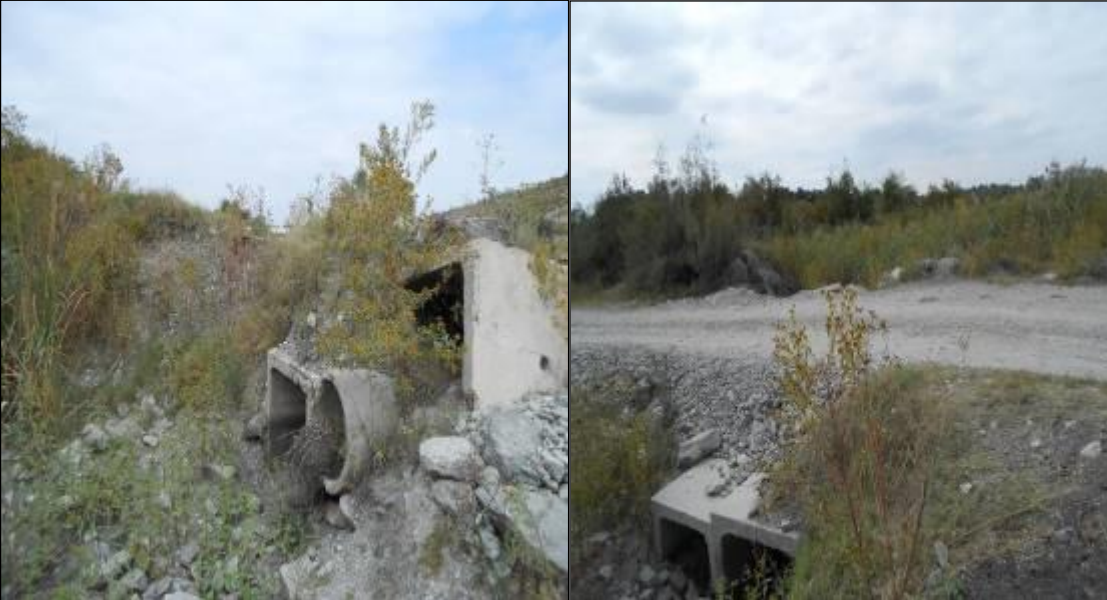
Table 98: Summary of the assessment undertaken at Site 41.

Present Ecological State	C
Wetland type	River
Morphology	Narrow, shallow channel. Dry river bed.
Riparian and in Stream Habitat	Riverbed dry at the time of the study.
Vegetation	<i>Acacia karroo</i> , <i>Cynodon dactylon</i> , <i>Conyza bonariensis</i> , <i>Phragmites australis</i> , <i>Flaveria bidentis</i> <i>Bothriochloa insculpta</i>
System Modifiers	Partially collapsed culvert. Erosion. Stockpiling.
Potential impacts of water use on environment	The road crossing will not significantly negatively impact on any water users.
Socio-economic impacts of water use	The road crossing will not significantly negatively impact on any water users.
Socio-economic advantages of water use	The road crossing plays a role in providing connectivity in the area thereby allowing economic activity in the area.
Potential impacts of water use on water resource	The culvert is very low and it might constrict water flow during heavy rainfall events.

Summary of proposed impact on water use will have on other users	The road crossing will not impact significantly on other water users.
Mitigation and Rehabilitation plan	Reconstruct the collapsed culvert. Insert erosion control berms. Control alien vegetation species.

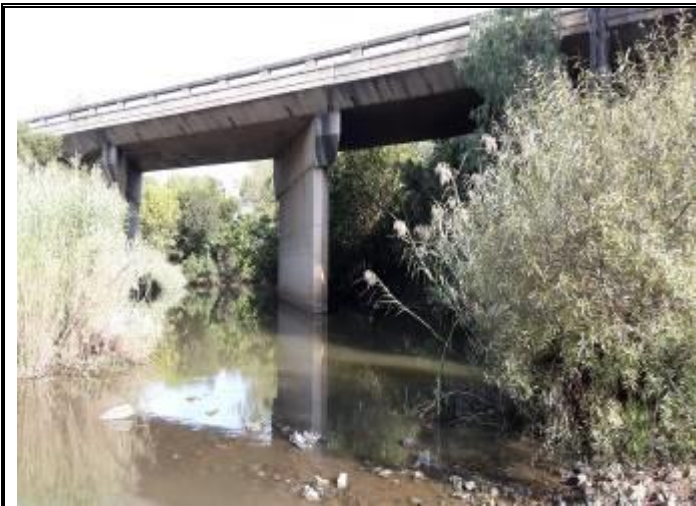
Figure 47: Upstream view of the SASS 22 site indicating the low flow at the time of the assessment.

- The upstream (SASS 22) and downstream (SASS 29) sites of the Hex River may be considered to be in a Class E/F (severely impaired) condition according to the Dallas (2007) classification system. Both sites can be classified as a Class E (seriously impaired) conditions according to the Dickens & Graham (2001) classification system. Site SASS 26 can be considered as Class D (largely impaired) according to the Dallas (2007) classification, and as a Class C (moderately impaired) condition according to the Dickens & Graham (2001) classification system. Site SASS 27A can be considered as Class C (moderately impaired) according to the Dallas (2007) classification, and as a Class B (largely natural) condition according to the Dickens & Graham (2001) classification system;

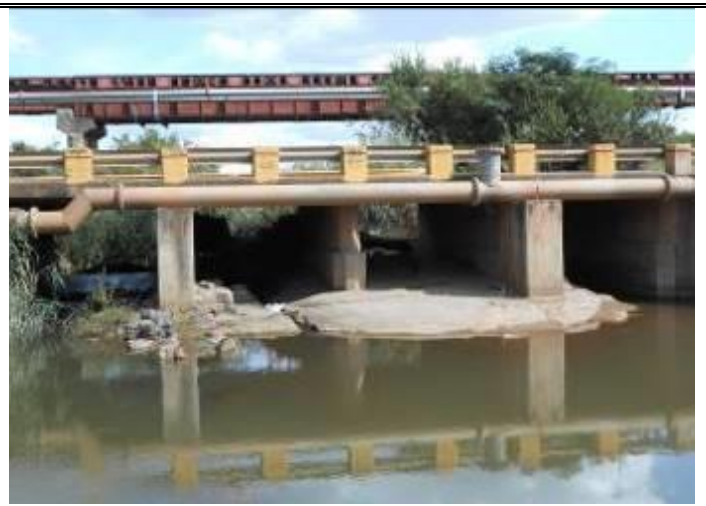
Figure 48: Upstream view of the SASS 26 site indicating the turbid water present at the time of the assessment.

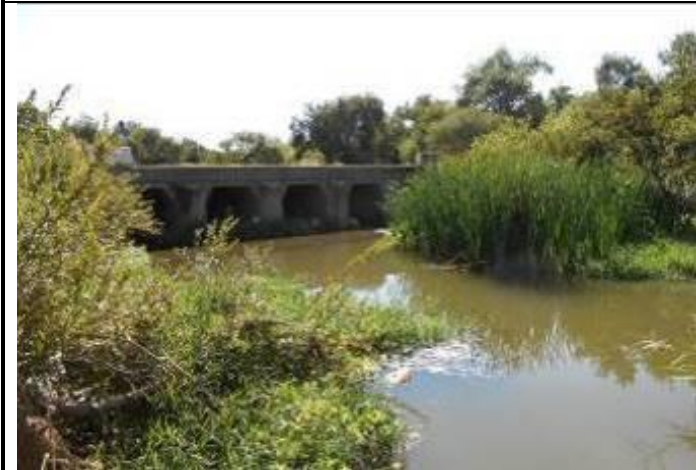
Figure 49: Downstream view of the SASS 27A site indicating the presence of turbid water at the time of the assessment.

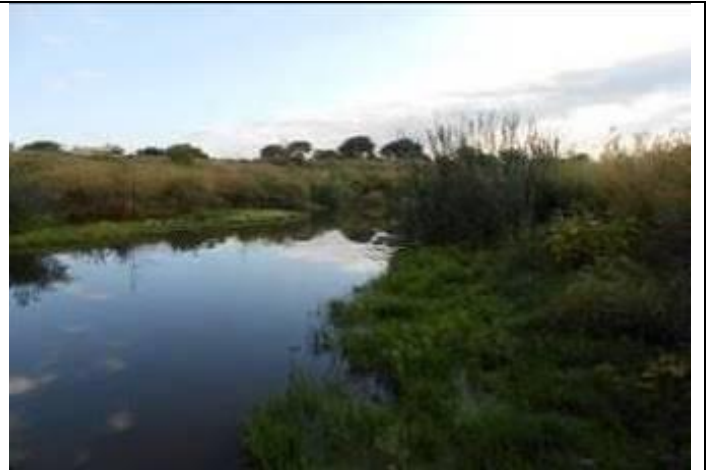
Figure 50: Downstream view of the SASS 29 site indicating the presence of abundant aquatic vegetation at the time of the assessment.

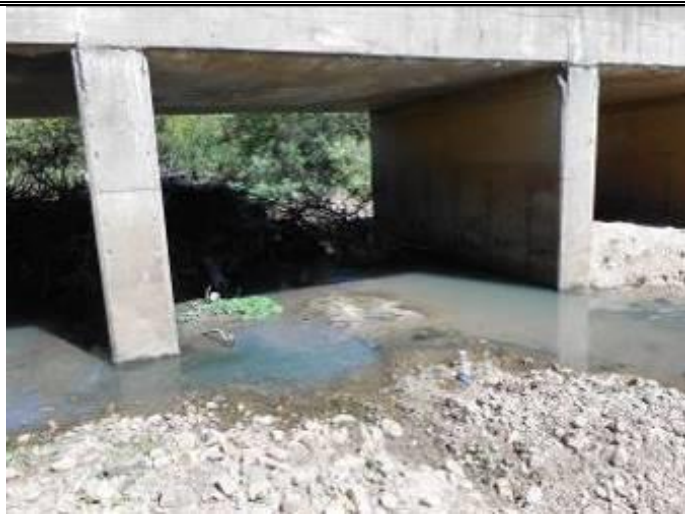
Figure 51: Upstream view of the SASS 31 site indicating the low flow and discoloured water at the time of the assessment likely due to presence of untreated sewage effluent.

- Both the upstream (SASS 31) and downstream (SASS 32) sites of the Dorpspruit may be considered to be in a Class E/F (severely impaired) condition according to the Dallas (2007) classification system. Both sites can be classified as a Class E (seriously impaired) conditions according to the Dickens & Graham (2001) classification system.

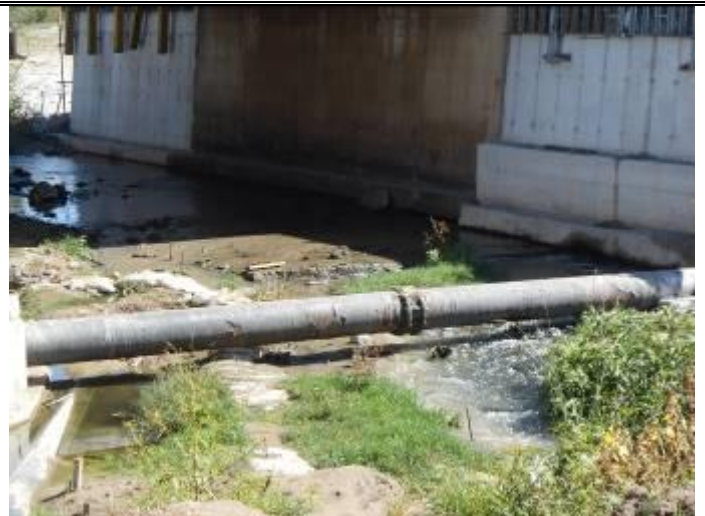
Figure 52: Upstream view of the SASS 32 site indicating the low flow present at the time of the assessment.

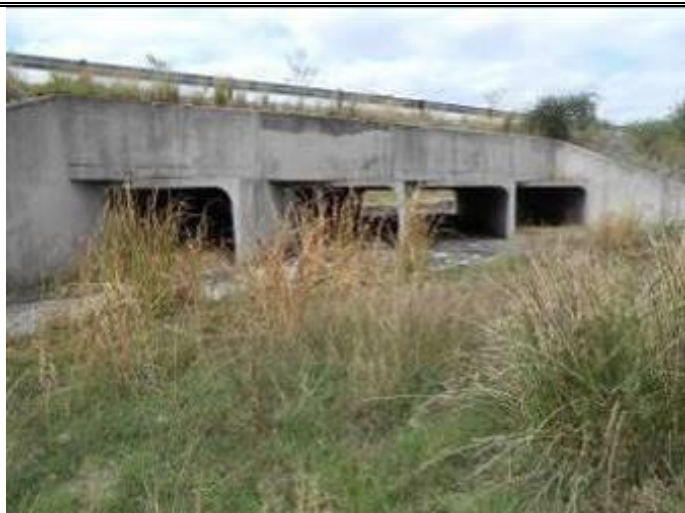
Figure 53: Local view of the SASS 4 site indicating the lack of flow at the time of the assessment.

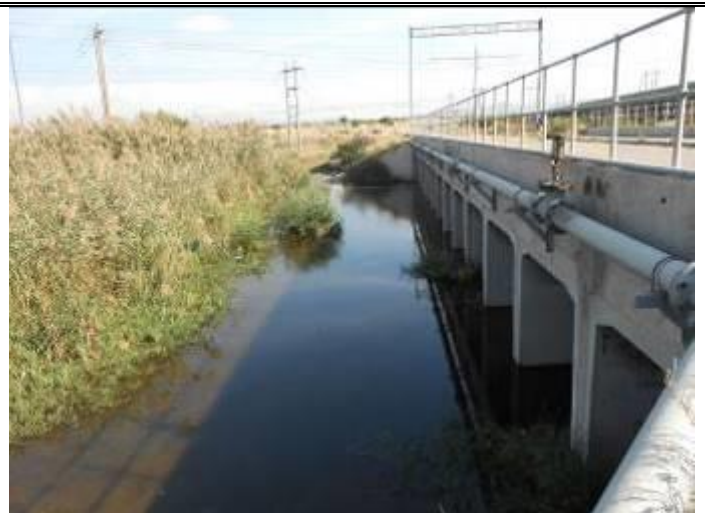
Figure 54: Downstream view of the SASS 9 site indicating the low flows and turbid water present at the time of the assessment.

- The EC value at site SASS 9 is critically elevated from natural conditions and is the highest EC recorded at the time of the assessment. It is possible that the run-off from the UG2 Concentrator and surrounding RPM activities are reaching the Klipfonteinspruit;

- The SASS 9 site of the Klipfonteinspruit may be considered to be in a Class C (moderately impaired) condition according to the Dallas (2007) classification system. The site can be classified as a Class C (moderately impaired) conditions according to the Dickens & Graham (2001) classification system;

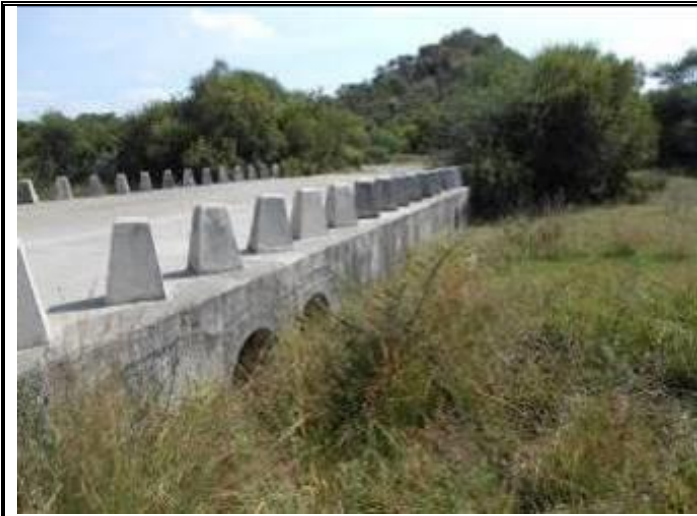
Figure 55: Local view of the SASS 19 site indicating the lack of flow at the time of the assessment.

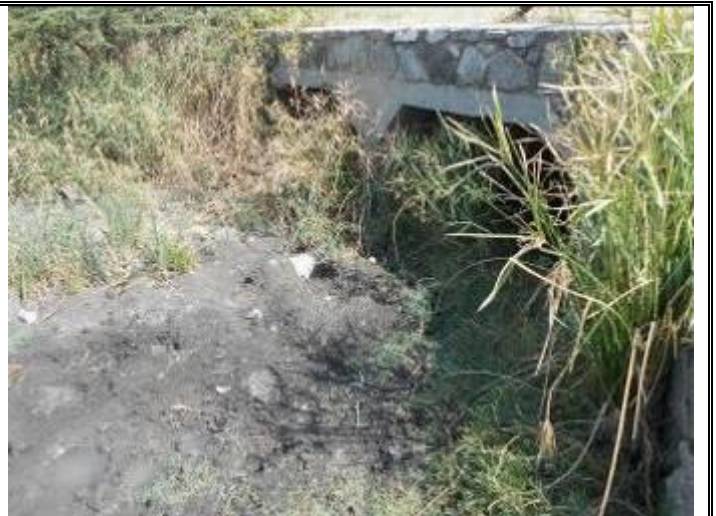
Figure 56: Downstream view of the SASS 15 site indicating the lack of flow at the time of the assessment.

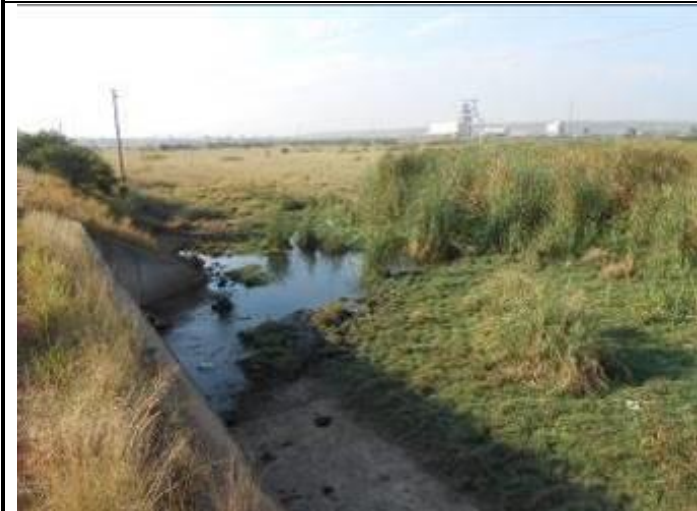
Figure 57: Upstream view of the SASS 21 site indicating the low flow at the time of the assessment.

- The EC recorded at site SASS 21 is elevated from natural conditions, indicating that dissolved salts are entering the system. Run-off and/or seepage from the

- The SASS 21 site of the Paardekraalspruit may be considered to be in a Class D (largely impaired) condition according to both the Dallas (2007) and Dickens & Graham (2001) classification systems.

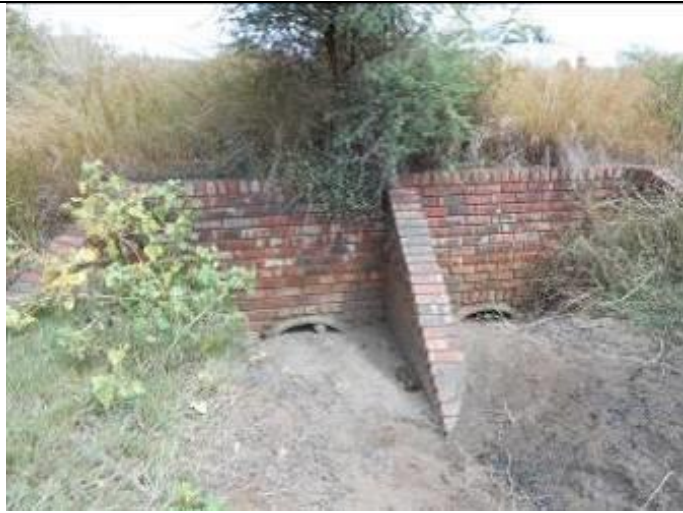
Figure 58: Upstream view of the SASS 35A site located on the Wildebeesfonteinspruit. The site was dry at the time of the assessment and culverts largely silted up.

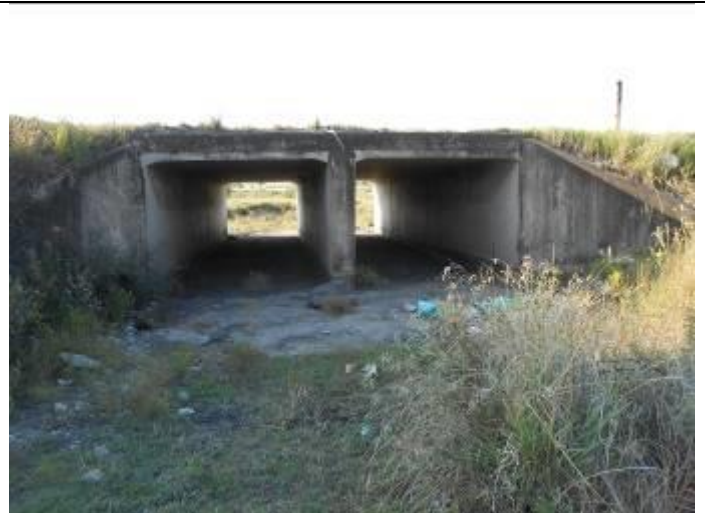
Figure 59: Downstream view of the SASS 39 site located on the Brakspruit. The site was dry at the time of the assessment.

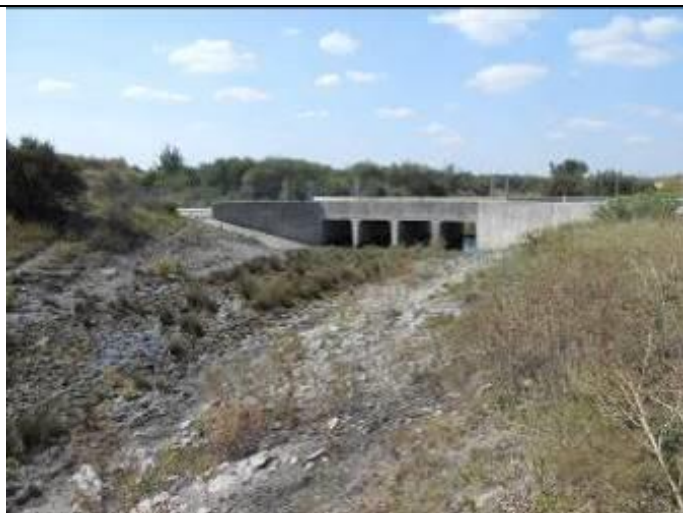
Figure 60: Upstream view of the SASS 40E located on the Hoedspruit. The site was dry at the time of the assessment.

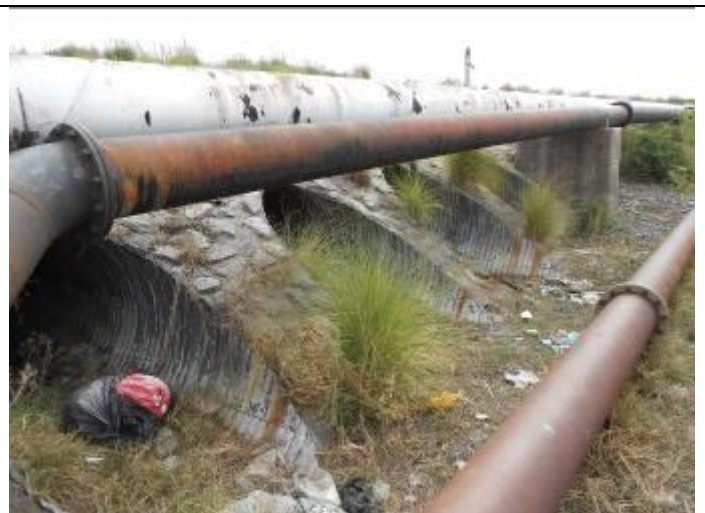
Figure 61: Downstream view of the SASS 12A site located on the Klippgatspruit. The site was dry at the time of the assessment.

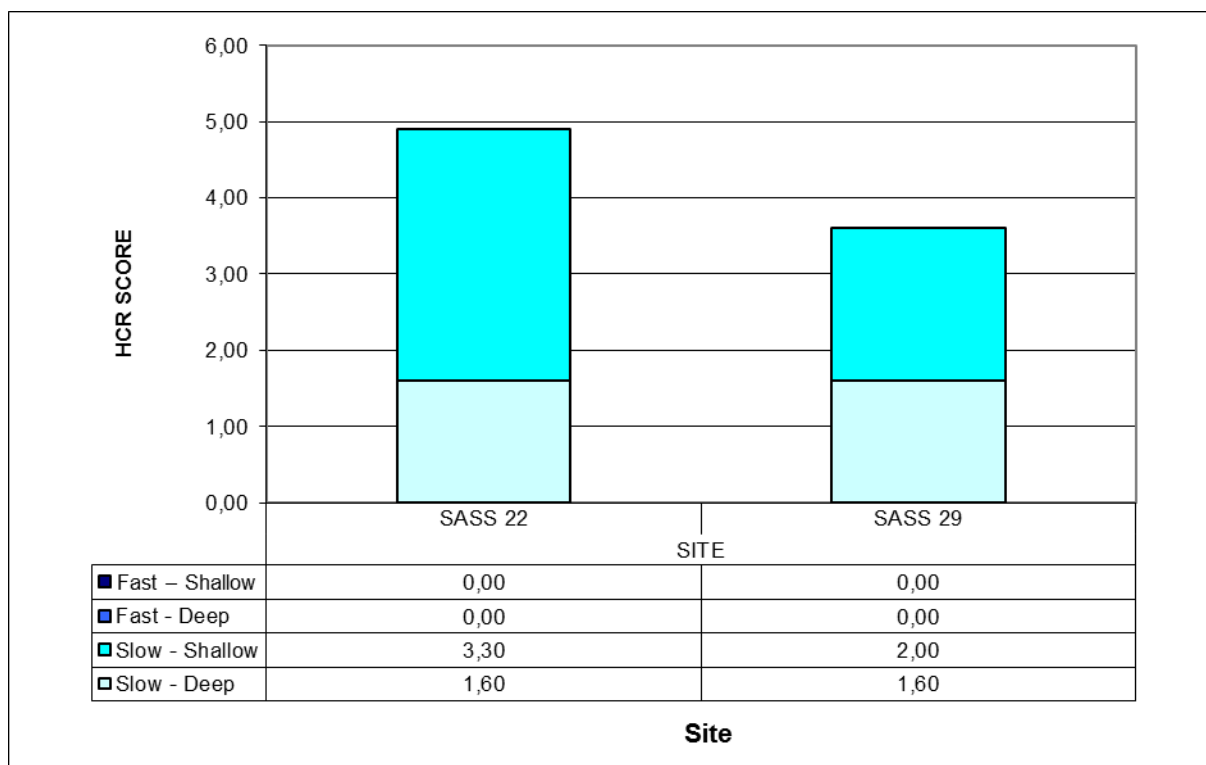
Figure 66: HCR scores for Sites SASS 22 and SASS 29.

Results indicate that slow-shallow conditions dominate the system followed by slow-deep conditions. The fish expected at Sites SASS 22 and SASS 29 will therefore be limited to fish with high intolerance values for fast-flowing water and to a lesser degree, species with a high intolerance value for deep habitats. Based on the HCR ratings, very similar fish species are expected at both sites as a result of the same diversity in depth flow classes present at these points.

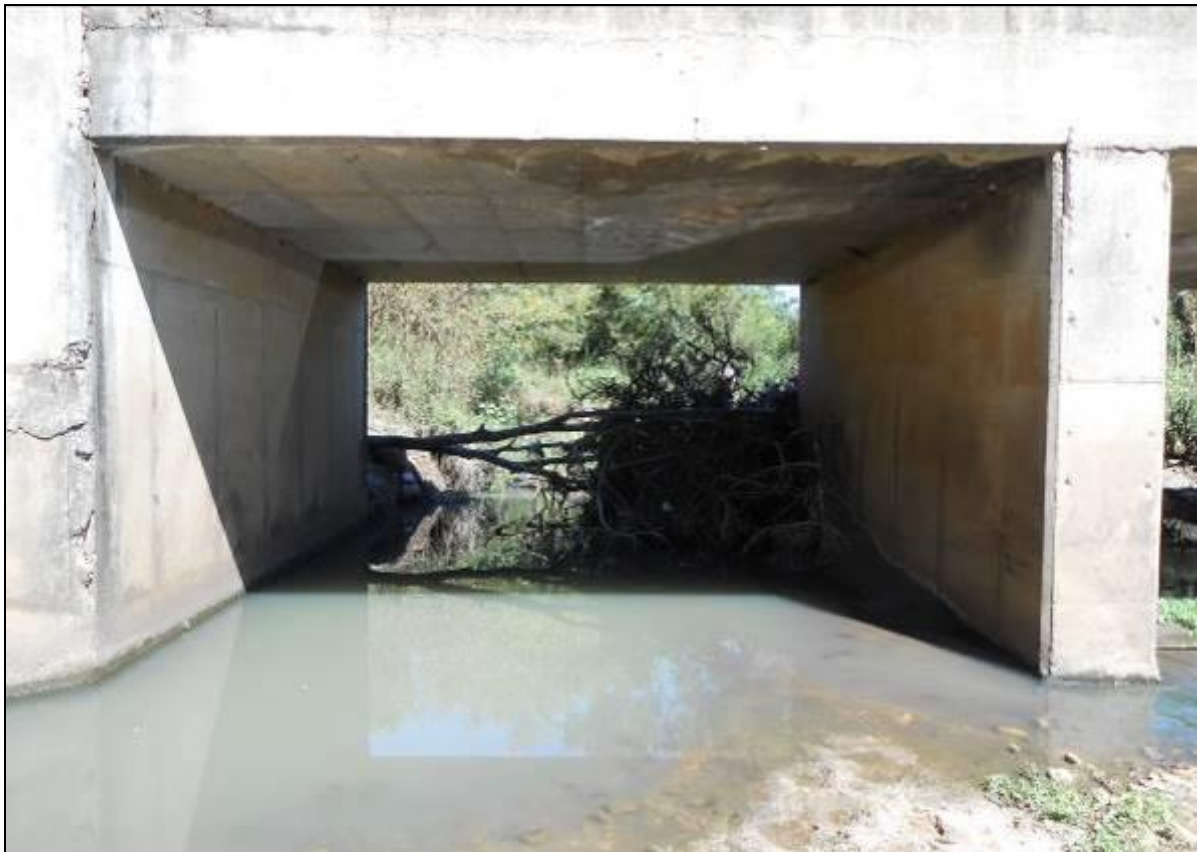
Large, woody debris is an important component of stream ecosystems. Where crossing structures restrict the ability of woody debris to pass downstream, crossings can inhibit or prevent the formation of natural debris dams and deflectors that are important habitat features for fish and wildlife, and play an important role in shaping channel characteristics.

Figure 70: Blockages present at monitoring sites, restricting movement of debris downstream.

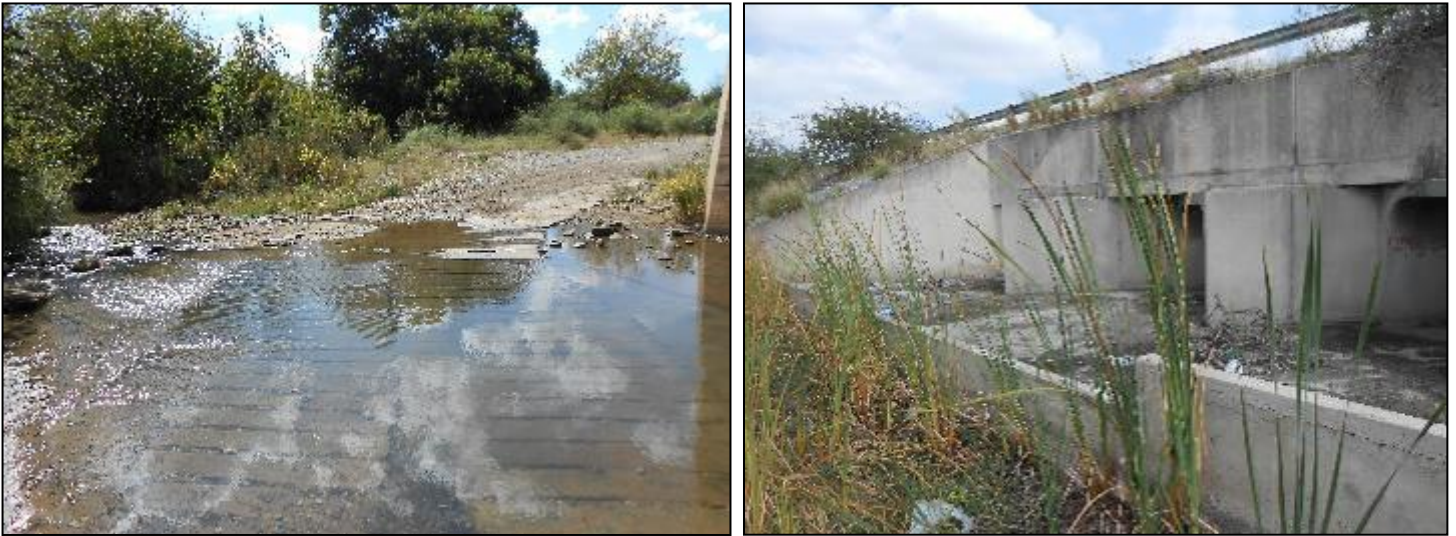
Figure 72: Discontinuity of natural stream substrate and physical migration barriers present at monitoring sites.
