THE TEACHER'S HOUSE (33/34)

Site Management Plan

Hidaya Jaffar Ali

Postgraduate Diploma Museum and Heritage Studies 2013

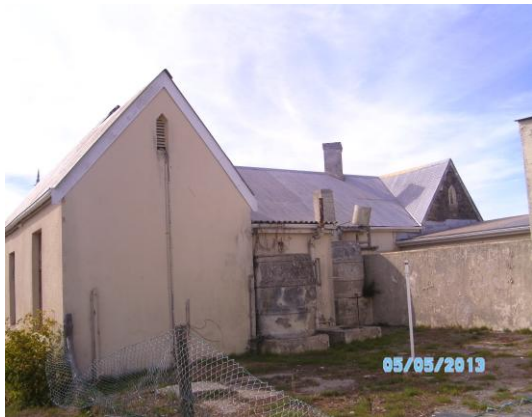
Western side elevation

The investigation analyzed that the condition of the building general is not good, and facing some challenges in conservation that include lack of maintenance and neglected. Cracks are evident on walls and mostly on the western side of the

house. Most of the windows glasses are broken and allow birds to enter and deteriorate some of the rooms and dropping are found in side, corrosion of reinforcements due to the structural failures which mostly on the door and windows of outside kitchen and the area where by the upper water tank is located. Generally the houses are surrounded by vegetation cover or growth that courses the path ways not seen properly. On the Southern side of the building which has un plastered wall the mortars are detached because of the rain water which come straight to the wall, also the plinth of the house is deteriorate and plaster are also removed which can cause the
