CONGELLA POWER STATION ("THE OLD SMOKEY")

110 SOUTH COAST ROAD ON:

Report by: G. S Bester (EPA)

**Revamped JLR Premises
110 South Coast Road
Umbilo Industrial Durban 4075**

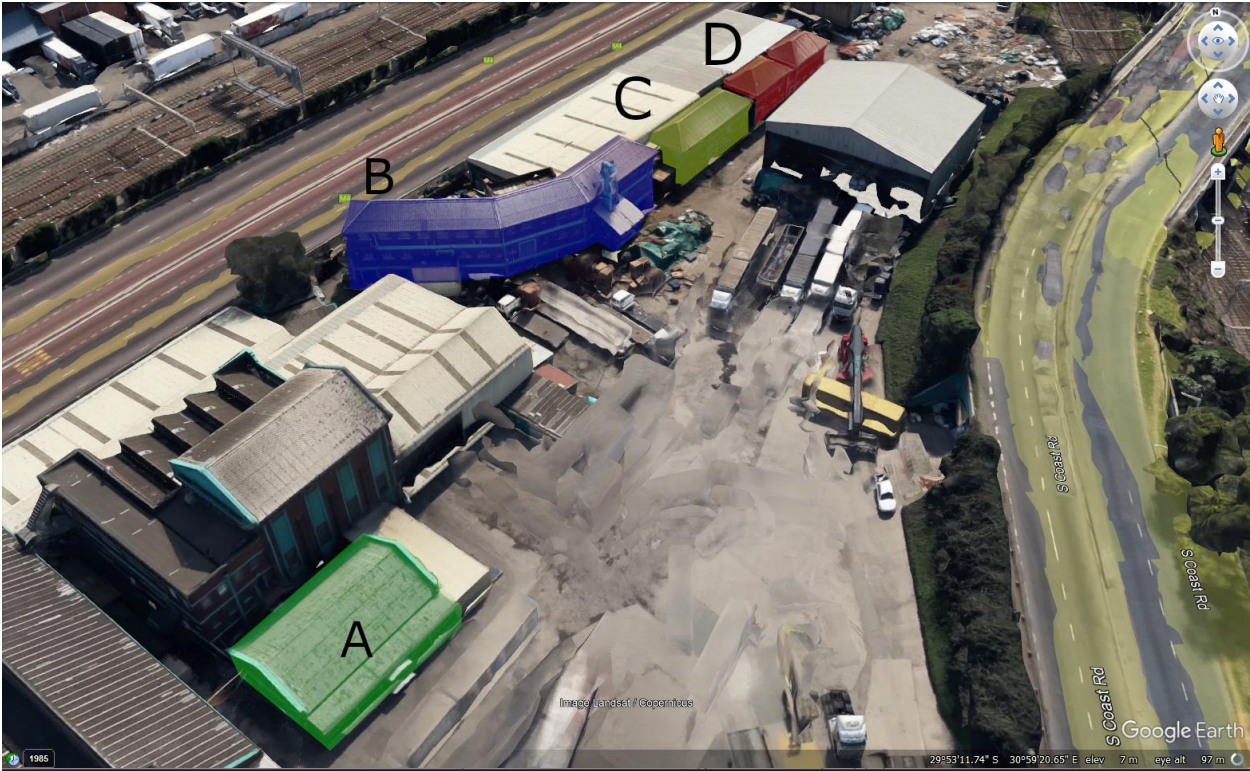
Building A were out of use for several years due to structural damage to the roof and floor. The building had also experienced structural and electrical problems before. The floods in 2022 compounded extensive and irreparable damage to the building.

It is the owner’s intention to follow due processes and apply for a demolition permit for buildings A, B, C and D.

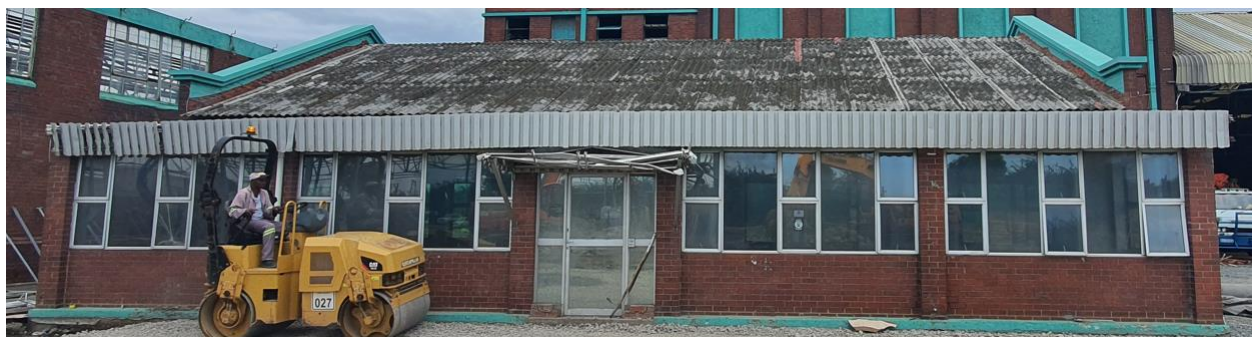
At some point the South East Porch has been enclosed with modern Anodised Aluminium windows. Although the windows may have had the promise of longevity, these windows have added no value to the character of the building. A side entrance door has also been added most likely at the same time when the newer more modern windows were installed. This too has been unsympathetic to the existing building.

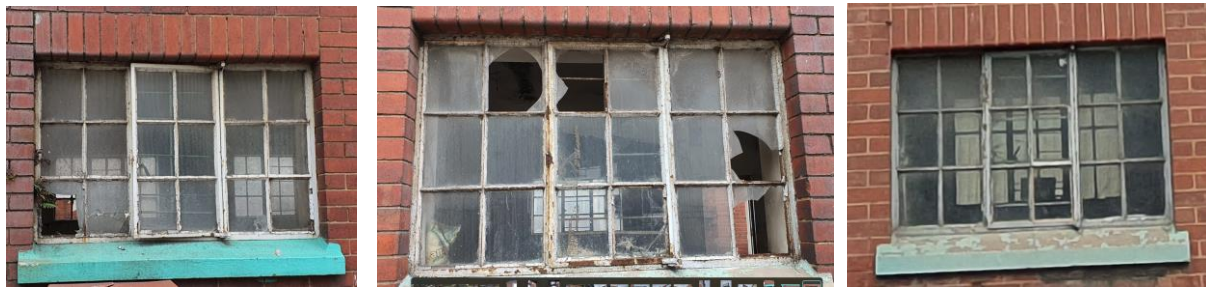
Steel windows have also been used which compliments the rest of the original buildings at the time. Again, many of the windows do not function and have broken glass.

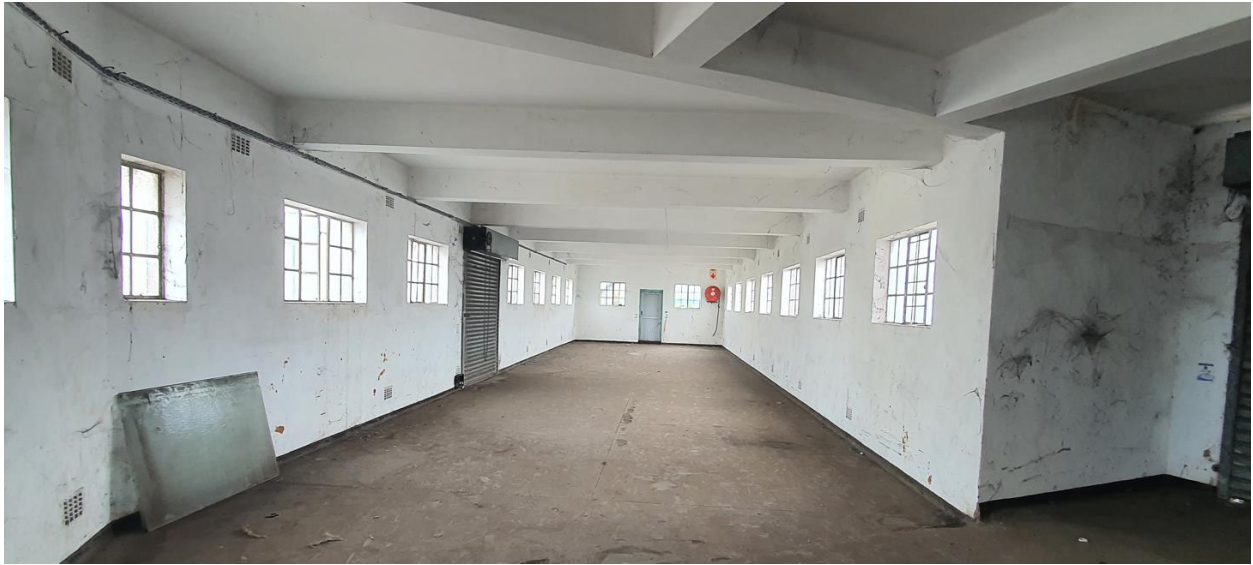
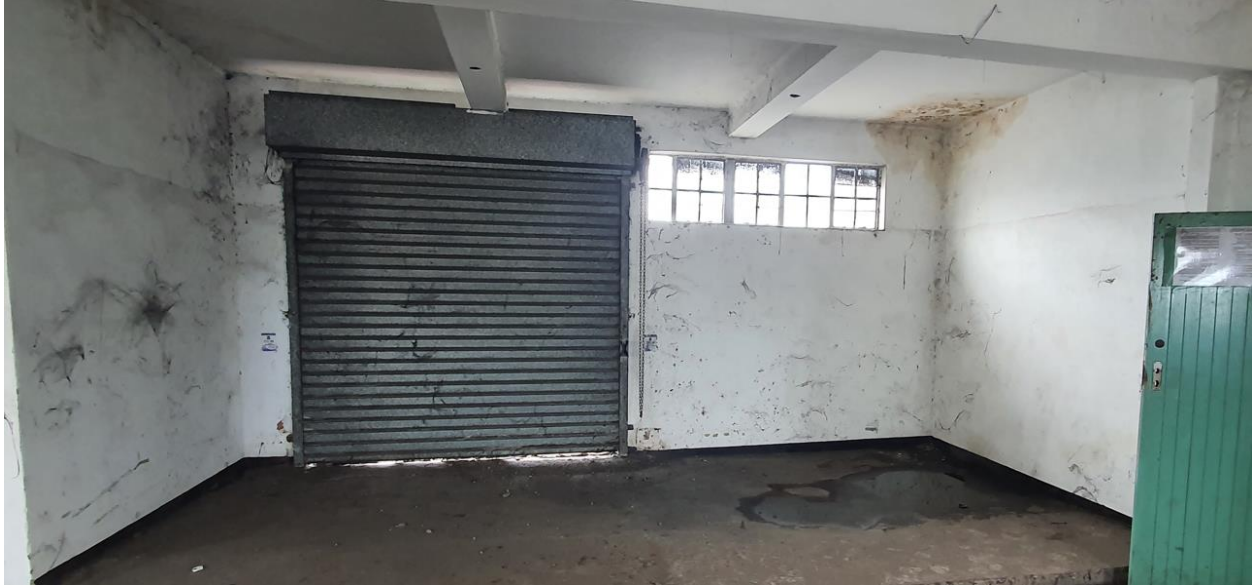
The first floor has been left completely vacant. There are no evidence of previous walls or rooms that may have been there in the past. The area has been used for grain and general storage in the past and roller shutter doors has been installed for that purpose.

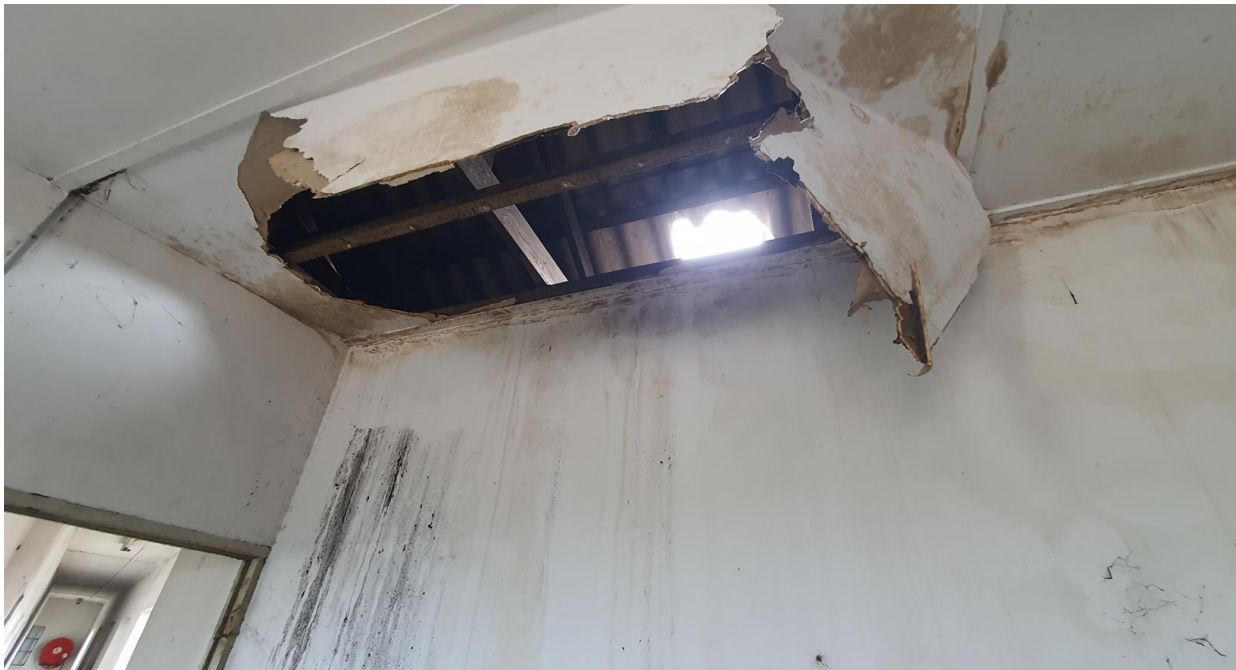
Roof Damage

The Third floor has room divisions with passages leading to what seems to have been communal kitchens and ablutions at some point. All the fittings and plumbing fixtures have been stripped or vandalised beyond repair. The existing roof have extensive damage which lead to water damage to the ceilings. The roof trusses are exposed and have been badly damaged by Wood Borah over the years. The roof sheeting is made from harmful Asbestos and will need to be removed by Health Specialists.

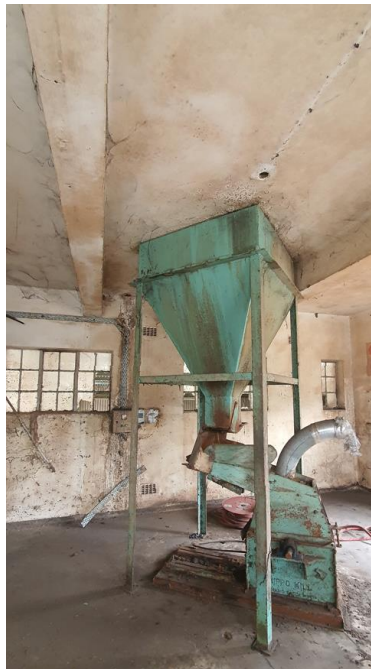
A portion of Building A can only be accessed from Building B. A separate room have at some point in the past been created for Grain supply. A conveyor belt fed the grain through the roof and into a room on the first floor where the grain would be funneled into bales. Extensive and ad-hoc remedial work was done to penetrate through the roof and floors for this purpose. This has severely weakened the structural integrity of the building.

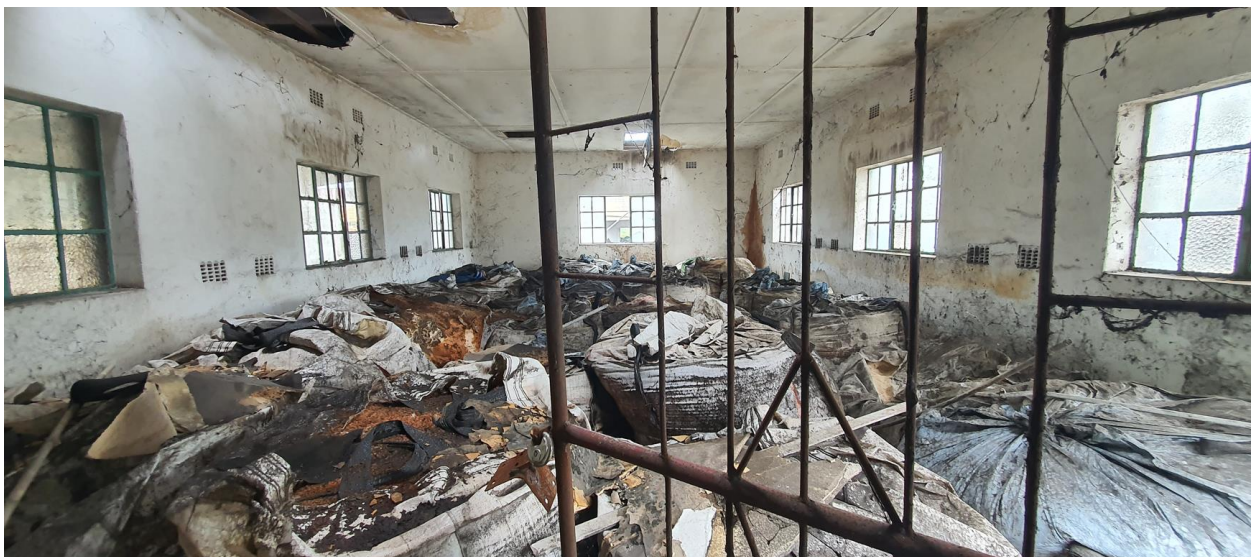
Building C and D have also experience extensive damage from the floods and subsequent vandalism and theft.

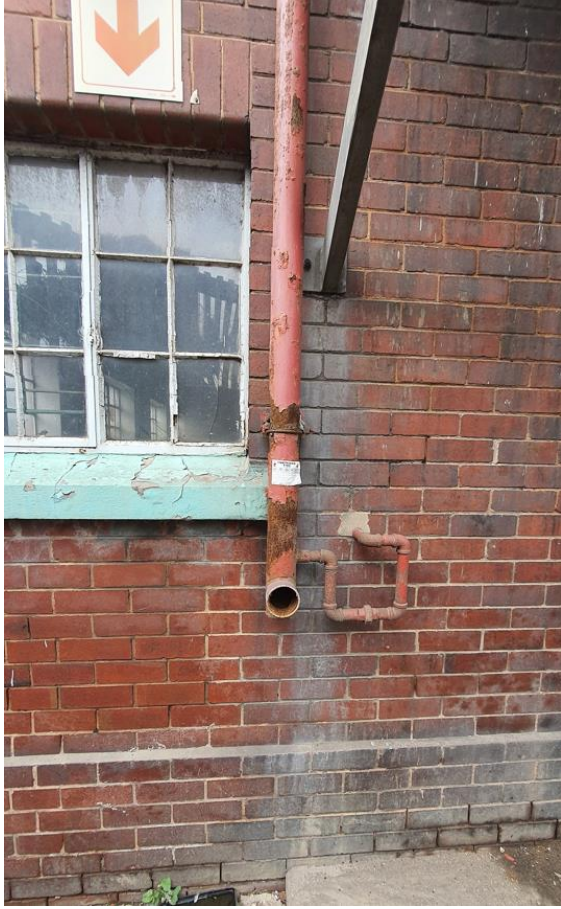
Important services such as fire hose reels and fire hydrants have been stolen and even some of the plumbing have been removed. Leaving the rest of the services to corrode under the Durban environment.

Redundant Fire Services

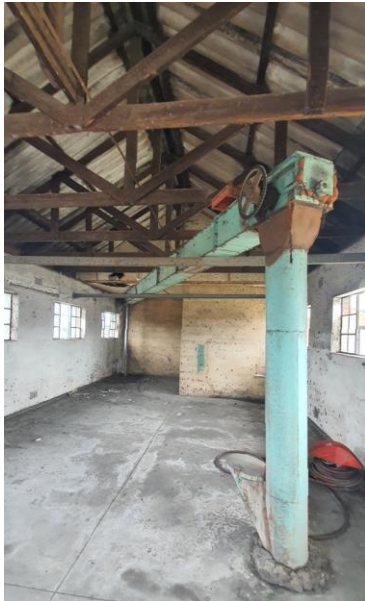
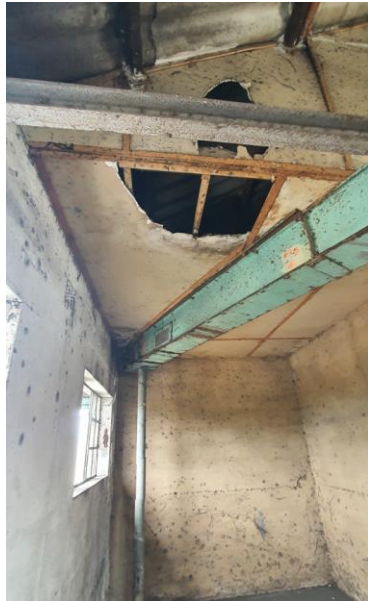
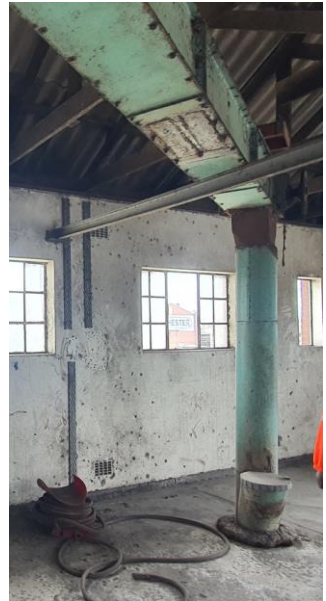
Thrid Floor Grain penetration through roof and floor

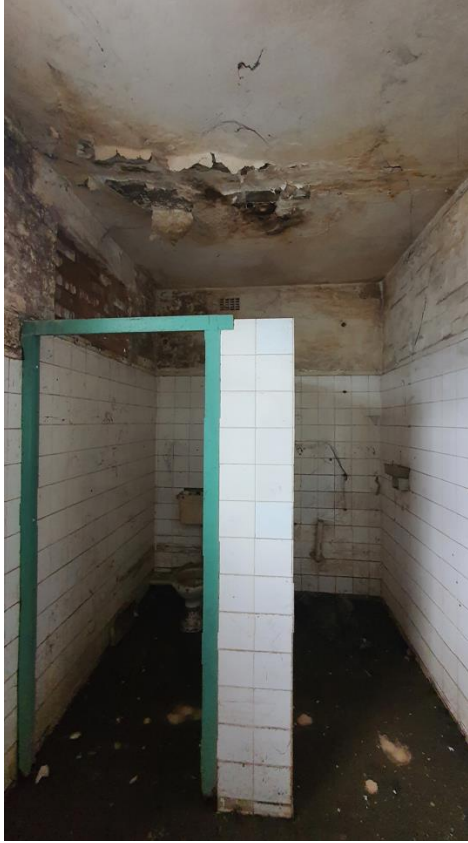
First Floor Ablution
