TAUNG SKULL WORLD HERITAGE SITE: BUILT LANDSCAPE INVENTORY OF SELECTED BUILDINGS AND STRUCTURES

The HIA, which is in the process of being conducted on the TSWHS, provides an opportunity to showcase the value of such an approach and output. The Built Landscape Inventory is a catalogue of buildings falling within both the Core and Buffer Zones and attempts to provide a very simplistic vantage point and baseline, from where the assessment and planning process can unfold. The purpose of the Built Landscape Inventory is to provide a list of key buildings, an assessment of the condition and the possible repurposing of the facilities into functional entities. This provides an initial recording of baseline data on the built landscape that can be further developed into a management [development and maintenance] plan for the built landscape at TSWHS.

The Built Landscape Inventory is compiled for the following Preliminary Zones and Sites on the TSWHS:

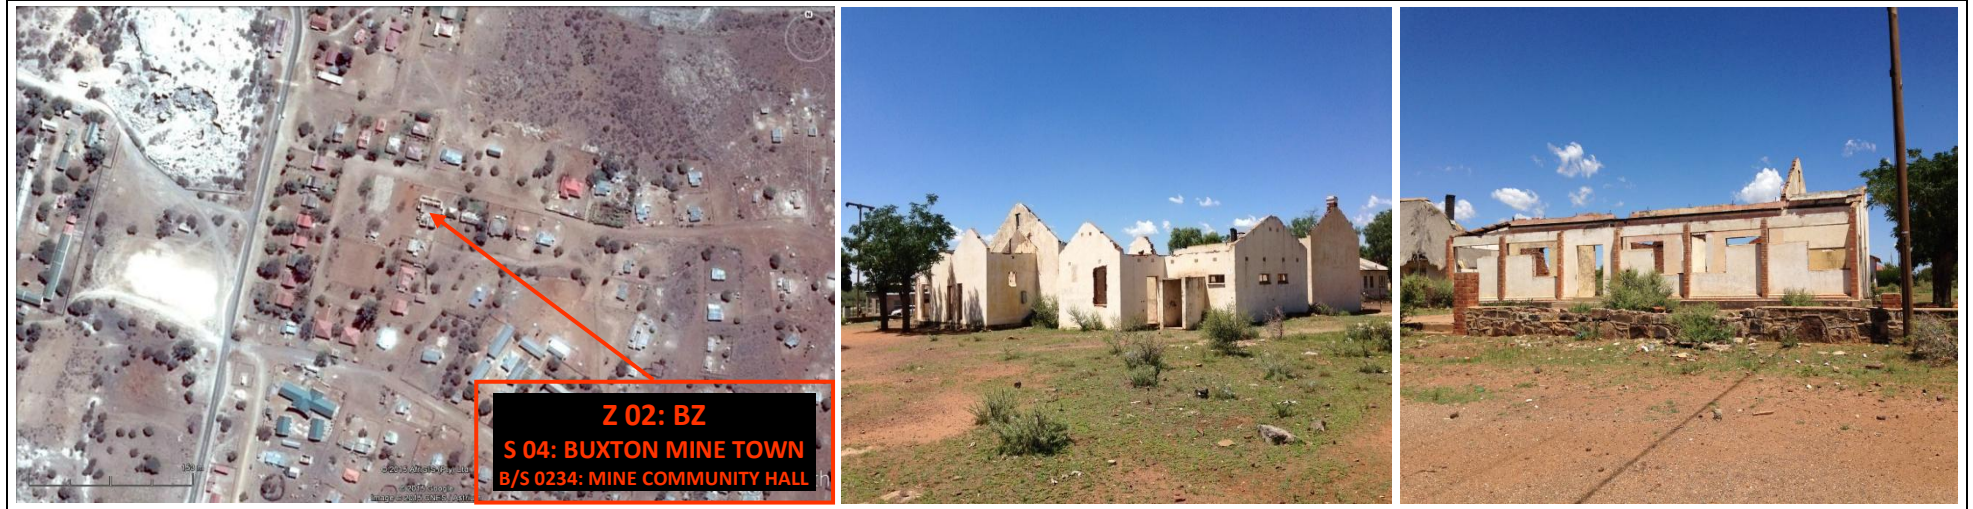
SITE & RELATIVE LOCALITY	BUILDING/STRUCTURE & RELATIVE POSITION	CONSTRUCTION MATERIALS & METHODS	HISTORICAL & CURRENT USES	CURRENT STATE & CONDITION	RESTORATION POTENTIAL & PRIORITY	PROPOSED FUTURE USES
<ul style="list-style-type: none"> ● Site 05: Buxton Mine Town ● Relative Locality: Approaching from the North, Site 05 is situated on the Eastern Side of the Main Entrance Road to the Norlim/Buxton Mine Town, past the Mine Complex on the right, past the Trading Store on the right, the Post Office on the left, and the Soccer Field on the right [refer to Figure 34] 	<ul style="list-style-type: none"> ● Building/Structure 0234: Mine Community Hall [refer to Photograph 34] ● Relative Position: Building [ruin] on Buxton Mine Town Site [refer to Figure 34] 	<ul style="list-style-type: none"> ● Construction Materials: Bricks, cement, steel, glass, wood and corrugated iron ● Construction Methods: Brick and plaster structure, covered by wooden roof trusses, clad with corrugated iron roof sheets 	<ul style="list-style-type: none"> ● Historical Use: Mine Community Hall ● Current Use: Not in use 	<ul style="list-style-type: none"> ● State: Vandalised and destroyed by fire ● Condition: Poor <ul style="list-style-type: none"> ○ Basic structure in poor condition, but should be restored ○ Fenestration and doors [steel and wood] removed, but should be replaced ○ Floor covering [not known] should be replaced ○ Roof support structure [wood trusses] should be replaced ○ Roof covering [corrugated iron roof sheets] should be replaced ○ All interior installations have been removed and should be replaced with authentic items ○ Basic services should be installed and connected 	<ul style="list-style-type: none"> ● Restoration potential: Poor ● Restoration priority: Low 	<p>To be determined</p>

FIGURE 34 • PHOTOGRAPH 34 • Zone 02 [Z 02]: Buffer Zone [BZ] • Site 05 [S 05]: Buxton Mine Town • Building/Structure 0234 [B/S 0234]: Mine Community Hall • Date: 24 February 2015

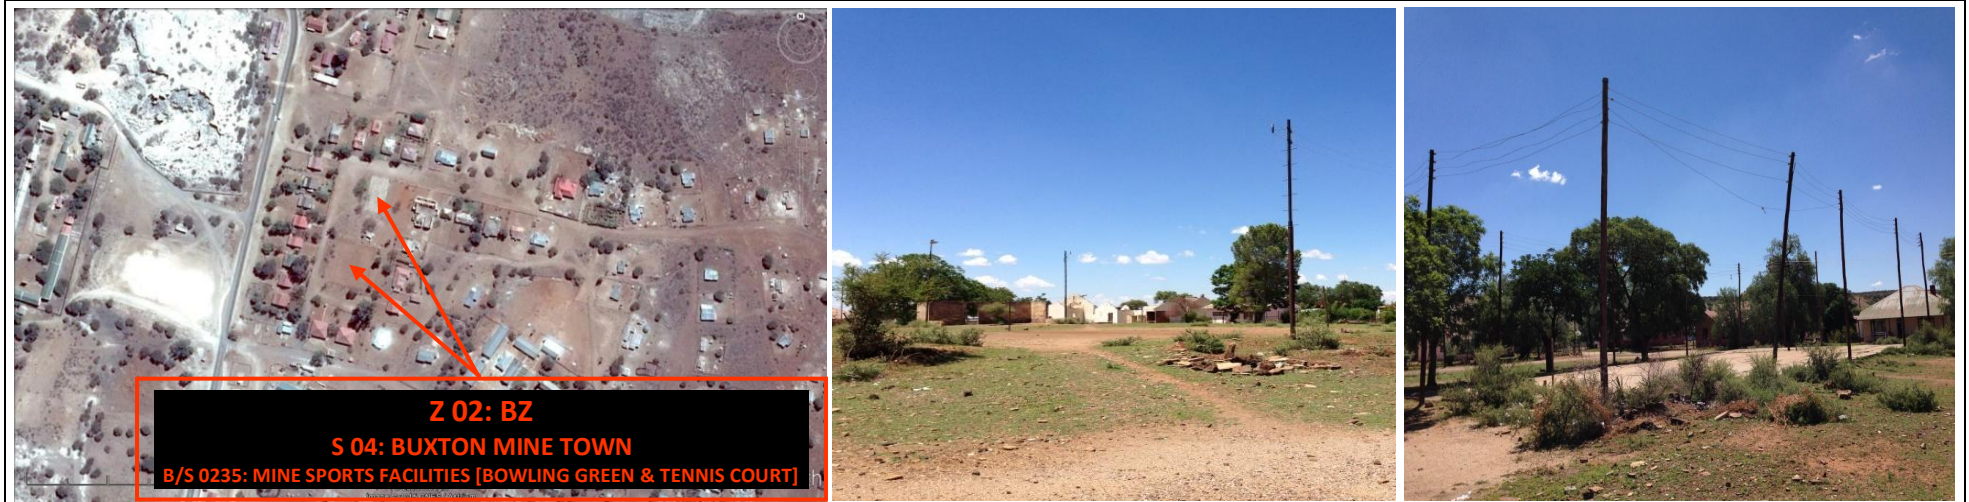
SHEET 35

SITE & RELATIVE LOCALITY	BUILDING/STRUCTURE & RELATIVE POSITION	CONSTRUCTION MATERIALS & METHODS	HISTORICAL & CURRENT USES	CURRENT STATE & CONDITION	RESTORATION POTENTIAL & PRIORITY	PROPOSED FUTURE USES
<ul style="list-style-type: none"> ● Site 05: Buxton Mine Town ● Relative Locality: Approaching from the North, Site 05 is situated on the Eastern Side of the Main Entrance Road to the Norlim/Buxton Mine Town, past the Mine Complex on the right, past the Trading Store on the right, the Post Office on the left, and the Soccer Field on the right [refer to Figure 35] 	<ul style="list-style-type: none"> ● Building/Structure 0235: Mine Sports Facilities [Bowling Green and Tennis Court] [refer to Photograph 35] ● Relative Position: Structures on Buxton Mine Town Site [refer to Figure 35] 	<ul style="list-style-type: none"> ● Construction Materials: Bricks, cement, steel, glass, wood and corrugated iron ● Construction Methods: Brick and plaster structure, covered by wooden roof trusses, clad with corrugated iron roof sheets 	<ul style="list-style-type: none"> ● Historical Use: Mine Sports Facilities [Bowling Green and Tennis Court] ● Current Use: Not in use 	<ul style="list-style-type: none"> ● State: Vandalised ● Condition: Poor <ul style="list-style-type: none"> ○ Basic structures in poor condition, but should be restored ○ All installations have been removed and should be replaced with authentic items ○ Basic services should be installed and connected 	<ul style="list-style-type: none"> ● Restoration potential: Poor ● Restoration priority: Low 	<p>To be determined</p>

FIGURE 35 • PHOTOGRAPH 35 • Zone 02 [Z 02]: Buffer Zone [BZ] • Site 05 [S 05]: Buxton Mine Town • Building/Structure 0235 [B/S 0235]: Mine Sports Facilities [Bowling Green & Tennis Court] • Date: 24 February 2015

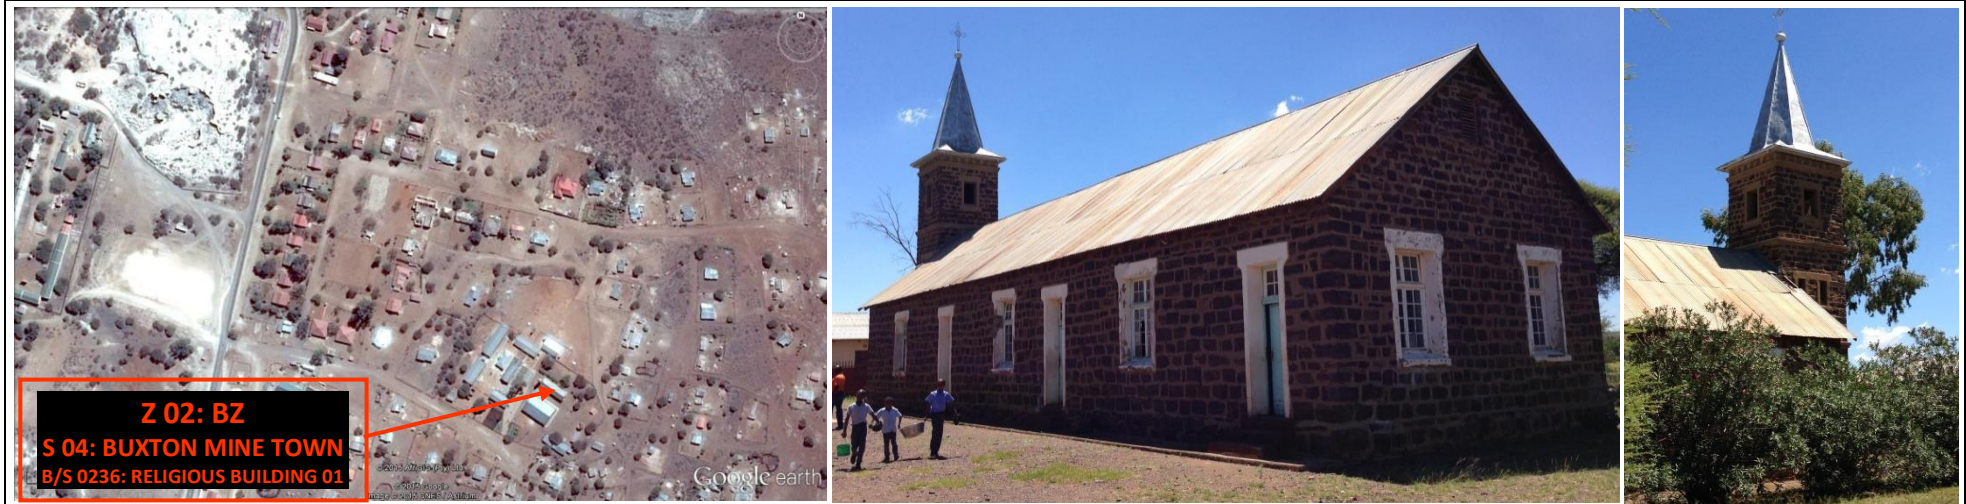
SHEET 36

SITE & RELATIVE LOCALITY	BUILDING/STRUCTURE & RELATIVE POSITION	CONSTRUCTION MATERIALS & METHODS	HISTORICAL & CURRENT USES	CURRENT STATE & CONDITION	RESTORATION POTENTIAL & PRIORITY	PROPOSED FUTURE USES
<ul style="list-style-type: none"> ● Site 05: Buxton Mine Town ● Relative Locality: Approaching from the North, Site 05 is situated on the Eastern Side of the Main Entrance Road to the Norlim/Buxton Mine Town, past the Mine Complex on the right, past the Trading Store on the right, the Post Office on the left, and the Soccer Field on the right [refer to Figure 36] 	<ul style="list-style-type: none"> ● Building/Structure 0236: Religious Building 01 [refer to Photograph 36] ● Relative Position: Building on Buxton Mine Town Site [refer to Figure 36] 	<ul style="list-style-type: none"> ● Construction Materials: Bricks, cement, steel, glass, wood and corrugated iron ● Construction Methods: Brick and plaster structure, covered by wooden roof trusses, clad with corrugated iron roof sheets 	<ul style="list-style-type: none"> ● Historical Use: Religious purposes ● Current Use: Religious purposes 	<ul style="list-style-type: none"> ● State: In use ● Condition: Good <ul style="list-style-type: none"> ○ Basic structure in good condition, but should be restored ○ Fenestration and doors [steel and wood] present, but should be restored and replaced, where necessary ○ Floor covering [not known] should be restored and replaced, where necessary ○ Roof support structure [wood trusses] present, but should be checked for structural integrity and should be restored and replaced, where necessary ○ Roof covering [corrugated iron roof sheets] present, but should be restored and replaced, where necessary ○ Some interior installations have been removed and should be replaced with authentic items ○ Basic services should be installed and connected 	<ul style="list-style-type: none"> ● Restoration potential: Good ● Restoration priority: Low 	<p>Same as current use</p>

FIGURE 36 • PHOTOGRAPH 36 • Zone 02 [Z 02]: Buffer Zone [BZ] • Site 05 [S 05]: Buxton Mine Town • Building/Structure 0236 [B/S 0236]: Religious Building 01 • Date: 24 February 2015

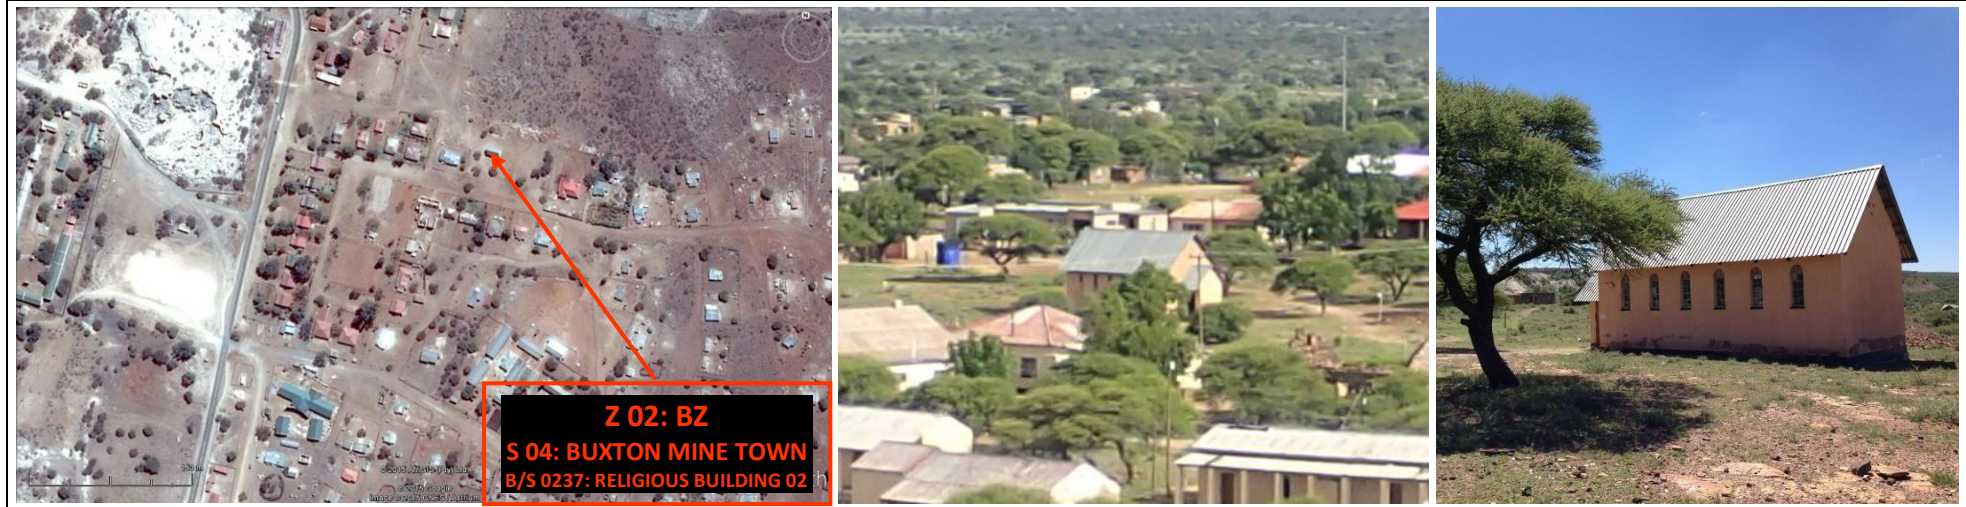
BUILT LANDSCAPE INVENTORY **SHEET 37**

SITE & RELATIVE LOCALITY	BUILDING/STRUCTURE & RELATIVE POSITION	CONSTRUCTION MATERIALS & METHODS	HISTORICAL & CURRENT USES	CURRENT STATE & CONDITION	RESTORATION POTENTIAL & PRIORITY	PROPOSED FUTURE USES
<ul style="list-style-type: none"> ● Site 05: Buxton Mine Town ● Relative Locality: Approaching from the North, Site 05 is situated on the Eastern Side of the Main Entrance Road to the Norlim/Buxton Mine Town, past the Mine Complex on the right, past the Trading Store on the right, the Post Office on the left, and the Soccer Field on the right [refer to Figure 37] 	<ul style="list-style-type: none"> ● Building/Structure 0237: Religious Building 02 [refer to Photograph 37] ● Relative Position: Building on Buxton Mine Town Site [refer to Figure 37] 	<ul style="list-style-type: none"> ● Construction Materials: Bricks, cement, steel, glass, wood and corrugated iron ● Construction Methods: Brick and plaster structure, covered by wooden roof trusses, clad with corrugated iron roof sheets 	<ul style="list-style-type: none"> ● Historical Use: Religious purposes ● Current Use: Religious purposes 	<ul style="list-style-type: none"> ● State: In use ● Condition: Good <ul style="list-style-type: none"> ○ Basic structure in good condition, but should be restored ○ Fenestration and doors [steel and wood] present, but should be restored and replaced, where necessary ○ Floor covering [not known] should be restored and replaced, where necessary ○ Roof support structure [wood trusses] present, but should be checked for structural integrity and should be restored and replaced, where necessary ○ Roof covering [corrugated iron roof sheets] present, but should be restored and replaced, where necessary ○ Some interior installations have been removed, but should be replaced with authentic items ○ Basic services should be installed and connected 	<ul style="list-style-type: none"> ● Restoration potential: Good ● Restoration priority: Low 	<p>Same as current use</p>

FIGURE 37 • PHOTOGRAPH 37 • Zone 02 [Z 01]: Buffer Zone [BZ] • Site 05 [S 05]: Buxton Mine Town • Building/Structure 0237 [B/S 0237]: Religious Building 02 • Date: 24 February 2015

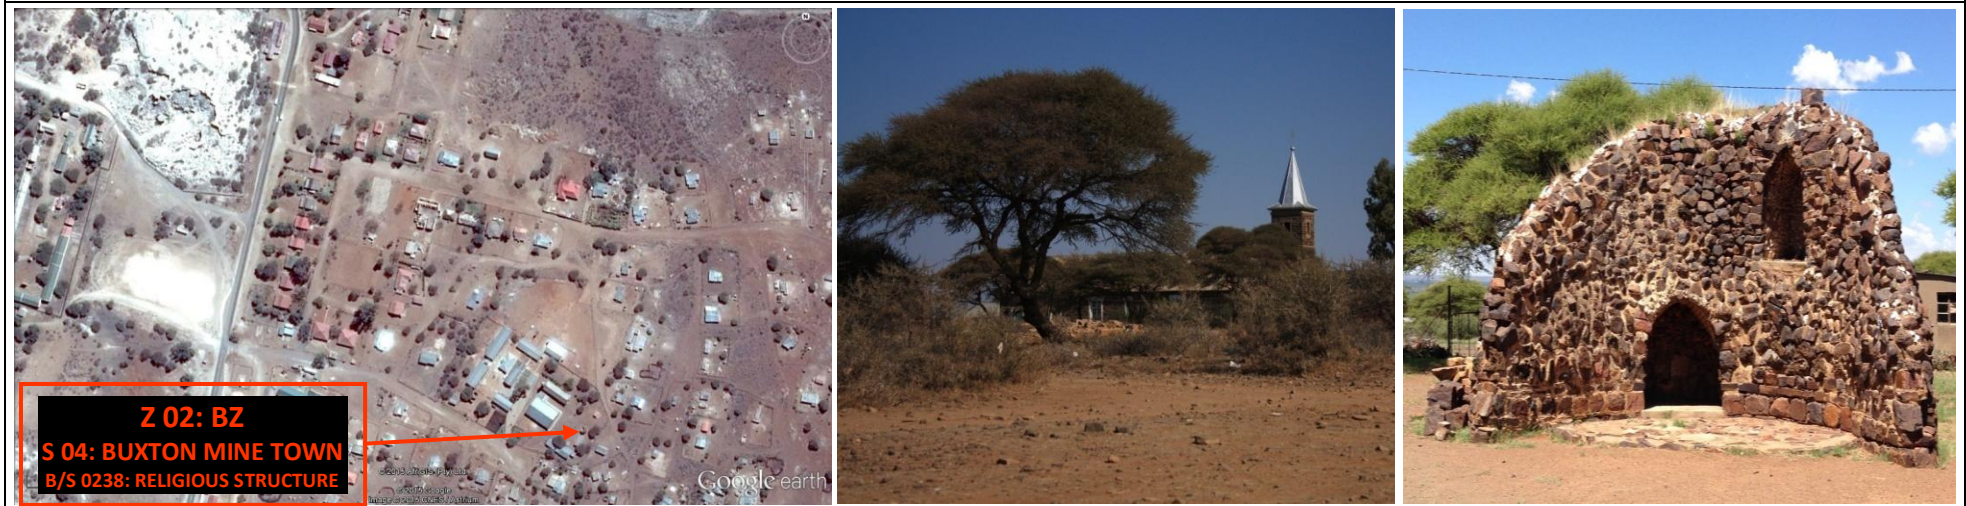
SHEET 38

SITE & RELATIVE LOCALITY	BUILDING/STRUCTURE & RELATIVE POSITION	CONSTRUCTION MATERIALS & METHODS	HISTORICAL & CURRENT USES	CURRENT STATE & CONDITION	RESTORATION POTENTIAL & PRIORITY	PROPOSED FUTURE USES
<ul style="list-style-type: none"> ● Site 05: Buxton Mine Town ● Relative Locality: Approaching from the North, Site 05 is situated on the Eastern Side of the Main Entrance Road to the Norlim/Buxton Mine Town, past the Mine Complex on the right, past the Trading Store on the right, the Post Office on the left, and the Soccer Field on the right [refer to Figure 38] 	<ul style="list-style-type: none"> ● Building/Structure 0238: Religious Structure [refer to Photograph 38] ● Relative Position: Structure on Buxton Mine Town Site [refer to Figure 38] 	<ul style="list-style-type: none"> ● Construction Materials: Bricks, cement, steel, glass, wood and corrugated iron ● Construction Methods: Brick and plaster structure, covered by wooden roof trusses, clad with corrugated iron roof sheets 	<ul style="list-style-type: none"> ● Historical Use: Religious purposes ● Current Use: Religious purposes 	<ul style="list-style-type: none"> ● State: In use ● Condition: Good <ul style="list-style-type: none"> ○ Basic structure in good condition, but should be restored 	<ul style="list-style-type: none"> ● Restoration potential: Good ● Restoration priority: Low 	<p>Same as current use</p>

FIGURE 38 • PHOTOGRAPH 38 • Zone 02 [Z 02]: Buffer Zone [BZ] • Site 05 [S 05]: Buxton Mine Town • Building/Structure 0238 [B/S 0238]: Religious Structure • Date: 24 February 2015

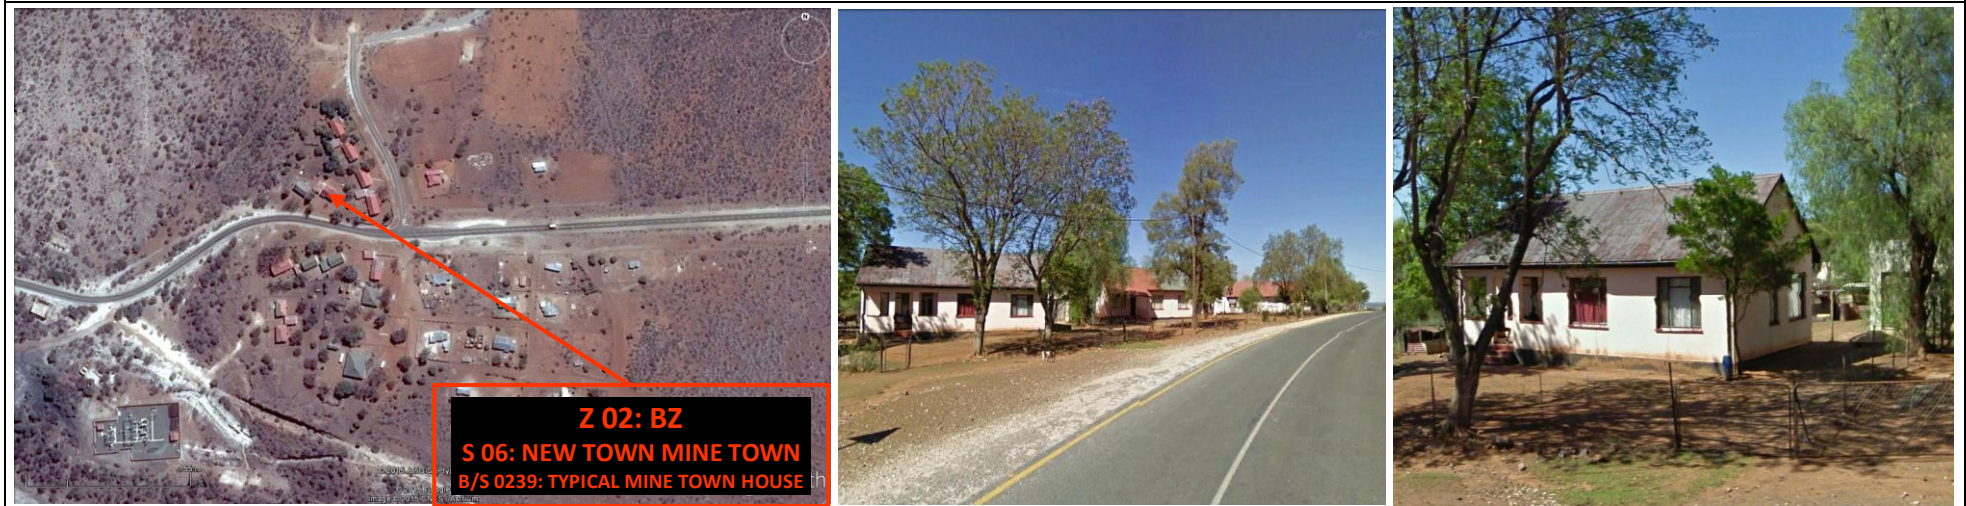
SHEET 39

SITE & RELATIVE LOCALITY	BUILDING/STRUCTURE & RELATIVE POSITION	CONSTRUCTION MATERIALS & METHODS	HISTORICAL & CURRENT USES	CURRENT STATE & CONDITION	RESTORATION POTENTIAL & PRIORITY	PROPOSED FUTURE USES
<ul style="list-style-type: none"> ● Site 06: New Town Mine Town ● Relative Locality: Approaching from the North, Site 06 is situated on the Northern and Southern Side of the Main Entrance Road to the Norlim/Buxton Mine Town, just after the turn-off to the Military Base Camp [refer to Figure 39] 	<ul style="list-style-type: none"> ● Building/Structure 0239: Typical Mine Town House [refer to Photograph 39] ● Relative Position: Building on New Town Mine Town Site [refer to Figure 39] 	<ul style="list-style-type: none"> ● Construction Materials: Bricks, cement, steel, glass, wood and corrugated iron ● Construction Methods: Brick and plaster structure, covered by wooden roof trusses, clad with corrugated iron roof sheets 	<ul style="list-style-type: none"> ● Historical Use: Residential Unit ● Current Use: Residential Unit 	<ul style="list-style-type: none"> ● State: In use ● Condition: Good <ul style="list-style-type: none"> ○ Basic structure in good condition, but should be restored ○ Fenestration and doors [steel and wood] present, but should be restored and replaced, where necessary ○ Floor covering [not known] should be restored and replaced, where necessary ○ Roof support structure [wood trusses] present, but should be checked for structural integrity and should be restored and replaced, where necessary ○ Roof covering [corrugated iron roof sheets] present, but should be restored and replaced, where necessary ○ Some interior installations have been removed and should be replaced with authentic items ○ Basic services should be installed and connected 	<ul style="list-style-type: none"> ● Restoration potential: Good ● Restoration priority: Low 	<p>To be determined</p>

FIGURE 39 • PHOTOGRAPH 39 • Zone 02 [Z 02]: Buffer Zone [BZ] • Site 06 [S 06]: New Town Mine Town • Building/Structure 0239 [B/S 0239]: Typical Mine Town House • Date: 24 February 2015

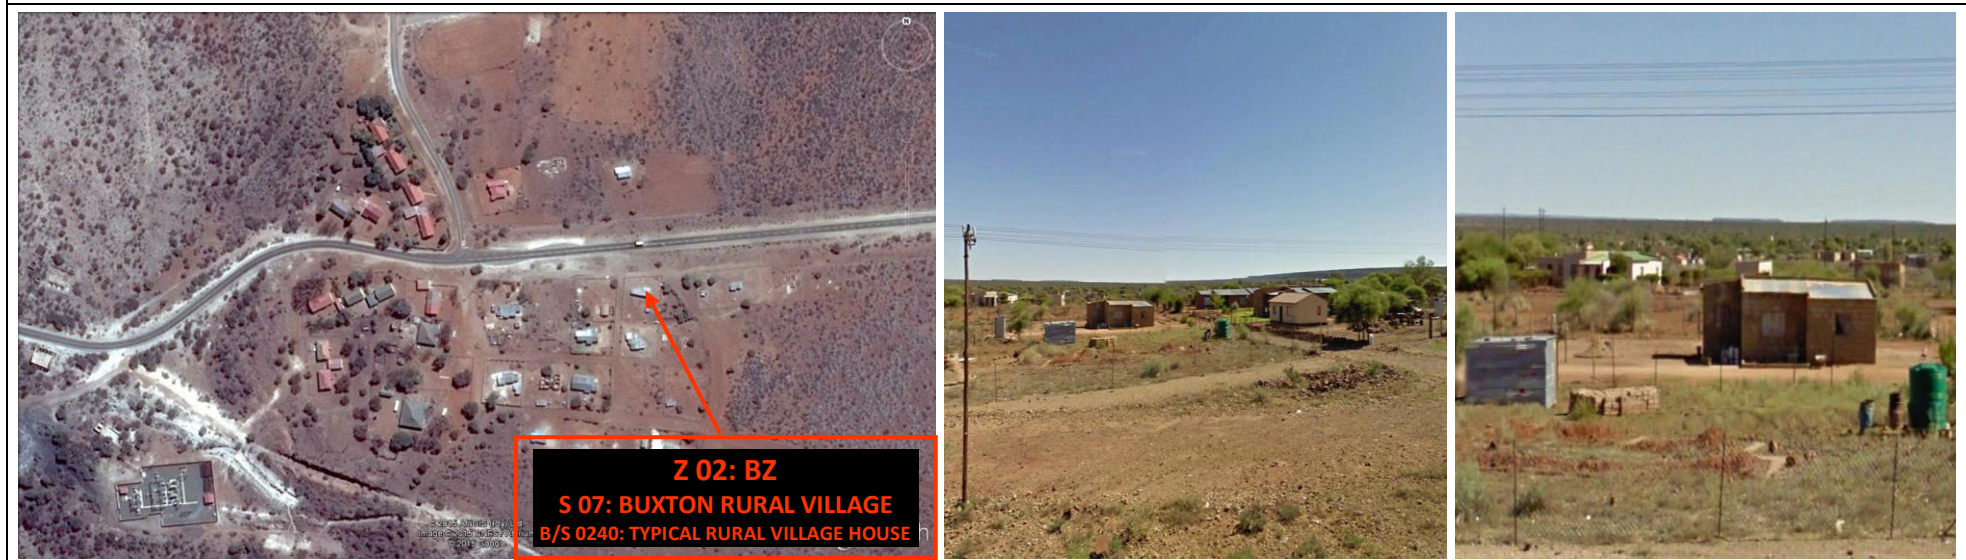
BUILT LANDSCAPE INVENTORY **SHEET 40**

SITE & RELATIVE LOCALITY	BUILDING/STRUCTURE & RELATIVE POSITION	CONSTRUCTION MATERIALS & METHODS	HISTORICAL & CURRENT USES	CURRENT STATE & CONDITION	RESTORATION POTENTIAL & PRIORITY	PROPOSED FUTURE USES
<ul style="list-style-type: none"> ● Site 07: Buxton Rural Village ● Relative Locality: Approaching from the North, Site 07 is situated on the Southern Side of the Main Entrance Road to the Norlim/Buxton Mine Town, just before the turn-off to the Military Base Camp [refer to Figure 40] 	<ul style="list-style-type: none"> ● Building/Structure 0240: Typical Rural Village House [refer to Photograph 40] ● Relative Position: Building on Buxton Rural Village Site [refer to Figure 39] 	<ul style="list-style-type: none"> ● Construction Materials: Bricks, cement, steel, glass, wood and corrugated iron ● Construction Methods: Brick and plaster structure, covered by wooden roof trusses, clad with corrugated iron roof sheets 	<ul style="list-style-type: none"> ● Historical Use: Rural Village Residential Unit ● Current Use: Rural Village Residential Unit 	<ul style="list-style-type: none"> ● State: In use ● Condition: Fair <ul style="list-style-type: none"> ○ Basic structure in fair condition ○ Fenestration and doors [steel and wood] in fair condition ○ Floor covering [cement floors] in fair condition ○ Roof support structure [wood trusses] in fair condition ○ Roof covering [corrugated iron roof sheets] in fair condition ○ Basic services should be installed and connected 	<ul style="list-style-type: none"> ● Restoration potential: Not applicable ● Restoration priority: Not applicable 	<p>Same as current use</p>

FIGURE 40 • PHOTOGRAPH 40 • Zone 02 [Z 02]: Buffer Zone [BZ] • Site 07 [S 07]: New Town Rural Village • Building/Structure 0240 [B/S 0240]: Typical Rural Village House • Date: 24 February 2015
