HERITAGE STATEMENT

118 Smiso Nkwanyana Rd (Goble Rd)

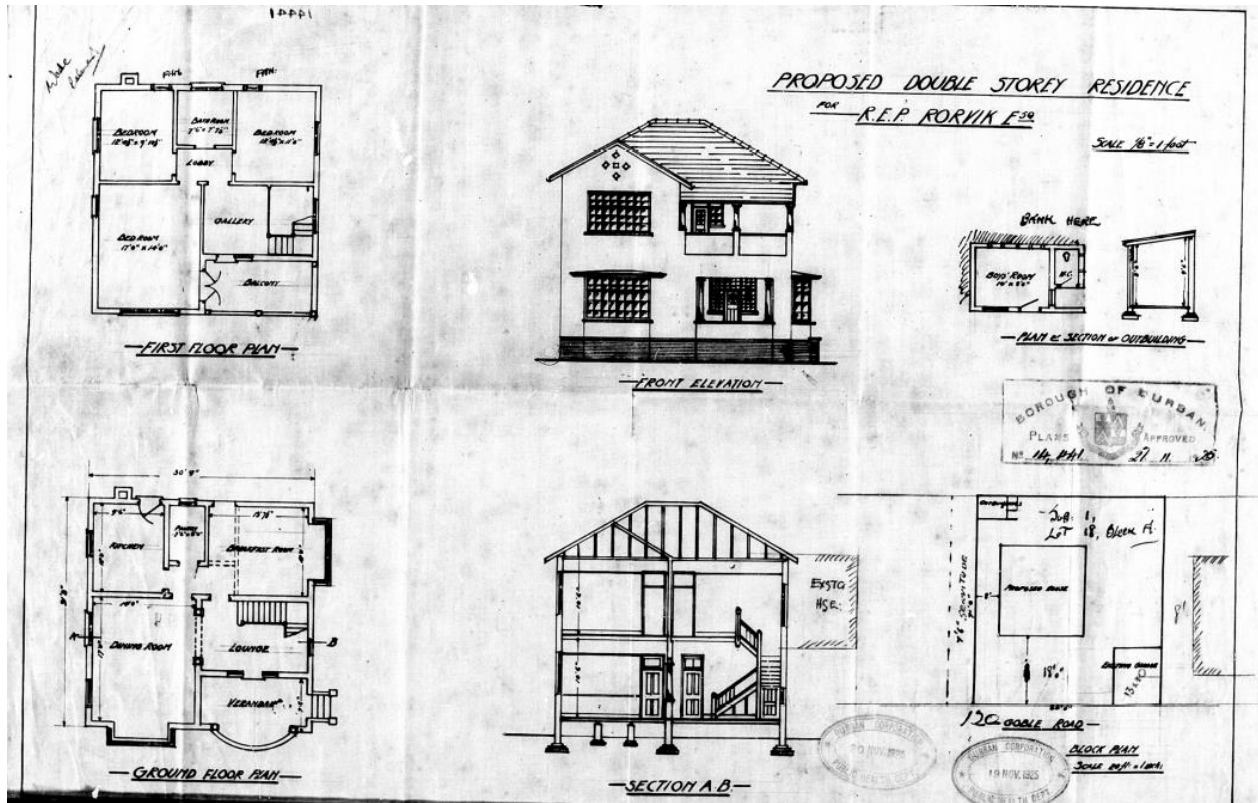
Figure 1: Original House Plans

Upon inspection of the plans available at eThekweni Municipality plans department, it appears that several plans were submitted, one even indicating that they were 'As built', but none of these plans were actually built. We therefore have compared the existing house to the original plans from 1925, shown in Figure 1 below, in order to detail the illegal additions and alterations done.
