**EXTENSION OF PHASE 1 (SAHRA ID 4150) HIA FOR
PROPOSED BRT SERVICE, PAUL KRUGER STREET,
PRETORIA, TSHWANE
FROM BLOED STREET TO SCHEIDING STREET,
EXCLUDING CHURCH SQUARE WITH SPECIFIC
REFERENCE TO SIDEWALKS AND VERANDAS**

November 2013

Report compiled by Sidney Miller.

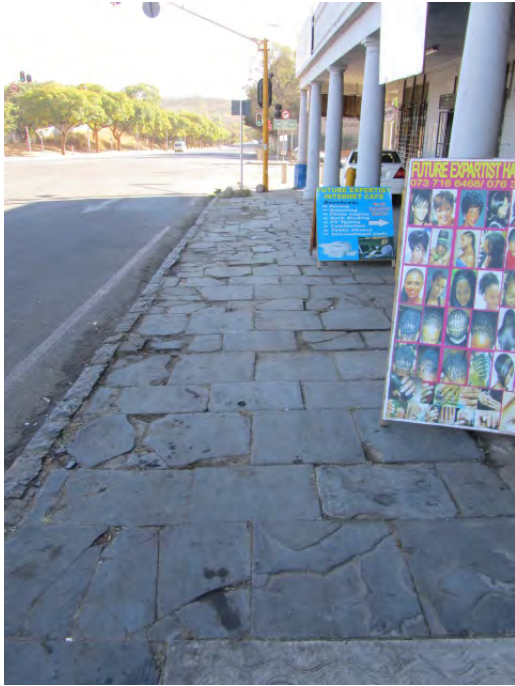
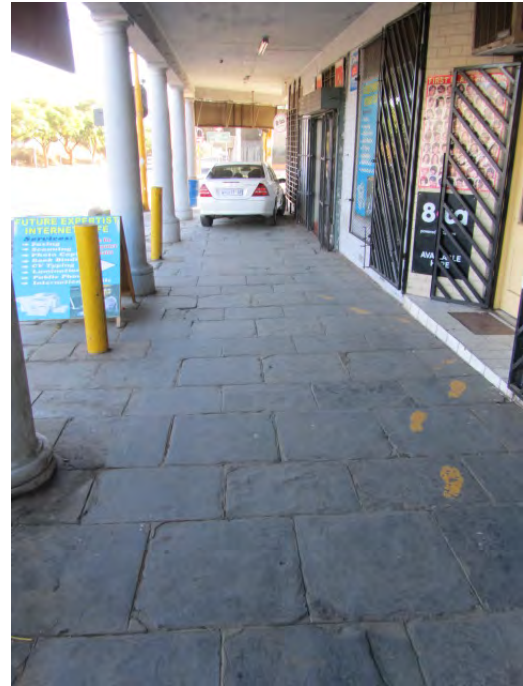
Figs 6 and 7 Historical slate flagstones, granite kerbing and pillars of sidewalk in front of protected building. (Photographs SM Miller 2012)

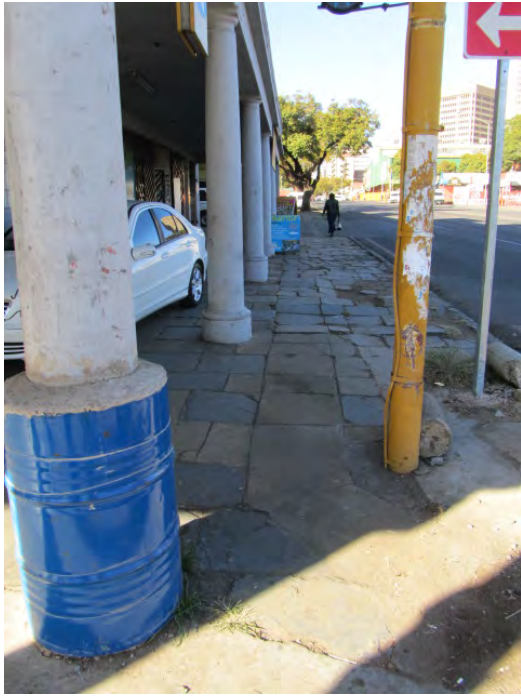
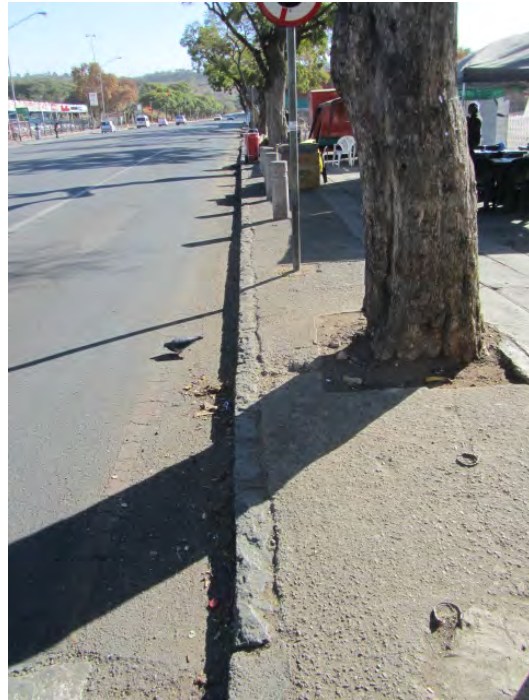
Figs 9 and 10 Historical slate flagstones on the sidewalk in front of protected building and granite kerbing on eastern side of Paul Kruger Street in Block 1. (Photographs SM Miller 2012)

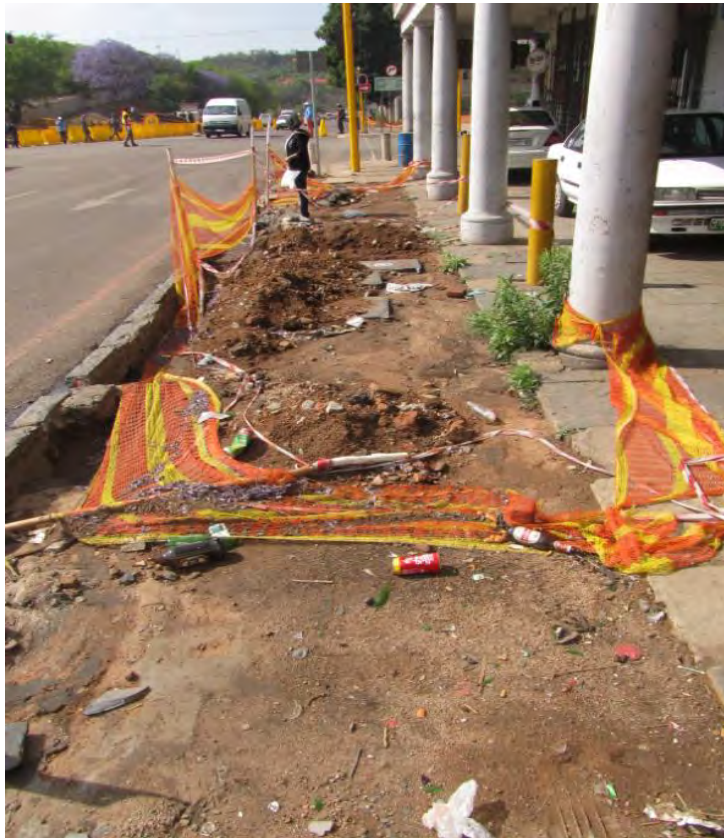
Fig. 20 Above is the historical slate flagstone sidewalk in front of protected building after an exploration for services. Compare to Figure 4. (Photograph SM Miller 2013)

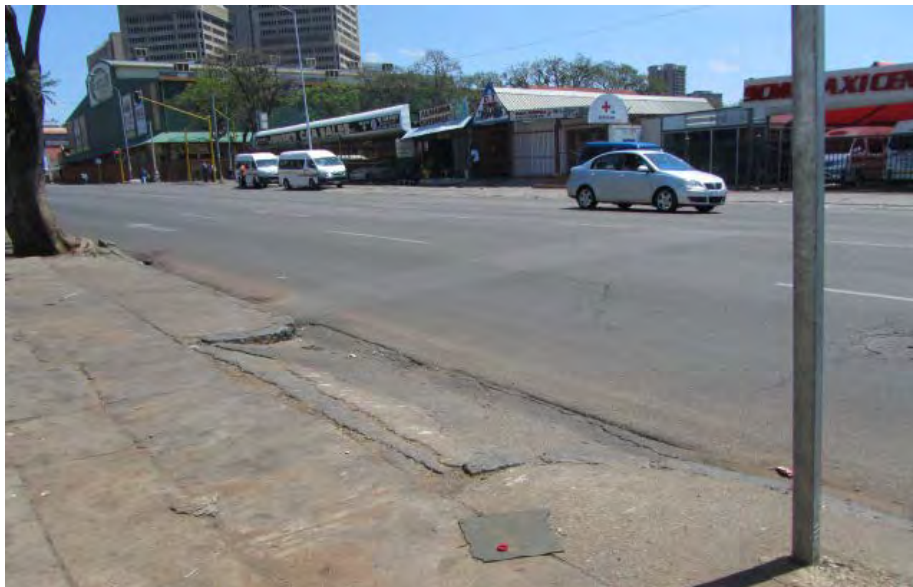
Fig. 21 Intervention for vehicular access to previous dwellings and existing businesses such as depicted above occurs along the eastern side of Paul Kruger Street. These vary from three to nearly 5 meters (Photograph SM Miller 2013)

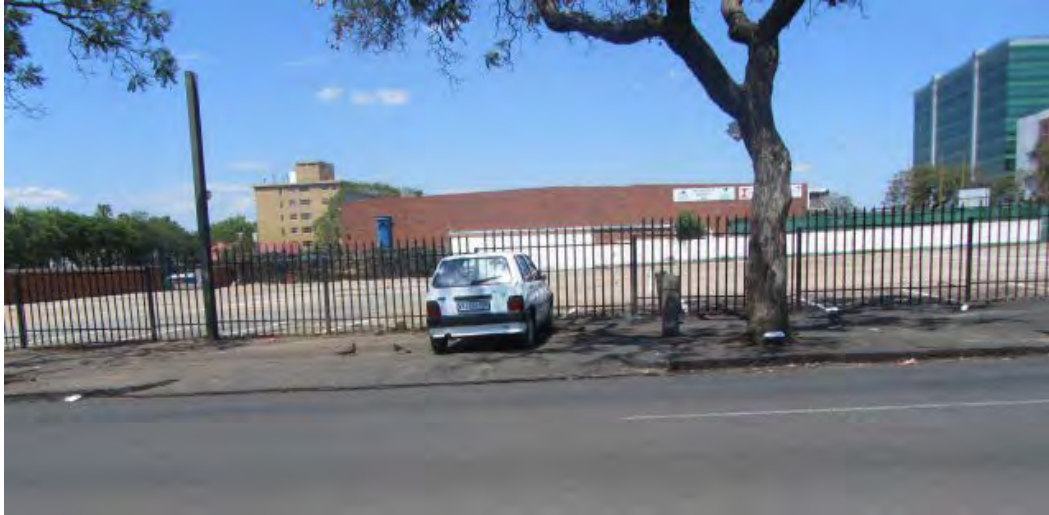
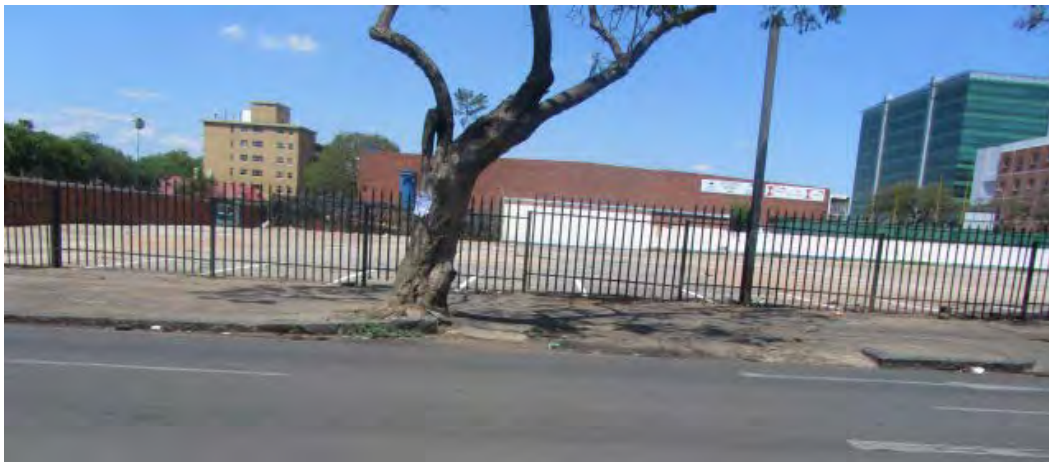
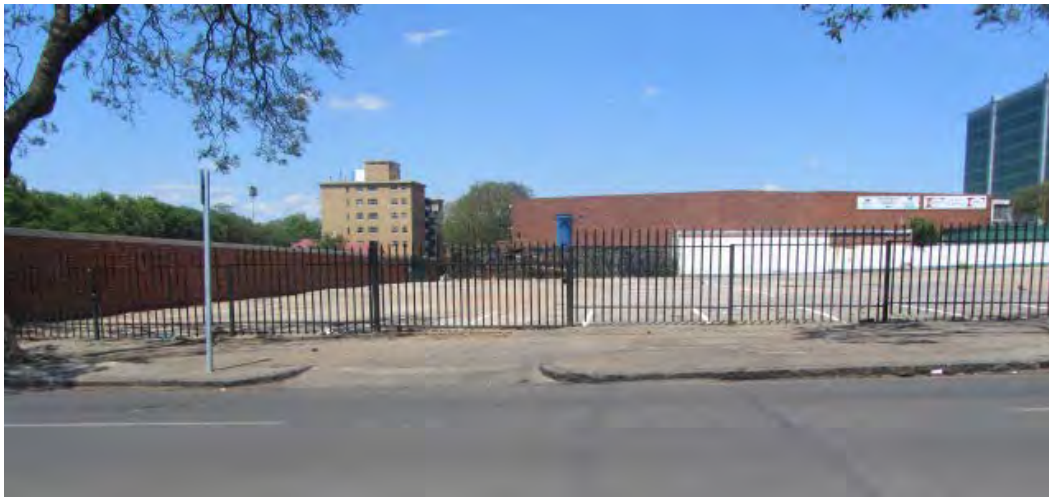
Figs 22 to 24 Although long sections of granite kerbing remain, there are 5 vehicular access breaks as depicted above. (Photographs SM Miller 2013)

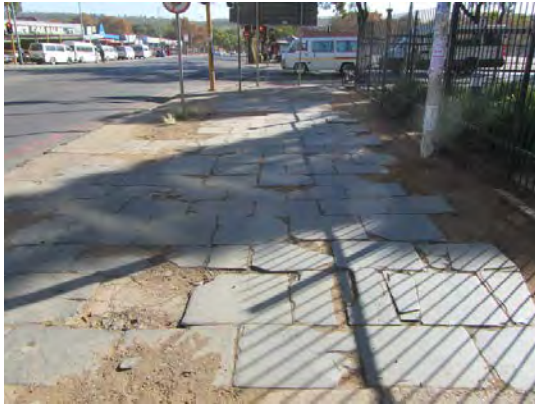
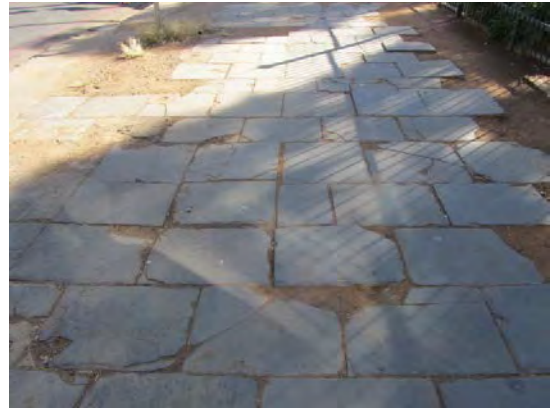
Figs 28 and 29 *Historical slate flagstones on the sidewalk along Paul Kruger Street on the north-eastern corner of Paul Kruger and Bloed streets. (Photographs SM Miller 2012)*

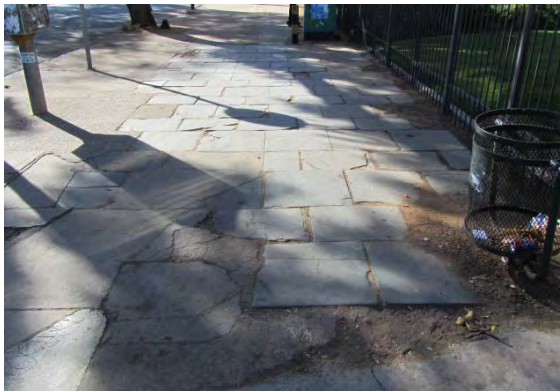
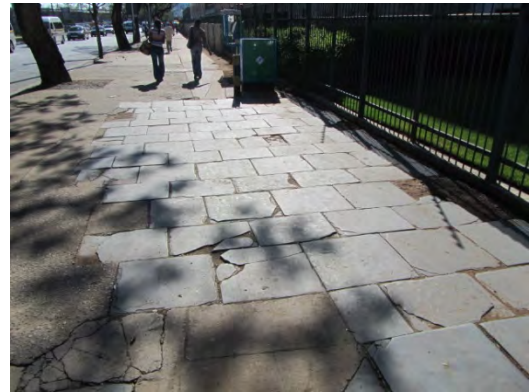
Figs 30 and 31 *Historical slate flagstones on the sidewalk along Bloed Street on the north-eastern corner of Paul Kruger and Bloed streets. (Left, Photograph SM Miller 2012. Right, Photograph SM Miller 2013)*

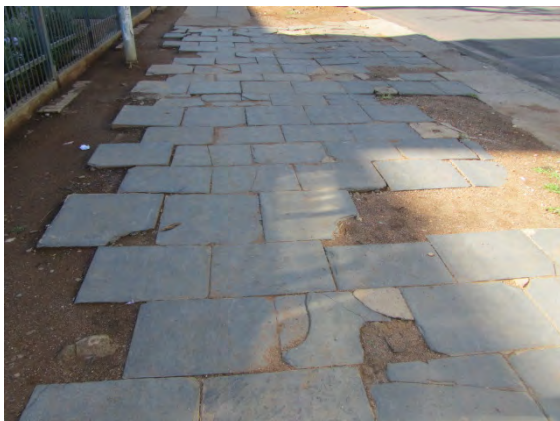
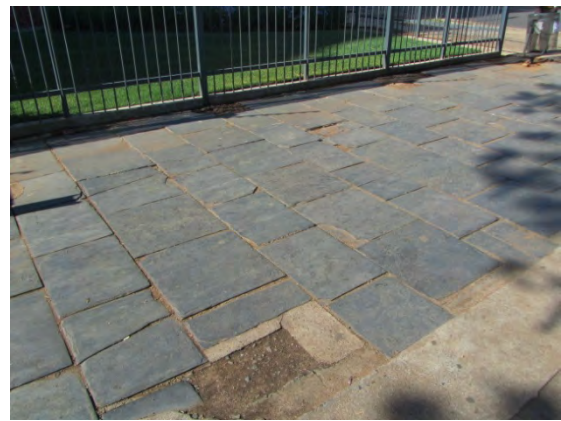
Figs 32 and 33 *Historical slate flagstones on the sidewalk along Paul Kruger Street on the north-eastern corner of Paul Kruger and Bloed streets. (Photographs SM Miller 2013)*

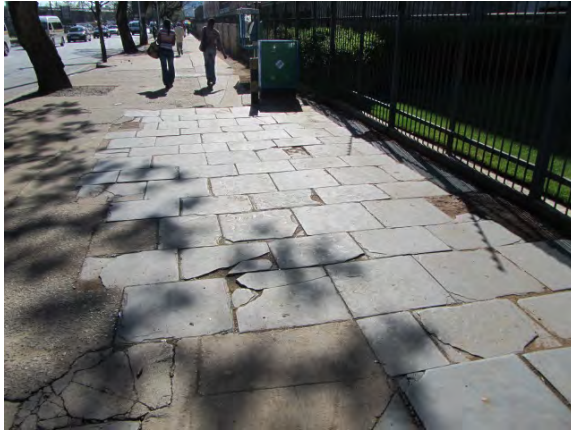
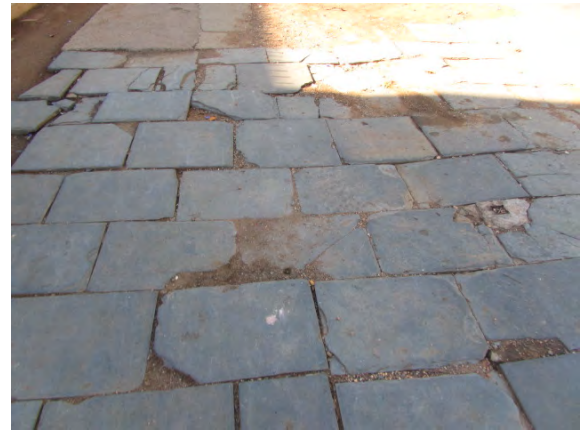
Figs 34 and 35 Historical slate flagstones on the sidewalk along Paul Kruger Street on the north-eastern corner of Paul Kruger and Bloed Street. (Photographs SM Miller 2013)

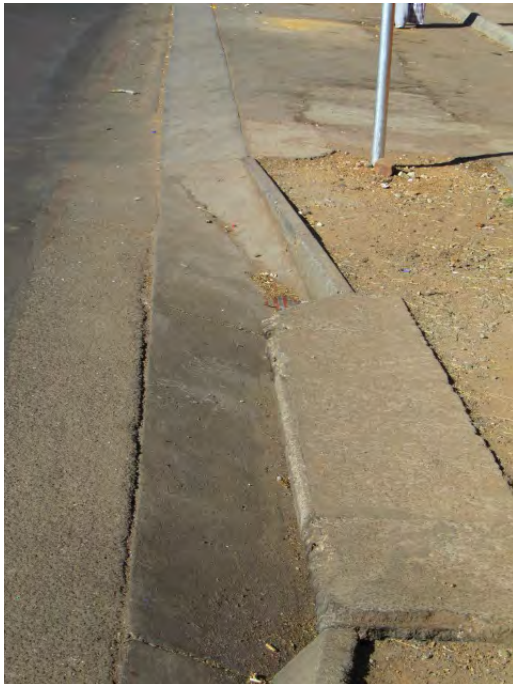
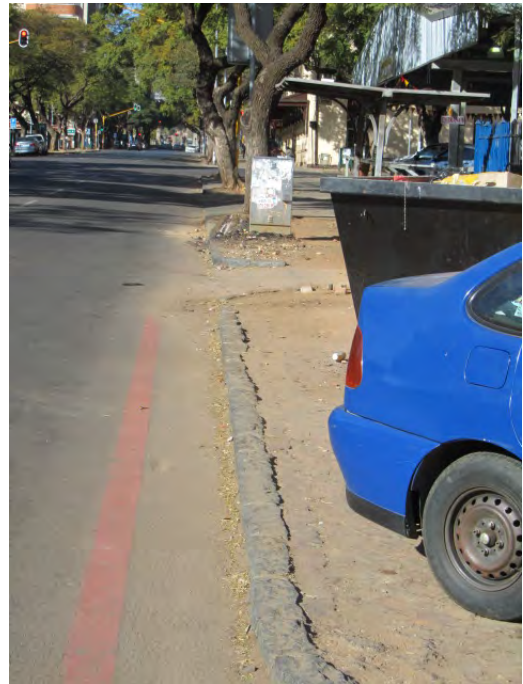
Figs 36 and 37 Kerbing along the northern and southern ends of the western sidewalk in Block 2. A section of the sidewalk has been forfeited for parking and a 50 meter section of granite kerbing was removed. Three vehicular access points exist in the northern section. (Photographs SM Miller 2012)

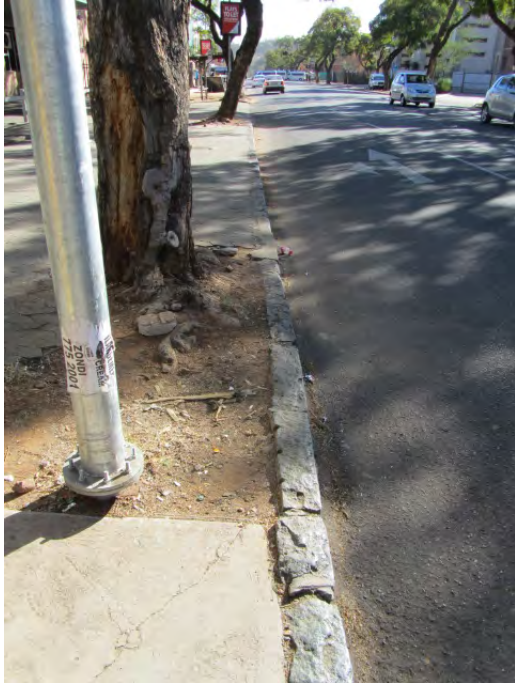
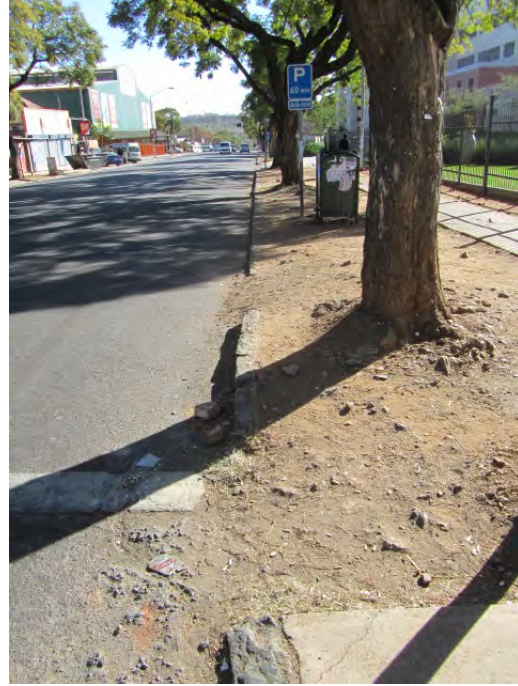
Figs 38 and 39 Granite kerb stones at the southern end of Block 2. (Photographs SM Miller 2012)

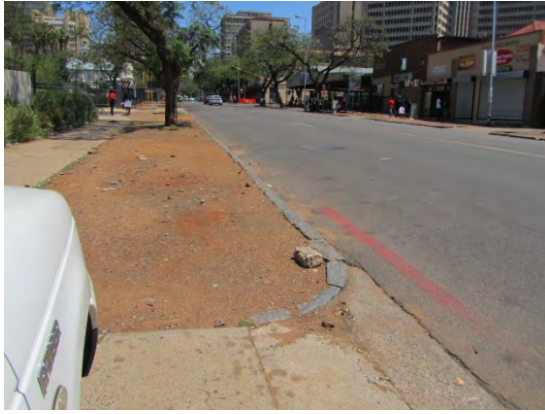
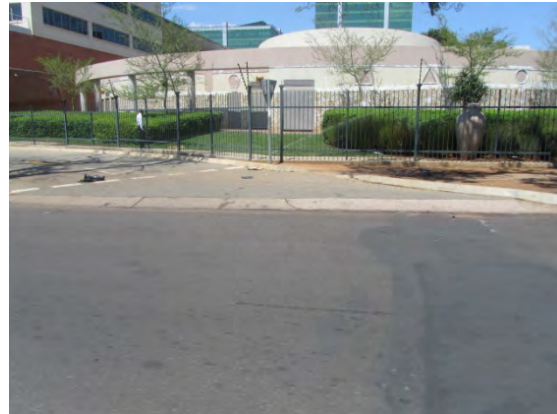
Figs 41 and 42 Granite kerbing on the east side of Block 2 Note the large vehicular exit area from the building in the background. (Photographs SM Miller 2013)

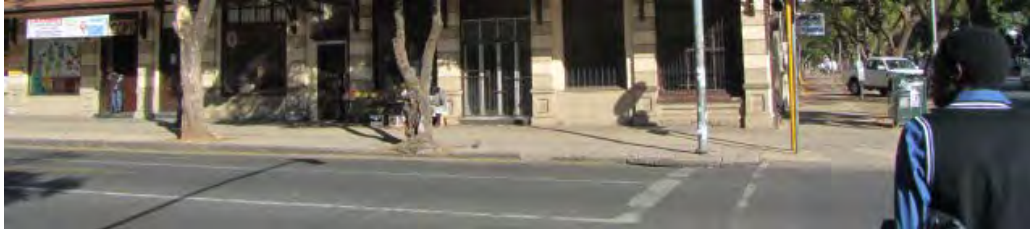
Fig. 47 Granite kerbing defining old roadway dimensions on north western side of block 3. Culverts and handicapped access provision impact on the historical kerb stones. (Photograph SM Miller 2012)

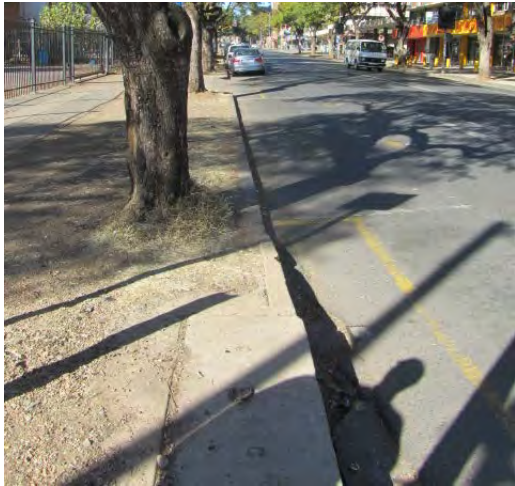
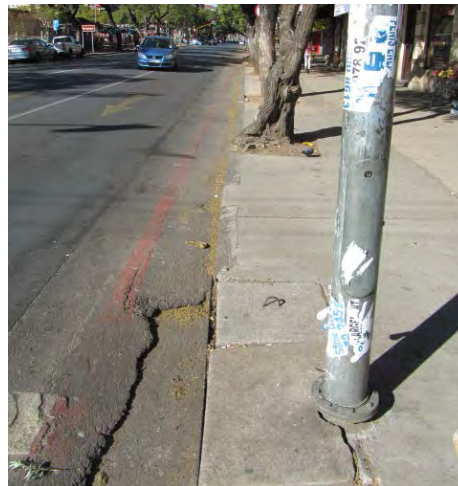
Figs 48 and 49 Location of historical granite kerbing on both the north-eastern and north-western ends of Block 3. Concrete strips are the main paving products on both sidewalks. (Photographs SM Miller 2012)

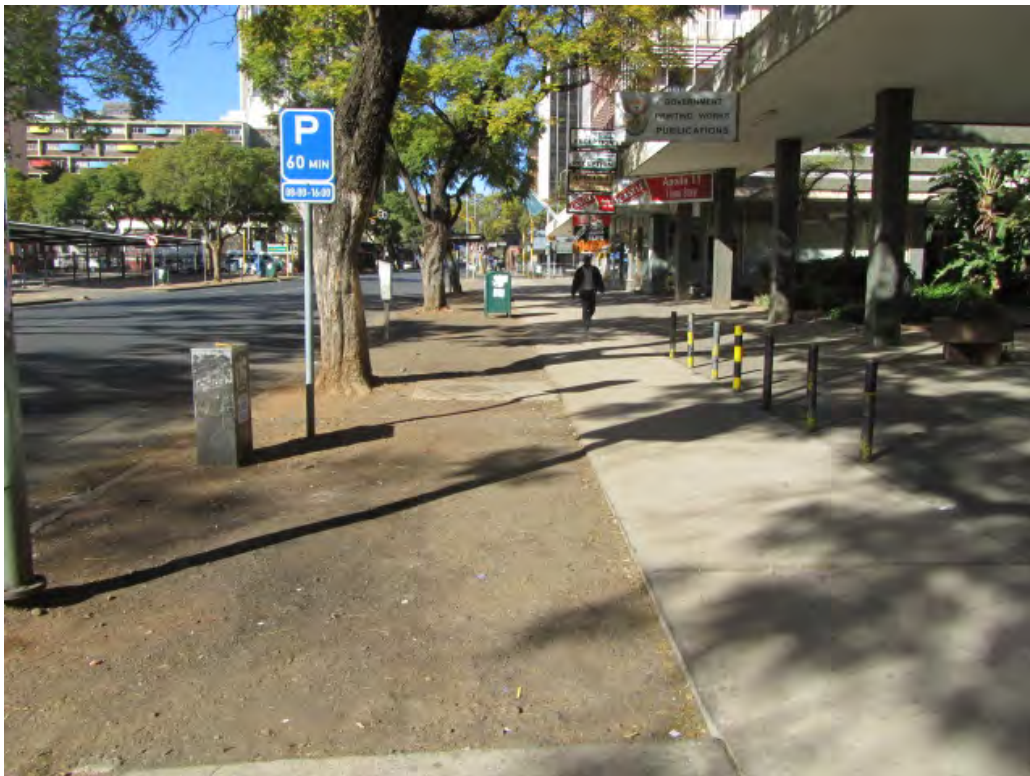
Fig. 52 No slate flagstones remained on either side of the road. (Photograph SM Miller 2012)

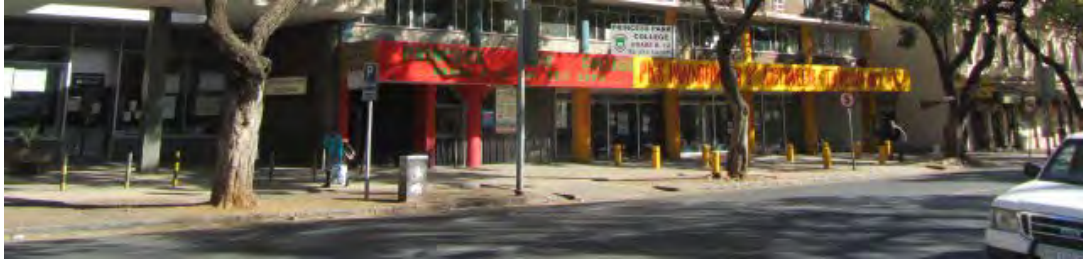
Fig. 57 Granite kerbing defining old roadway and vehicular access on both sides of red- and yellow-painted building. (Photographs SM Miller 2012)

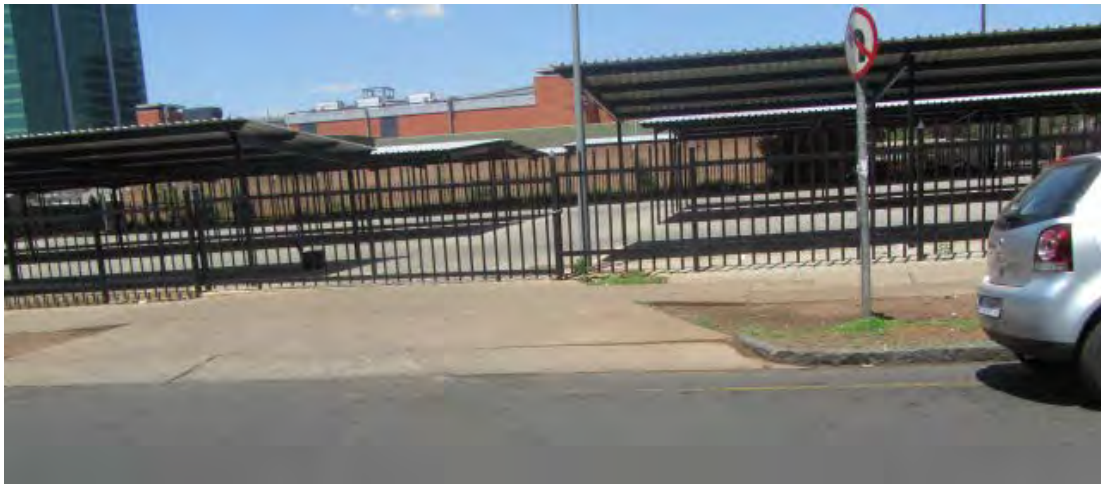
Fig. 58 Granite kerbing on the east side of Block 3, also showing vehicular access areas for the parking in the background. (Photograph SM Miller 2013)

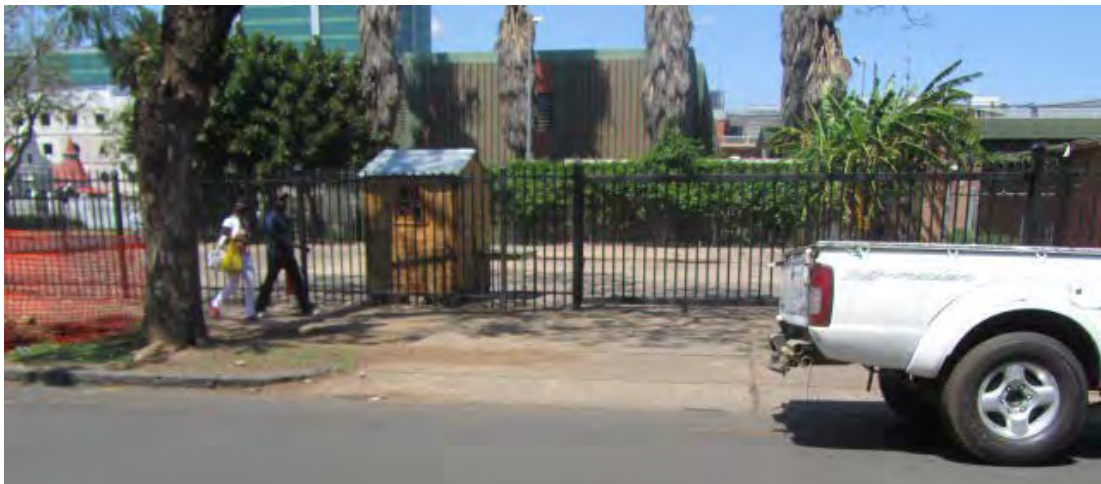
Fig. 59 Granite kerbing on the east side of Block 3, also showing vehicular access for the parking area in the background. (Photograph SM Miller 2013)

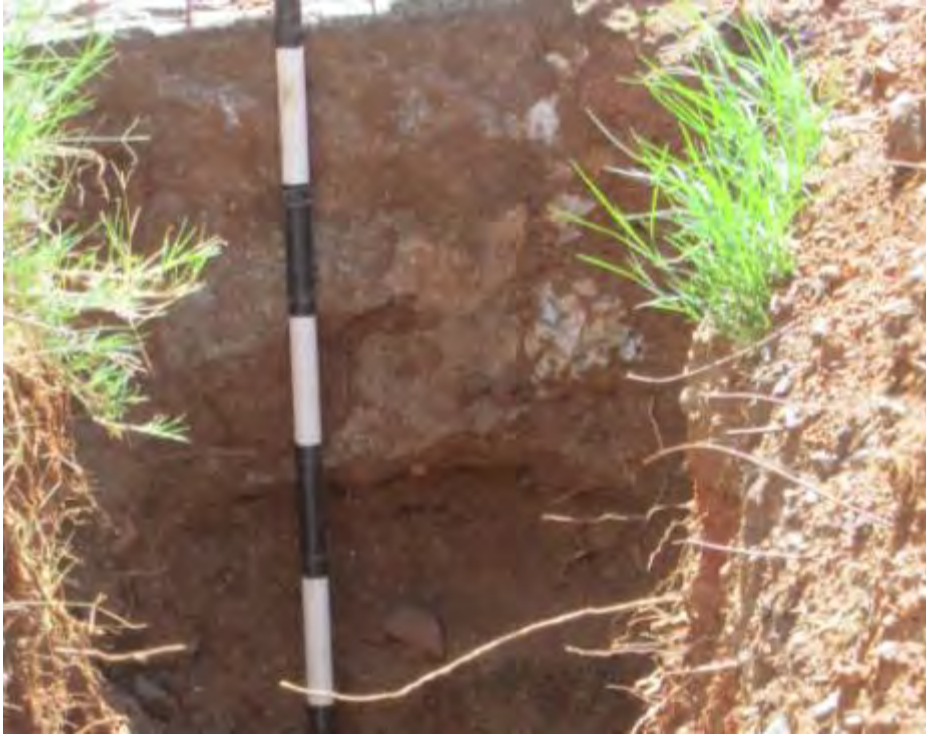
Fig. 60 The above photograph records the depth of the granite kerbing on the east side of Block 3, being around 350 mm (7 inches). This may vary as the kerb stones were handmade. (Photograph SM Miller 2013)

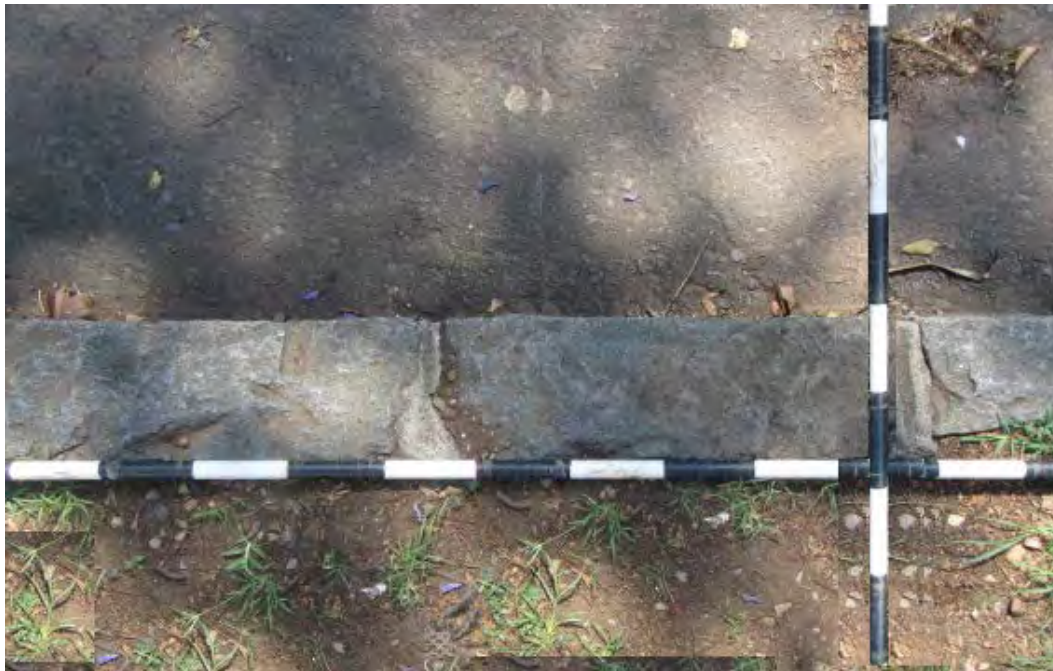
Fig. 61 Width of granite kerbing on the west side of Block 3 of between 150 to 200 mm (6 and 8 inches.) This may vary as the kerb stones were handmade. (Photograph SM Miller 2013)

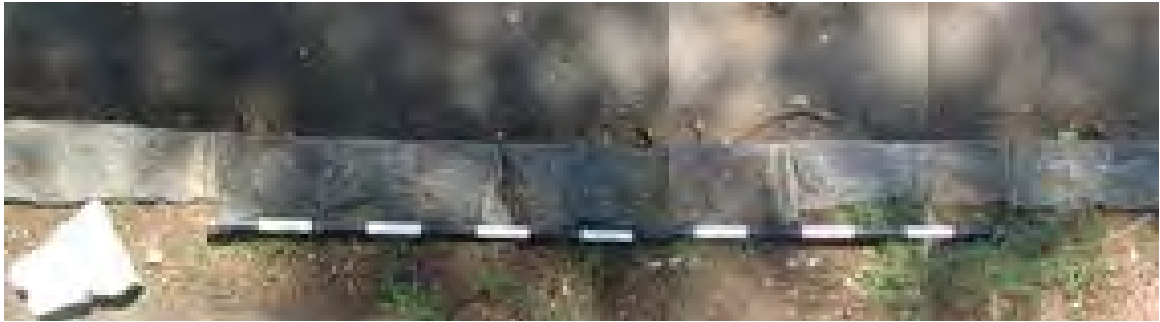
Fig. 62 Length of the granite kerbing on the west side of Block 3, being from 300 to 500 mm (12 and 20 inches). This may vary as the kerb stones were handmade. (Photograph SM Miller 2013)

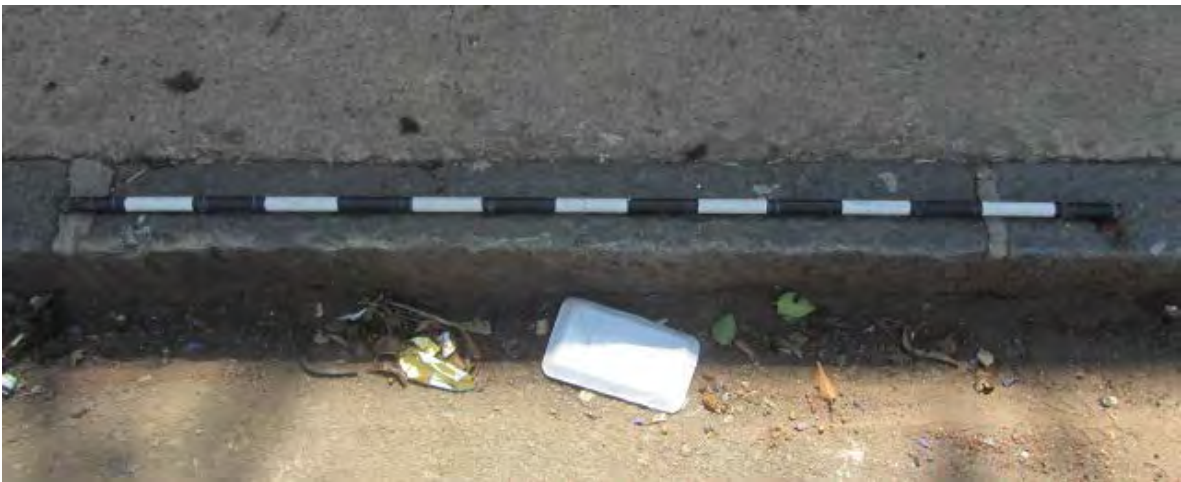
Fig. 63 In some areas the granite kerbing is even more variable up to a length of 1300 mm (four foot six inches). (Photograph SM Miller 2013)

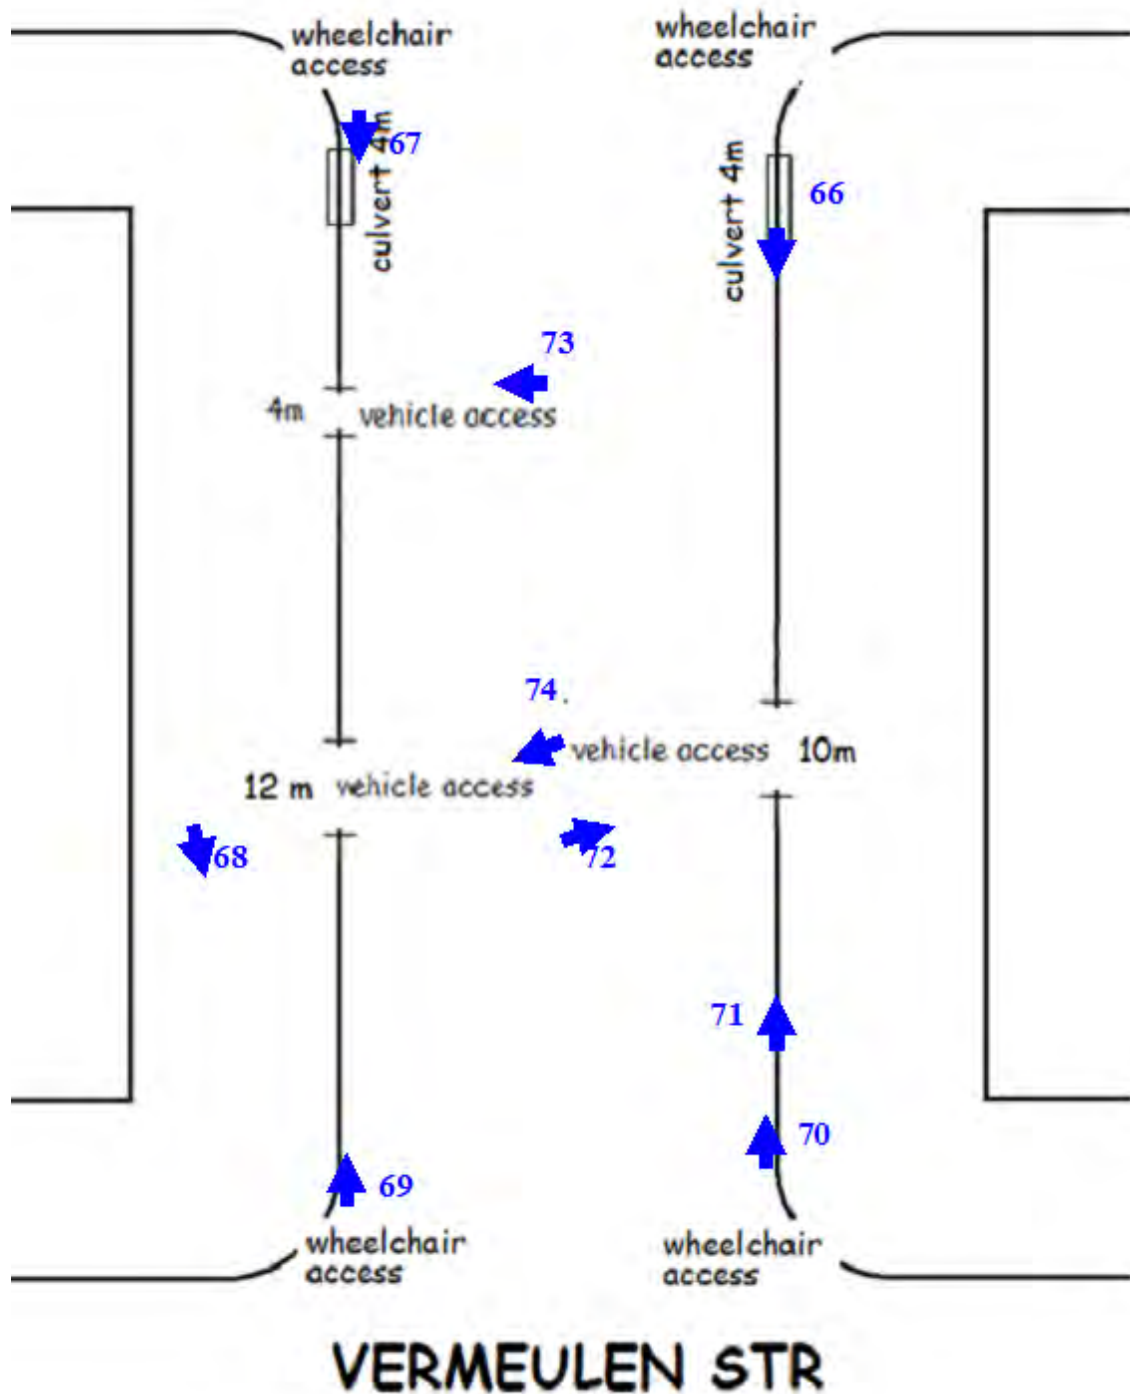
- 1 Contains 0 square meters of residual slate flagstone paving.
- 2.1 Block 4 total length ~ 148 meters.
- 2.2 Approximately 138 meters of granite kerbing remain on eastern side of Paul Kruger Street. (See Fig. 65)
- 2.3 Approximately 132 meters of granite kerbing remain on western side of Paul Kruger Street. (See Fig. 65)

Fig. 65 Block 4, schematic representation for photo documentation. The drawing also indicates remaining portions of granite kerbing, wheelchair access, vehicular access and culverts, all factors that reduce the length of remaining granite kerbing.

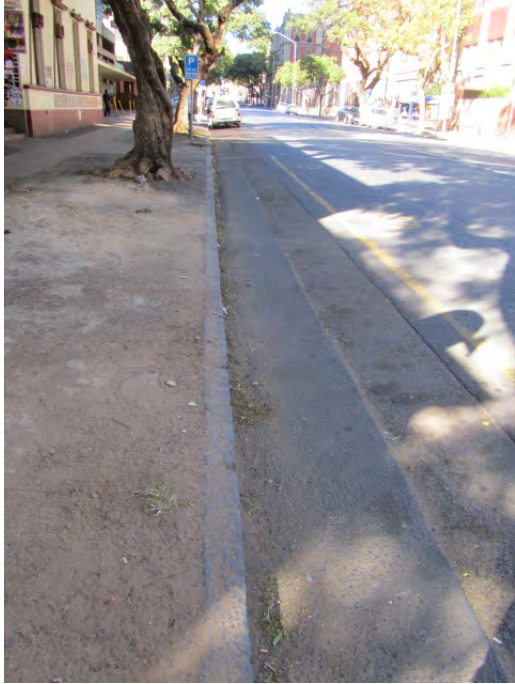
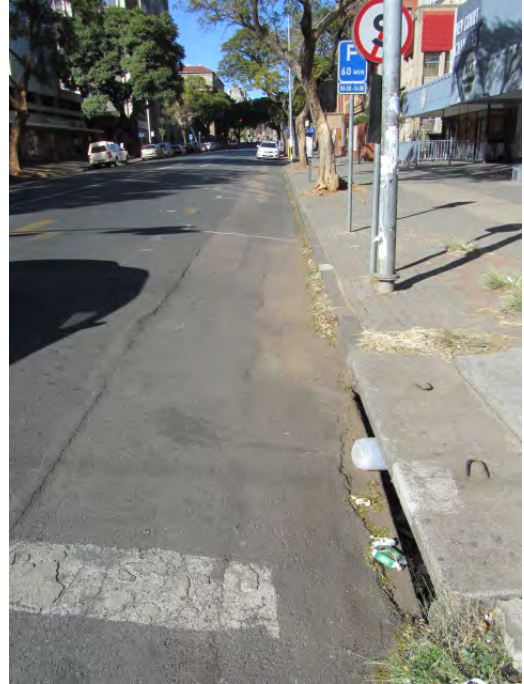
Figs 66 and 67 *Historical granite kerbing on the northern end of Block 4.
(Photographs SM Miller 2012)*

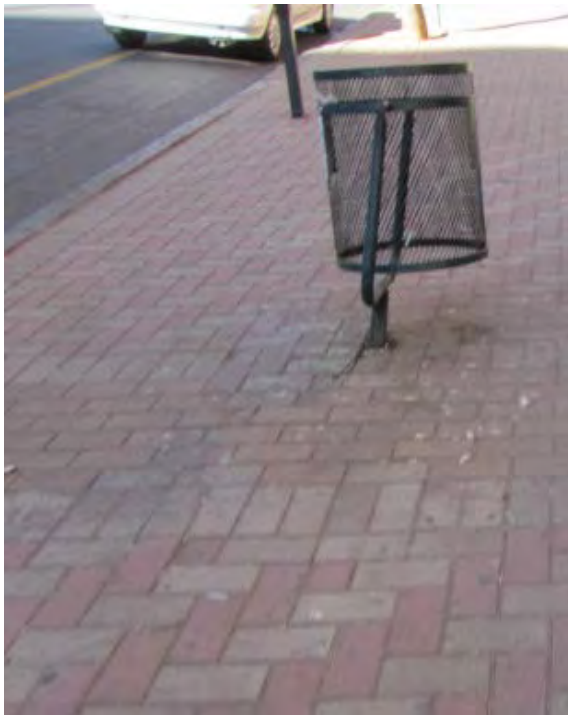
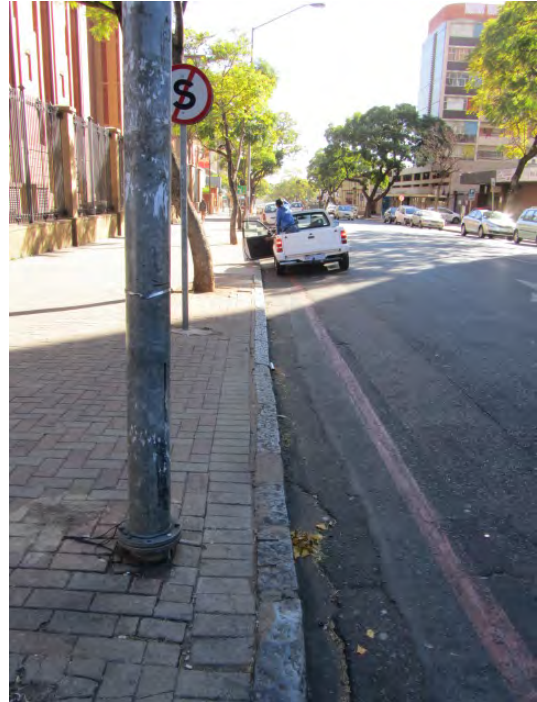
Figs 68 and 69 *Left: Entirely no historical slate flagstone paving remain on Block 4.
Right: Historical granite kerbing on the southern end of Block 4
(Photographs SM Miller 2012)*

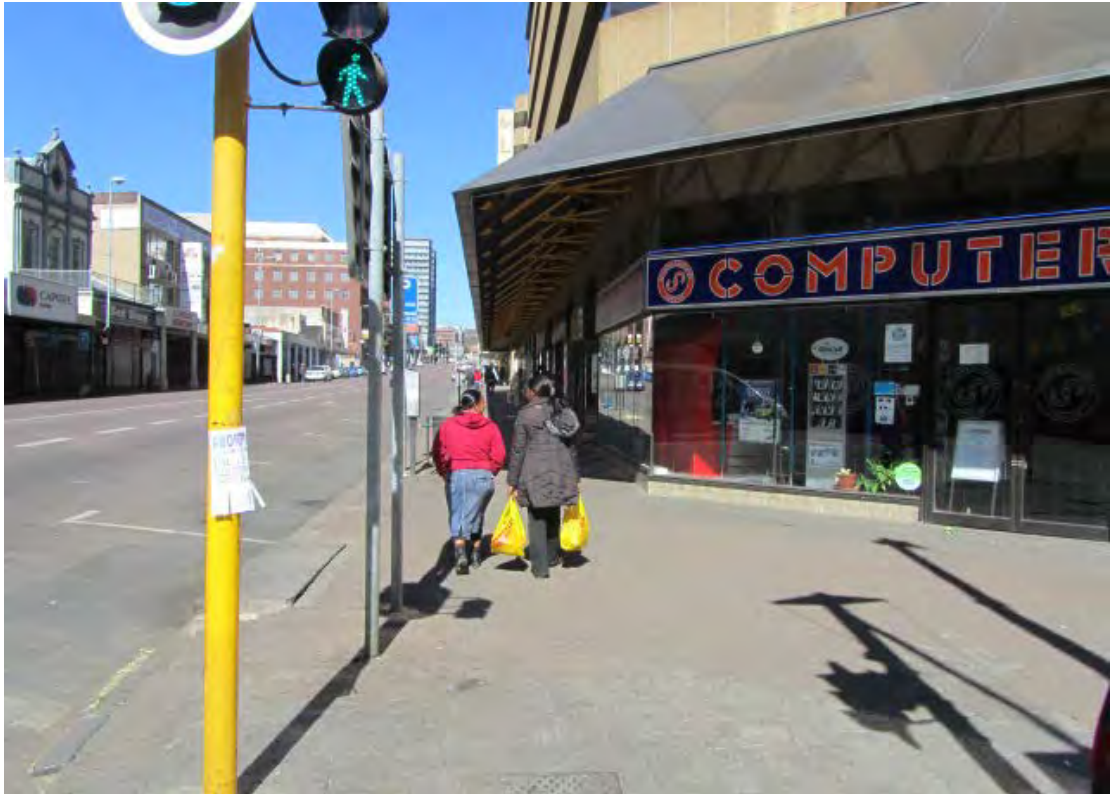
Fig. 77 North-western corner of Block 5. Culverts of various lengths and variable locations intrude on historical granite kerb stones, often close to street corners. (Photograph SM Miller 2012)

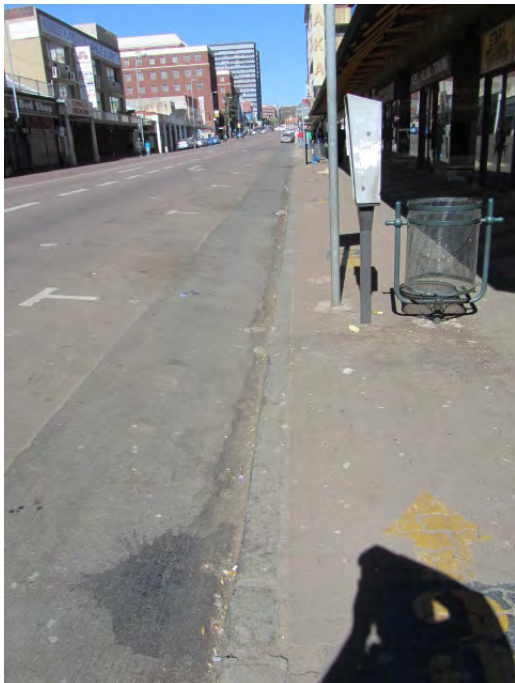
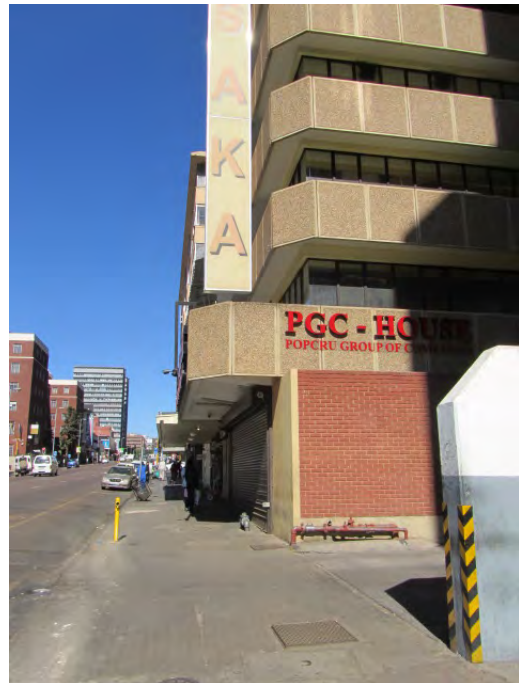
Figs 78 and 79 Above left is the granite kerbing on the north-western side of Block 5. Above right are the vehicular access areas for PGC-HOUSE where the granite kerbing was not removed but lowered for access. (Photographs SM Miller 2012)

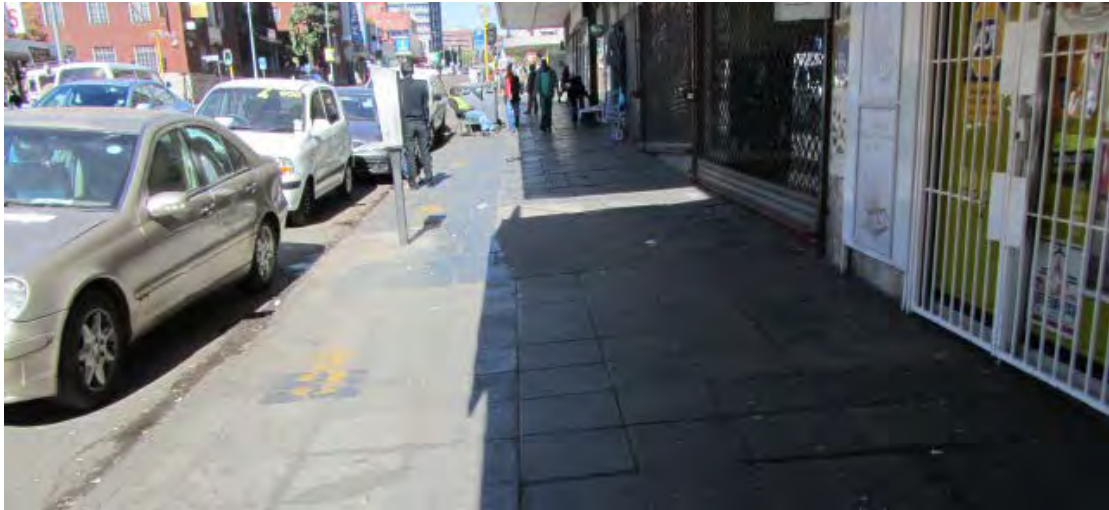
Fig. 80 Granite kerbing on the north-western side of Block 5. In the centre of the image are random remaining slate flagstones. (Photograph SM Miller 2012)

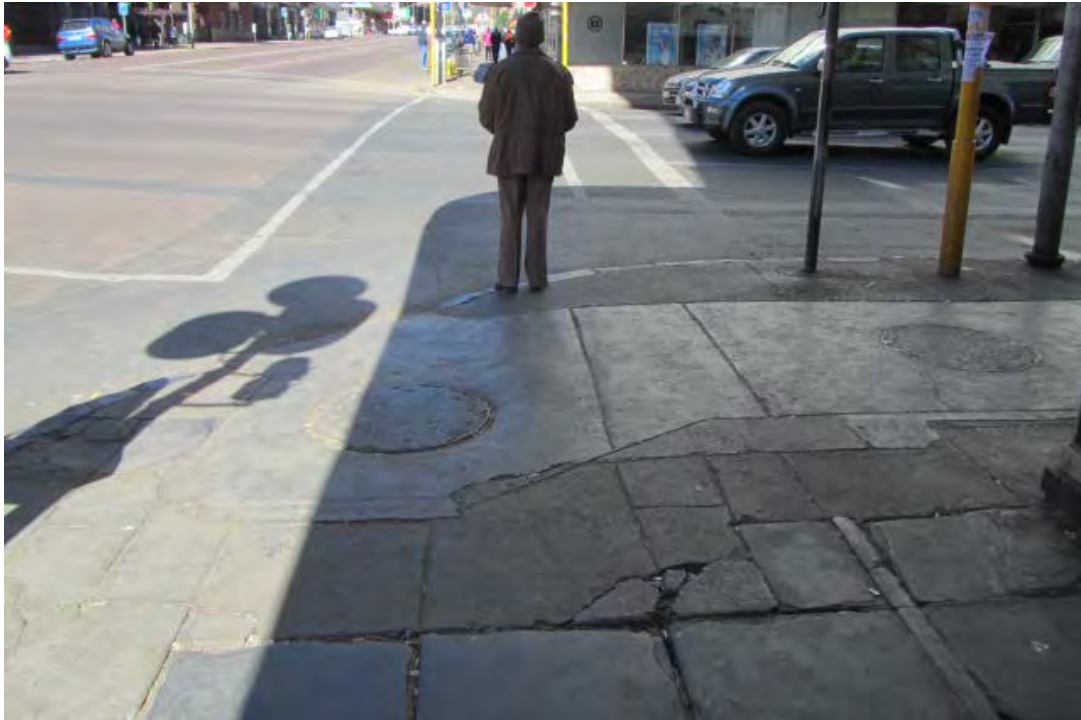
Fig. 82 Southwest corner of Block 5 where historical granite kerbing was retained but adjusted to a lower level to enable wheelchair access. This is apparent at most corner localities. (Photograph SM Miller 2012)

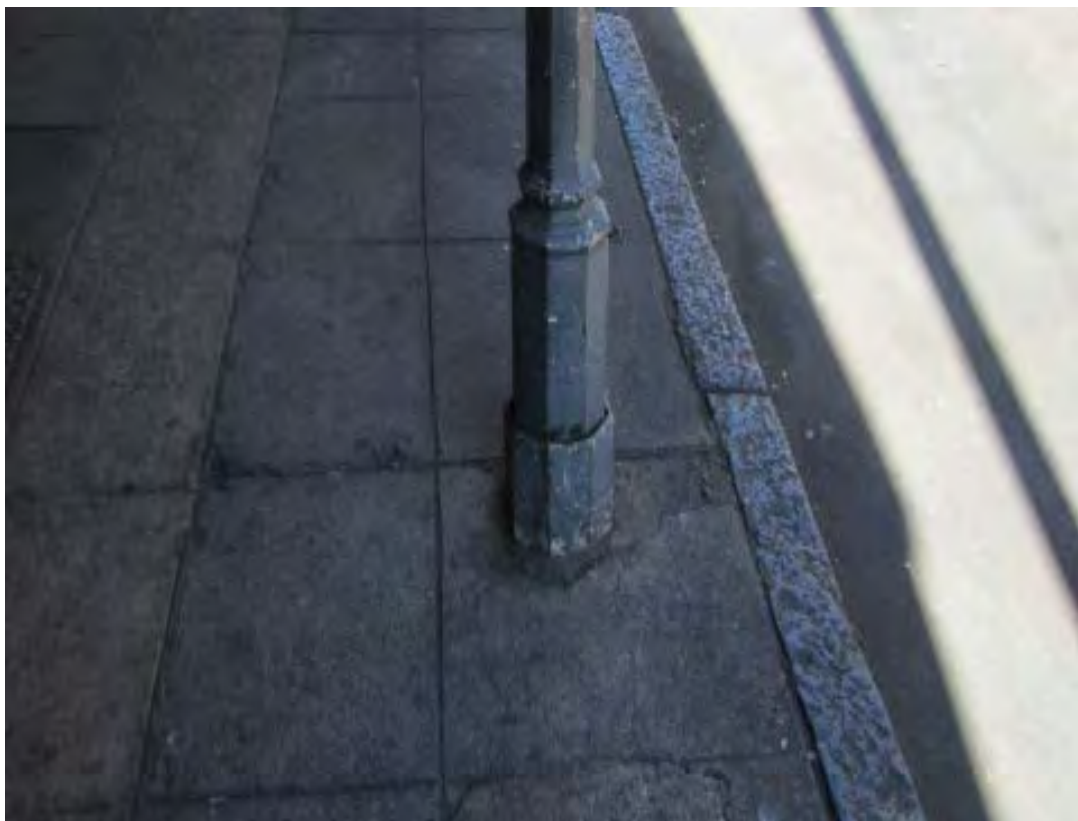
Figure 8 *Only a few of these Edwardian shop veranda cast iron column bases remain on Paul Kruger Street. It is important that they are retained. (Photograph SM Miller 2012)*
