**EXTENSION OF PHASE 1 (SAHRA ID 4150) HIA FOR
PROPOSED BRT SERVICE, PAUL KRUGER STREET,
PRETORIA, TSHWANE
FROM BLOED STREET TO SCHEIDING STREET,
EXCLUDING CHURCH SQUARE WITH SPECIFIC
REFERENCE TO SIDEWALKS AND VERANDAS**

November 2013

Report compiled by Sidney Miller.

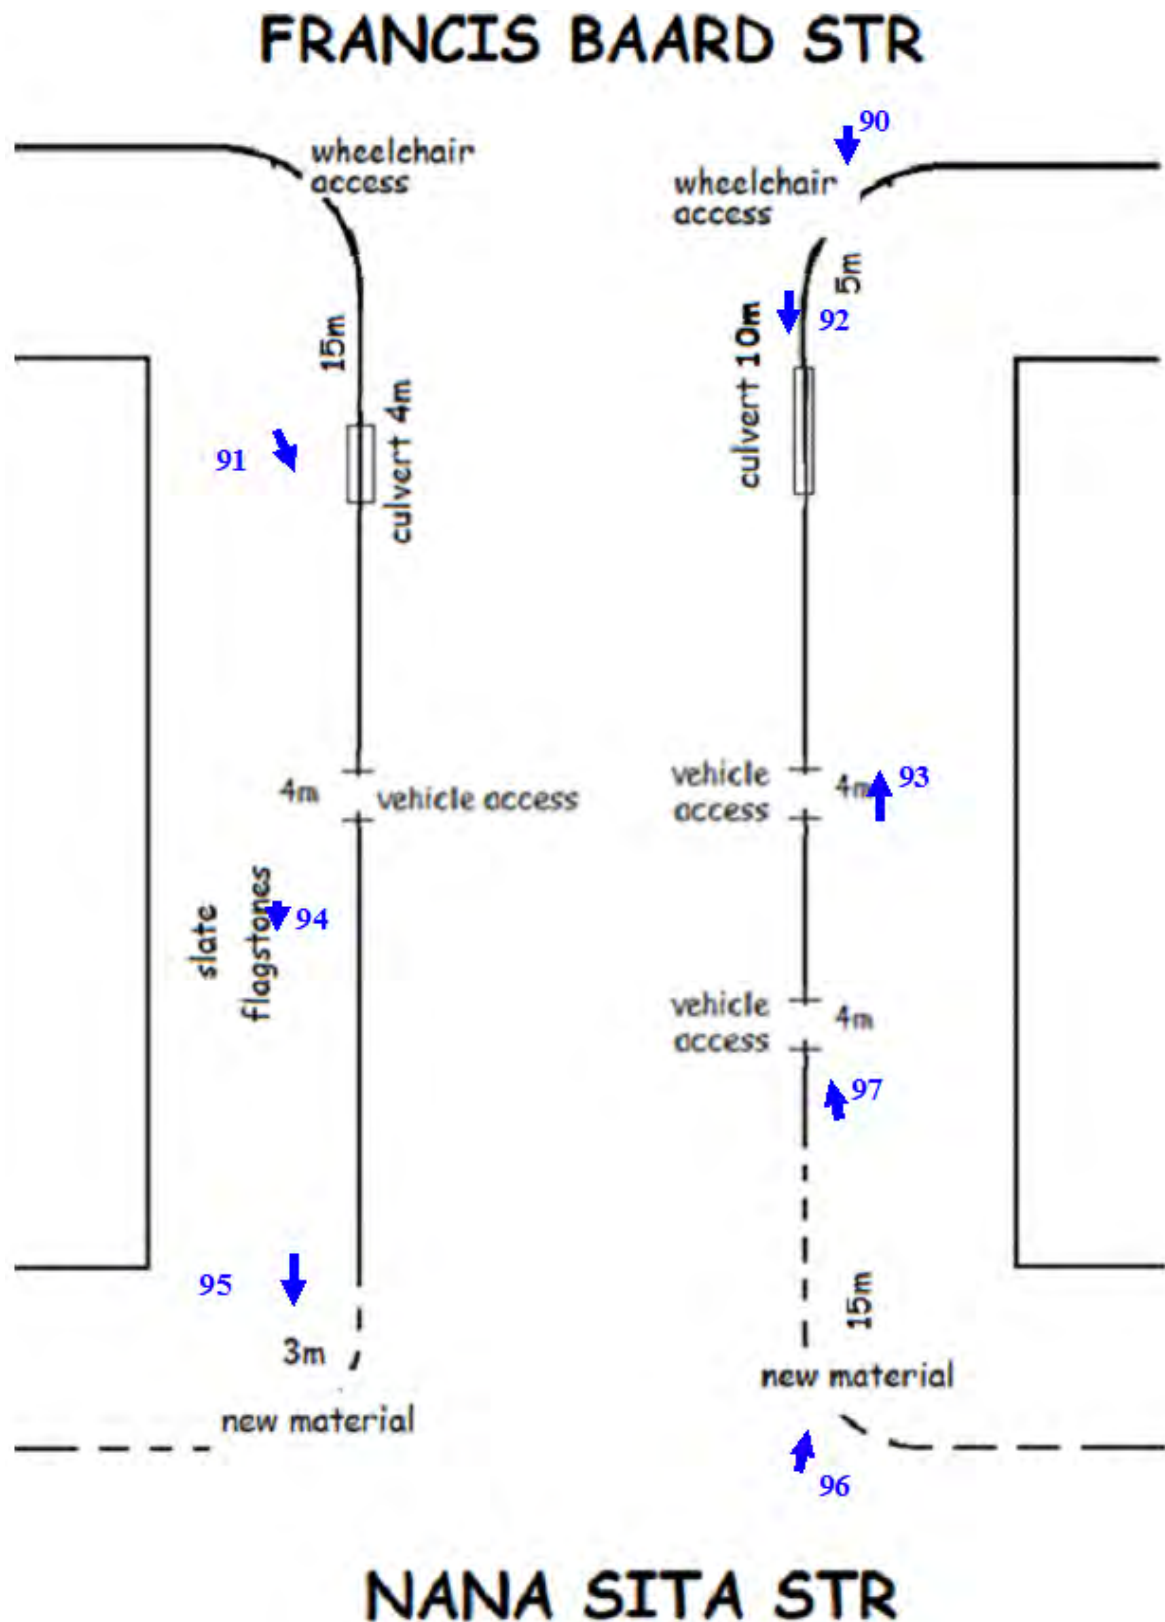
- 1.1 This block contains approximately 3.5 square meter of slate flagstone paving at the south-western corner. These comprise a small number of flagstones without historical contexts. (See Fig. 94)
- 2.1 Block 6 total length ~ 114 meters.
- 2.2 Approximately 100 meters of granite kerbing remain on eastern side of Paul Kruger Street. (See Fig. 89)
- 2.3 Approximately 80 meters of granite kerbing remain on western side of Paul Kruger Street. (See Fig. 89)

Fig. 89 Block 6, schematic representation for photo documentation. The drawing also indicates remaining portions of granite kerbing, wheelchair access, vehicular access and culverts, all factors that reduce the length of remaining granite kerbing.

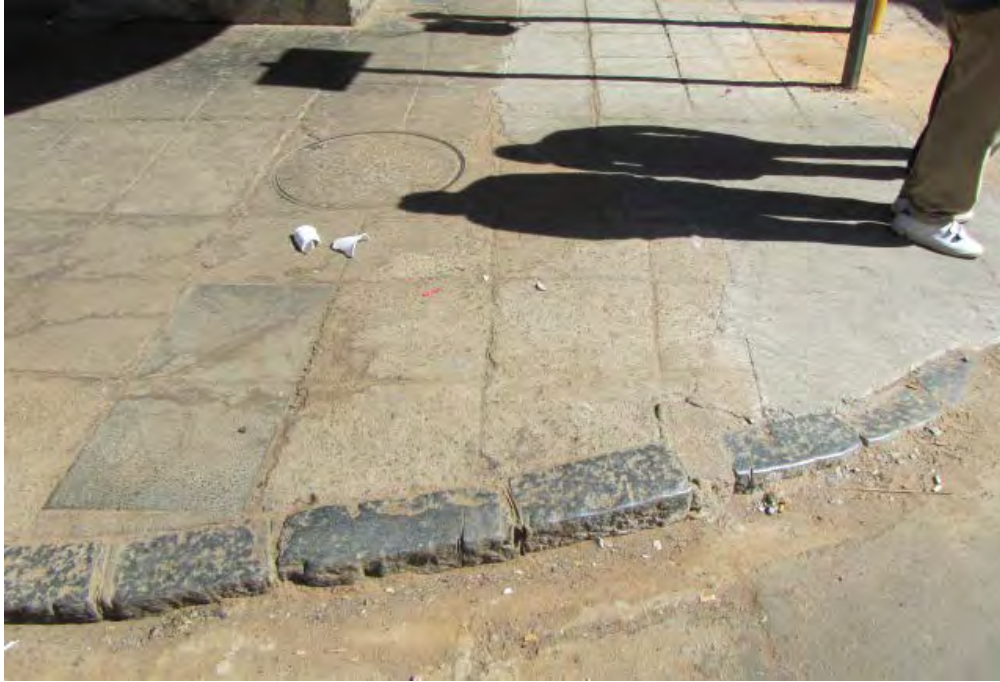
Fig. 90 A range of paving material and the granite kerbing. Note the use of short sections to create a corner radius. (Photograph SM Miller 2012)

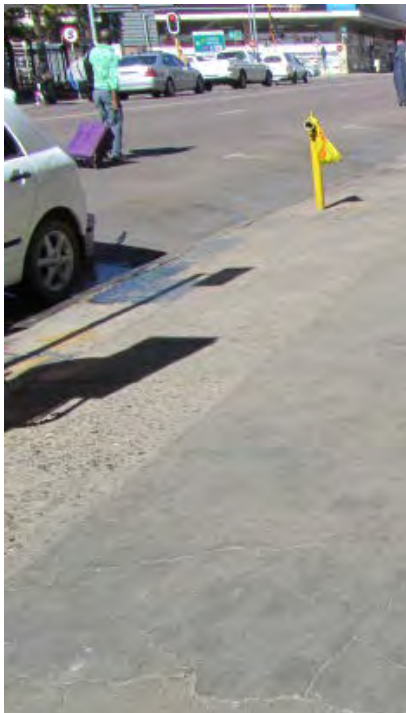
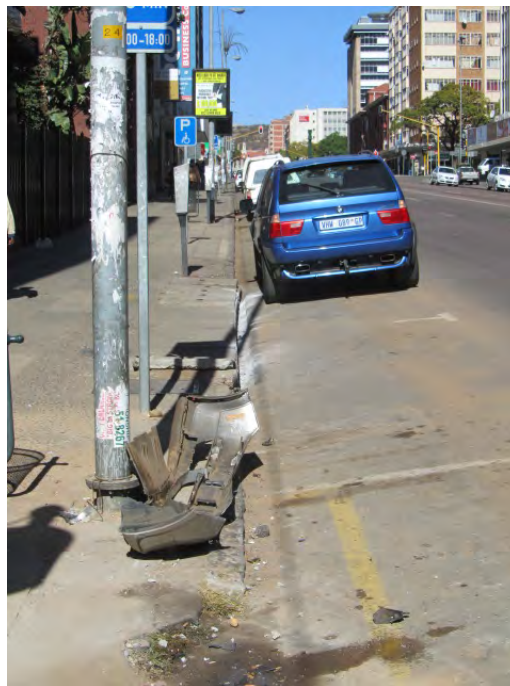
Figs 91 and 92 Two views along granite kerbing. Note complete absence of slate flagstones. (Photographs SM Miller 2012)

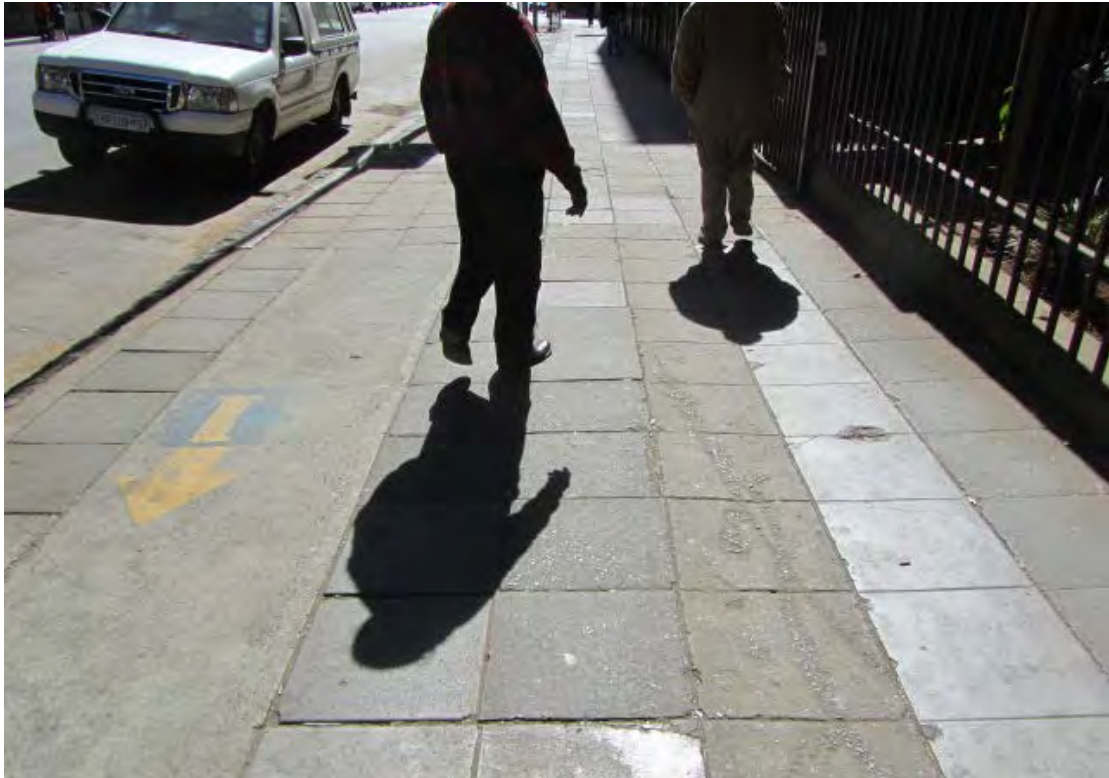
Fig. 93 View of granite kerbing. Note complete absence of slate flagstones. (Photograph SM Miller 2012)

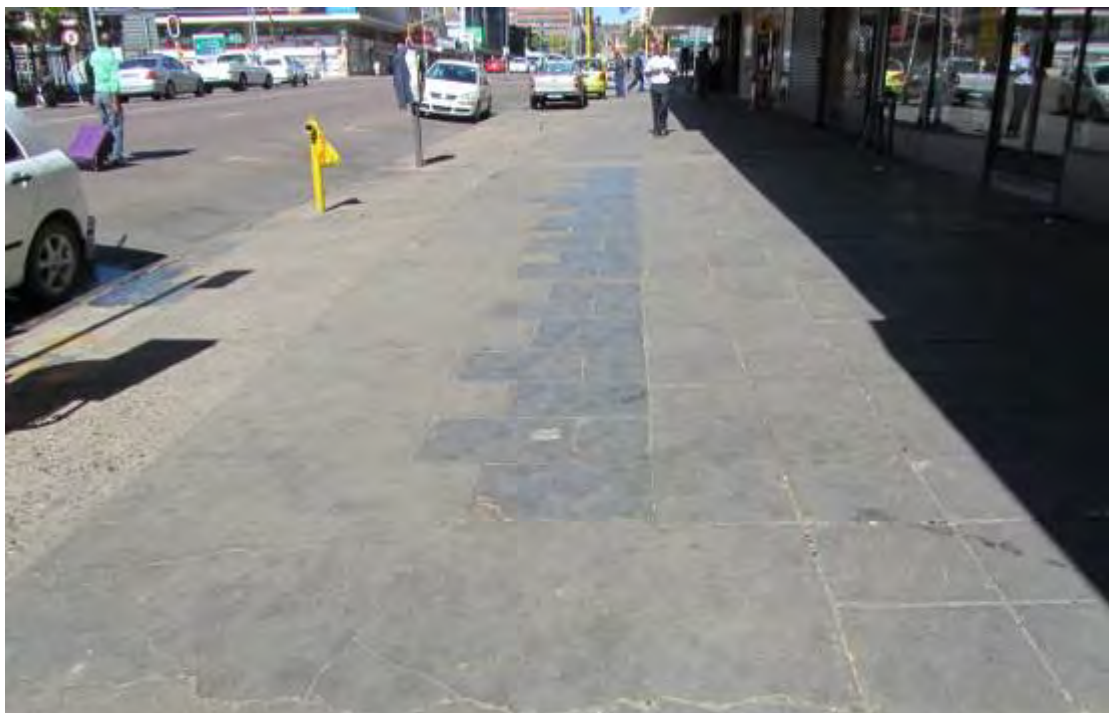
Fig. 94 A variety of paving material on the western side of Paul Kruger Street in Block 6. Remnants of slate flagstone paving are also visible. (Photograph SM Miller 2012)

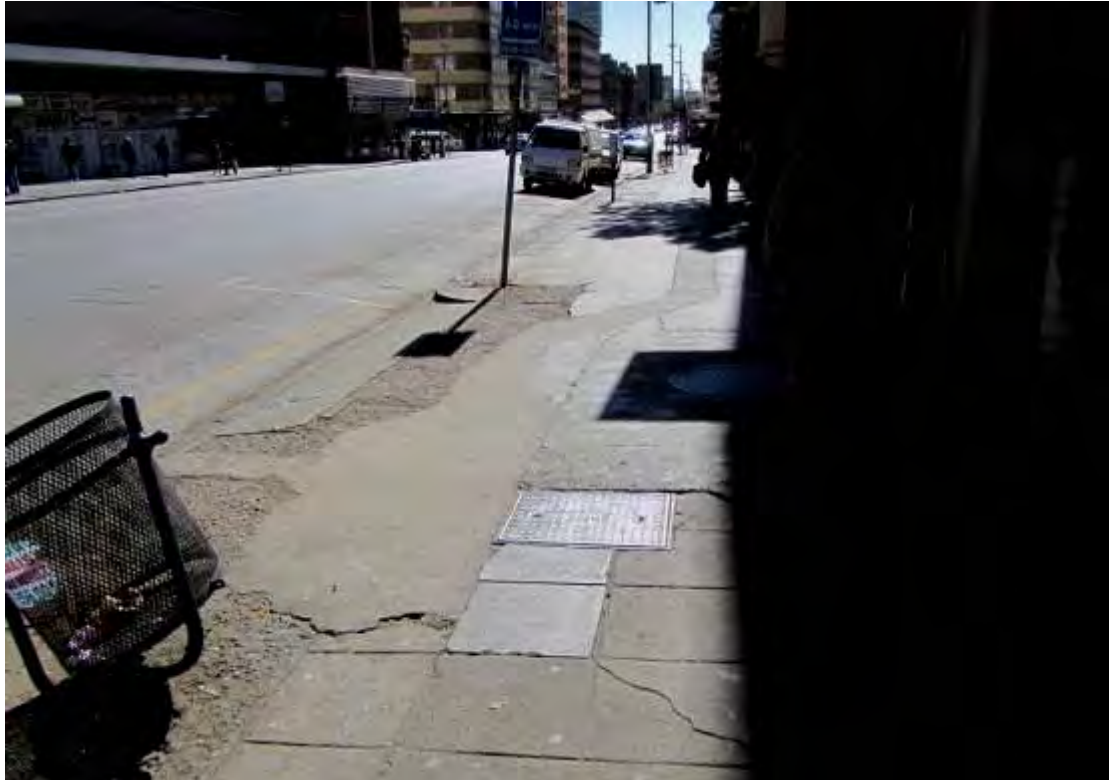
Fig. 97 A variety of paving material suggesting a perceived lack of standards for the construction of Tshwane sidewalks. Also note the vehicular access area. (Photograph SM Miller 2012)

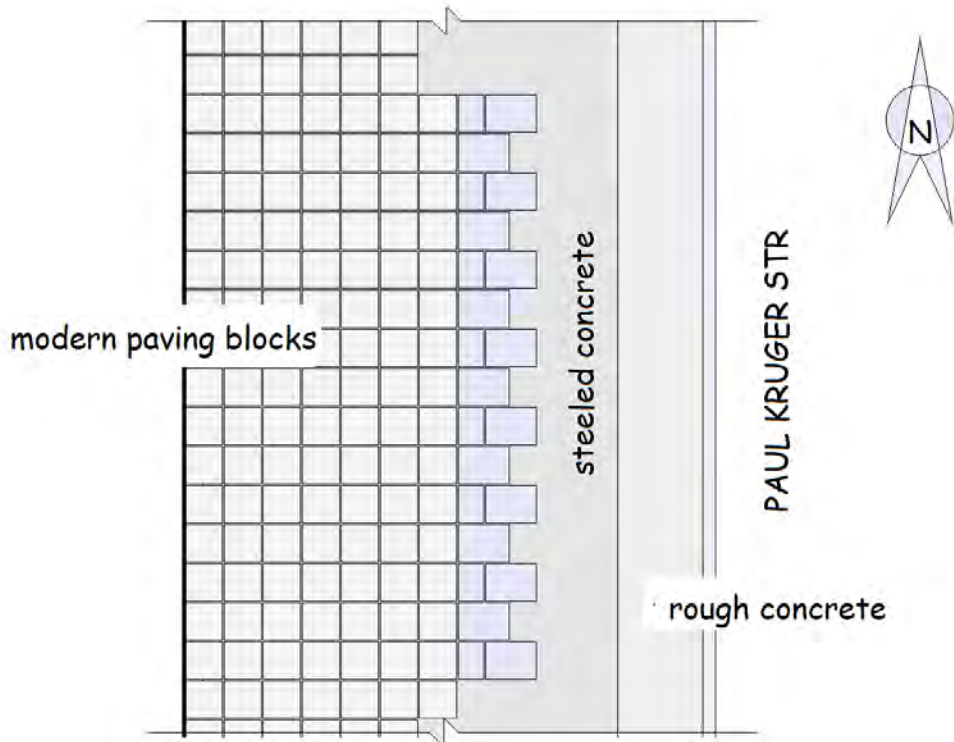
Fig. 98 A record of the small number of remaining slate flagstones on the western side of Block 6 just north of Nana Sita Street.

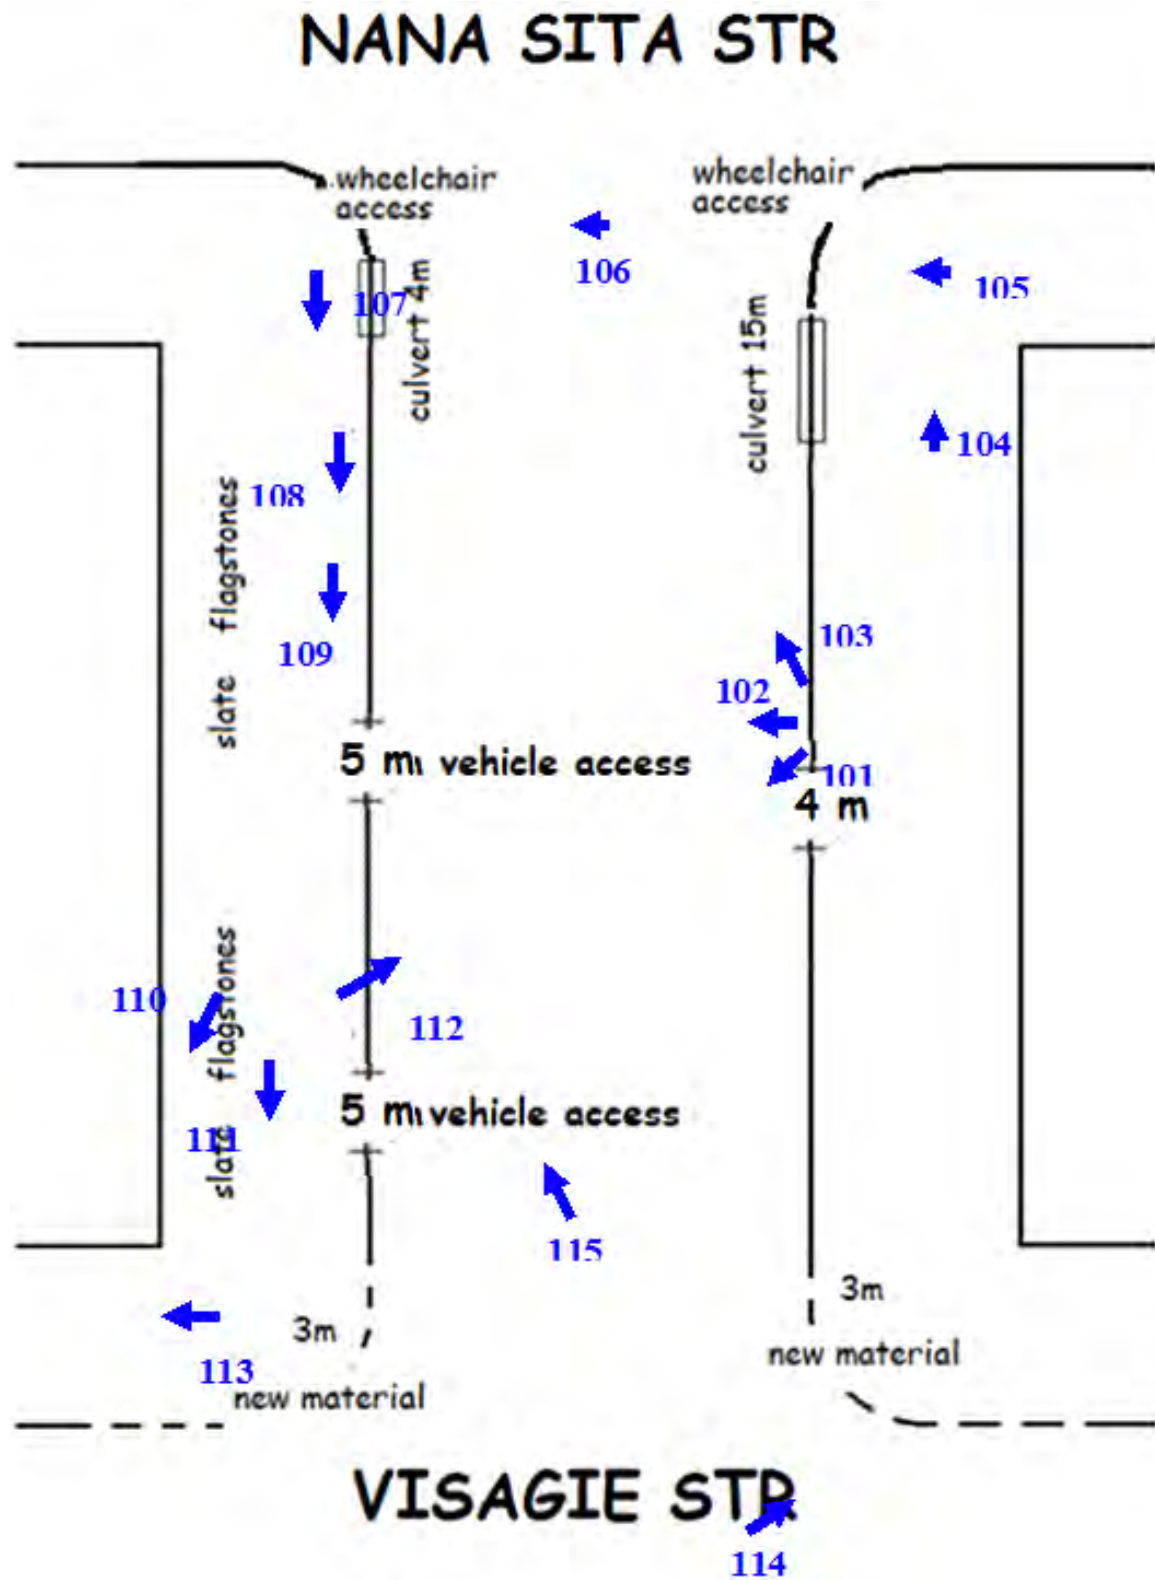
- 1.1 Contains approximately 400 square meters of slate flagstone paving at south-western side of Block 7.
- 1.2 Approximately 200 square meters are cracked and damaged in this area.
- 1.3 Approximately 200 square meters may be recovered from and reused.
- 2.1 Block 7 total length ~ 144 meters.
- 2.2 Approximately 110 meters of granite kerbing remain on eastern side of Paul Kruger Street. (See Fig. 76)
- 2.3 Approximately 120 meters of granite kerbing remains on western side of Paul Kruger Street. (See Fig. 76)

Fig. 100 Block 7, schematic representation for photo documentation. The drawing also indicates remaining portions of granite kerbing, wheelchair access, vehicular access and culverts, all factors that reduce the length of remaining granite kerbing.

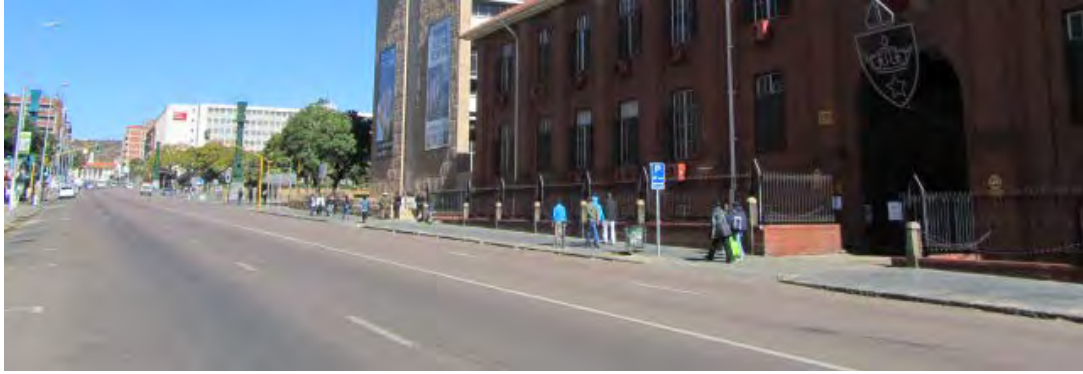
Fig. 101 Historical granite kerb stones and slate flagstones. Note effect of the blue-grey colour of the slate flagstones. (Photograph SM Miller 2012)

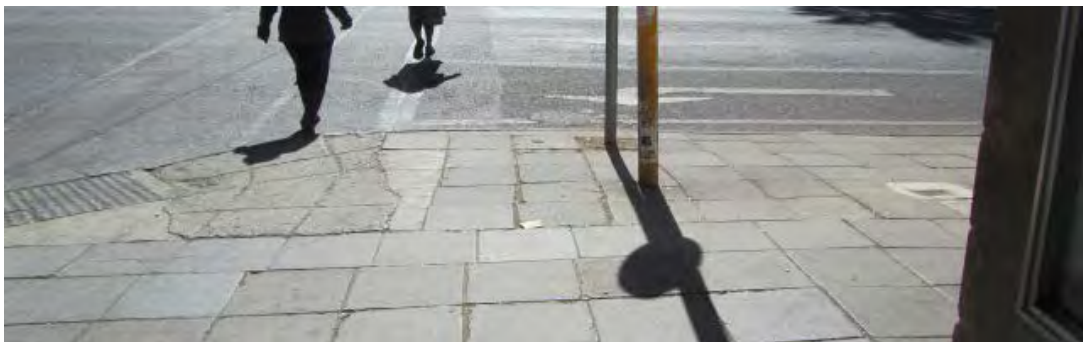
Fig. 104 Termination of the eastern sidewalk on Nana Sita Street. (Photograph SM Miller 2012)

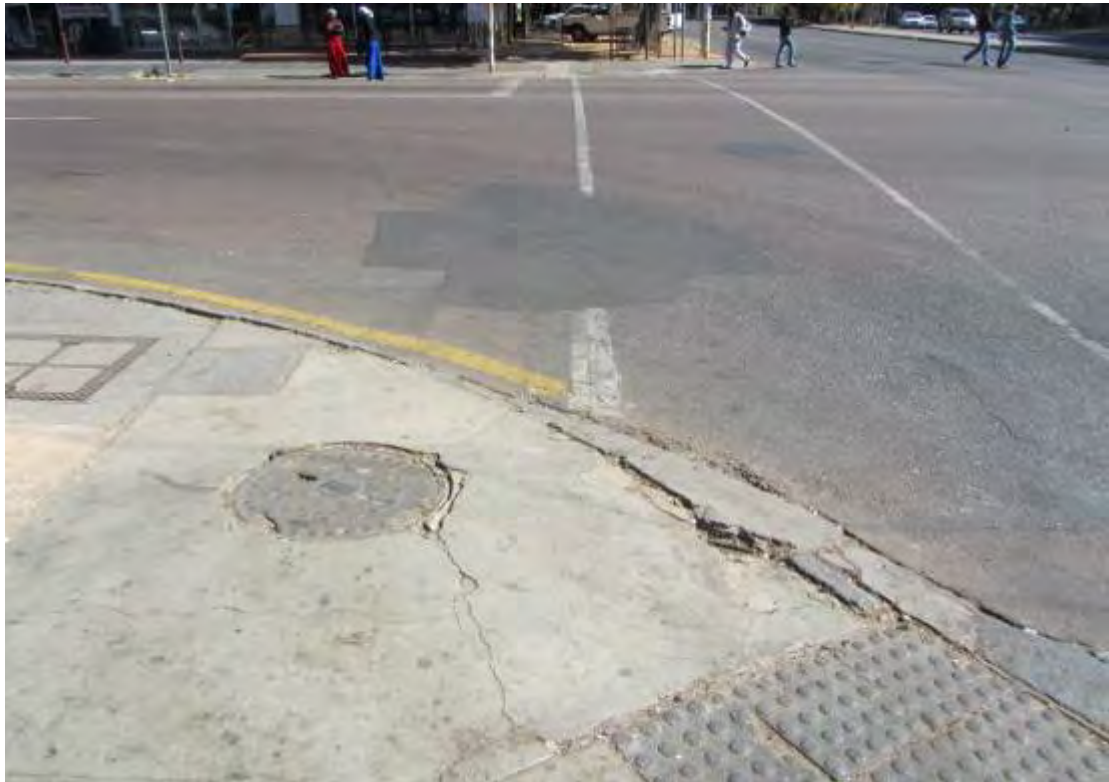
Fig. 105 In most cases wheelchair access were facilitated without the removal of historical granite kerb stones. (Photograph SM Miller 2012)

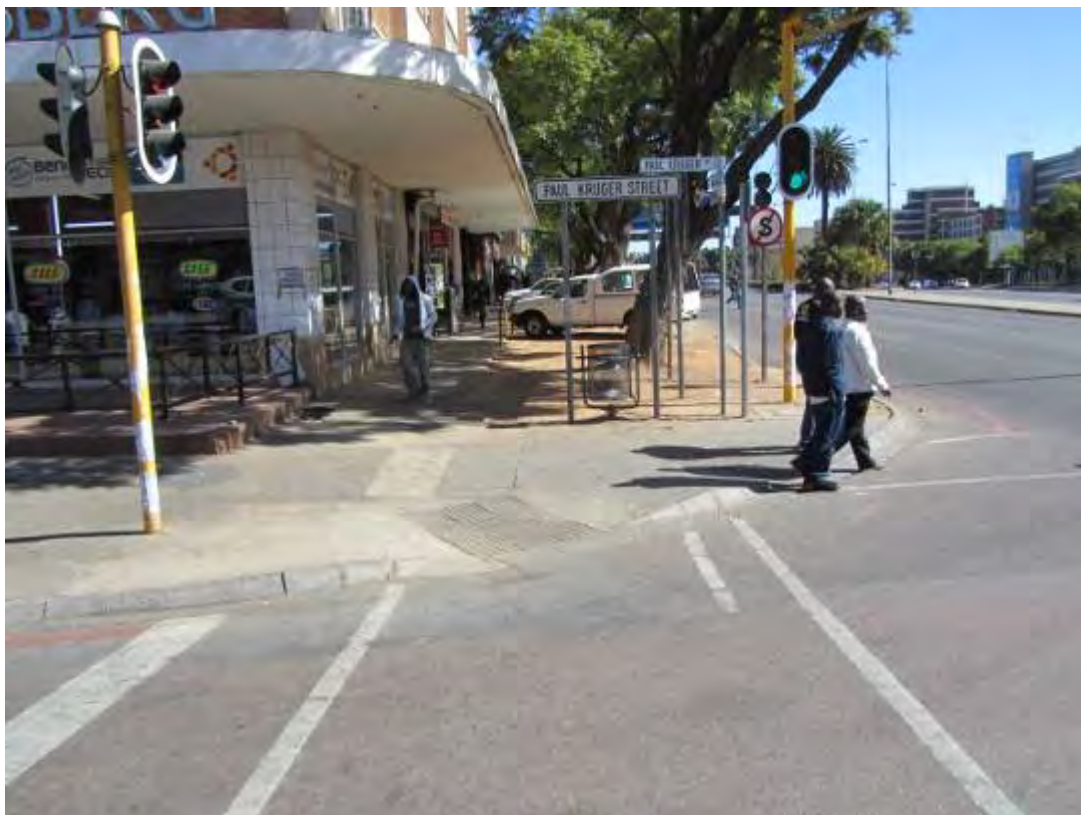
Fig. 106 At several locations new kerbing was installed during provision of wheelchair accessibility. (Photograph SM Miller 2012)

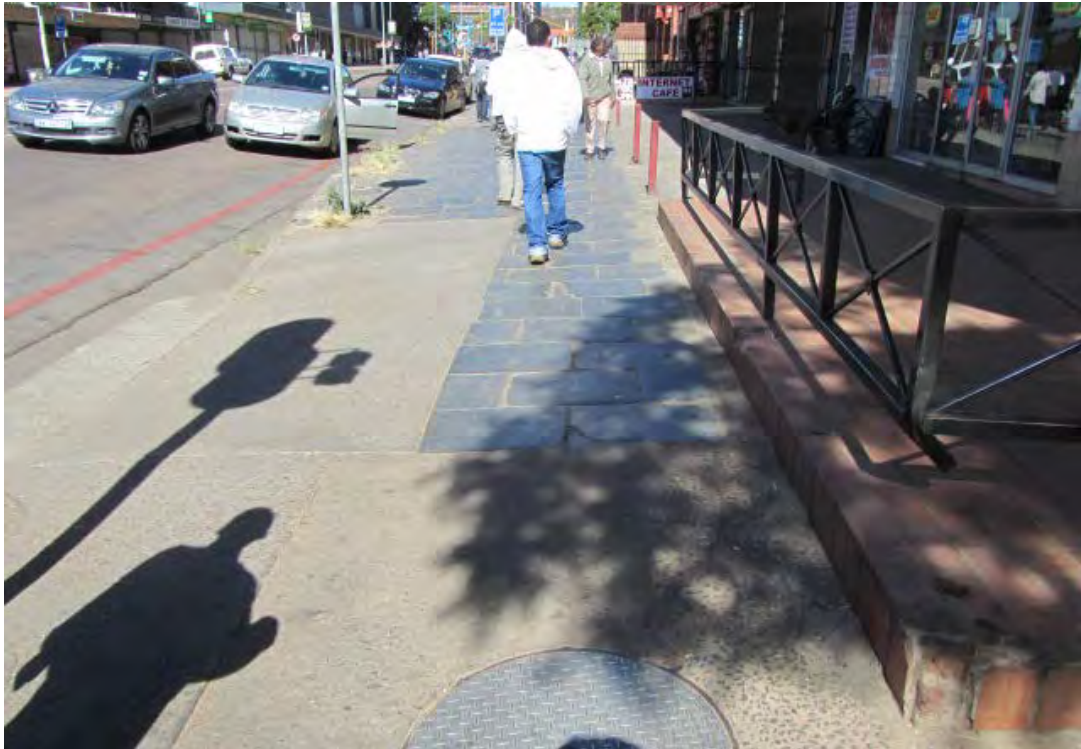
Fig. 107 On the western side of Block 7 a particularly large section of slate flagstone paving survives. It may be on account of the smaller rectangular format of the flagstones that have been used. (Photograph SM Miller 2012)

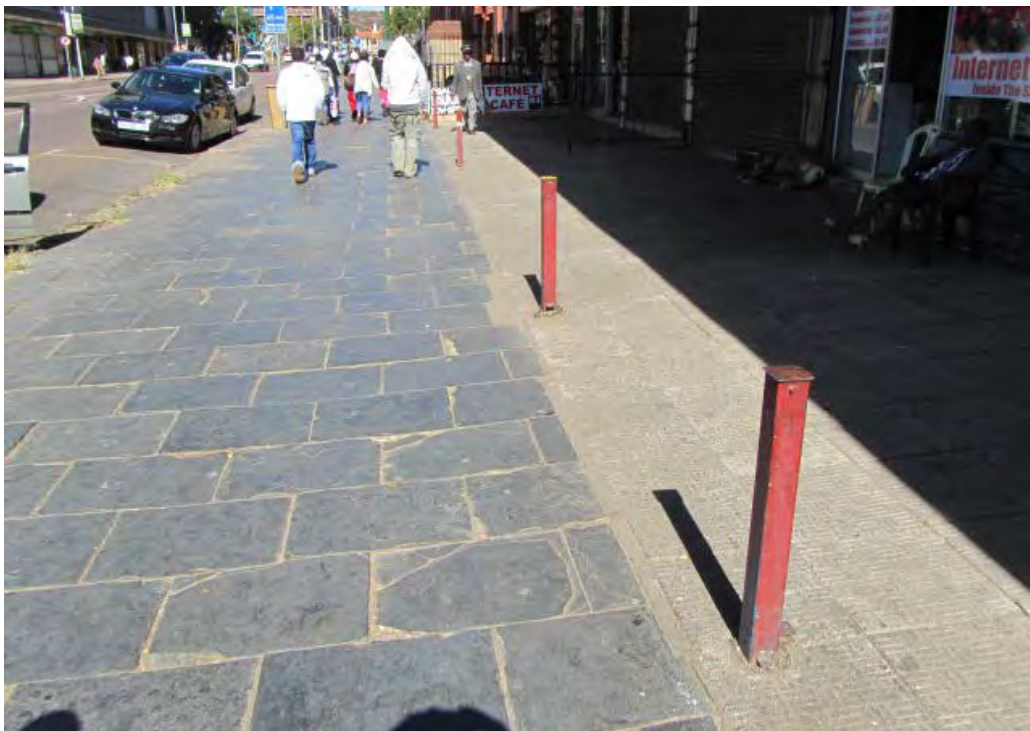
Fig. 108 Another section of slate flagstone paving on the western side of Block 7. Here only rectangular units were used. (Photograph SM Miller 2012)

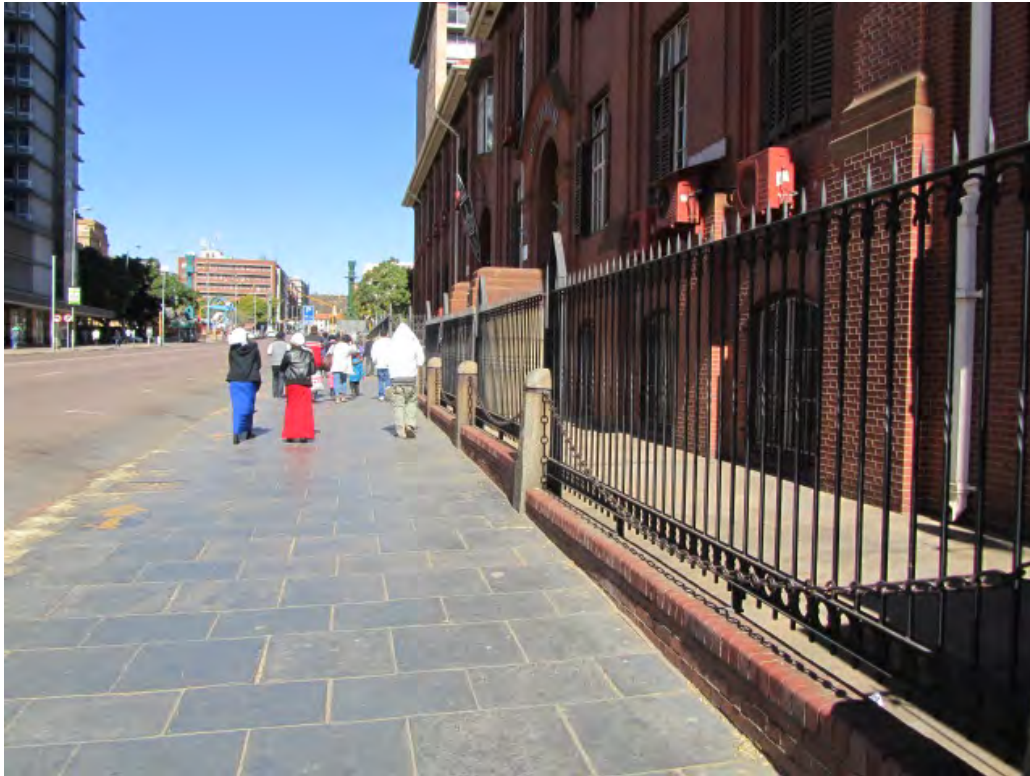
Fig. 109 A record of yet another section of slate flagstone paving on the western side of Block 7. Note style of alternating square blocks with rectangular ones. (Photograph SM Miller 2012)

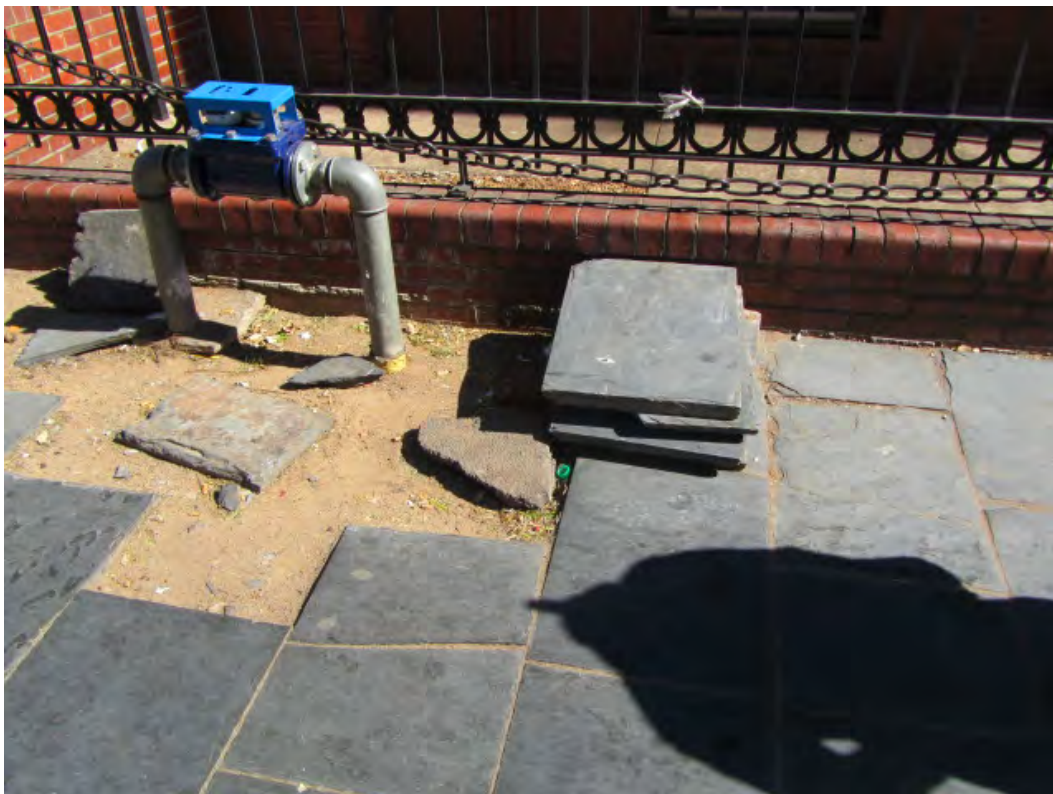
Fig. 110 Smaller sections of flagstone are used around fixtures. (Photograph SM Miller 2012)

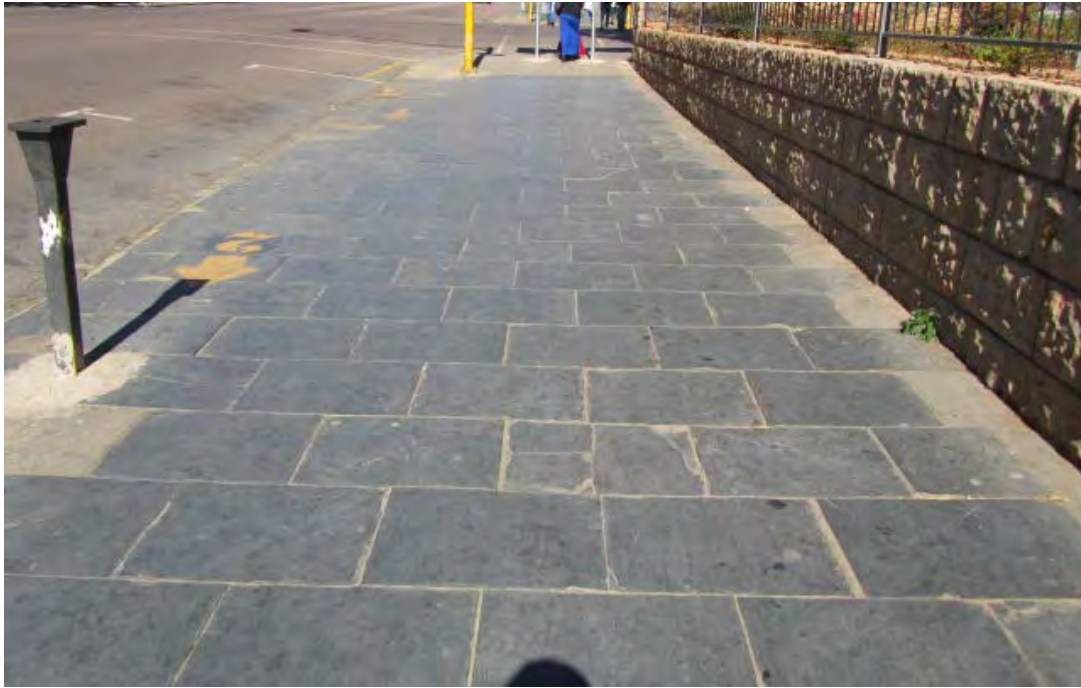
Fig. 111 Another section of the slate flagstone paving on the south-western side of Block 7. Here again only rectangular flagstones were used (*Photograph SM Miller 2012*)

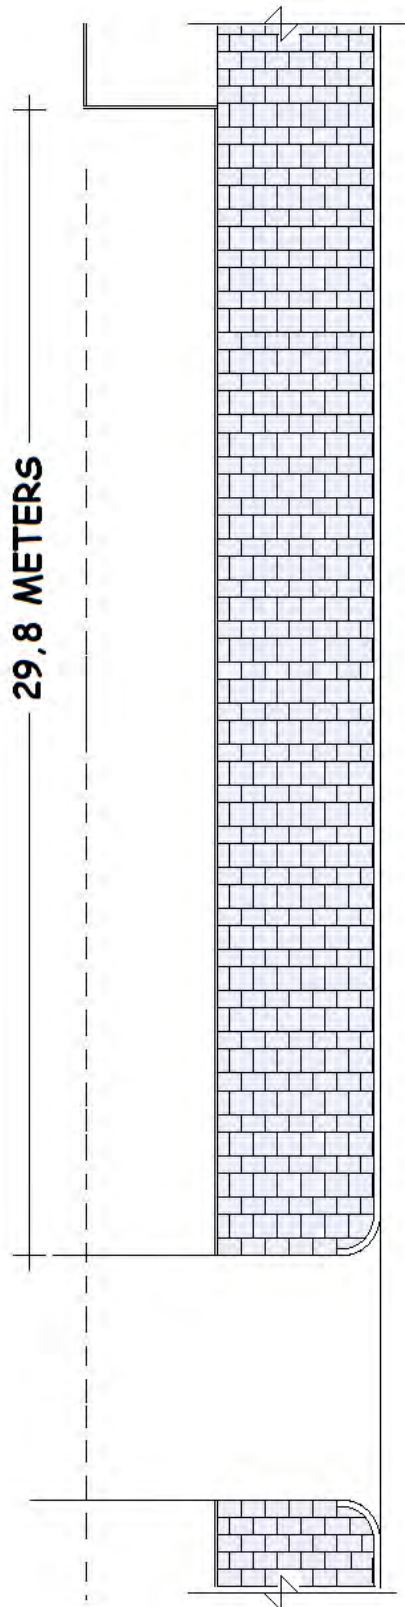
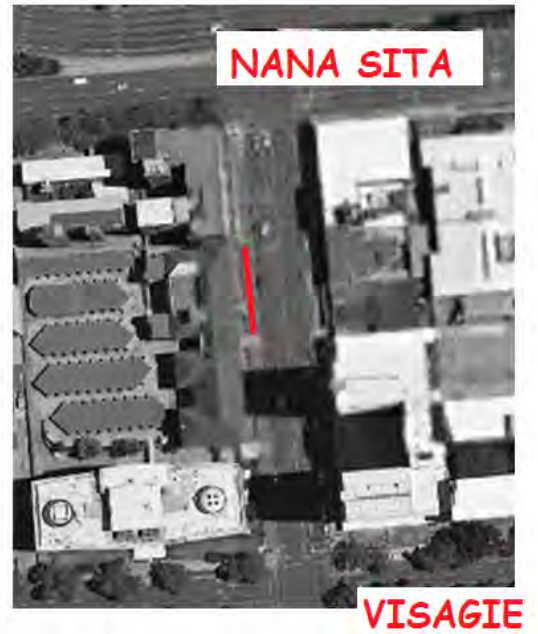
Fig. 118 Reconstruction of present condition of slate flagstone paving in the central portion of Block 7 between Visagie Street and Nana Sita Street, disregarding cracked and lost units. Its position is indicated with a red line on the inset.

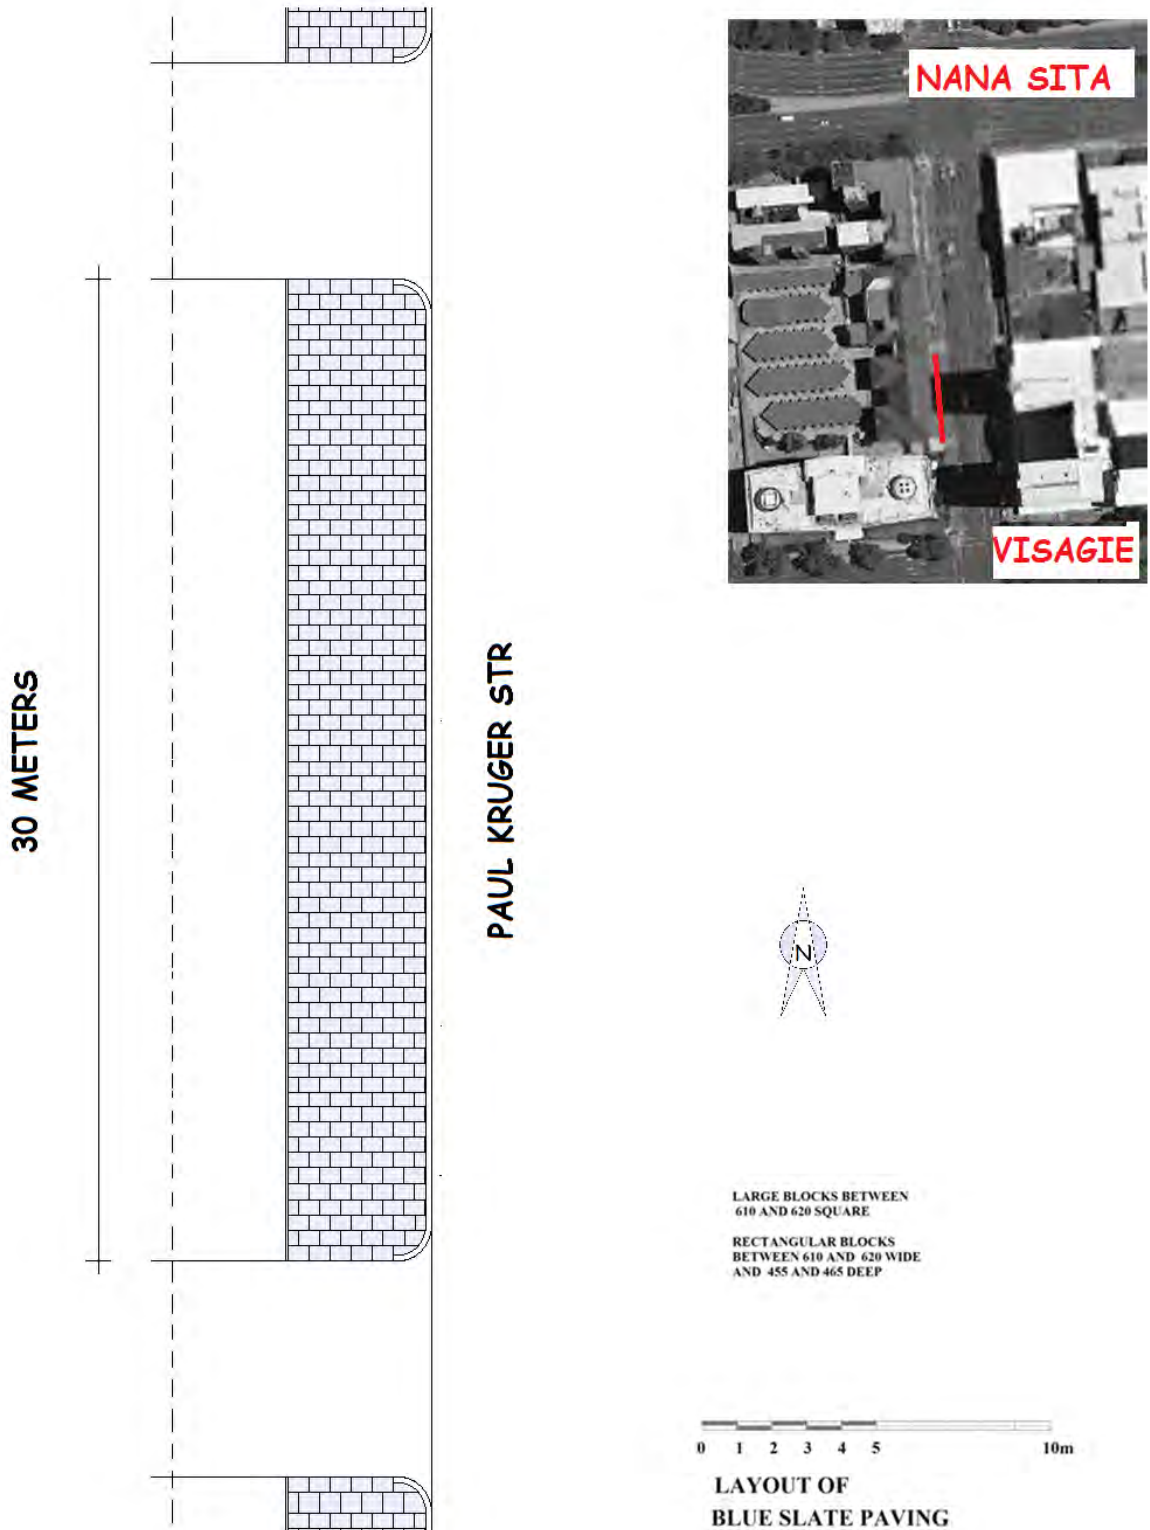
Fig. 119 According to the site survey this is a probable facsimile of the present condition of the slate flagstone paving in the central portion of Block 7 between Visagie Street and Nana Sita Street, disregarding the cracked and lost units. Its position is indicated with a red line on the inset.

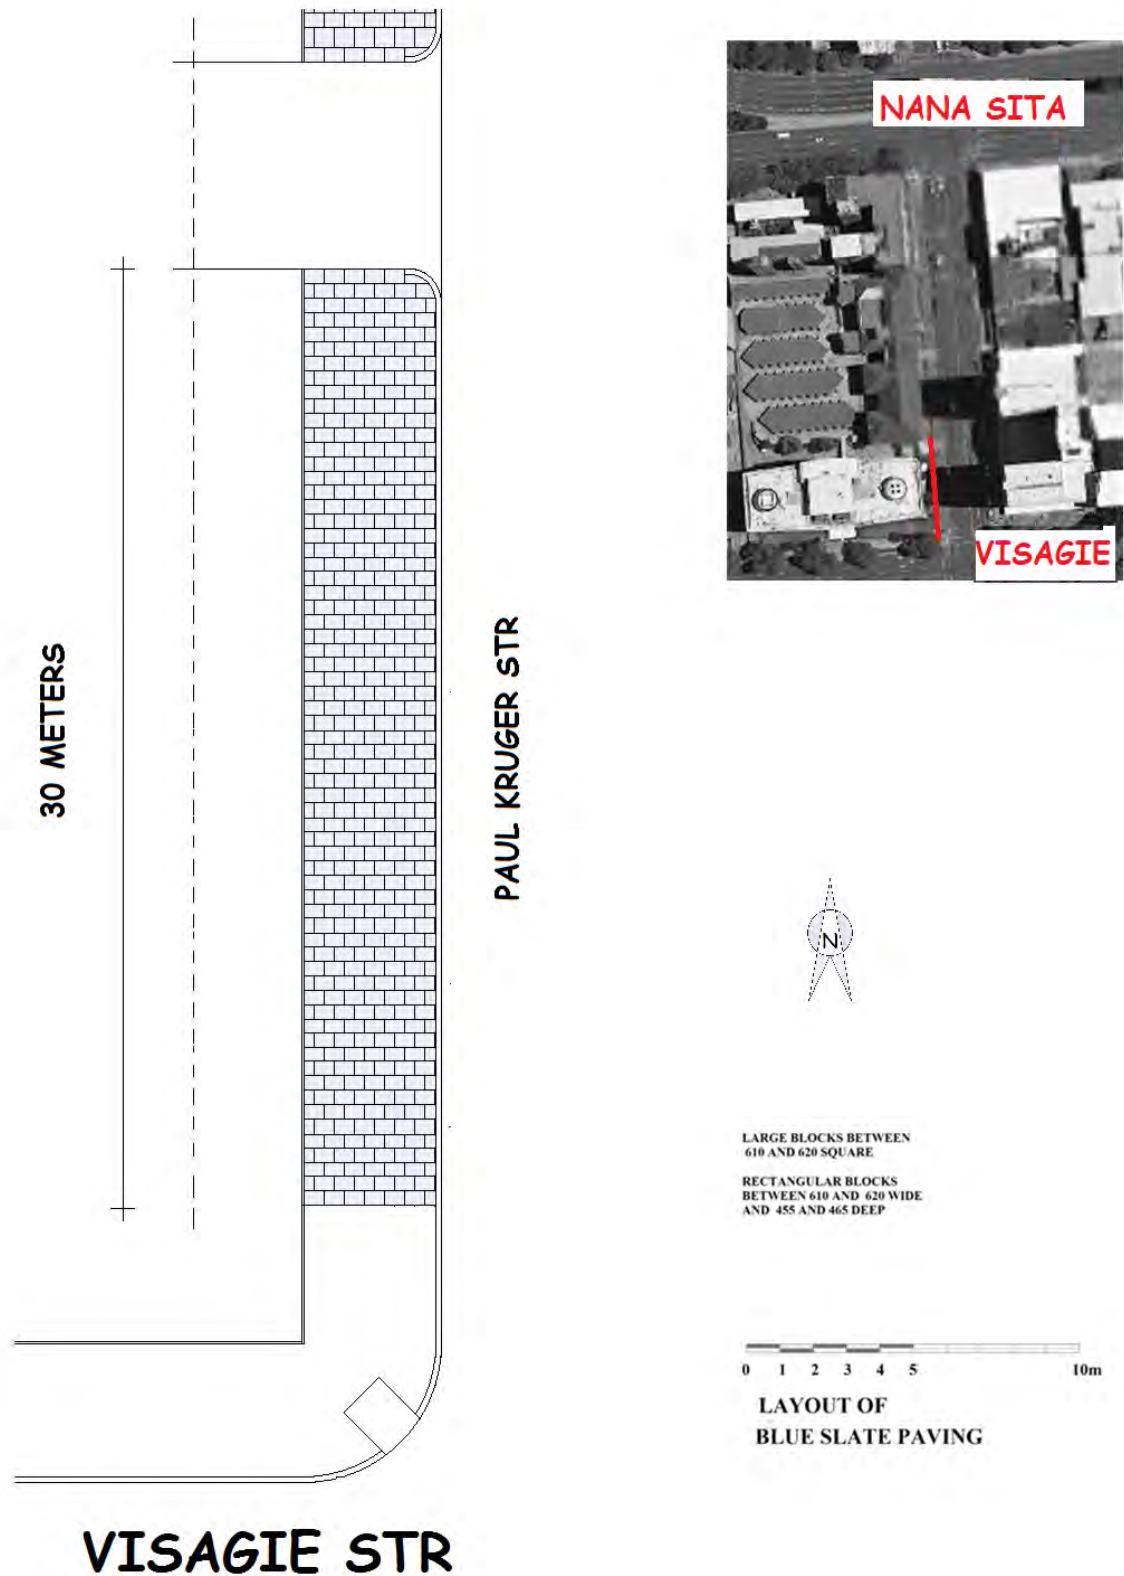
Fig. 120 Reconstruction of present condition of slate flagstone paving on the south-western corner of Paul Kruger and Visagie streets, disregarding cracked and lost units. Its position is indicated with a red line on the inset.

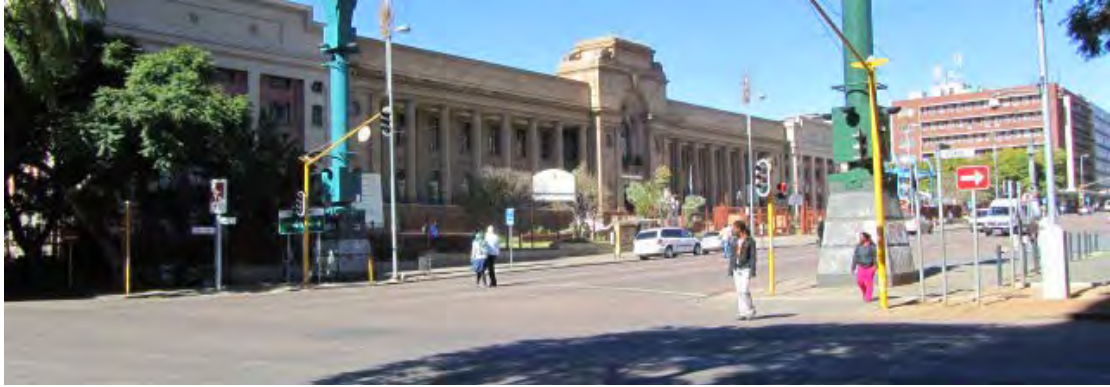
Fig. 123 Block 8, which includes the Old Town Hall, contains the largest section of in situ slate flagstones. This area will have to feature in proposal on preservation and also the design of new elements. (Photograph SM Miller 2012)

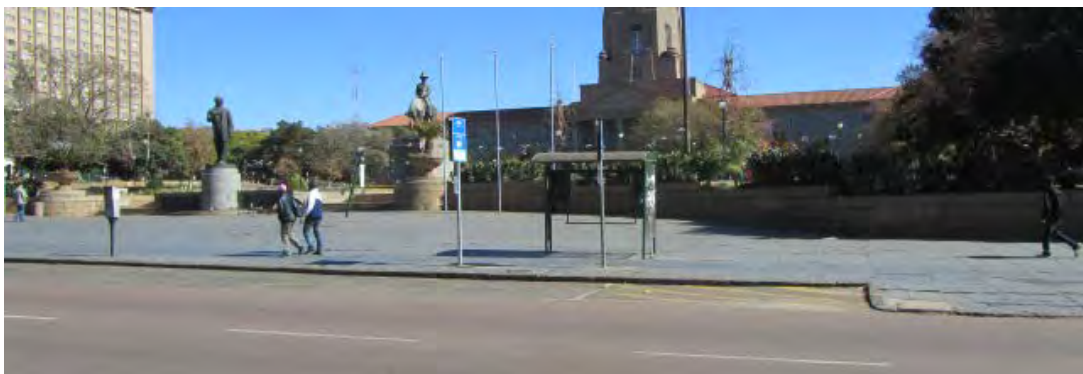
Fig. 124 The harmony between historical building, paving and monuments is captured in this image. Note the inappropriate street furniture. Also compare to Figs 126 and 13.1 (Photograph SM Miller 2012)

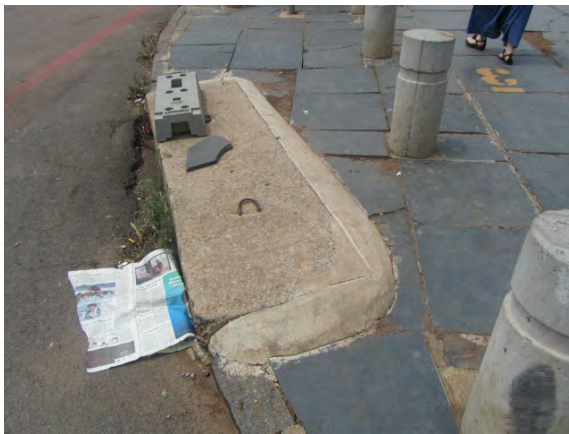
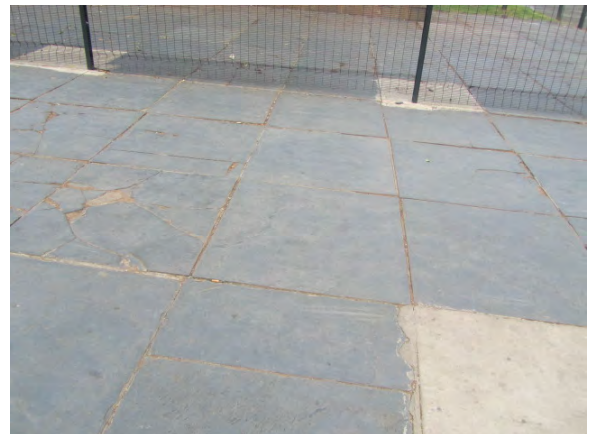
Figs 125 and 126 Left is an example where inappropriate material that is not compatible with the historical features has been used. The installation of storm water drainage that necessitated culverts resulted in this unfortunate solution. Above right we see the impact of the installation of a security fence on the historical flagstone paving. (Photograph SM Miller 2013)

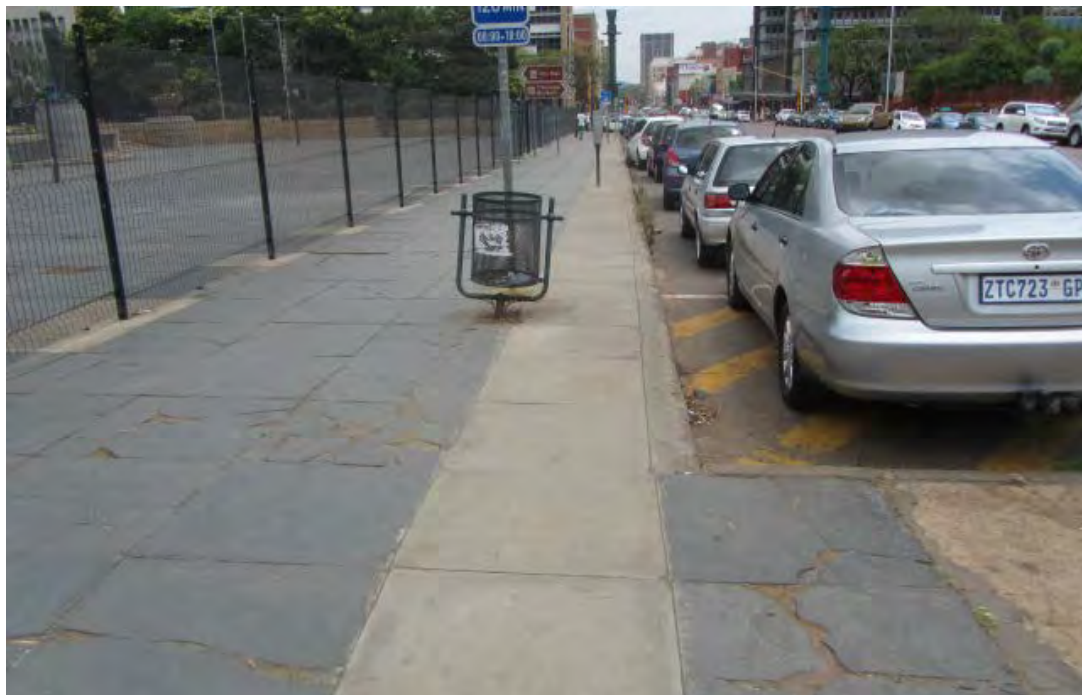
Fig. 131 Since 2012, when the original Phase 1 study was undertaken, this security fence was erected through one of the most pleasant public spaces in Tshwane, which contains two of the most important historical buildings in the city. Besides, thousands of children move through this locale on visits to the Museum. This feature detracts from their educational experience (Photograph SM Miller 2013)
