**EXTENSION OF PHASE 1 (SAHRA ID 4150) HIA FOR
PROPOSED BRT SERVICE, PAUL KRUGER STREET,
PRETORIA, TSHWANE
FROM BLOED STREET TO SCHEIDING STREET,
EXCLUDING CHURCH SQUARE WITH SPECIFIC
REFERENCE TO SIDEWALKS AND VERANDAS**

November 2013

Report compiled by Sidney Miller.

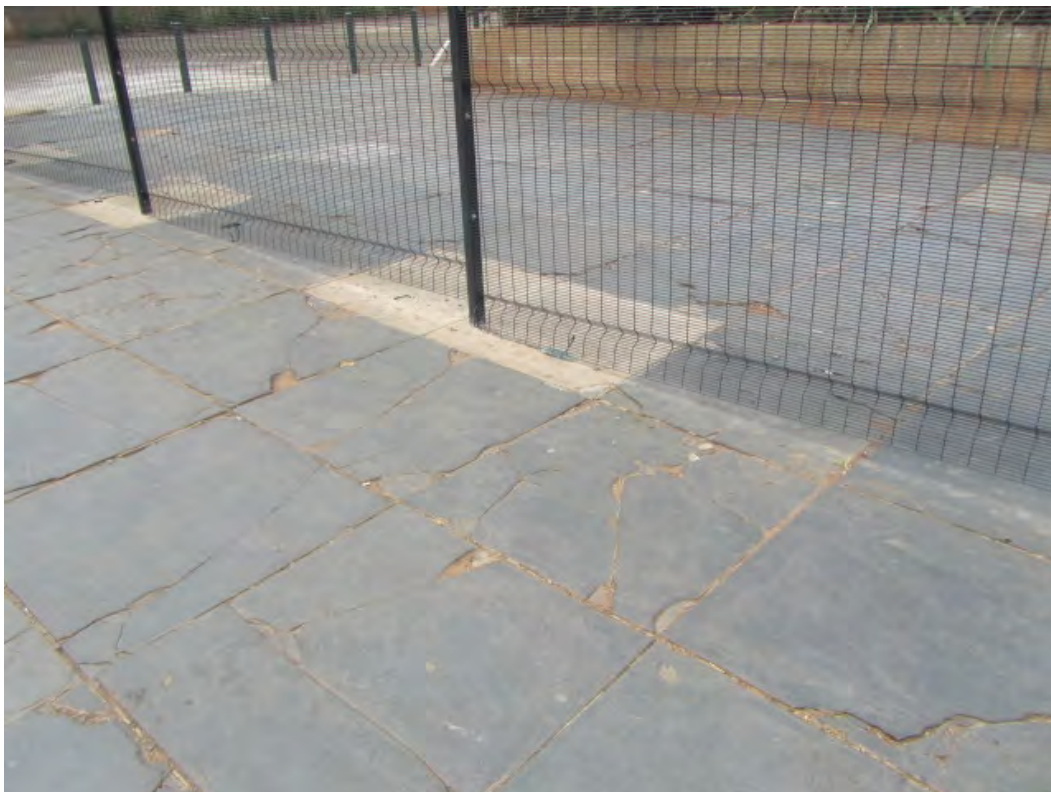
Fig. 136 The above image captures the current state of preservation of the slate flagstones in front of the Old Town Hall. It is estimated that no more than 10 to 20 percent of the large format (three feet square) flagstones are still intact. (Photograph SM Miller 2013)

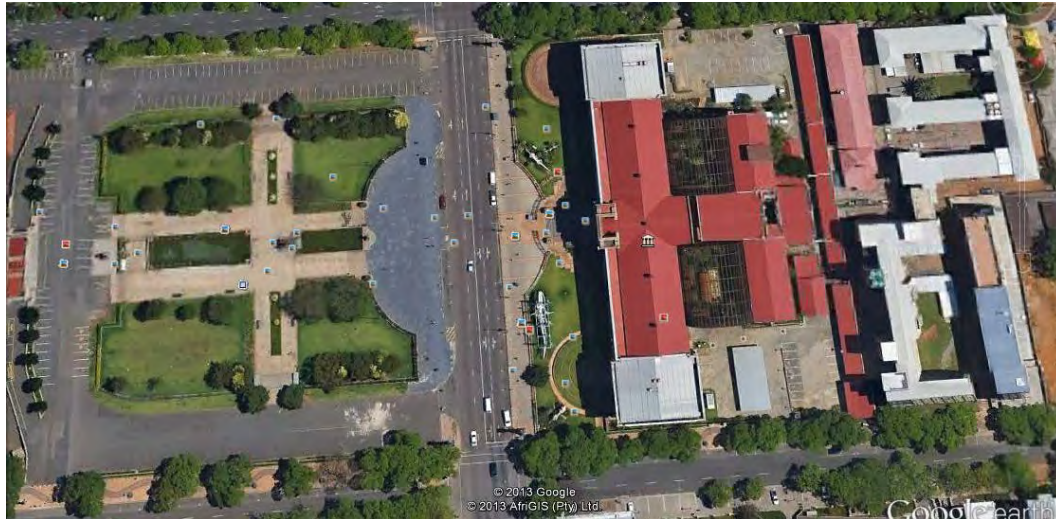
Fig. 140 Google Earth View image of the public space between the Old Town Hall and the Museum in 2009 before the placement of the new security fence. The historical context of this public space has been compromised by the placement of the security fence.

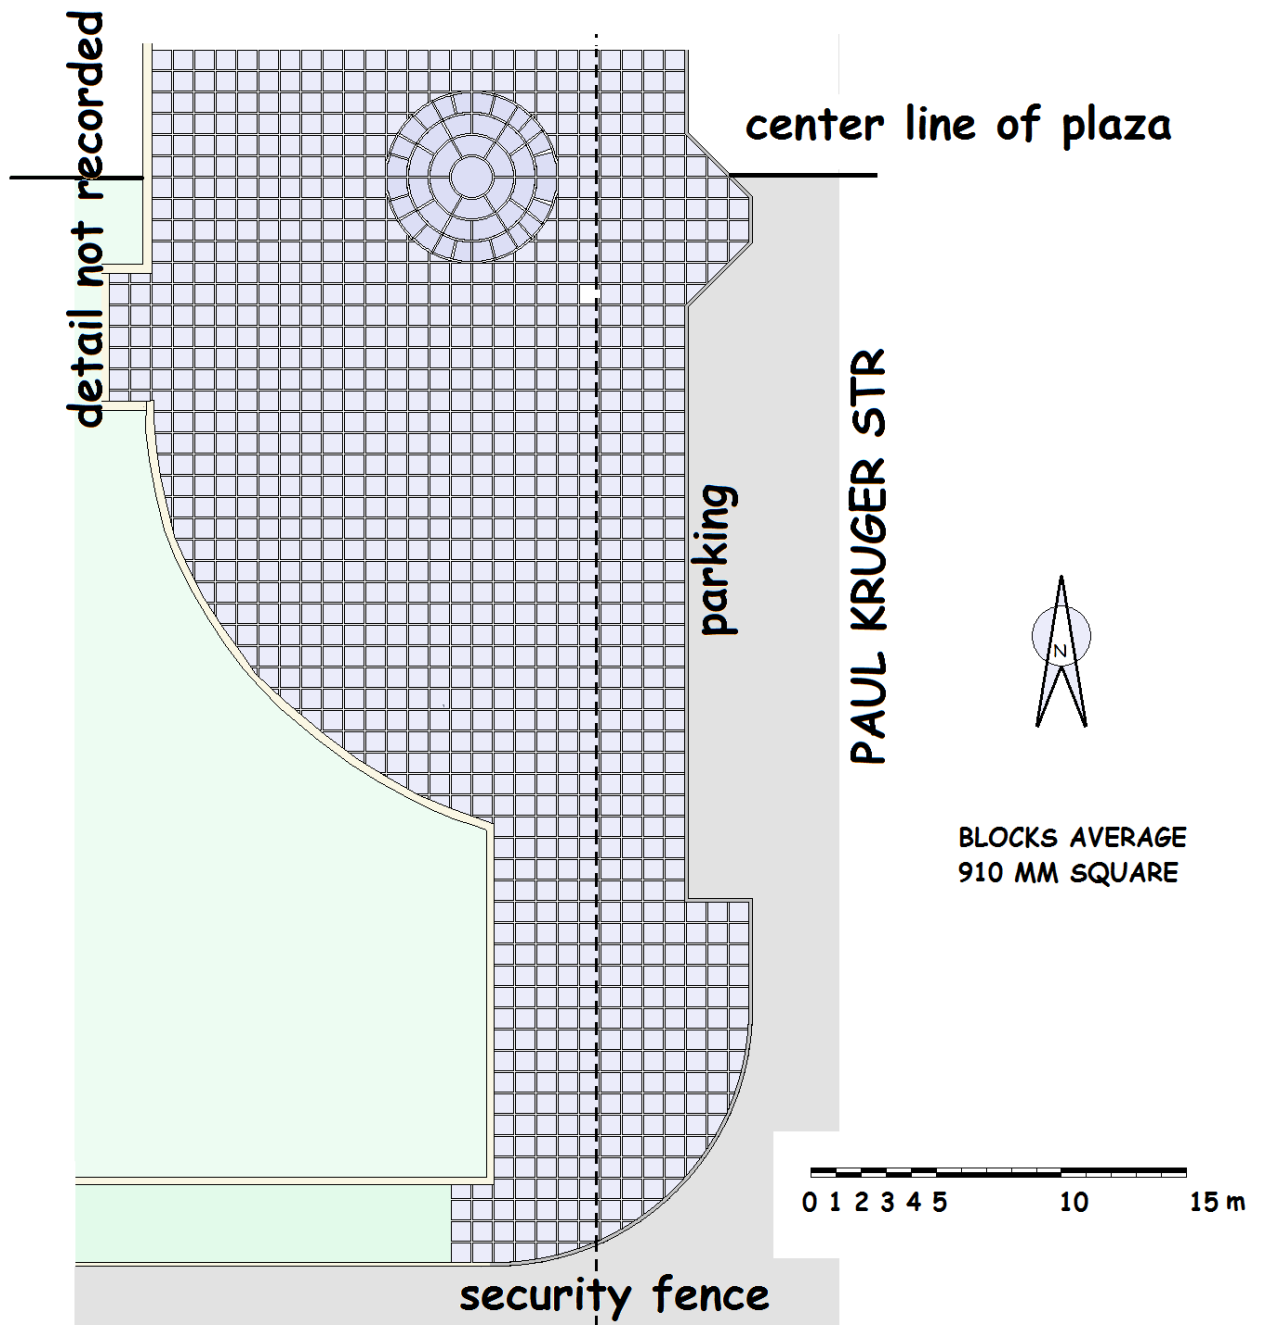
Fig. 143 Reconstruction of the present condition of slate flagstone paving on the southwestern corner of Paul Kruger and Visagie streets, disregarding cracked and lost units. To identify the drawing's position refer to Fig. 142 above.

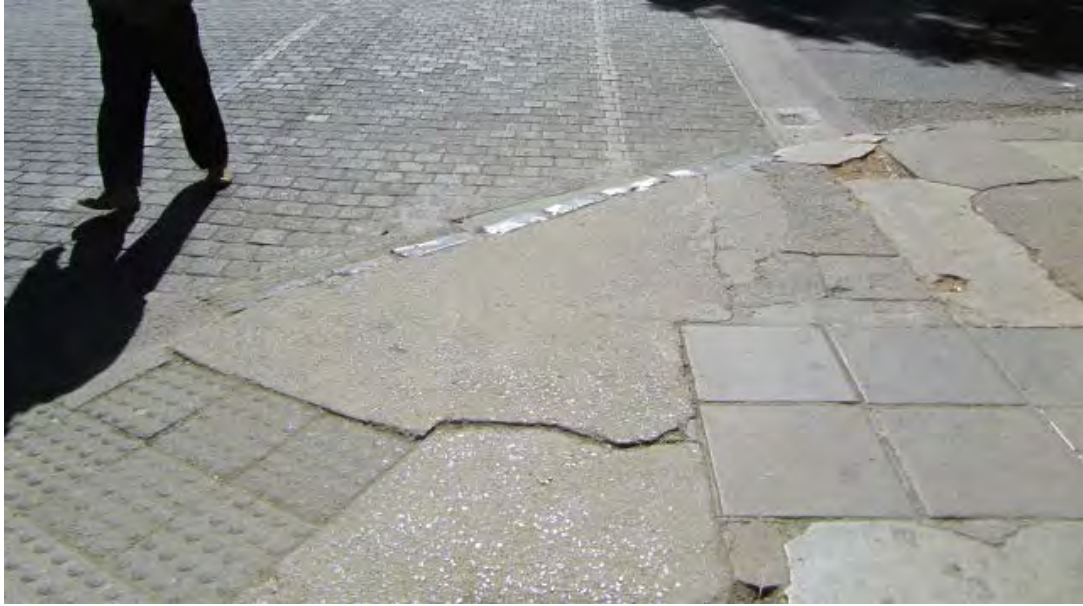
Fig. 146 New road paving as part of the Museum walk renovation several years ago. Sidewalk paving is neither aesthetically pleasing, nor is it safe for pedestrians.. (Photograph SM Miller 2012)

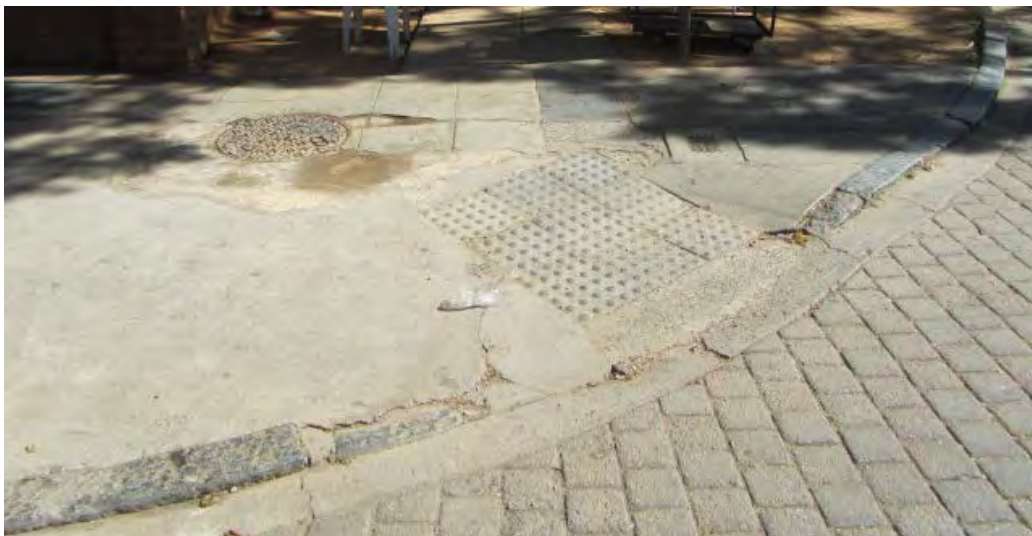
Fig. 148 Wheelchair access where the historical granite kerbing typically has been removed to adjust levels. (Photograph SM Miller 2012)

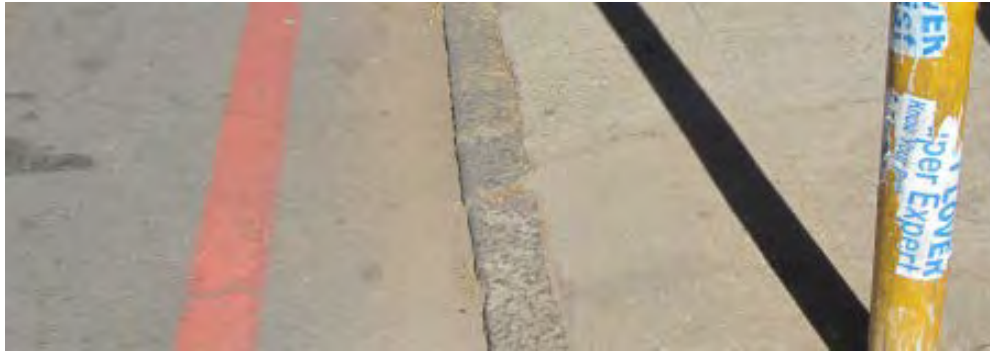
Fig. 149 The image above captures a typical situation in the city where the level of granite kerbing is impacted upon by continuous road re-surfacing. (Photograph SM Miller 2012)

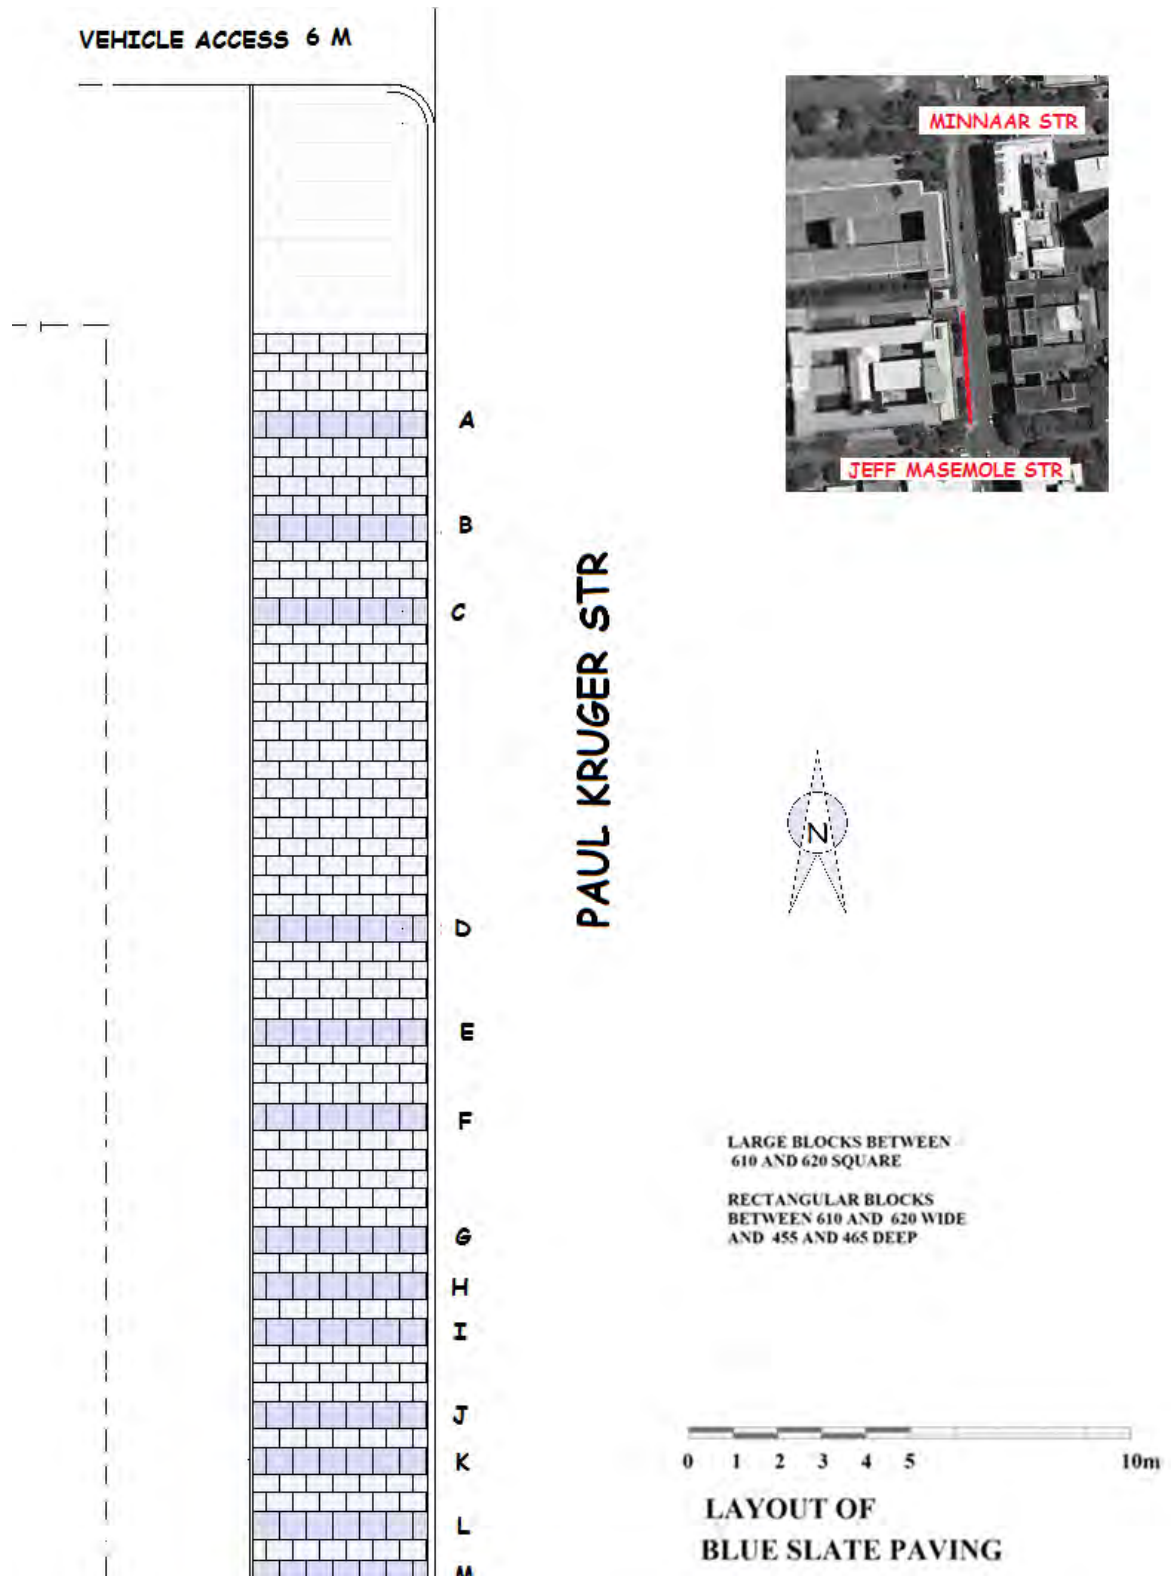
Fig. 158 Reconstruction of present condition of slate flagstone paving on the central western section of Block 9, disregarding cracked and lost units. Its position is indicated with a red line on the inset.

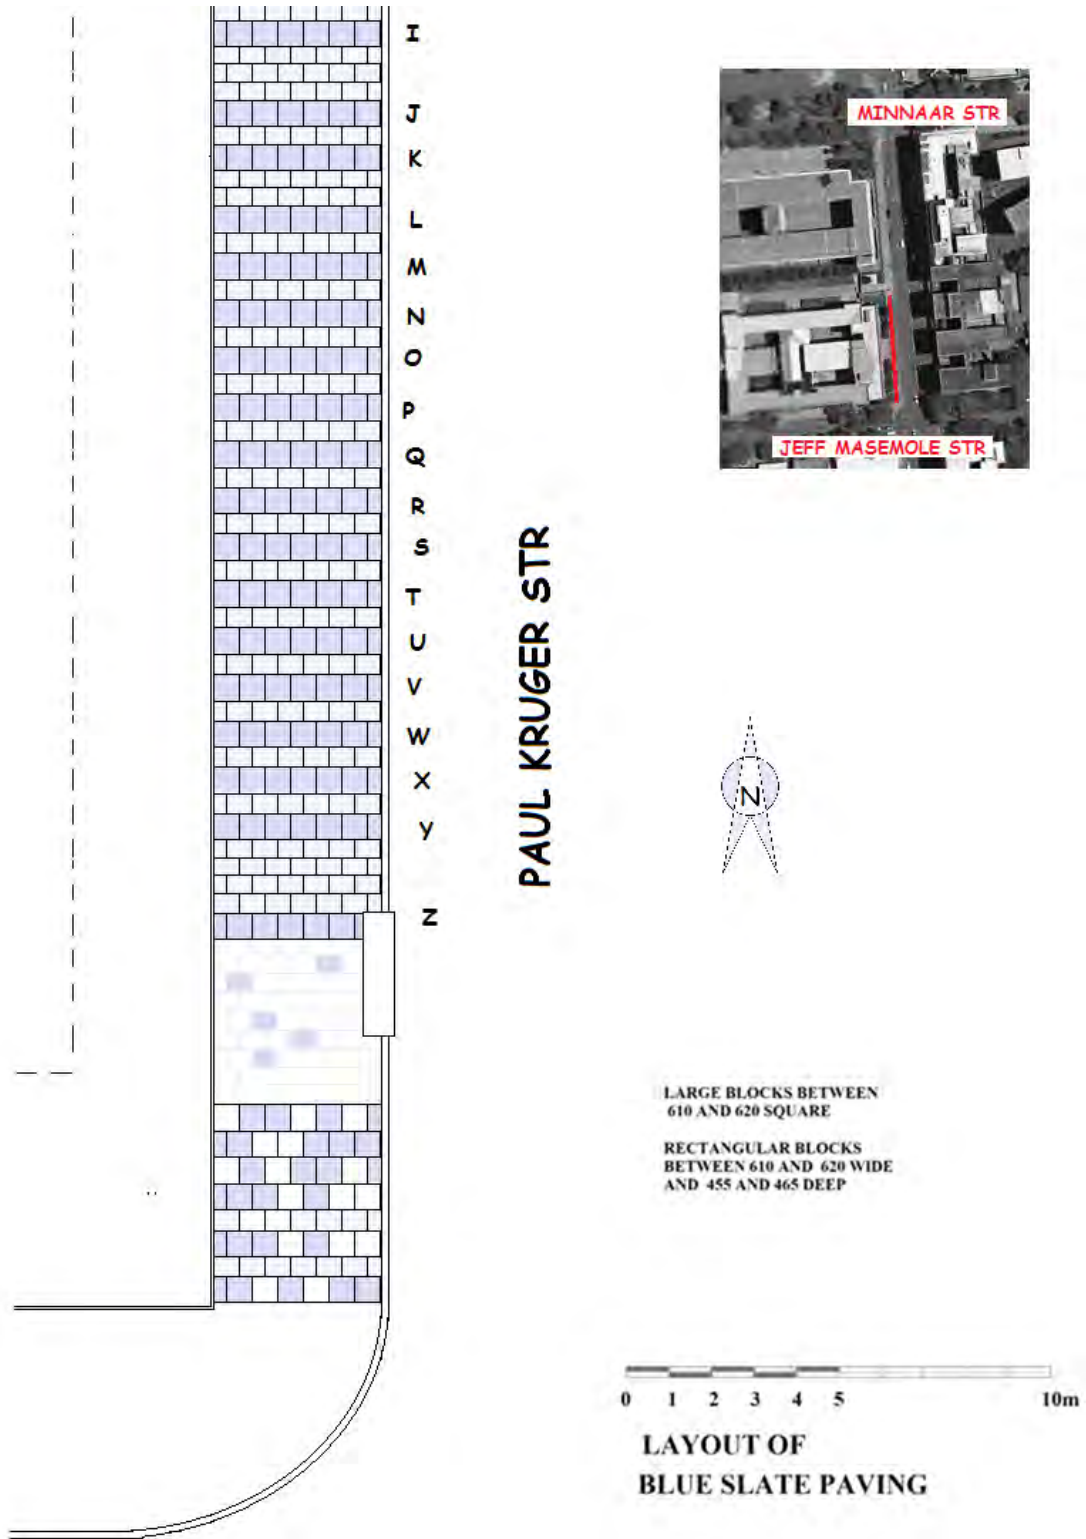
Fig. 159 Reconstruction of the present condition of the slate flagstone paving on the south western corner of Block 9, disregarding cracked and lost units. Its position is indicated with a red line on the inset.

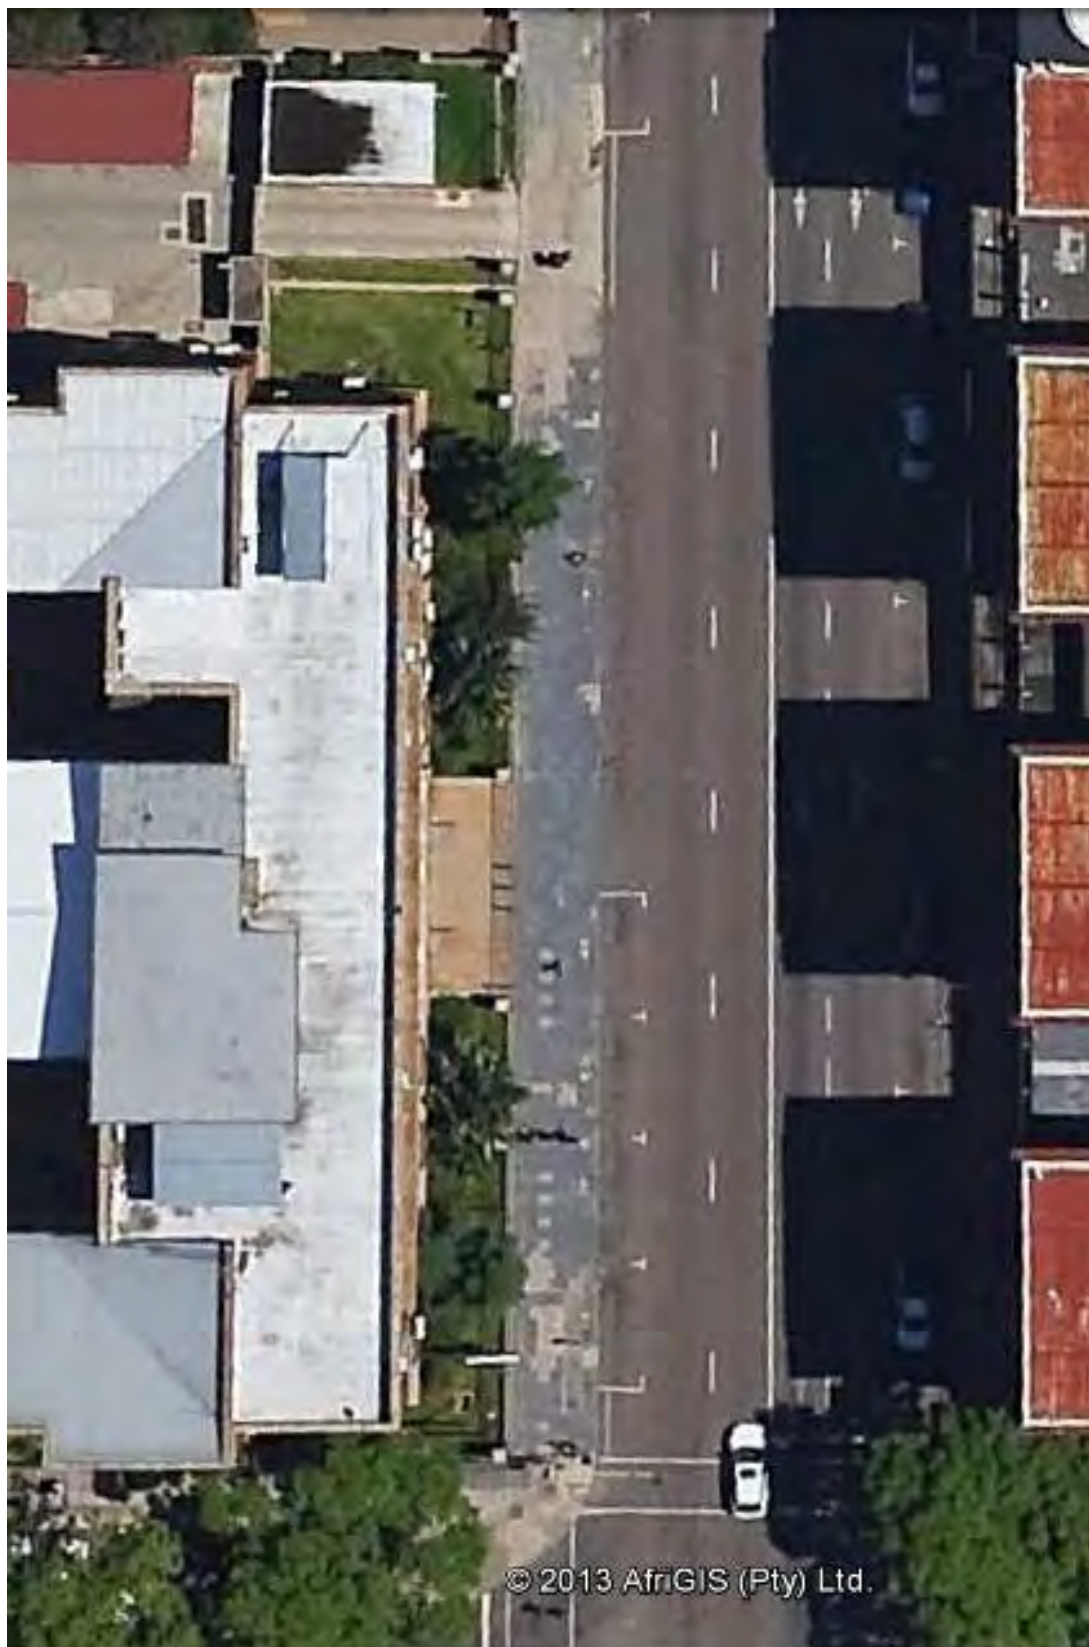
Fig. 160 Google Earth (2009) view of the slate flagstone paving on the south-western corner of Block 9.

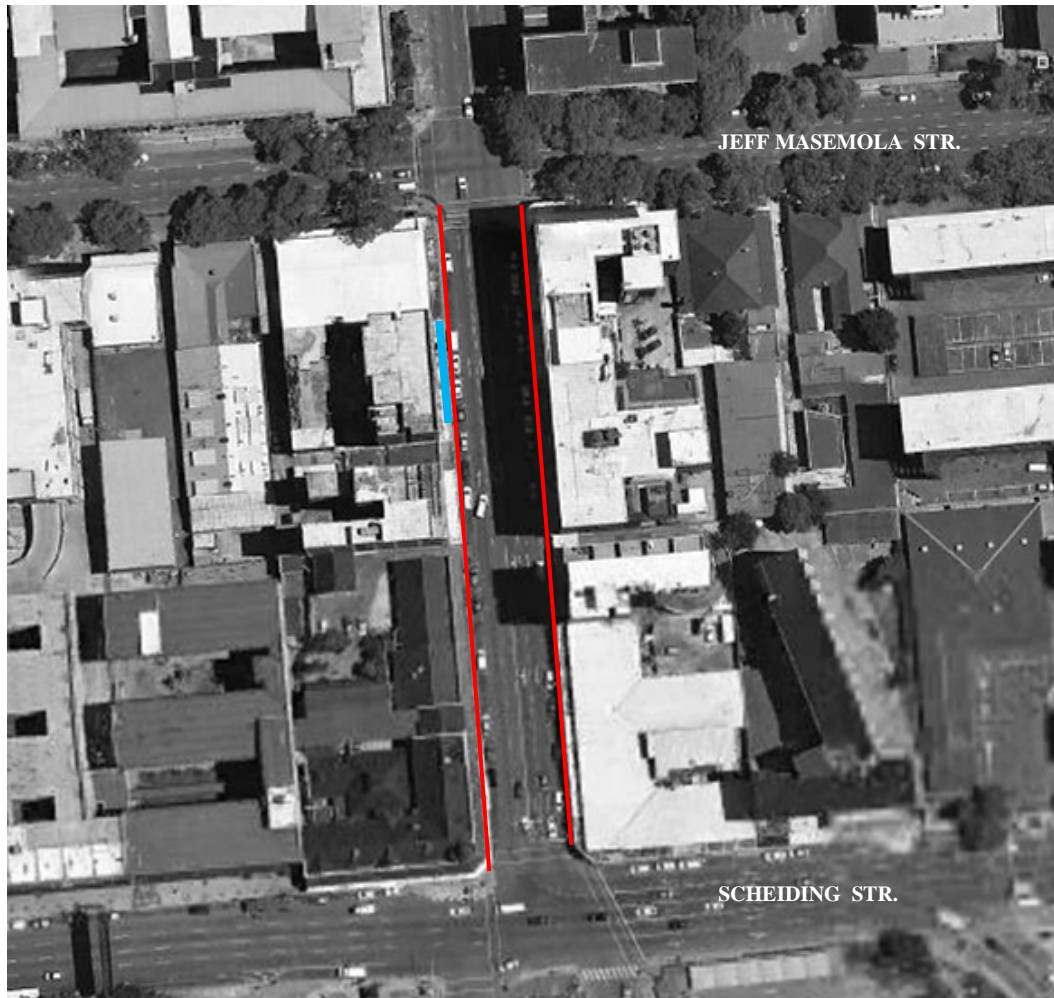
Fig. 161 Google Earth (2009) image of Block 10 with position of slate paving (blue) and granite kerbing (red) highlighted.

- 1.1 Contains approximately 138 square meters of slate flagstone paving at central portion of block 10.
- 1.2 Approximately 60 square meters are cracked and damaged in this area.
- 1.3 Approximately 78 square meters may be recovered from this area and reused.
- 2.1 Block 10 total length ~ 141 meters.
- 2.2 Approximately 110 meters of granite kerbing remain on eastern side of Paul Kruger Street. (See Fig. 162)
- 2.3 Approximately 110 meters of granite kerbing remain on western side of Paul Kruger Street. (See Fig. 162)

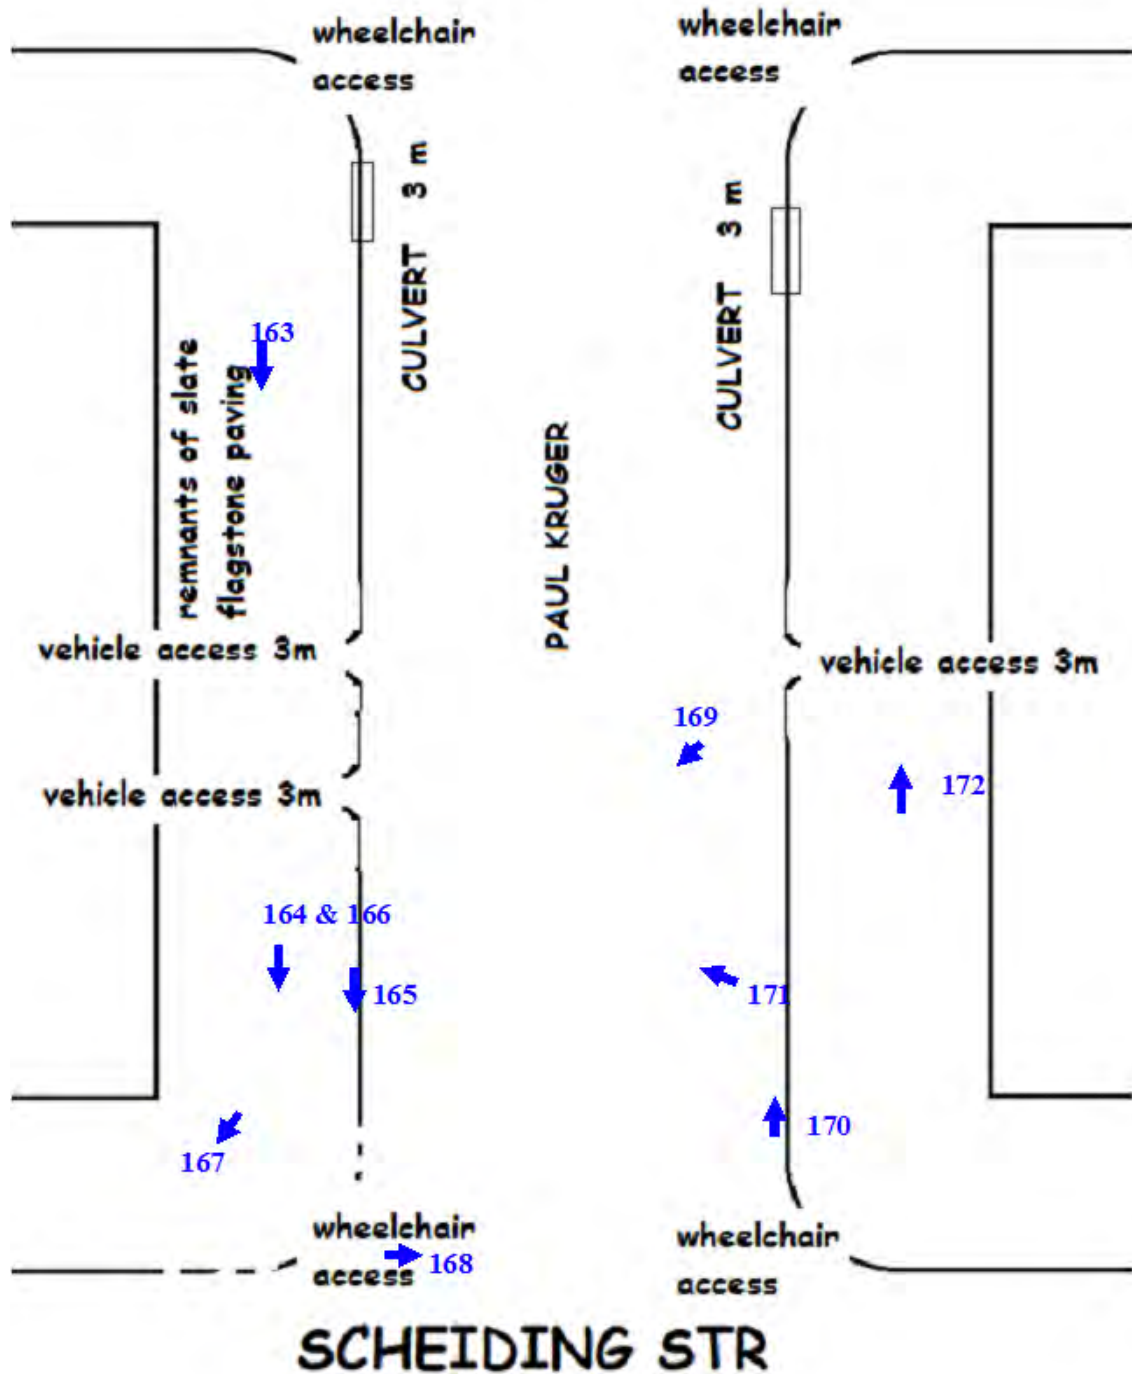
Fig. 162 Block 10, schematic representation for photo documentation. The drawing also indicates remaining portions of granite kerbing, wheelchair access, vehicular access and culverts, all factors that reduce the length of remaining granite kerbing.

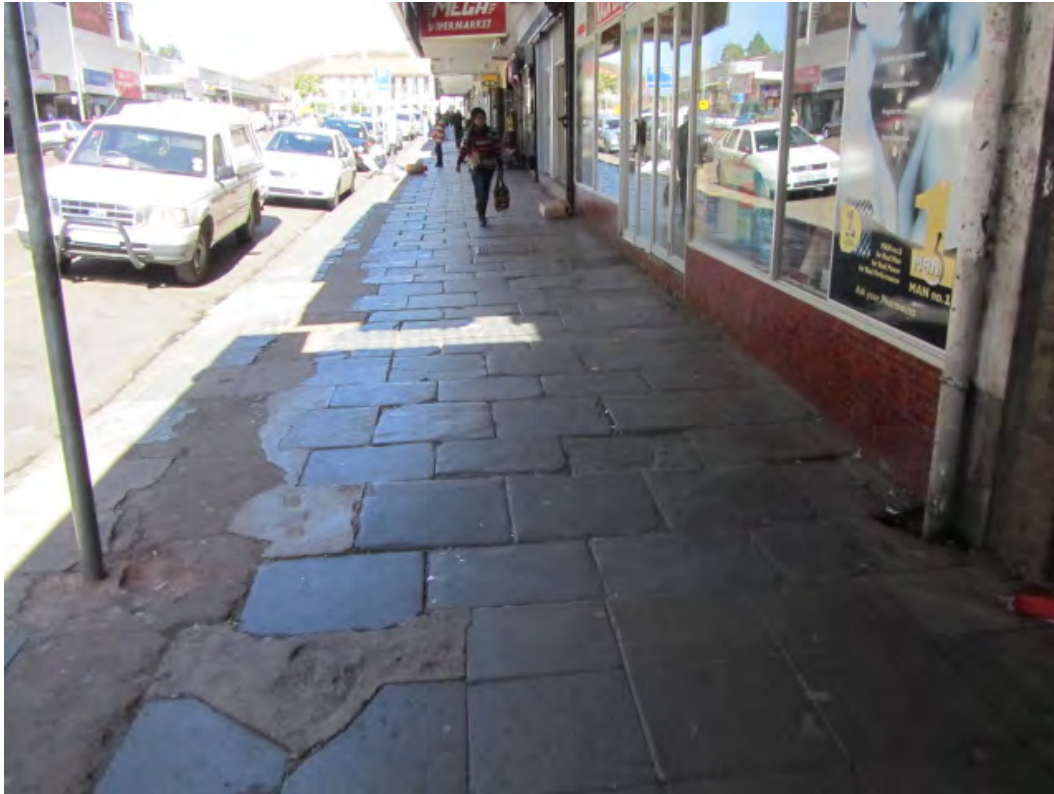
Fig. 163 Slate flagstone paving in the central western side of Block 10. Note the impact of placement of services. (Photograph SM Miller 2012)

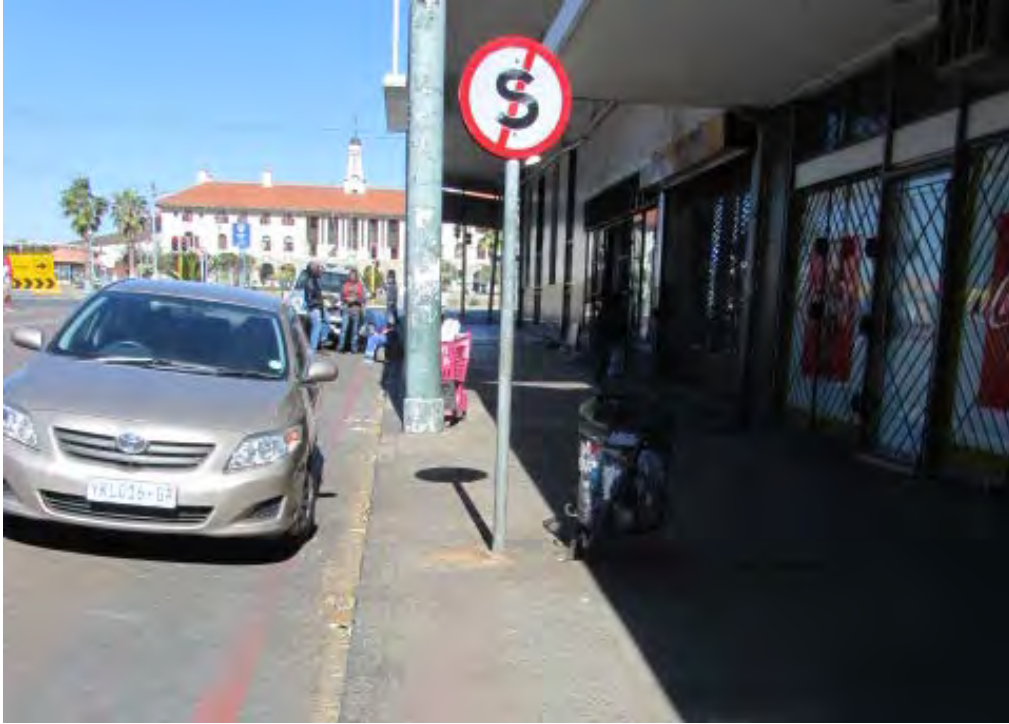
Fig. 165 Record of the canopy support columns of the old Victoria Hotel and the granite kerb stones that indicate definition of street and paving limits. (Photograph SM Miller 2012)

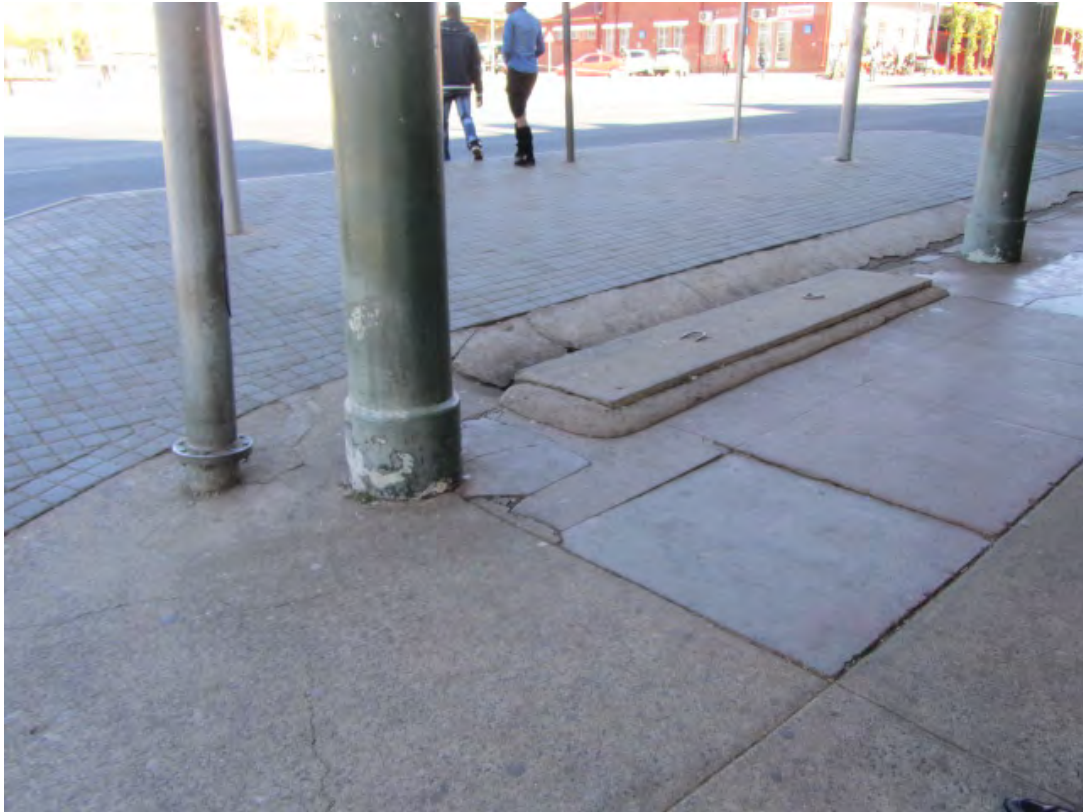
Fig. 167 Transition in pavements on the south-western corner of Block 10. (Photograph SM Miller 2012)

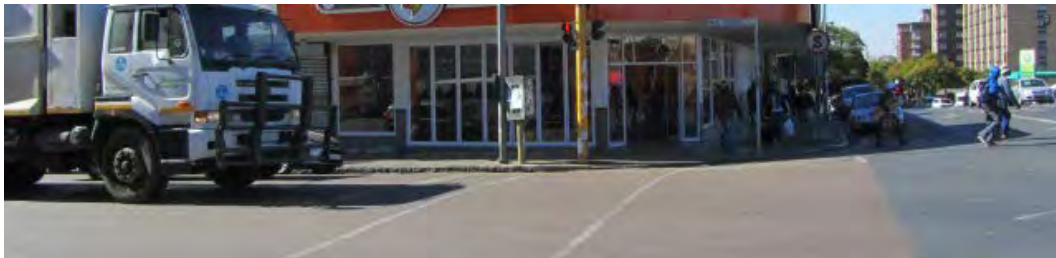
Fig. 168 Granite kerbing on the south-eastern corner of Block 10. (Photograph SM Miller 2012)

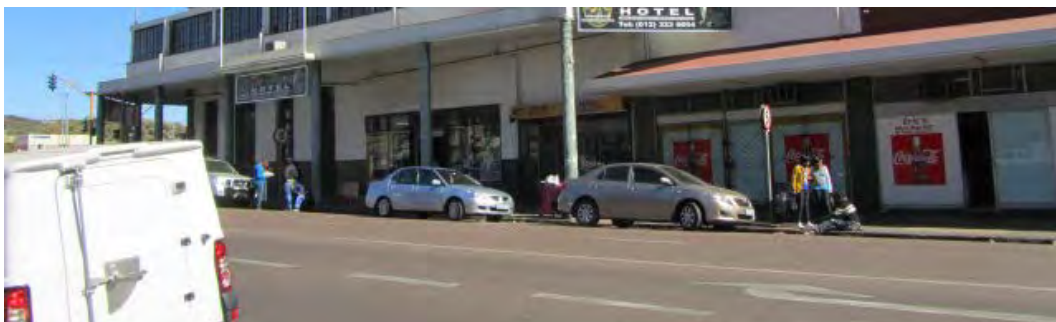
Fig. 169 Another view of the granite kerbing on the south-western corner of Block 10. (Photograph SM Miller 2012)

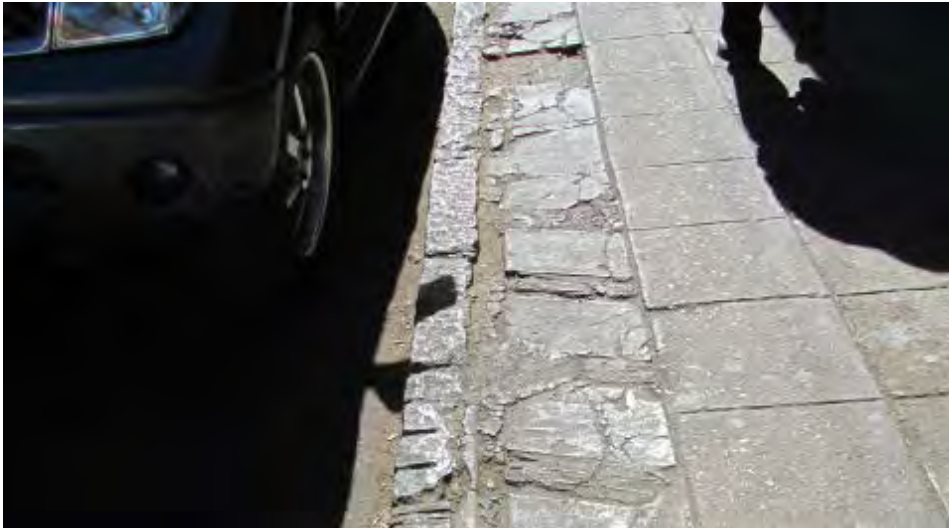
Fig. 170 Granite kerbing on the south-eastern corner of Block 10. (Photograph SM Miller 2012)

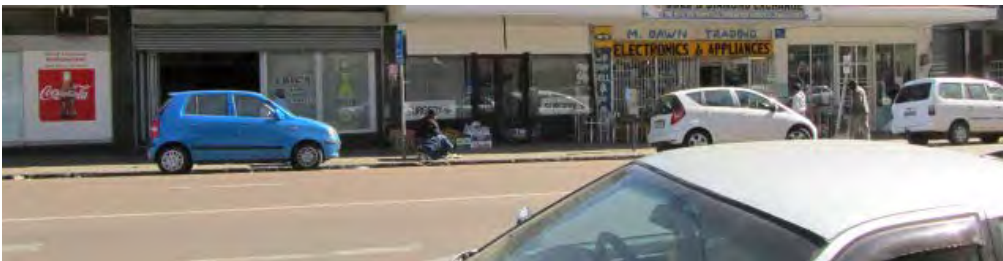
Fig. 171 Granite kerbing on the central western section of Block 10. (Photograph SM Miller 2012)

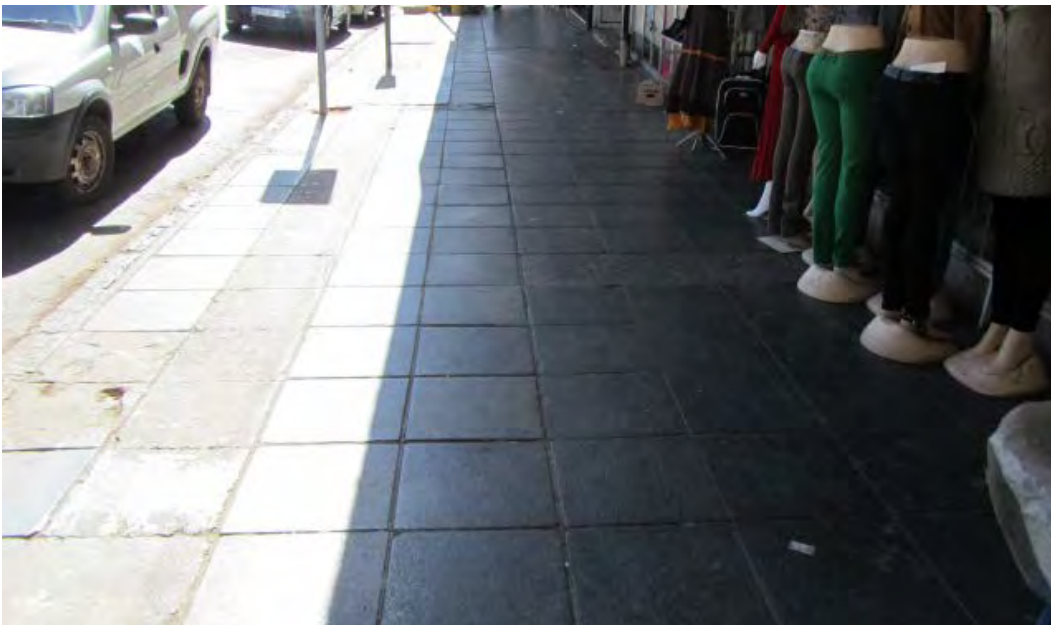
Fig. 172 Modern paving and the granite kerbing on the central western section of Block 10. (Photograph SM Miller 2012)

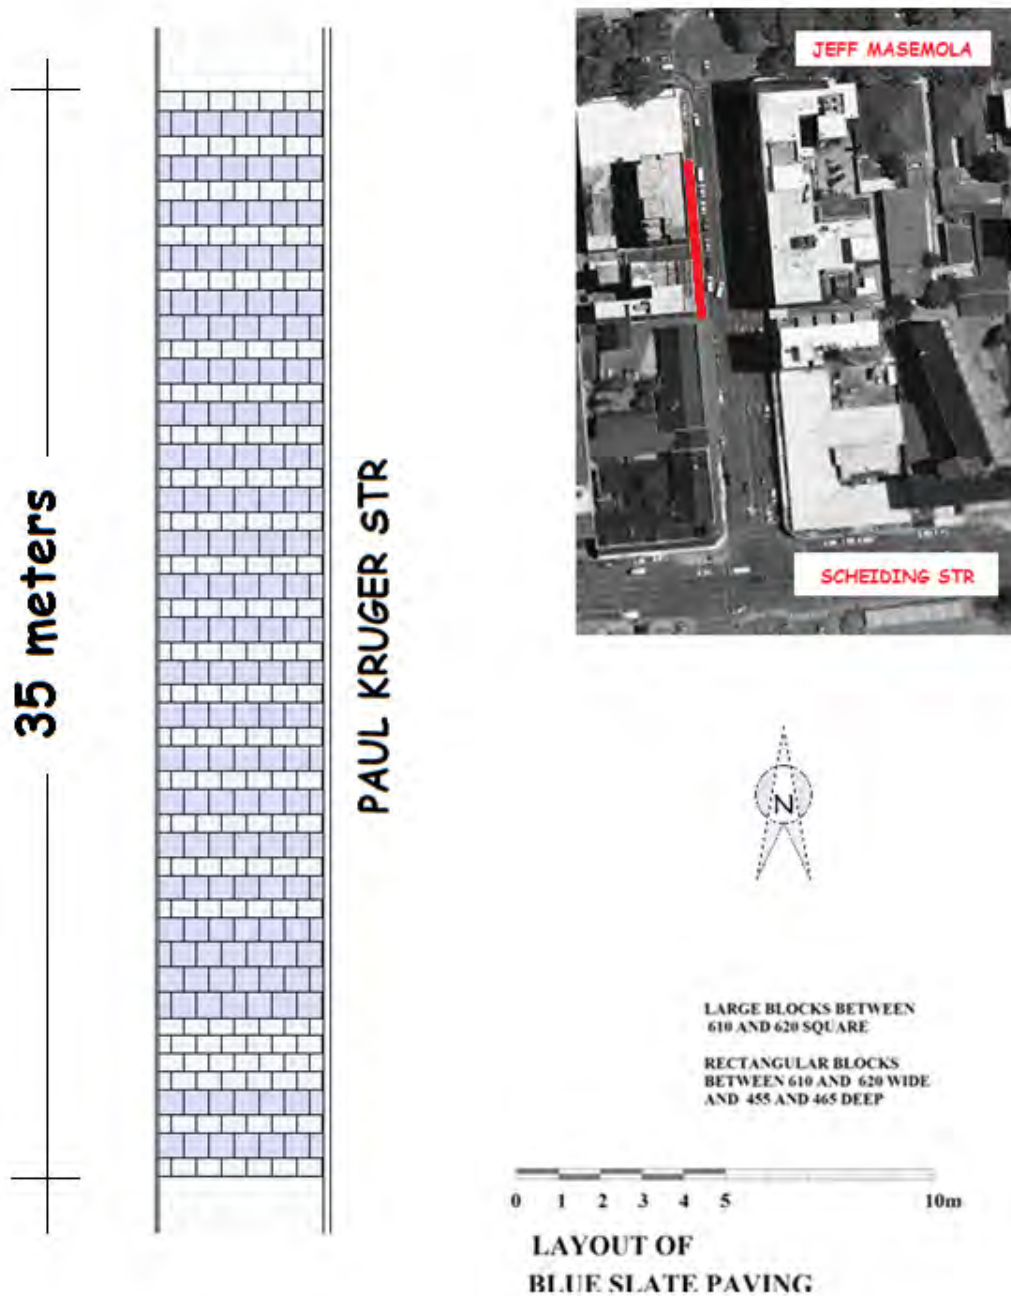
Fig. 173 Reconstruction of the present condition of slate flagstone paving on the western central section of Block 10 disregarding cracked and lost units. Its position is indicated with a red line on the inset.

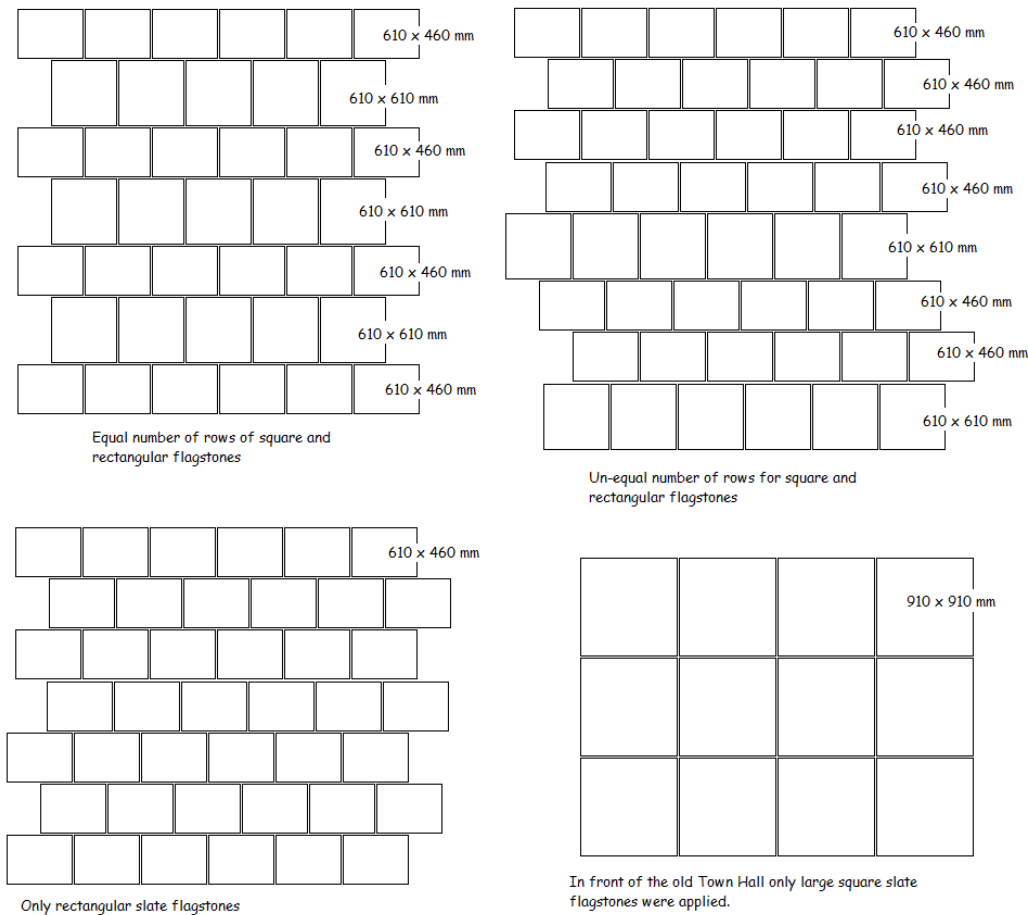
12.3 In the first place it was found that originally only three sizes of slate flagstones were used. These were on the average 910 mm square, 610 mm square and 610 x 455 mm rectangular (Fig. 174). These stones were originally laid in three basic patterns, but in time these patterns evolved owing to need.

Fig. 174 Recorded dimensions of slate flagstones and the typical patterns in which these have been laid. The fourth format, documented only in front of the Old Town

Hall, is badly damaged and will require special attention in the architectural designs.

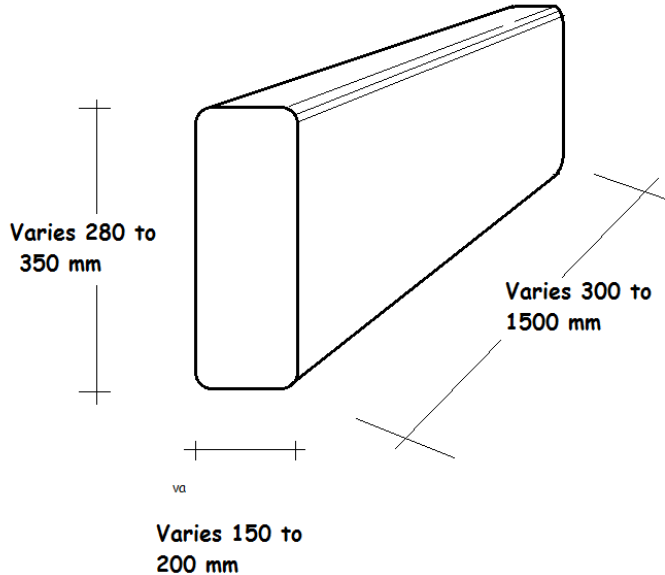
12.4 Secondly, it was recorded that the granite kerb stones, although rather uniform in height (280 to 350 mm) and depth (150 to 200 mm) were variable in length from 300 mm to 1500 mm.

Fig. 175 Typical measurements of the granite kerb stones.
