**New Multi Product Pipeline
(NMPP) Project**

Final Heritage Audit

2684358-J-A00-AM-ST-004-12

June 2013

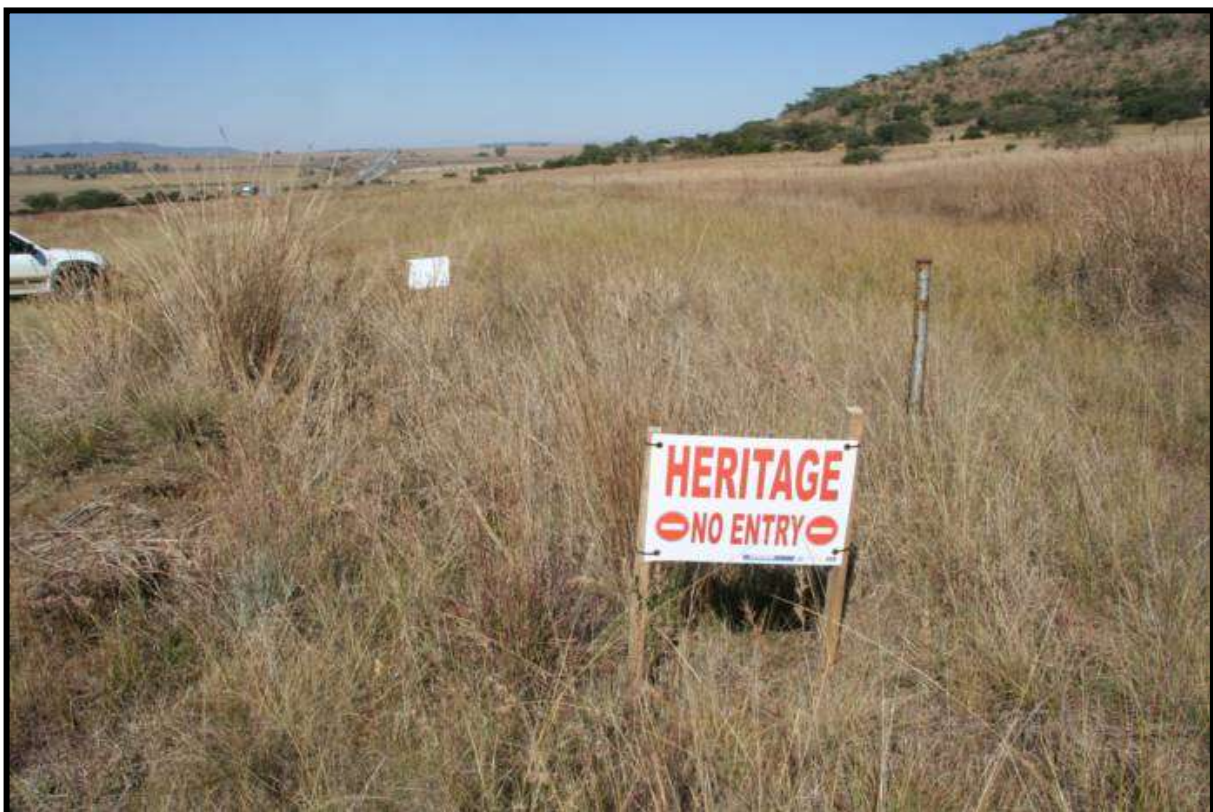
Fig. 19: GLK122b – Feature 569

The features were fenced off and clearly demarcated before RoW clearance. However, the one grave was demolished during construction. The general area of the grave was fenced off afterwards (fig. 19).

Management: Fencing should remain

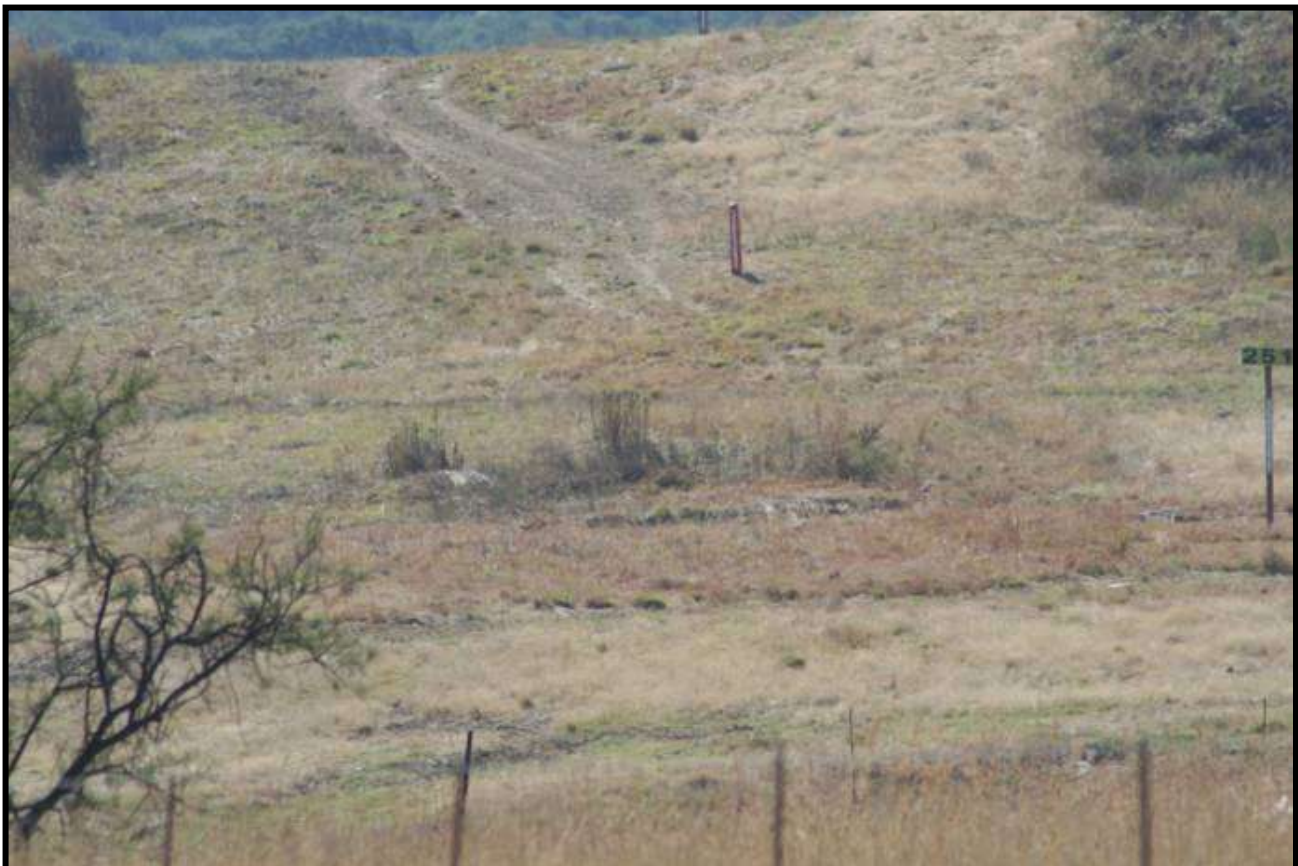
Fig. 24: Cemetery at GR1

The cemetery at GR1 consisted of six graves. The graves were fenced off and demarcated before RoW clearance and the pipeline was realigned accordingly. The cemetery was not affected during construction (fig. 24).

Management: The fencing should remain around the cemetery.

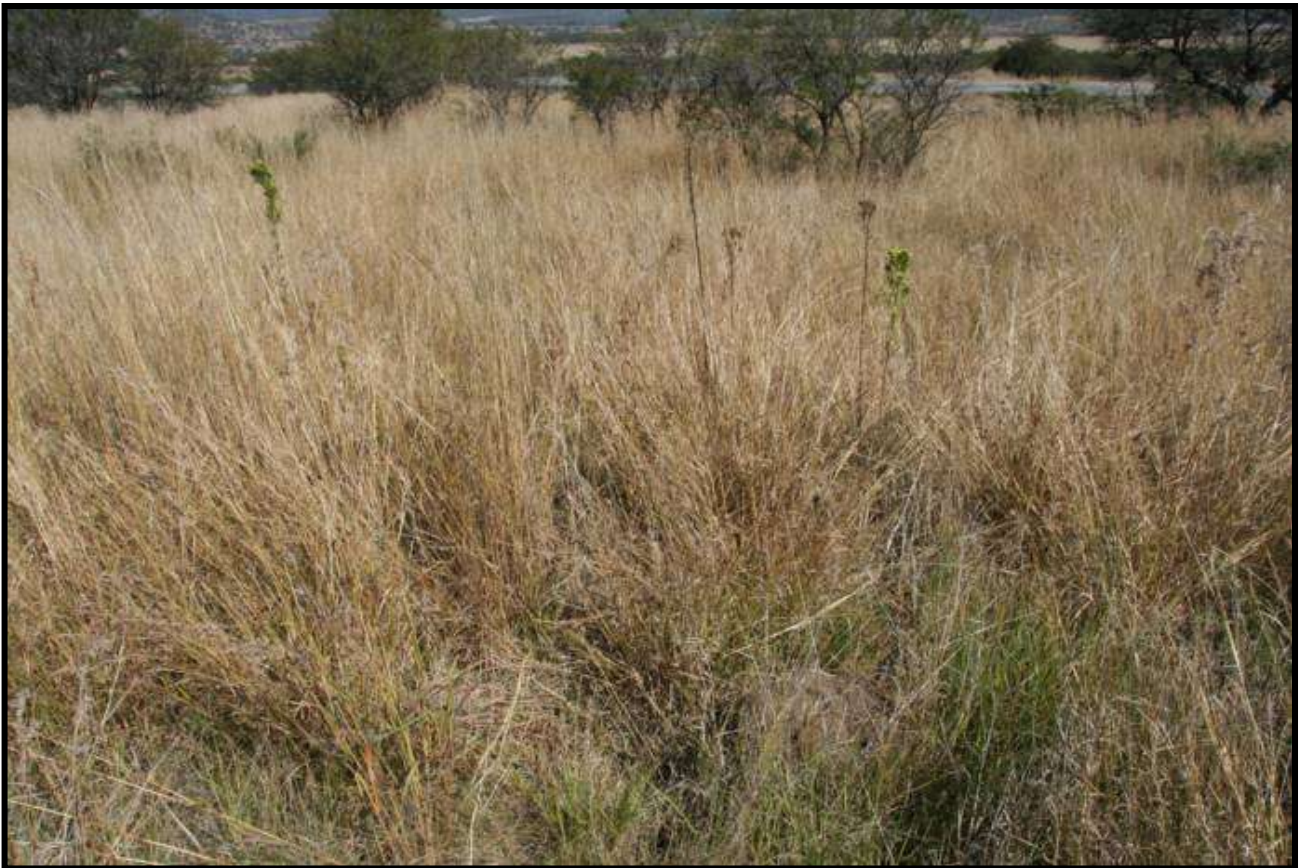
Fig. 26: VAL55 Grave

VAL55 is a possible grave in the RoW. The possible grave was fenced off and demarcated before RoW clearance (fig. 26). The grave was not affected by construction.

Management: The fencing should remain around the grave.

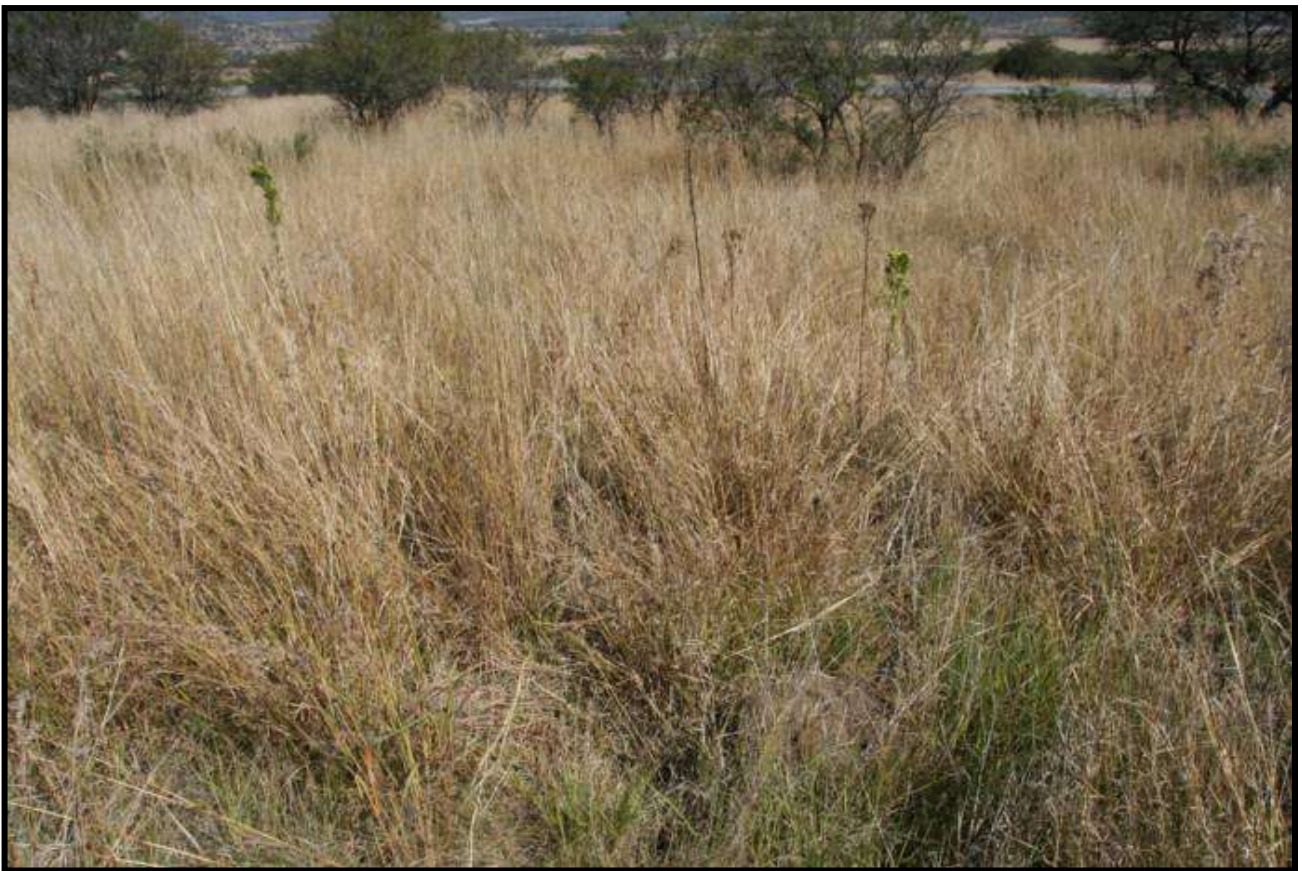
Fig. 27: GLK075 Grave

GLK075 consisted of a two recent houses and a grave (fig. 27). The grave was demarcated before RoW clearance. The houses were demolished with permission and the graves were not affected.

Management: The fencing around the graves should remain.

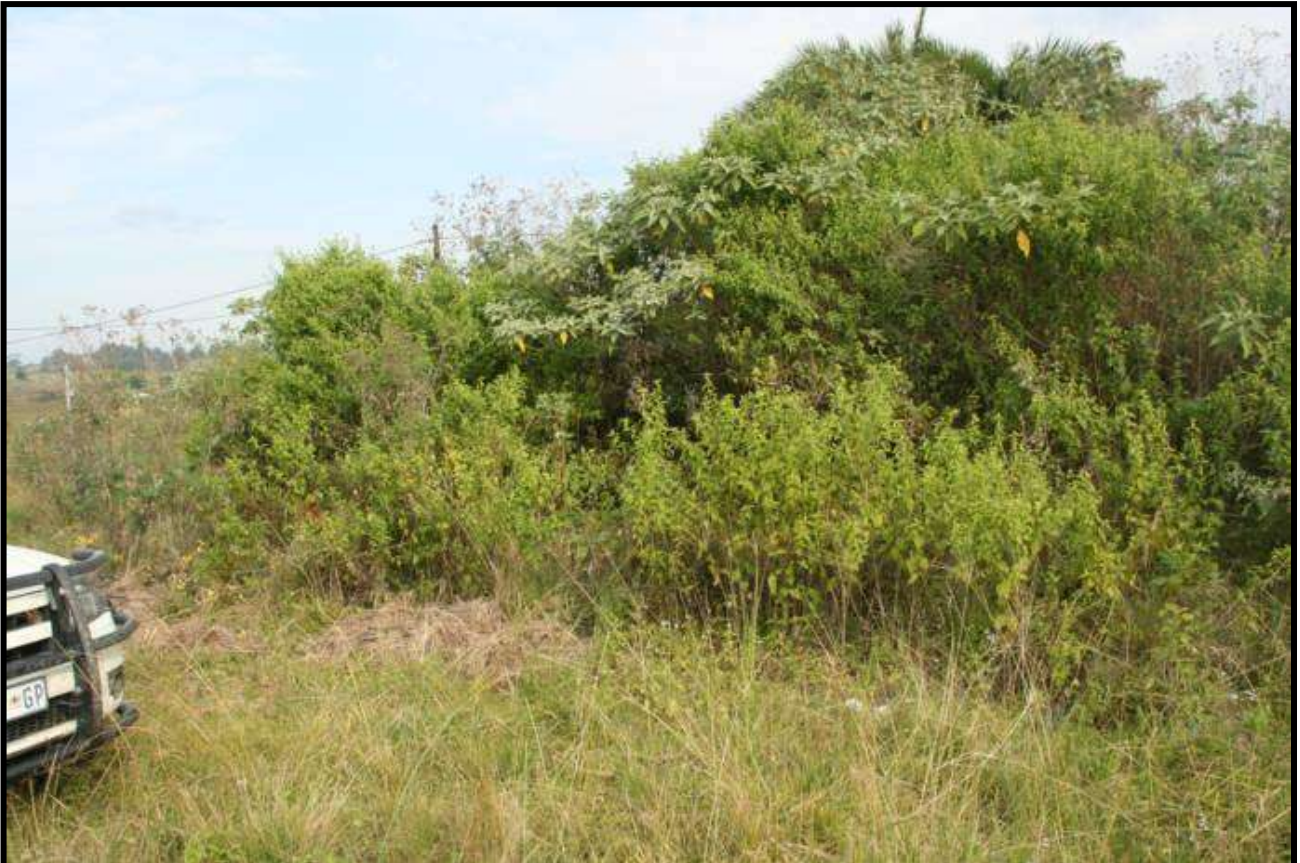
Fig. 53: Community Graves at KP37.250

KP37.250 is an area identified by the community as having graves (fig. 53). The area was demarcated before RoW clearance. No damage has occurred to the area.

Management: Fence poles should remain at the site

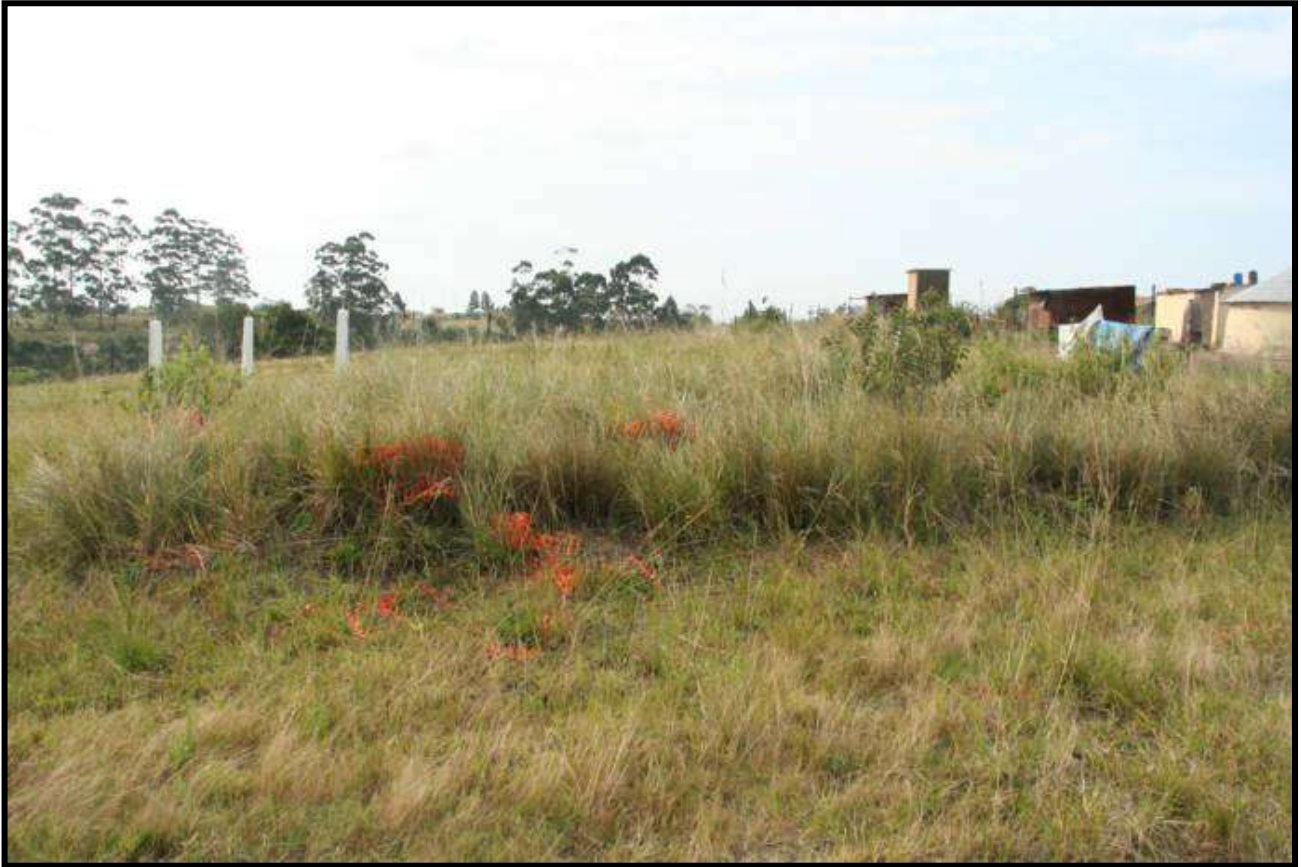
Fig. 54: Community Graves at KP37.100

KP37.100 is an area identified by the community as having graves (fig. 54). The area was demarcated before RoW clearance. No damage has occurred to the area.

Management: Fence poles should remain at the site

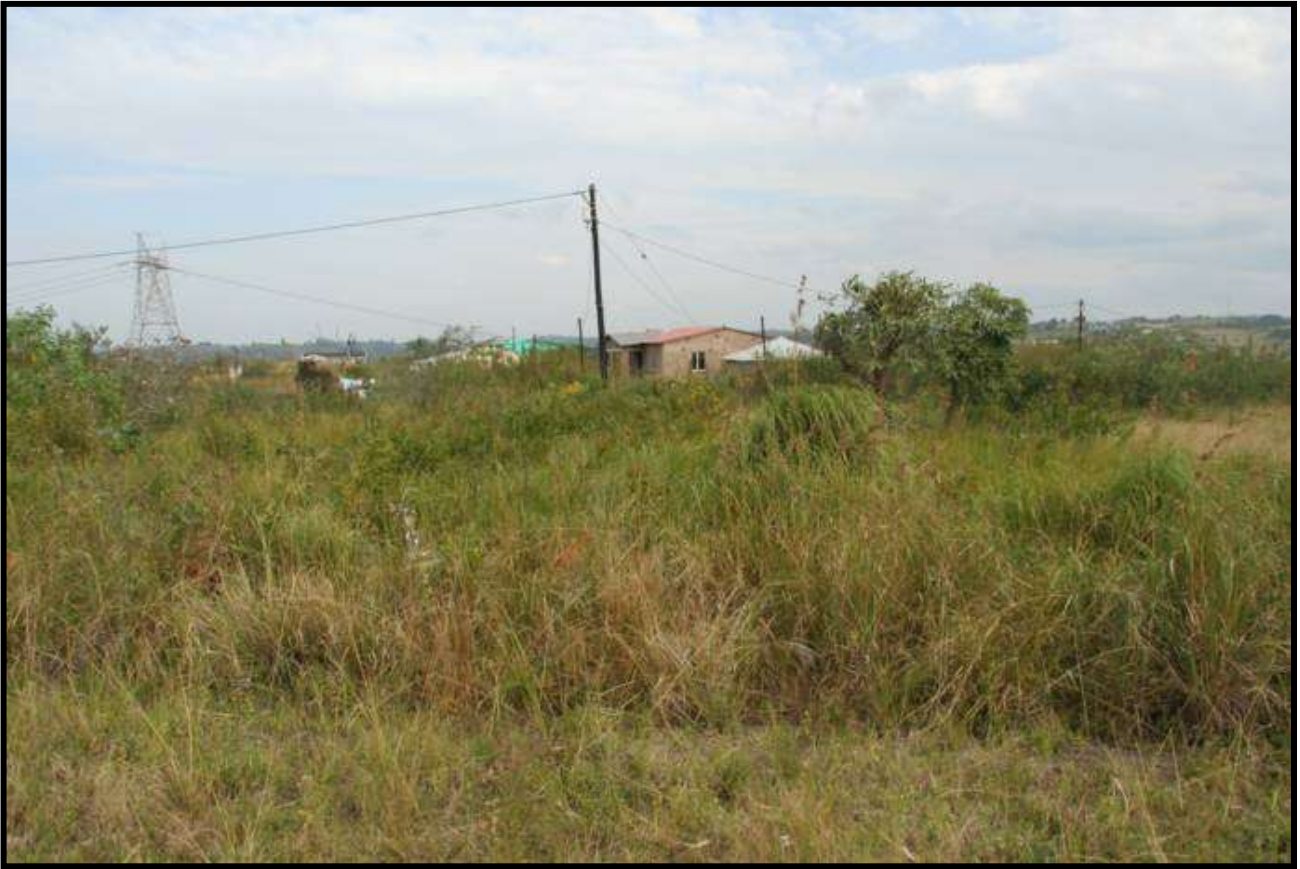
Fig. 55: Community Graves at B34G

KP37.100 is an area identified by the community as having graves (fig. 55). The area was demarcated before RoW clearance. No damage has occurred to the area.

Management: Fence poles should remain at the site
