**ARCHAEOLOGICAL IMPACT ASSESSMENT REPORT ON THE REDAN  
ENGRAVING SITE: SPRINGFIELD MINING PROJECT SITUATED  
BETWEEN VEREENIGING AND MEYERTON, IN THE SEDIBENG  
DISTRICT MUNICIPALITY, GAUTENG PROVINCE**

Assessment conducted under Section 38(3) of the National Heritage Resource Act (No. 25 of 1999)

**September 2020 (reviewed April 2022)**

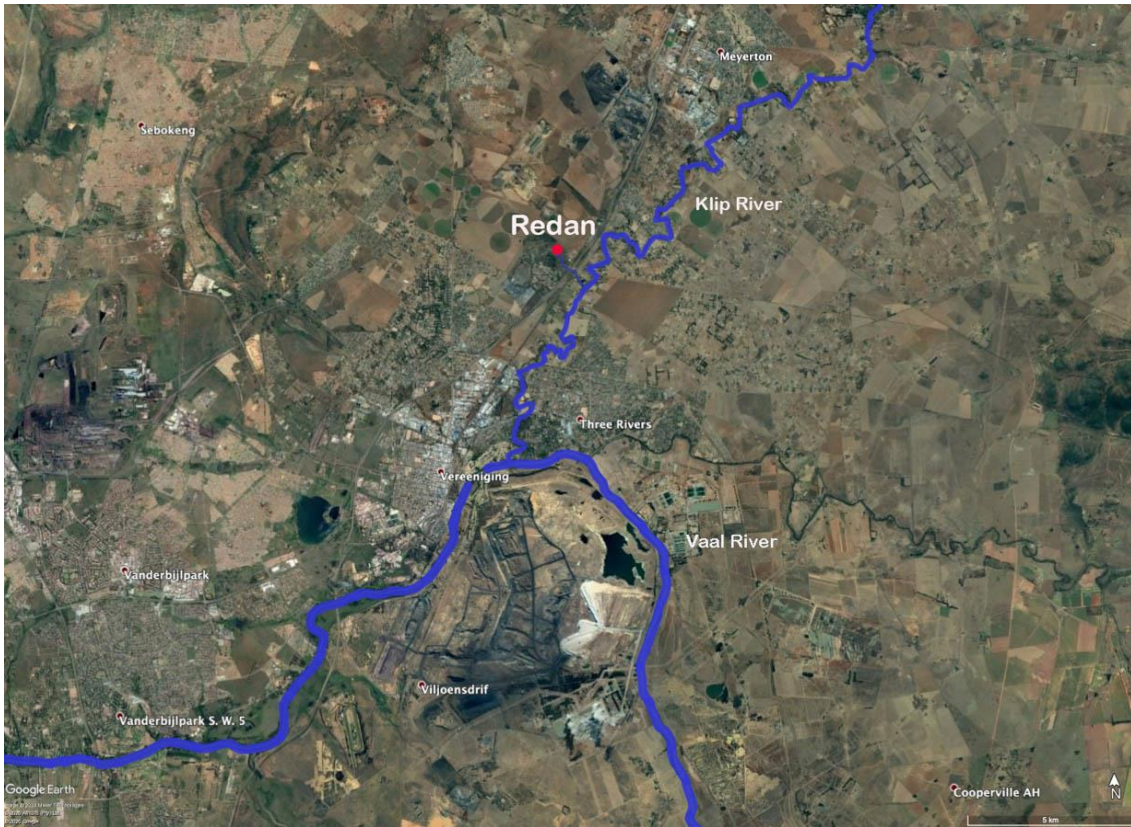
Figure 1. The Redan engraving site is situated close to a wetland that was formerly a stream that flowed into the Klip River. Its location close to water might have been an important part of Khoi women's initiation rites

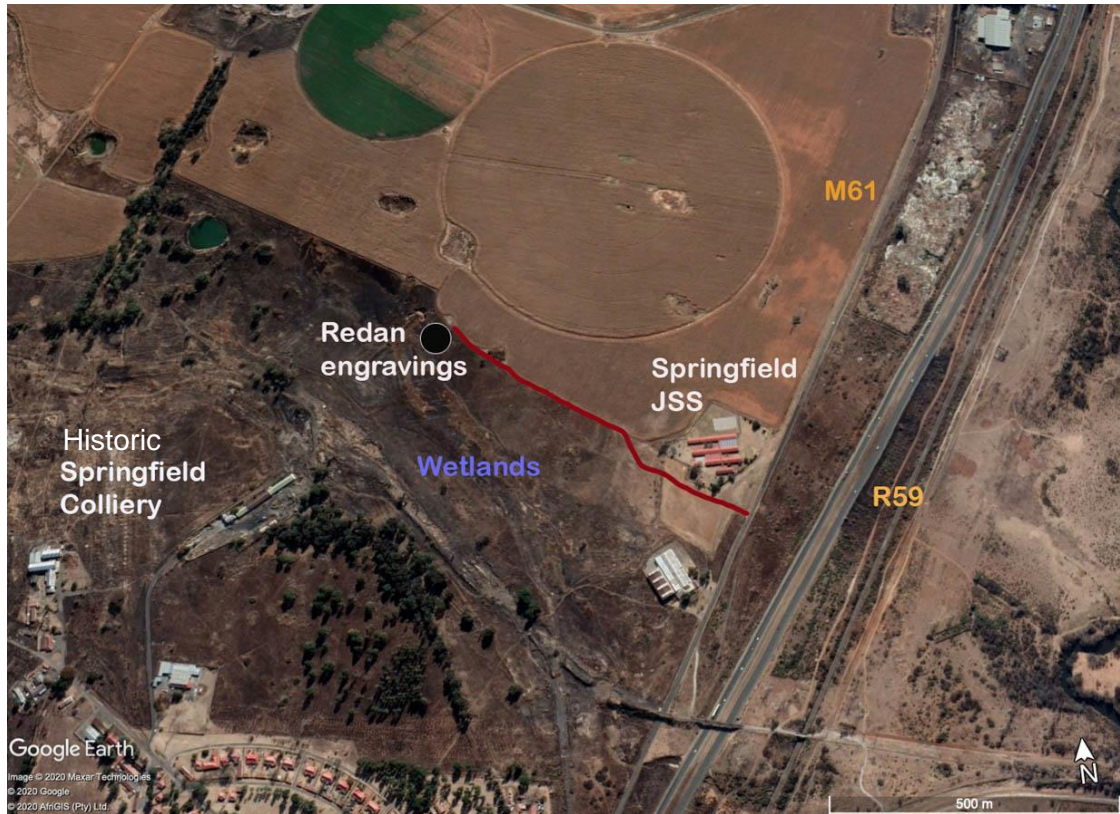
Figure 2. The Redan engraving site is located about 700 m west of the M61

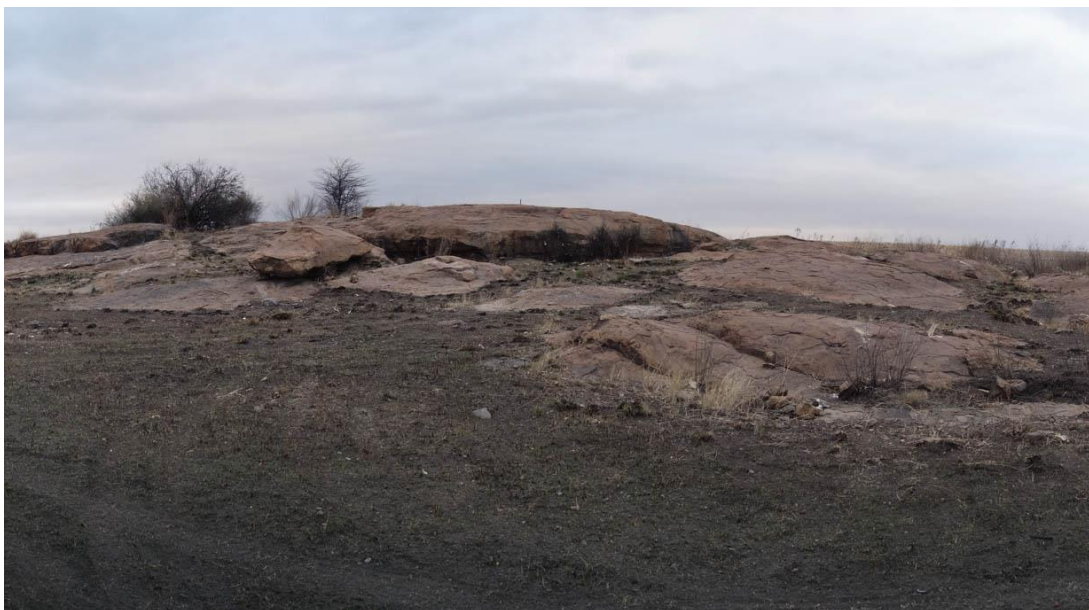
Figure 3. View of the Redan engraving site looking to the east. Behind the sandstone outcrops are agricultural fields

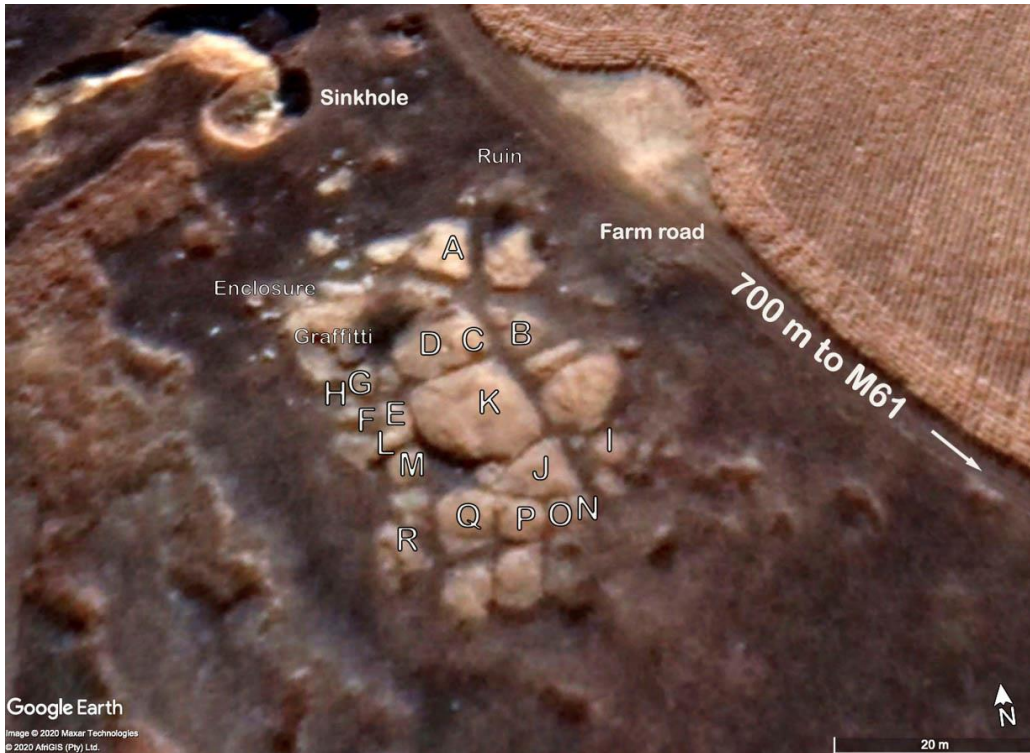
Figure 4. Overview of the Redan engraving site with each of the engraved outcrops labelled according to the survey carried out by Willcox & Pager (1967) (Google Earth 2020)

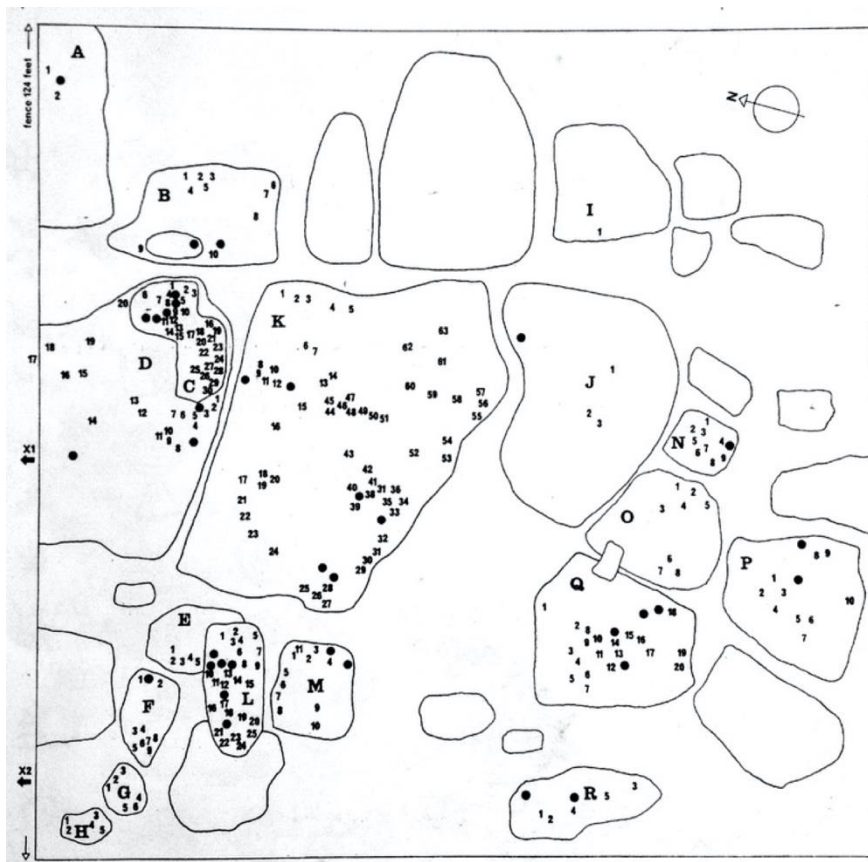
Figure 5. Diagram of the position and number of engravings recorded on the rocks at Redan by Harald Pager in the 1960s (Willcox & Pager 1967)

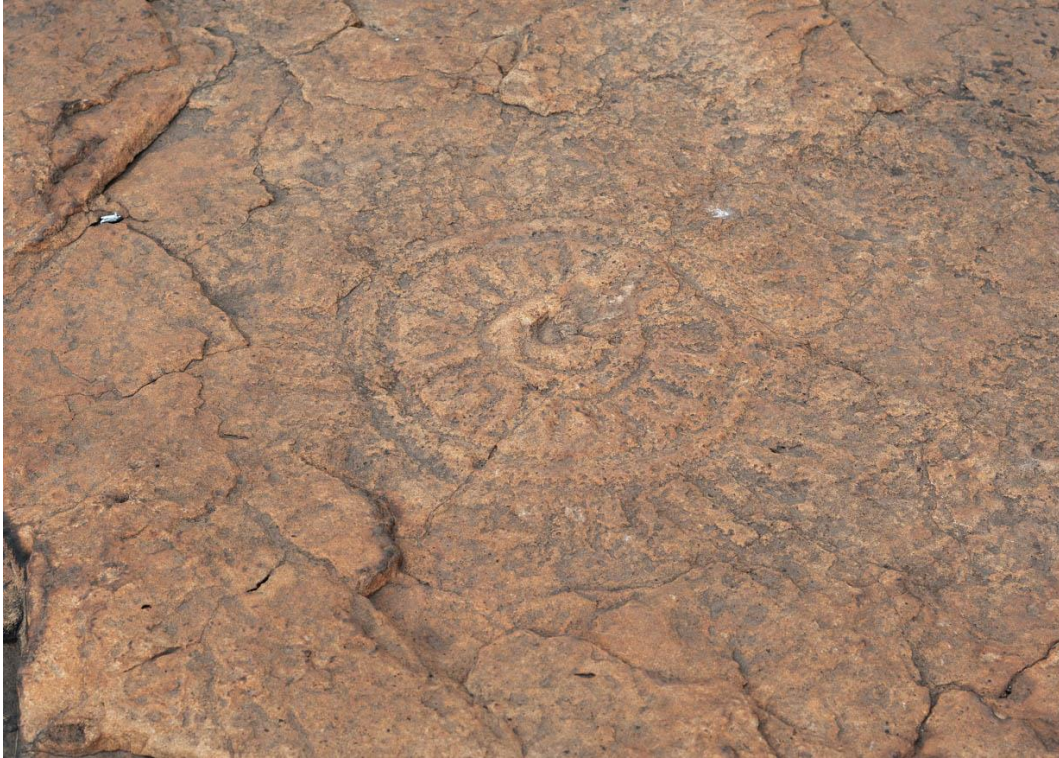
*Figure 7. Every engraving a Redan is unique, but most of them are geometric designs such as this one, which has concentric circles and 'rays'. Rock K*

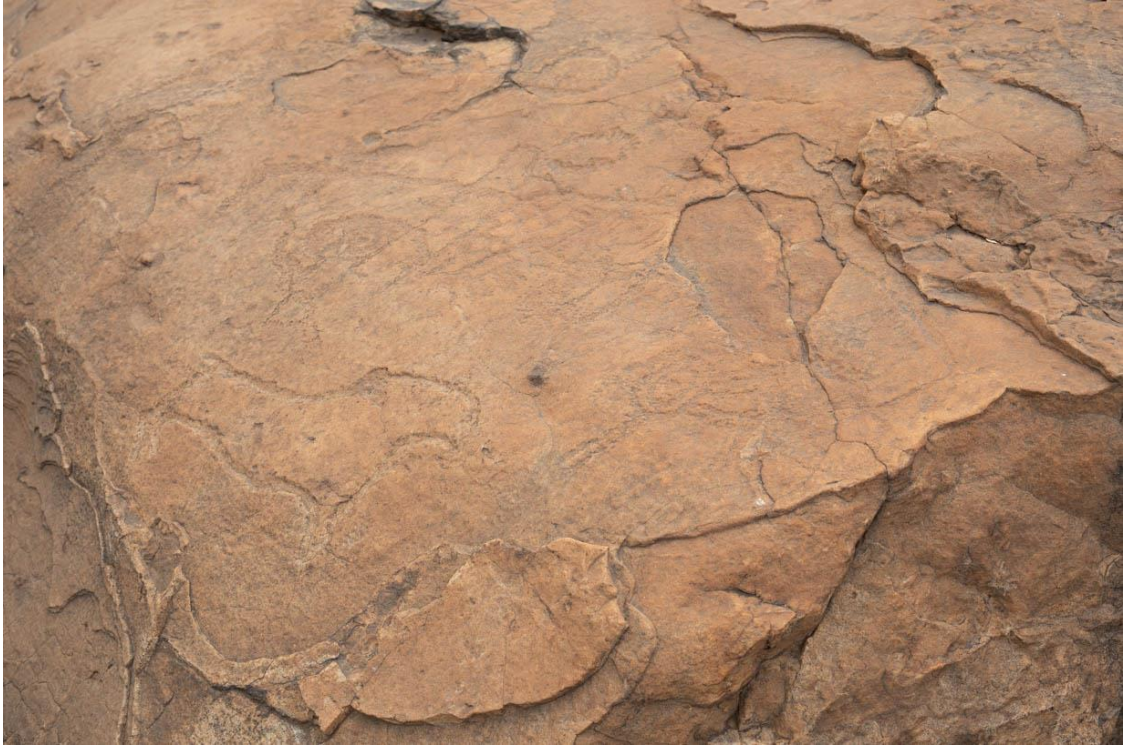
*Figure 8. Possible engraving of a lion (bottom left of picture) alongside geometric designs. Rock C*

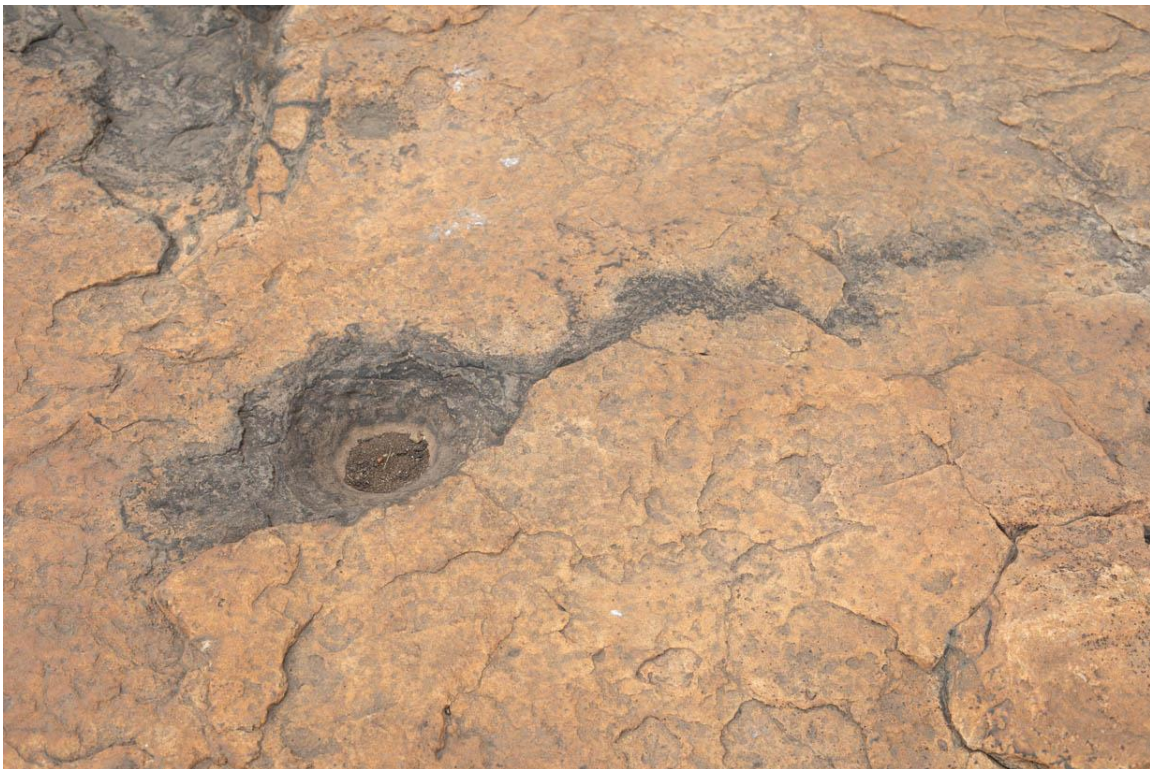
*Figure 9. One of the cupules (small cavities) hollowed out by people. The dark colour of the cupule and the water trail could be staining from mineral deposits. Rock K*

in the rock where water accumulates after good rains (Willcox & Pager 19767: 492). The cupules are stained black and the water that overflows from the cupules and the natural depression and trickles down the rock also leaves a black stain. The presence of these cupules is an important archaeological feature at Redan site because such arrangements of cupules around water are not common. There are also smaller areas of smoothed rock (ca. 200 x 200 mm) and seven grooves also that were made around the largest of the natural depressions (Willcox & Pager 1967: 492; Prins 2005: 245).

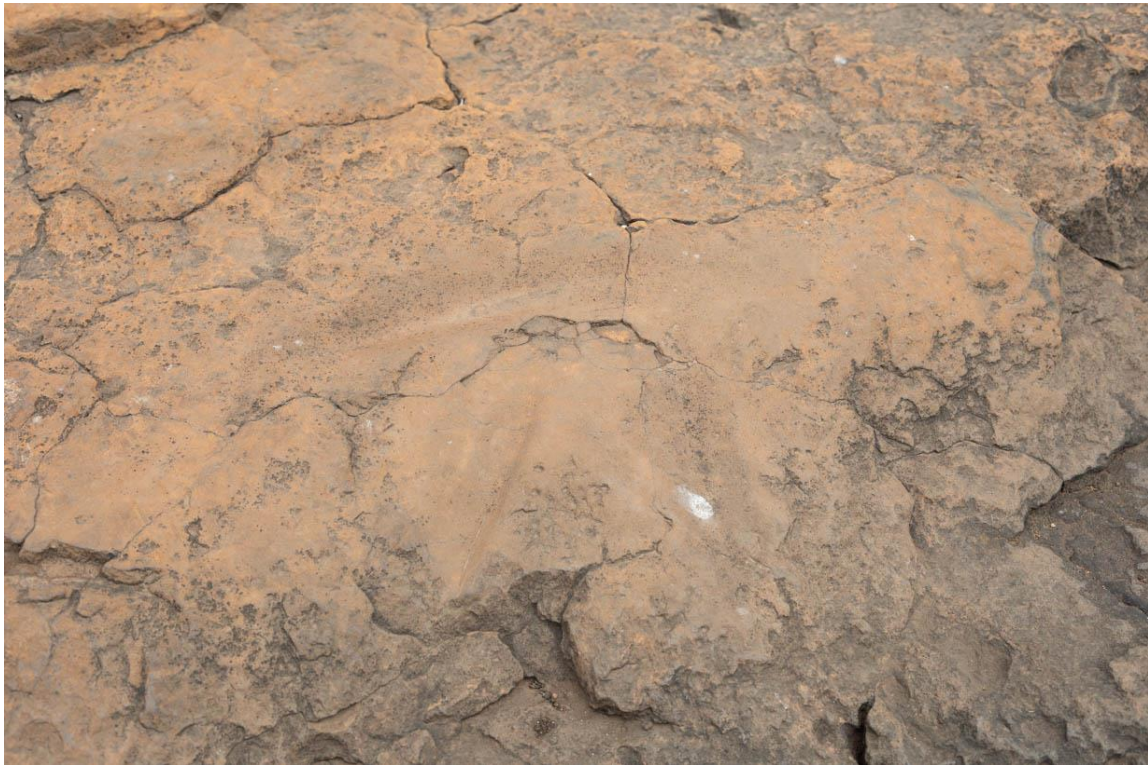
*Figure 10. The rock has been smoothed friction caused by people rubbing the rock. Here people made shallow grooves by rubbing the rock with unknown objects (perhaps stone). Rock K*

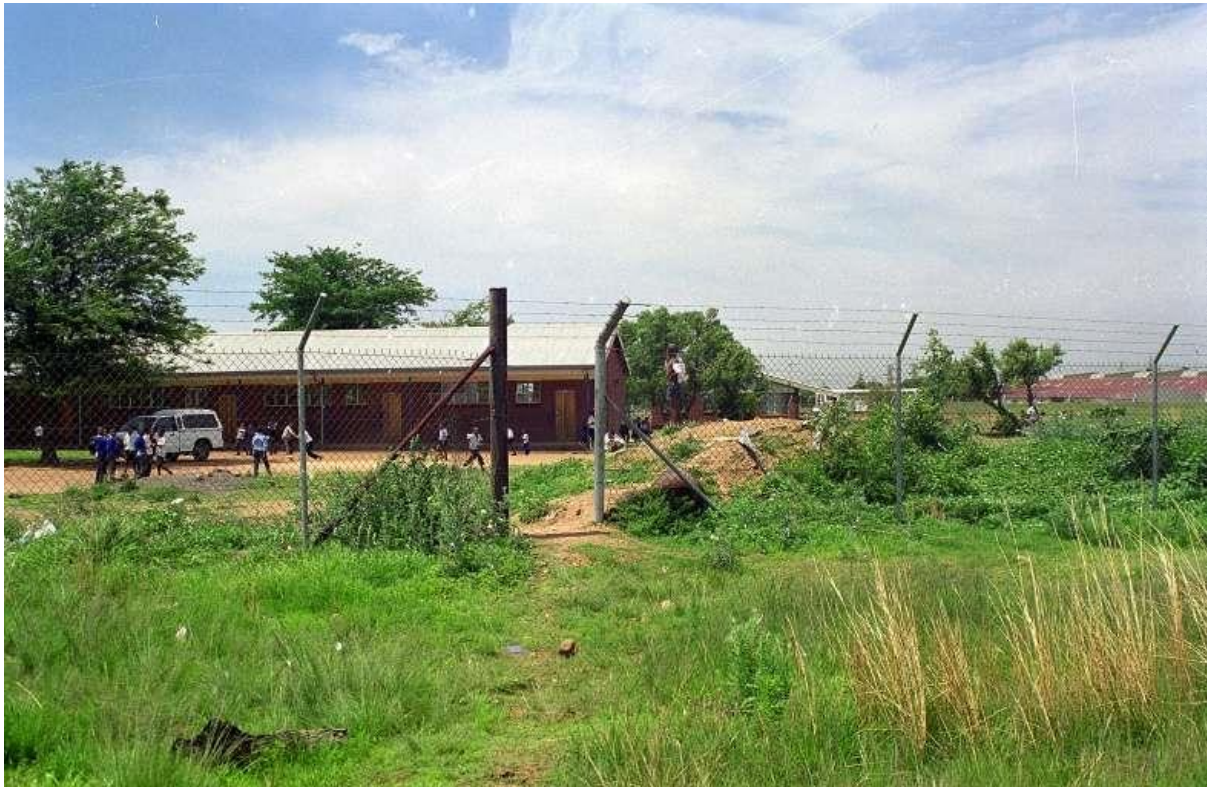
Around the time that it was declared a National Monument the site was enclosed by a 2 m high diamond mesh fence with angled steel poles, barbed wire and a gate, together with a National Monuments Commission plaque. Despite these measures the Redan engraving site remained under threat from human activity. The fence was subsequently torn down and removed by looters and the site became degraded by litter and a small amount of graffiti. There was unsupervised access to the site via a gate at the nearby Springfield Junior Secondary School.

*Figure 12. This gateway at the Springfield Junior Secondary School was used to access the site in the past.  
Photo credit: African Rock Art Digital Archive RSA-RED1-55P*
