5 FIELDWORK AND FINDINGS

A controlled surface survey was conducted on foot and by a vehicle by an archaeologist from PGS. The fieldwork was conducted 24 September 2020. The tracklogs (in yellow) for the survey are indicated in **Figure 19**.

The study area is a proposed powerline situated about 5 km north of Aliwal-North running from the N6 highway in a south-westerly direction through a valley towards the Orange River. The eastern part of the proposed line runs west from the edge of the N6 over a large open field that is predominantly used as grazing for cattle. A disused railway line runs across this landscape from south to north.

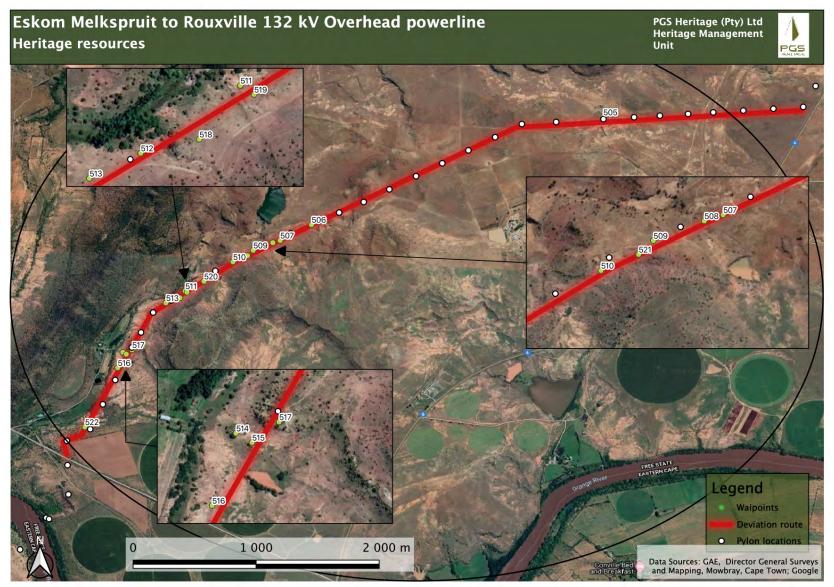
Figure 20 – Locality of the heritage resource– Identified heritage sites and a surface scatter of stone tools throughout the project area

Large sections of the alignment are characterised by a background scatter of Middle and Later Stone Age material. Two major concentrations of lithics at waypoints **507 and 511** has a **moderate heritage significance** with a **heritage grading of IIIB**.

The structures at **509**, **514**, **515** and **517** are the remains of historic structures and can most probably be associated with farmworker homesteads. These homestead are generally known for the presence of stillborn burials as associated with indigenous burial practices. Due this fact these structures are given a **moderate heritage significance** and an **IIIB heritage rating**.
