# **AN ARCHAEOLOGICAL INVESTIGATION OF THE KAT BALCONY: THE CASTLE**

Prepared for

**Gabriël Fagan Architects**

September 1999

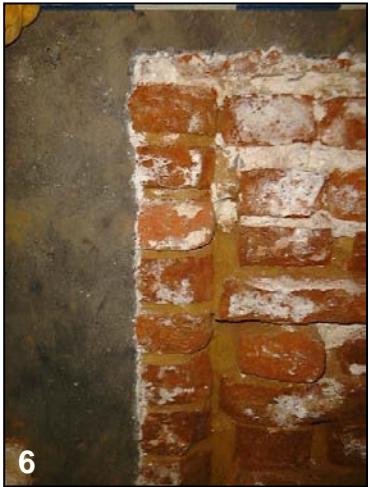
The vaulted structure was constructed using red brick (210x100x50) with the bricks of the roof held together with lime plaster while the vertical walls were bonded with mud mortar. Removal of plaster from the front wall of the vault revealed a bricked-up opening which presumably was intended to allow access to the space below the balcony (Plate 6). On removing some of the brick infill however, we found that the space was entirely filled with deposit. Stratigraphic layering, particularly a band of white soil immediately adjacent to the vault roof (Plate 7), suggested that the fill had been in place before the vaulted roof had been constructed and was in fact used in lieu of a timber form to support the vault during construction (one can see how the wet plaster that had squeezed from between the bricks during construction had been rounded by impressing into the sand and had also incorporated particles of the sand into it).

Edge of the opening to the vault clearly seen after tinted plaster removed.
