# AN ARCHAEOLOGICAL IMPACT ASSESSMENT OF A PORTION OF LAND AT THE CITRUSDAL HOT SPRING

February 2002

**Archaeology Contracts Office**

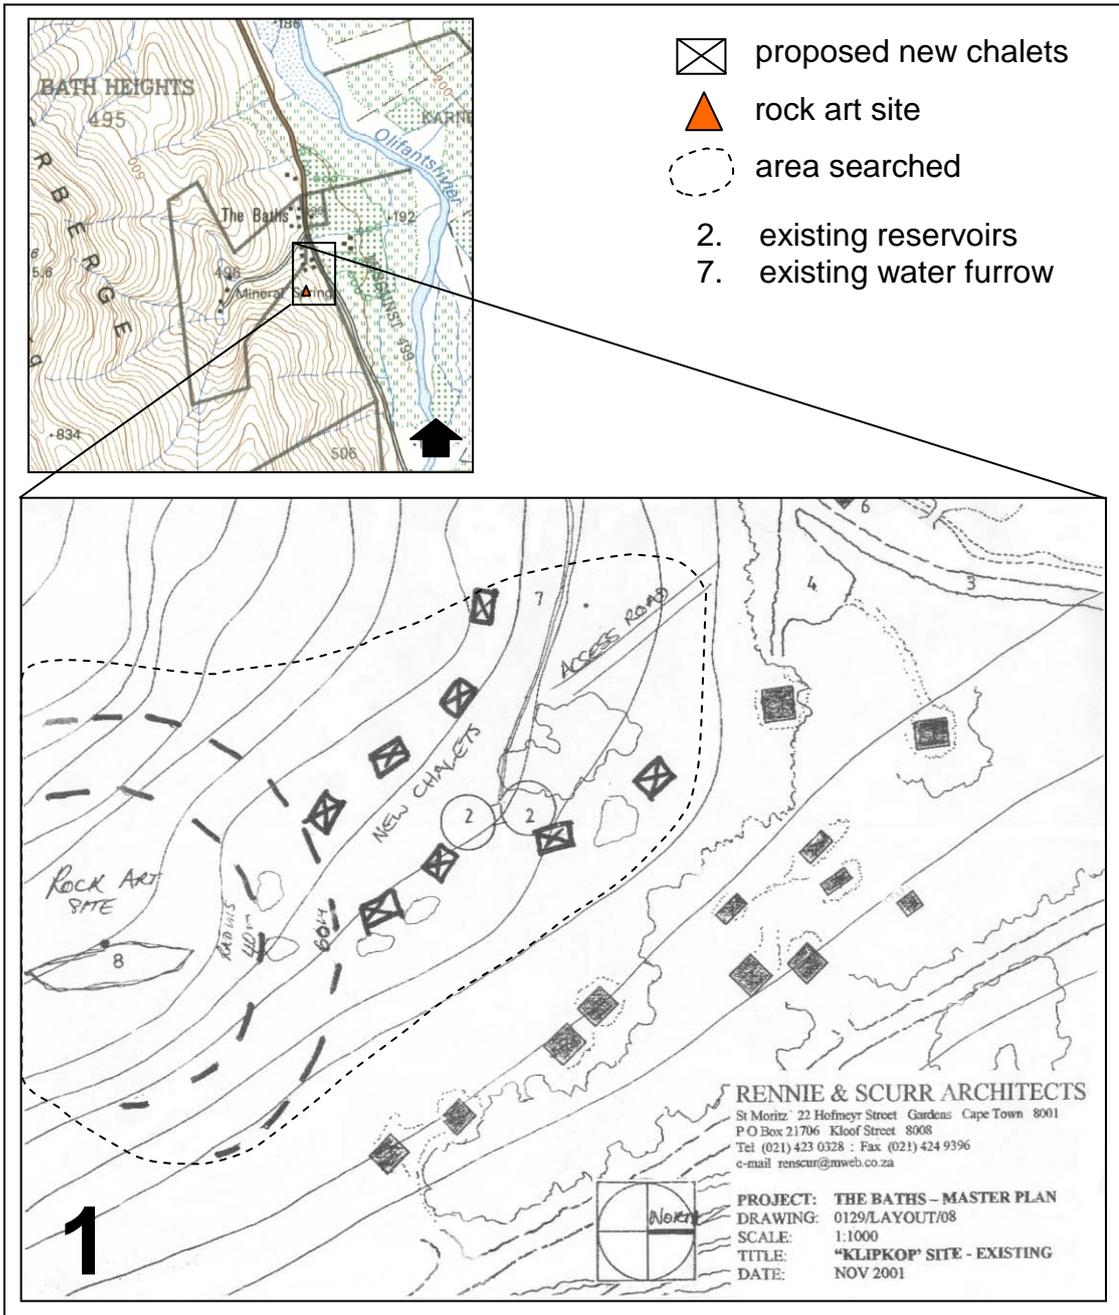
This is the main site located at 32°44'20.7"S and 19°02'27.4"E. The site consists of a slightly overhanging, west facing rock face, approximately 4-5 meters in height, and approximately 15-20 meters wide (Plate 2). A flat floor some 4-5 meters wide made this an attractive site for the precolonial inhabitants of the area, and is the only site with a

“level” floor and good paintable rock surface in the searched area. The site would not provide much cover during rain and as a result many of the paintings are faded, or covered by a white deposit, probably a buildup of dissolved minerals leaching from above.

Crude graffiti is present on the main panel. This has been executed by scratching with a stone. A kite-shaped design, several vertical lines, and scratching over the face of a human figure were noted.
