# **A HERITAGE SCOPING STUDY OF THE FARM HANGLIP, PLETTENBERG BAY**

**Chris Mulder and Associates Incorporated**

May 2004

**Archaeology Contracts Office**

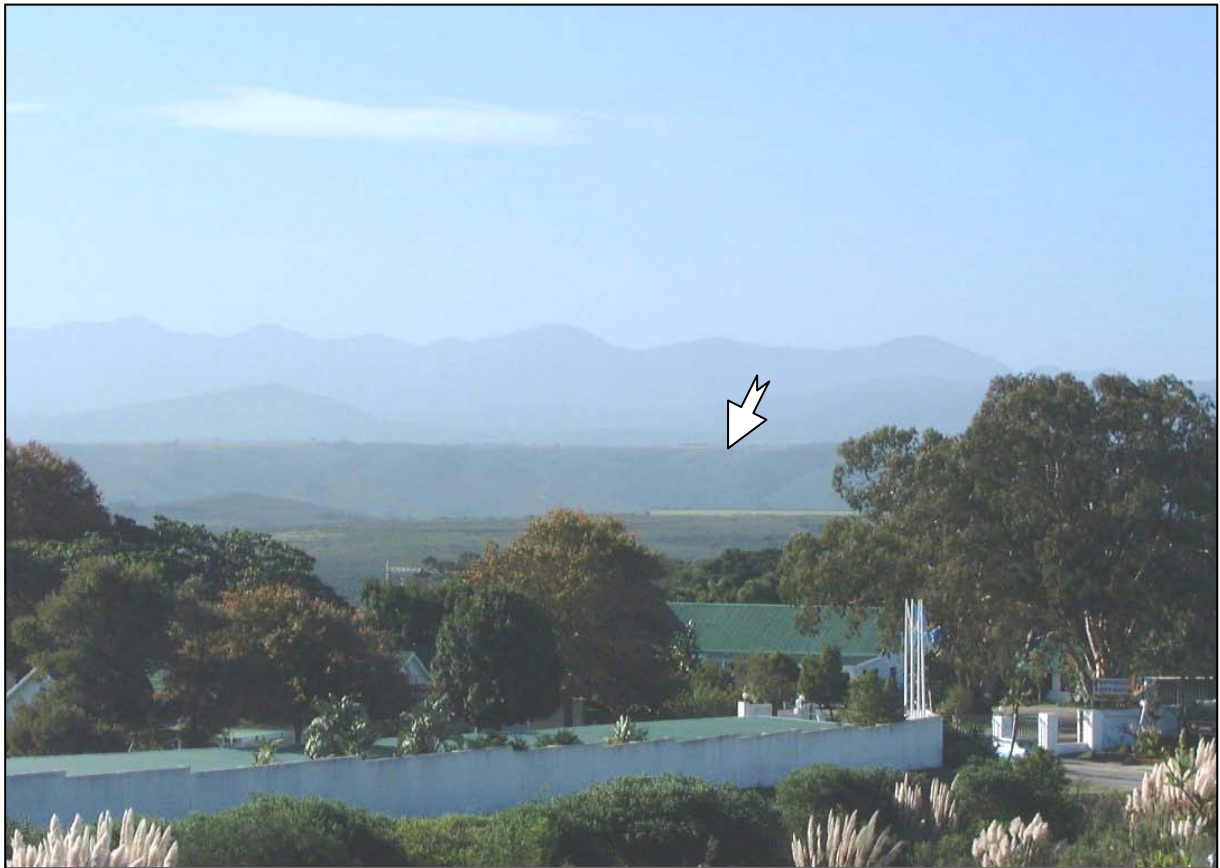
**Plate 1:** Looking north towards the site from the outskirts of Plettenberg Bay. The uppermost escarpment of the survey area is arrowed.

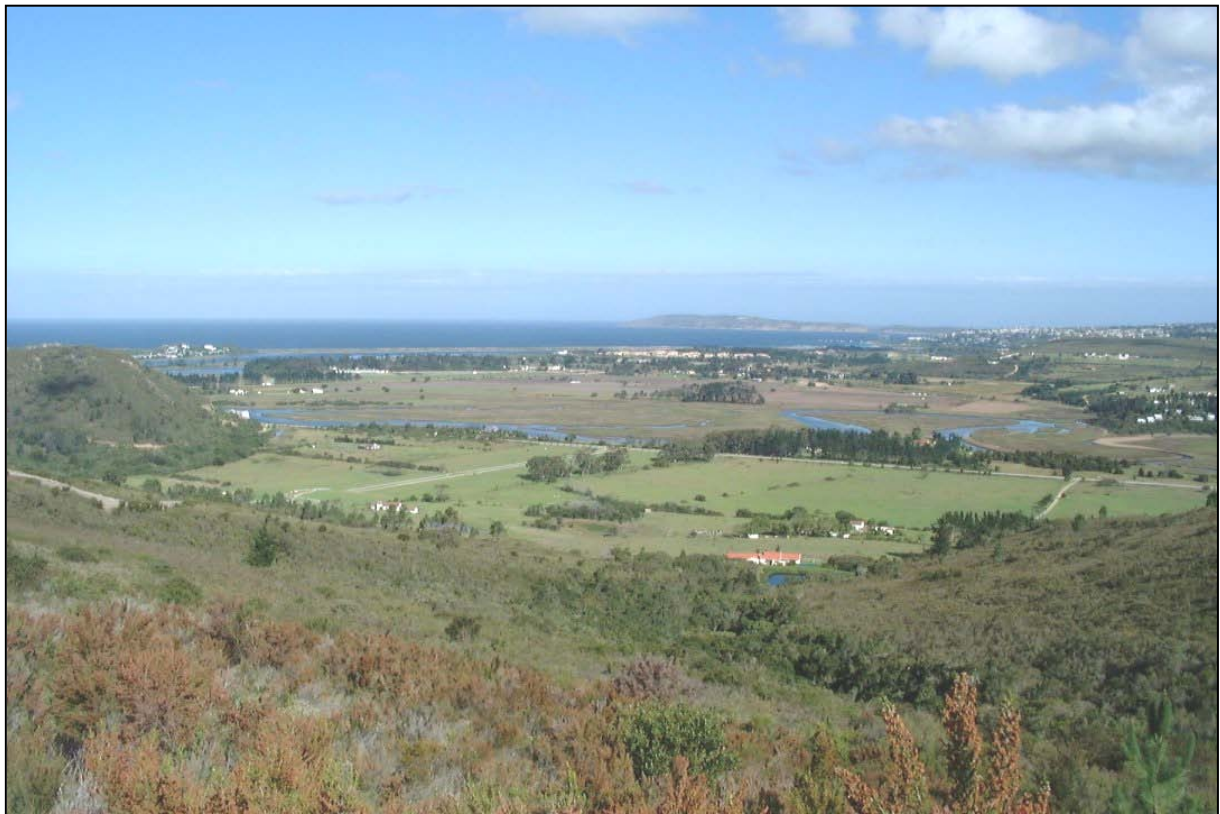
**Plate 2:** Looking south towards Plettenberg Bay from the escarpment of the survey area. The Robberg Peninsula is visible at centre top, while the old floodplain of the Bitou River is visible at centre middle.

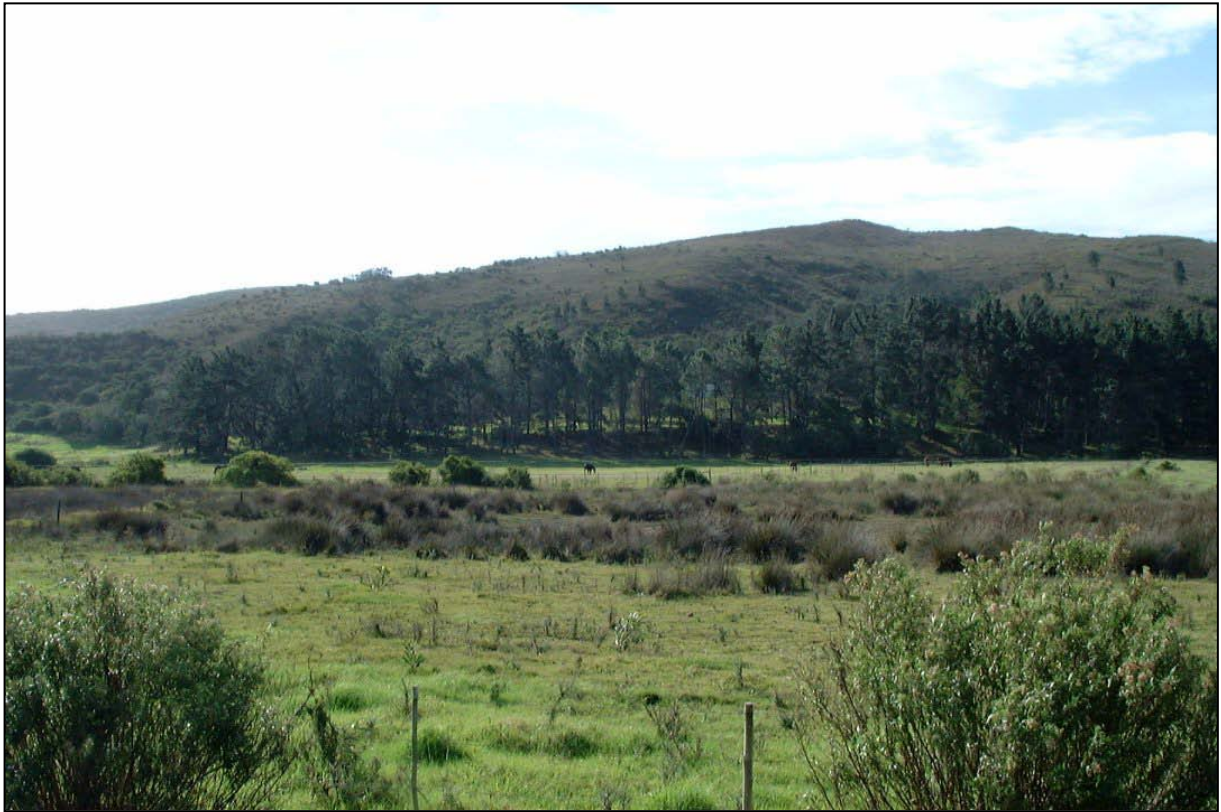
**Plate 3:** Looking north across the old floodplain of the Bitou River towards the slopes leading up to the escarpment.

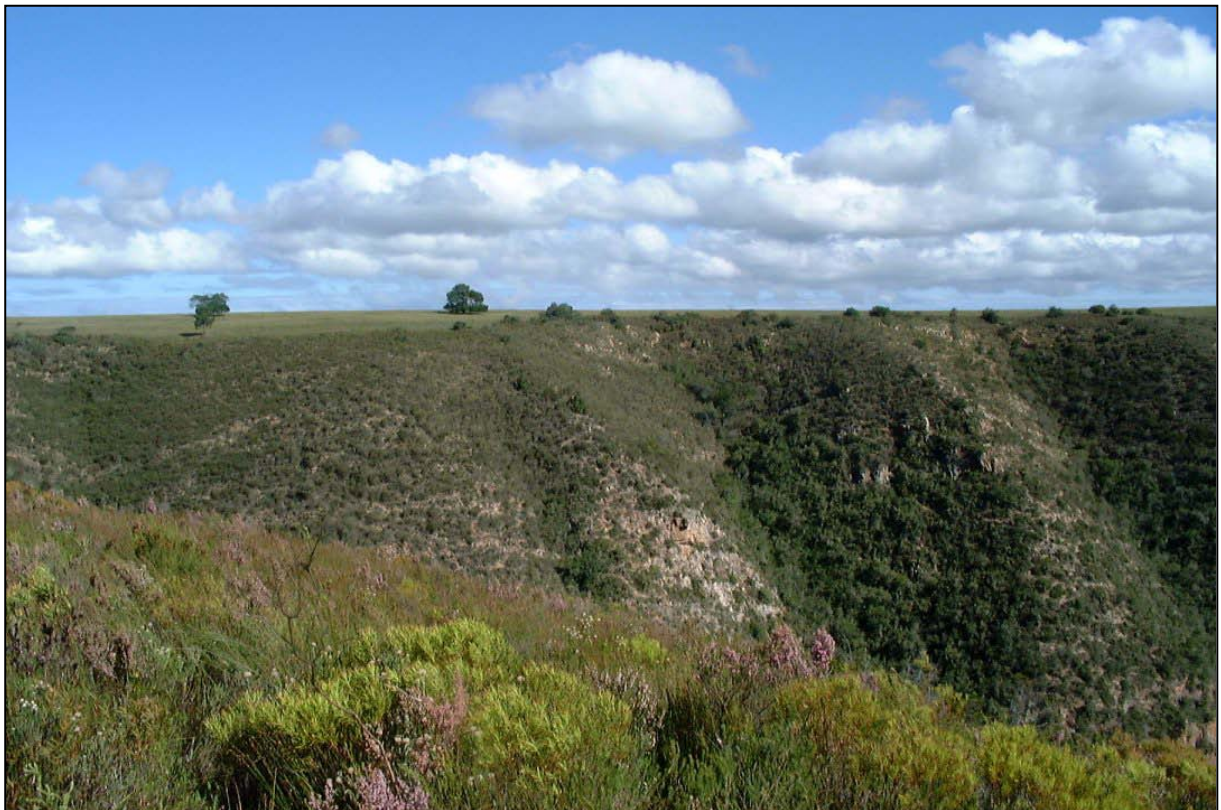
**Plate 4:** Looking south across the deep ravine in the north to the flat expanse of the escarpment.
