**PROPOSED REZONING AND SUBDIVISION OF A PORTION OF VAALEVALLEY  
219, MOSSEL BAY, WESTERN CAPE PROVINCE**

**ARCHAEOLOGICAL HERITAGE IMPACT ASSESSMENT**

**FINAL REPORT**

28 September 2005

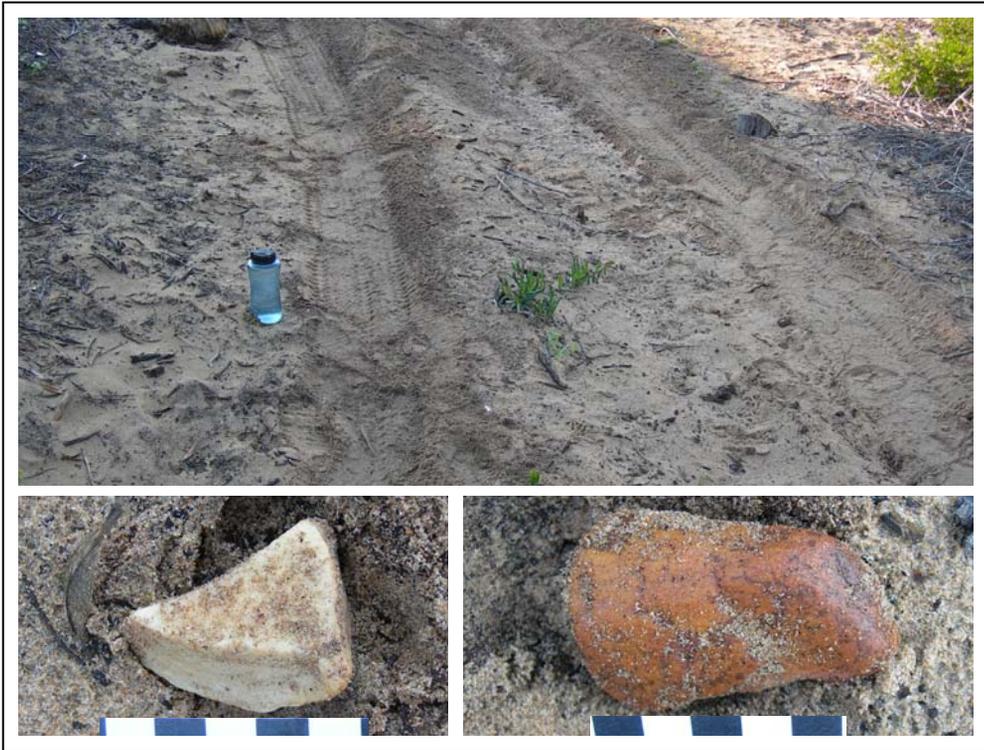
4. S34.11215 E22.12399 (Plate 11)

Plate 11. Two stone “artefacts” (manuports) in vehicle track at occurrence 4. Scale intervals are in centimeters.

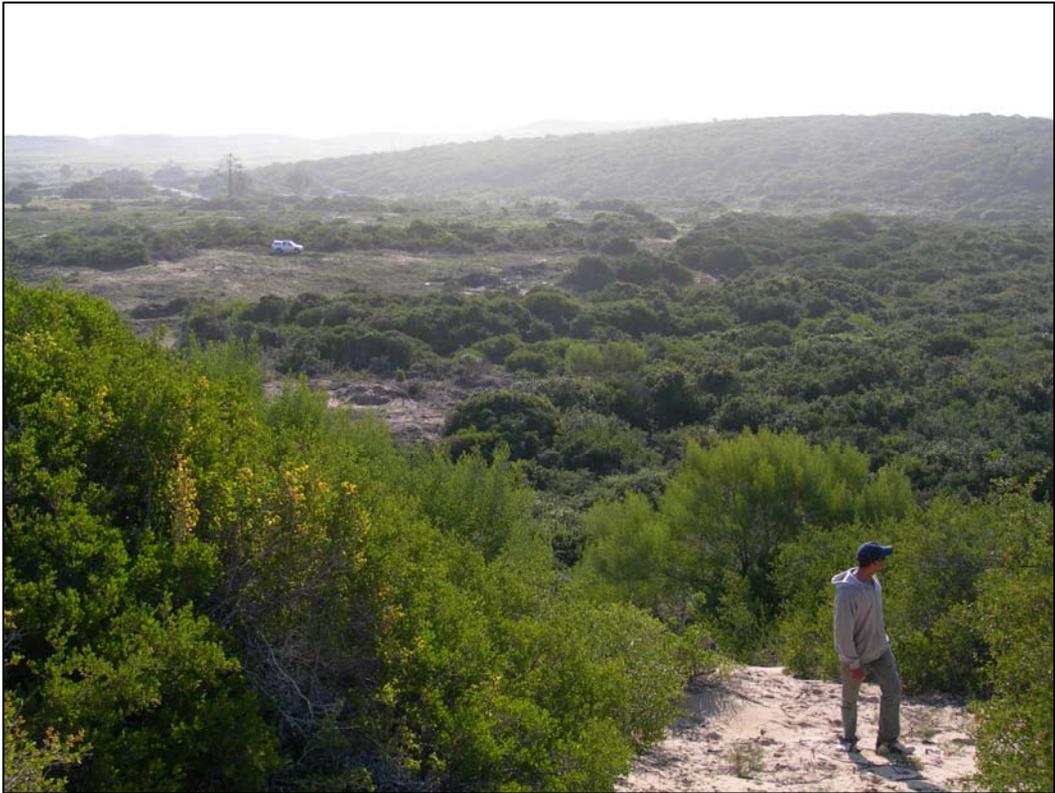
10. S34.11517 E22.11993 (Plate 17)

Plate 17. Location of occurrence 10 on dune slope immediately east of disturbed area.

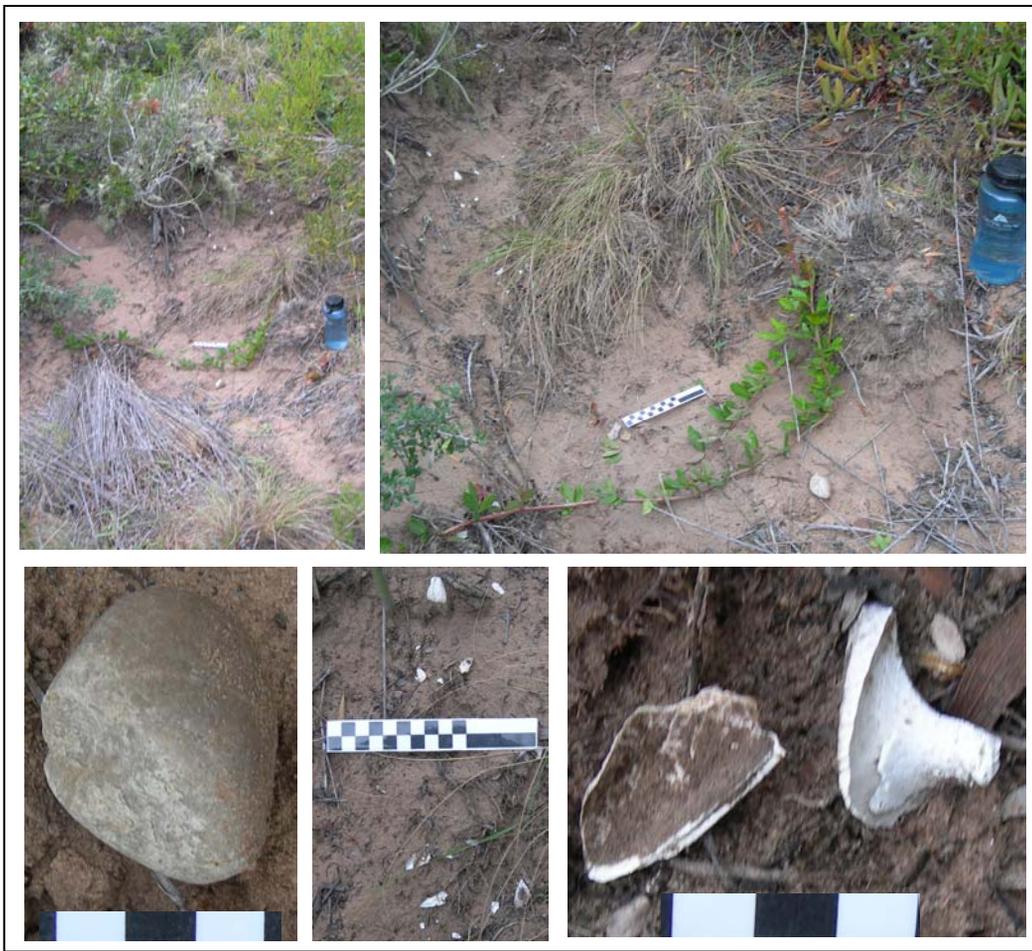
Plate 19. Low density scatter of marine shell and quartzite stone artefact at occurrence 12. All scale bar intervals are in cm.

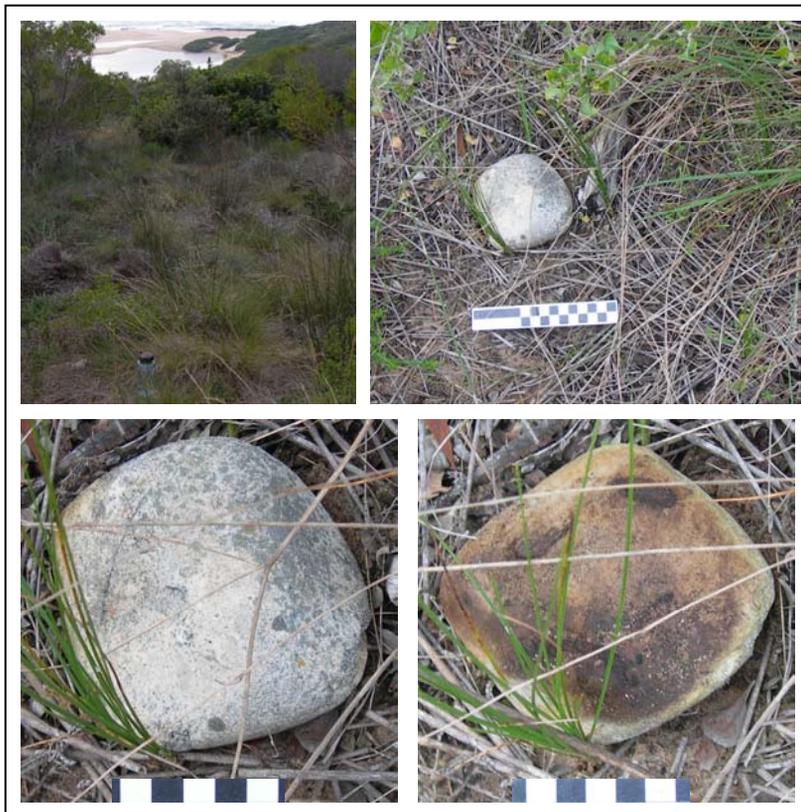
Plate 20. Isolated manuport at occurrence 13. Both sides of the stone are shown. All scale intervals are in cm.

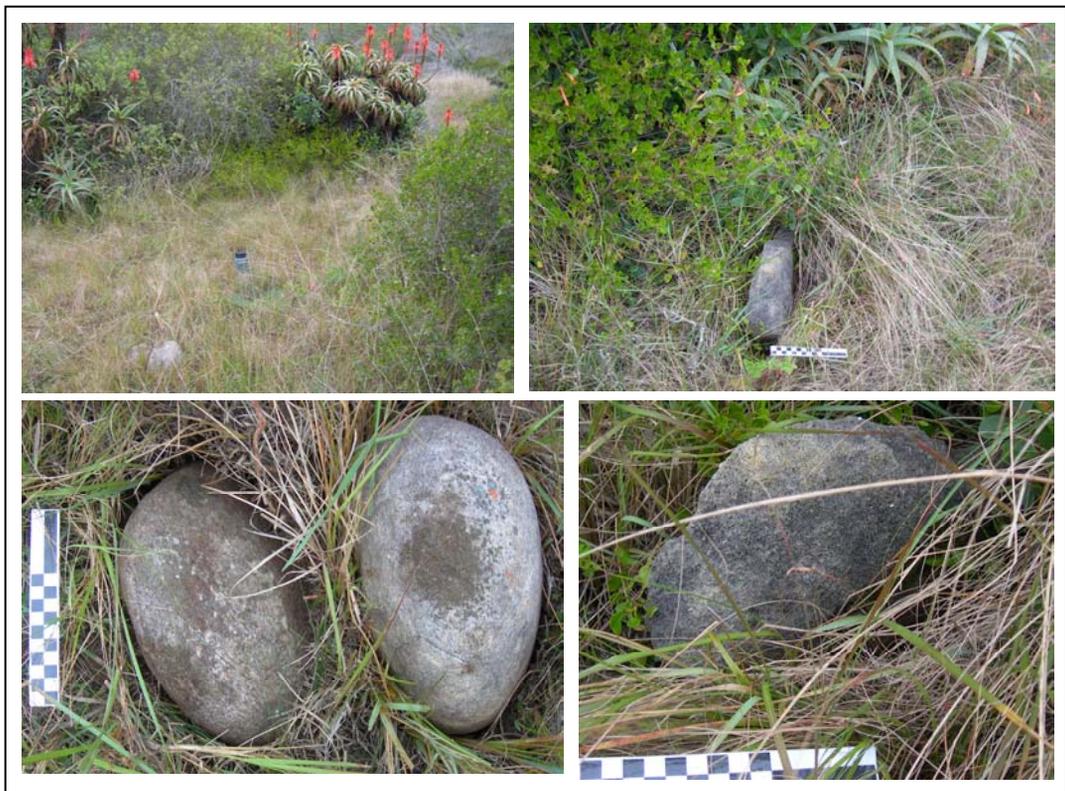
Plate 21. Vertically “planted” quartzite (left) and calcrete (right) manuports at occurrence 14. The scale intervals are in cm.

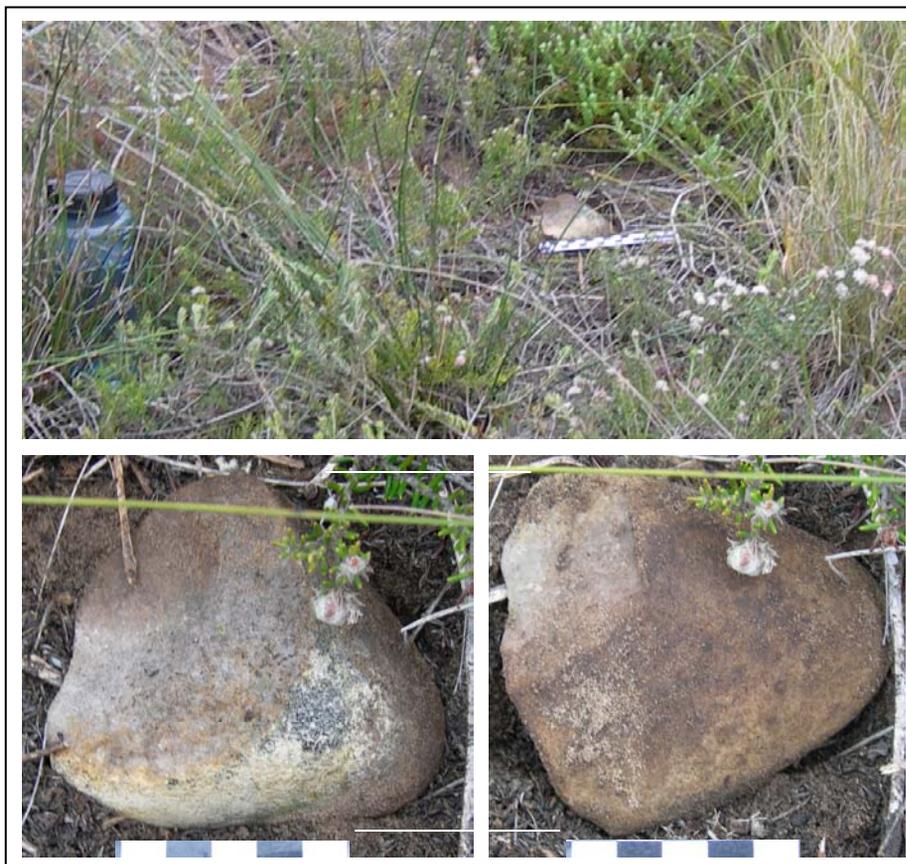
Plate 23. Isolated and flaked quartzite cobble at occurrence 16. Scale intervals are in cm.

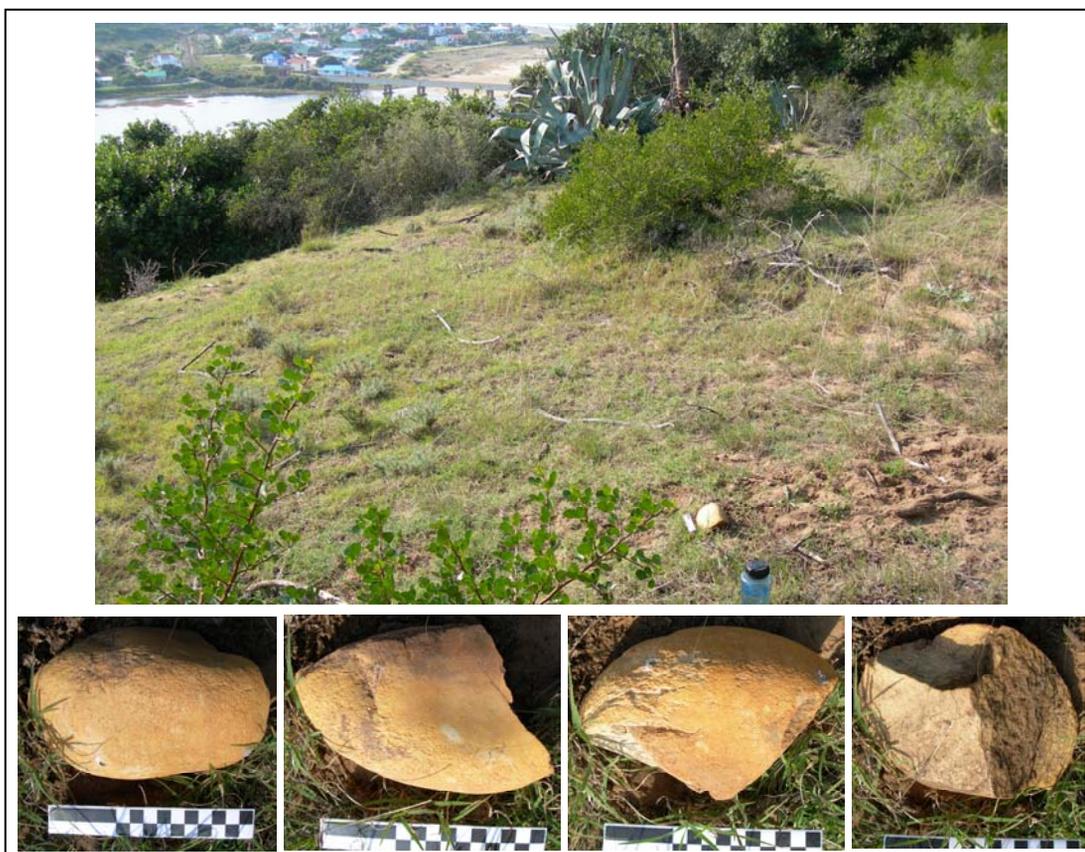
Isolated, broken lower grind stone and another manuport some 8 m to the north.

Plate 24. Broken lower grind stone at occurrence 17. Scale intervals in cm.

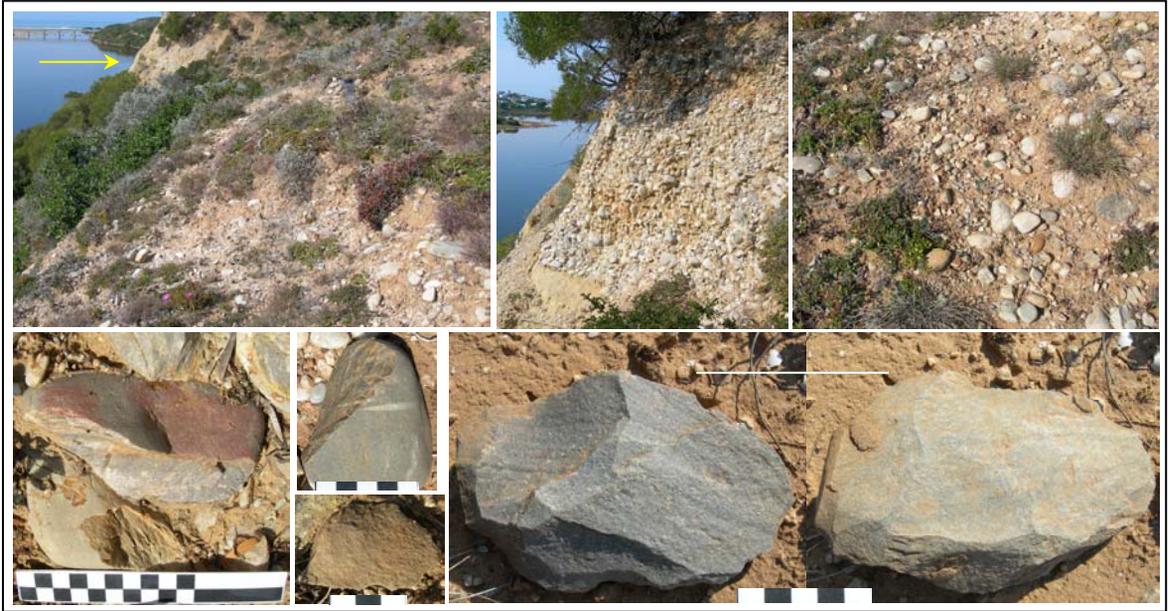
Plate 26. Quartzite stone artefacts among exposed and eroding Enon conglomerates at occurrence 19 (bottom 4 images to right). Yellow arrow indicates bedded Enon enlarged in centre top image. Bottom left image shows *in situ* Enon cobbles with percussion and flake scars. Top right image shows scatter of eroded Enon cobbles that includes stone artefacts.

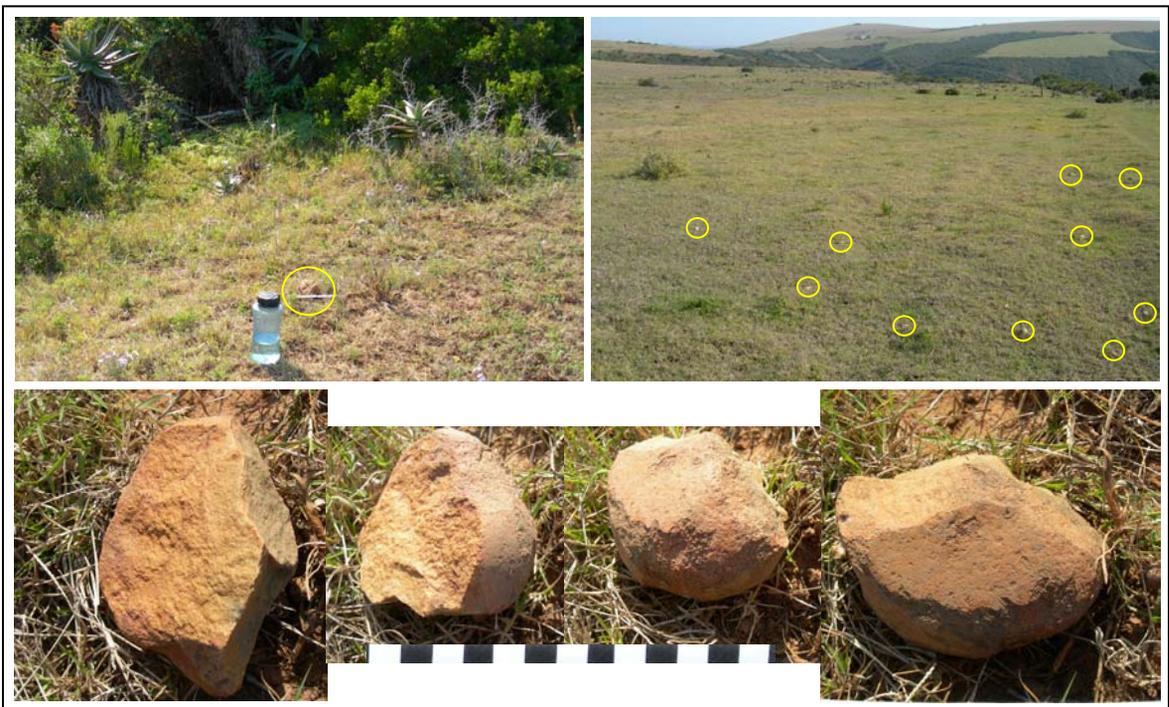
Plate 27. Isolated stone artefact at occurrence 20 (top left), low-density scatter of manuports at occurrence 21 (top right) and combination hammer stone, grind stone and core at occurrence 22 (bottom). Scale intervals are in cm.

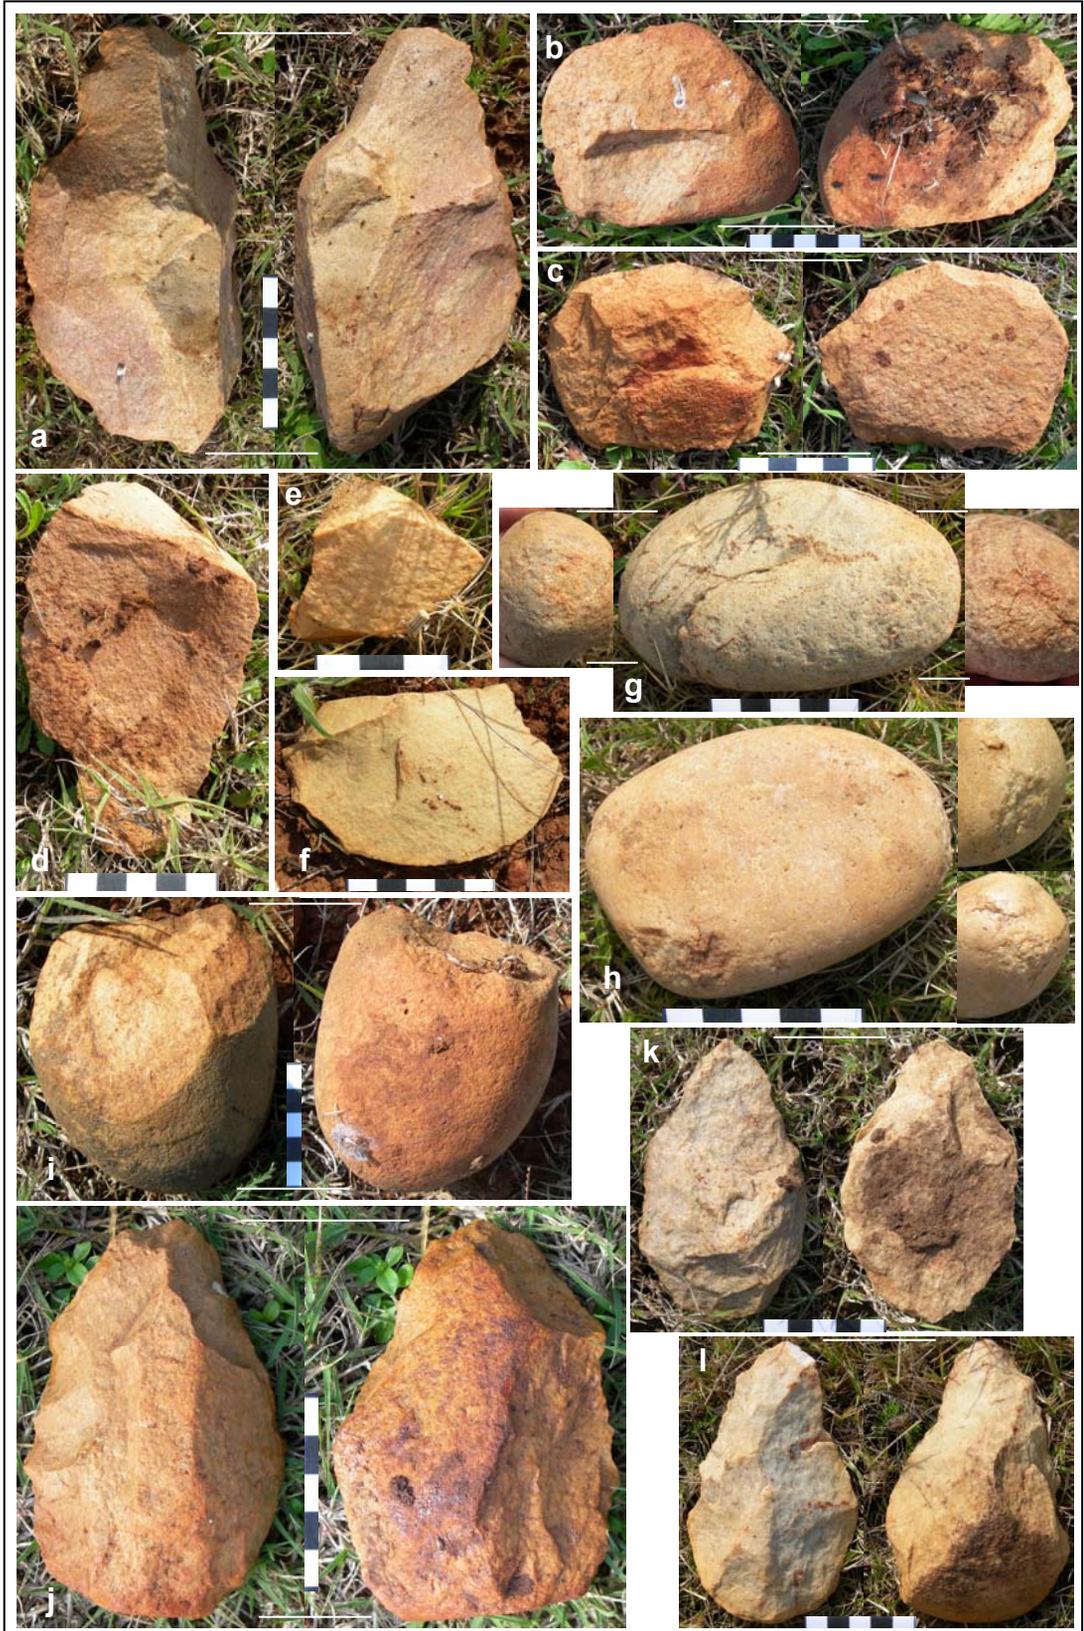
The scatter varies in artefact density with the densest areas containing up to 10 artefacts per 4 m<sup>2</sup>. It is estimated that, as far as ESA sites are concerned, this is a medium to high-density scatter. Since the ground is covered with grass for the most part, it is highly likely that many more artefacts lie beneath grass and possibly subsurface. This would certainly increase the artefact density. Some artefacts display fresher fracture surfaces and these may be the result of damage during plowing or the artefacts may be more recent in origin (MSA or LSA). Nevertheless, the majority of artefacts are of ESA age. It is surprising that the stones were not cleared for plowing and cultivation. No piles of stones resulting from clearing were seen in the vicinity of this field or occurrence.

Plate 30. Examples of stone artefacts observed at occurrence 28 include cores (a, b & c), flakes (d, e & f), hammer stones (g & h), cobble tools (i) and bifacial hand axes (j, k & l). Merged images - except g and h - display dorsal and ventral surfaces. All scale bar intervals are in cm.

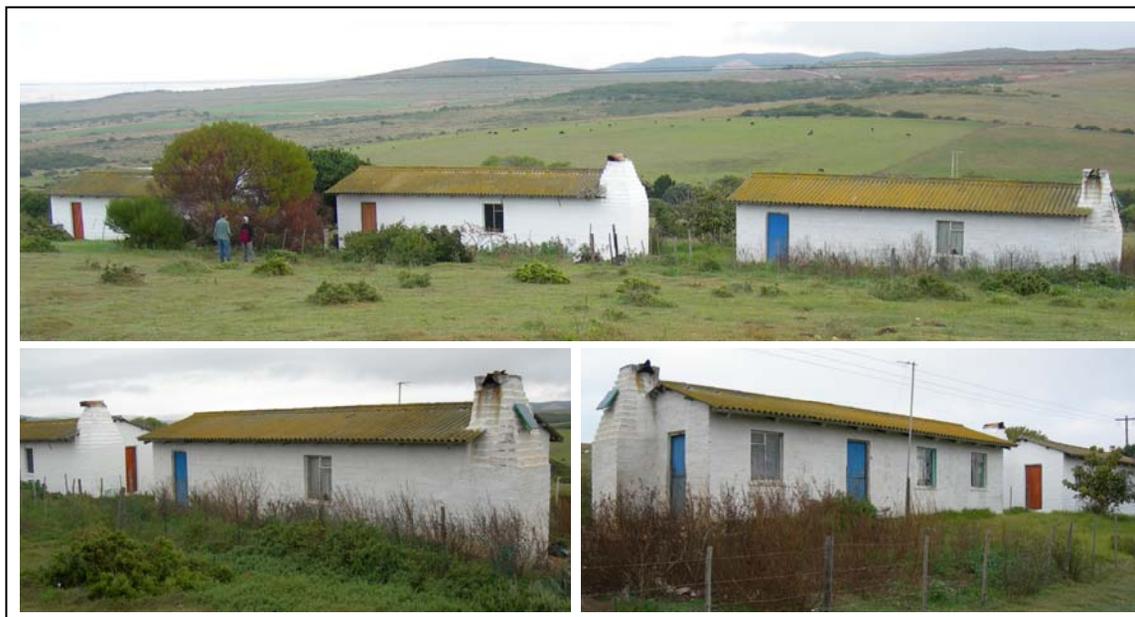
Plate 34. Modern labourer's cottages at occurrence 33 viewed from the east to northeast (top and bottom left), and from the north to northwest (bottom right).

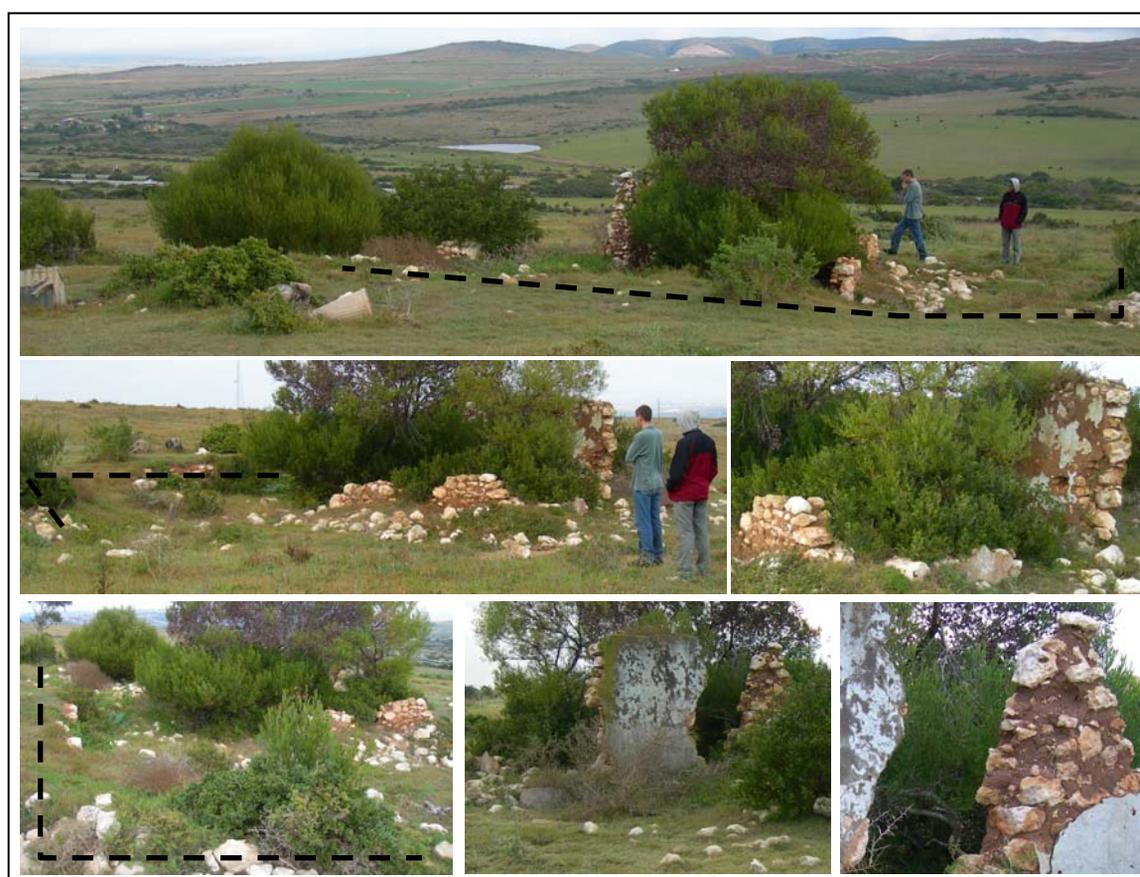
Plate 35. Ruins of calcrete structure at occurrence 33 viewed from the east to northeast (top), and from the north to northeast (middle left). Dashed lines represent remains of the same walling viewed from different angles. Middle and bottom right images are close-ups of the best surviving walls.

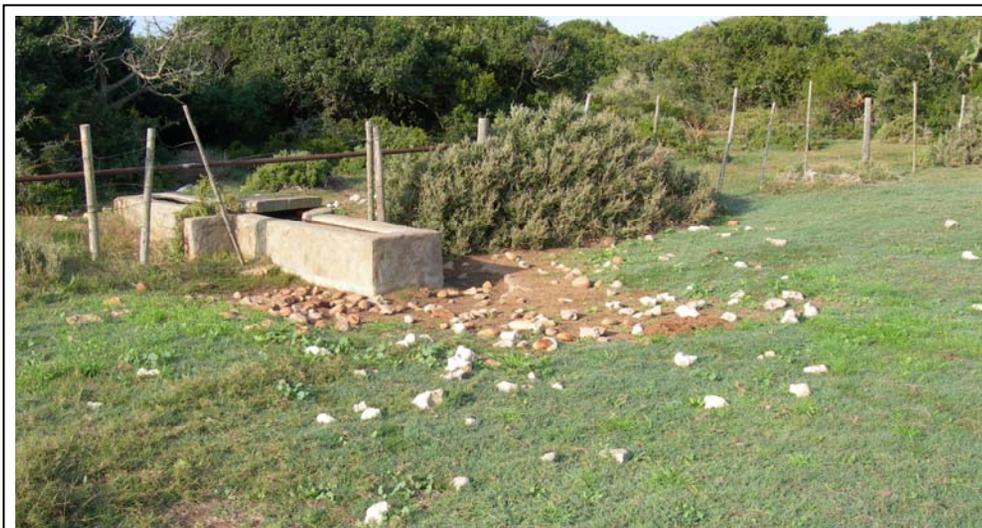
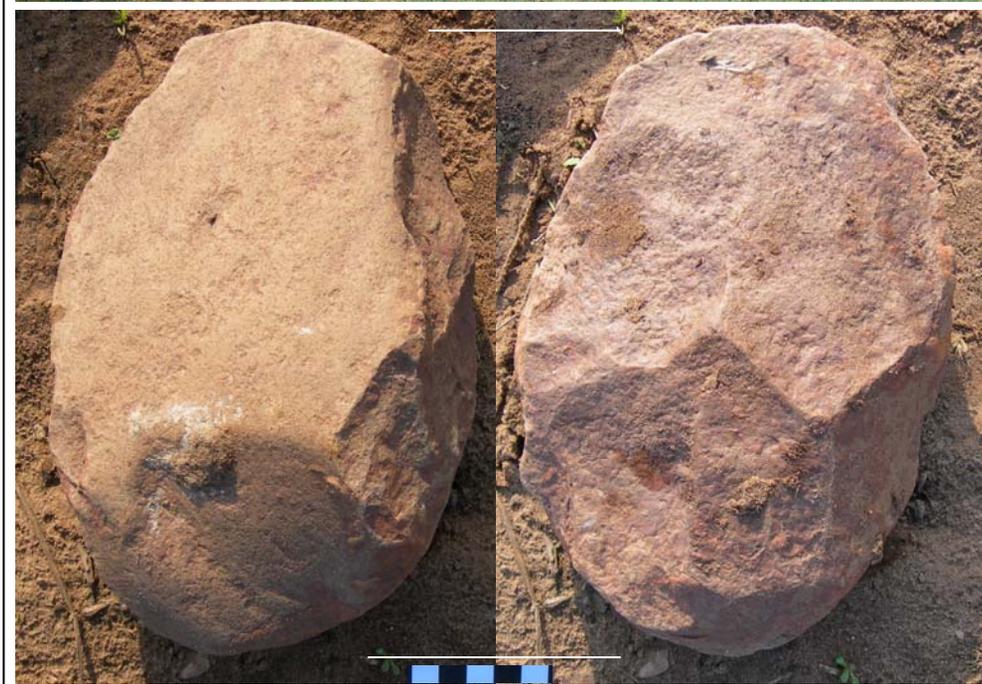
Plate 36. Small, dispersed scatter of mostly cobbles and calcrete at occurrence 35 (top), but a few stone artefacts were seen including the large ESA artefacts displayed above. Scale intervals are in cm.

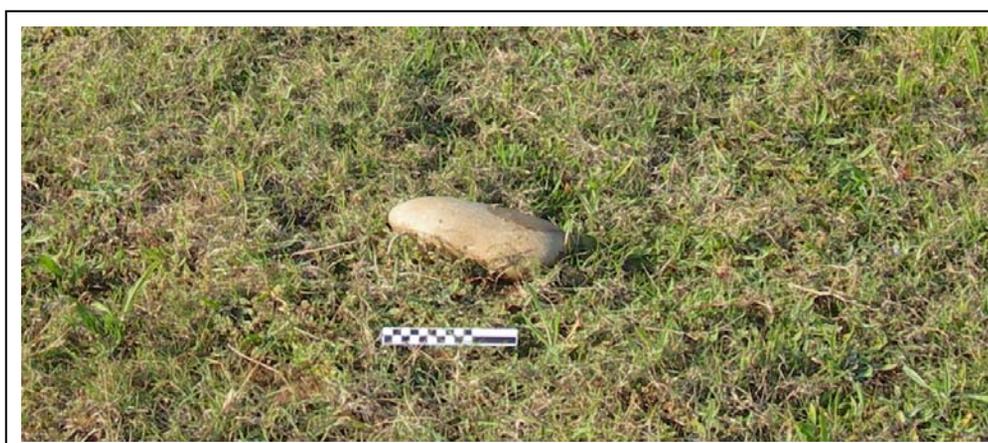
Plate 37. Isolated manuport at occurrence 36. Scale intervals are in cm.

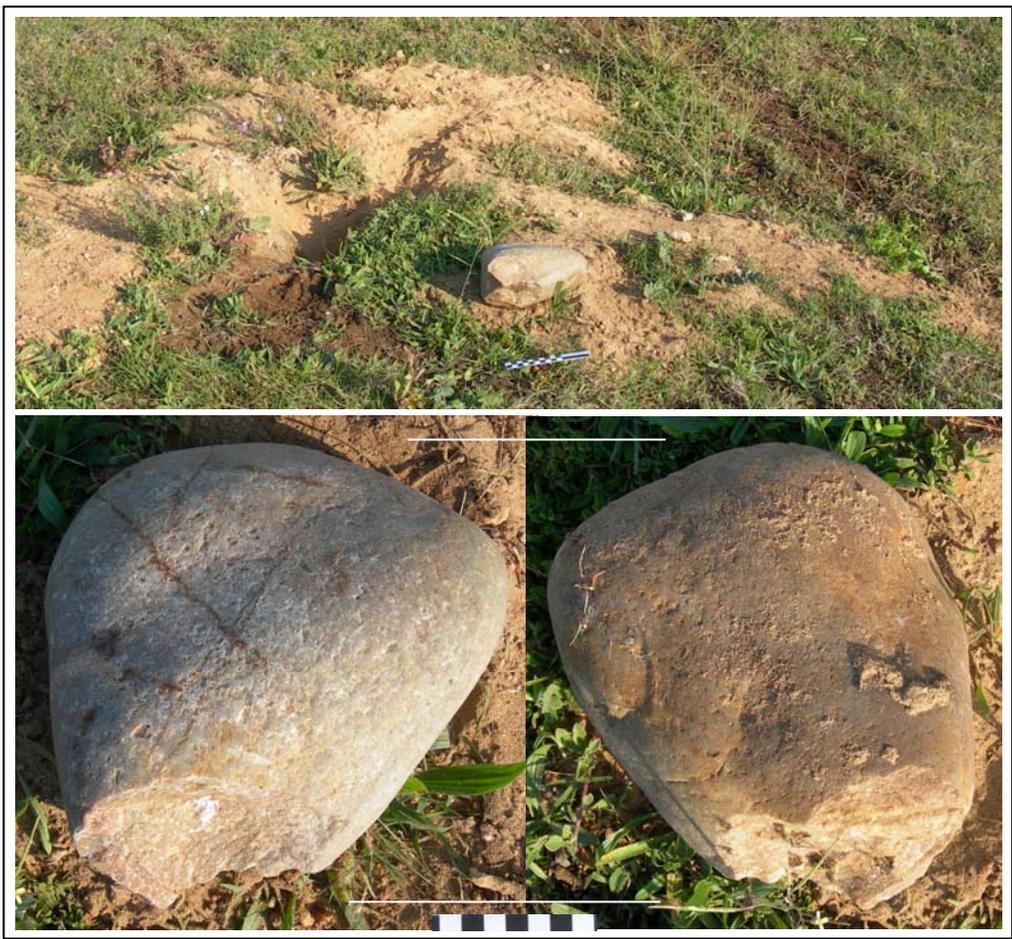
Plate 38. Isolated, flaked quartzite cobble at occurrence 37. Scale intervals are in cm.

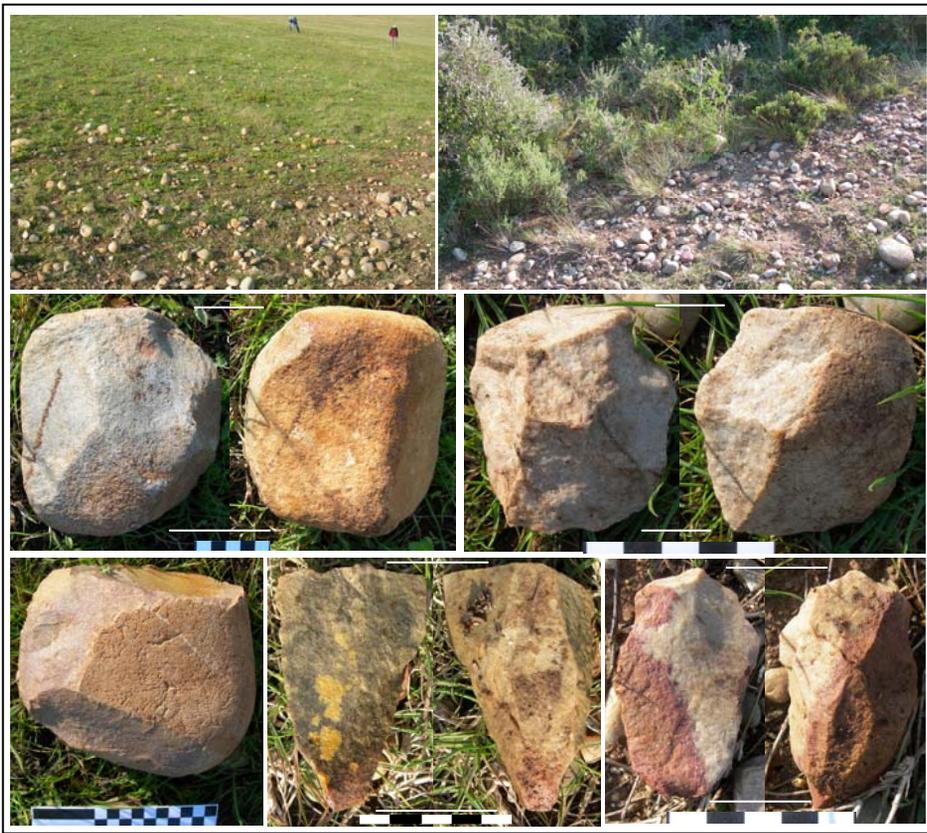
Plate 40. Large scatter of Enon derived cobbles including stone artefacts of mostly MSA origin at occurrence 39. Displayed are hammer stones, cores (middle & bottom left) and retouched flakes (bottom middle and right). Scale intervals are in cm.

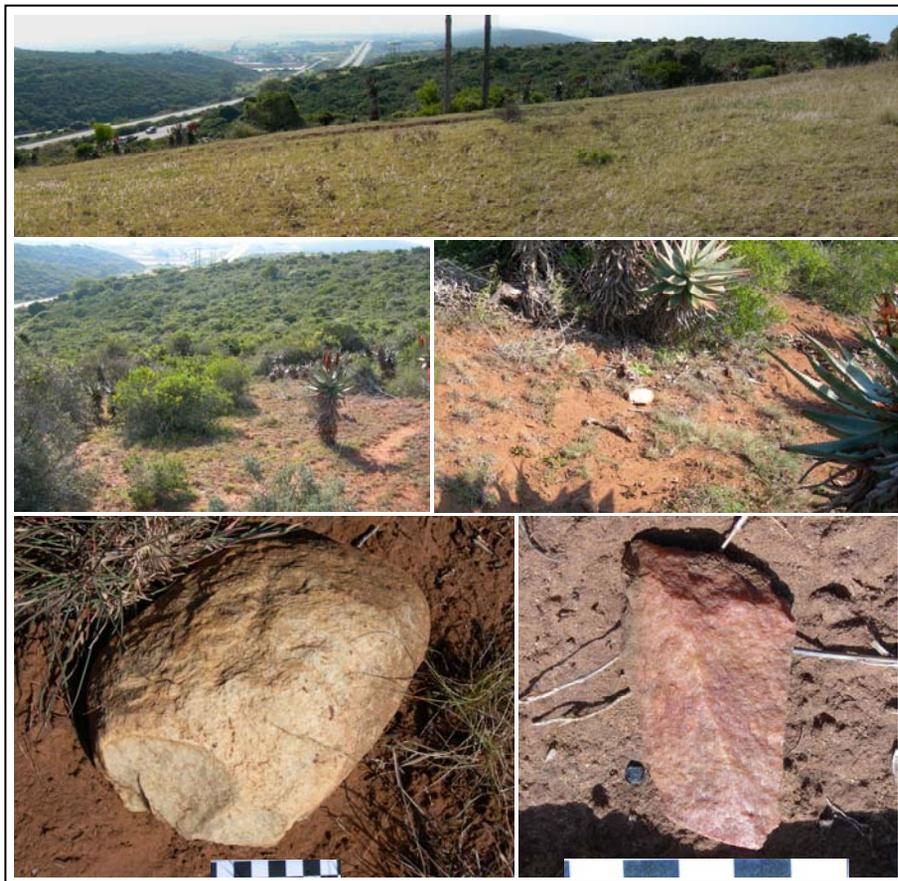
Plate 41. Low density artefact scatter at occurrence 40. Scale intervals are in cm.

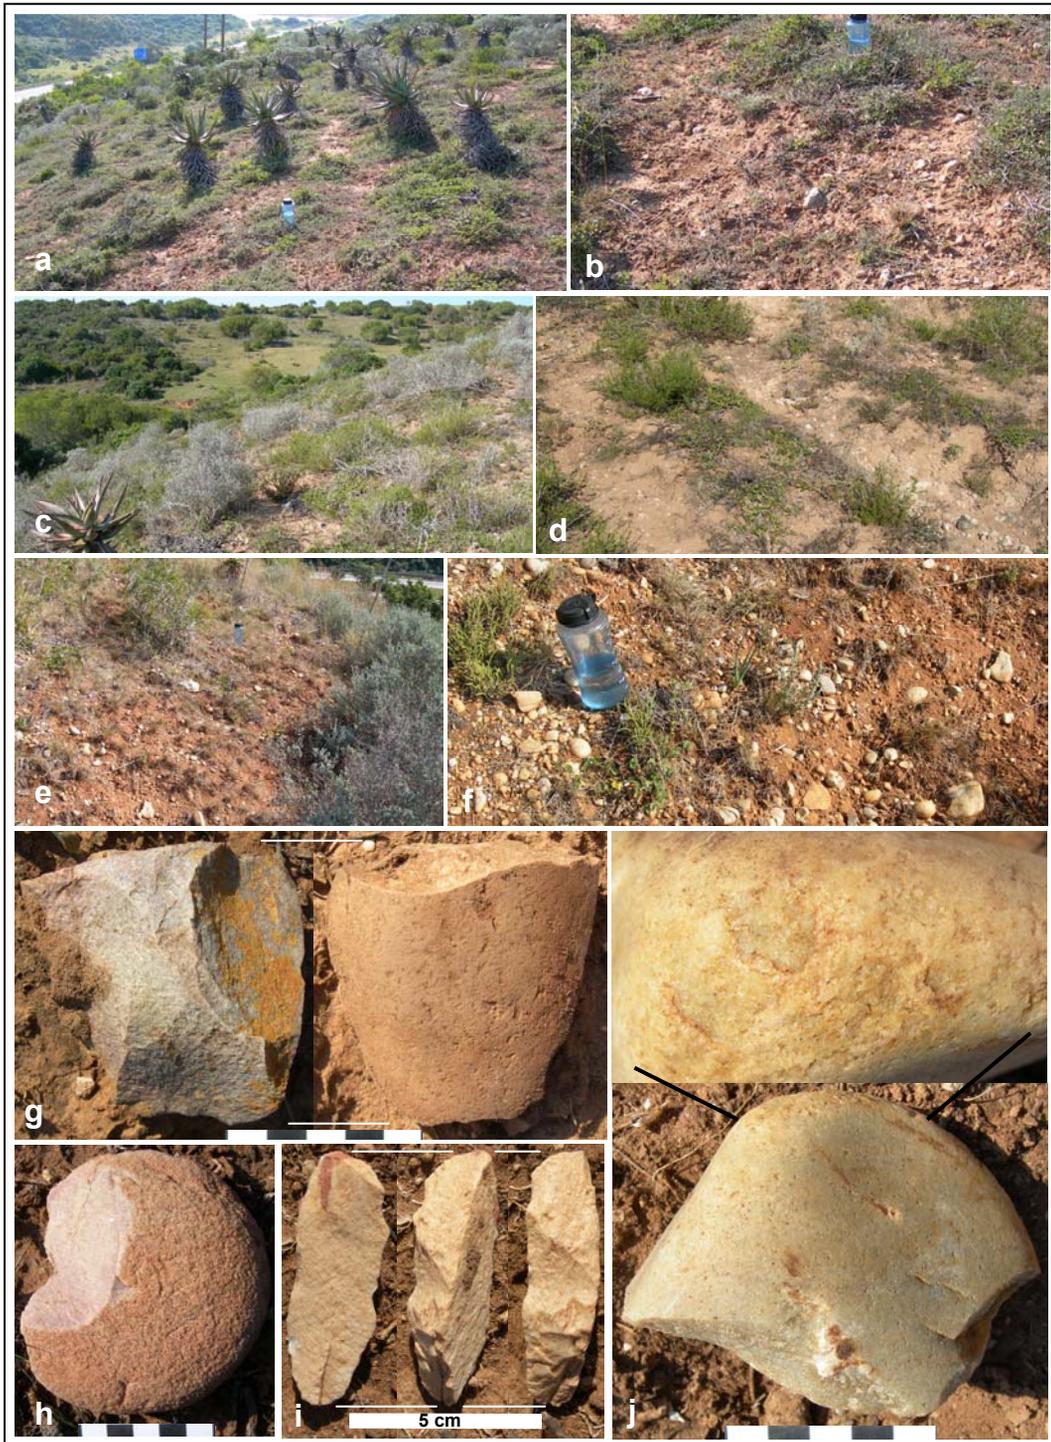
Plate 42. Stone artefacts observed in sparsely vegetated areas at occurrence 41. Examples of exposed ground surfaces are shown in a, c and e while close-ups of those areas are displayed in b, d and f respectively. Artefacts include cores (g & h), hammer stones (h & j), flakes (i) and a single retouched flake (i). Scale intervals are in cm except for the scale bar in i.

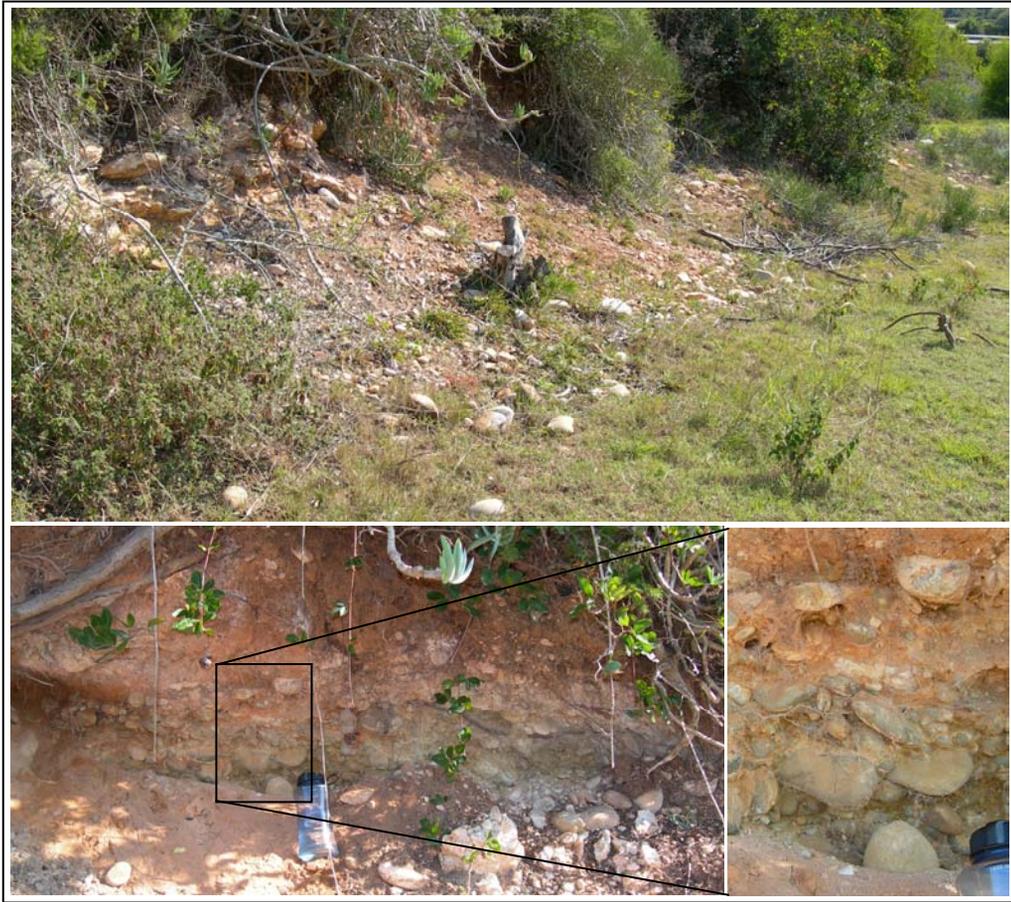
Plate 43. An example of exposed Enon conglomerates at occurrence 35. The N2 is visible in upper right corner of top image. One liter water bottle for scale.

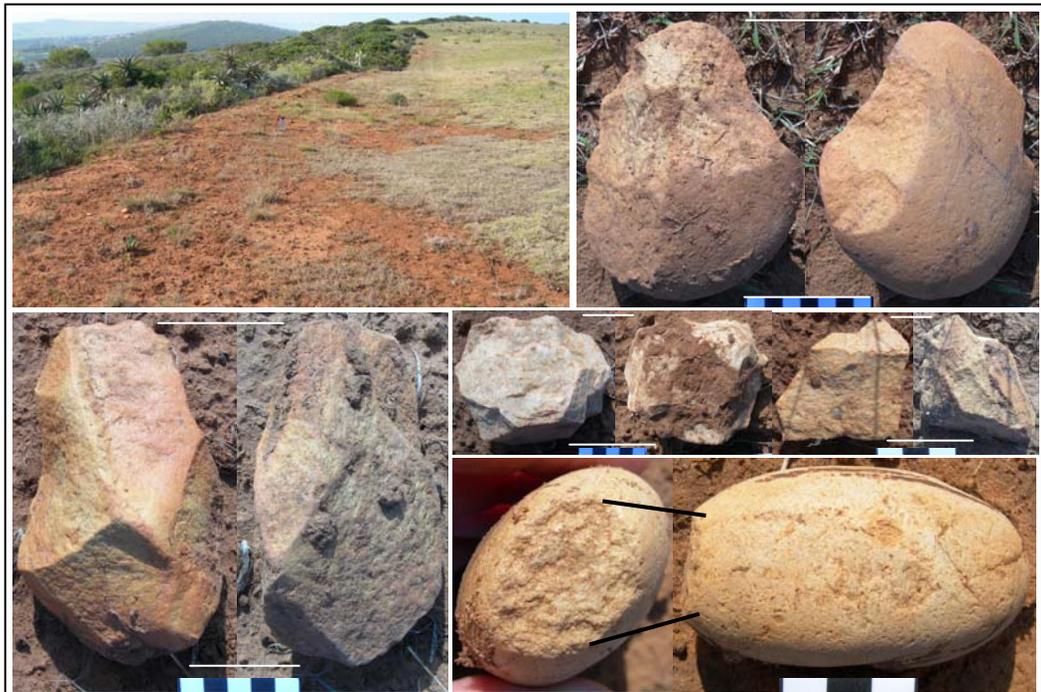
Plate 44. ESA and MSA artefacts at occurrence 43 that is on the western edge of a cultivated field (top left). Stone artefacts include crude bifacial tools and/or cores (top right & bottom left), cores and flakes (middle) and hammer stones (bottom right). Scale intervals are in cm.

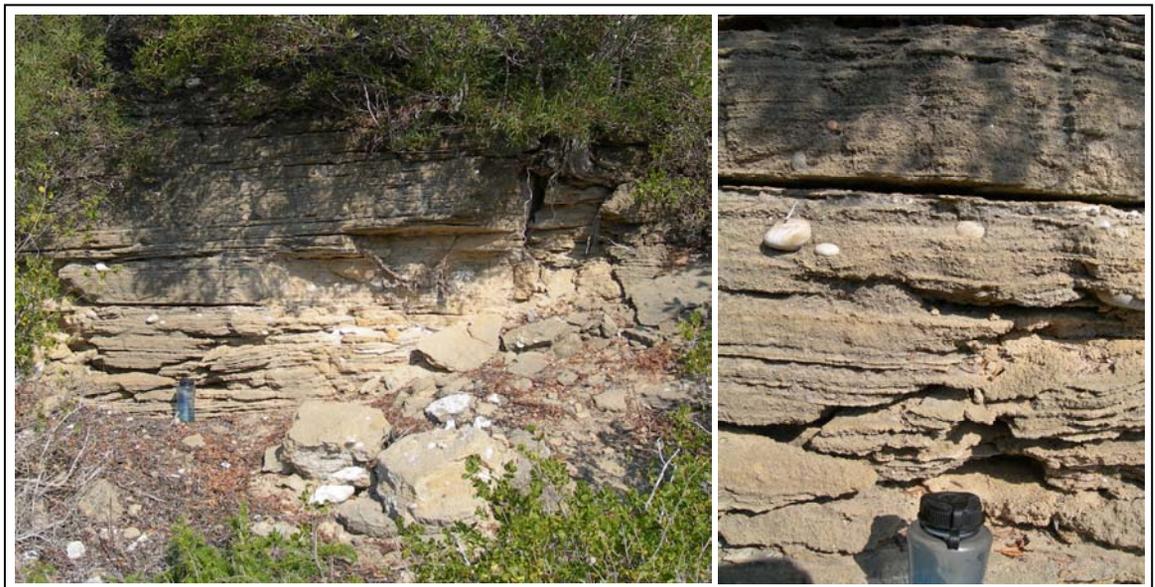
Plate 46. Geological/palaeontological feature at occurrence 23 that appears to be a dune/aeolianite or raised beach. One liter bottle for scale.

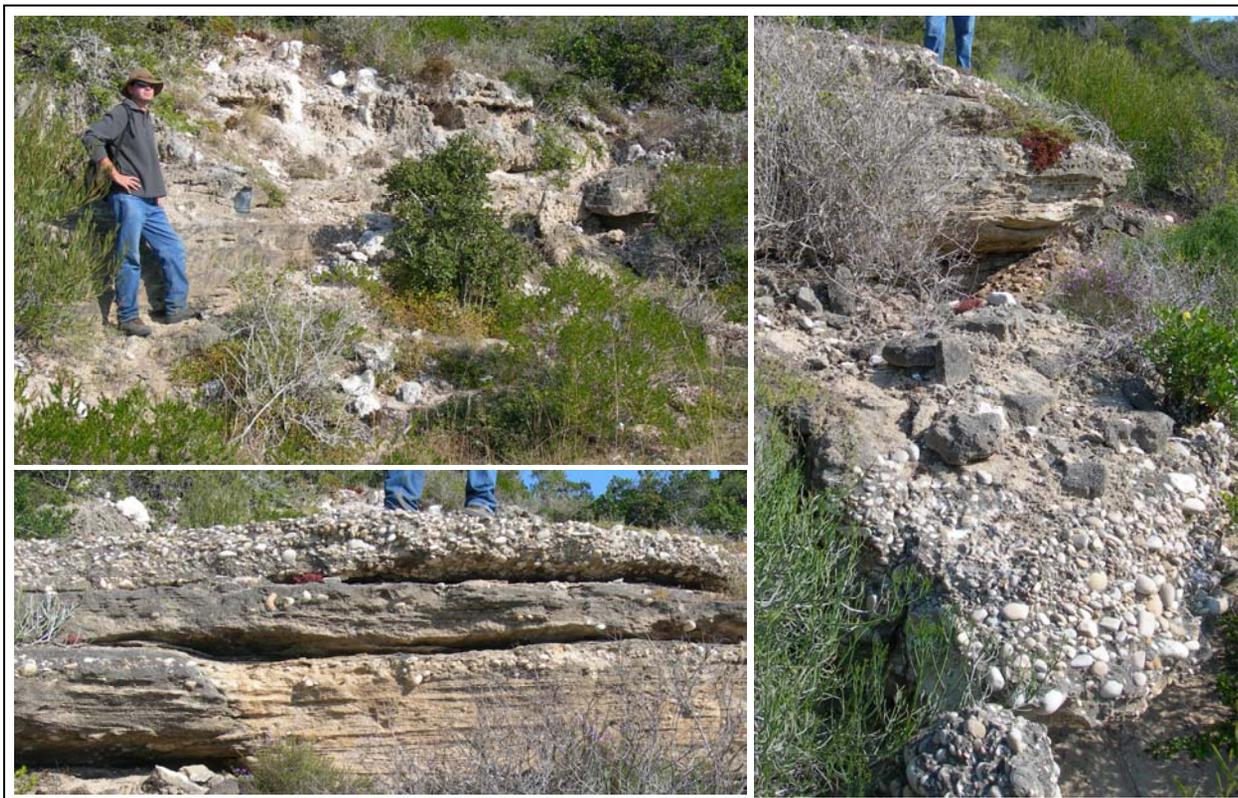
Plate 47. Geological/palaeontological feature at occurrence 24. Calcrete caps a raised beach (top) and the latter is inter bedded with a conglomerate of pebbles and small cobbles that may or may not be of Enon origin (bottom and right).
