ARCHAEOLOGICAL MONITORING OF EARTHWORKS AT THE ARABELLA HOTEL SITE, CAPE TOWN FORESHORE

March 2002

Archaeology Contracts Office

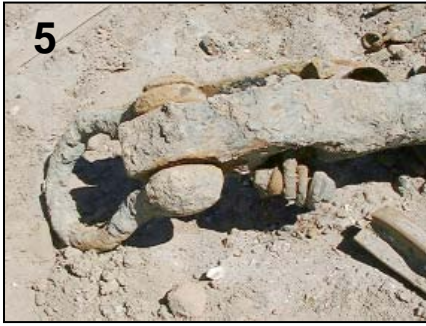
shown in Plate 3 is made from wrought iron and has curved arms tipped with flukes. These were used throughout the 19th century. This specimen was sent to the Maritime Museum at the waterfront for curation. The anchor in Plate 4 had lost its arms although the mechanism at the top of the shank was well preserved (see plate 5). Neither anchor had a stock (an "L" shaped iron bar that passed through the shank just below the chain ring at

right angles to the arms, that prevented the anchor from lying flat on the seabed causing the arms and flukes to dig in).

As this specimen was found over the festive period it could not immediately be collected by the Maritime Museum. Despite requests to the earthmoving contractor to keep it to one side, it disappeared from site and was presumably dumped along with the fill.
