# **AN INITIAL SCOPING STUDY OF THE SANBONA WILDLIFE RESERVE, BARRYDALE**

**Earthworks**

September 2002

**Archaeology Contracts Office**

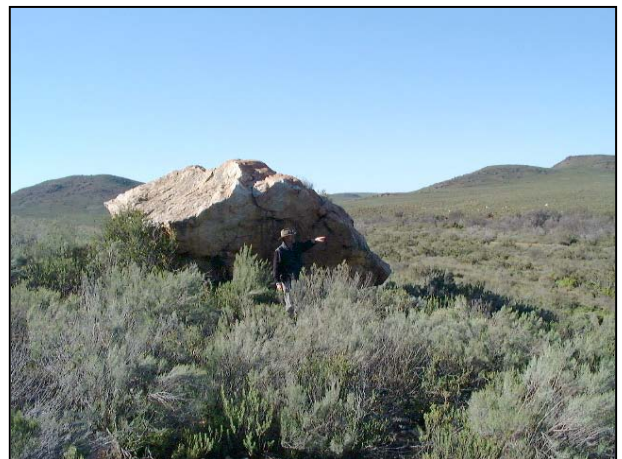
**Site name:** TILNEY 1 (T1)  
**Position:** 33°46'13.6"S 20°36'46.0"E  
**Type of site:** Prehistoric rock art site.  
**Period of use:** Later than 2000 years ago  
**Description:** Several rock paintings (1 human figure and several other daubes of red paint) located on the side of a large quartzite boulder. A fragment of Cape Coastal Pottery was found close to the boulder.  
**Use:** A San painting site, possibly associated with a short term camp site.  
**Sensitivity:** Site is vulnerable to inappropriate treatment by visitors such as wetting and touching, or even graffiti.  
**Protected by legislation:** Yes  
**Related features:** Not established

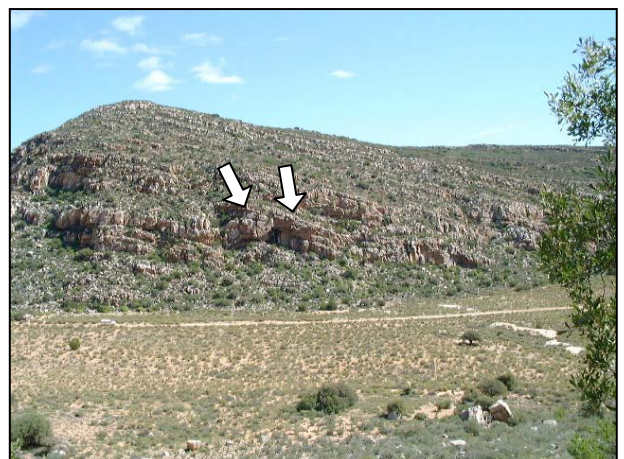
**Description:** A rock shelter with a shallow deposit and artifacts (the upper shelter on the photograph). Rock art is very faded and difficult to discern. Two chert thumbnail scrapers, flakes and potsherds were noted on the surface. There are two lower grinding stones, one of which is stained with ochre.

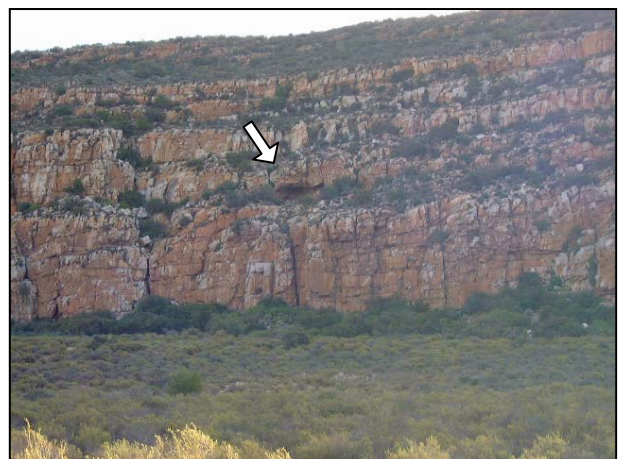
**Description:** Rock painting consists of a faded line of about 9 human figures, a small human figure, 2 eland torsos. No artefactual material was noted.

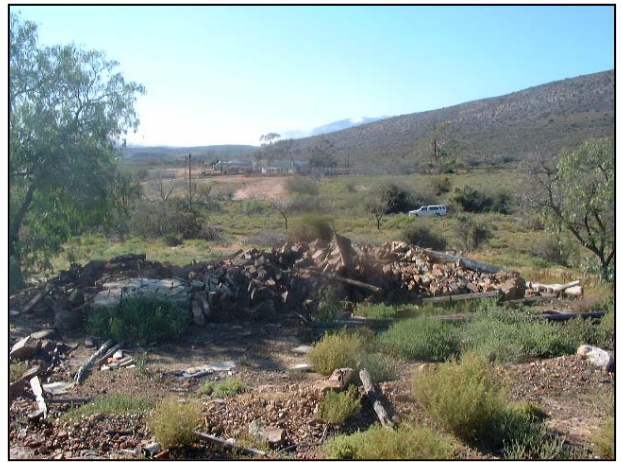
**Description:** The remains of an historic farming settlement associated with a spring (dry). One of the farm buildings has been recently demolished – the building rubble contains mud brick and other vernacular materials. There is also a ruined stone and mud structure, the remains of some walled

fields, a circular stone kraal (which may have started out as a *trapvloer*). Much of the material used in the stone walls consist of calcrete (or manganese?) that has been excavated from the area of the nearby spring. The spring itself has been excavated out and diverted into a channel. A single sherd of Cape Coastal pottery was observed. Around the spring and solidified into the calcretes is a blade rich Middle Stone Age assemblage. Most of the material of this extensive dense scatter is made from a light grey quartzite.

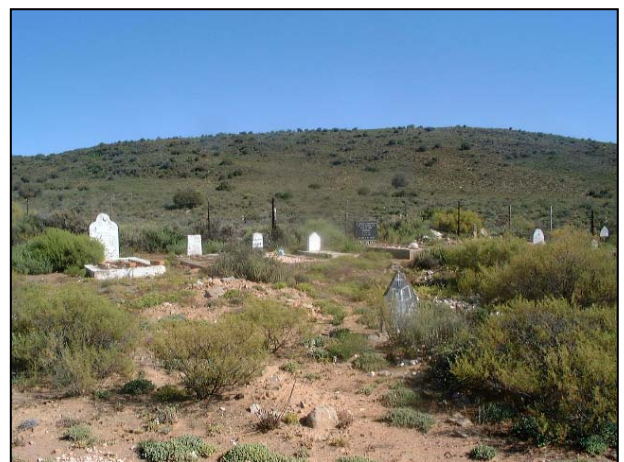
**Description:** A small graveyard (about 20 graves) enclosed by a wire fence. Some of the graves bear inscriptions (surnames Davids, Van der Braaf). Others are characterized by simple head and foot stones (cement, shale or granite). Indications are that the some graves continue to be visited by next of kin.

**Sensitivity:** Graveyards can be socially sensitive, especially if they are celebrated by any given community who may require rights of access. Grave stones are vulnerable to vandalism. While simple graves do erode naturally over time, increased erosion as a result of surrounding activity can speed up the process.

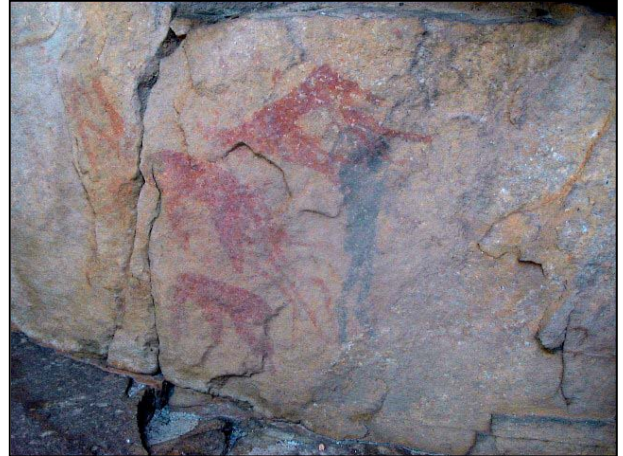
**Site name:** Jakkalsfontein 2 (JKF2)  
**Position:** 33°45'23.0"S 20°42'22.6"E  
**Type of site:** Rock shelter and painting site (late Stone Age)  
**Period of use:** Older than 200 years  
**Description:** A small rock painting site in a narrow kloof about 10m above a stream. The site contains several painted images, some of which have enigmatic streamer-like attachments. Other images include an eland, some black painted figures.  
**Use:** San painting site.  
**Sensitivity:** Paintings vulnerable to mistreatment such as touching and wetting of paintings.  
**Protected by legislation:** Yes  
**Related features:** n/a

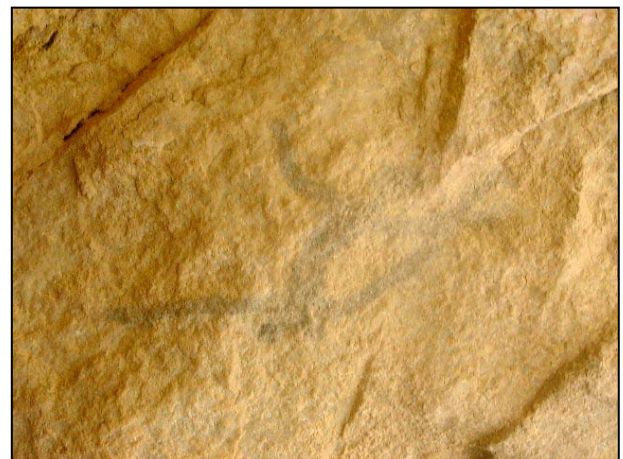
**Site name:** Jakkalsfontein 3 (JKF3)  
**Position:** 33°45'23.0"S 20°42'23.3"E  
**Type of site:** Painting site (late Stone Age)  
**Period of use:** Older than 200 years  
**Description:** Directly opposite site 2 in the kloof, site is a small hole in the cliff. Images consist of a meandering line composed of red dots.  
**Use:** San painting site.  
**Sensitivity:** Paintings vulnerable to mistreatment such as touching and wetting of paintings.  
**Protected by legislation:** Yes  
**Related features:** n/a

**Site name:** Jakkalsfontein 4 (JKF4)  
**Position:** below site 3 and opposite site 2.  
**Type of site:** Painting site (late Stone Age)  
**Period of use:** Older than 200 years  
**Description:** A prominent shelter containing a prominent black figure painted on the ledge to the right. A single potsherd was noted outside the site.  
**Use:** San painting site.  
**Sensitivity:** Paintings vulnerable to mistreatment such as touching and wetting of paintings.  
**Protected by legislation:** Yes  
**Related features:** n/a

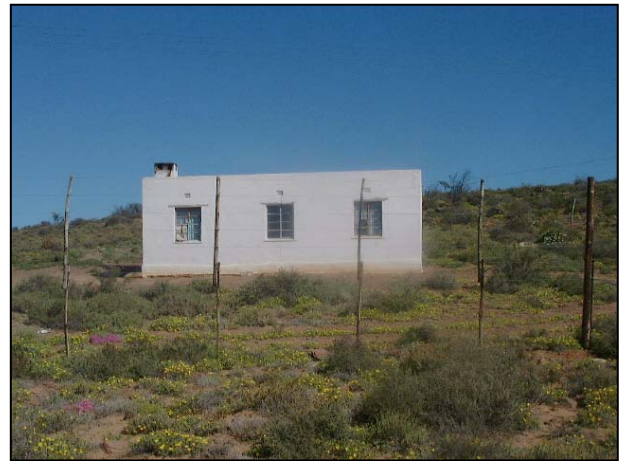
**Site name:** Keeskraal 1 (KK1)  
**Position:** 33°41'08.8" S 20°38'51.7"E  
**Type of site:** Vernacular farm workers house  
**Period of use:** 20<sup>th</sup> century (1930 –1950).  
**Description:** Simple single room dwelling, flat roof, cooking hearth on end, steel window frames.  
**Use:** Typical housing for farm workers, stylistic origin in 19<sup>th</sup> century structures.  
**Sensitivity:** Often demolished without assessment of significance, such structures are typical of farm workers accommodation in the Karoo and other parts of South Africa.  
**Protected by legislation:** Yes, if structure is older than 60 years.  
**Related features:** n/a

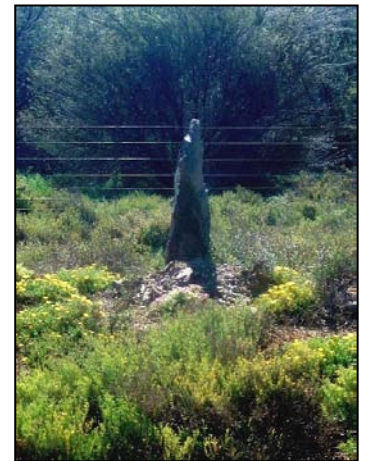
**Site name:** Keeskraal 2 (KK2)  
**Position:** 33°41'14.4" S 20°38'38.7"E  
**Type of site:** Typical historic boundary marker/beacon  
**Period of use:** 18-20<sup>th</sup> century  
**Description:** Typical boundary marker/beacon, elongated slab of shale placed upright in the ground.  
**Use:** Boundary marker, fence support.  
**Sensitivity:** These markers are evidence of the way that the landscape was partitioned in historic times. They are vulnerable to demolition or removal during fencing operations.  
**Protected by legislation:** Yes  
**Related features:** Fences, other farm boundaries.

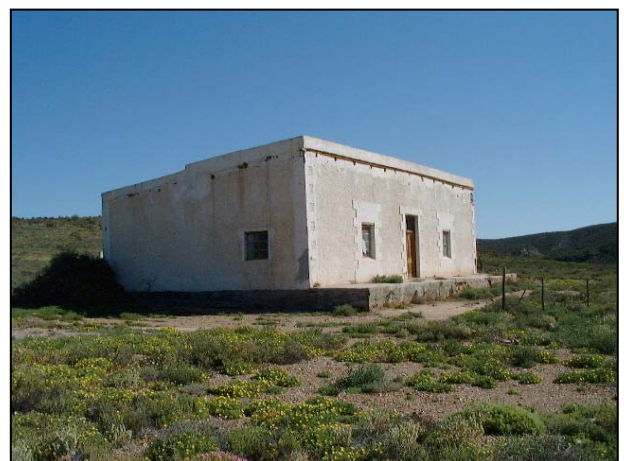
**Site name:** Brakrivier 1 (BR1)  
**Position:** 33°41'26.4 "S 20°37'48.7"E  
**Type of site:** Historic building  
**Period of use:** Early – mid 19<sup>th</sup> century  
**Description:** Vernacular flat roof house with Georgian elements. Low parapet along front of roof, possible low solder under roof. Interior consists of 6 rooms laid out in typical vernacular style (*voorkamer*, *agterkamer*, side rooms and rear kitchen). Ceiling consists of heavy imported pine boards supported by joists (in original condition). Some architraves have been bricked up.  
**Use:** Recent use is unknown, originally a dwelling house.  
**Sensitivity:** Well preserved structure, excellent example of regional architectural style. Vulnerable to neglect and decay, illegal removal of woodwork and vandalism.  
**Protected by legislation:** Yes  
**Related features:** Not established
