PHASE 1 ARCHAEOLOGICAL ASSESSMENT OF ROBBEN ISLAND WORLD HERITAGE SITE.

April 2001

Archaeology Contracts Office

University of Cape Town

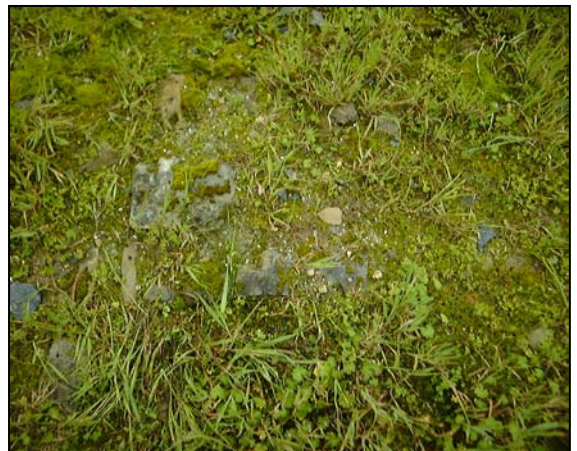
JPEG: wpt45

DESCRIPTION: The technical hut south of the harbour is built on a mound, which predates WW2. Within this mound is evidence of earlier stone wall footings which probably relate to a structure known as the white house indicated on the map of 1897. Very little artefactual material was observed apart from 2 sherds of oriental porcelain.

FURTHER RESEARCH: An excellent prospect for archaeological excavation. Will require an initial pilot study, and measures to conserve exposed structures. May be suitable material for interpretive display.

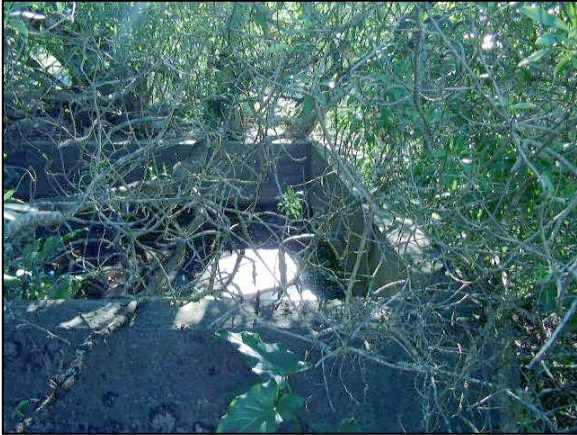
WPT: 73

DESCRIPTION: Two stone and cement reservoirs filled with rubble and debris, one still has water in it. The features are hidden in a thicket and dug into the ground surface.

CHRONOLOGY: Similar in style to Leper period reservoir, suspect 19th century.

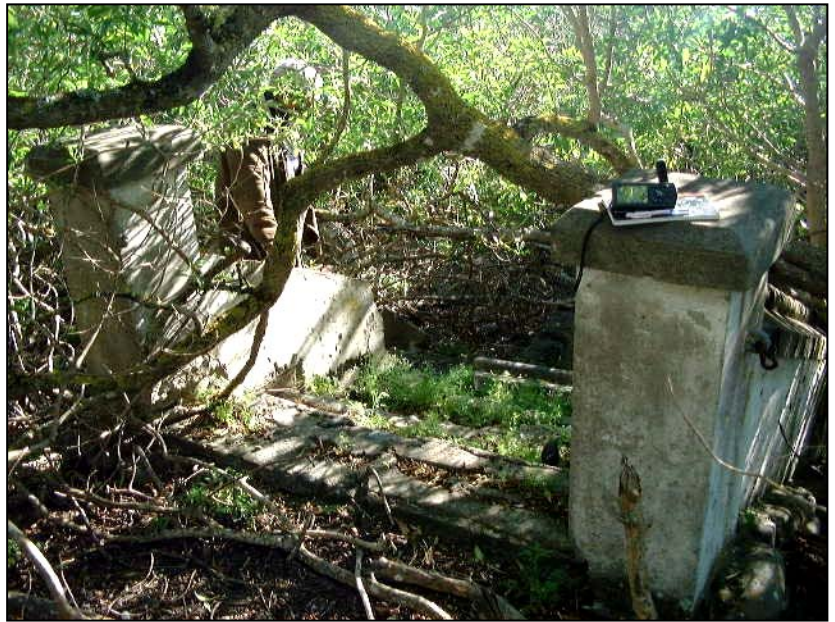
JPEG: wpt76

DESCRIPTION: A flight of stairs in thick bushes – appears to have been of the sort that was designed to ascend a gardened incline onto a stoep. Just over the dirt track behind the stairs are foundations and slabs of broken cement floor. There is evidence of older stone walling underneath, showing that the building that stood here incorporated an older structure. A map of the leprosy settlements (CCP 1/2/1/92 (1895)) indicates this area to have been the site of the “childrens leper ward”.

FURTHER RESEARCH: Potential site for archaeological investigation, further map and archival work may be fruitful.

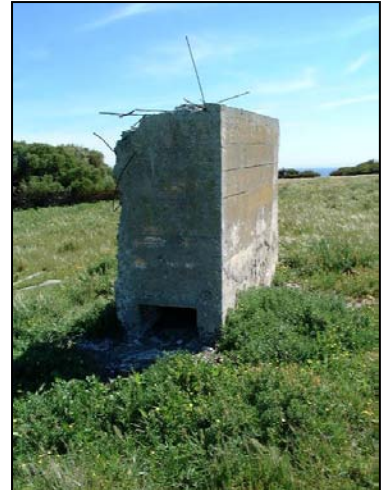
JPEG:wpt120

VULNERABILITY: Natural deterioration.

FURTHER RESEARCH: Oral history from WW2 veterans.

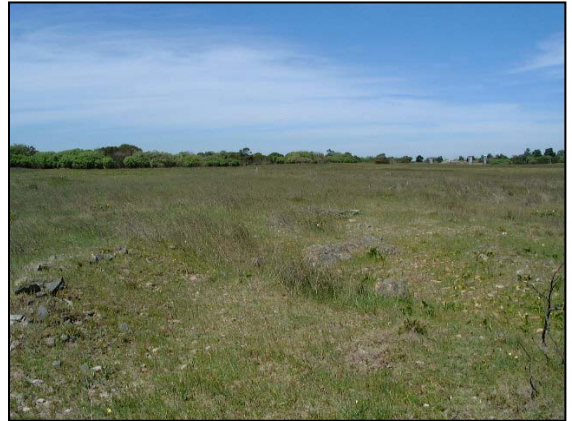
DESCRIPTION: A long shallow excavation with a concrete fence post in the middle.
CHRONOLOGY: 20th century - more specific information not available at this time.
CONTEXT: A person-made landscape feature of undetermined purpose.
LINKAGE: Geographical association with airport
SIGNIFICANCE: Unknown.
VULNERABILITY: Not impacted at present.
FURTHER RESEARCH: Oral history may provide some information.
JPEG: Wpt133.

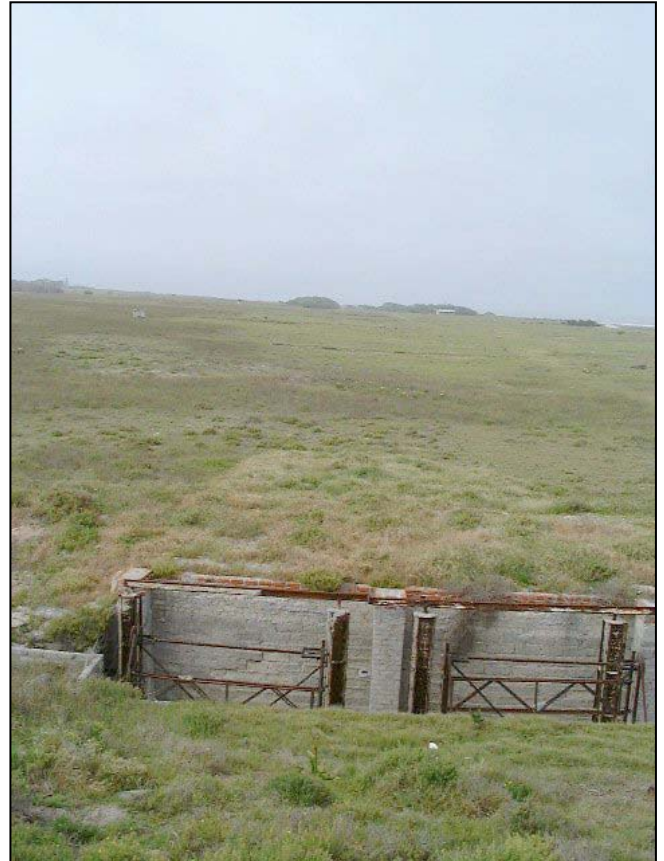
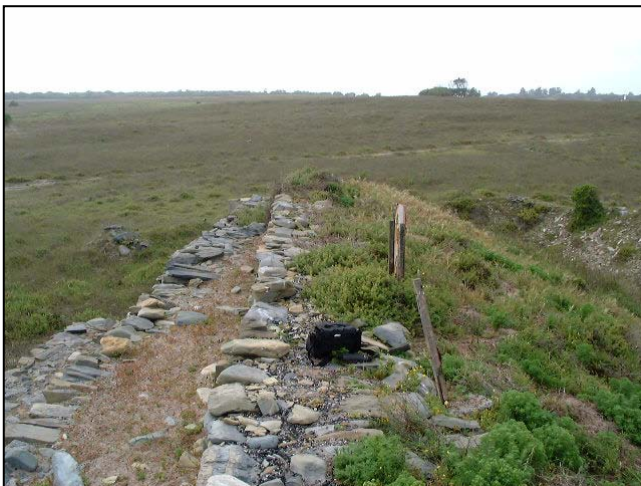
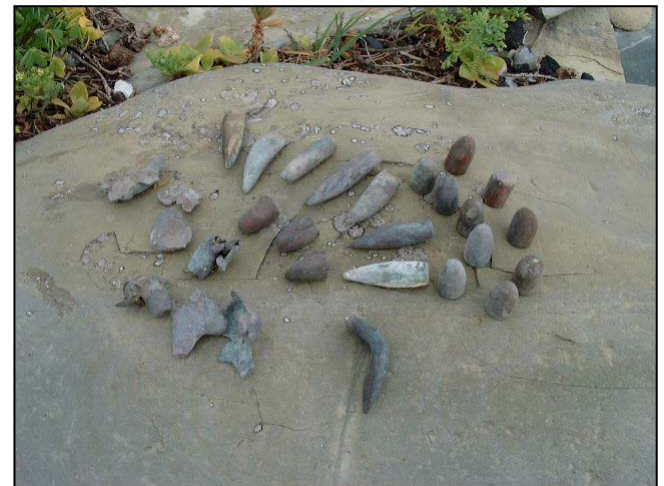
JPEG: Wpt 135 A,B,C

DESCRIPTION: The berm of the rifle range. The north side of the berm is built of three tiers of shale, while the south side (shot absorbing) consisted of piled earth and calcrete chunks. Graffiti on the stone work reads "finis 1972". The berm top is covered with fragmented 9mm pistol rounds and 7.62 mm R1 rifle rounds. The rifle range was evidently heavily used during the apartheid era. Below the berm is a trench used by personnel to operate the target hoisting apparatus. The framework of this mechanism still exists, albeit corroded beyond salvage. Extending southwards from the berm are shooting positions interspersed at approximately 100m intervals. Many of these are littered with R1 cartridge cases. A brick shed close to the berm may have been used as a target store. The south end is associated with a small building equipped with a kitchen, fresh water tank and braai area - testimony to the fact that target practice was combined with leisurely activities.

VULNERABILITY: Rifle shells and bullets may be illegally collected and target mechanism is corroding.

FURTHER RESEARCH: Oral history.

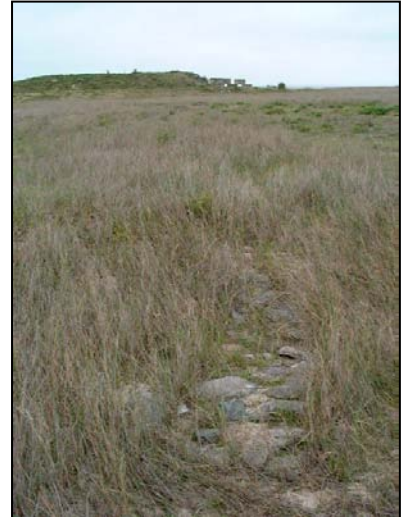
JPEG: Wpt 136

DESCRIPTION: A dry stonewall alignment with a corner on the rifle range that pre-dates the rifle range. The wall alignment may be related to early walled gardens of the DEIC period.

FURTHER RESEARCH: Possible archaeological excavation and detailed mapping.

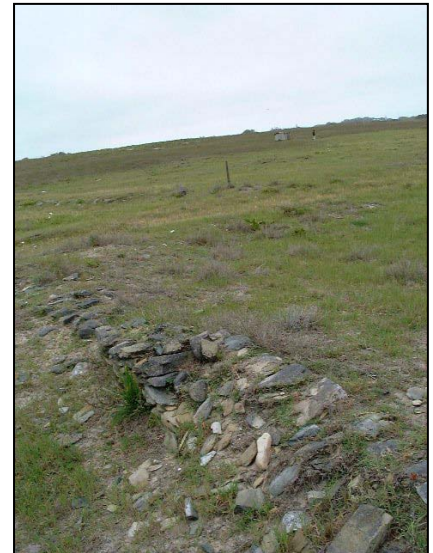
JPEG: wpt138

DESCRIPTION: A low dry stonewalled rectangular alignment on the rifle range. Approximate size is about 30x30m, very similar to the alignments found on the north west side of the island. We interpret this as being a field or vegetable garden.

FURTHER RESEARCH: Detailed mapping and possible archaeological investigation.

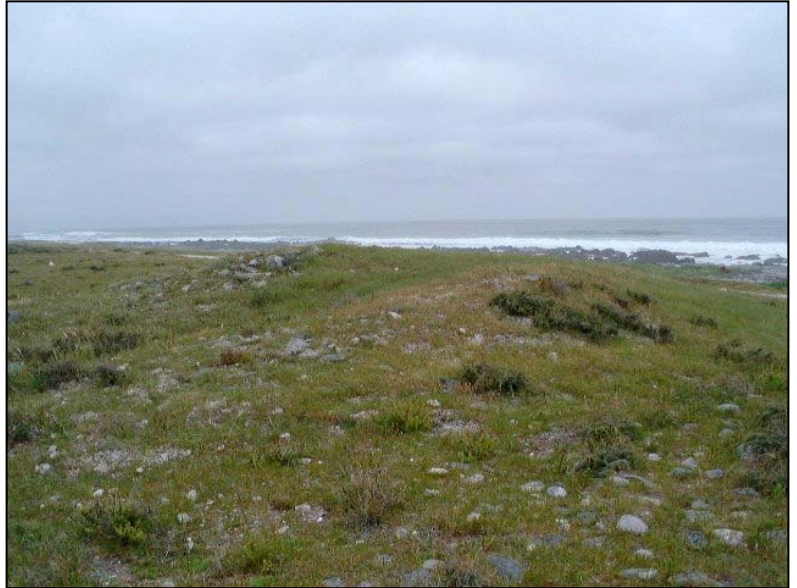
JPEG: wpt 149

DESCRIPTION: An upright stone set in mound near the foghorn.

FURTHER RESEARCH: Archaeological investigation is likely to confirm identity of the feature.

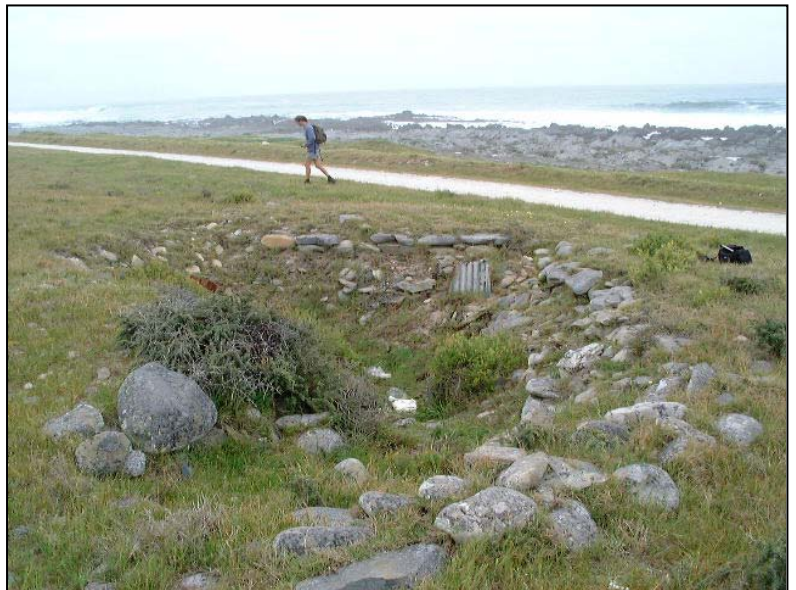
JPEG: Wpt 150

DESCRIPTION: A triangular stone lined pit with zinc shuttering inside, likely to be a rifle post.

VULNERABILITY: These trenches have a very casual appearance and may be unwittingly damaged by persons intent on "clearing up" old zinc sheeting on the island, or used as rubbish pits.

FURTHER RESEARCH: Some archaeological investigation may be helpful in confirming identity of the site. Oral history research could potentially provide significant information.

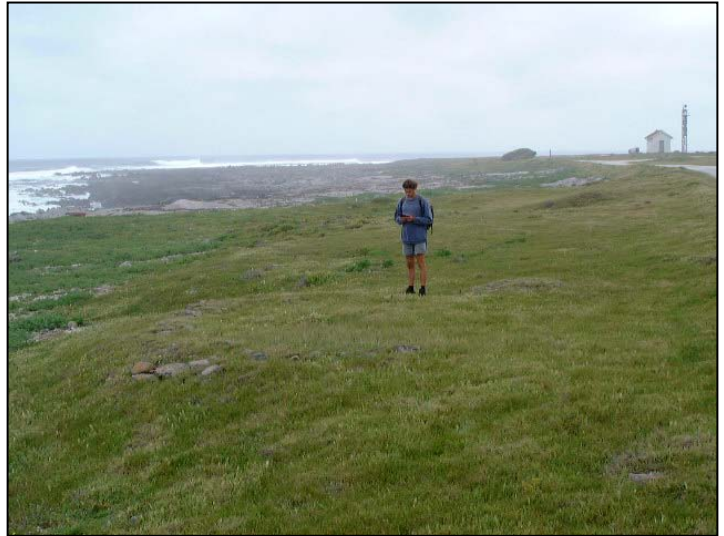
JPEG: wpt 151.

DESCRIPTION: A mound, which may be the remains of a lime kiln. Nearby is a stone marked U3.

FURTHER RESEARCH: Archaeological excavation will confirm identity and state of preservation of the find.

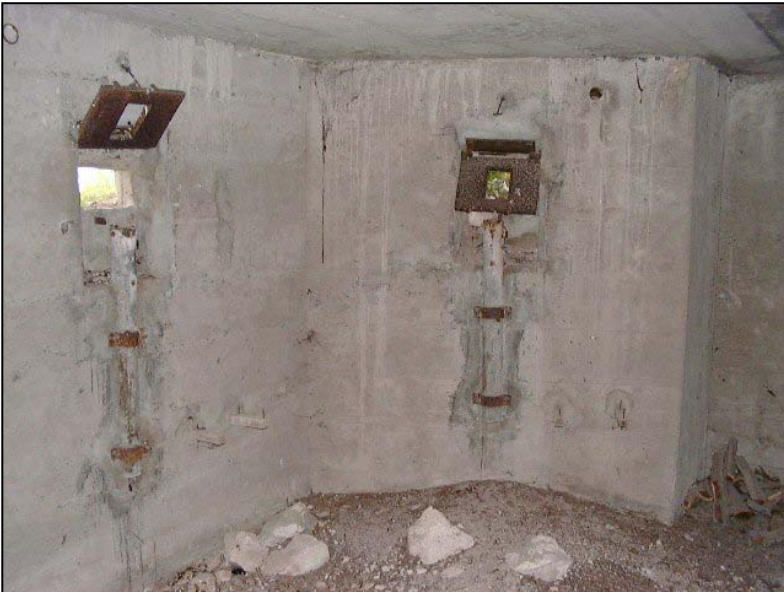
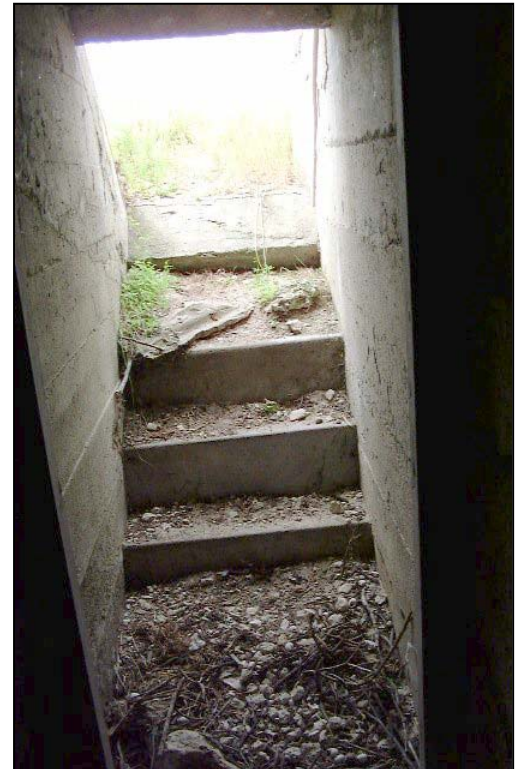
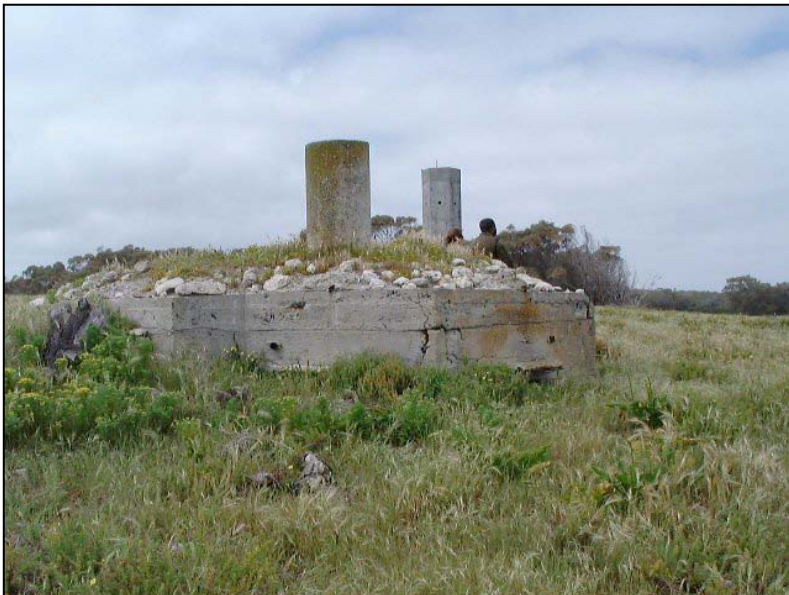
JPEG: wpt154

VULNERABILITY: Gradual corrosion of metal components.

FURTHER RESEARCH: Oral history, archival research.

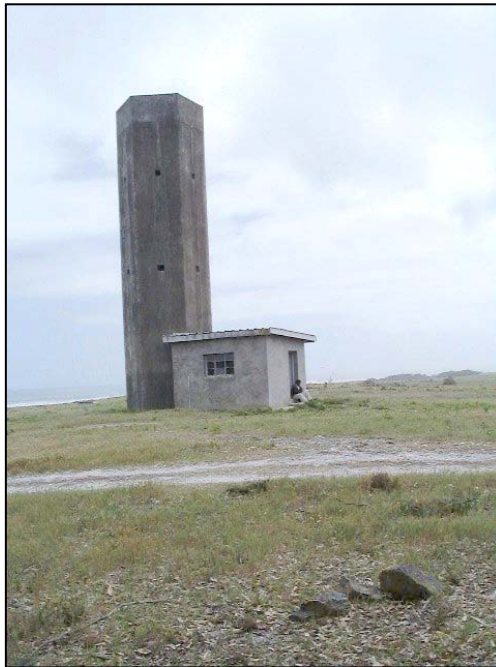
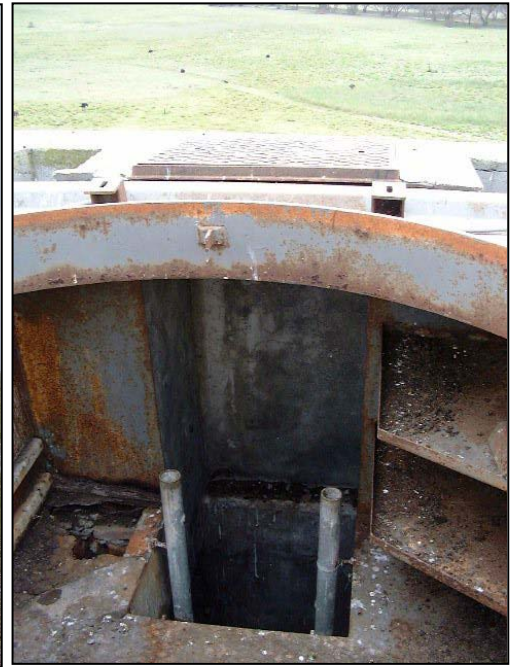
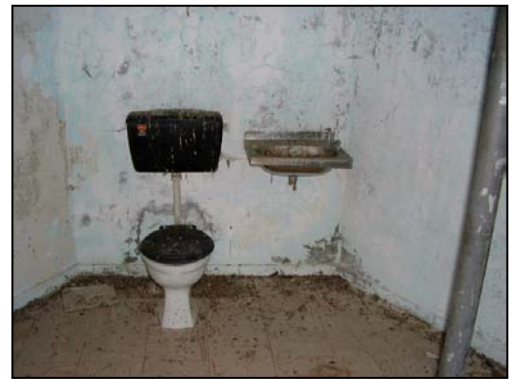
JPEG: Wpt 155.

DESCRIPTION: A hexagonal 3 story high concrete observation tower indicated by Riley to be a radar position. Nearby a portion of machinery (?radar mounting) lies on the ground in long grass. Observation ports have been covered over with wood and perspex. There is no evidence of heavy steel shutters characteristic of the WW2 period buildings. Access between the floors is via steel ladders. The ground floor of the tower has plastic tiles on the floor and contains a toilet.

This adjoins a room, which contains a stainless steel sink, and has steel framed windows.

VULNERABILITY: Corrosion of metal components. Accumulation of bird droppings in interior. Corrosion of ladders.

FURTHER RESEARCH: Oral history, archival research.

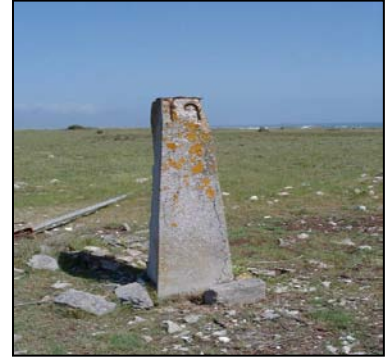
JPEG: wpt156.

DESCRIPTION: A toppled radio mast, the base of which is associated with piled earthworks.

VULNERABILITY: Deterioration of metal components.

FURTHER RESEARCH: Oral histories, archival research.

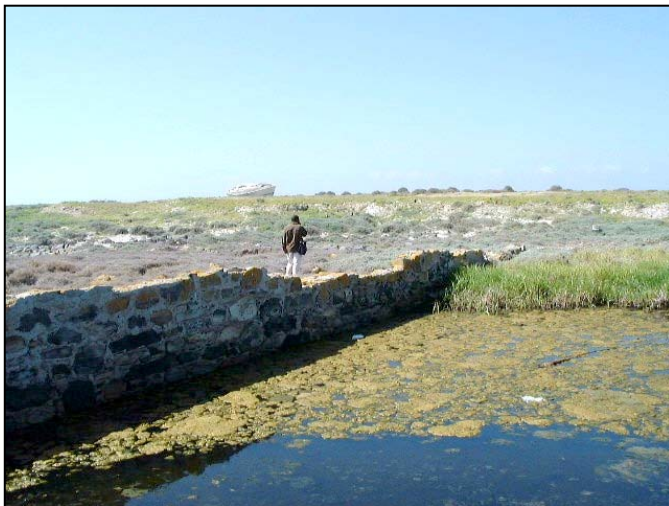
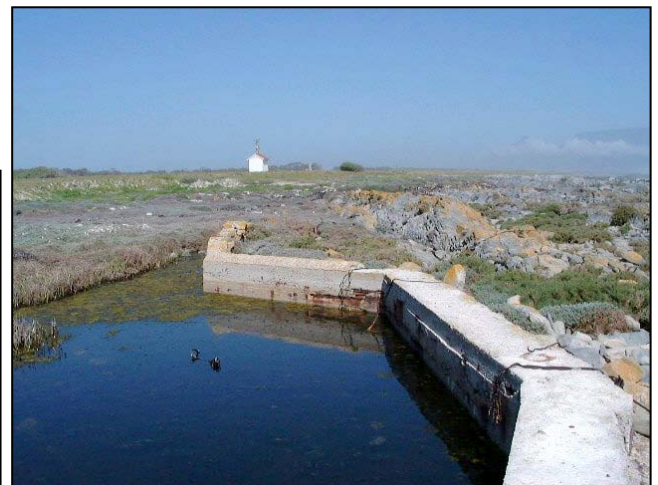
WPT: 158

DESCRIPTION: A small walled dam popularly known as the "lepers pool". The dam is built of cement with shell inclusions, and in places, steel reinforcing. Although the dam takes the form of a tidal pool set

among rocks on the shoreline, it is unlikely to have been influenced by seawater apart from at high spring tide and northwesterly storms. The dam was probably built to catch water from a fresh water seepage that flowed into the sea at this point.

VULNERABILITY: Natural deterioration and weathering.

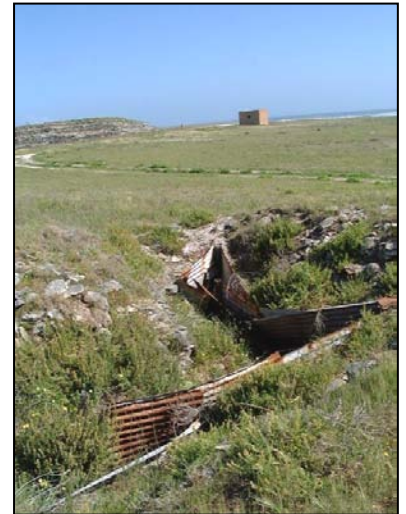
DESCRIPTION: A "V" shaped trench lined with corrugated iron. This is probably a WW2 rifle trench.
CHRONOLOGY: 1942.
CONTEXT: WW2 defences.
LINKAGE: Close to informal track linking with Perimeter Road.
SIGNIFICANCE: In conjunction with the machine gun posts, rifle posts made up part the immediate defense in the event of enemy landings.
VULNERABILITY: Corrosion of corrugated iron. Collapse of sides.
FURTHER RESEARCH: Oral history, archival research.
JPEG: wpt159

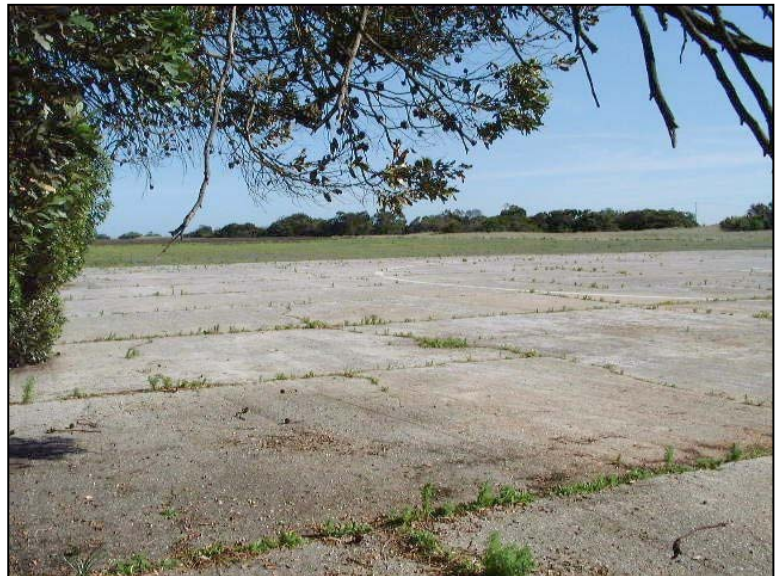
DESCRIPTION: The above 10 waypoints represent co-ordinates on airport runways. The airport consists of two asphalt landing strips, each about 700m in length orientated in south east and north west directions. The site is currently disused and overgrown.
CHRONOLOGY: The airport was built during WW2 to provide access for supplies, personnel, and possibly as a point from which to operate aircraft playing an active defensive role.
CONTEXT: Part of WW2 defensive system.
LINKAGE: Linked by tracks from each runway to Perimeter Road and to maximum-security prison.
SIGNIFICANCE: An important component of the WW2 defenses, but also used during the apartheid era.
VULNERABILITY: Slow deterioration of asphalt surface as a result of plant growth.
FURTHER RESEARCH: Oral history, archival research.
JPEG: wpt161

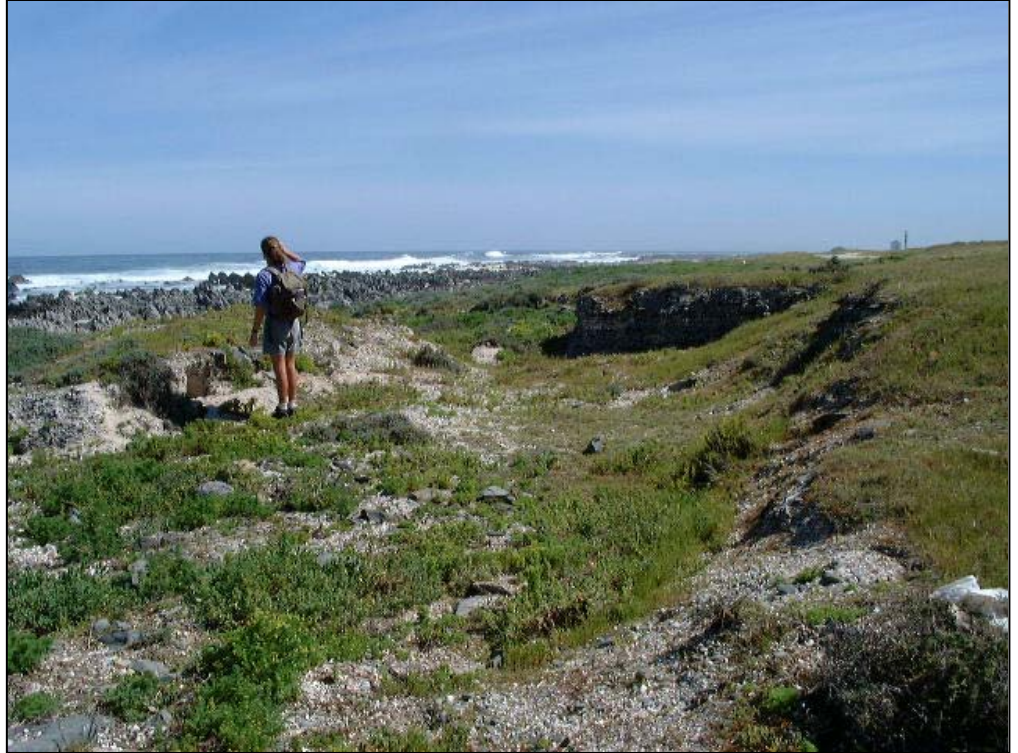
JPEG: wpt173.

DESCRIPTION: A coastal shell mine in a very shelly area of the coast. Dense accumulations of shell along the high water marked have been excavated for material that was probably burned in the lime kilns for making lime and mortar.

FURTHER RESEARCH: n/a

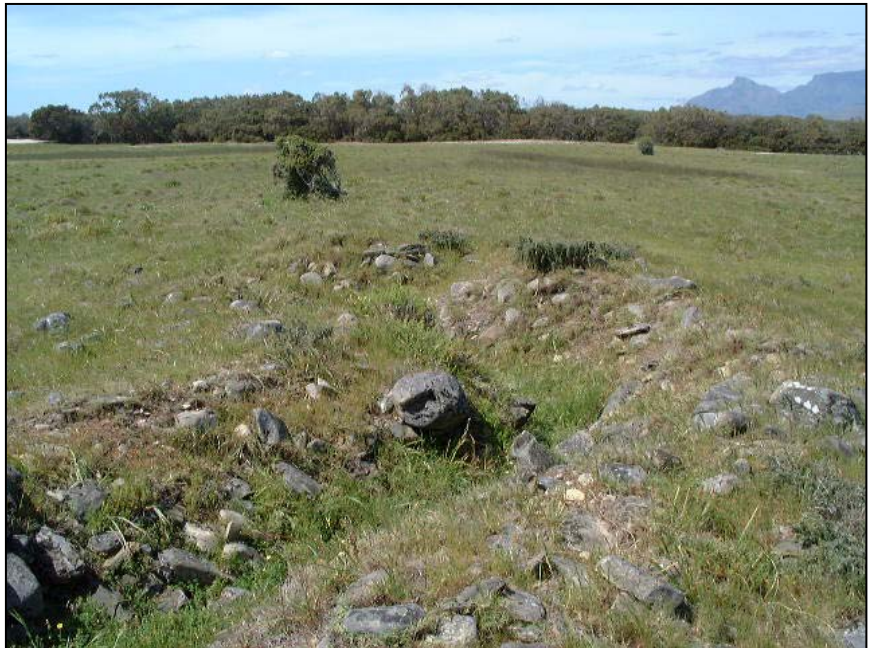
JPEG: wpt 182

VULNERABILITY: Gradual disturbance by vegetation growth, trampling by animals.

FURTHER RESEARCH: Archival research, oral history, limited excavation may be of benefit.

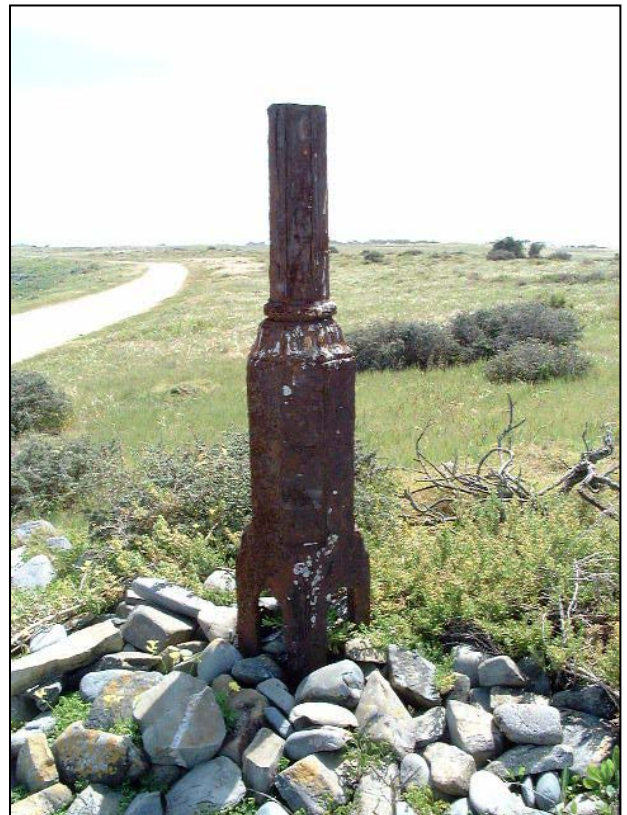
JPEG: wpt183.

VULNERABILITY: Slow corrosion.

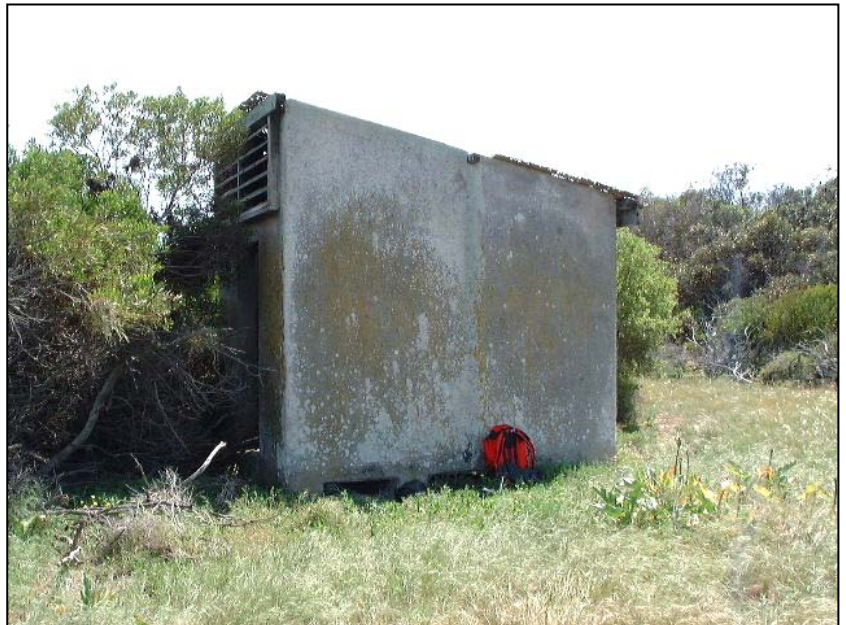
JPEG: Wpt 188.

VULNERABILITY: Has suffered from corrosion of metal work, rotting of woodwork, penguin residence.

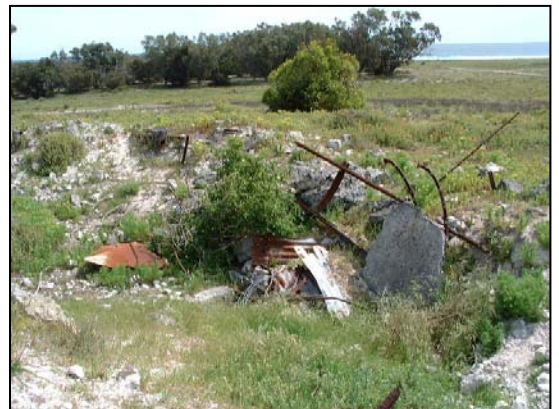
JPEG: wpt 193.

DESCRIPTION: An old rifle trench (?) filled with chunks of cement, corrugated iron and a piece of tramline.

FURTHER RESEARCH: Oral history, archival records, clearing out of rubbish and limited excavation.

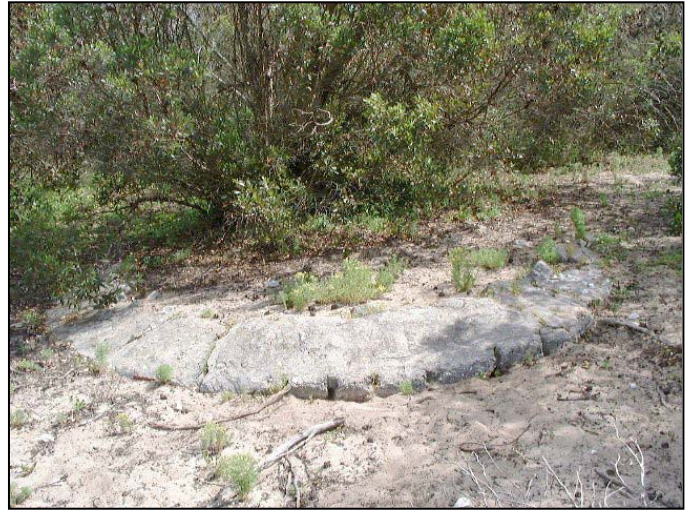
JPEG: wpt 194

DESCRIPTION: Cape Corps Memorial. A cement and shell commemorative feature, decorated with sea shells and engraved with names and numbers of personnel.

VULNERABILITY: A site threatened by alien vegetation growth and root movement, which is degrading the concrete work. Parts of the site have become covered with sand and debris.

FURTHER RESEARCH: Physical clearing of the site, recording of names, ranks and numbers, detailed photography and genealogical research.

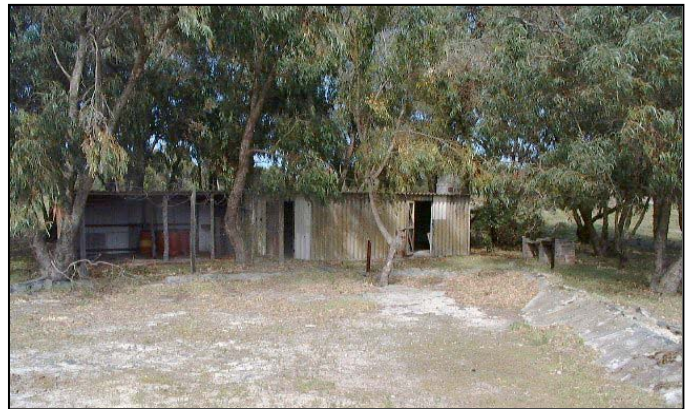
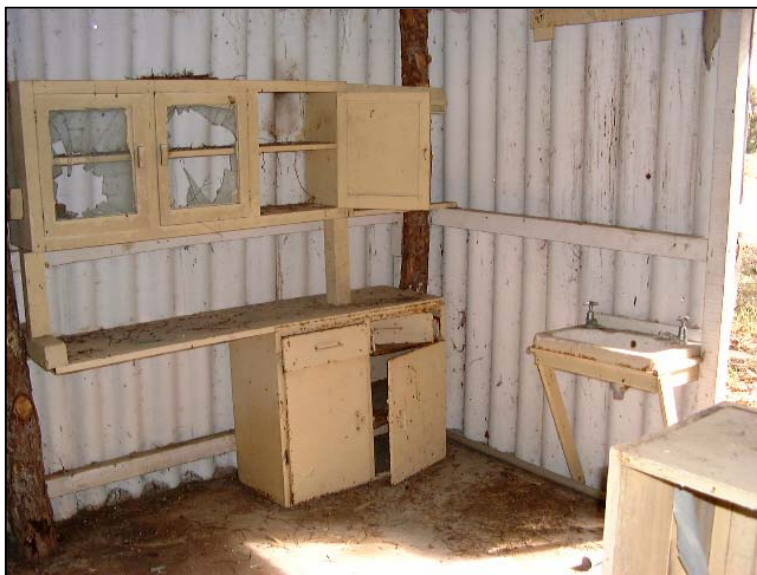
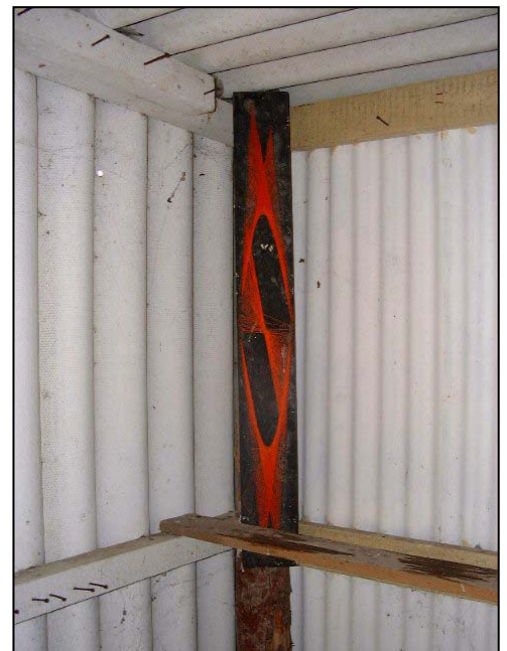
JPEG: wpt195abc

DESCRIPTION: A small shed with a kitchen located below No 1 gun on the Table Bay side. Nearby are animal drinking troughs, a braai area and a large shallow dam in a gully. Suspect that this is the area referred to as "the duck pond".

VULNERABILITY: Weathering of structure, damage by birds.

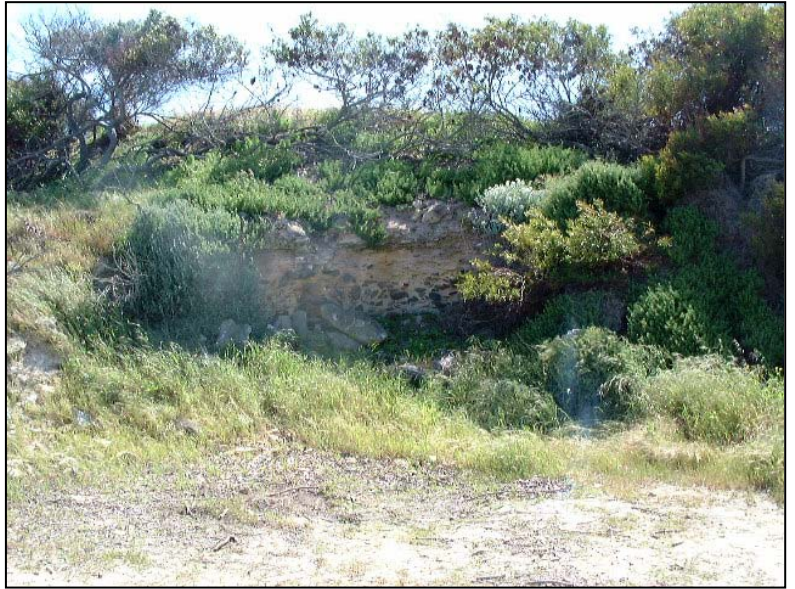
JPEG: Wpt196

DESCRIPTION: A dense exposure of fossil shell representing an ancient raised beach is visible in a quarry on the south side of the island. The quarry is currently used as a dumping area for garden and domestic refuse. The fossil shell exposure, which is raised some 12m above the present sea level is extremely old - possibly dating back several million years.

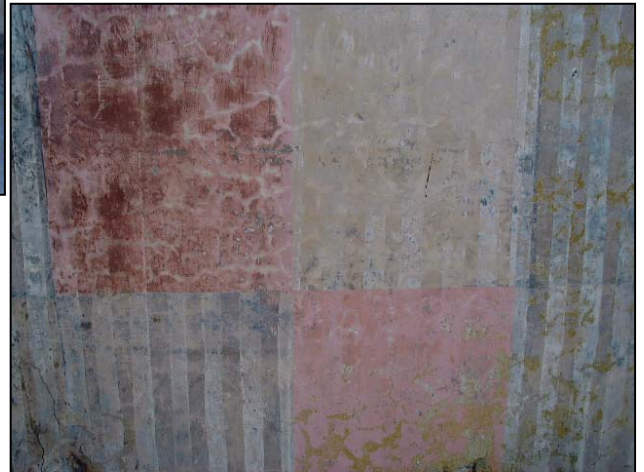
DESCRIPTION: Power station building (T225) with engine mountings and cable conduits in the interior. Most of the fittings have been removed, apart from the windows. Building appears to have had several different paint schemes - initially painted red and cream, later painted with WW2 camouflage. Roof is pitched ((?) to disguise it as a civil building) but actually built of flat cast reinforced concrete. Outside the building is an open cable trench leading towards one of the two search light positions on the southern shore. Site probably provided power for barracks and southern shore AA emplacements.
CHRONOLOGY: Used to provide power to facilities during WW2.

VULNERABILITY: Metal fittings and paintwork are deteriorating.

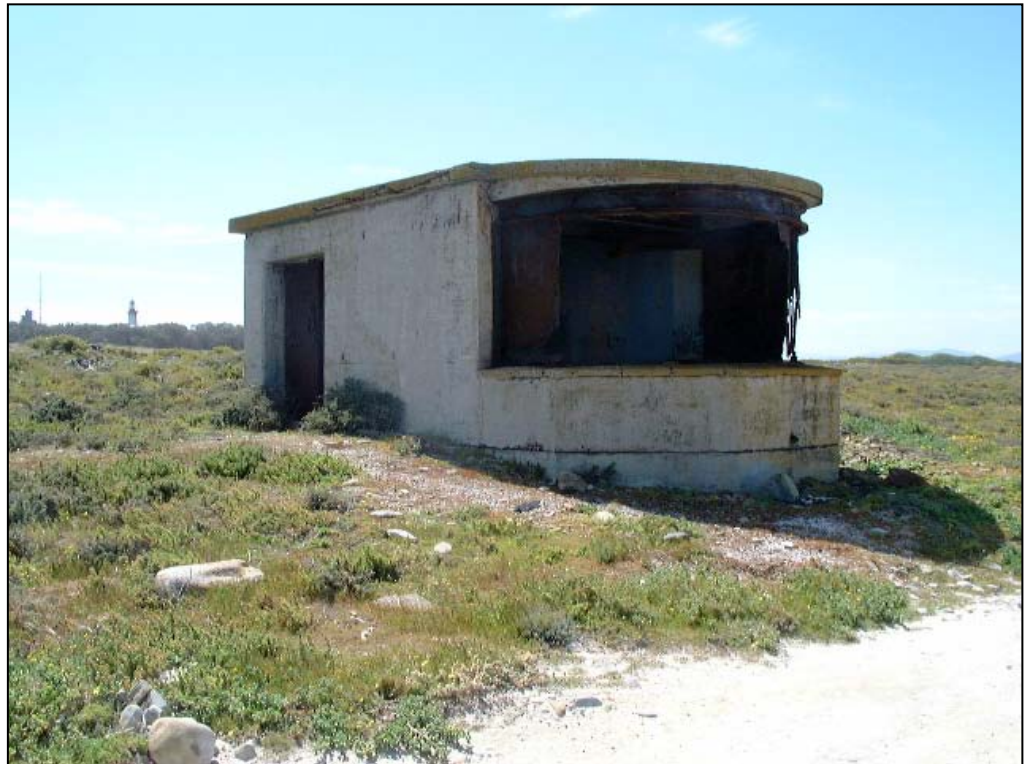
JPEG: Wpt199

DESCRIPTION: Concrete searchlight position. Front shutters have been very badly corroded; the electrical system has been stripped. Interior is painted light blue. Exterior may have originally been camouflage paint but not much of this has survived. There is a cable trench leading towards the powerhouse.

VULNERABILITY: Advanced deterioration of paintwork and metal fittings, some spalling of concrete.

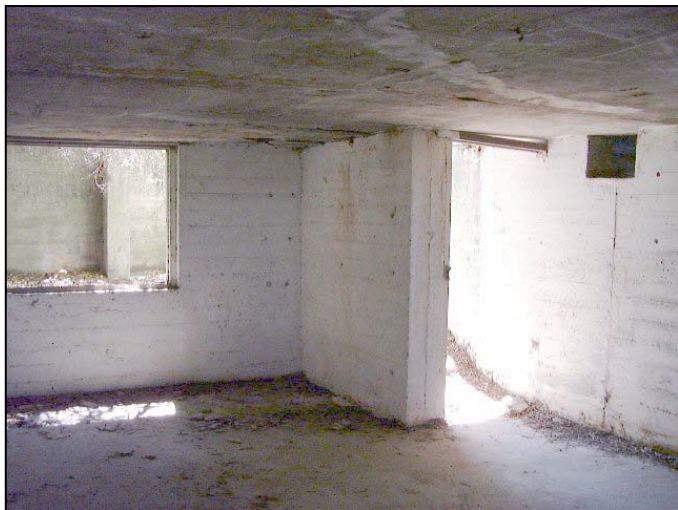
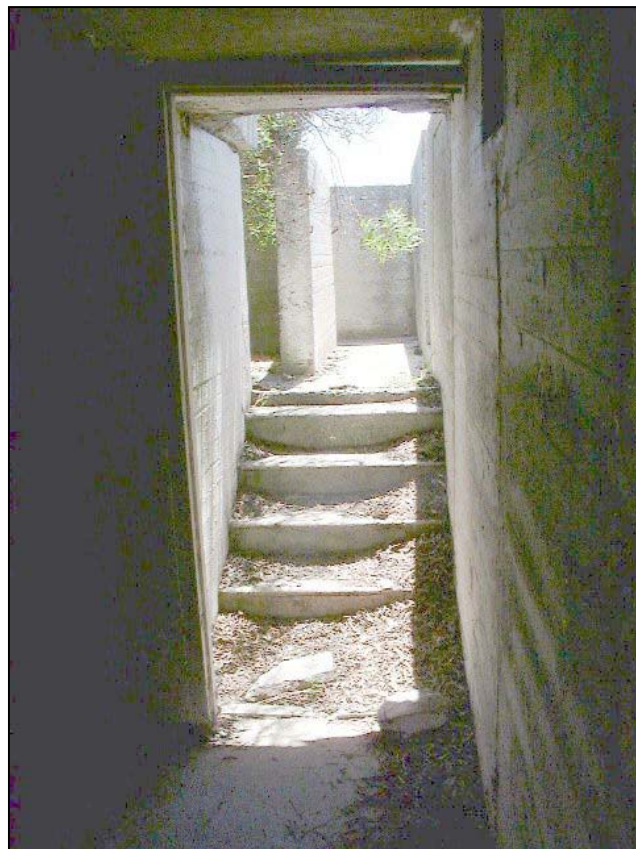
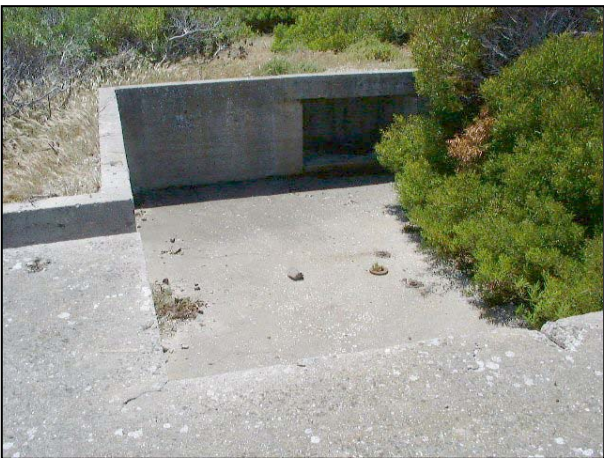
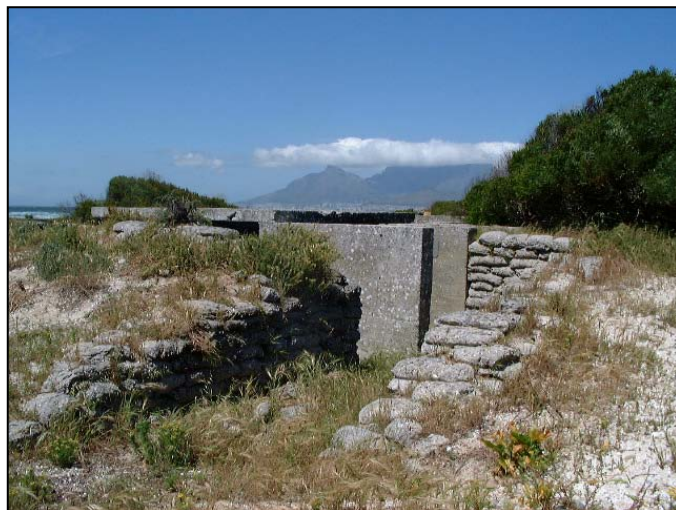
DESCRIPTION: A complex of 5 semi-buried concrete bunkers, each with a gun mounting organized round a large central bunker. Gun mountings with electrical connections are present - possibly for 40mm Bofors heavy machine guns (anti-aircraft weapons) or 3.5 inch AA. In general, more research is required to understand the role of this site in the WW2 defenses.

VULNERABILITY: Some deterioration of concrete, inundation by alien vegetation growth.

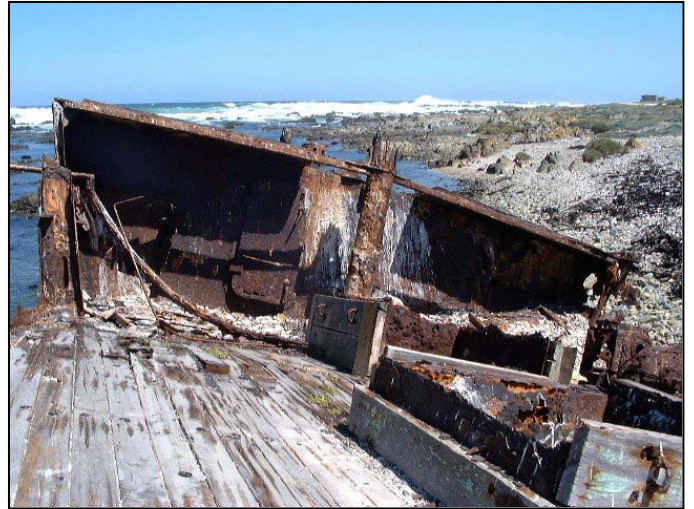
JPEG: Wpt204.

VULNERABILITY: Vessel has deteriorated (expected and inevitable) as a result of natural processes.

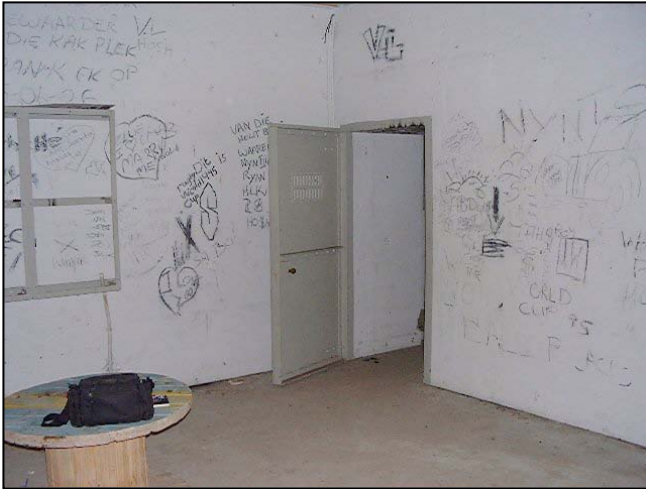
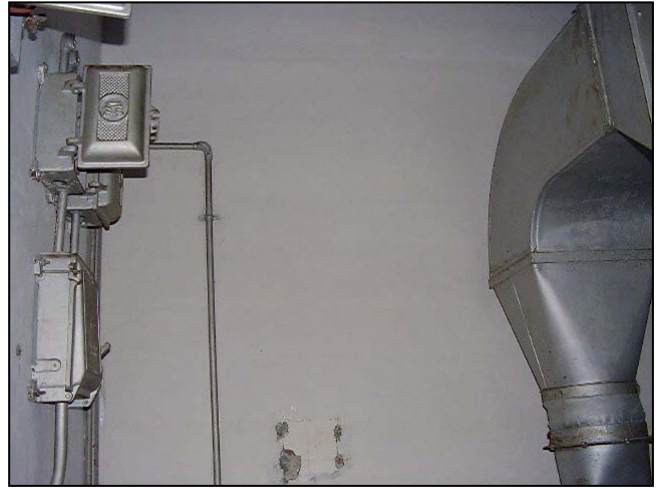
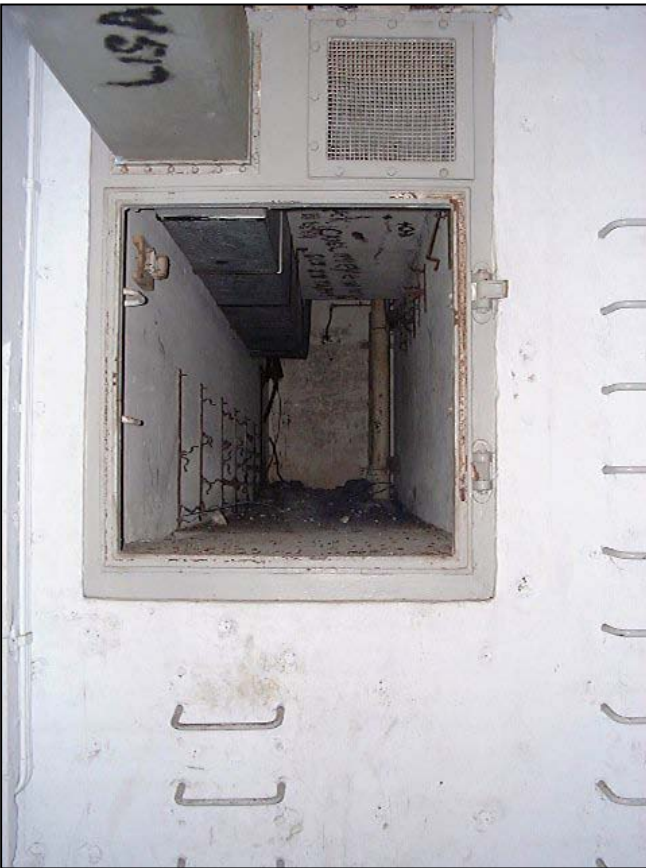
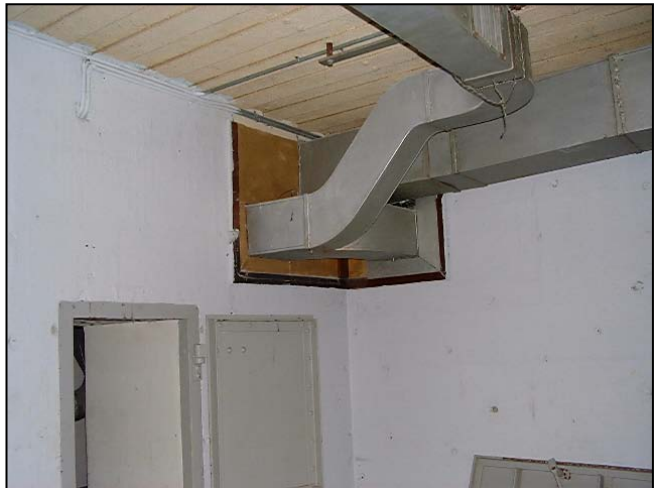
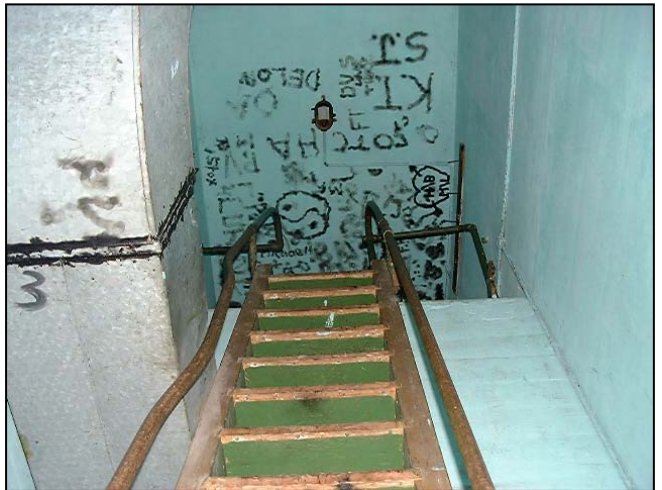
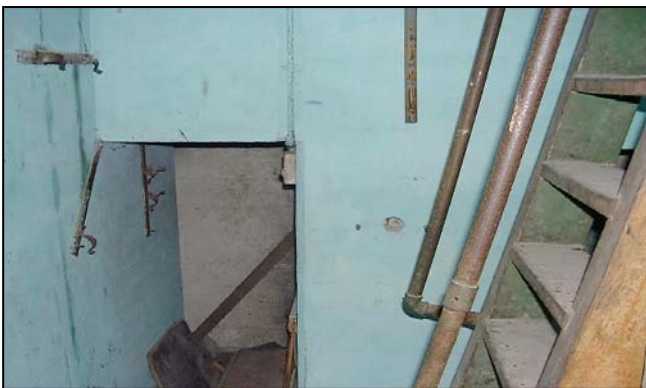
JPEG: Wpt 220a-k.

DESCRIPTION: Underground plotting room. A deeply buried WW2 bunker accessed by a series of ladders leading approximately 10m underground from a concrete and steel hatchway. The only surface indication that the bunker exists is the presence of several mushroom ventilators and the steel access hatch with steel balustrade. Below the ground surface is a complex of 4 rooms with steel doors. One of the rooms contains the air-conditioning system for the bunker – electric fans, which drew in air via ventilation shafts from the surface mushroom ventilators. Within the complex is evidence of many cable conduits for power and probably telephone connections. A most of the original fittings have been stripped. The entire underground complex is

VULNERABILITY: Slow deterioration of paintwork and metal fittings, danger of flooding without operational sump drainage system.

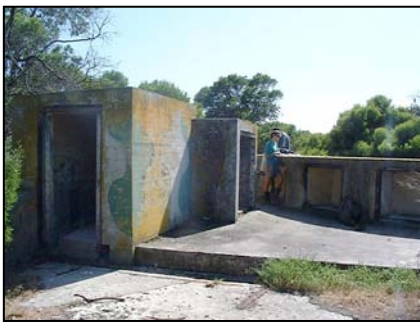
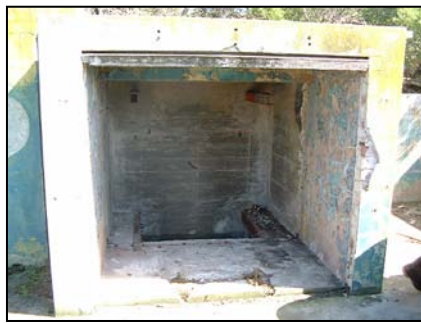
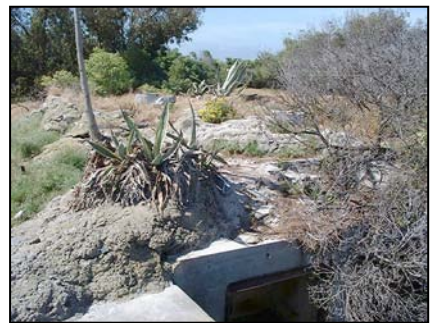
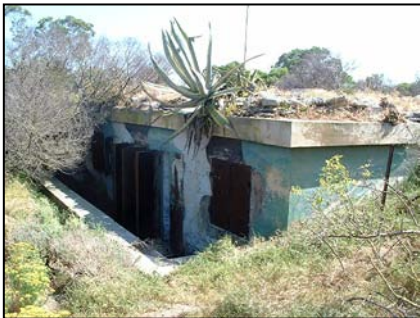
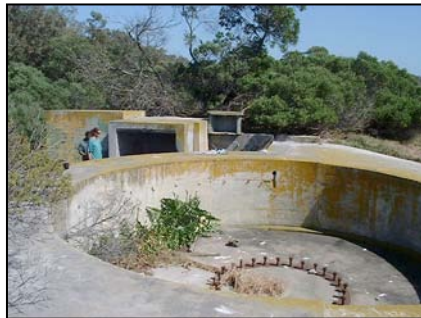
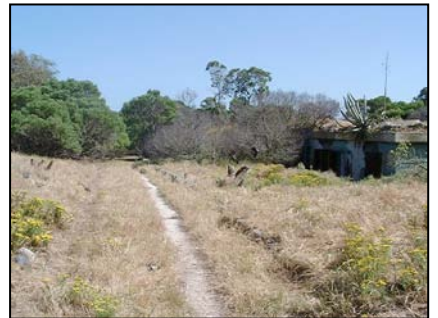
VULNERABILITY: Underground structures are subject to seasonal flooding. Camouflage paint is deteriorating, corrosion of ventilators and other steel fittings. Old garden features and paths are overgrown with alien vegetation.

Magazines: A flight of stairs provides access to underground magazine about 10m below surface. The magazine surrounded by a ground water control tunnel with a sump located close to the entrance of the magazine. Steel door leads to magazine interior where steel shell racks are still in place. Also present is shell hoist tunnel and ventilation shafts leading to mushroom ventilators on the surface. The shell hoisting equipment and electric motor has been removed as have all the bronze bolts and fixtures that were used in areas where explosive were stored. The entranceway to the magazine is presently flooded by ground water as a result of

neglect of the sump pumping system.
