PHASE 1 ARCHAEOLOGICAL ASSESSMENT OF ROBBEN ISLAND WORLD HERITAGE SITE.

April 2001

Archaeology Contracts Office

University of Cape Town

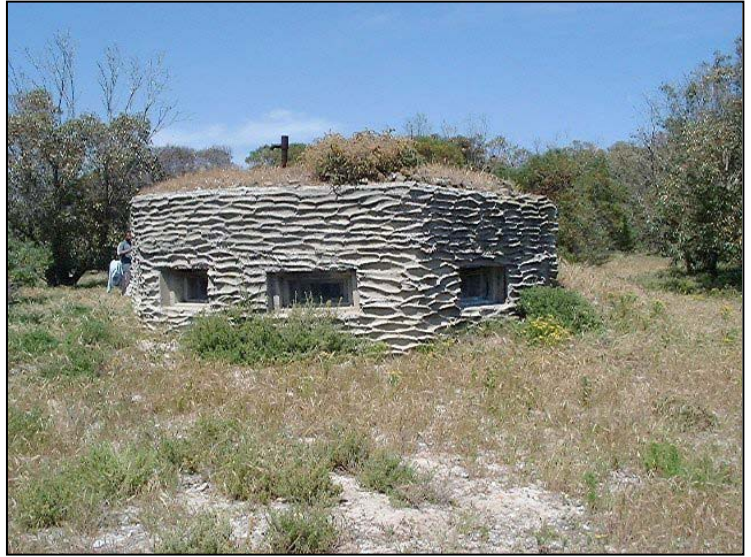
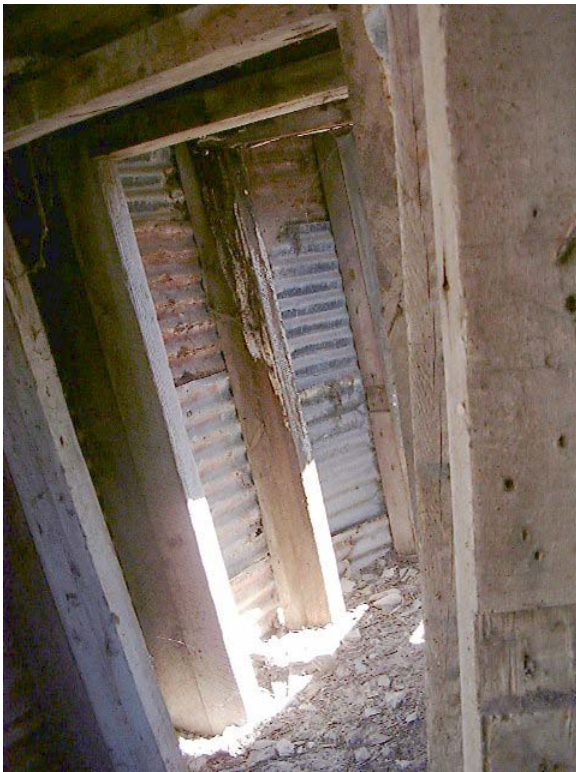
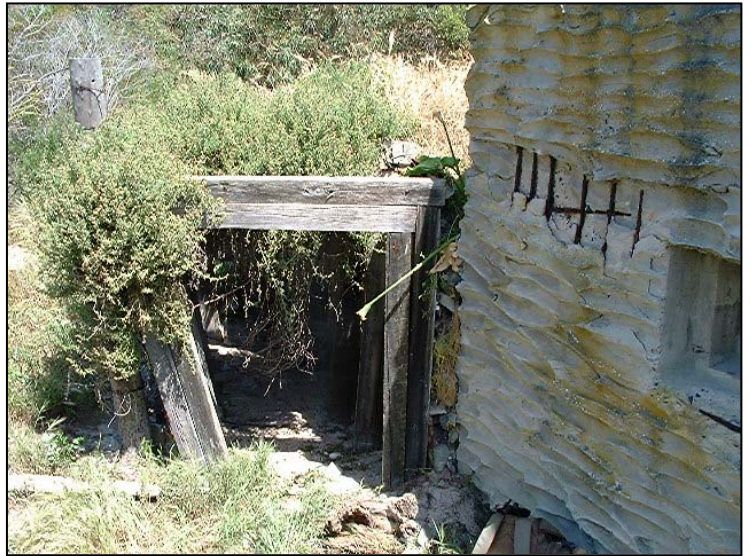
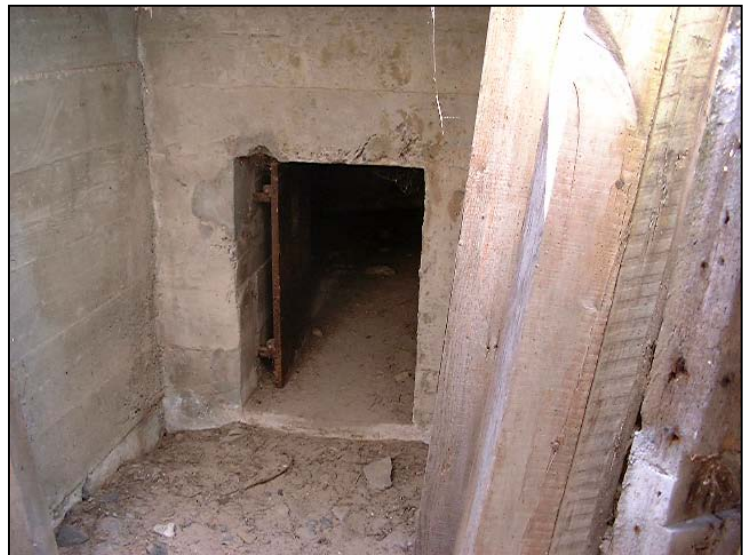
VULNERABILITY: Deterioration of metal fittings, collapse of corrugated iron and wood tunnel, accumulation of penguin guano.

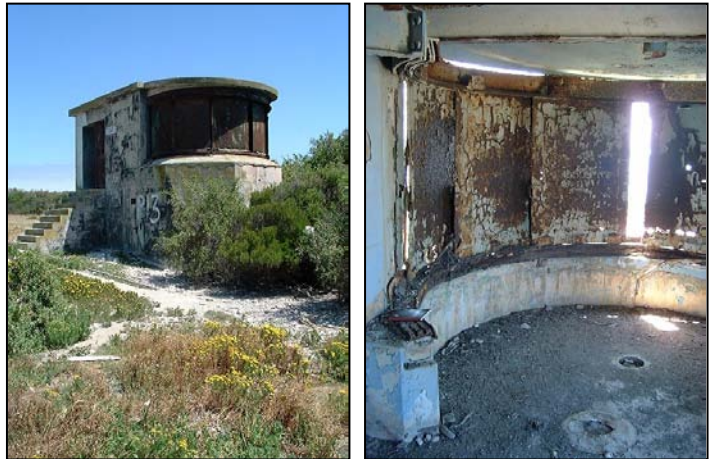
JPEG: Wpt 225a,b.

DESCRIPTION: A concrete search light position facing in a northeasterly direction over the Blouberg channel. The steel shutters are in place but highly corroded. Electrical wiring has been stripped. The exterior is painted in camouflage paint. The position is marked "P13" and "T225".

VULNERABILITY: Deterioration of metal work and camouflage paint.

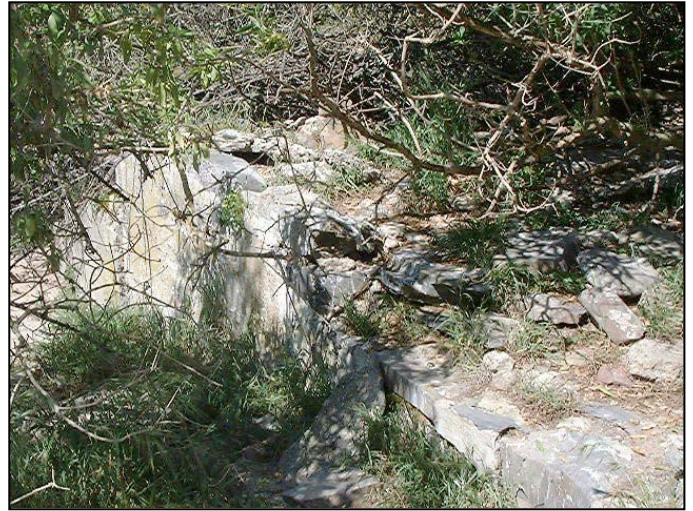
233: Collapsed shale walls, remains of an antique galvanized bucket.

VULNERABILITY: A very well hidden site in thick bush; is currently impacted by natural decay, especially tree growth and root movement.

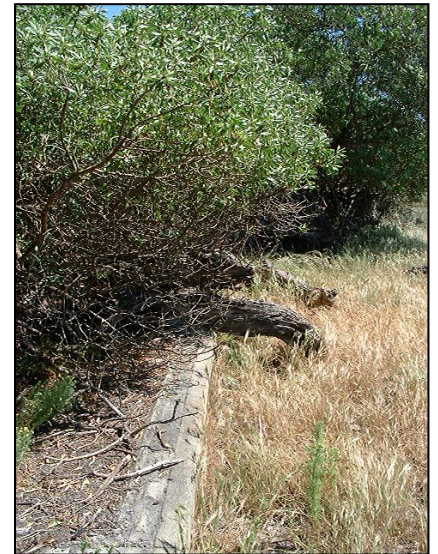
JPEG: Wpt241

DESCRIPTION: A concrete building foundation, heavily overgrown, close to a very large pine tree. Lying around are large quantities of shell. May indicate that the area was used for storing shell for lime burning.

CONTEXT: Unidentified building and possible activity to do with lime burning.

FURTHER RESEARCH: Map work and archival research may help establish identity.

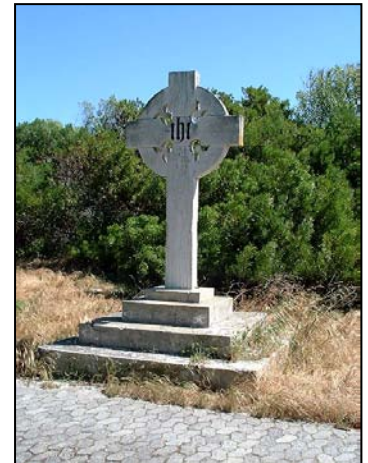
JPEG: wpt245.

DESCRIPTION: A large wooden Celtic cross close to the staff cemetery.

FURTHER RESEARCH: Archival, oral history.

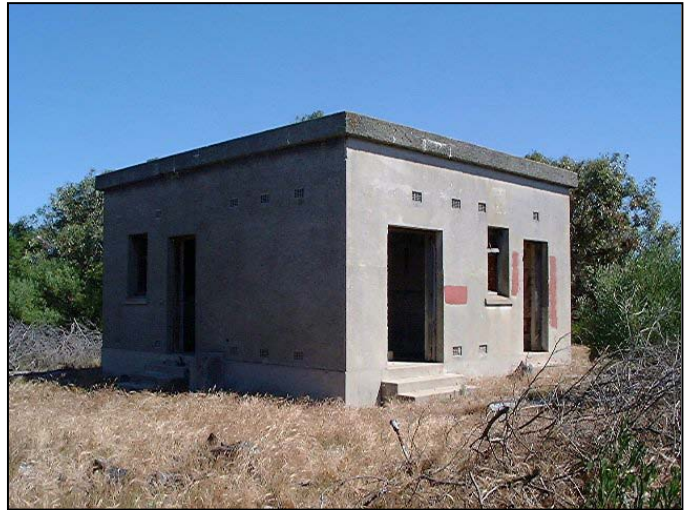
JPEG: Wpt248.

VULNERABILITY: A seldom visited structure that appears to be well preserved. Metal components are corroding and vegetation is encroaching.

FURTHER RESEARCH: Oral history may be of assistance, however, it must be borne in mind that certain WW2 facilities were highly classified and information is difficult to come by today.

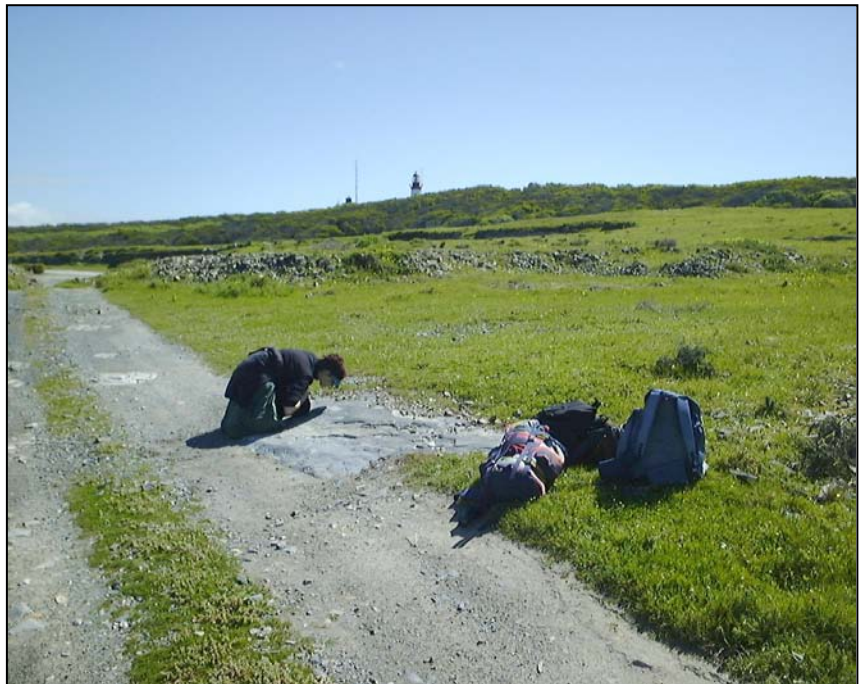
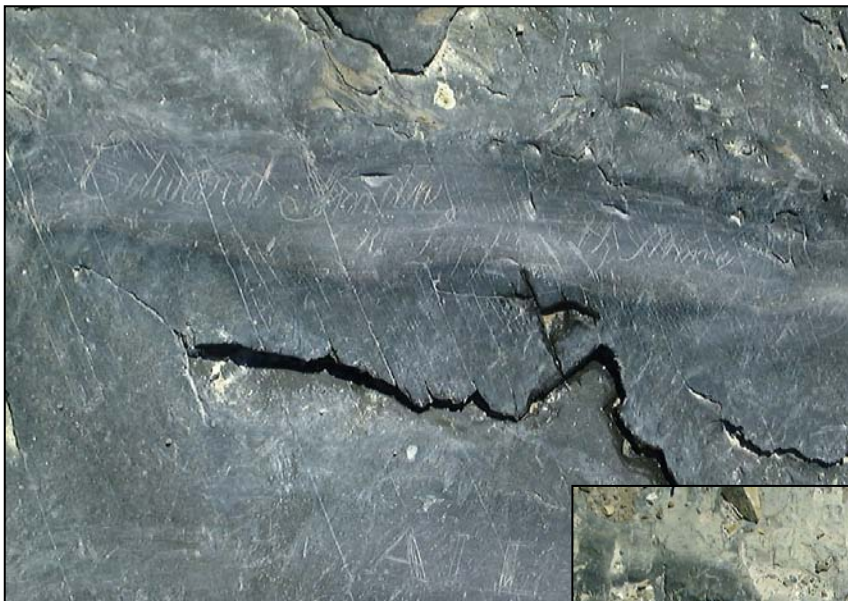
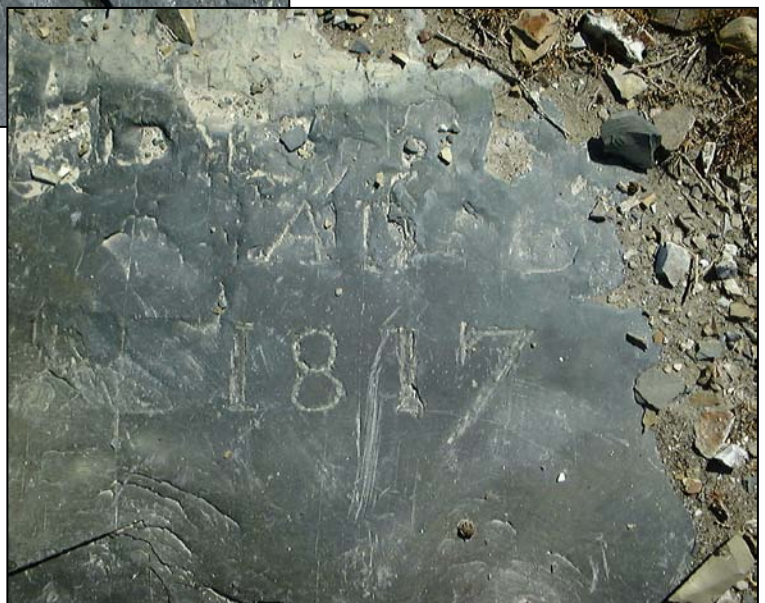
JPEG: wpt301a-c

DESCRIPTION: A slab of smooth shale, which partially lies in the access road to the quarry. This is covered with 18th and 19th century inscriptions (1745 - 1818), some of which are very faint. There are likely to be more inscriptions on parts of the rock that are currently buried under shallow overburden. The exposed parts of this site are under immediate threat as it lies in a road leading into the quarry used by tourist busses. Vos first recorded the site in 1987. Illustrations in his report indicate that deterioration of the inscriptions has taken place over the last 10 years

VULNERABILITY: This site has degenerated despite recommendations for mitigation. Tour busses continue to drive over the site and erode away the graffiti. Some aspects that were visible in 1998 are no longer discernable. Access road must be closed.

FURTHER RESEARCH: Area should be excavated (more graffiti under loose sand) and graffiti recorded in detail.
